Insight Rebuilding Houston "Wash and Wear Buildings"

By Joseph W. Lstiburek, Ph.D., P.Eng., Fellow ASHRAE

Rebuilding Houston

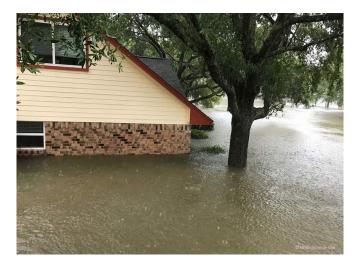
Photograph 1: "Black Water" Extreme Event – The problem with flood damaged buildings is that the damage is done by dirty water. Everything imaginable and unimaginable is in flood water. Photograph courtesy of Dave Yelovich.

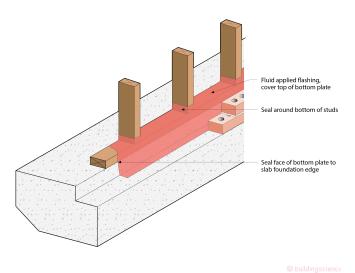
Figure 1: Fluid Applied Flashing - The intent is to turn the bottom plate of the existing frame wall into a pan flashing. The fluid applied flashing should completely cover the top of the bottom plate and seal upwards around each stud. The fluid applied flashing needs to run down the exterior face of the bottom plate and seal to the seat in the concrete supporting the brick veneer. There will probably be a "jog" or an "offset" at the intersection of the bottom plate and the upper corner of the seat in the slab depending on whether the original wall sheathing (now removed) lined up with the seat or was framed to overlap the seat.

Now apply a fluid applied flashing to the bottom of the wall (**Figure 1**). The intent is to turn the bottom plate of the existing frame wall into a pan flashing. The fluid applied flashing should completely cover the top of the bottom plate and seal upwards around each stud. The fluid applied flashing needs to run down the exterior face of the bottom plate and seal to the seat in the concrete supporting the brick veneer. There will probably be a "jog" or an "offset" at the intersection of the bottom plate and the upper corner of the seat in the slab depending on whether the original wall sheathing (now removed) lined up with the seat or was framed to overlap the seat.

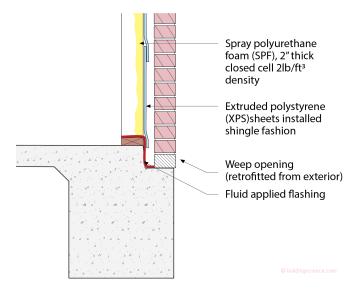
Figure 2: Extruded Polystyrene Sheathing - A thin flexible sheet of extruded polystyrene (XPS)...3/8 inch... is installed shingle fashion between the brick veneer and the exterior face of the studs. The sheathing is installed shingle fashion and overlaps the exterior of the bottom plate.

Two approaches can now be used. The first involves a thin flexible sheet of extruded polystyrene (XPS)...3/8 inch...that is installed shingle fashion between the brick veneer and the exterior face of the studs (**Figure 2**). The XPS is "wedged" in place with XPS wedges at stud locations (**Figure 3**). The thin flexible XPS sheet is "fished" in behind the studs with the wedges holding it in place. That is why the brick ties needed to disappear. The XPS sheet needs to be limited in height to probably no more than three feet to allow the wedges to be "smushed" into place from the top downwards. The wedges are only temporarily needed. The "attachment" of the XPS sheathing is accomplished with spray polyurethane foam (SPF) of the closed cell "flavor" (**Photograph 6** and **Figure 4**).

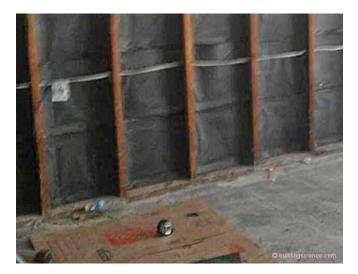
Photograph 7: Drainage Mat – The drainage mat is installed directly against the interior of the brick veneer...with the filter fabric facing inwards. Photograph courtesy of Joseph Pauwels.

The second approach involves installing a drainage mat with a filter fabric directly against the interior of the brick veneer...with the filter fabric facing inwards (**Figure 5**, **Figure 6** and **Photograph 7**). This approach eliminates the need for the "wedges"...but it requires the use of a thicker layer of SPF. The SPF needs to "catch" the stud cavity, filling it at least 3 inches thick in order to provide the racking resistance. Once again, we have to coat all of the interior surfaces with acrylic latex paint prior to the installation of the interior gypsum board.

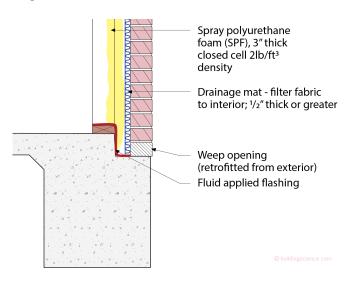
Figure 5: Drainage Mat – A drainage mat with a filter fabric is installed directly against the interior of the brick veneer...with the filter fabric facing inwards. This approach eliminates the need for the "wedges"...but it requires the use of a thicker layer of SPF.

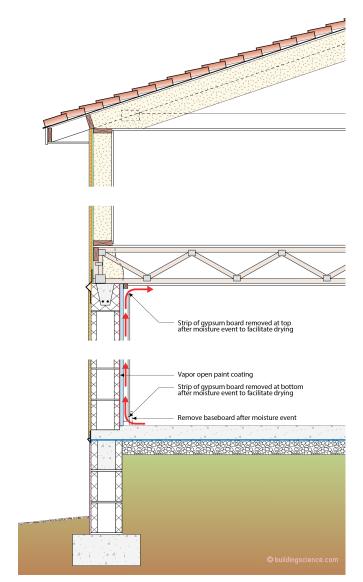
Figure 9: Best Way to Build - You need to build up. And you should build the first floor out of concrete block. And then drop a second floor on top of that out of wood frame. Note the use of a vapor open coating on the inside face of the concrete block to facilitate the wash, rinse and dry cycle. For sure with "black water" you will have to discard the interior gypsum board. But with just hurricane "rain wetting" the drying thing becomes easy.

You need to build up. And you should build the first floor out of concrete block. And then drop a second floor on top of that out of wood frame (Figure 9). Welcome to Florida construction. It would work great in Houston...or anywhere it floods. The only add to Figure 9 in the over 10 years since I first drew it for the Katrina rebuild is the addition of a vapor open coating on the inside face of the concrete block to facilitate the wash, rinse and dry cycle. For sure with "black water" you will have to discard the interior gypsum board. But with just hurricane "rain wetting" the drying thing becomes easy. I know this because buildings built this way had absolutely no issues after Hurricane Irma. Naples, Fl was hit with sustained 140 mph winds and the new houses laughed it off. A few tiles blew off. Almost every window leaked. But, things were dried quickly and Naples is back in shape. The trees did not fare well, but the new buildings worked just fine5.

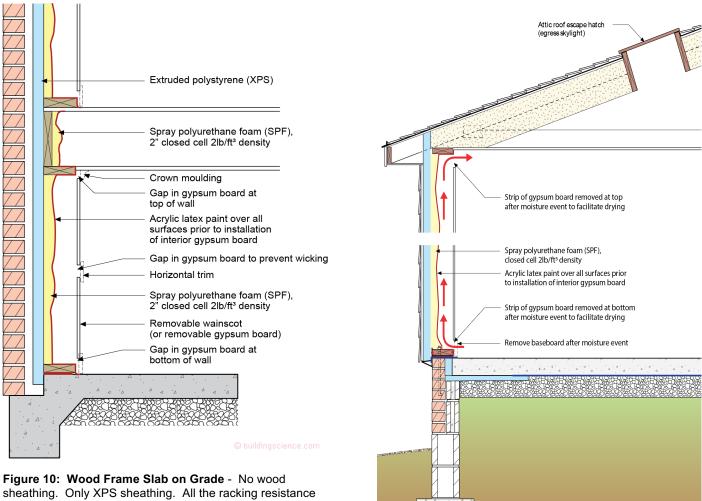
sheathing. Only XPS sheathing. All the racking resistance comes from closed cell SPF. Everything is painted on the interior prior to installation of the interior gypsum board. There is horizontal trim half way up the wall on the interior....if you get lucky you will only have to trash half the wall because the water does not rise up too high. Note the crown molding gap and the baseboard gap to facilitate drying. Sure you don't want to build up higher?

OK, yeah, I know, you are not going to build up.... An old engineer can dream can't he? And you are not going to build out of concrete block. OK. **Figure 10** is the best we can do. No wood sheathing. Only XPS sheathing. All the racking resistance comes from closed cell SPF. Everything is painted on the interior prior to installation of the interior gypsum board. There is horizontal trim half way up the wall on the interior....if you get lucky you will only have to trash half the wall because the water does not rise up too high. Note the crown molding gap and the baseboard gap to facilitate drying. Sure you don't want to build up higher?
