# Public Housing Breaks the Mold Part II: Veterans Era Housing

In Part I, we discussed the particular moisture- and air guality-related problems of midrise housing, and we took a close look at two cases. Here we explore issues unique to Veterans **Era Housing and** present three cases where moisture problems were successfully addressed.

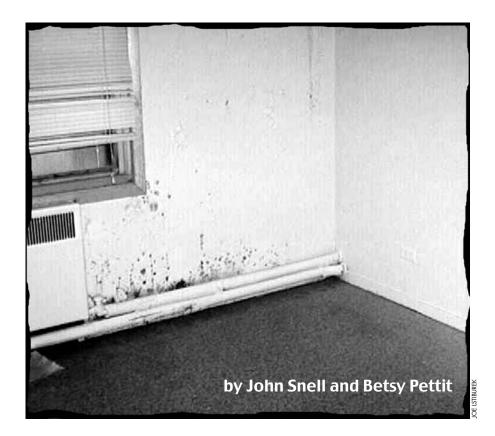
Mold growth on exterior walls was one of the most visible symptoms of moisture problems at this Cleveland Housing Authority apartment.

Investigators concluded that high interior moisture levels, due to inadequate ventilation and to high moisture source strength, caused the sensation of dampness. They also decided that the mold and mildew, window condensation, interior paint damage, and plaster damage were caused by high interior moisture levels combined with cool surfaces.

The recommended solution was to reduce interior vapor pressure and to increase internal air flow.

**Reduce interior vapor** pressure. Installing controlled mechanical ventilation in each apartment would dilute interior moisture and other pollutants.We recommended installing exhaustonly ventilation to provide approximately 15 CFM per occupant, extracting air from the washrooms and stairwell/hallway areas, and exhausting this air to the exterior via ductwork.Ventilation should operate continuously in order to maintain interior moisture levels between 30% and 45% relative humidity at  $72^{\circ}$ F during the winter months.

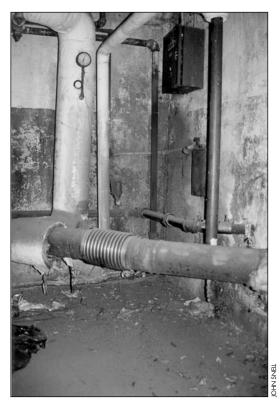
The 50-year-old steam heating distribution system was at the end of its life expectancy.

Repair water leaks. We recommended replacing the failed underground steam heating distribution system with individual gas-fired, high-efficiency distributed forced hot water heating and DHW systems, one per building. We also recommended installing lowvolume toilets and other measures to help pay for the cost of repairing or replacing the leaking potable water and heating system piping with additional water cost savings. Water meters should be read regularly to monitor the consumption at West Broadway. Future water leaks should be identified and repaired quickly.
