Forensic Engineering Practice Lessons

Case Study of a Multi Building Cladding Failure
in New Zealand

Brian Hubbs, P.Eng.
Principal, RDH Building Science Inc.
bch@rdh.com

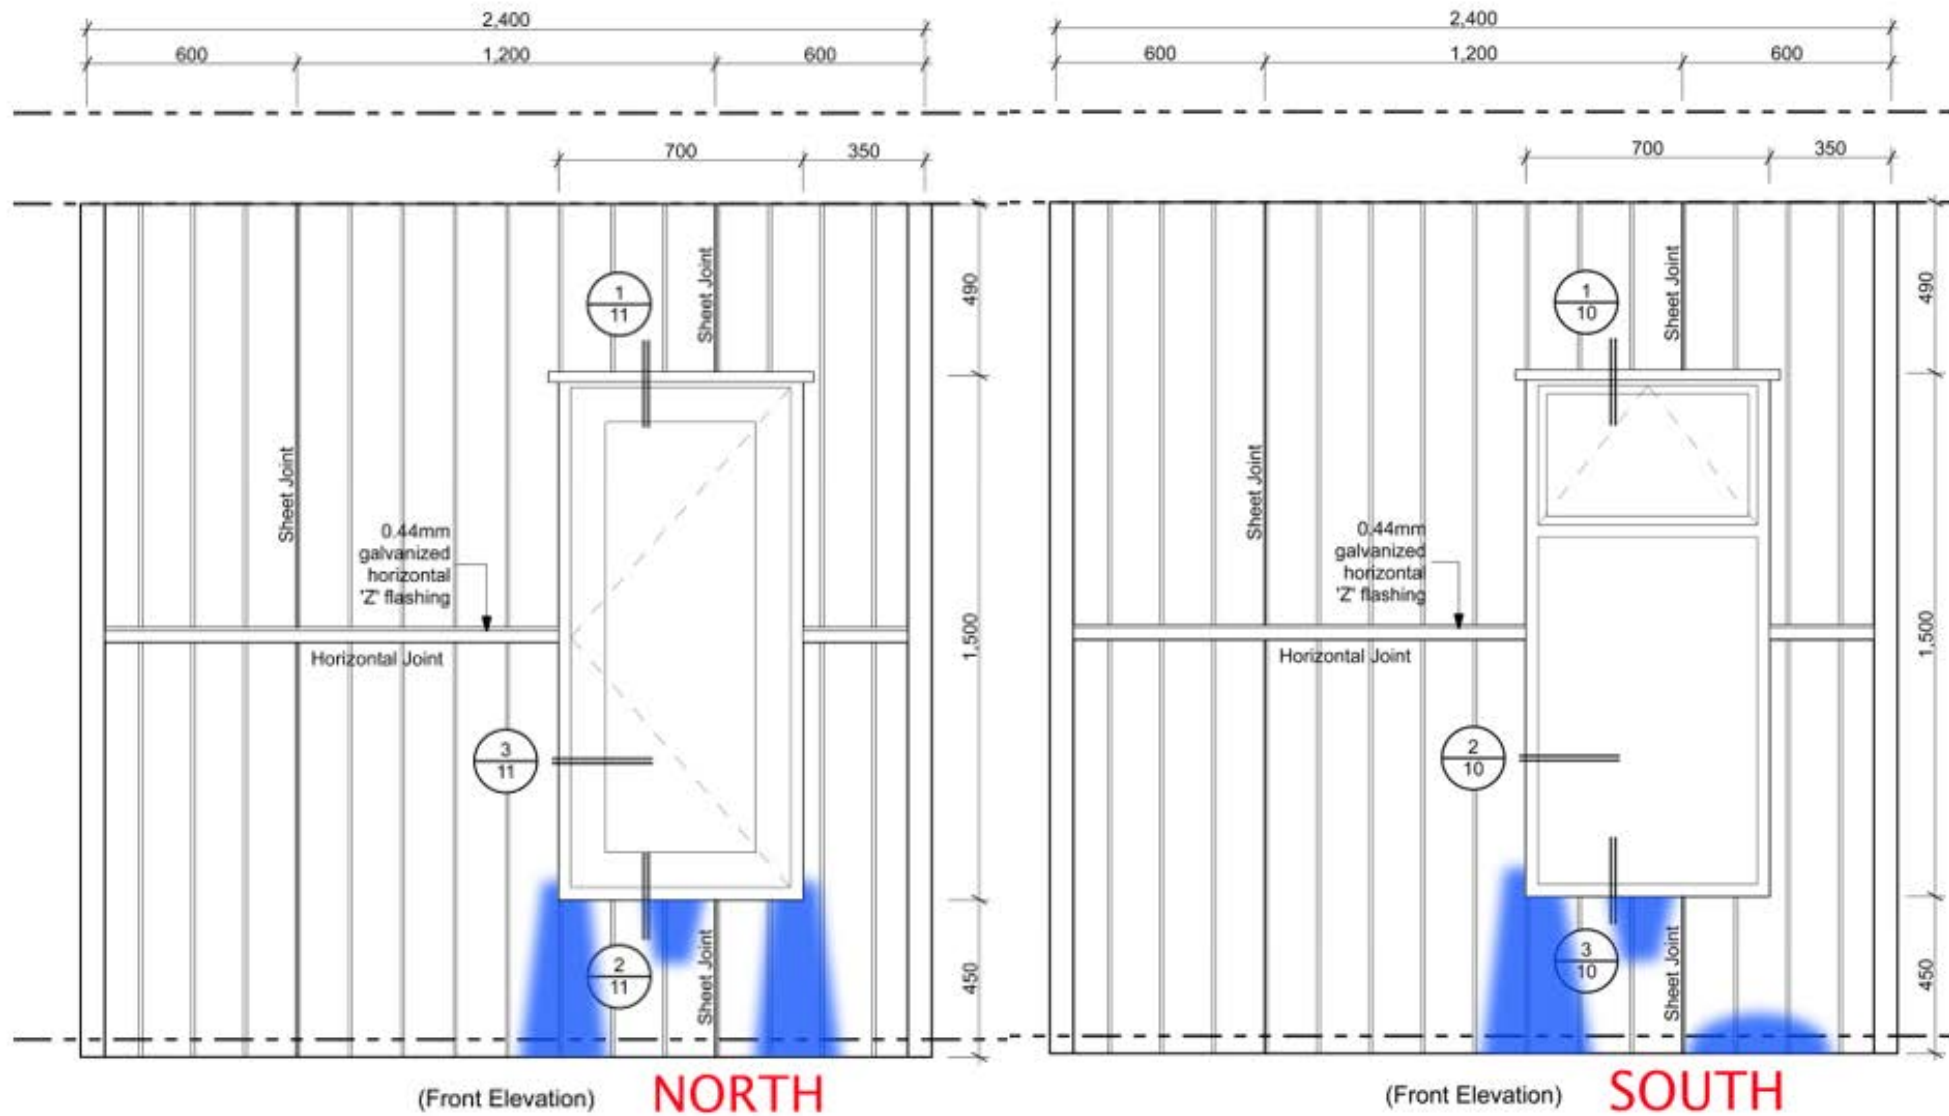
Figure 17.11 Test hut North and South walls, exterior view, leaking from façade testing

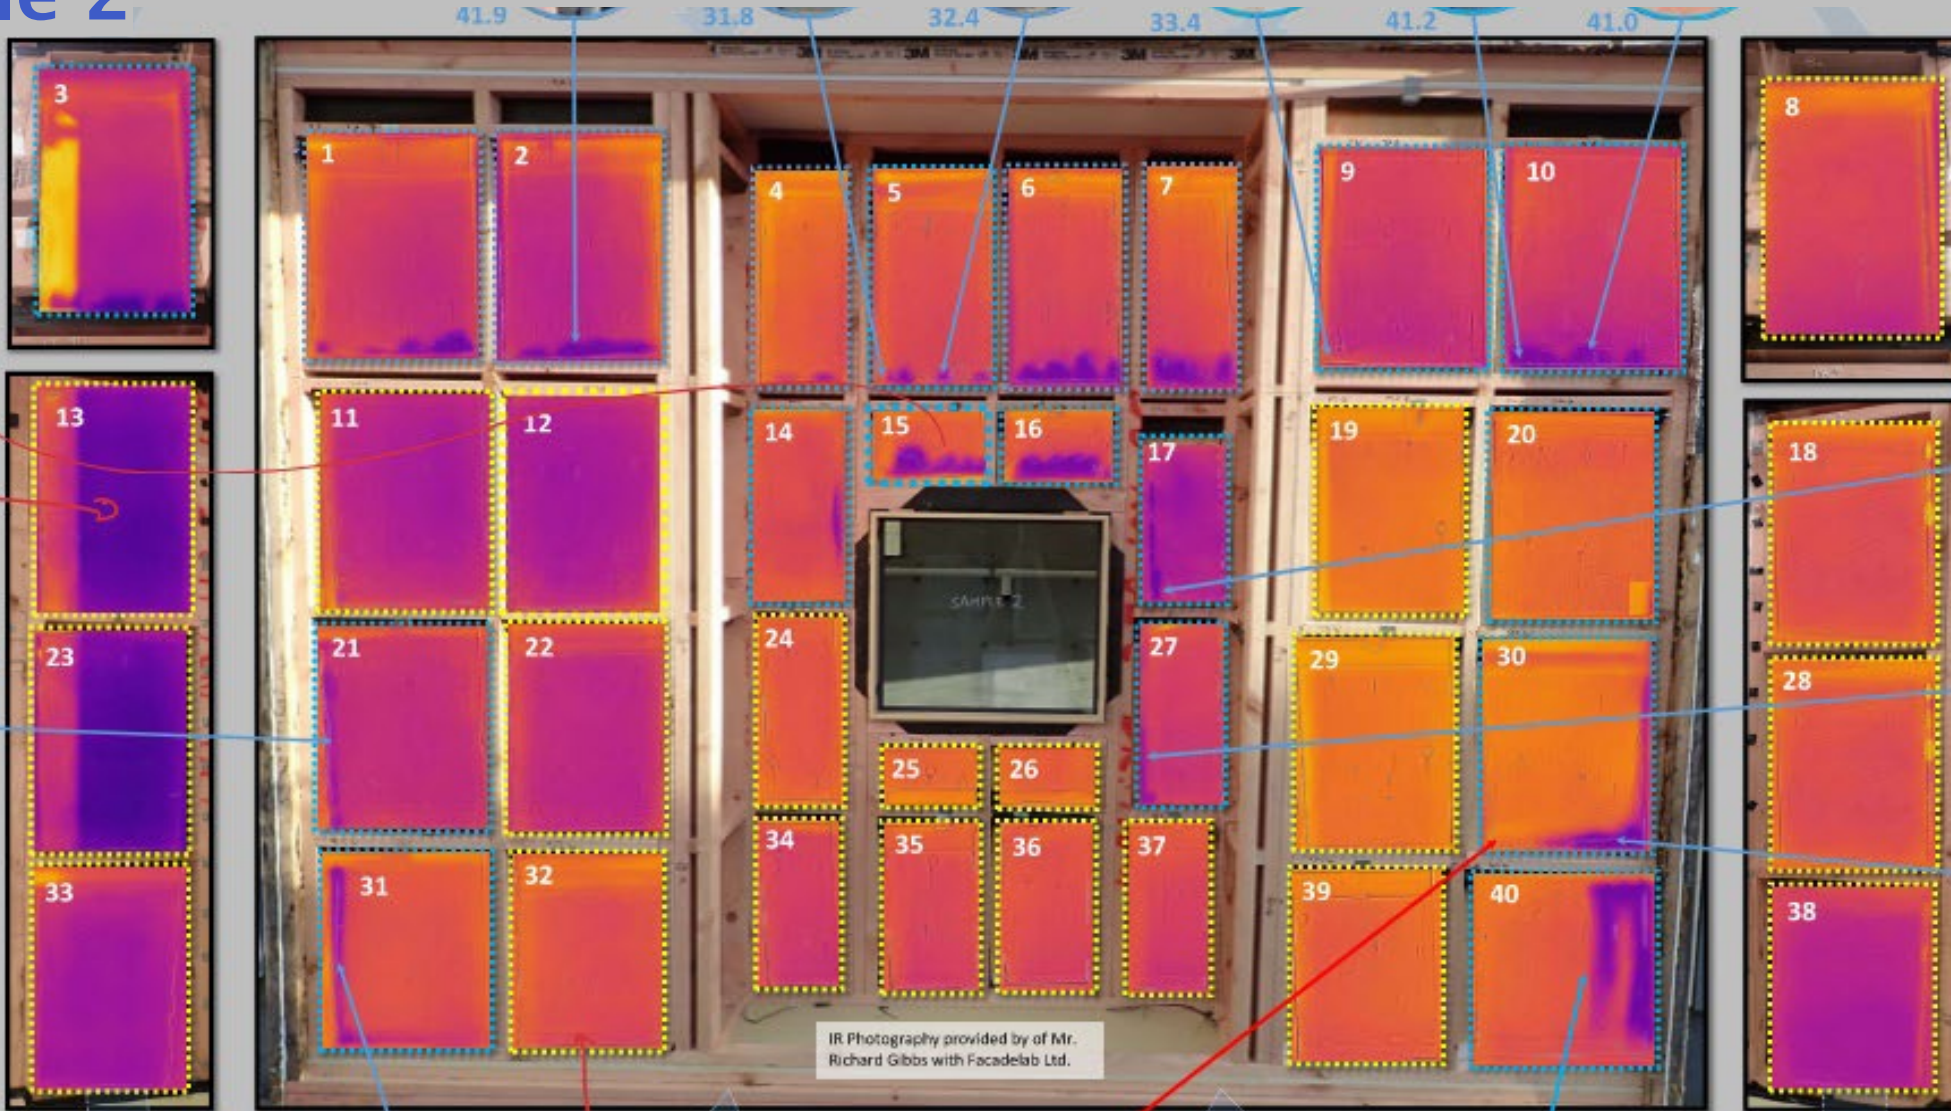
Defendants Report -Thermographic scan after water testing Sample 2

NOTE: Moisture in plywood panels 1 through 10, 14 through 17 and 27 are as a result of the water spray and test pressures applied during AS/NZS 4284 Testing.

These anomalies are where they did not remove B.P.
