Air Pressure and Building Envelopes

Research Report - 0995

Joseph Lstiburek

Joseph Lstiburek, Principal, Building Science Corporation, Westford, MA

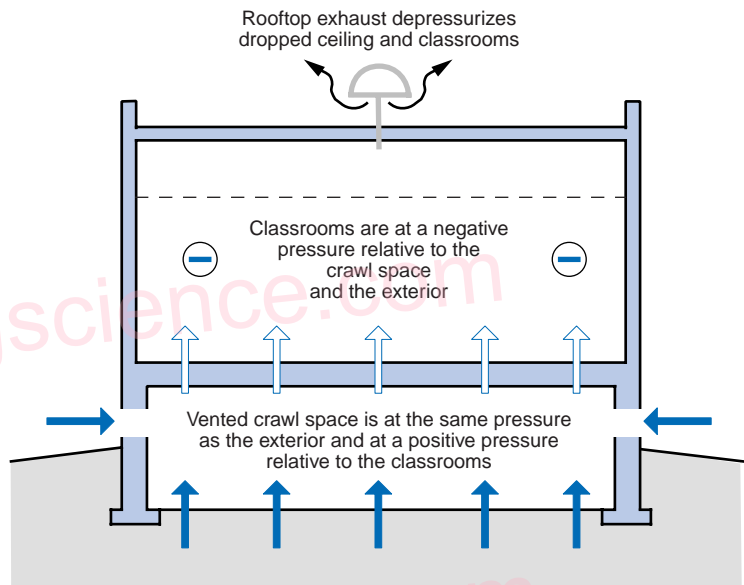
Problem Pressure Relationship

micromanometer indicated that the classroom was operating at 4 Pascal's negative with respect to the crawl space (Figure 1). Furthermore, interior wall cavities were found to operate at 1 Pascal negative with respect to the classroom.

- The classrooms in this school operate at a negative pressure with respect to the crawl space

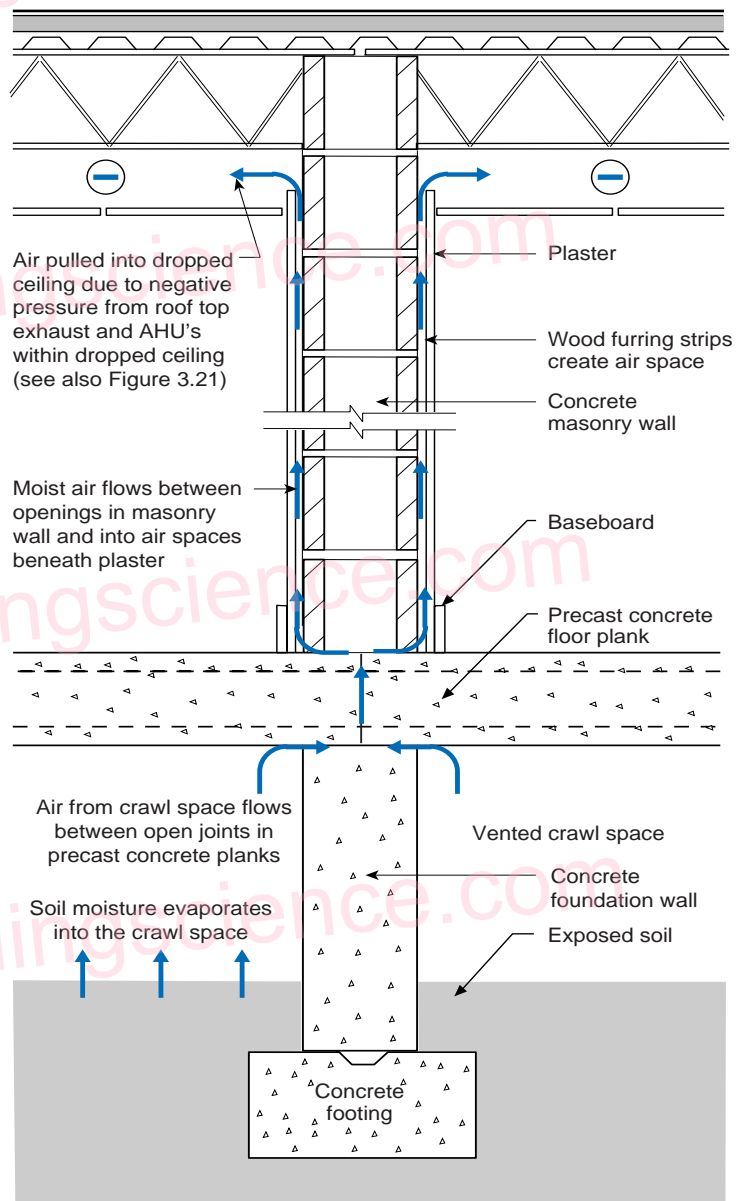
Figure 2

Moisture (the primary pollutant) in the soil in the crawl space is evaporated due to the elevated temperatures in the crawl space. Warm moisture saturated air migrates through openings in the floor slab into the air space created by the plaster and wood furring (the pathway). The air is pulled into the air space between the plaster and wood furring as a result of the operation of the roof top exhaust fans and the operation of the air handling units (the pressure "drivers"). The moisture saturated air cools once it is in the furring space leading to condensation and saturation of the building materials at this location. The saturation of the building materials leads to their deterioration and the creation of odors and other biological agents (the secondary pollutants). These secondary pollutants enter the classroom and come in contact with the teacher and students (the receptors).

Moisture Movement

- This wall section illustrates moisture movement from the crawl space into the wall cavities and dropped ceiling

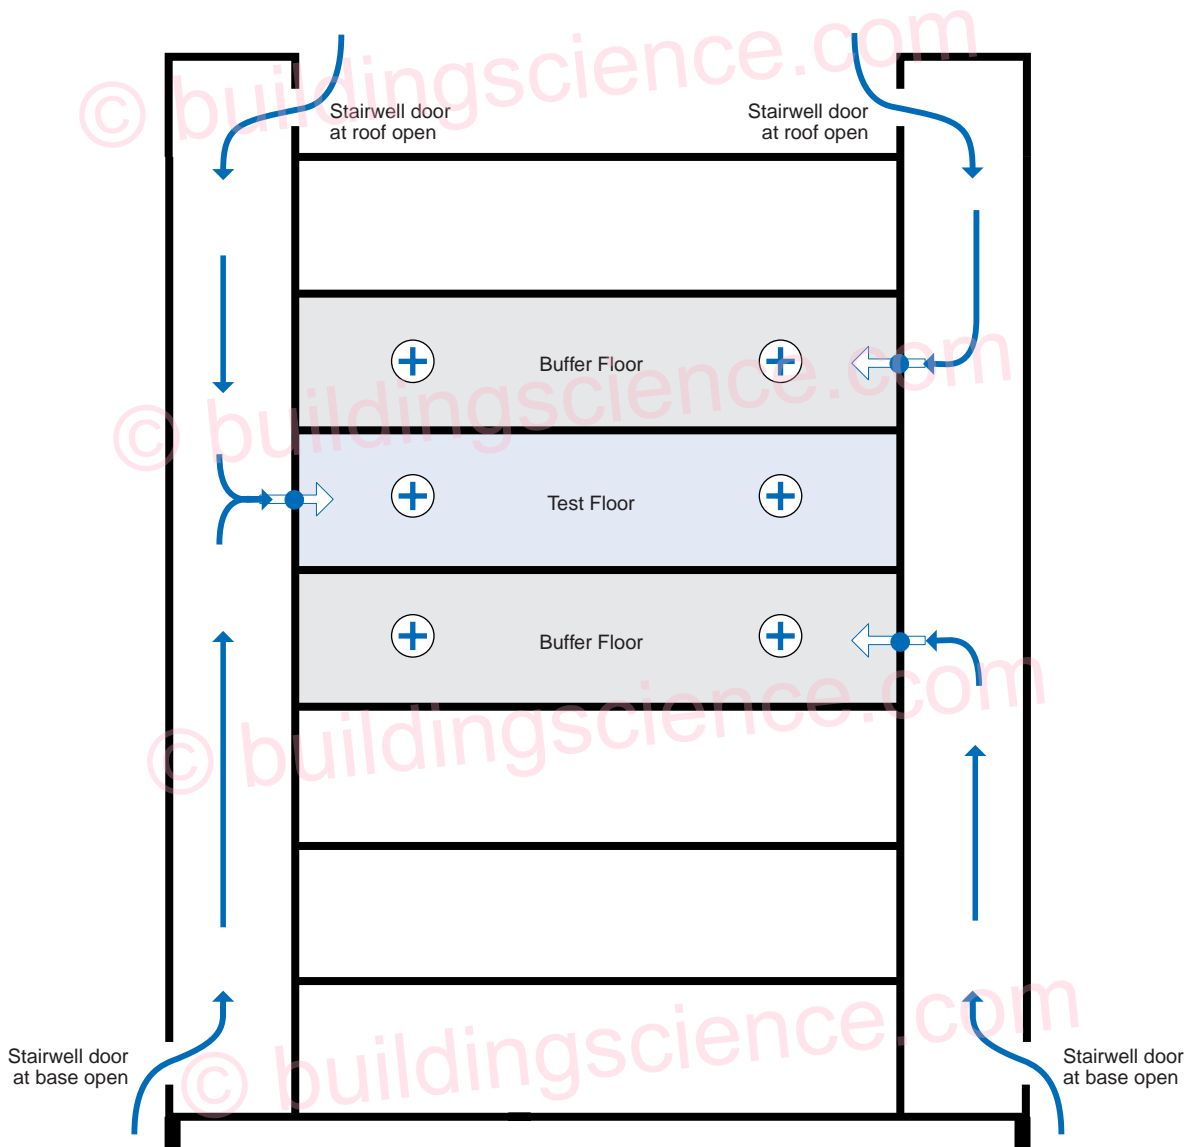
Figure 6
Air Leakage Test Zones

Leakage testing of individual floors was conducted using variable speed pressurization fans. Two types of measurements were taken. The first involved pressurizing an individual floor by extracting air from a stairwell whose exterior doors were opened to the exterior. The floors above and below the floor being tested were maintained at exterior pressure by opening all windows and corridor doors. The second type of measurement involved pressurizing the floors above and below the test floor as well as the elevator shafts to identical pressures to the test floor thereby providing isolation of test floor leakage to floors above and below. The experimental set-up is presented in Figure 6.

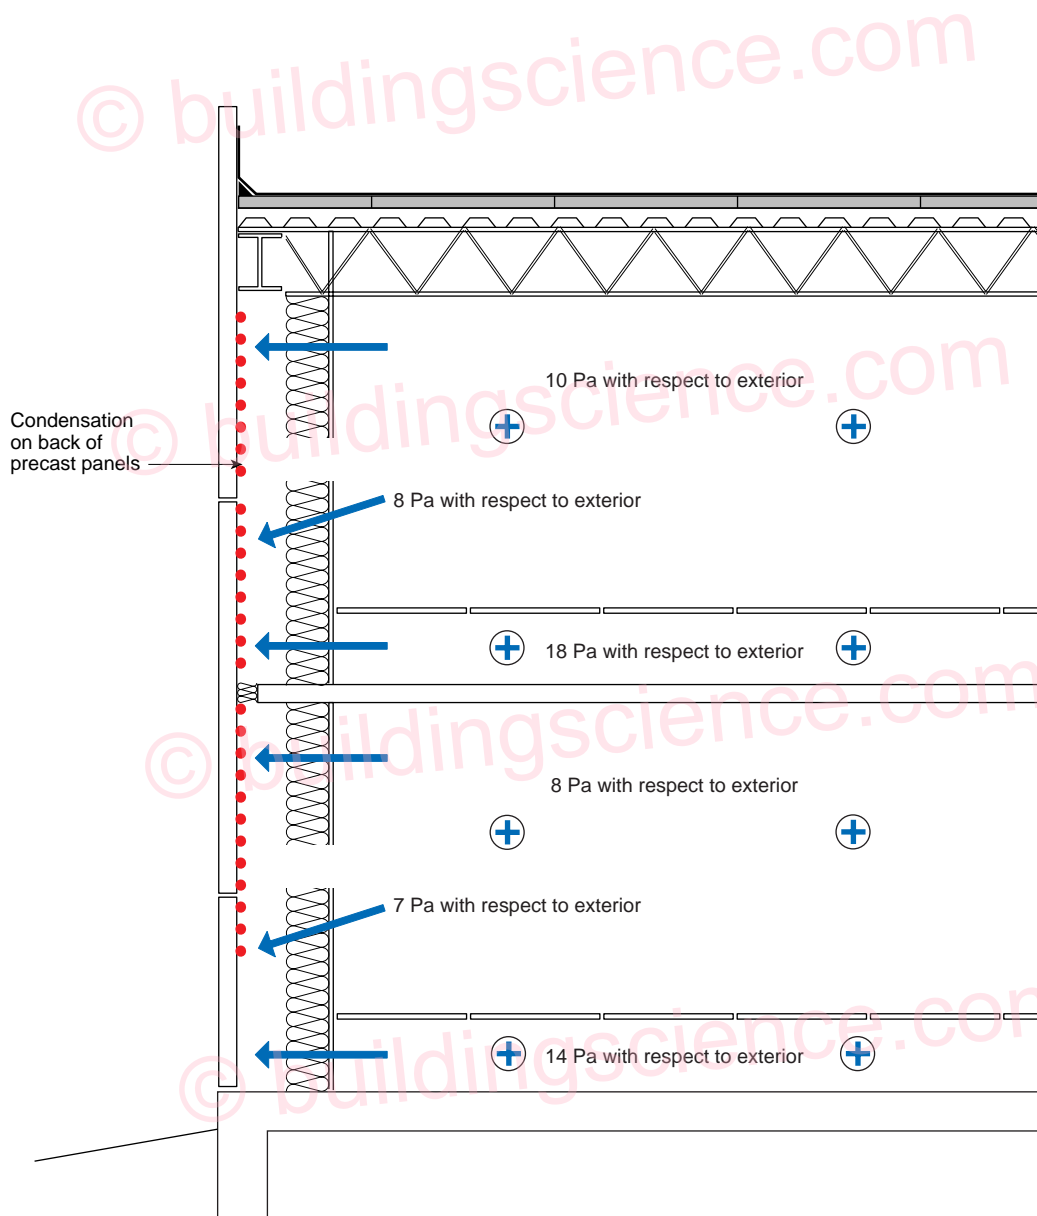
Figure 11
Unintended Pressurization of Interstitial Cavity

Air pressure differential measurements of the facility and interstitial cavities ("pressure mapping" of the facility) were taken when exterior temperatures were approximately 15 degrees C. Wind conditions were dead calm. The air pressure differential relationships as measured are presented in Figure 11.

The pressurization of both the occupied space and the area under the raised floors leads to the exfiltration of interior moisture laden air into the interstitial cavities between the precast panels and the interior insulated steel stud walls.

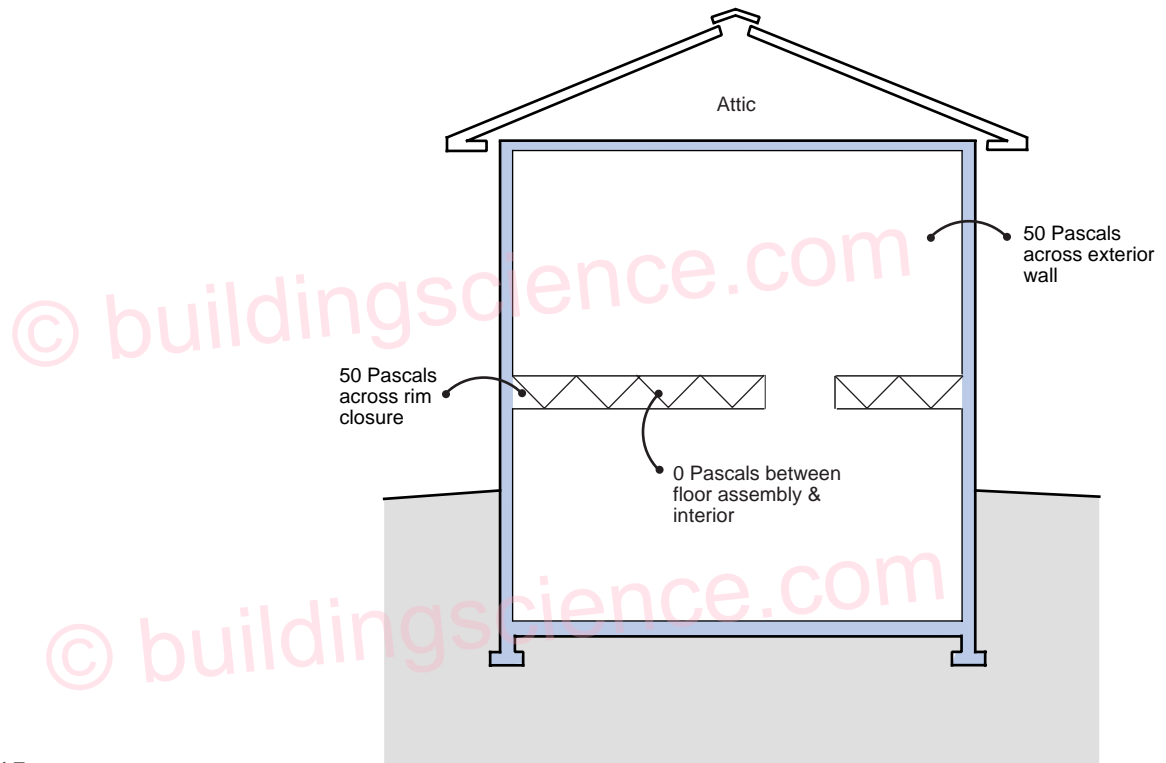
Figure 15

A similar approach was used to determine leakage between floor assemblies and the exterior. In Figure 15, a more complex building envelope is depressurized 50 Pascal's relative to the exterior. This building envelope describes a two story building with a floor assembly separating the two stories. An open stair well connects the two stories. The floor assembly is constructed from open webbed floor trusses creating a floor plenum. If the interior of the building is depressurized 50 Pascal's relative to the exterior, and if the floor assembly is "inside" the building, no air pressure difference should exist between the floor assembly and the interior.

Tight Rim Closure

- Floor assembly “inside” well-defined pressure boundary
- Pressure boundary continuous at rim closure

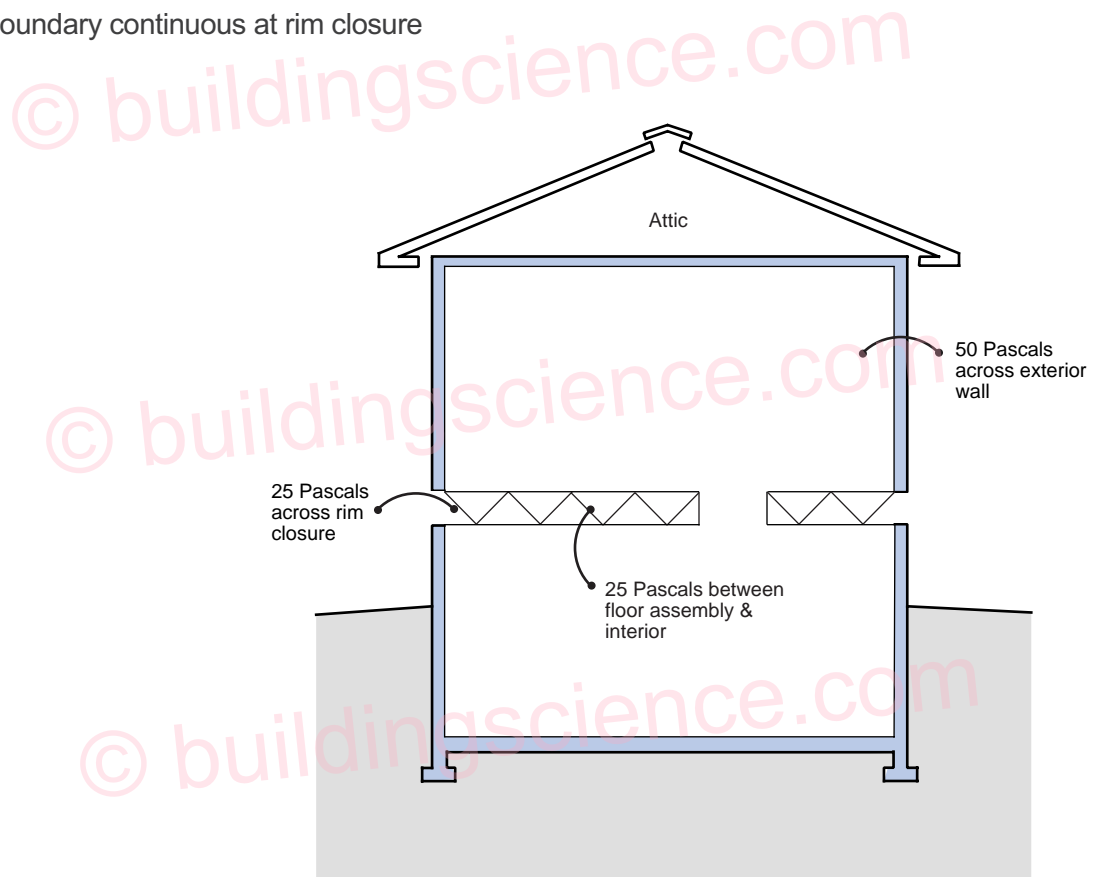
Figure 16

Leaky Rim Closure

- Floor assembly “outside” pressure boundary
- Pressure boundary not continuous at rim closure
