# BSC Information

*What's Wrong With This Project?*

## Inset Flanged Window

## Sheet 702

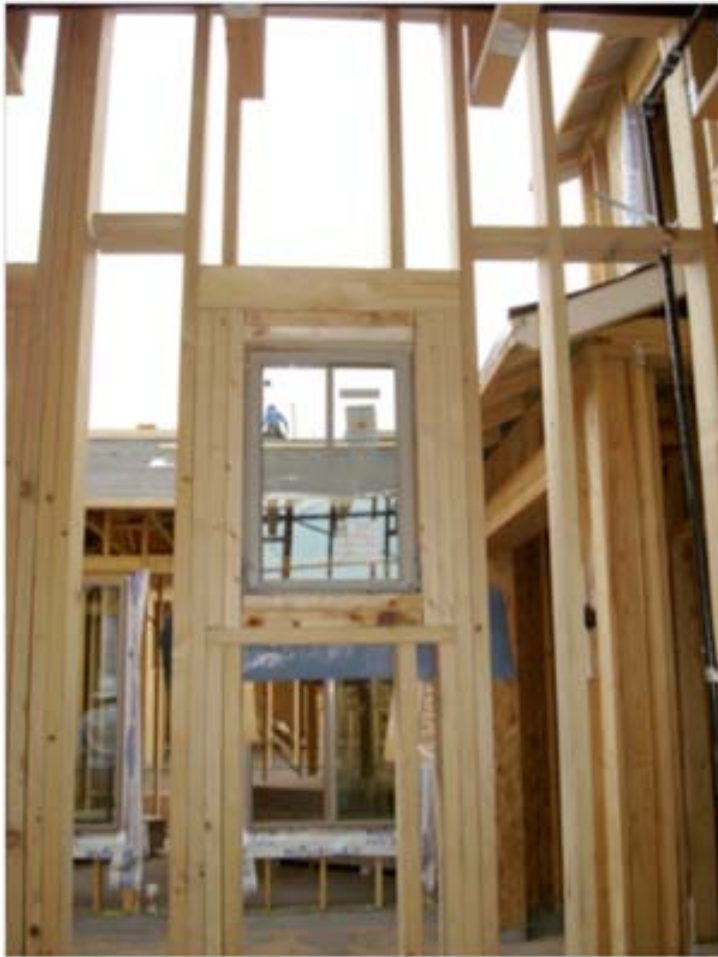
Inset flanged windows in a 2x6 wall resulted in significant extra wood around window opening.

These walls are framed at 2x6 and architectural considerations resulted in an inset window design. The windows are on the interior edge of the wall. The windows are flanged windows, so in order to install the windows on the interior edge, a double 2x4 interior window buck needed to be installed in the 2x6 wall framing. This resulted in significant excess wood, which could have been avoided had the windows been installed on the exterior surface of the wall.

Had Advanced Framing techniques been used an overall savings of approximately \$2,000 per building would have been realized. The money could have been available to improve other building components to make them more energy efficient in addition to increasing the builder's profit margin and improving the marketability of the product.

Install windows on the exterior surface of the wall using Advanced Framing techniques.
