Building America Case Study Technology Solutions for New and Existing Homes

Monitoring of Double Stud Wall Moisture Conditions in the Northeast

Devens, MA

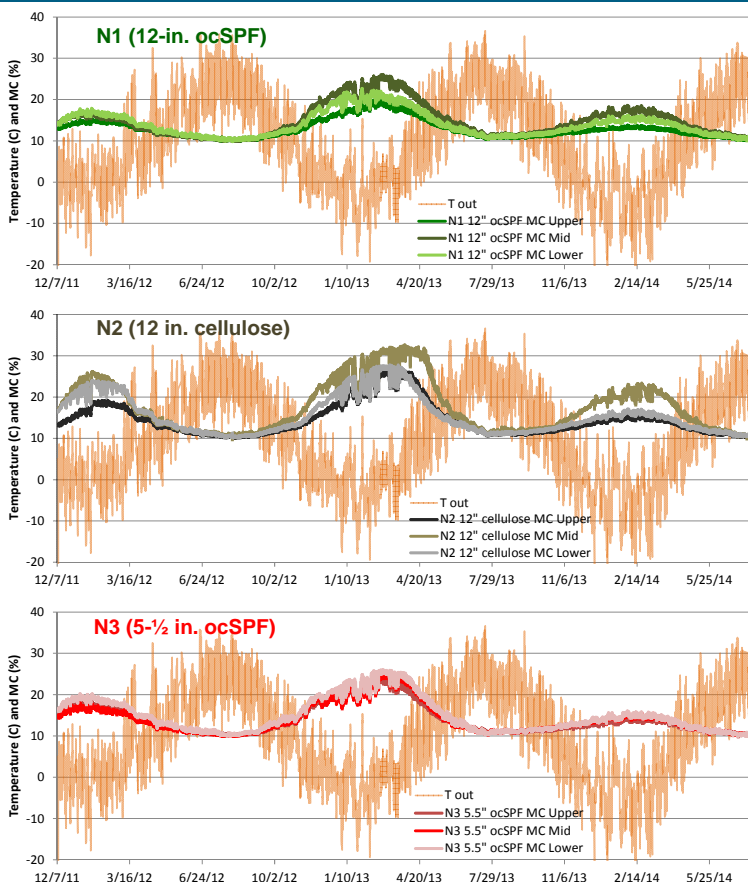
North side sheathing moisture contents w. exterior temperature

Under “normal” interior conditions (functioning ventilation system, wintertime RH 10-30%), ocSPF walls (both 12” and 5-1/2”) with latex paint as interior vapor control (Class III) showed low risk; all sheathing moisture contents remained below 20%. However, the 12” cellulose wall had moisture contents over 20% on the north side.

Under high interior humidity loading (non-functional ventilation system, 40-50% interior RH), all test walls showed moisture contents and sheathing-insulation interface RHs well into the high risk range. The cellulose walls showed particularly high moisture contents (sheathing over 30%), while the ocSPF walls showed MCs in the 18-25% range. In addition, the monitoring showed evidence of liquid water condensation (which can result in quick degradation) in all walls, the condensation was substantial in the cellulose walls.

The cellulose walls clearly showed the highest moisture accumulation: the use of interior vapor control more restrictive than Class III (latex paint) is recommended. A Class II vapor retarder (e.g., variable permeability membrane or vapor retarder paint) will reduce moisture risks to more reasonable levels. However, it is entirely likely that there are many double stud walls insulated with cellulose with only Class III vapor control that are providing fine service. A Class I vapor retarder (polyethylene) is not recommended, due to the complete elimination of inward drying.

The ocSPF walls had less moisture accumulation than the cellulose walls; it is a marginal judgment call whether a Class II vapor retarder is needed or warranted. The ocSPF material used provides reasonable vapor control at the thicknesses applied (2.0 to 2.5 perms in 12"). The use of a Class II vapor retarder would definitely be conservative, but the double stud walls insulated with ocSPF have a history of providing excellent performance in this builder's houses.
