# Field Testing of Compartmentalization Methods for Multifamily Construction

Building America Report - 1506

March 2015

Kohta Ueno and Joseph Lstiburek

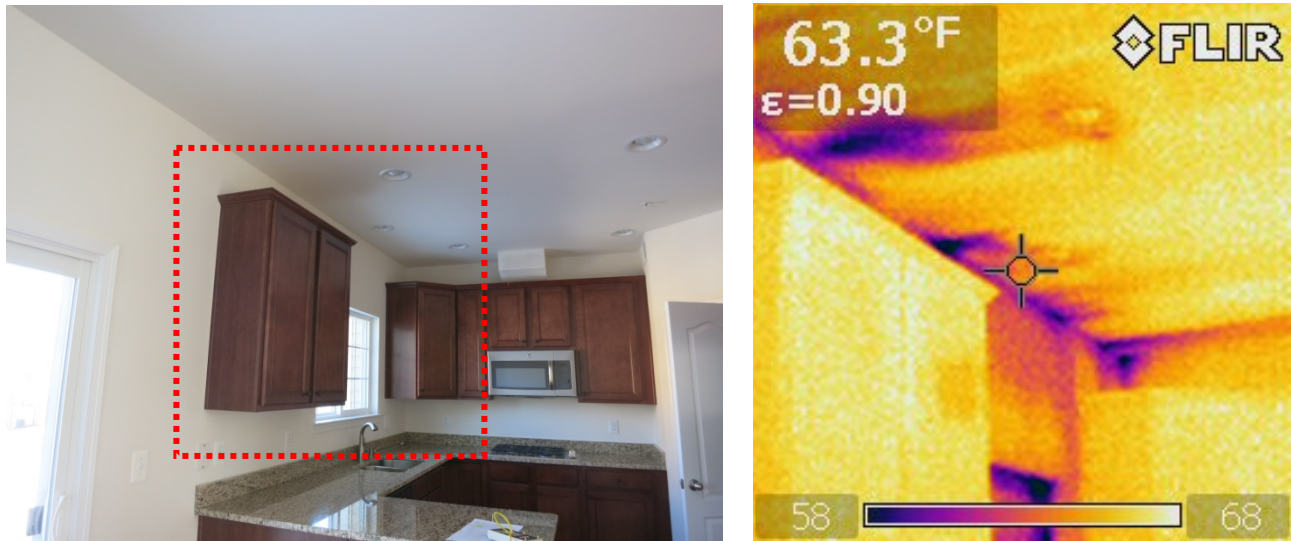
One consistent issue arose at the second- to third-floor ceiling/floor assembly (across several units); this is shown at a rear second-floor kitchen in Unit 6704 (conventional construction) in Figure 24 and Figure 25 (keyed to “A” in Figure 23). Air is entering the floor framing cavity from the exterior at the third-floor overhang detail.

Figure 24. Rear second-floor kitchen, Unit 6704 (middle)

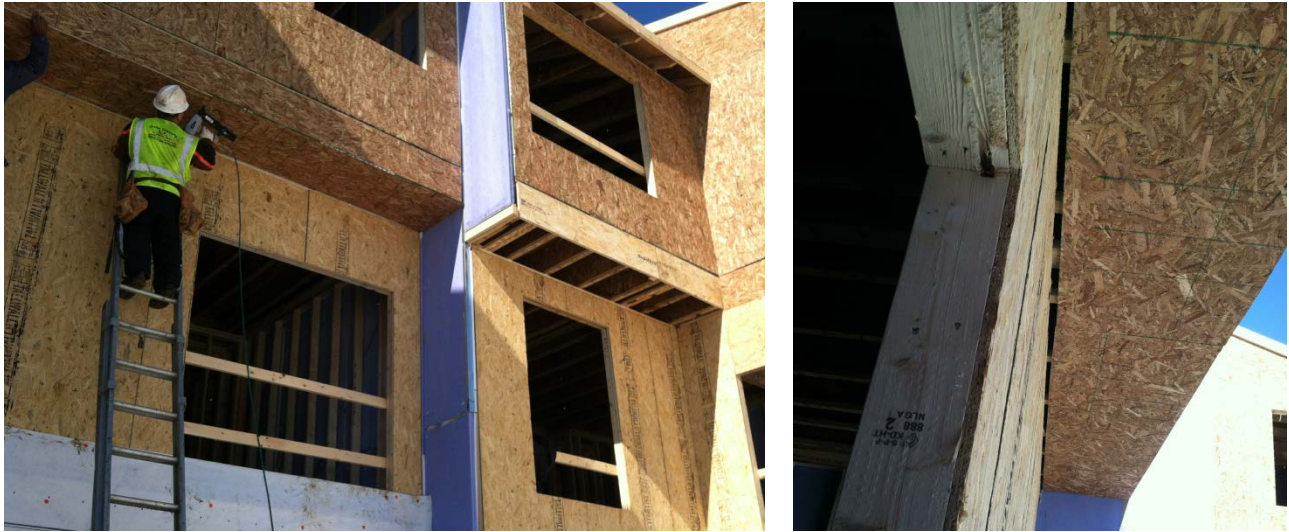
Figure 26 shows the construction of this detail on the adjacent building in frame. The underside of the overhang was sheathed with OSB, but large sheathing gaps were common. No visible blocking detail separated the overhang floor cavity from the main floor cavity.

**Figure 26. Overhang detail in framed building, showing gap in sheathing at inside corner**

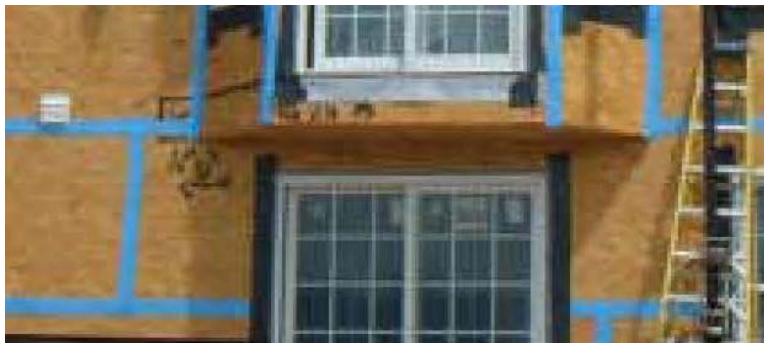
Surprisingly, this leakage was even seen in one of the two taped sheathing units (6700), albeit in a much reduced form. A possible explanation is shown in Figure 27: although the flat sheathing seams were taped, the inside and outside corners of the overhanging bay were left untaped.

**Figure 27. Overhang detail at taped sheathing condition**

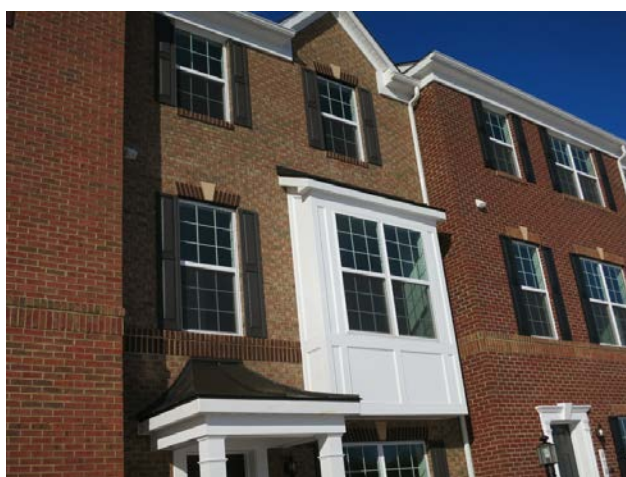
The projecting bay at the front of Unit 6702 (middle, improved, and taped) had significant air leakage at the ceiling, visible at the framing (Figure 29; keyed to “B” in Figure 23). An exterior view of the bay is seen in Figure 30. The metal roof of the bay does not appear to be vented; no further investigation or disassembly was done.

Figure 30. Front bump out bay detail at unit 6702

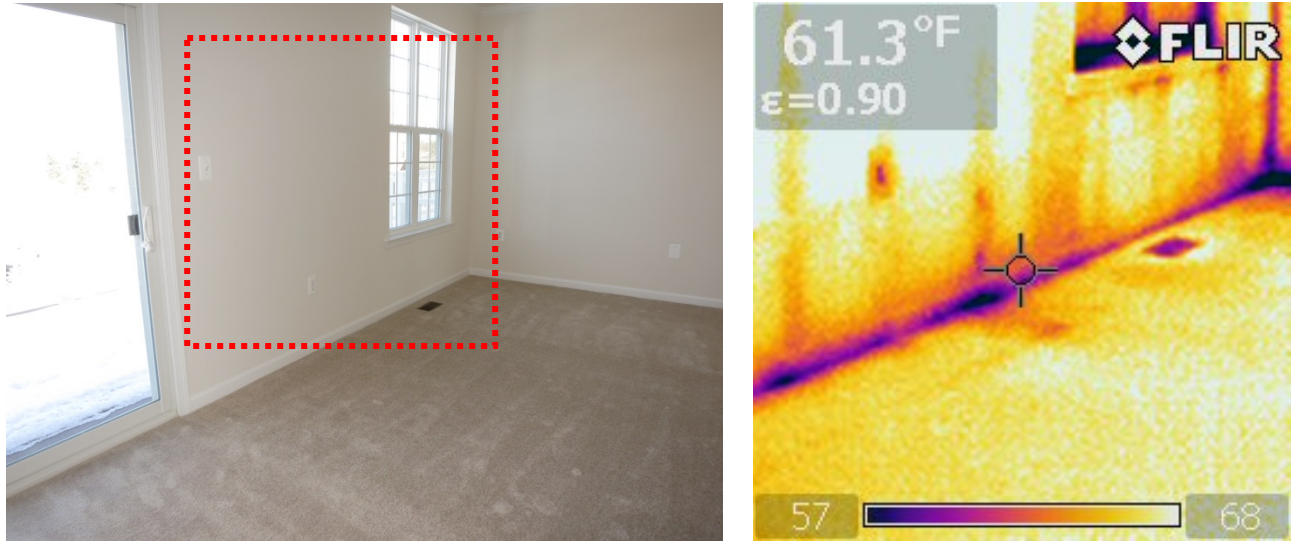
Air leakage was seen in multiple units at the baseboard at exterior walls (Figure 31).

**Figure 31. Air leakage at first-second floor/ceiling assembly, Unit 6702**

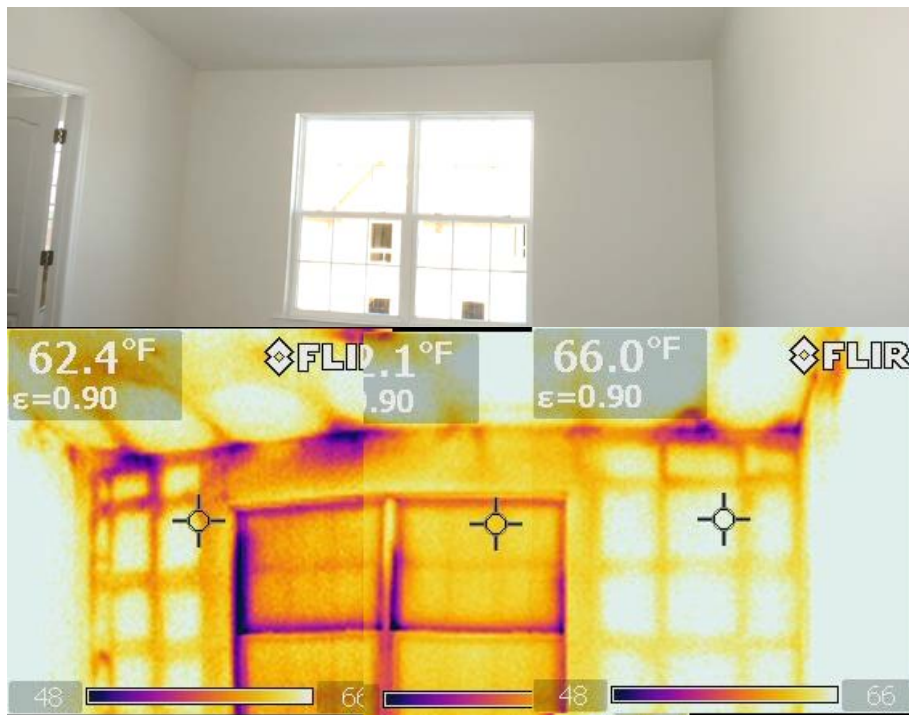
Leakage was consistently seen at the top (third)-floor roof-wall connection, often at the rear of the units (keyed to “C” in Figure 23). The rear of the building has some type of cross-framing detail (possibly horizontal strapping or resilient channel); the leakage might be due to insufficient sealing of the top of the cavity. The fact that the leaks coincide with the roof trusses (where access and visibility would be limited) is consistent with this theory.

**Figure 32. Rear wall/vaulted ceiling leakage, Unit 6706**

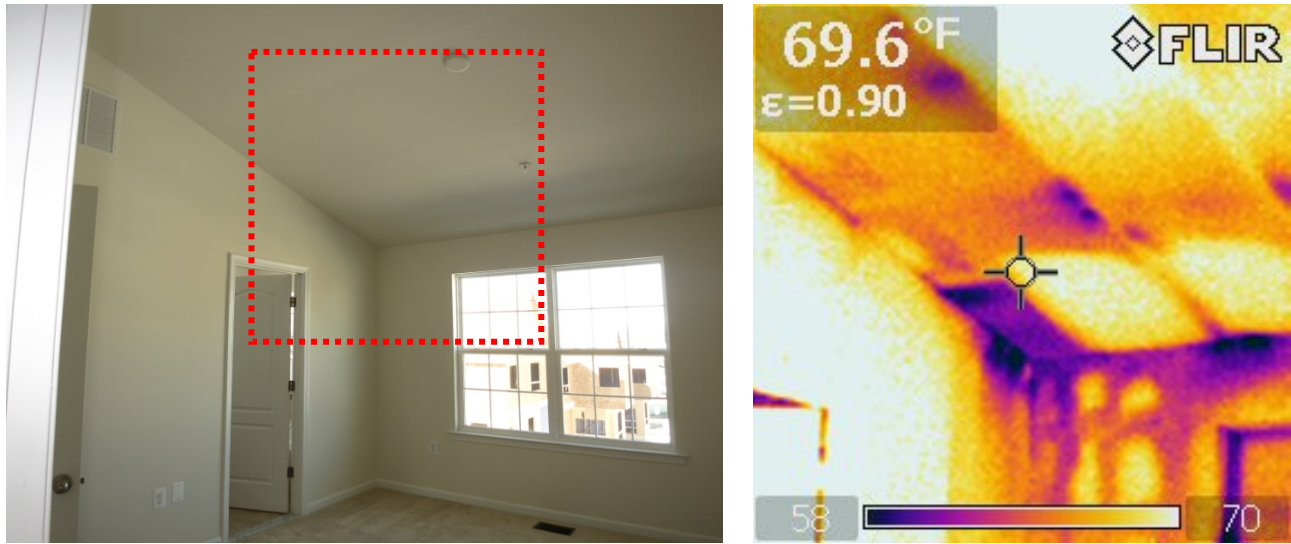
Issues were also seen in the vaulted ceiling (Figure 33).

Figure 33. Vaulted ceiling air leakage, Unit 6706

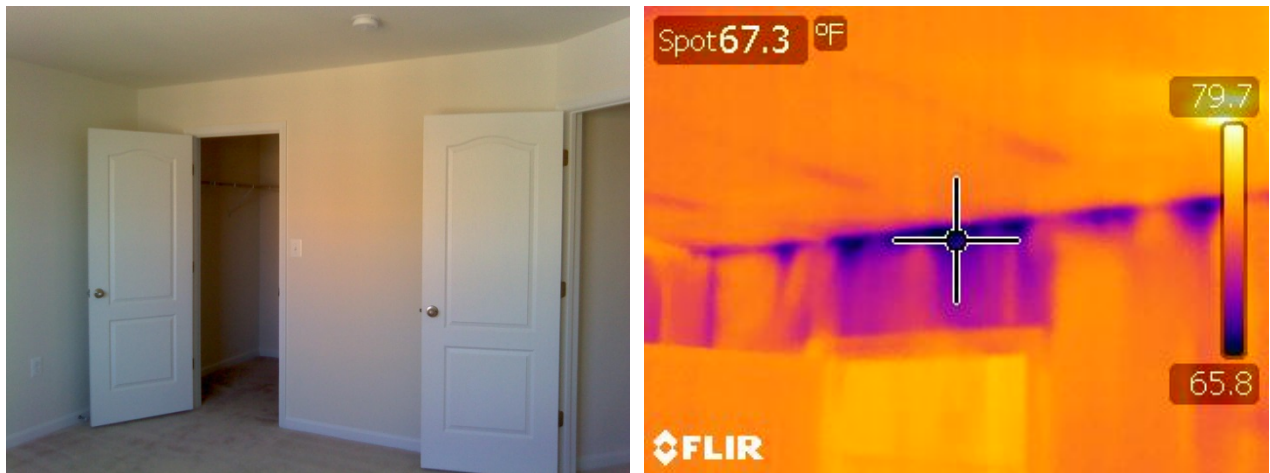
At several interior walls under the vented/unconditioned attic, noticeable air leakage was visible at the top plate (Figure 34 and Figure 35, keyed to “D” in Figure 23). Unfortunately, this indicates that the interior top plate detail (Figure 8) was not executed correctly or consistently.

Figure 34. Interior wall under attic (third floor), Unit 6702

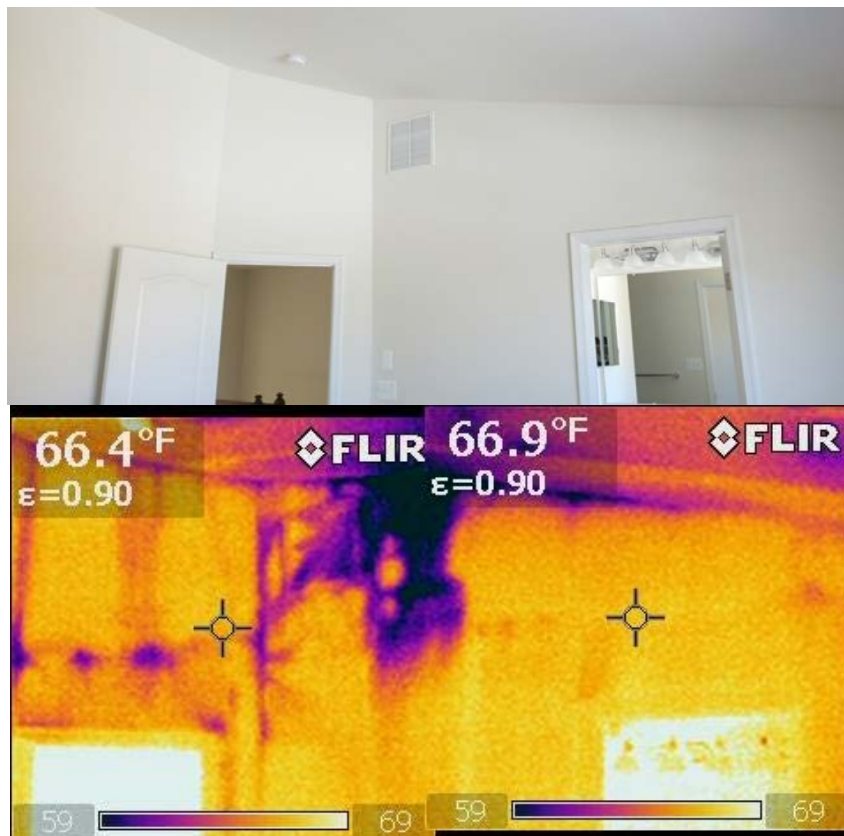
The transitions from vaulted ceilings to flat attics were good in some cases, but poor in other cases (Figure 36; keyed to “E” in Figure 23). The attic sides of the knee walls were sheathed with thin profile sheathing (Figure 37), but apparently, some air sealing details were not executed correctly.

Figure 36. Return duct air leakage and attic knee wall leakage (Unit 6704)

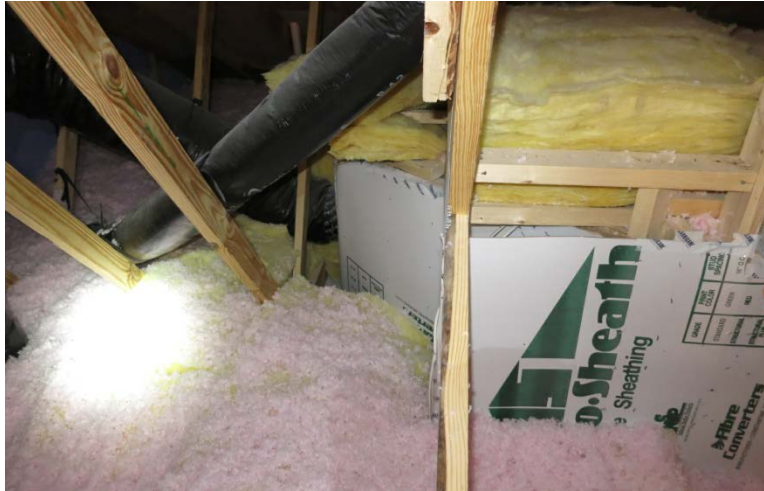
**Figure 37. Attic knee wall condition and sheathing (Unit 6704)**

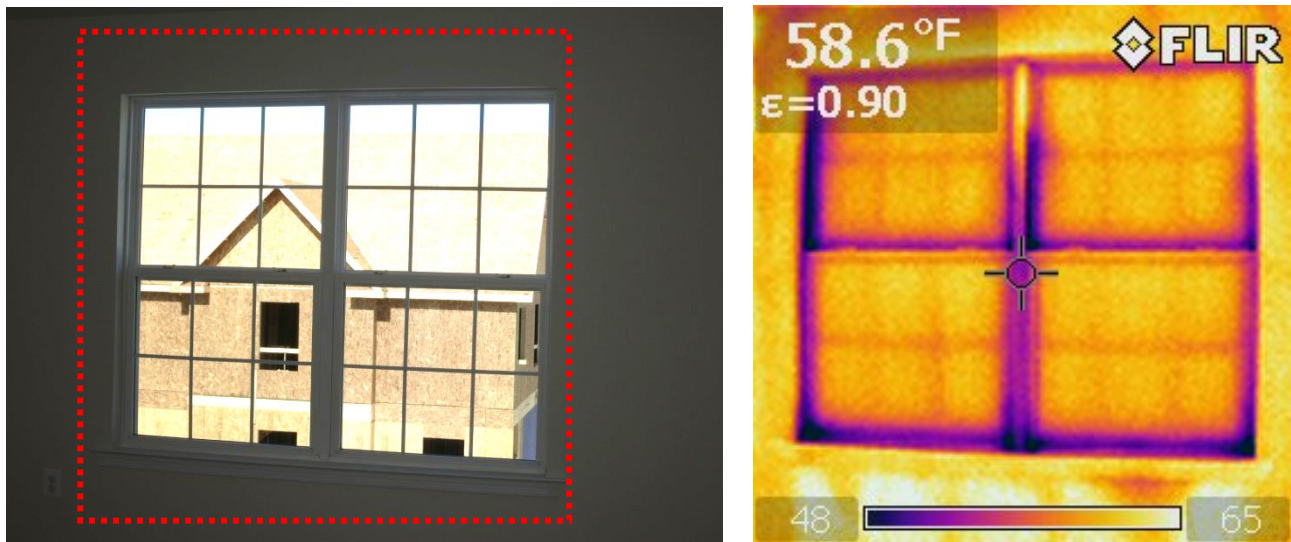
**Figure 38. Window air leakage (window unit, sash-to-frame)**

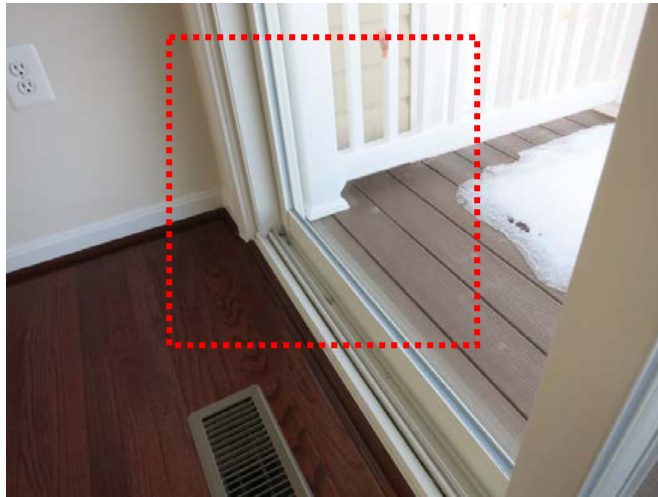
Figure 39. Sliding glass door air leakage at weep hole (door unit)

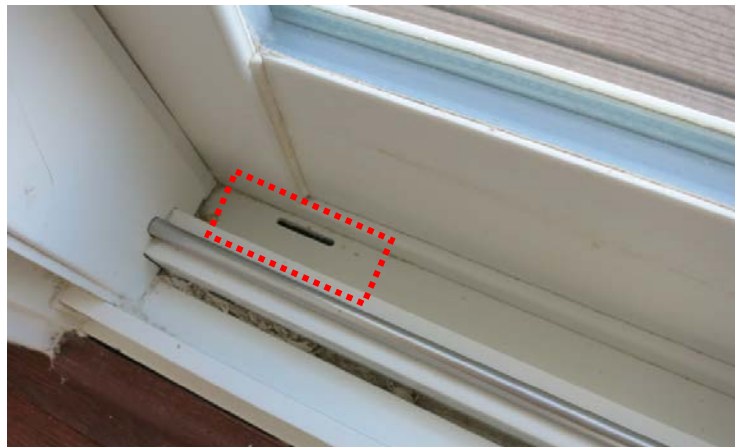
Figure 40. Sliding glass door air leakage at weep hole (door unit)

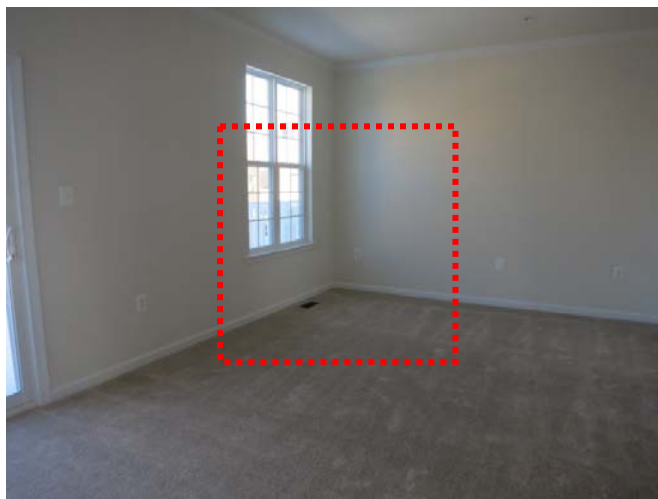
Figure 41. Window air leakage (window-to-wall connection at sill), Unit 6706

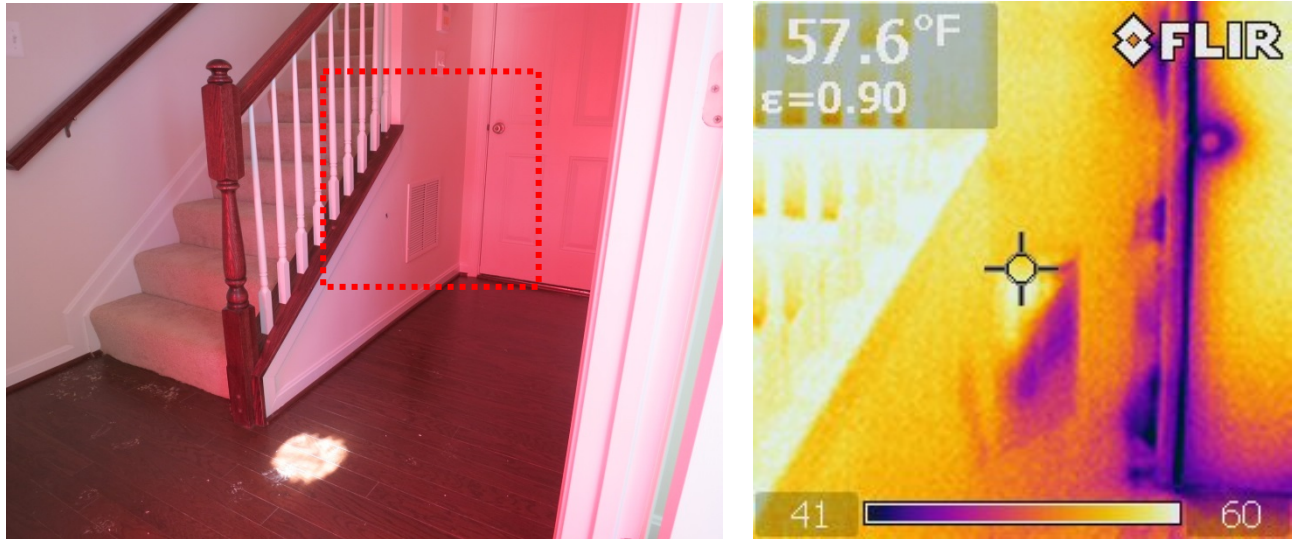
Similarly, the door to the garage showed air leakage at both the unit (door jamb gasket) and at the frame-to-wall connection (Figure 42).

**Figure 42. Air leakage at door (door jamb gasket and frame-to-wall connection)**

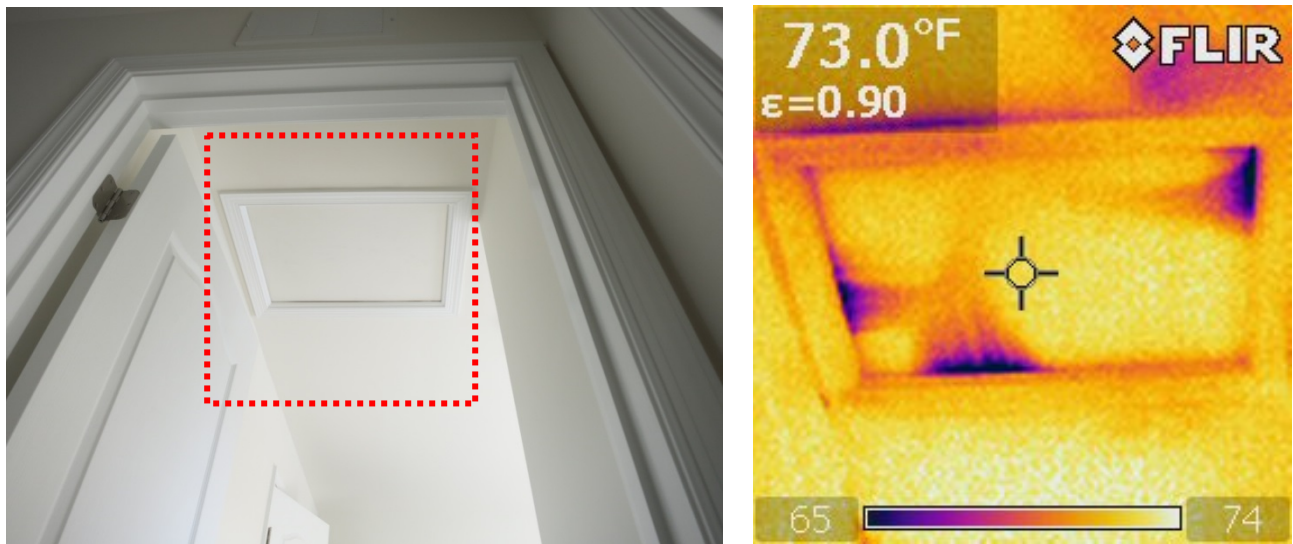
The attic hatch showed air leakage plumes (Figure 43, keyed to “F” in Figure 23), despite the presence of a bulb gasket. The hatch was insulated with a 10-in. block of expanded polystyrene foam (~R-40); however, it was evidently not sufficient to compress the gasket fully. The units were depressurized in this test, which would tend to pull the hatch downward. Apparently, some type of mechanical clamping may be required for a good seal.

**Figure 43. Attic hatch air leakage**

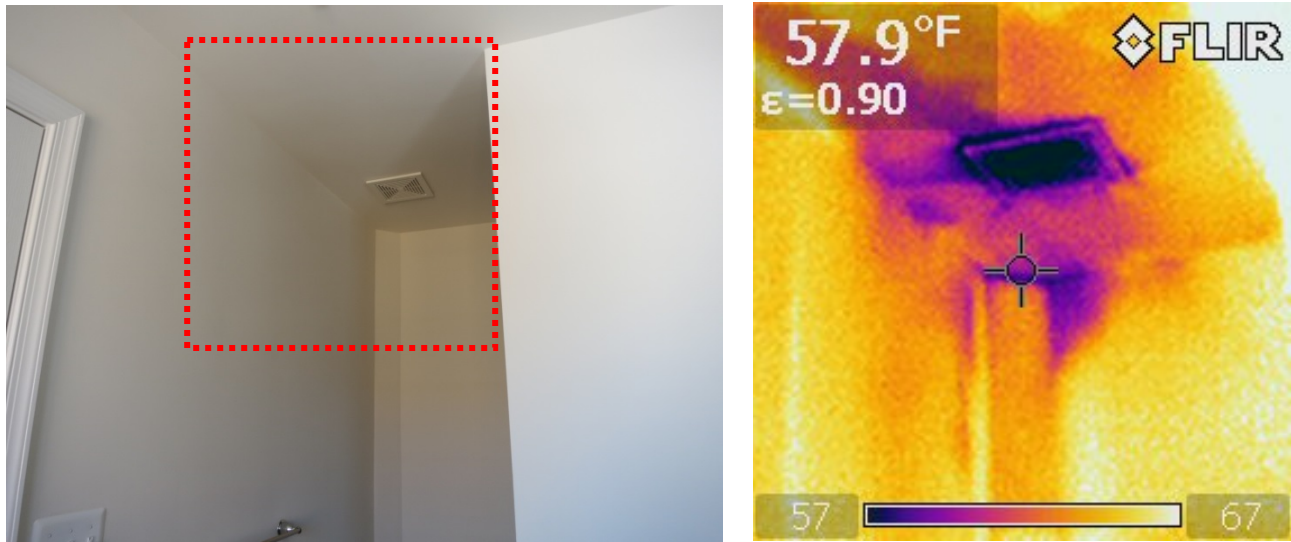
The bathroom exhaust fans were also leakage sources, both through the fan (i.e., flapper not sealing correctly), and around the fan unit (gaps between the fan body and ceiling gypsum board).

**Figure 44. Exhaust fan air leakage (through unit and around unit)**

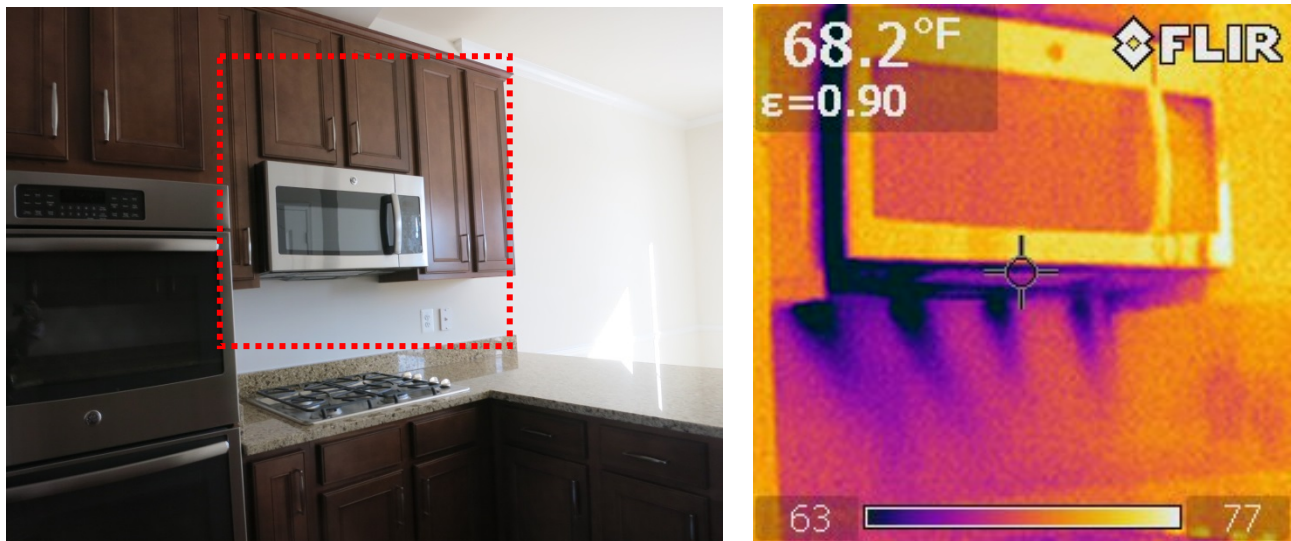
Similarly, the microwave oven/range hood was a source of leakage in some cases (Figure 45).

**Figure 45. Microwave/range hood air leakage (through unit and around unit)**

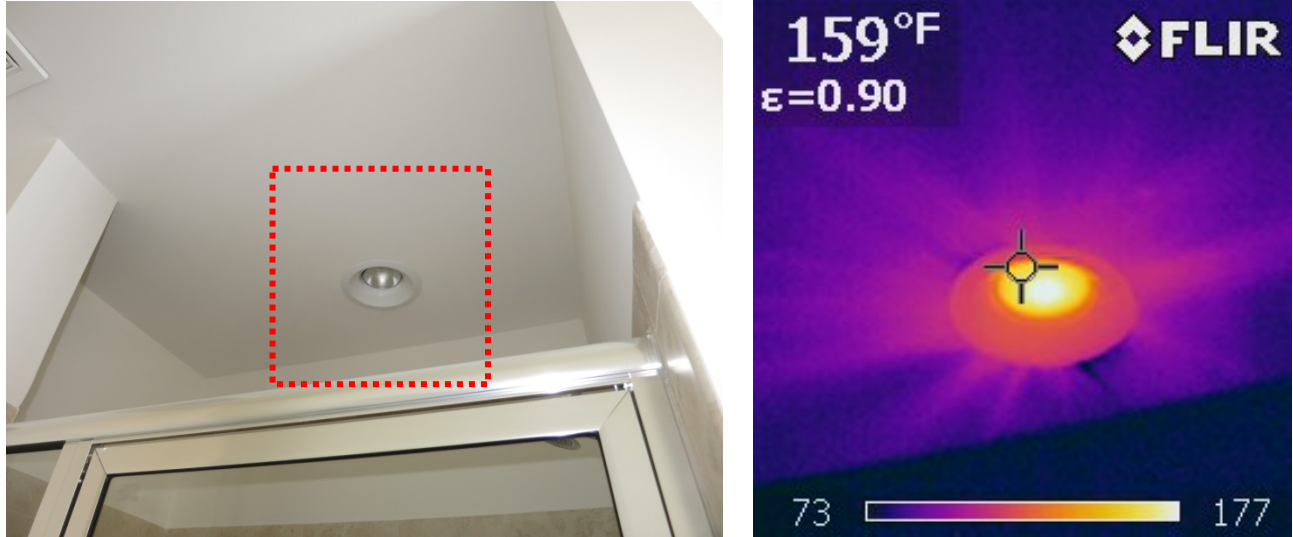
Leakage was observed around recessed lighting below the unconditioned attic (Figure 46). Similarly, electrical fixtures and box covers had similar leakage issues (see Figure 33, showing vaulted ceiling).

Figure 46. Bathroom recessed light air leakage (around unit/trim ring)

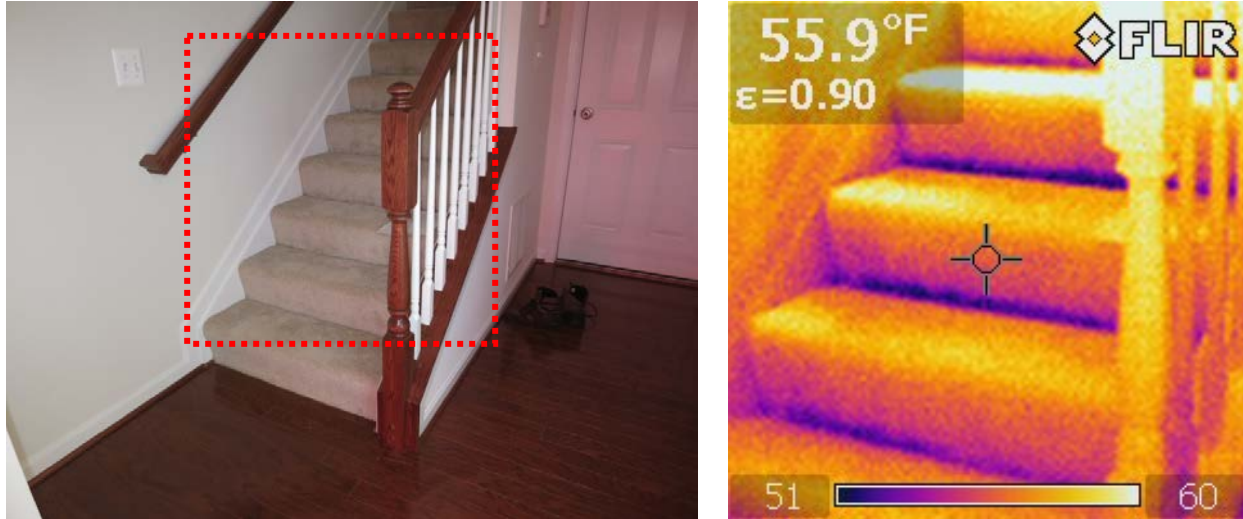
**Figure 48. Air leakage at stair tread-to-riser joints, location (A)**

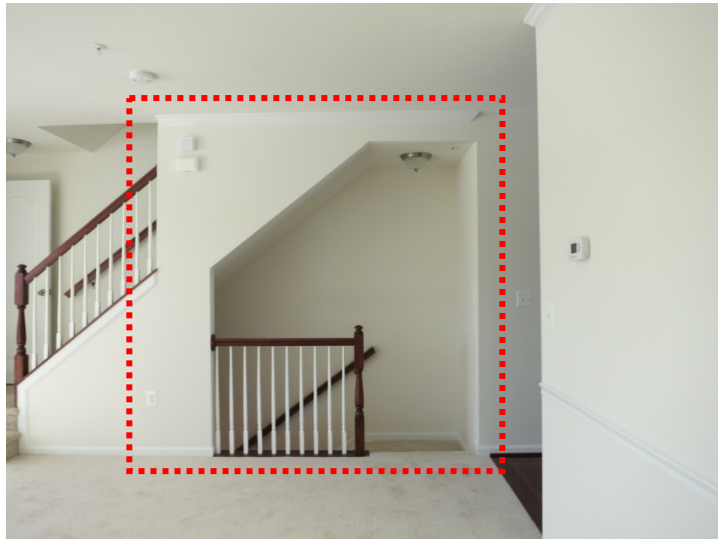
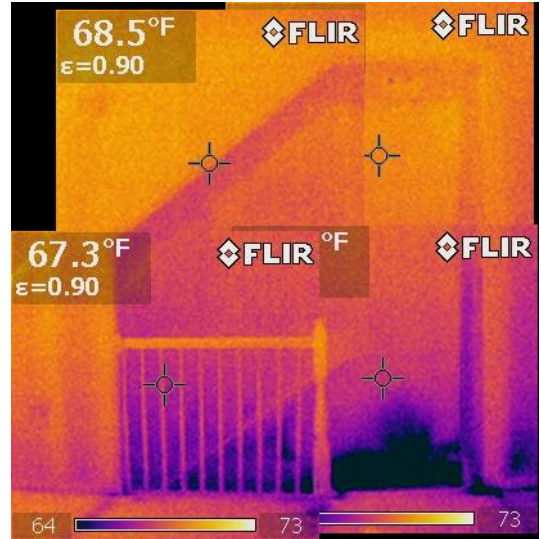
Similar issues were seen at the top of the stairs, at the landing between the first and second floors (Figure 50).

Figure 50. Air leakage at stair landing (first-to-second floor)

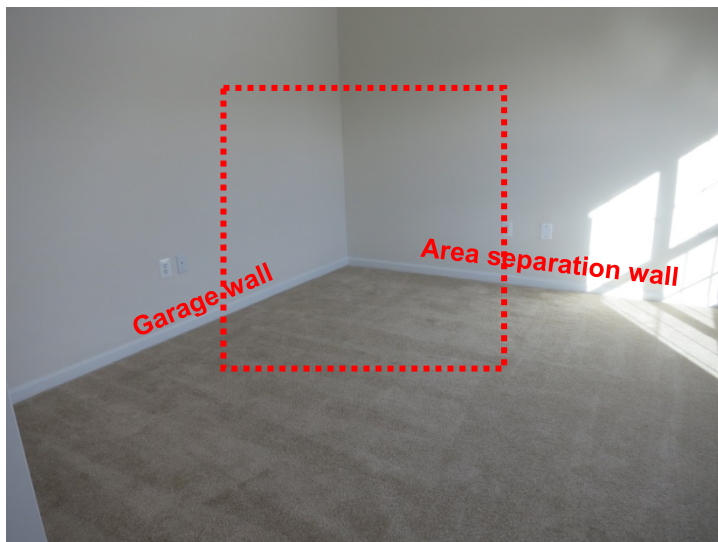
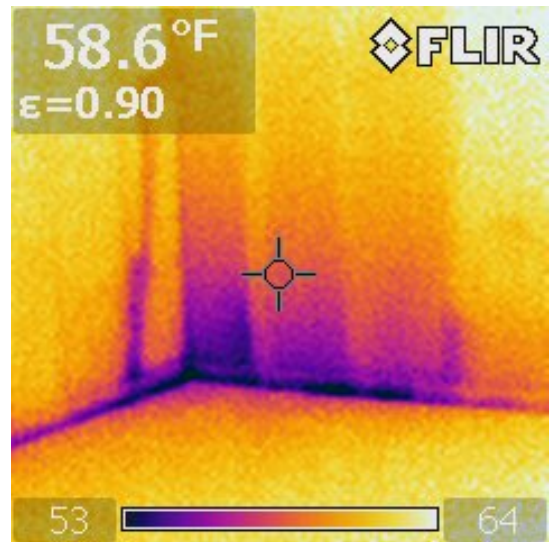
Figure 51. Garage tee wall intersection, Unit 6700, location B

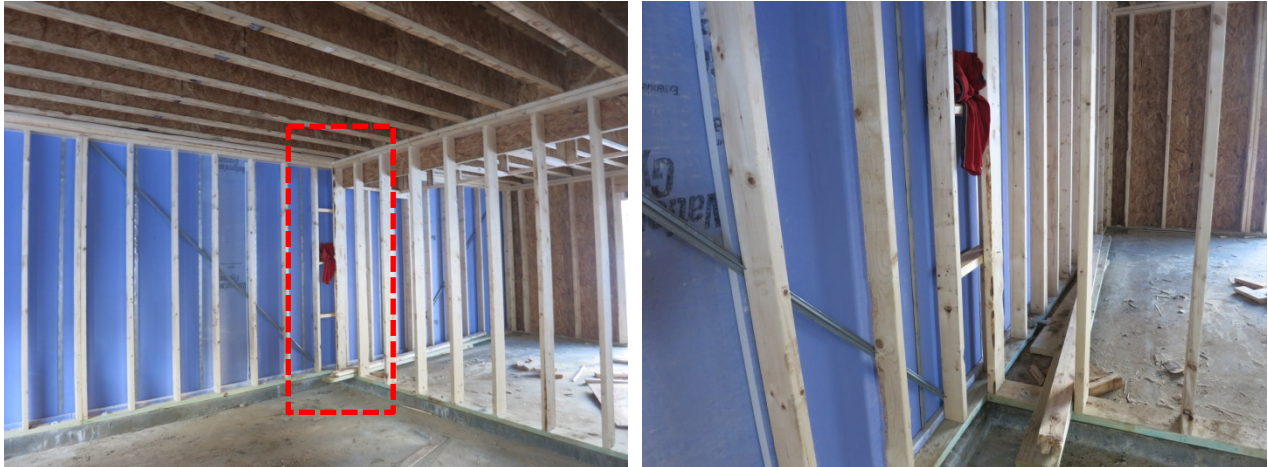
**Figure 52. Garage tee wall intersection, showing ladder blocking**

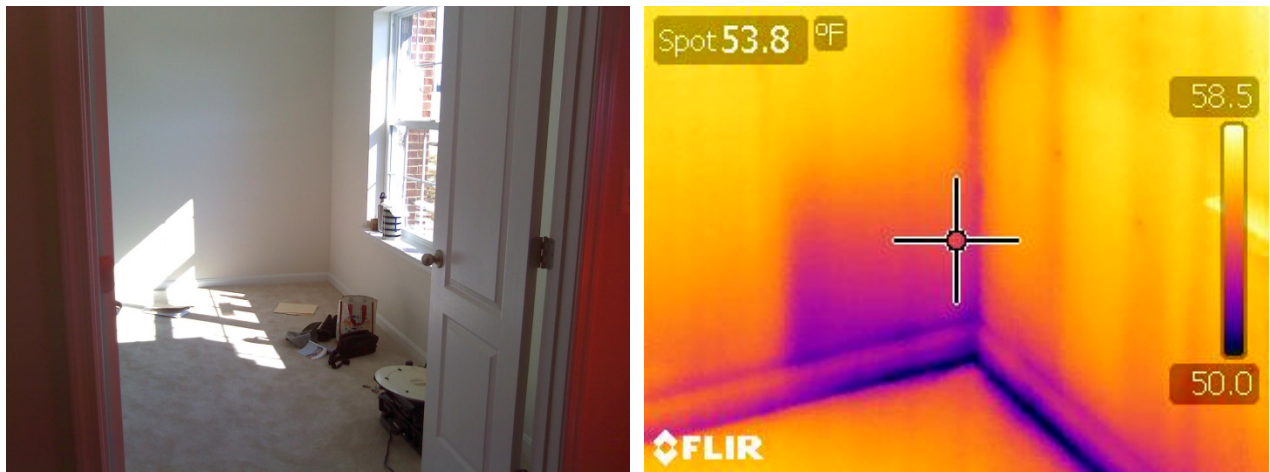
**Figure 53. Area separation wall “jog” at exterior, location C**

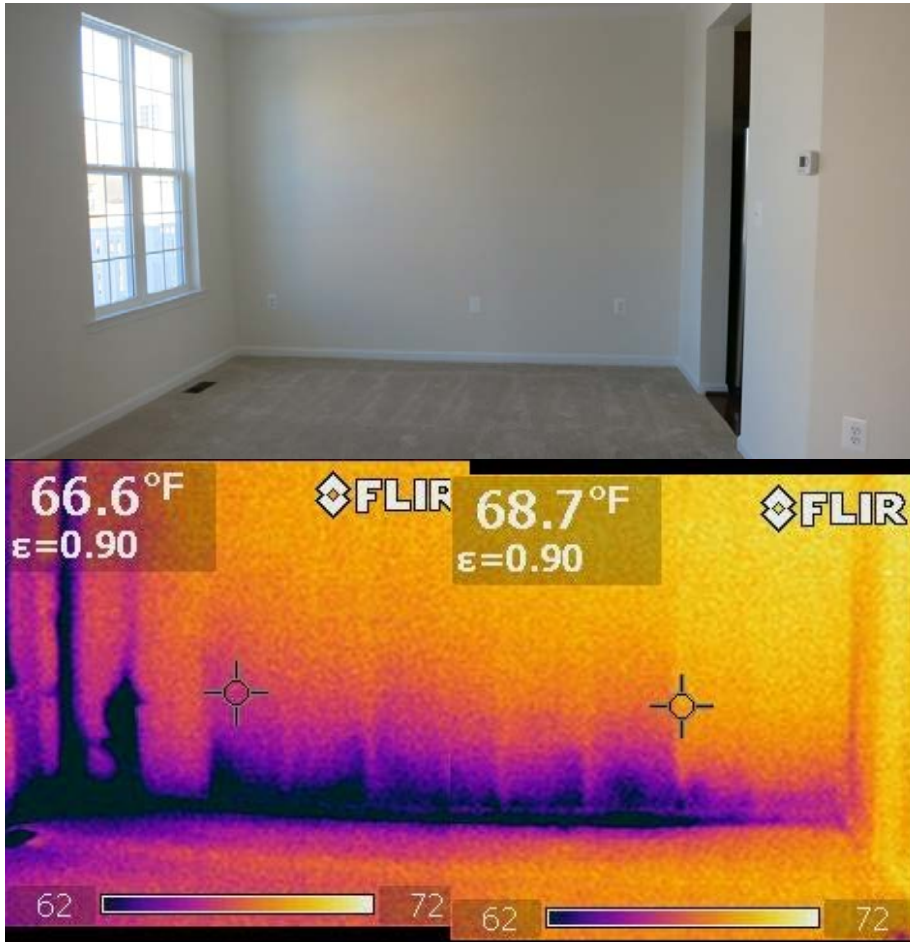
Figure 54. Second-floor living room leakage pattern over garage, Unit 6706, location D

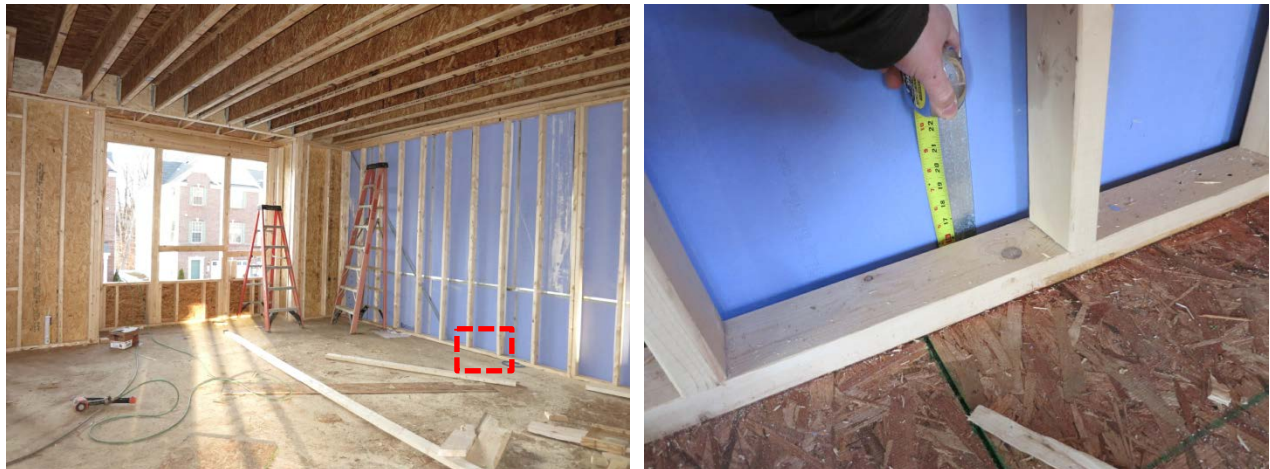
Figure 55. Missing gypsum fireblocking at garage ceiling rim joist area

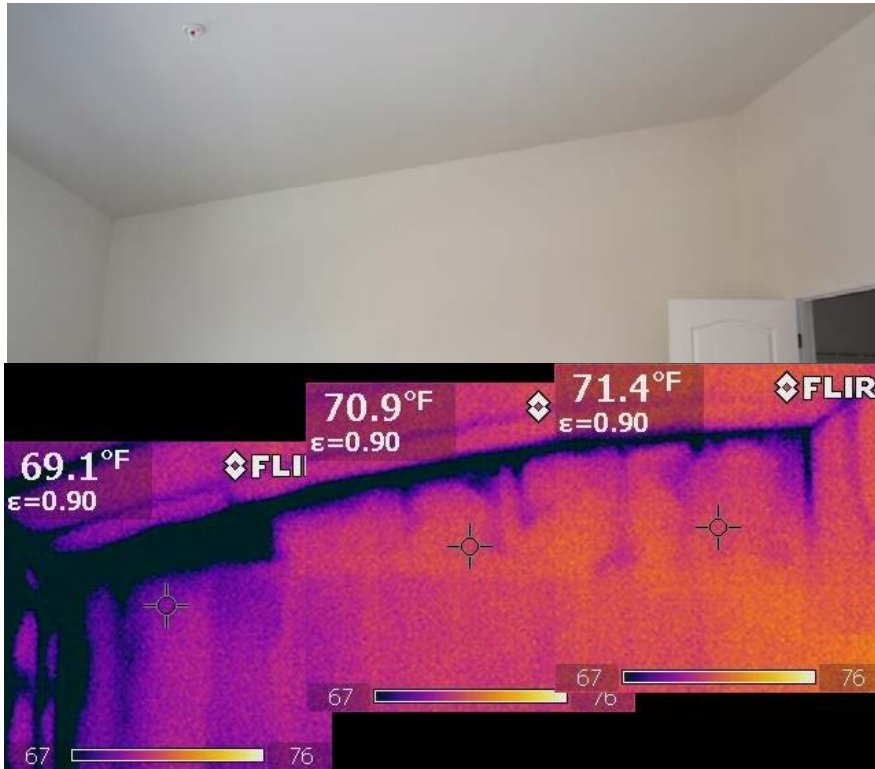
**Figure 56. Leakage at vaulted ceiling connection to separation wall, Unit 6706**

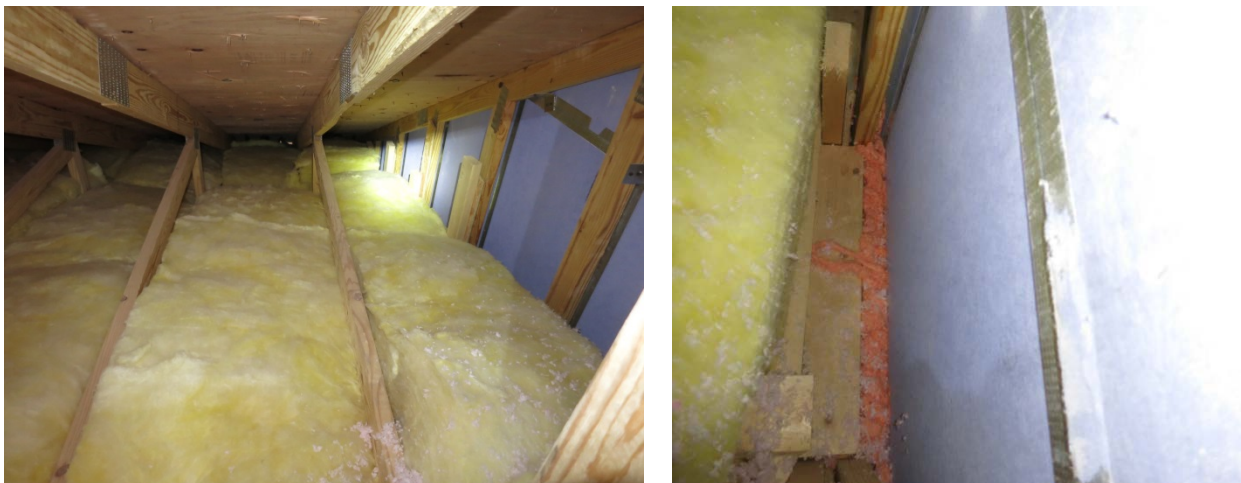
**Figure 57. Vaulted attic and separation wall conditions, Unit 6704**

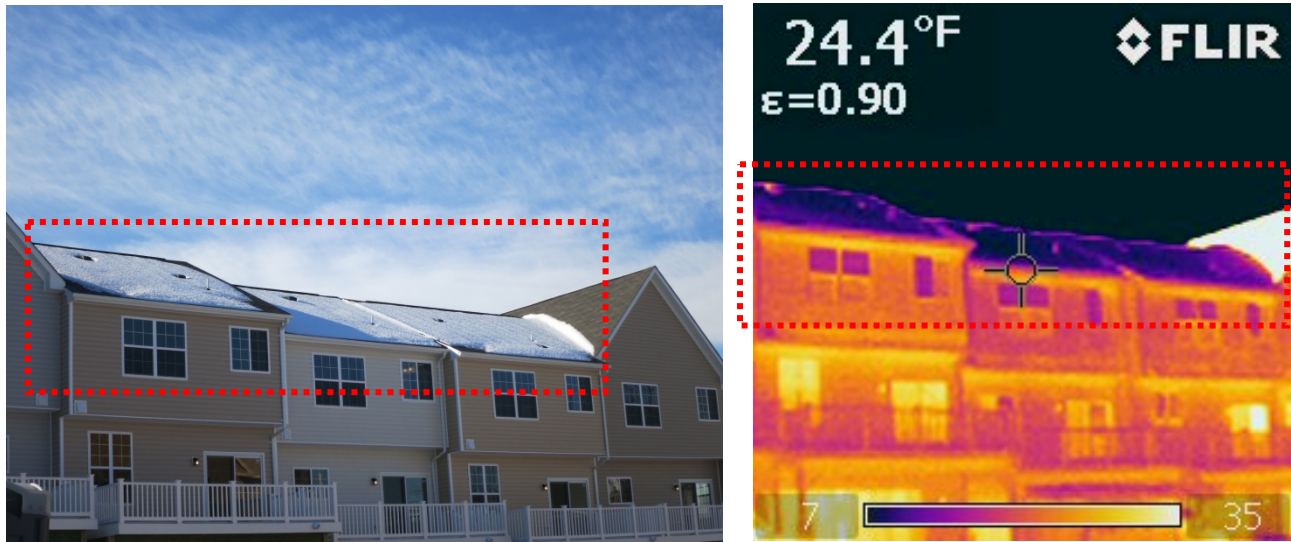
Figure 58. Exterior infrared of three middle unit attic demising walls

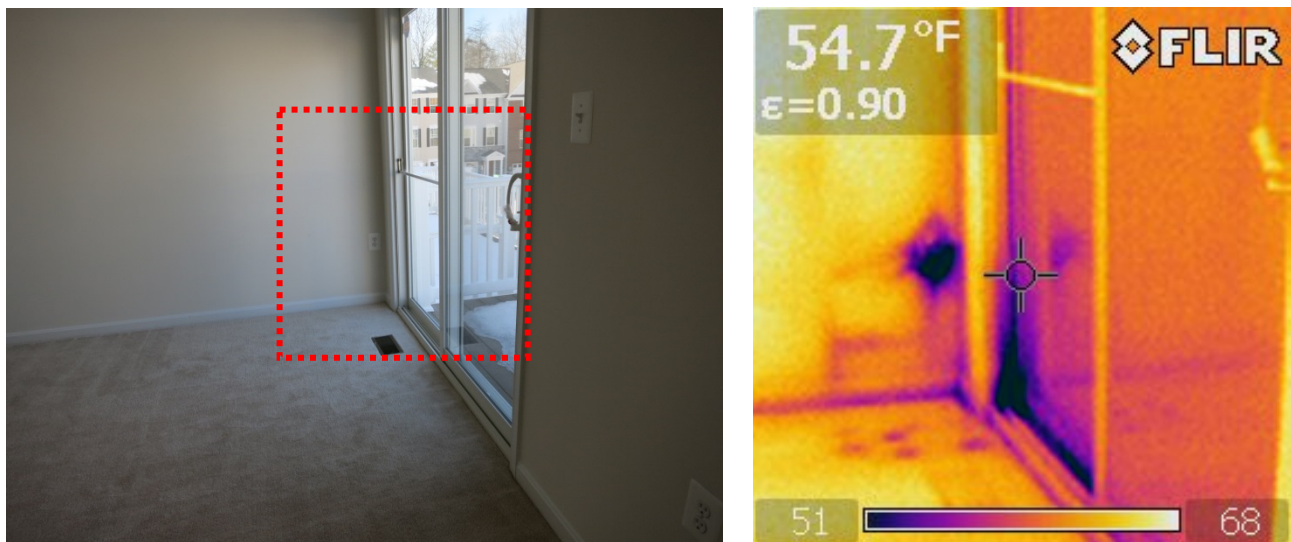
Figure 59. Area separation wall leakage at exterior “jog,” Unit 6706

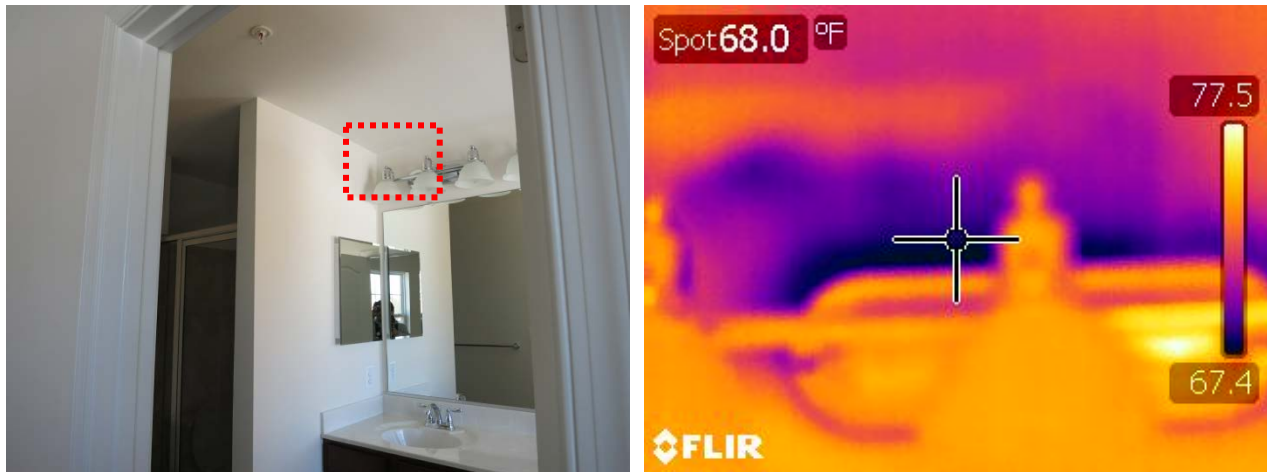
**Figure 61. Air leakage at light mounted on area separation wall**

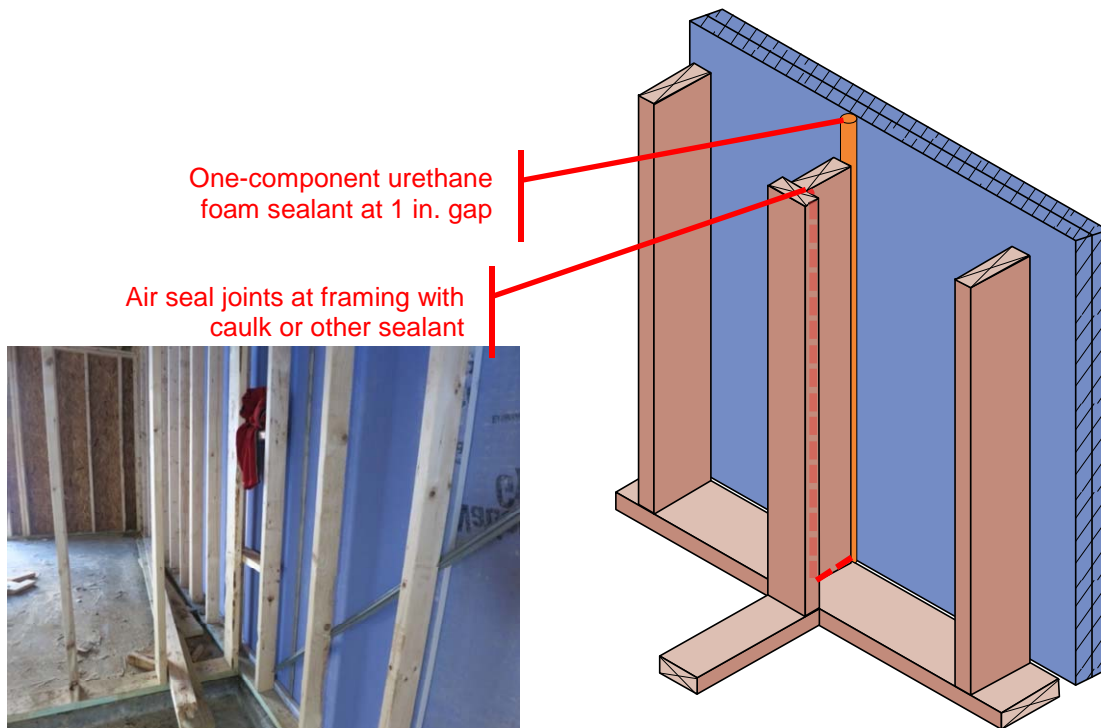
**Figure 76. Garage tee wall intersection, current (L) and proposed air sealing details (R)**
