Leveraging Limited Scope for Maximum Benefit in Occupied Renovation of Uninsulated Cold Climate Multifamily Housing

Building America Report - 1106

21 December 2011 (Rev. March 2012)

K. Neuhauser, D. Bergey, and R. Osser
Building Science Corporation

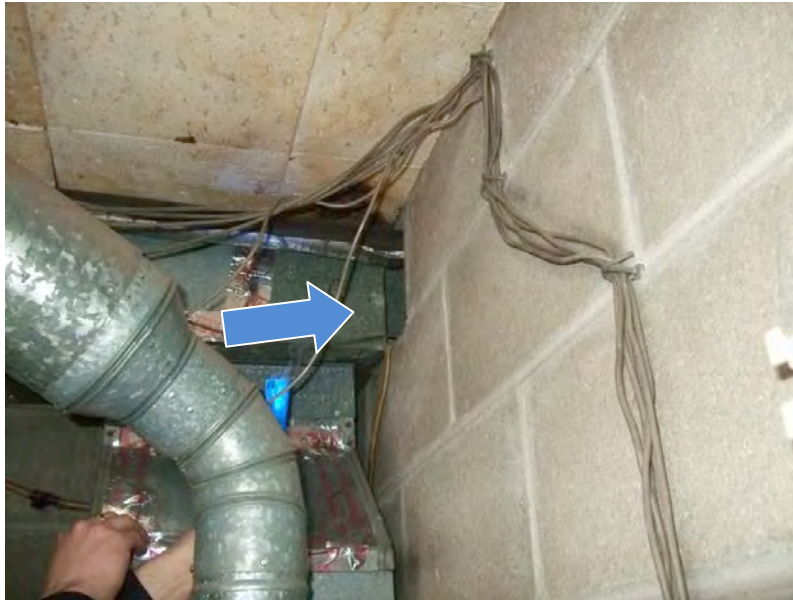
Figure 2. Typical gap around supply plenum in separation between mechanical room and apartment.

- Seal the gap around the duct plenums (both supply and return) connecting the apartment to the mechanical closet (see Figure 2).
- Remove register grilles throughout the apartment and seal from the inside of the duct to the face of the drywall with appropriate tape. Trim the tape at the face of the drywall so that the register flanges will conceal the tape (see Figure 3).
- Caulk the steel frame of the entry door to the drywall; replace door gasketing where it does not provide a good seal.
- Seal the demising wall to exterior wall. At the corner of the demising wall and the exterior wall, remove a 2- to 4-in. wide strip of drywall from exterior wall to allow the drywall of the demising wall to be sealed to the exterior wall (concrete frame or concrete masonry unit [CMU] backup) (see Figure 4).³

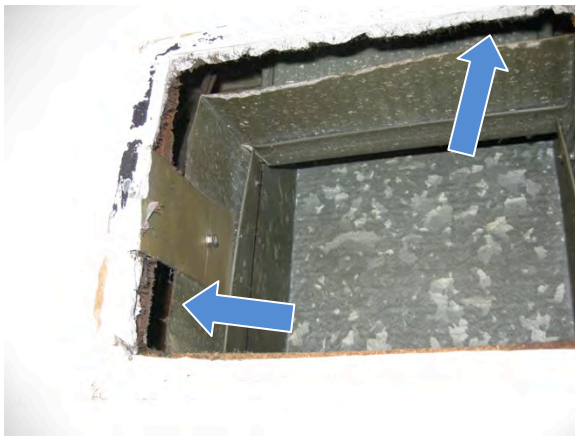
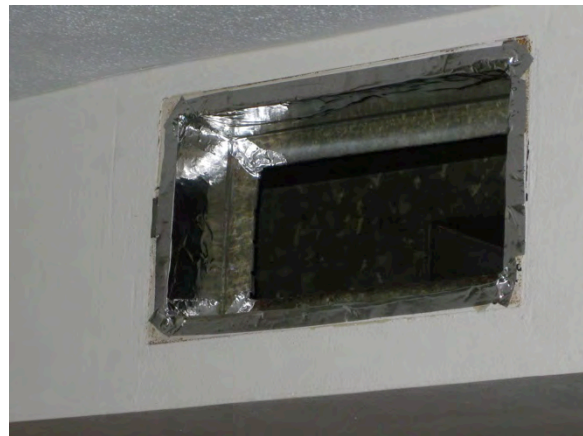
Figure 3. Left: Gaps between duct boot and drywall created a bypass for heating distribution and also represented significant leakage pathways into the demising wall and, consequently, between apartments; Right: The work scope called for metal extension sleeves and foil mastic tape to seal from the existing duct, over the extension sleeve to the face of the drywall.

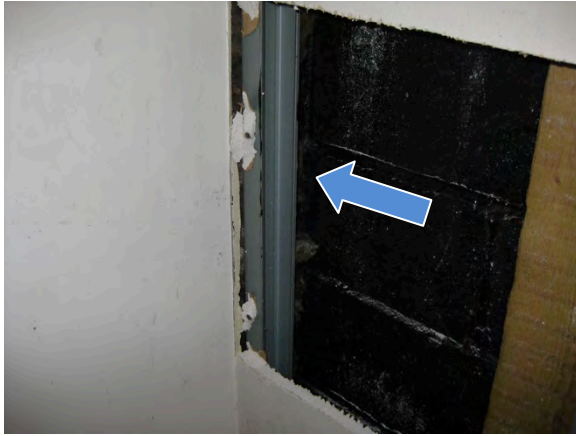
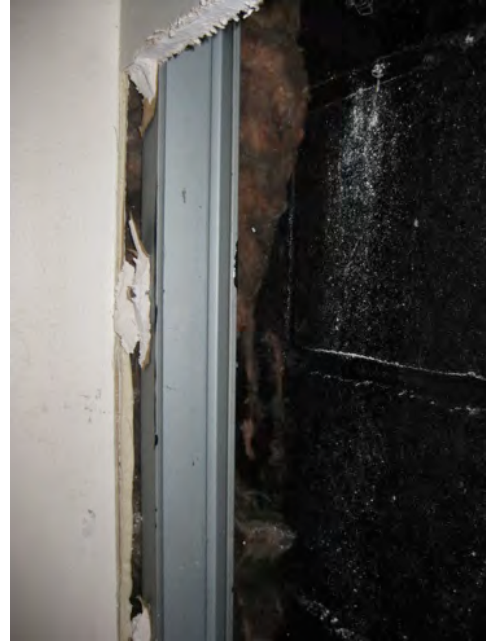
Figure 4. Furring cavity of exterior wall communicates with demising wall. Left: Drywall removed at section of exterior wall adjacent to demising wall; Right: Close-up of connection between furring cavity of exterior wall and demising wall.

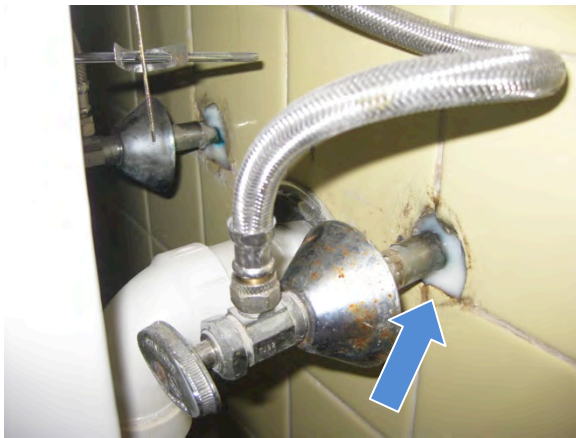
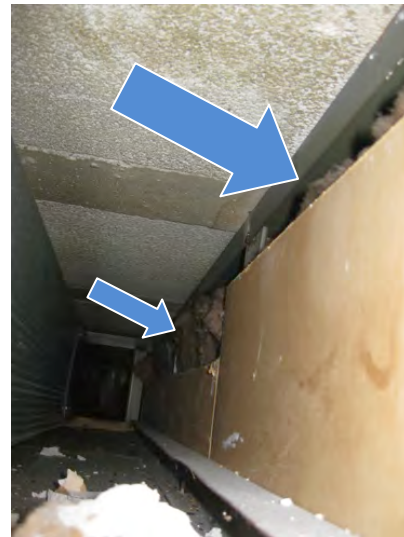
Figure 5. Left: Annular seal at easily accessible plumbing penetration; Right: Within the duct soffit enclosure, the demising wall is not continuous to the ceiling.

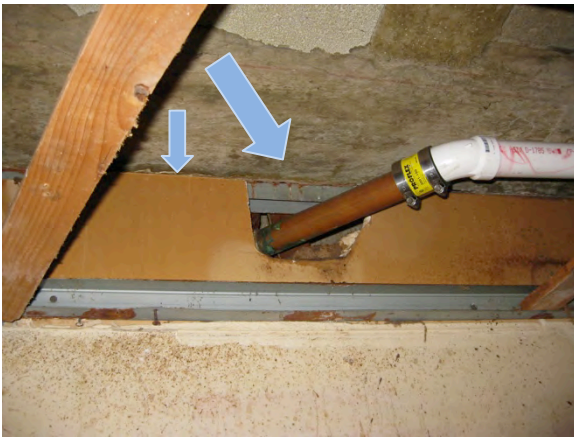
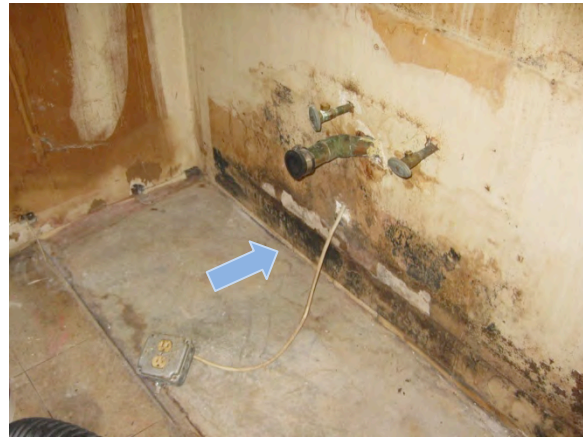
Figure 6. Left: Large discontinuities in demising wall surface round plumbing and other services above the soffit. Drywall surface is not sealed to floor/ceiling above; Right: Demising wall surface is not sealed to floor slab.

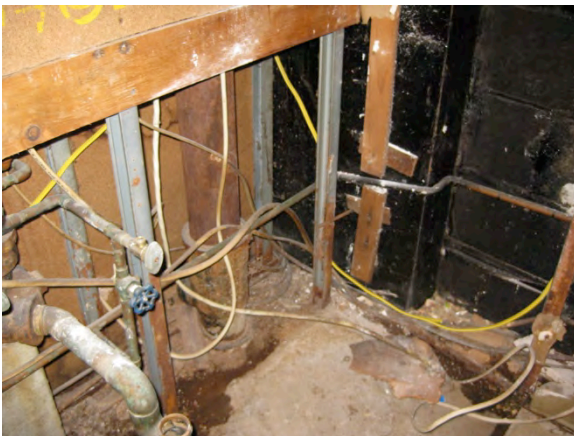
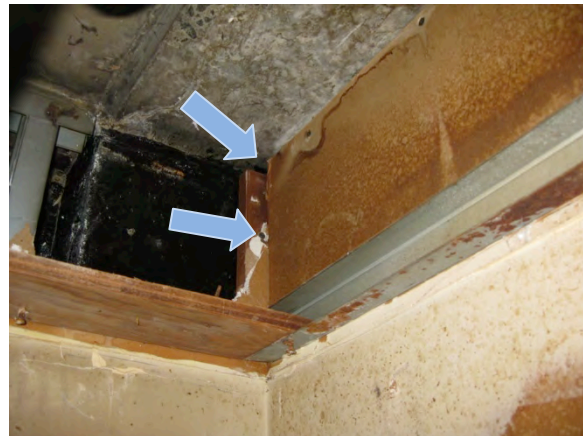
Figure 7. Left: Where work exposes the joint between the exterior wall and floor slab, there is an opportunity to ensure a robust air seal at this joint; Right: As seen in this exposed section above the kitchen soffit, the demising wall does not connect to the exterior wall structure. This leaves a path for airflow around the demising wall.

- Where the base of the exterior wall is exposed, clean the floor-exterior wall junction and apply a liquid-applied waterproof membrane to seal the block wall to the floor slab.
- Connect and seal the drywall of the demising wall to the exterior wall at the side of the kitchen adjacent to the exterior wall.
- Where the unused duct stub penetrates the surface of the demising wall, cut back the duct to allow the drywall to extend and seal to the floor/ceiling assembly, then cap and seal the duct.
- Provide airtight electric boxes throughout or seal each electric box with appropriate sealant.
- Where CMU backup wall of exterior wall is exposed, apply mastic over accessible cracks or minor holes. Patch major holes (broken block) in CMU wall.

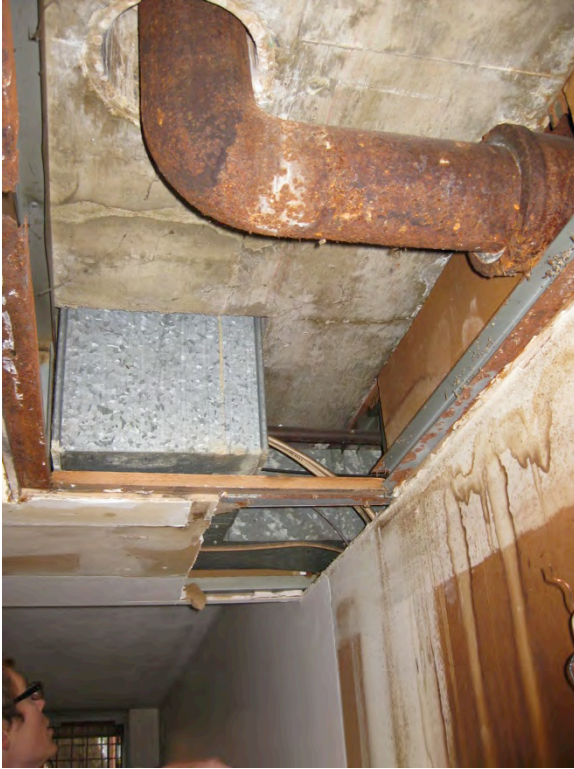
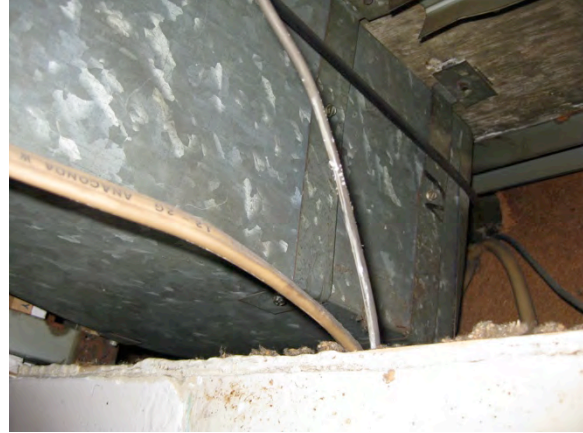
Figure 8. Dead-end stub of supply plenum extends through demising wall. Left: View of supply plenum with kitchen soffit and cabinets removed; Right: View into demising wall cavity through large opening around dead-end stub of supply plenum.

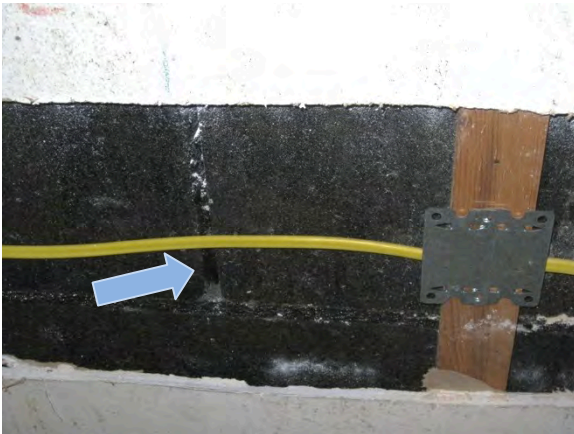
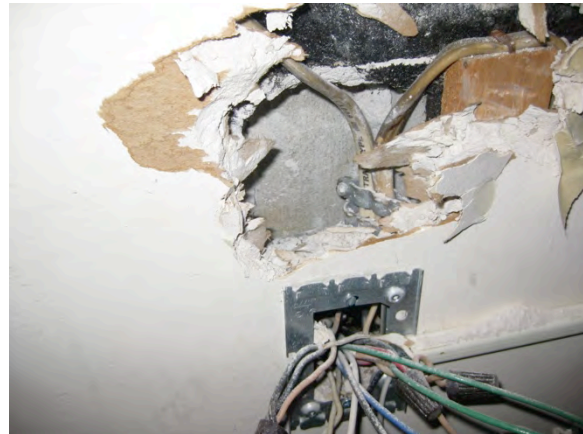
Figure 9. Left: Small hole in mortar joint of exterior wall; Right: Large existing hole in CMU of exterior wall apparently created to accommodate electrical and communication services.

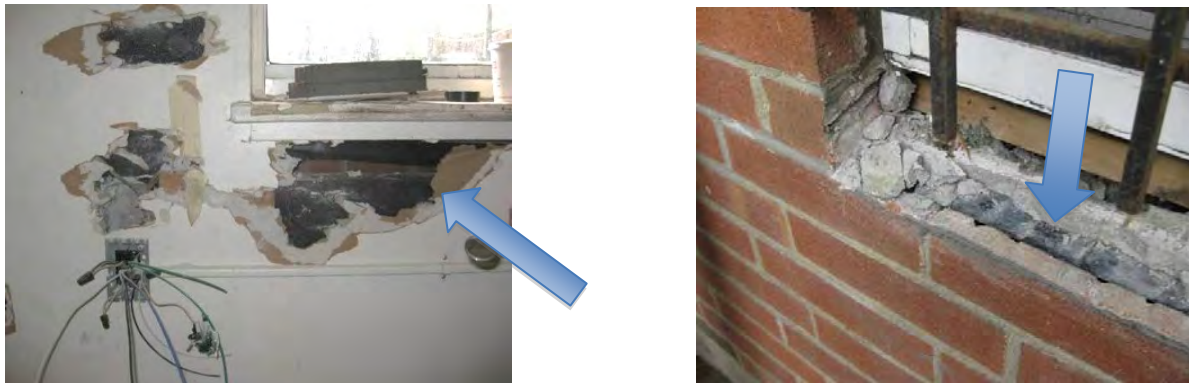
The window replacement represents an important opportunity to address airflow control because of the large openings in the airflow control layer observed around the window openings. The windows had been installed to wood bucks. A large (but, as discovered later, variable) gap existed between the wood buck and the CMU opening. In Figure 11, the back of the brick veneer is clearly visible through the gap between the sill buck and the CMU. Because the CMU backup wall, with its dampproof coating on the interior side, was the primary infiltration control layer for the apartments, the window replacement details and installation sequence needed to provide a means to seal between the wood bucks and the CMU opening.

Figure 11. Destructive investigation into existing window assembly and installation. Left: Interior view of existing window installation in mock-up unit. Note the gap between masonry opening and sill; Right: Exterior view of existing window installation in mock-up unit. Note the sill membrane forming a trough that is filled with mortar.

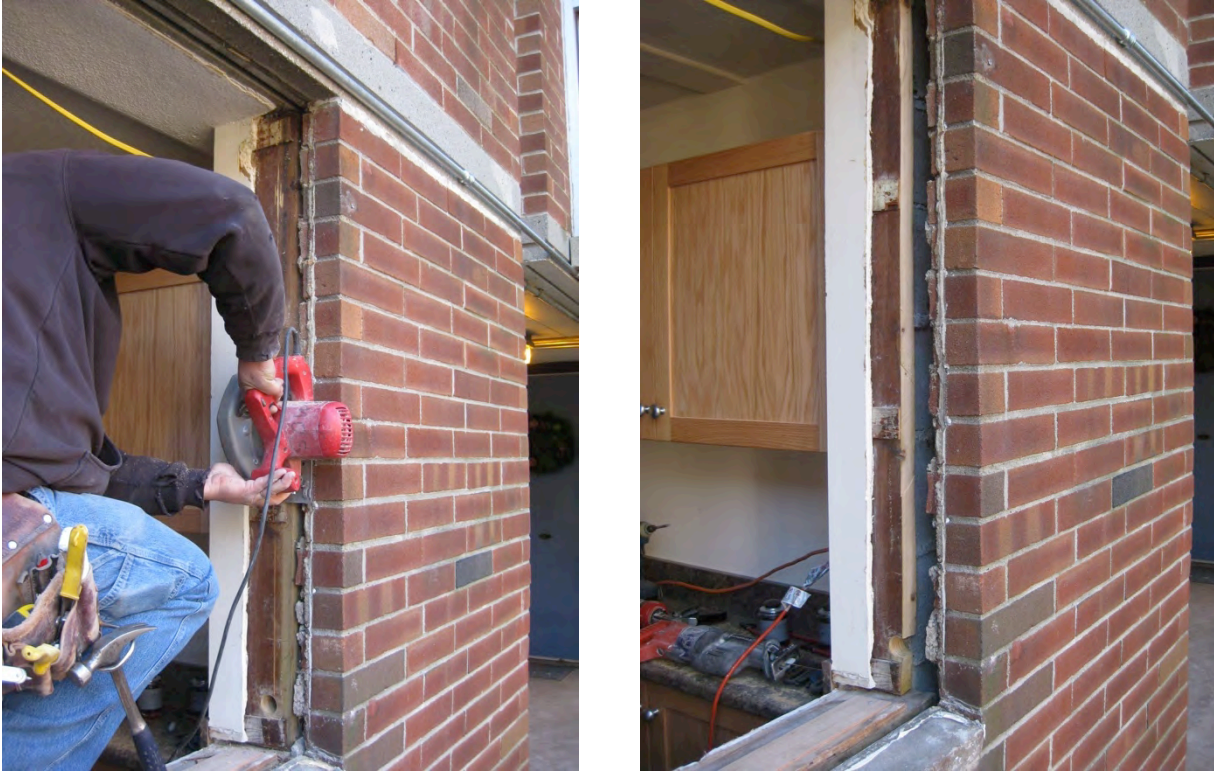
Figure 13. Left: Wood jamb buck being cut to allow access to joint between buck and masonry opening; Right: Wood jamb buck cut showing both working and visual access to the gap to be sealed.

The window installation details in the construction bid documents called for drilling the wood bucks at regular intervals and injecting a foam sealant into the gap. This was a less-than-desirable solution because it did not offer the opportunity to visually verify a continuous seal. The window installation subcontractors devised and demonstrated an alternate approach involving cutting the wood bucks to allow access to the gap to be sealed. The wood buck is cut approximately flush with the face of the CMU backup wall. The gap between the wood buck and the CMU opening is then accessible through the cavity between the brick and the CMU.

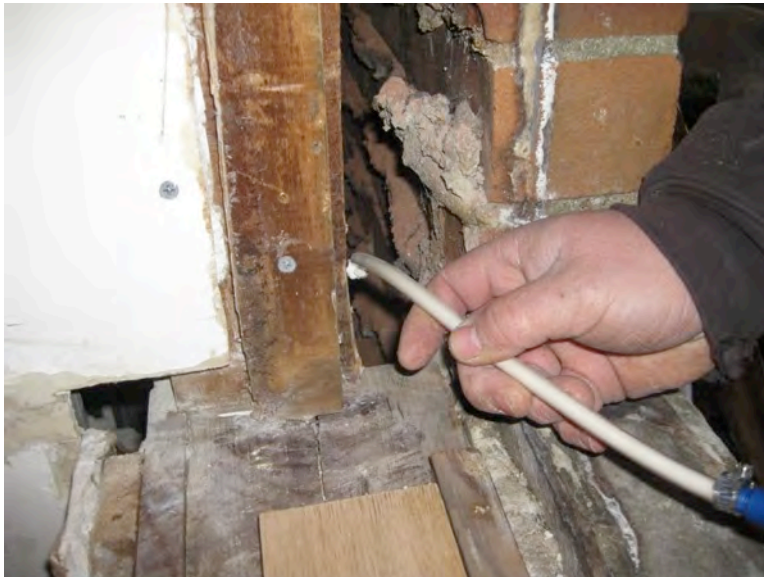
Figure 14. Foam sealant being applied between off-cut wood buck and CMU

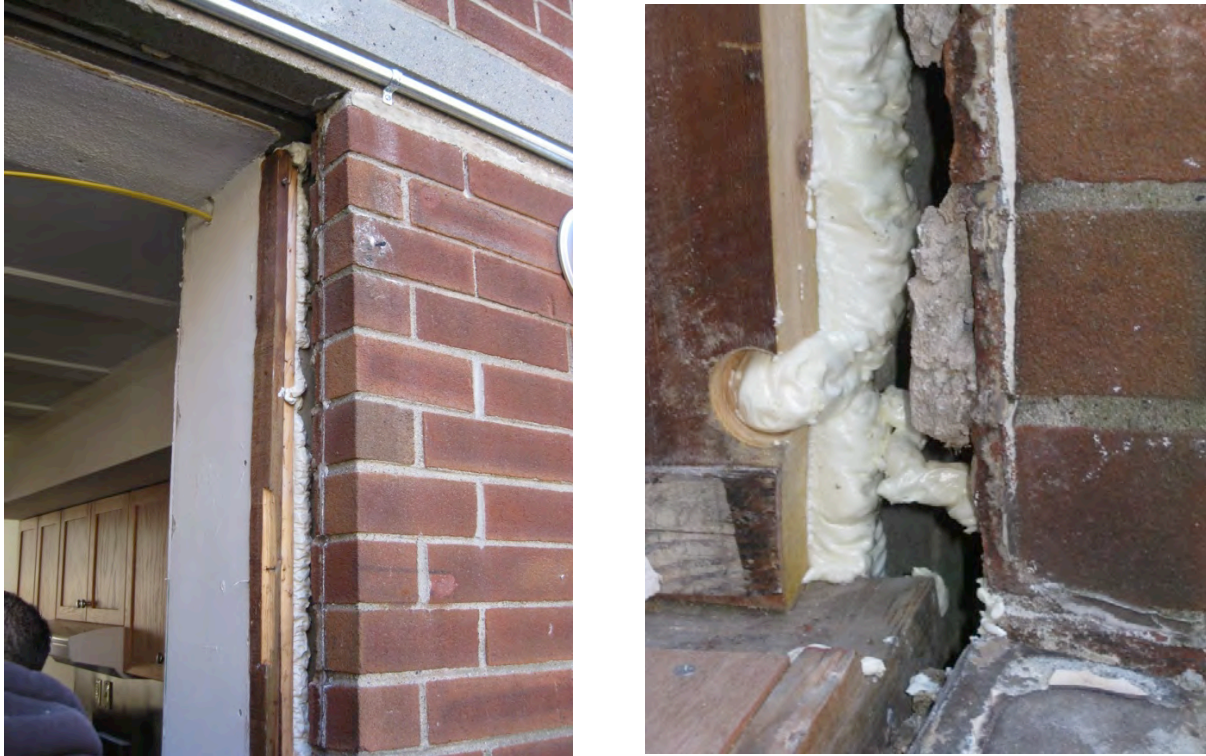
Figure 15. Left: Visual access enables verification of seal between buck and masonry opening; Right: Foam sealant in gap between wood buck and CMU backup wall.

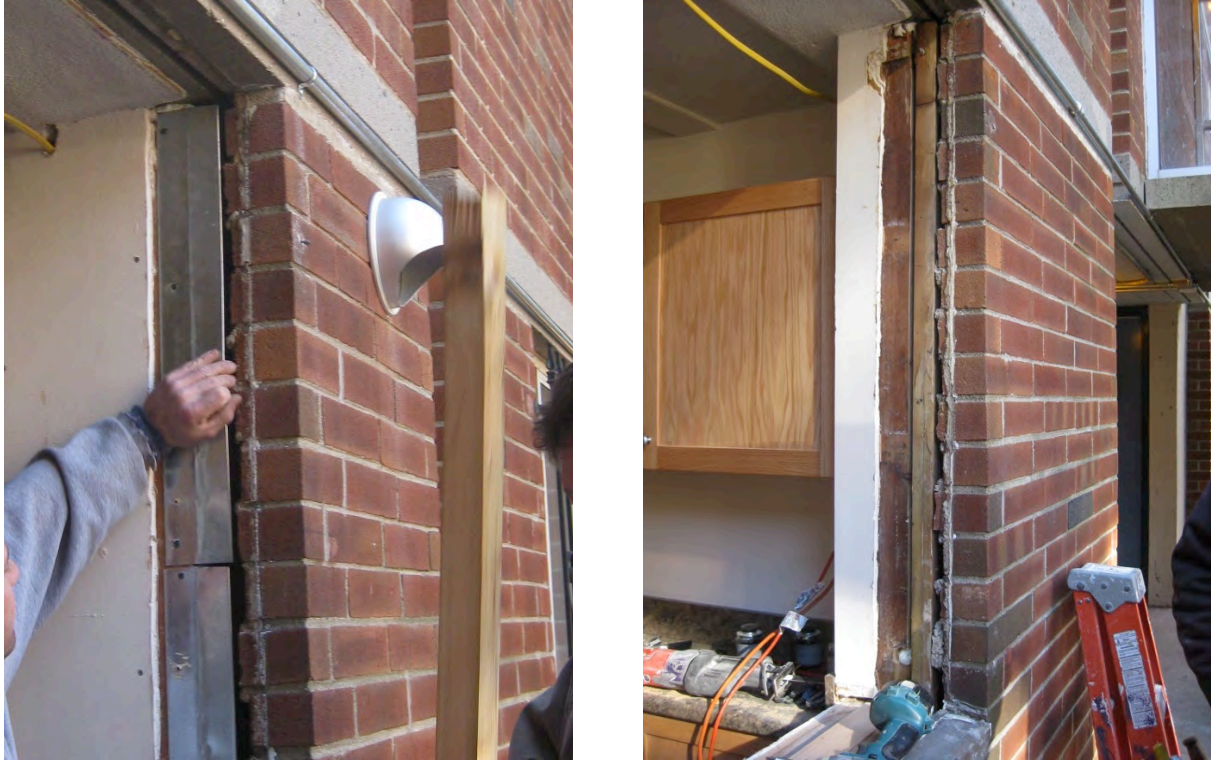
Figure 16. Left: Metal coil stock support for jamb flashing between wood buck and brick return; Right: Wood buck off-cut reattached as jamb flashing support.

When the wood buck was cut away approximately flush with the face of the CMU backup wall, it left a significant gap between the buck and the brick. The window unit covers this gap, but a jamb flashing is needed at the jamb of the opening. Therefore, a substrate for the jamb flashing was needed to allow this flashing to bridge the cavity between the CMU backup wall and the brick. A piece of metal coil stock was used in the first mock-up unit window installation. Subsequently, the window installation subcontractor demonstrated that the off-cut of the wood buck could be reattached as a substrate for the jamb flashing membrane provided that the application of foam sealant at the jamb buck was not excessive.

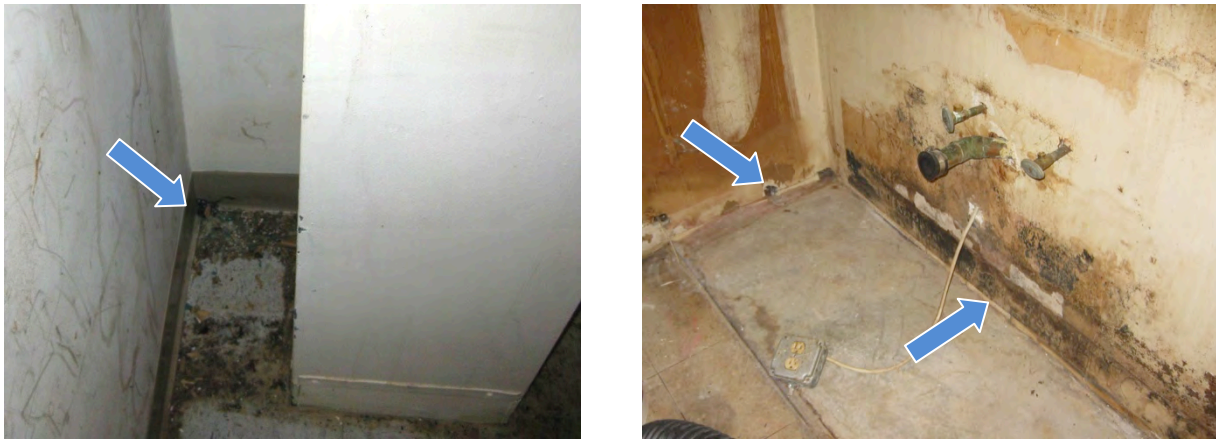
Figure 17. Left: Copious evidence of rodent activity on floor of second floor closet; Right: Rodent hole behind kitchen cabinet location and apparent pre-existing attempt at sealing base of wall to floor with joint compound.

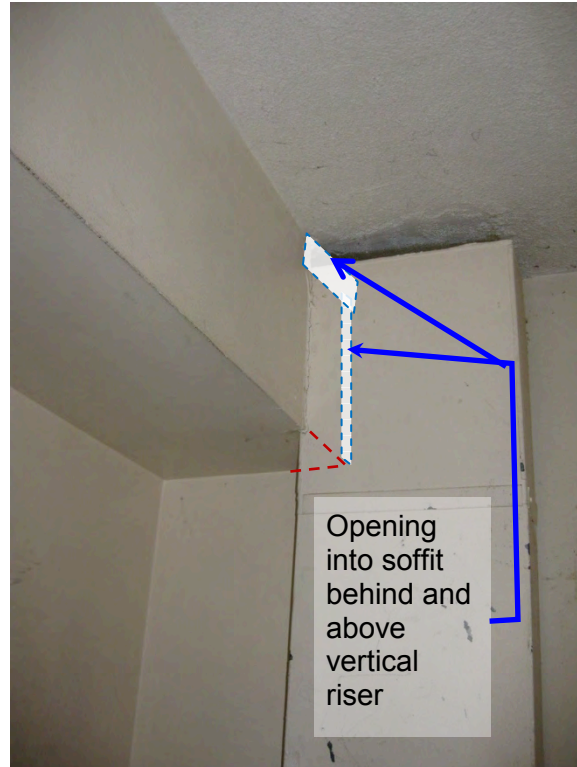
BSC observed a condition in this apartment unit where the duct soffit (which, in turn was opened to the demising wall) is open to the apartment. This opening was found to contribute significantly to the total enclosure air leakage of the apartment. BSC worked with the general contractor and architect to devise a suitable remedy for this situation that was added to the air sealing scope of work. The remedy had to accommodate considerable variability found for the particular condition.

Figure 18. Opening into soffit at second floor of low-rise mock-up apartment.

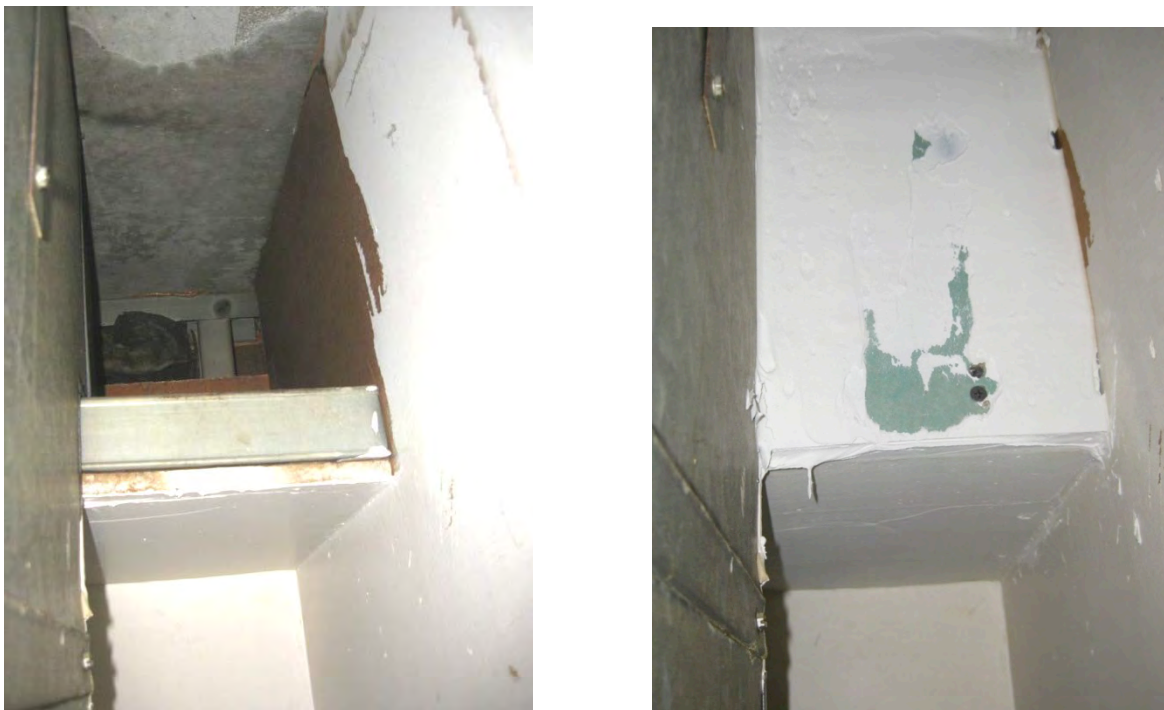
Figure 19. Left: Opening into duct soffit along side vertical riser. View into soffit and demising wall cavity (with dirty batt insulation) beyond; Right: drywall closure for duct soffit.

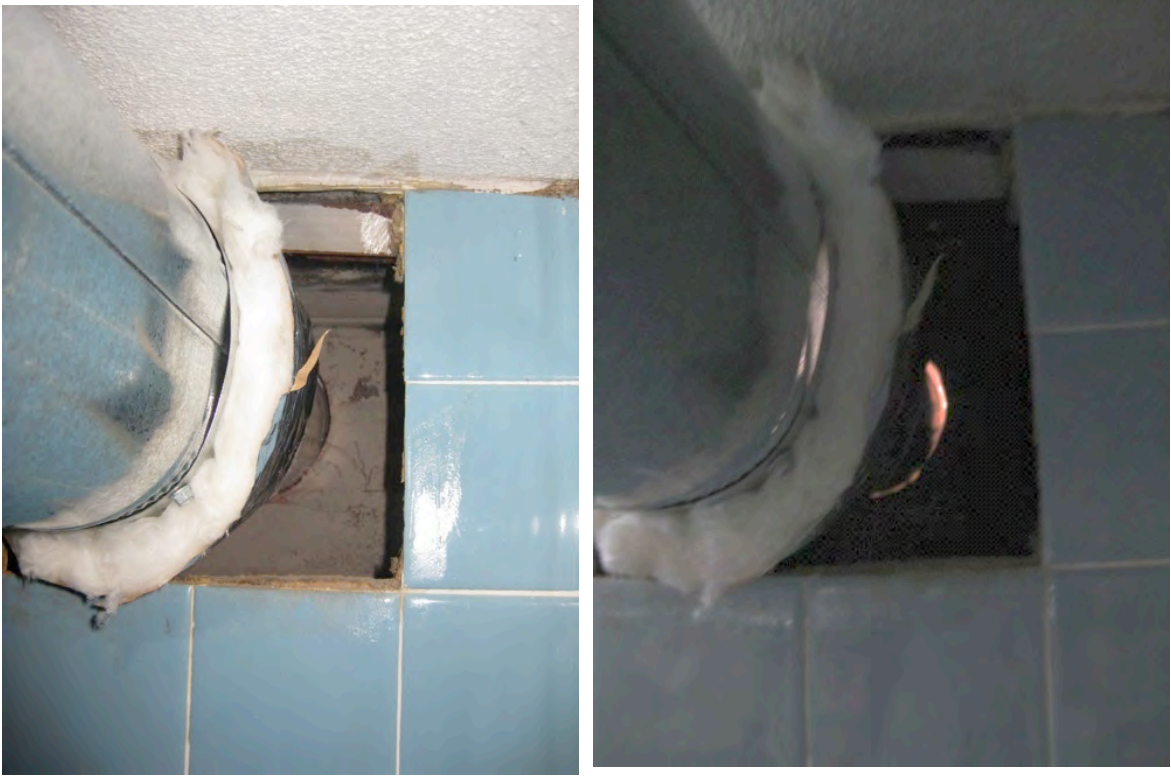
Figure 20. Left: Early attempt at sealing exhaust duct. Note annular seal between sleeve and duct but not between duct sections or sleeve and wall; Right: Backlit image of early attempt at sealing exhaust duct illustrates where air seal is needed.

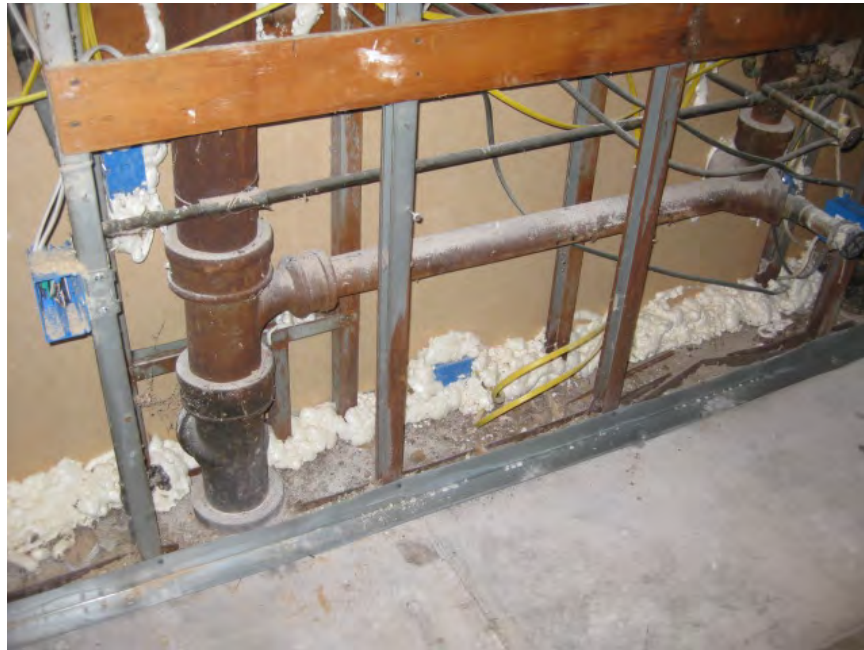
Figure 21. Demising wall at kitchen air sealed from open side of wall.

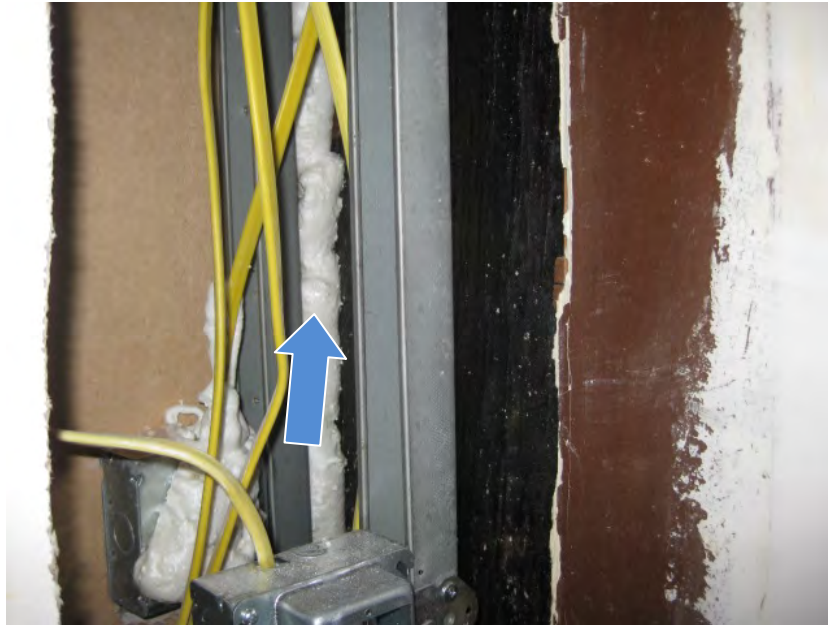
Figure 22. Airflow control connection between drywall and exterior wall achieved through open side of wall.

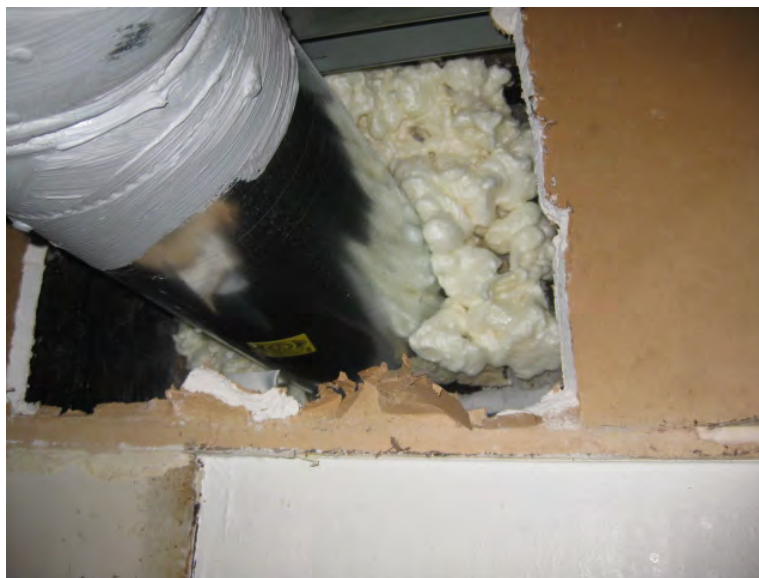
Observation of the rapid sequence air sealing work also revealed instances where clarification of the intent of the scope is needed. In observing progress in two apartments, BSC noted that a new bathroom exhaust duct passing through the exterior wall assembly had been sealed at different locations in each apartment. In the first apartment, the wallboard of the furred out exterior wall had been cut away to allow the duct to be sealed at the penetration through the CMU of the exterior wall. In the other apartment, the drywall was cut neatly around the exhaust duct that appeared to have been sealed to the drywall.

Figure 23. Large opening in drywall around exhaust duct allows access to exhaust duct penetration through CMU backup wall – the primary airflow layer for the exterior wall.

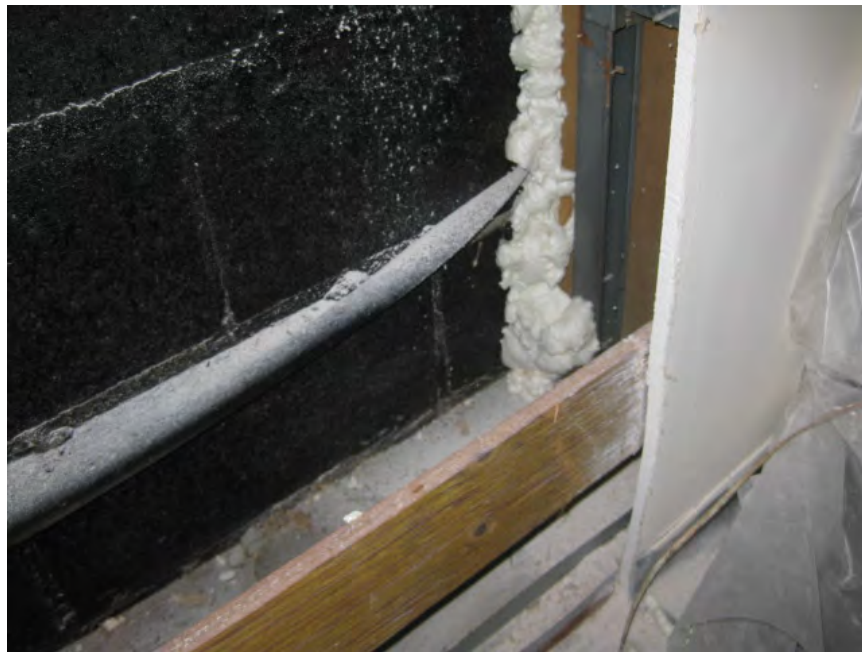
Figure 24. Inside of CMU layer in exterior wall. Note dampproof coating and through-wall flashing

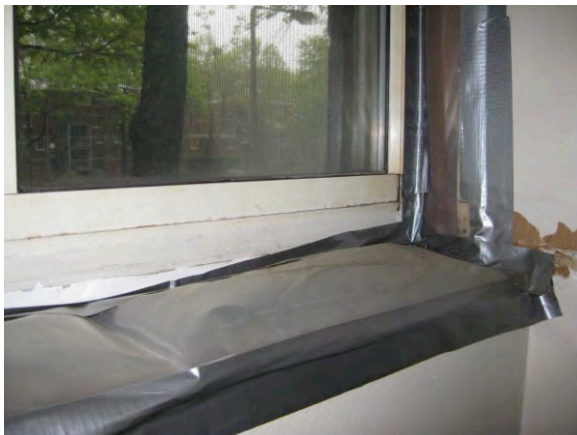
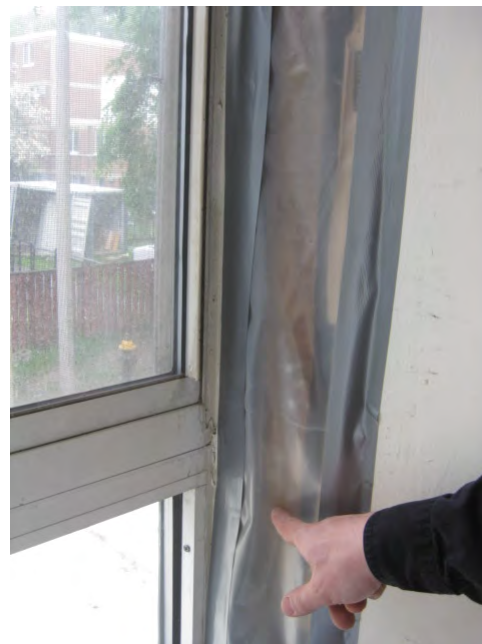
Figure 25. Left: Plastic sheeting at sill of window opening billowing inward during depressurization testing; Right: Plastic sheeting at window jamb return billowing inward during depressurization testing.

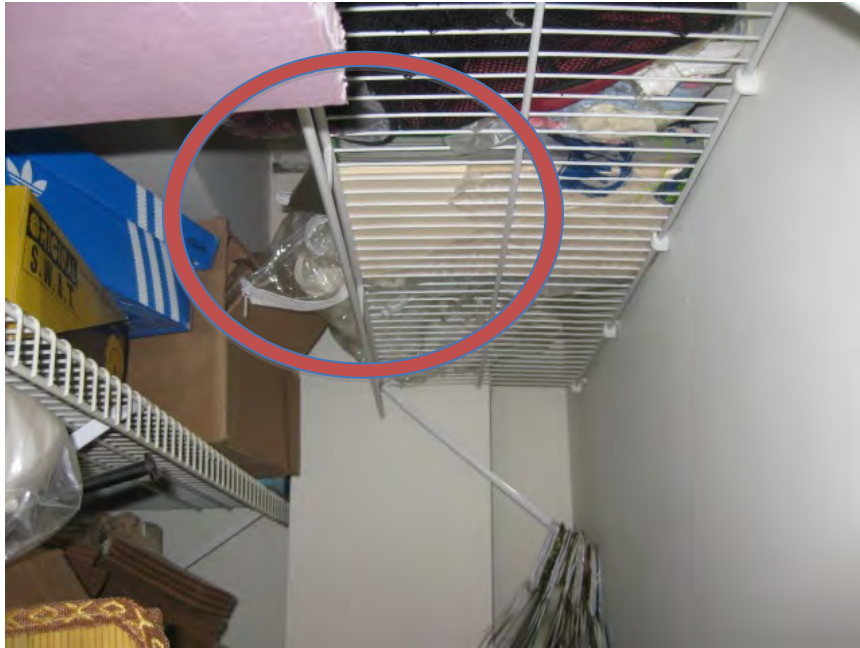
Figure 26. Duct riser to duct soffit connection at the back of a narrow closet in end-unit apartments.

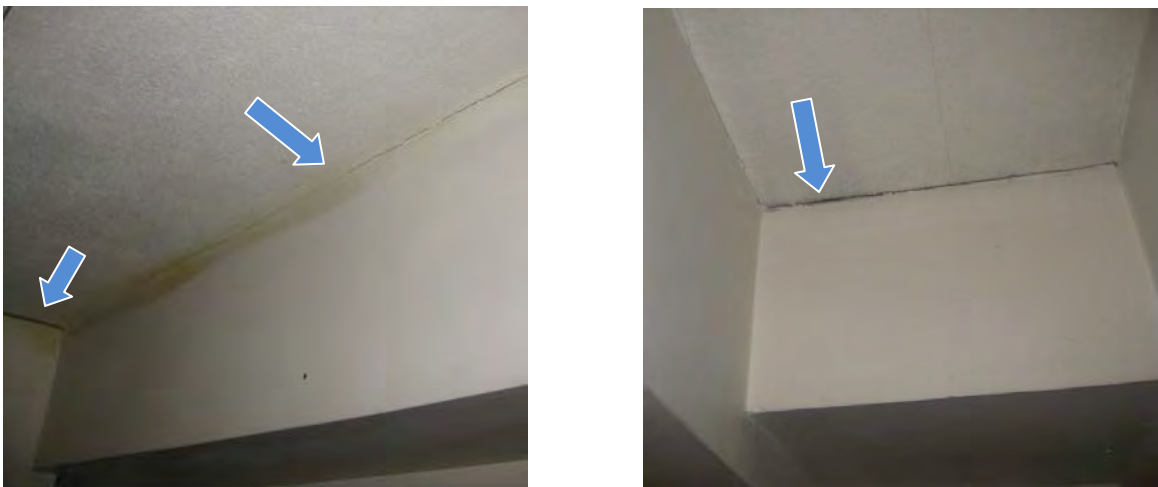
- At several locations on the second floor walls and soffits, the drywall surface appears to have settled downward, creating a gap between the drywall and the underside of the floor/ceiling assembly (Figure 27).

Figure 27. Gaps between drywall and floor/ceiling assembly observed at second floor

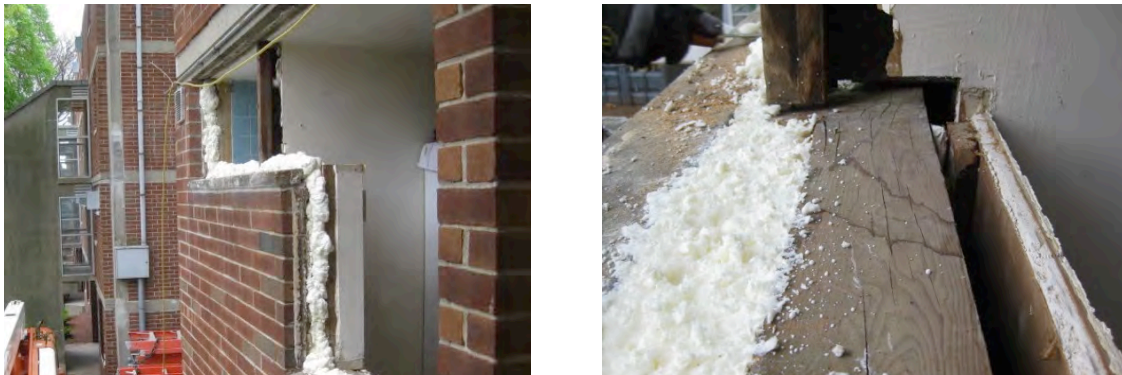
Figure 28. Left: Expanding foam sealant installed to bridge the cavity between the brick and the CMU; Right: Expanding foam sealant trimmed to provide substrate for flashing membrane.

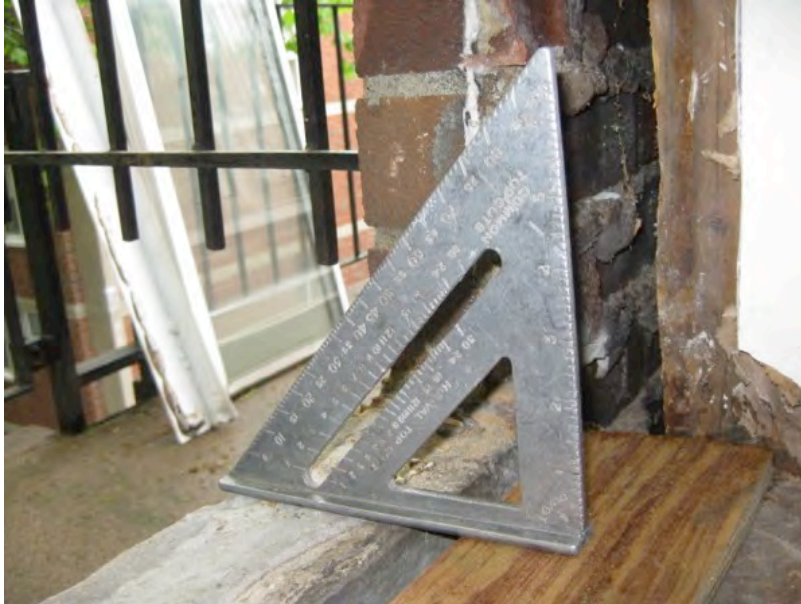
At the first apartment where windows were installed as part of the regular construction process, problems with the size of the window became apparent. Although the windows fit within the rough openings given by the existing wood bucks, the height of the stone sill at the exterior relative to the height of the sill buck varies. For the sill flashing to be above exterior sill trim and/or slope onto the exterior sill trim, the window openings require varying amounts (heights) of blocking at the sill. Because of the tight tolerances of the window size relative to the rough opening, the window installers were not always able to install sufficient blocking to raise the sill flashing above the exterior trim (see Figure 29 and Figure 30).

Figure 29. Sill blocking even with height of exterior sill prior to installation of exterior sill trim piece.

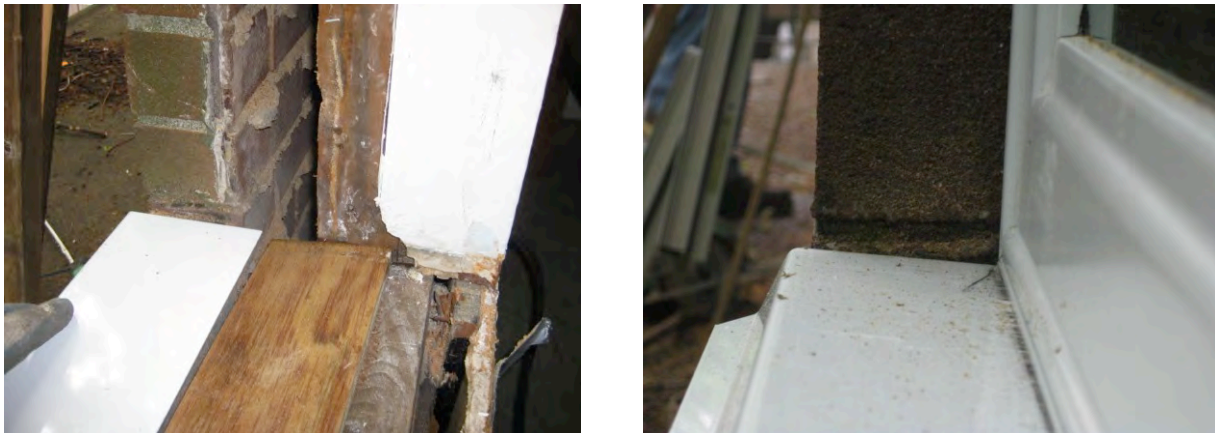
Figure 30. Left: Exterior sill trim above height of sill blocking; Right: Back-sloped sill trim.

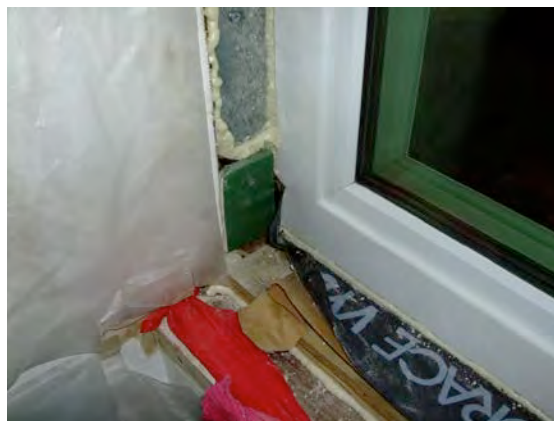
Figure 31. Corner of sill pan flashing in a very tight spot. Note that backing is left on the portion of the flashing membrane to the inside of the window to facilitate turning the membrane up at the sill to form a back dam.

Preformed corner pieces would be preferable to a membrane for the sill pan flashing as these would be less likely to be abraded, cut, or torn by the corners of the window during window installation.

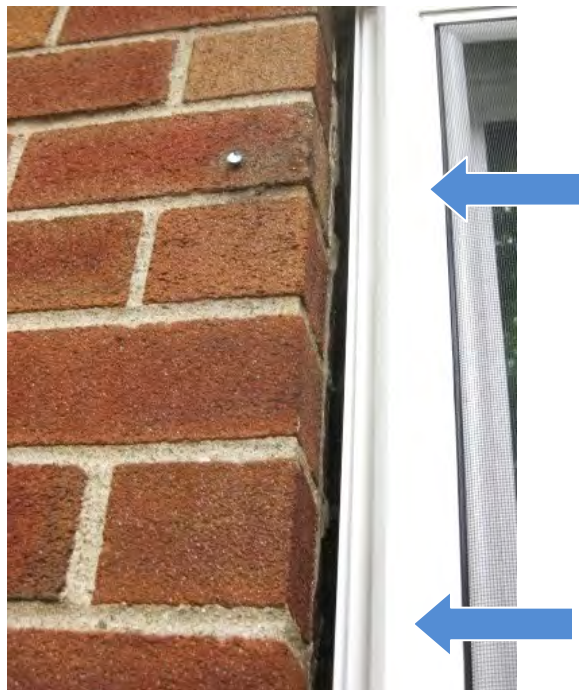
It is possible that dust and debris on the brick surface prevented good adhesion of the membrane. In this project, it was not possible to scour the brick clean because of the presence of asbestos-containing caulk on the brick around the window opening. A liquid-applied primer may have helped with the adhesion of the membrane. It is also possible that a membrane better suited to adhering to irregular surface would provide a more robust jamb flashing for the window opening. BSC recommended that the installation incorporate the use of a liquid primer at the brick openings.

Figure 32. Jamb flashing membrane poorly adhered to brick substrate as evident in gaps between the membrane and the brick.

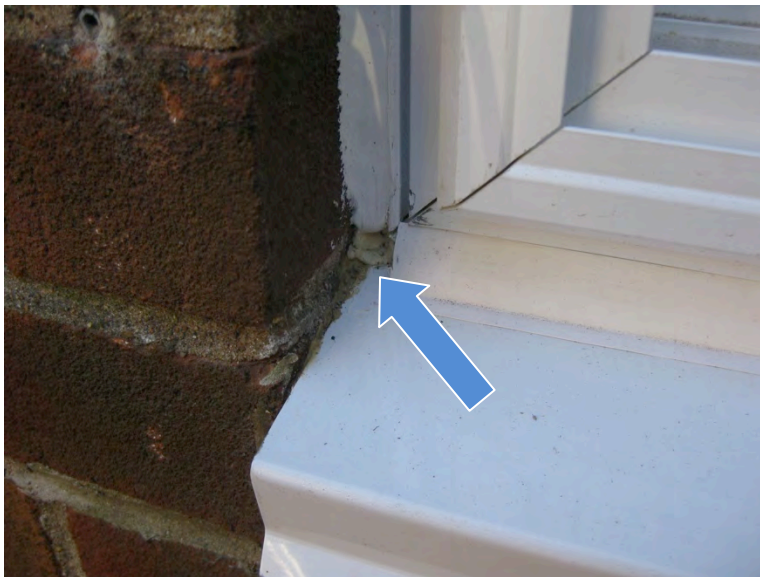
Figure 33. Sealant joint stopped short to allow drainage also presents potential path of water entry.

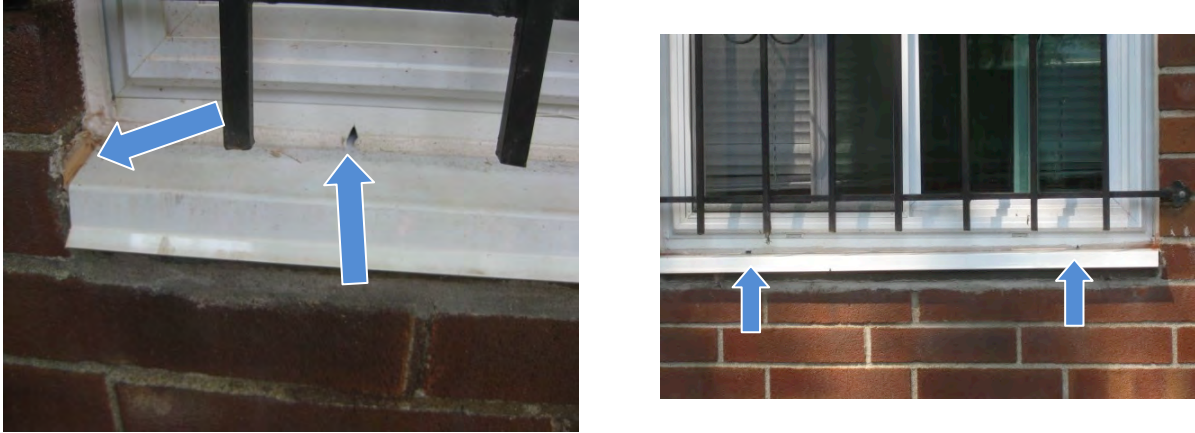
Figure 34. Left: Sealant joint between sill aluminum sill trim and brick, and “V” cut weep notched into sill trim closure; Right: Weep holes at $\frac{1}{4}$ points of the sill closure trim.

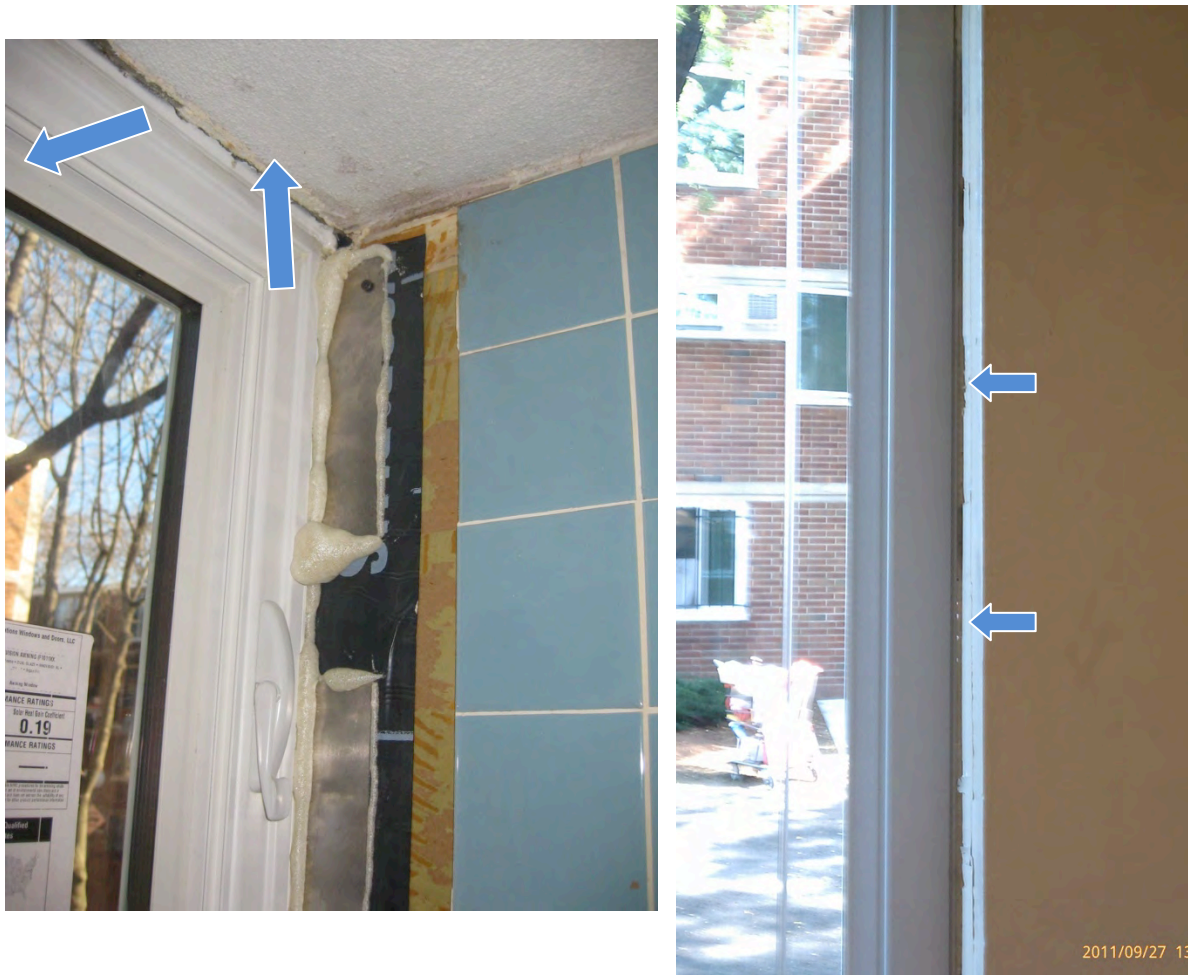
Figure 35. Left: Expanding foam sealant at window jamb and fillet bead of sealant at head of early window installation; Right: Poor seal at window perimeter with gaps permitting view to outside.

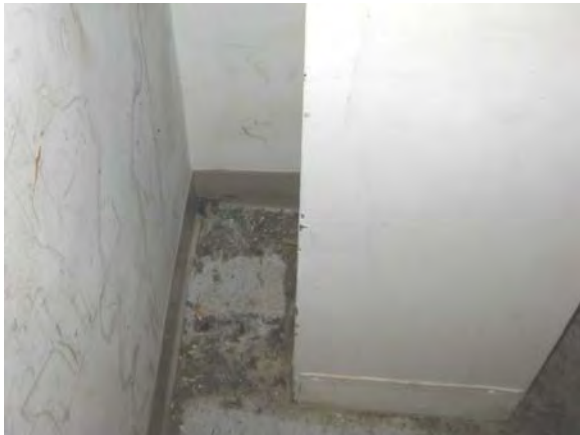
Figure 1: Copious evidence of rodent activity in second floor closet

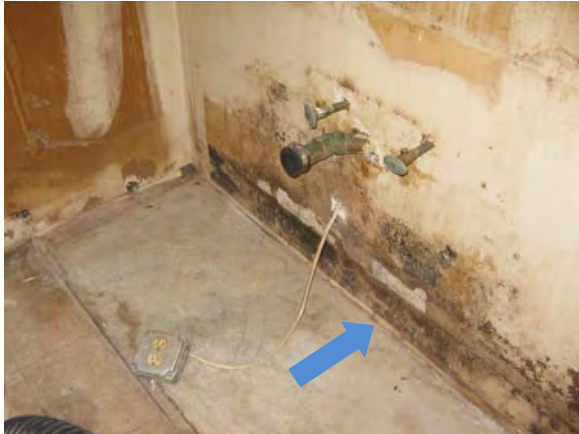
Figure 3: Apparent existing joint compound sealing at base of kitchen wall

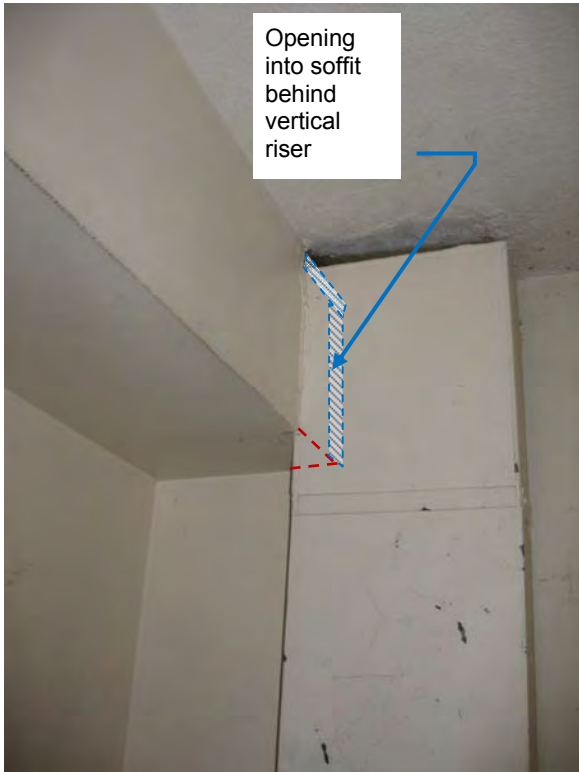
Figure 6: Opening into soffit at second floor of previous low-rise mock-up apartment
