Leveraging Limited Scope for Maximum Benefit in Occupied Renovation of Uninsulated Cold Climate Multifamily Housing

Building America Report - 1106

21 December 2011 (Rev. March 2012)

K. Neuhauser, D. Bergey, and R. Osser
Building Science Corporation

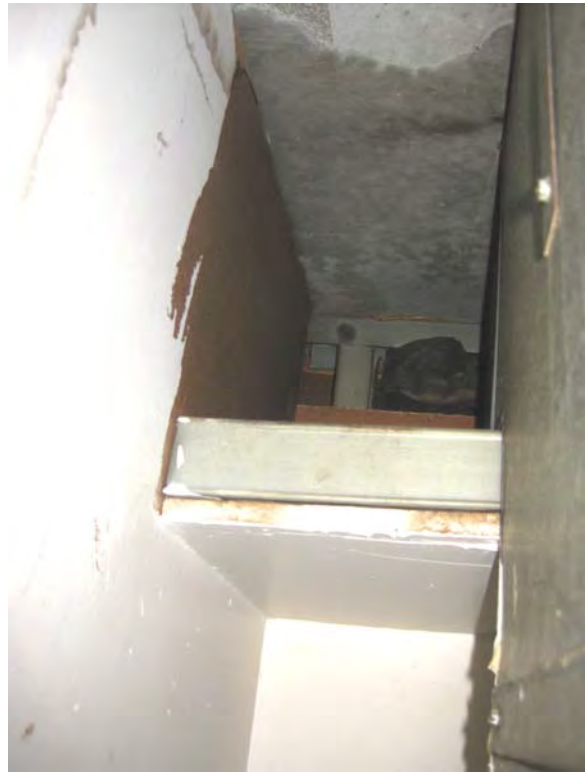
Figure 7: Opening into soffit at second floor of present low-rise mock-up apartment. Note opening into demising wall.

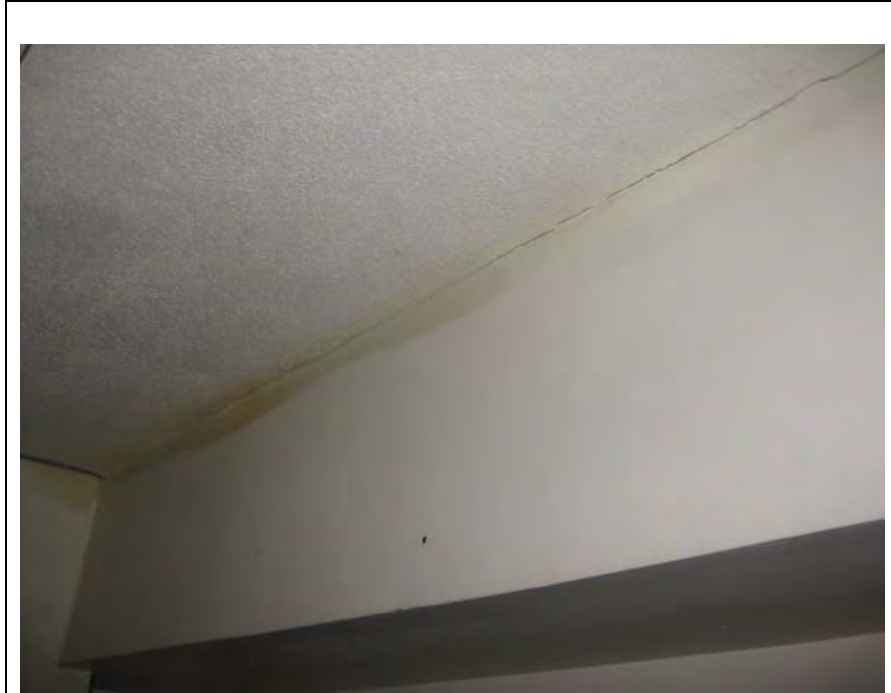
Figure 8: Gap between drywall and floor/ceiling assembly at second floor

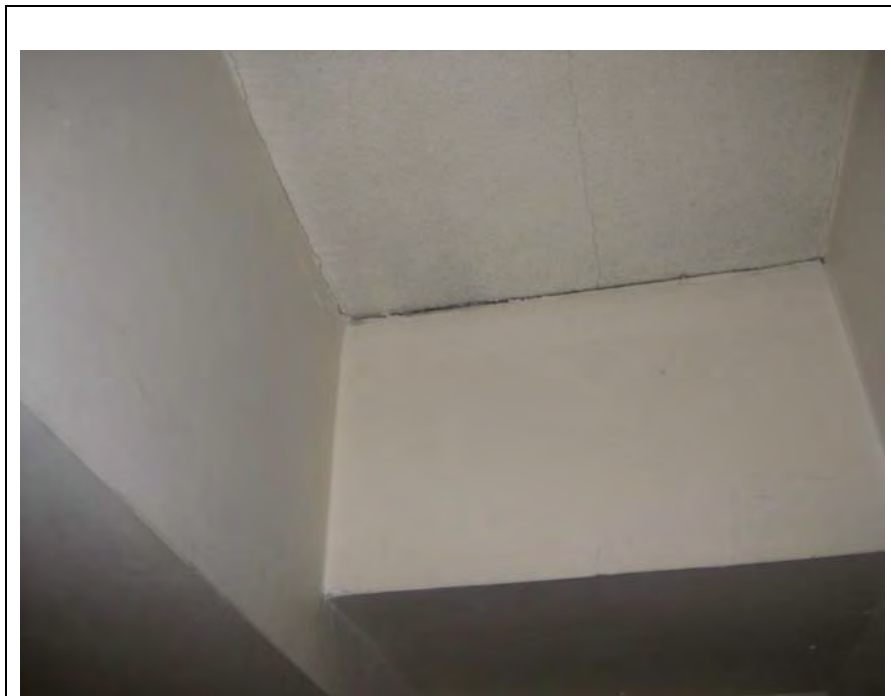
Figure 9: Gap between drywall and floor/ceiling assembly at second floor
