## 2. HABITAT FOR HUMANITY OF GREATER LOWELL, FARMHOUSE RENOVATION, BEDFORD, MA

#### Farmhouse Retrofit Prototype, Gate 3

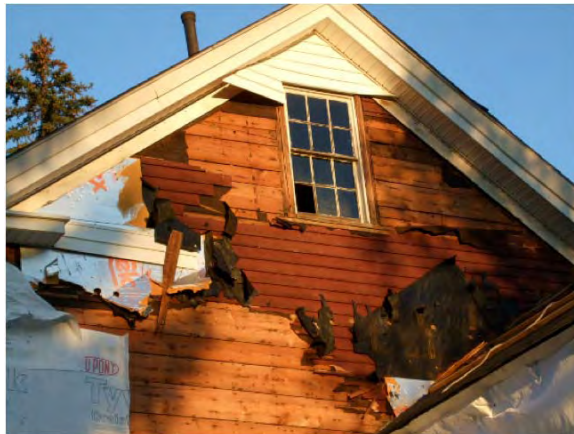
Figure 2.5 shows the multiple layers removed during the demolition process, including the existing vinyl siding, thin-profile foam sheathing underlayment, building paper, wood clapboard, another layer of building paper, and the original board sheathing. For the most part, the existing board sheathing and the structure were in excellent condition.

**Figure 2.5: Demolition photo showing multiple layers of exterior wall cladding**

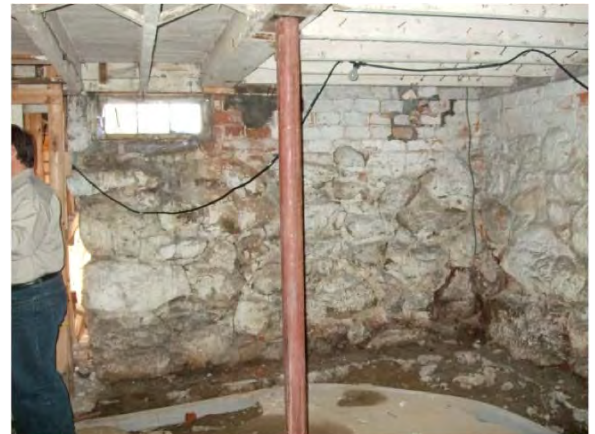
Figure 2.6 shows an interior of the basement, which is a rubble wall foundation; this type of foundation wall construction is a particular challenge for retrofit insulation, due to its uneven surface and questionable water-stopping abilities. The brick seen at the upper portion of the wall is non-structural infill. The exposed above-grade portion of the foundation is large (~5' long) granite block, supporting a timber (8x8) sill beam.

**Figure 2.6: Existing rubble stone foundation**

- Foundation:** As mentioned earlier, rubble stone foundations are a particular challenge for retrofit insulation. One of the approaches recommended in “Building Science Digest 103: Understanding Basements” by Joseph W. Lstiburek, Ph.D., P.Eng. (based on his *ASHRAE Journal* article, “Understanding Basements,” July 2006) is interior urethane spray foam insulation. This air-impermeable and vapor-impermeable material prevents air and vapor diffusion based condensation of interior moisture, and greatly reduces the transmission of ground-sourced moisture to the interior of the basement. It is a system with excellent performance; in addition, the exposed rim joist at the basement can be sprayed simultaneously, greatly improving condensation control and airtightness. This sprayed-on system has no problem with the uneven surface of a rubble stone foundation. A 2-3” layer of spray foam (R-13 to R-19.5) is specified.

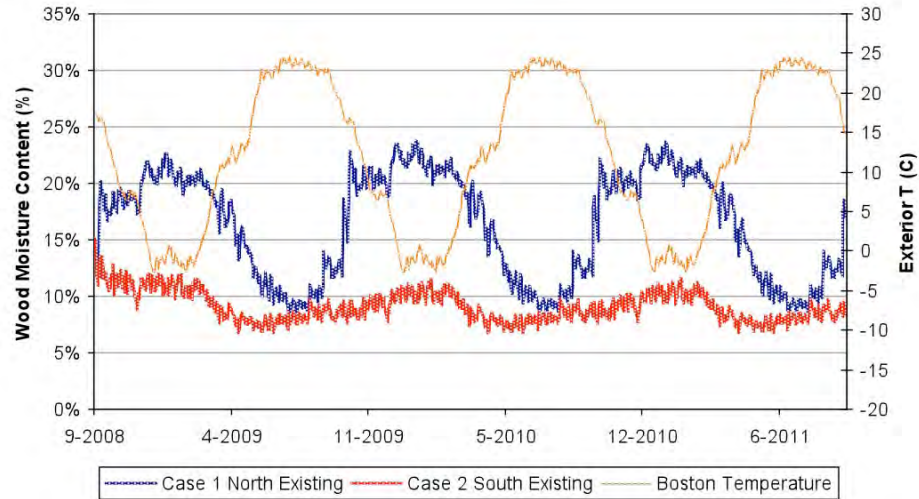
**Figure 2.14: 0.5% rainfall penetration in original wall**

In contrast, in the original assembly the north wall sheathing moisture content rises to roughly 22%. When the same rainfall entry rate is applied to the renovated wall, moisture content rises continually every season, for the three year simulation. However, if the rain penetration is reduced to 0.25%, the moisture content of the north side sheathing stays at safe levels.

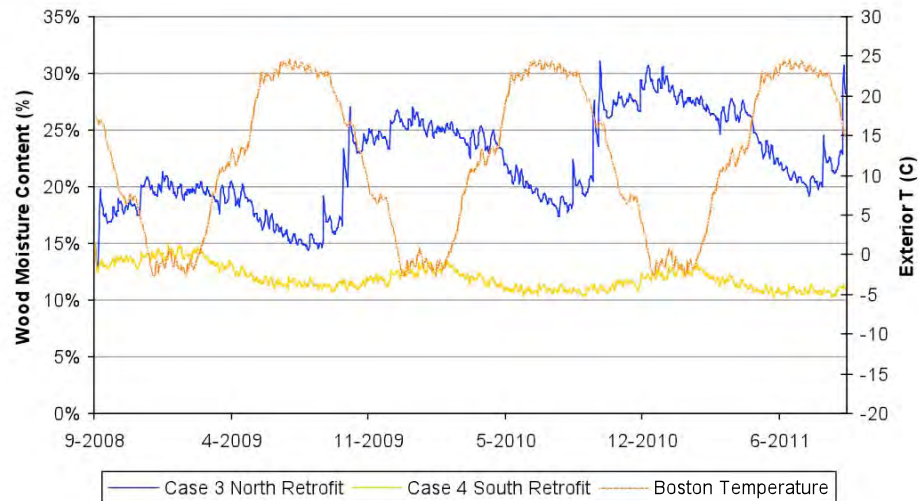
**Figure 2.15: 0.5% rainfall penetration in retrofit wall**

Overall, the results showed that this technique does indeed increase risks: a wall that had a small rain leak into the stud bay cavity (0.5% of incident rain) would cycle from dry to wet seasonally; after the retrofit, this same amount of rain resulted in a seasonally rising pattern. However, cutting the rain leakage to 0.25% (by half) of the incident rainfall resulted in safe behavior. This indicates that rain penetration of the structure is an increased risk due to this retrofit; however, improvement of the rain management details done concurrently can safely address these concerns. Note that many assumptions are

These results were used to demonstrate that if an exterior foam retrofit is done, it is vital to assure that windows and mechanical penetrations are flashed properly. Also, during disassembly/stripping of cladding, any signs of water damage should be investigated and dealt with. If new windows are to be installed in rough openings, a pan flashing draining to the exterior should be installed (as shown in A-16 and A-17 on “2008-11-04 Farmhouse Drawing Set.pdf”).

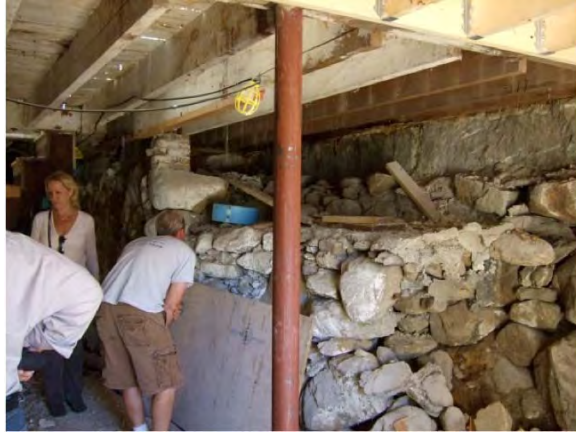
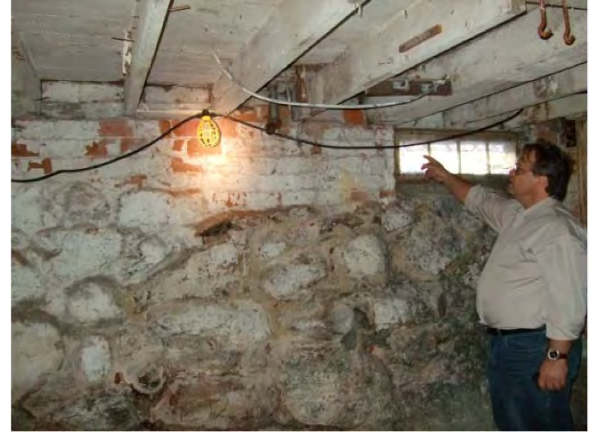
Due to these concerns, the design team and the contractor consultant visited the site, to evaluate the risks (see **Figure 2.17** and **Figure 2.18**). One goal was to determine whether or not we require the lifting of the sill beam to place a capillary break (peel & stick membrane) between the sill and the foundation.

**Figure 2.17: Evaluation of foundation risks**

**Figure 2.18: Evaluation of foundation risks**

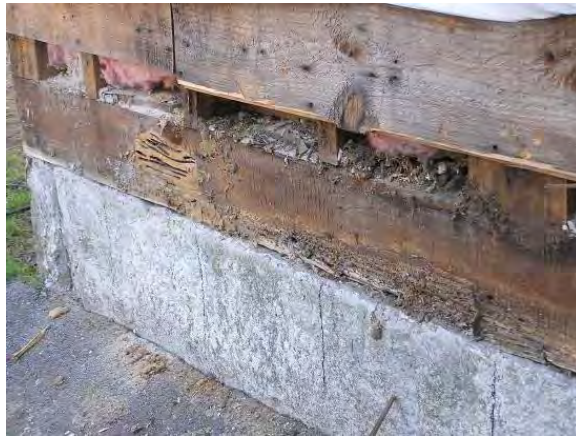
It was determined that risks were high, so this “lift” procedure was undertaken. During the initial disassembly and lift, it was immediately noted that there was decay damage at multiple locations at the sill beam (see **Figure 2.19** and **Figure 2.20**).

**Figure 2.19: Sill beam decay visible after removal of board sheathing**

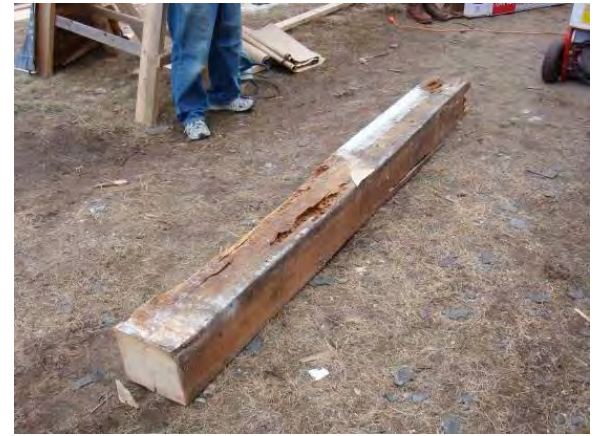
**Figure 2.20: Sill beam decay noted at foundation-contact portions**

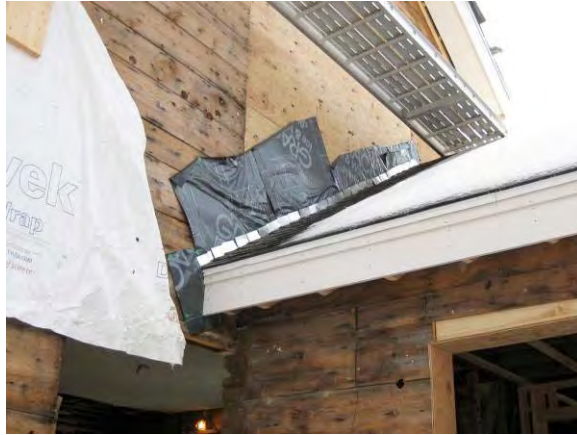
In many cases, construction proceeded ahead of design, or differently than the specific details of the design. In these cases the team consulted with the builder and revised details in order to preserve the performance objectives. The roof-wall interface detail in **Figure 2.30** shows an example of a detail created for one of these situations. **Figure 2.28** also shows a detail that was revised after construction followed a different direction than indicated on the project drawings. The revision was formulated and agreed to in a discussion with the site supervisor during a site visit. It was necessary to provide an alternative method of achieving air barrier continuity at this location, when the earlier solution was not implemented.

Figure 2.28: Step flashing applied behind intended location of drainage plane

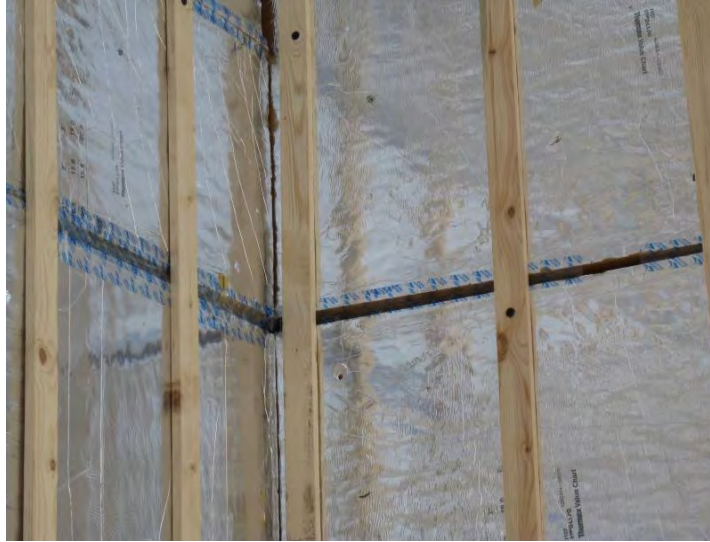
In general, it appears that the air barrier concept has not caught on with the crews. There are several places with large gaps between sheets of foam. The foam corners are very loose with no membrane applied. In some cases, furring would need to be removed to apply membrane over the corners.

**Figure 2 - Gaps in Foam Sheathing**

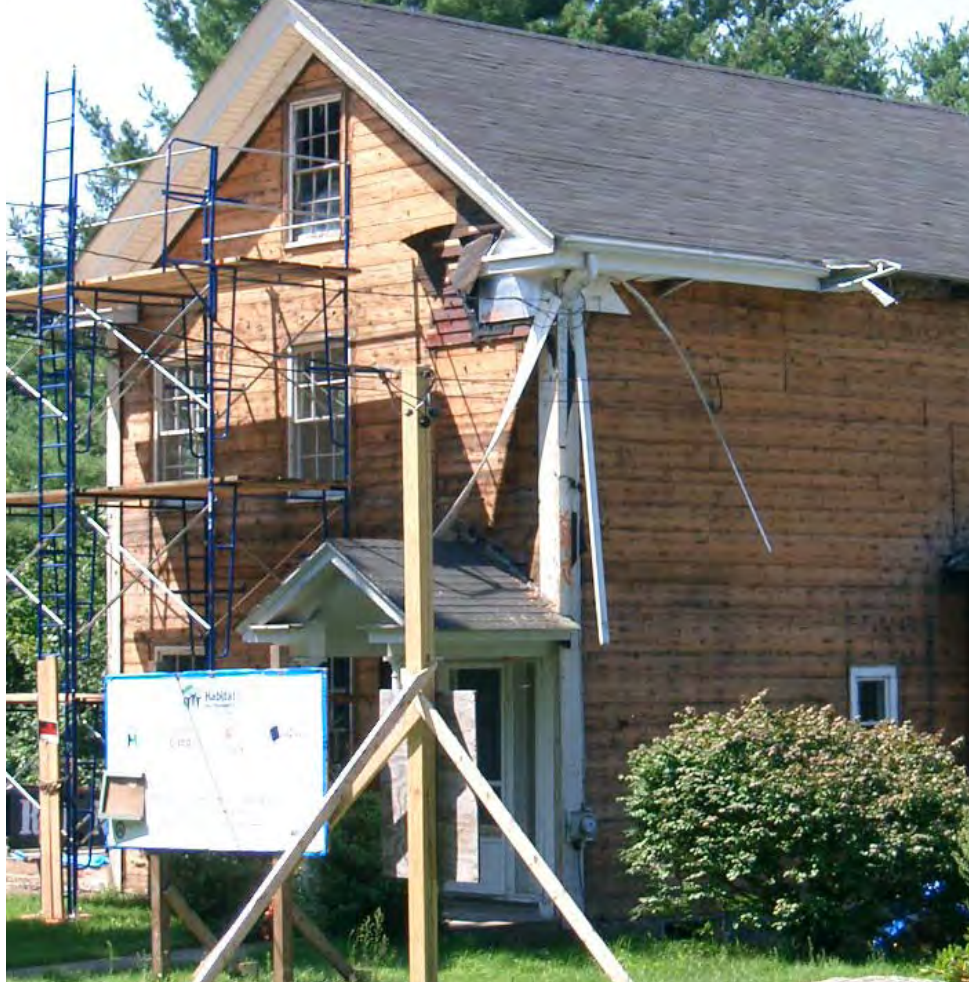
As shown in the image below, the earlier cladding of the building included wide corner boards (I'm guessing around 8-9"). It is also apparent that the front entry roof did return over the corner board. We will use cues from the earlier configuration to guide historically appropriate exterior trim.

**Figure 1 - Earlier trim details revealed during demolition**

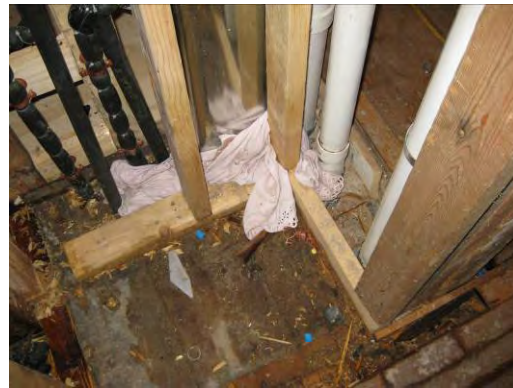
**Figure 5 - plumbing and ductwork holes**

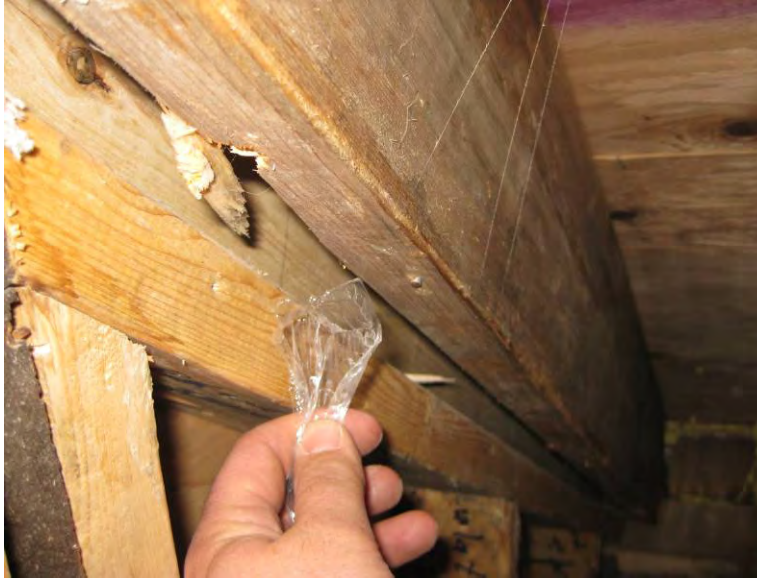
Tight spacing of framing in this location did not allow access with canned foam in order to seal this bay.

**Figure 10 – observation of air flow at narrow rafter bay at addition roof rake**

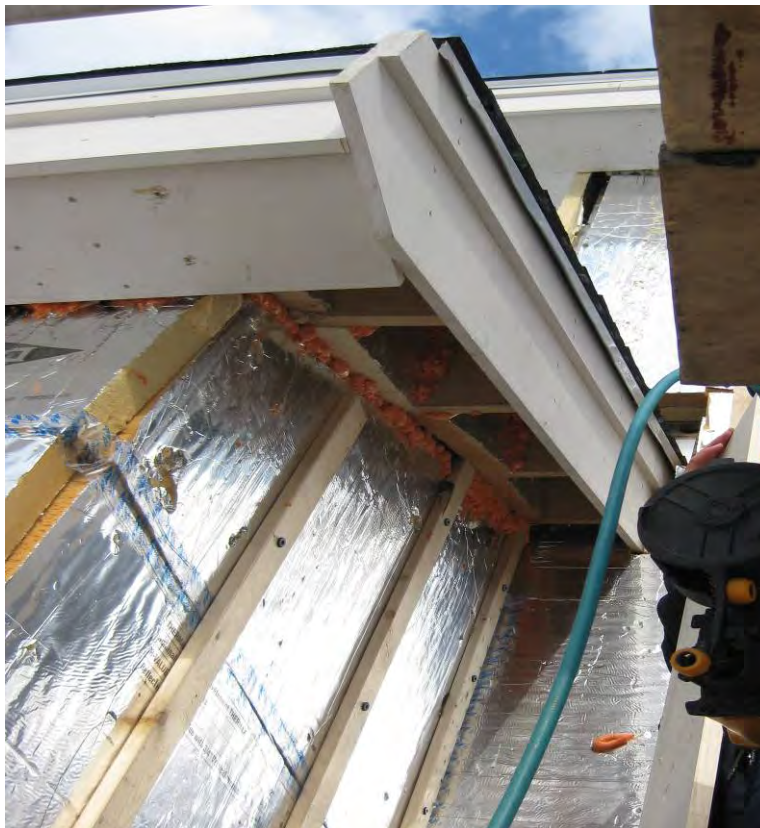
**Figure 11 - addition roof rake during construction prior to air sealing remediation**

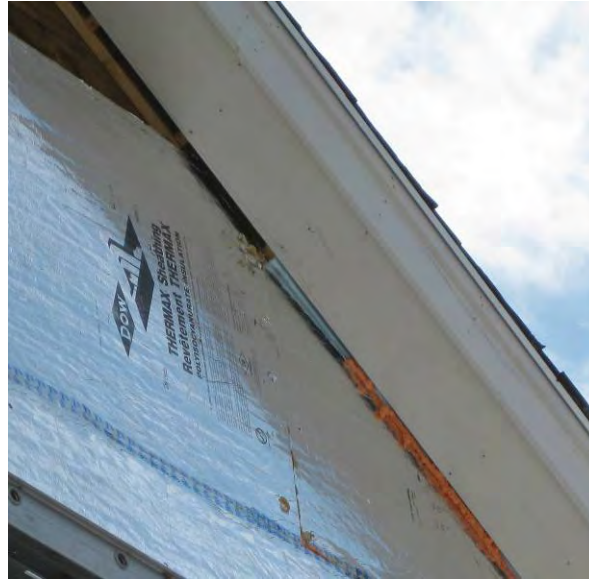
**West facing roof rake** – significant air leakage was felt at the top of the West-facing gable wall of the existing structure. In a quick pass over suspected trouble spots, air leakage was not felt at the top of the East-facing gable. Different construction suggests an explanation for this difference in observed air barrier performance. The East gable has two layers of foam with the second layer notched to fit around rake extension framing and then foamed to framing and roof deck. On the West gable, there is a single layer of foam. This single layer of foam is butted against ledger of rake extension framing with a less-than-convincing attempt to seal the edge of the foam sheathing to the rake extension framing.

**Figure 12 - insulating sheathing at West gable**

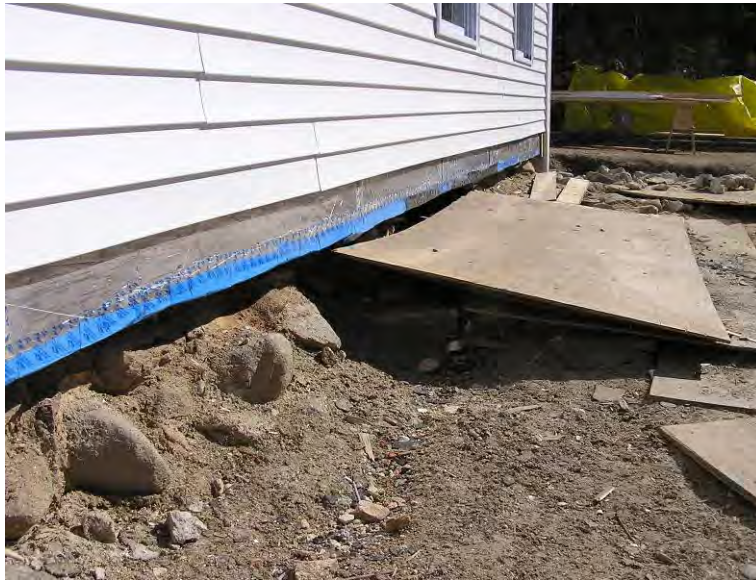
**Building Sill** – Significant design effort was devoted to air barrier transition at the building sill. In general, the designed appeared to be implemented successfully. At some locations, it was clear that one particular brand of membrane used in the design failed to adhere to the substrate. At a location on the Northeast corner, repair of the lower sheathing was carried out without using a new piece of the Straight Flash VF which had been adhered to the sheathing.

**Figure 13 - sill to wall air barrier transition**

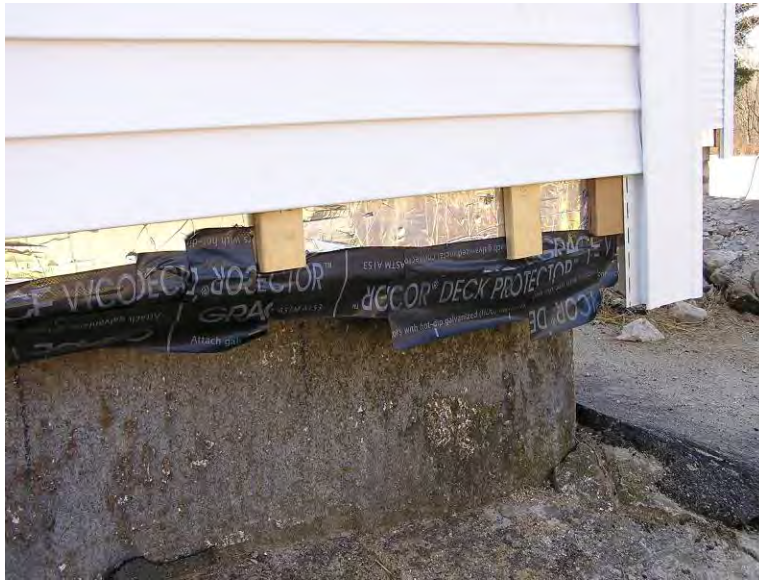
**Figure 15 - flashing membrane did not adhere to the StraightFlash VF transition membrane**

Note, the builder has indicated that the membrane shown in this photo was subsequently replaced with membrane that proved to have better adhesion to the substrates.

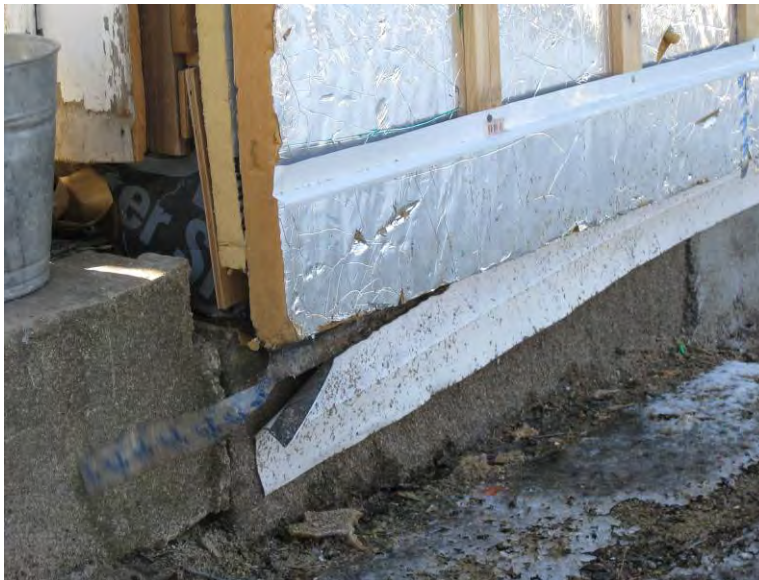
**Figure 16 - transition membrane at Northeast corner failed to re-adhere after replacement of sheathing board**

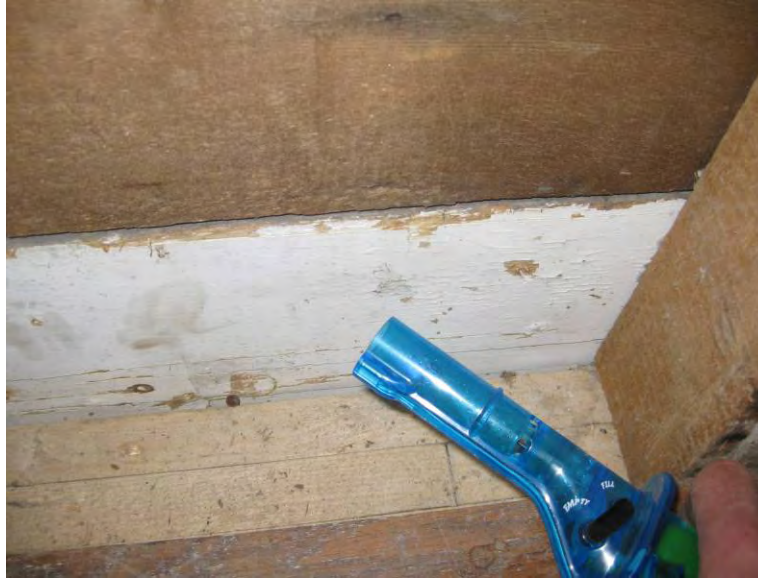
**Figure 17 - air movement observed at sill**

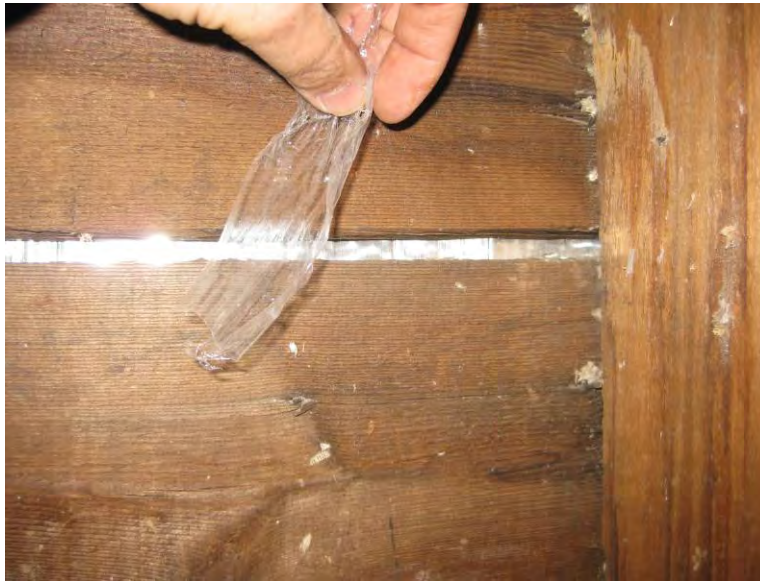
**Figure 18 - air flow observed between sheathing boards near inside corner**

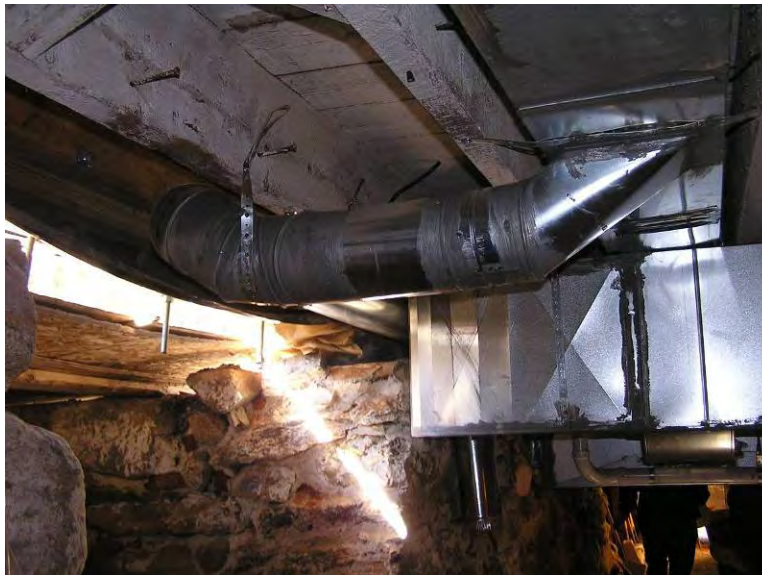
**Figure 19 - duct work as observed at earlier site visit**
