4. DAVID WEEKLEY HOMES EAGLE SPRINGS AND WATERHAVEN COMMUNITIES, HOUSTON, TEXAS

4.1 Executive Summary

Gate 3 - Community: Eagle Springs / Waterhaven, David Weekley Homes, Houston, TX

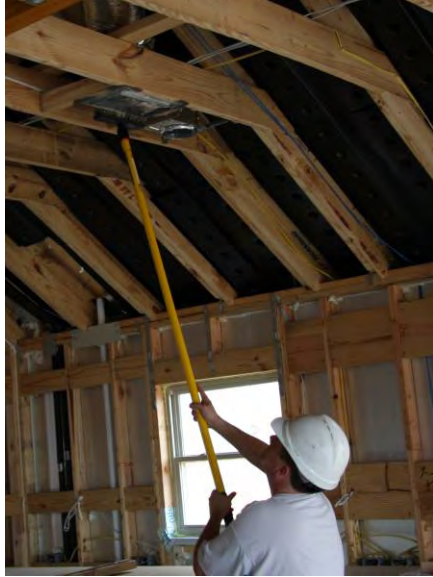
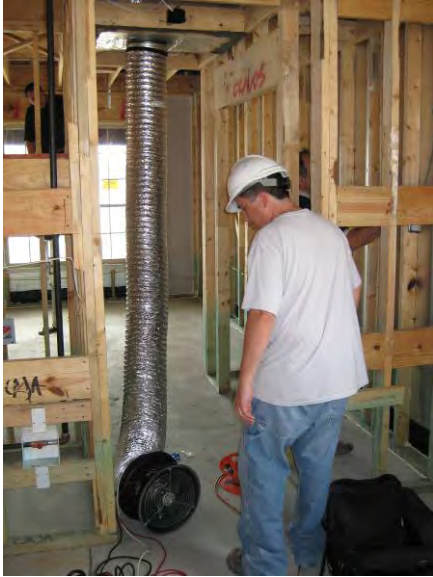
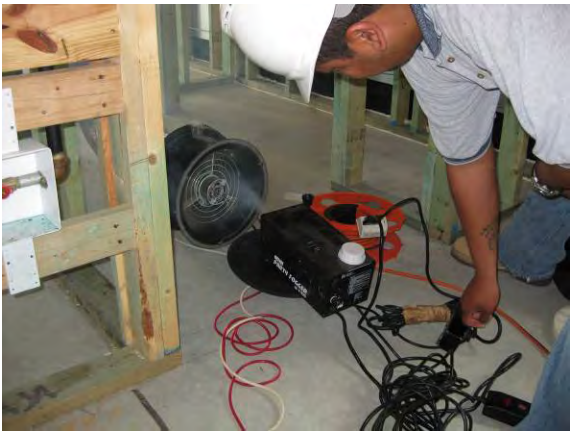
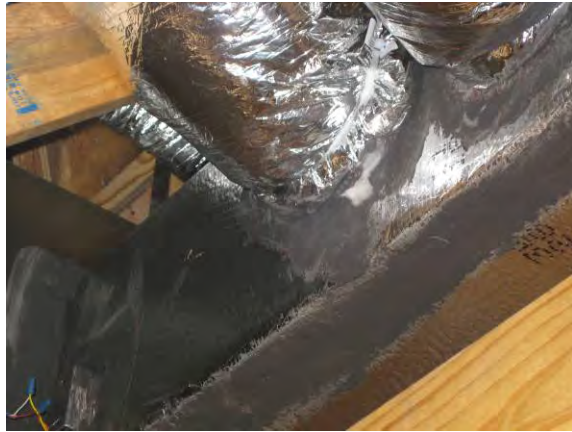
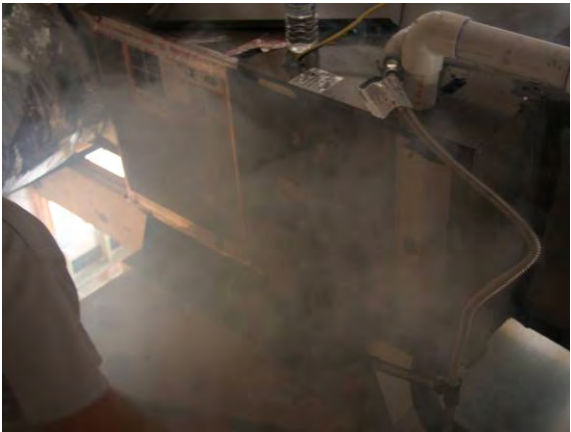
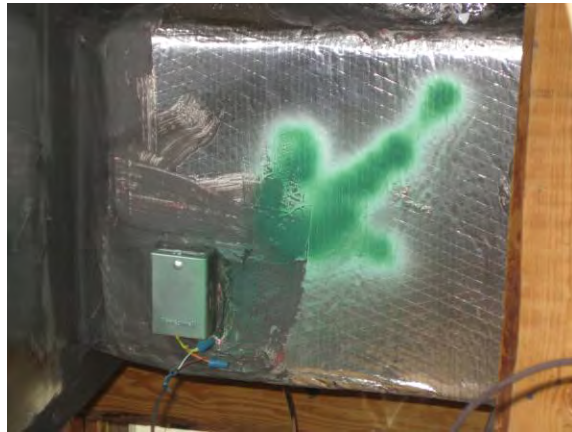
The first house (18322 West Williams Bend Drive) had a target of around 75 cfm₂₅ and an actual leakage of around 95 cfm₂₅. Using the smoke machine, leakage was observed to be coming from the AHU cabinet, joints between the supply and return plenums and the flex duct, and out of the zone valve boxes attached to the supply plenum. The joints between the supply and return plenum and the flex duct did have mastic but there was substantial leakage at several of the joints.

The second house (18226 West Williams Bend Drive) had a target of around 95 cfm₂₅ and an actual leakage of around 125 cfm₂₅. The tester again used the smoke machine and identified leakage in the same areas as the first house, but with substantially more leakage from the AHU cabinet.

In both cases the leaking areas were marked with spray paint and EnergySense failed the house on its inspection and will reinspect after the HVAC contractor provides further air sealing.

The photos below illustrate the testing process and the major leakage areas found.

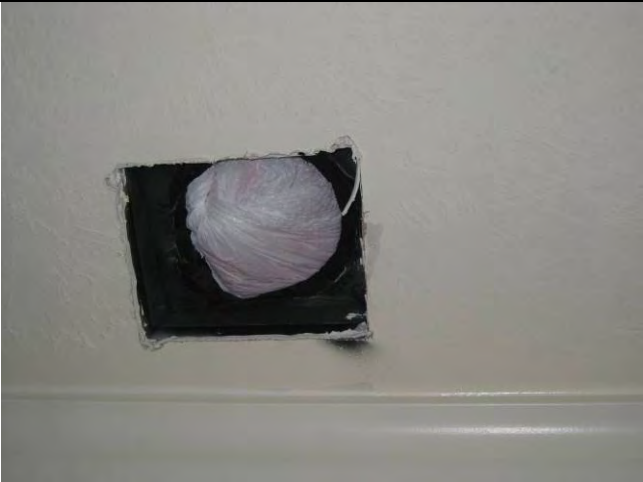
<p data-bbox="159 737 797 840">Expansion of fiberglass cylinder should completely fill supply duct. No airflow was felt around fiberglass plug during the depressurization testing.</p>

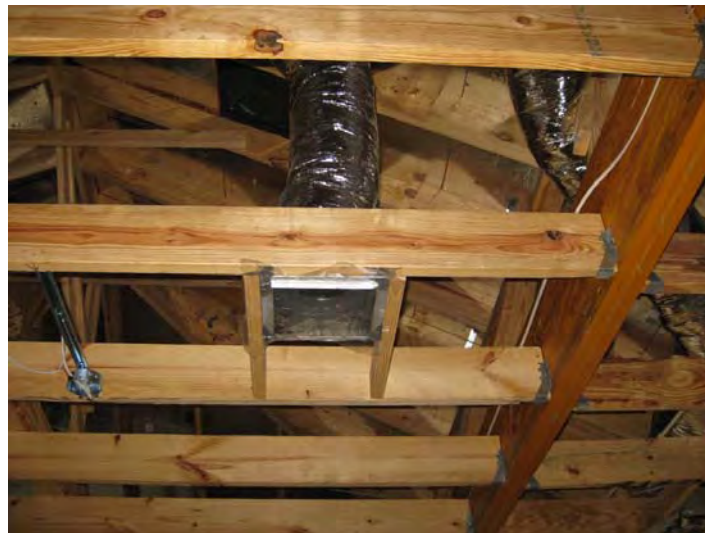
Sunset Ridge – BSC found one home in a condition comparable to the Energy Sense testing condition. Neither cavity insulation nor drywall had not been installed in this home and duct mask was still adhered to the supply boots. BSC personnel verified adhesion of this duct mask and installed duct mask at return for installation of the duct blaster equipment. The duct leakage test result obtained by BSC for this home was 35% higher than the reported result from Energy Sense.

Figure 1 - supply boot with duct mask

Note that the duct mask from Energy Sense testing two days prior is still in place. Adhesion and seal of the in-place duct mask was verified before testing.

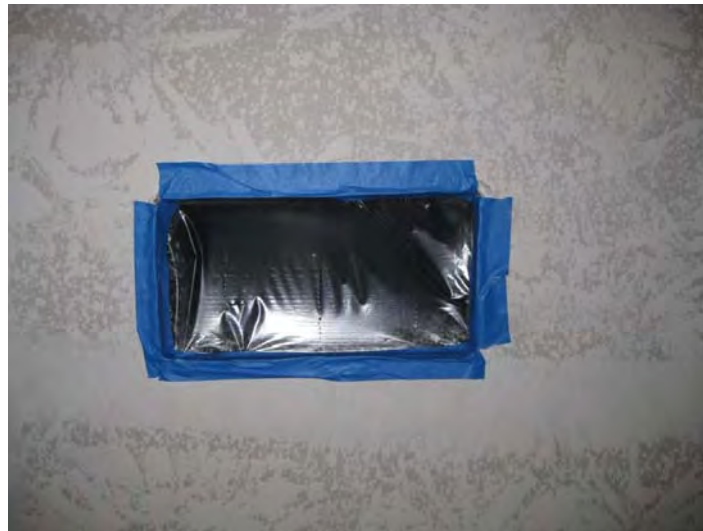
Bridgeland – After many calls to builders and after checking on home sites at multiple developments in person, BSC was compelled to test duct work in homes where “at rough” conditions could not be replicated. In the Bridgeland development, BSC conducted a duct leakage test at two homes where drywall had already been installed. In one case, spray-applied texture had already been applied to the drywall surfaces. In order to replicate conditions of the Energy Sense testing as nearly as possible, duct mask was applied to the inside of the sheet metal boot flanges as depicted in Figure 2 below.

Figure 2 - Supply boot with duct mask adhered to inside of flange

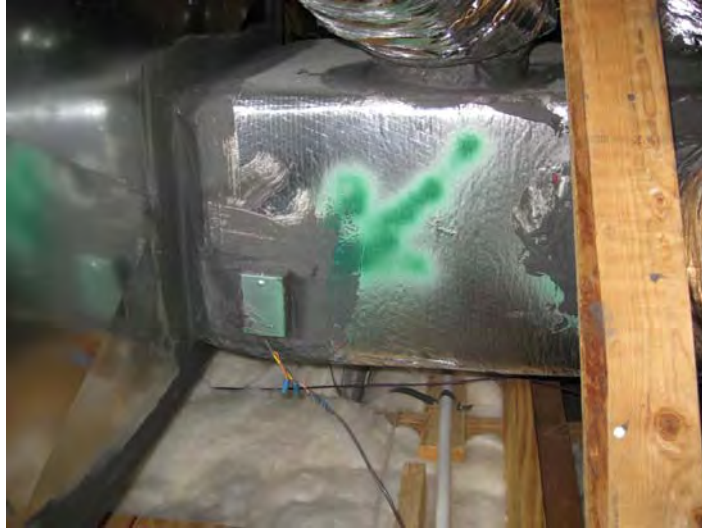
In one of the homes, the BSC duct leakage test results were essentially the same as those reported by Energy Sense for the home’s duct system. This home had been visited previously by both Energy Sense and BSC while BSC was observing Energy Sense “at rough” testing (see Site Visit Report for February 26 and 27). At that time, Energy Sense had determined that the system failed to meet the duct leakage target and used an artificial fog generator to identify leakage locations. Energy Sense then marked these leakage locations with spray paint. Energy Sense retested the system on March 4th. Observations on March 12th confirmed that locations marked by Energy Sense had been further sealed by the HVAC contractor using mastic since the initial testing.

Figure 3 - Remedial duct sealing at area noted by Energy Sense
