## Case Studies in Building Commissioning (If you don't measure it – Don't believe it)

B. K. (Kent) Browning, PE  
*KWR Engineering Services, LLC*  
 7705 Callbram Lane  
 Austin, Texas 78736  
 (512) 288-6523  
 KWR-Services@engineer.com

Agenda  
 Commissioning vs TAB  
 Air Barriers / Thermal Barriers  
 Duct Leakage  
 Example Commissioning Findings

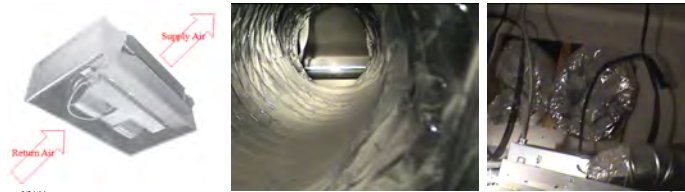
- ~400,000 sq ft, \$56M property
- ‘Others’ had reported duct leak problems
- Referred to us because was in litigation
- Designed for sheet metal ducts
- Built with flex / ductboard
- Initial job was to inspect & report findings

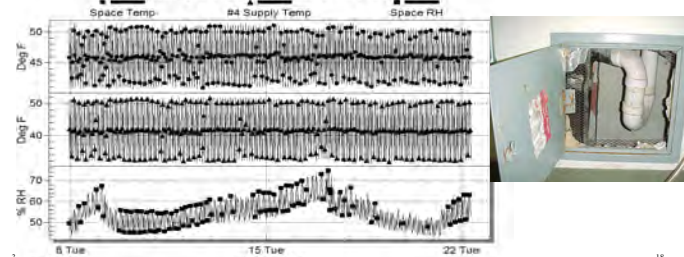
### Archive

- Poor humidity control
- Dehumidifiers were failing within 1<sup>st</sup> month of installation
- Repeated failures until dehumidifiers were abandoned & replaced with portable dehumidifiers
- Temperature control considered acceptable

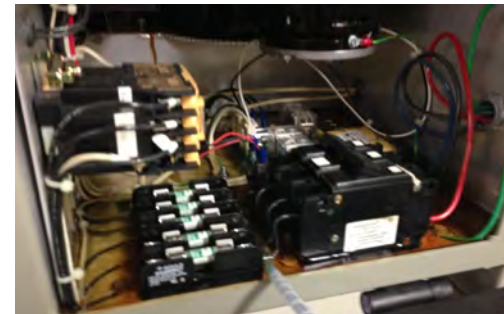
### Archive – 6/24/2013

- Electrical compartment full of water again
- Ductboard had failed
