Corrosion of Galvanized Fasteners used in Cold-Formed Steel Framing

Ian N. Robertson Ph.D., P.E.

Steel Framing Alliance
and
University of Hawaii

November 2000 - November 2004

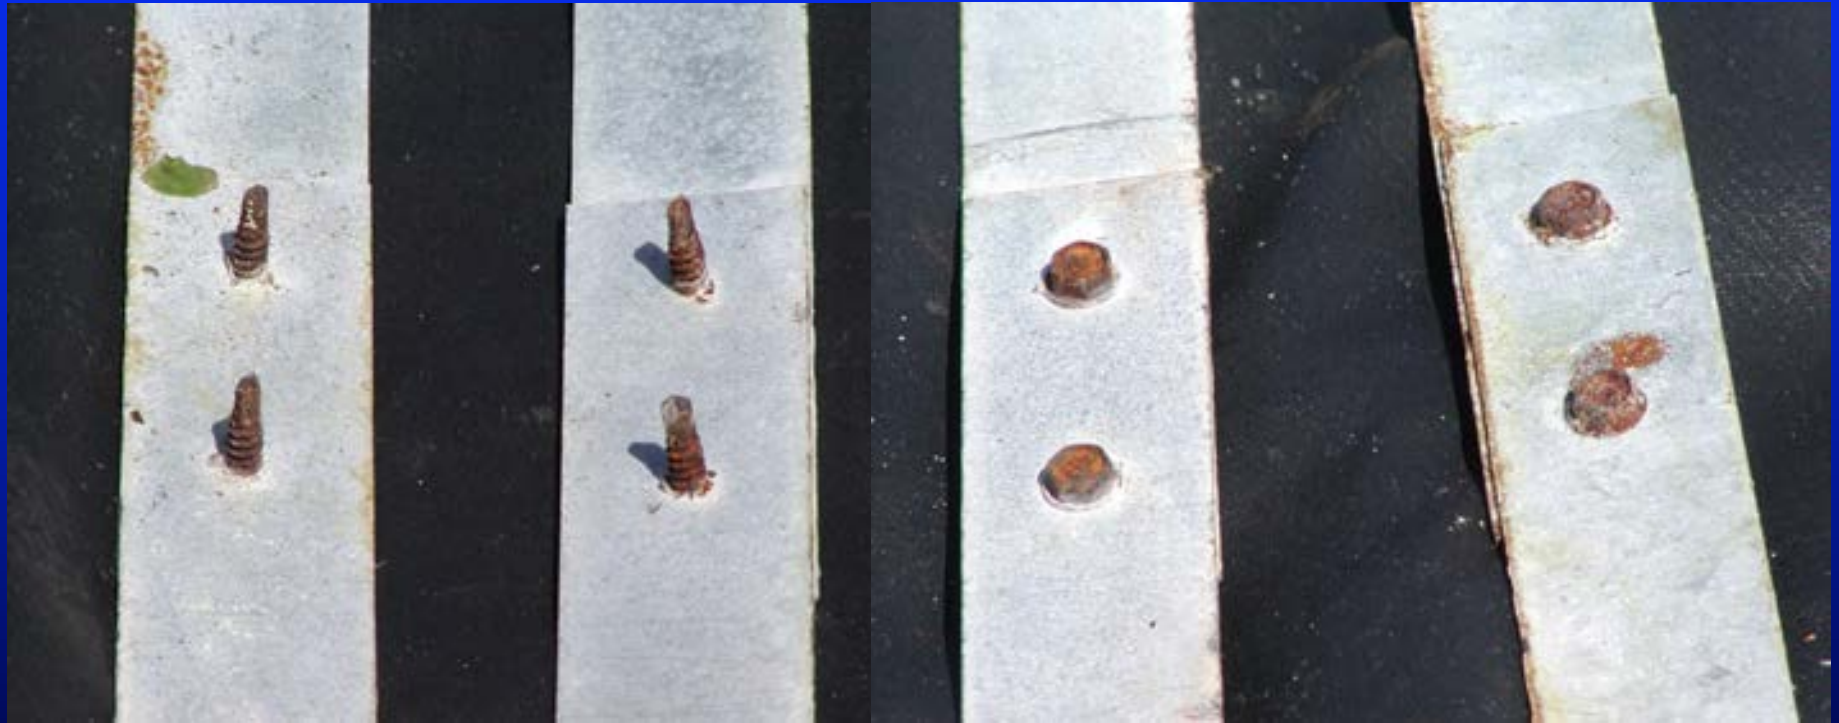
MCBH Coastal – Exterior Connections 7 Months Exposure

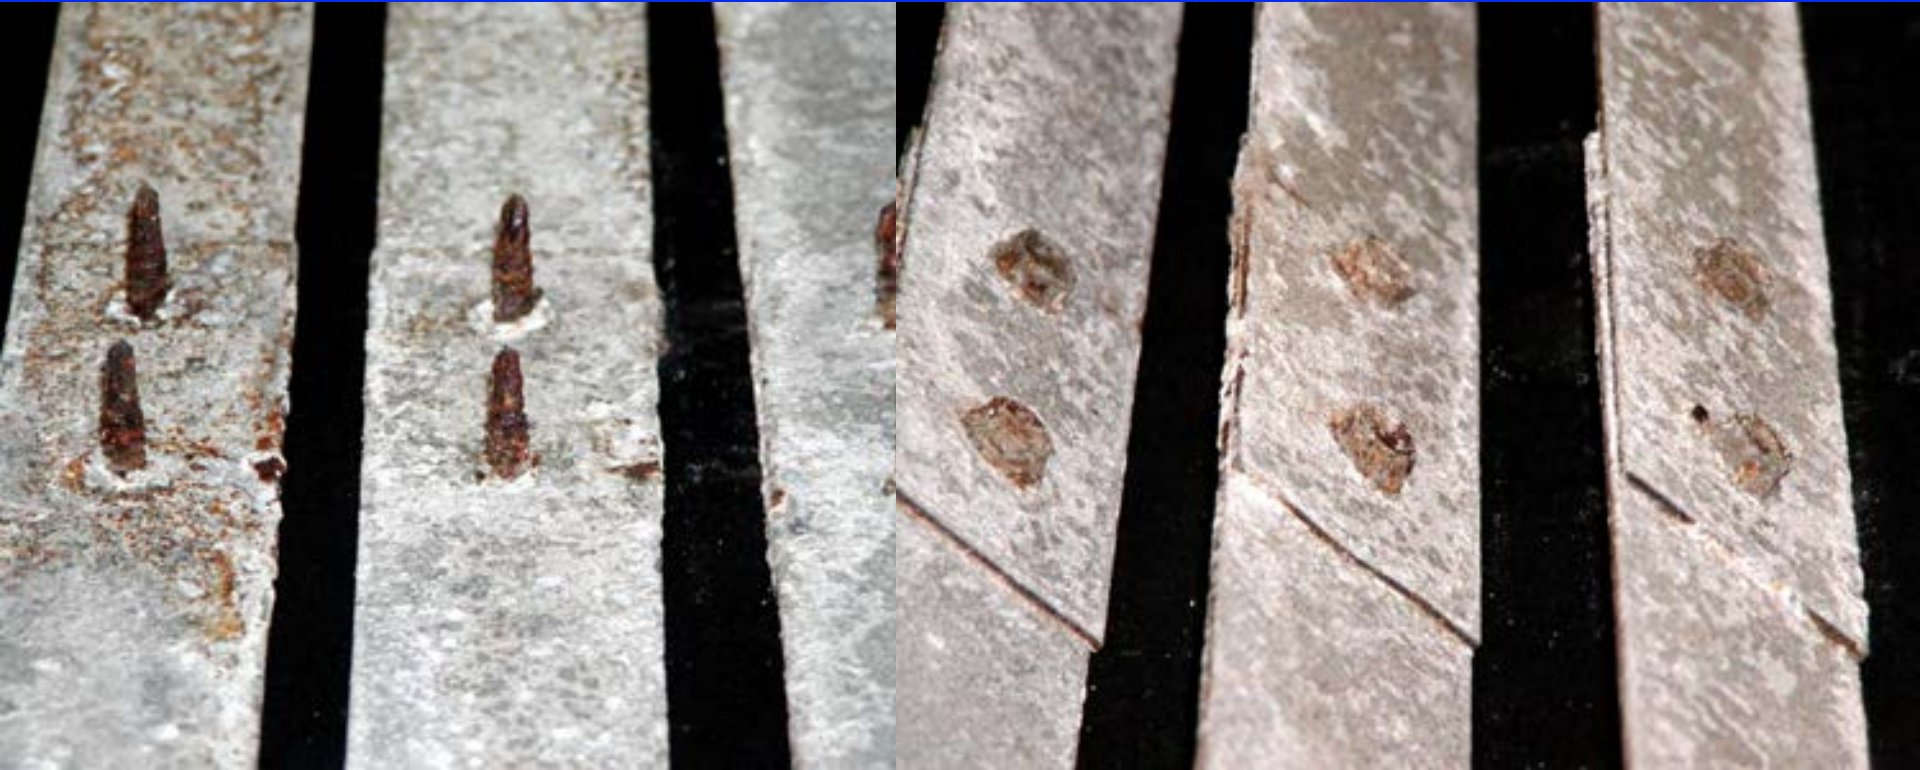
MCBH Coastal – Open Crawl Connections 7 Months Exposure

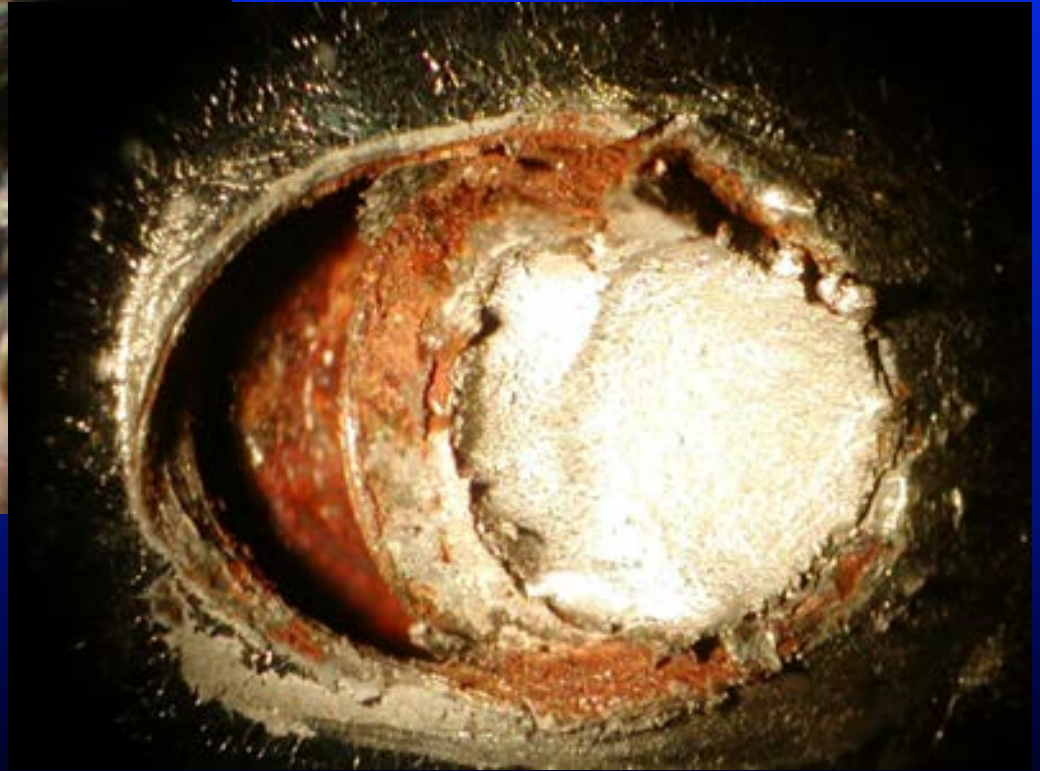
Failed
Connection -
Original

Failed
Connection –
1537 Cycles

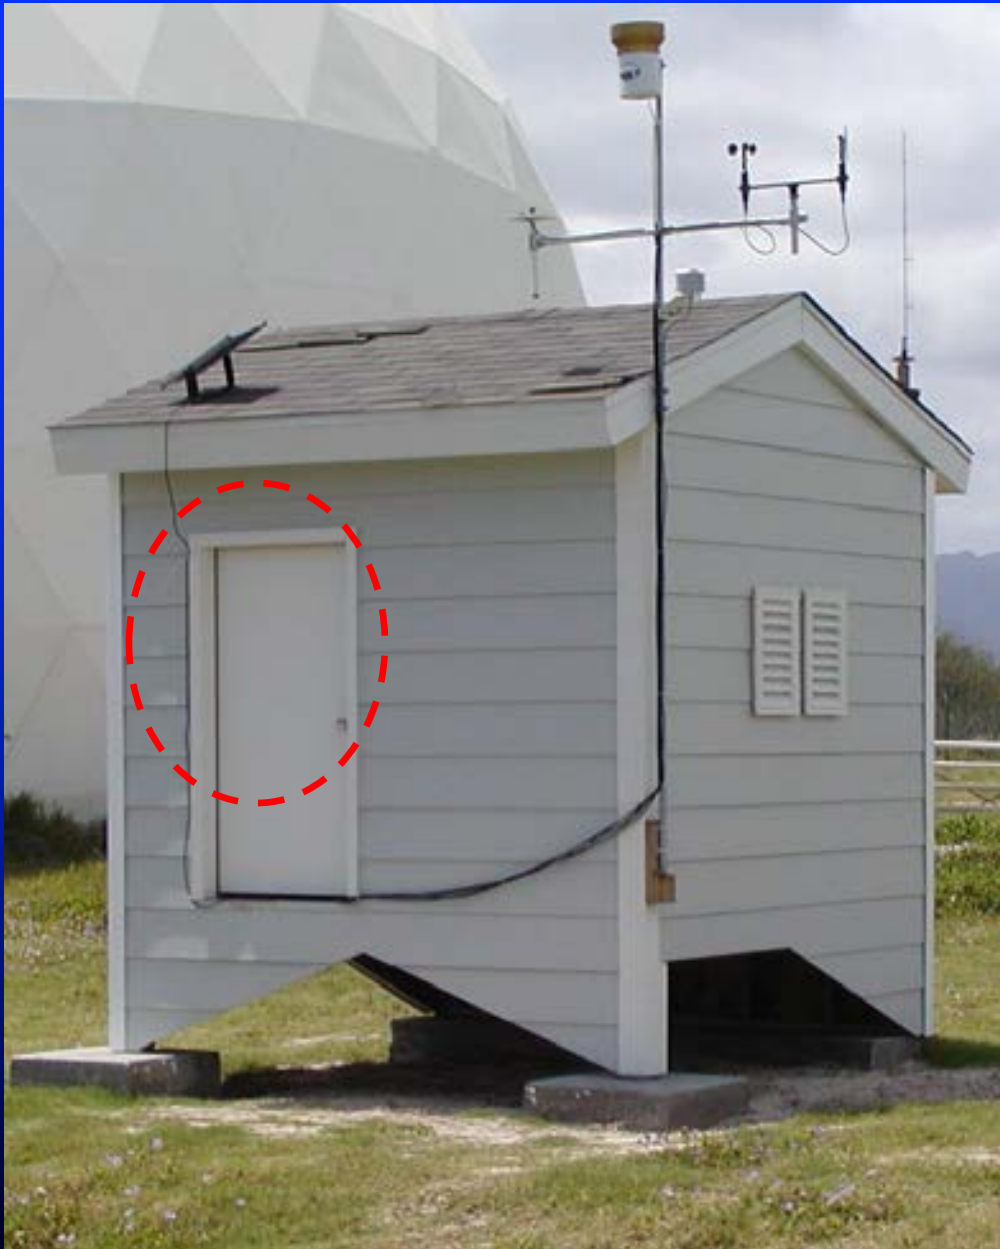
Plywood sheathing and vinyl siding

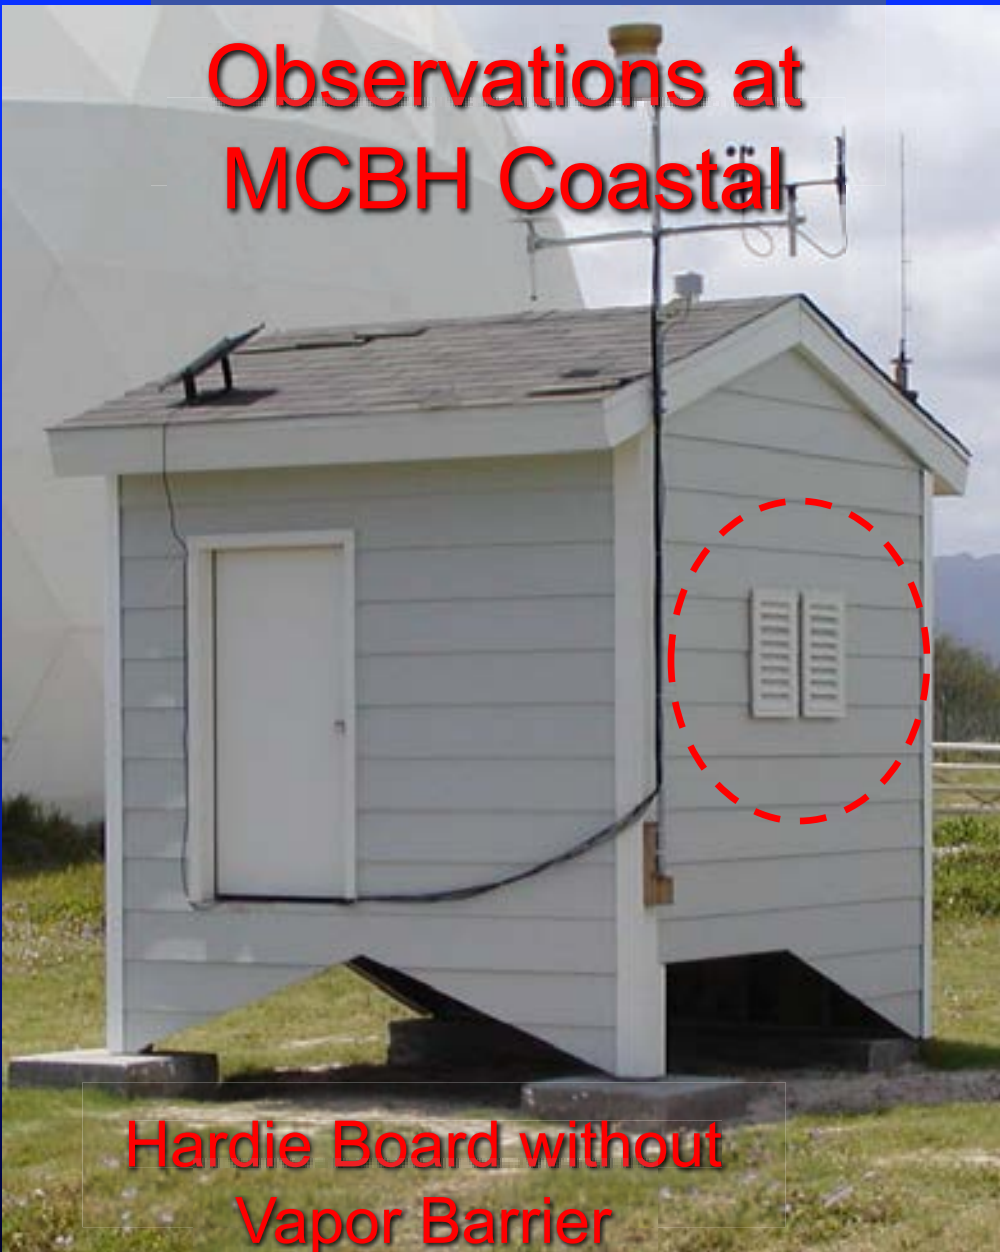
Hardie Board without
Vapor Barrier
