Monitoring of Unvented Roofs with Fibrous Insulation, Diffusion Vents, and Interior Vapor Control in a Cold Climate

Building America Report - 2001

September 2020

K. Ueno and J.W. Lstiburek

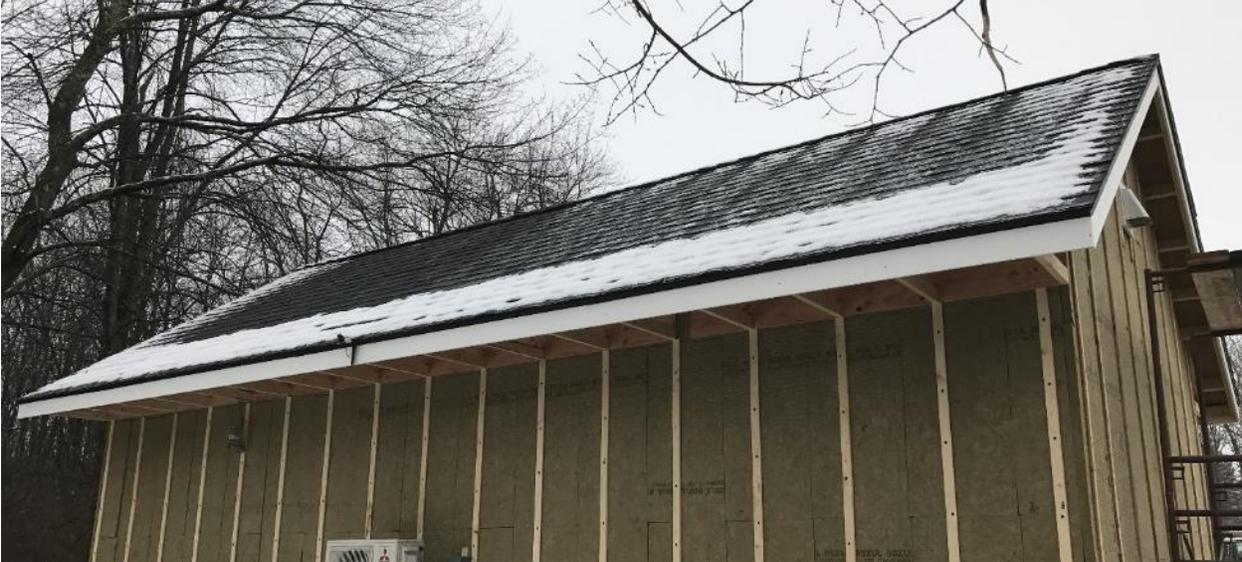
Figure 109. Snow melt patterns on north-facing roof, showing rafter thermal bridging

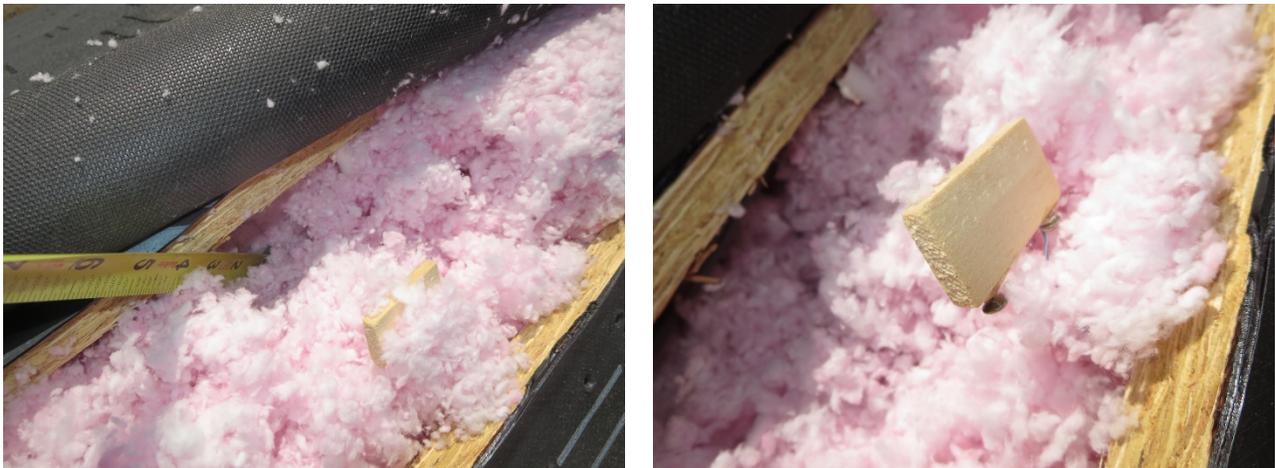
Figure 122. Void at Roof 1 ridge insulation (left) and ridge wafer condition (right)

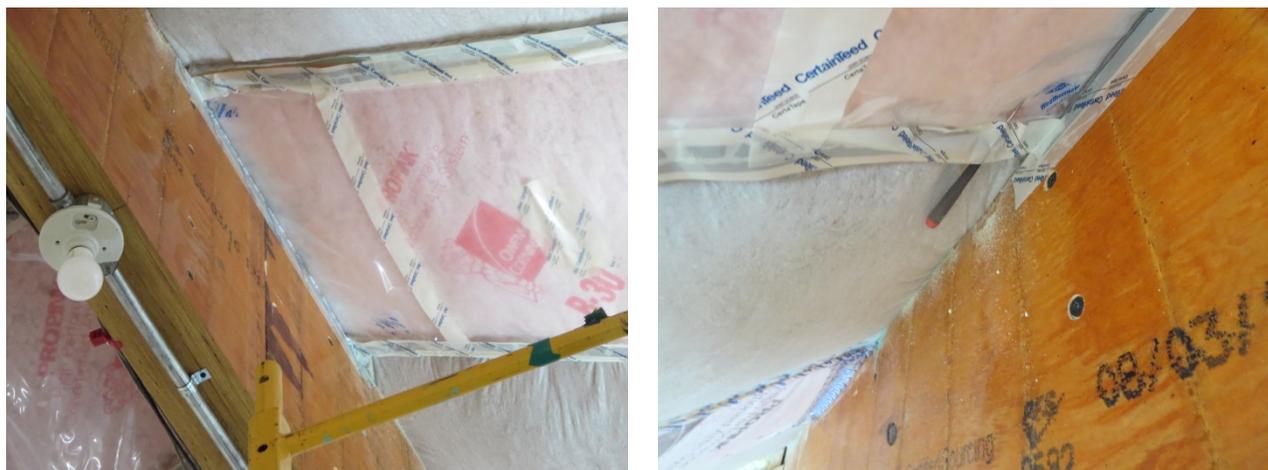
Figure 127. Roof 2, showing loss of adhesion of housewrap tape near ridge

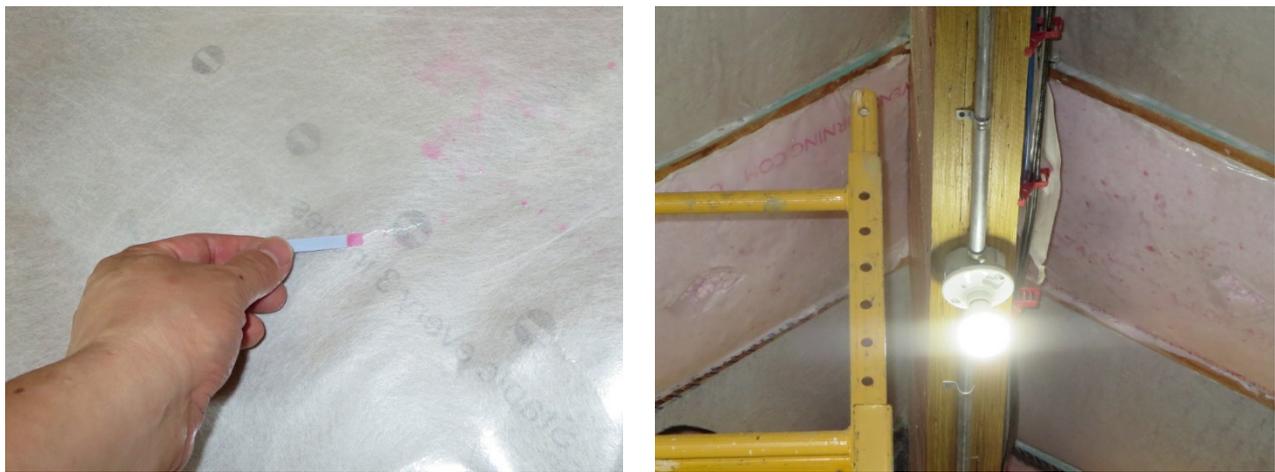
Figure 134. Roof 3 condensation wicking into water indicator paper, staining of insulation netting

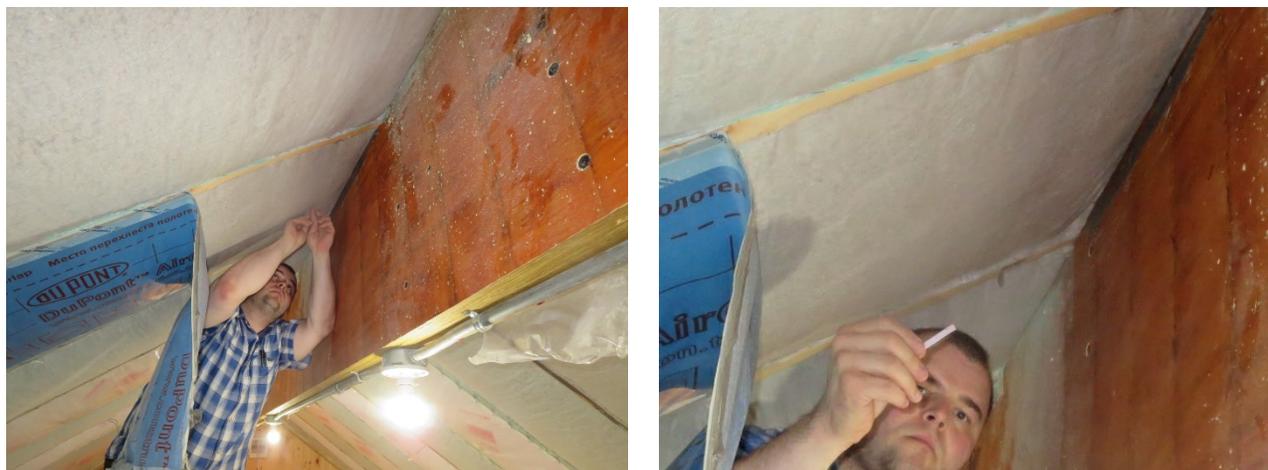
Figure 135. Roof 5 wetness at vapor retarder-netting interface

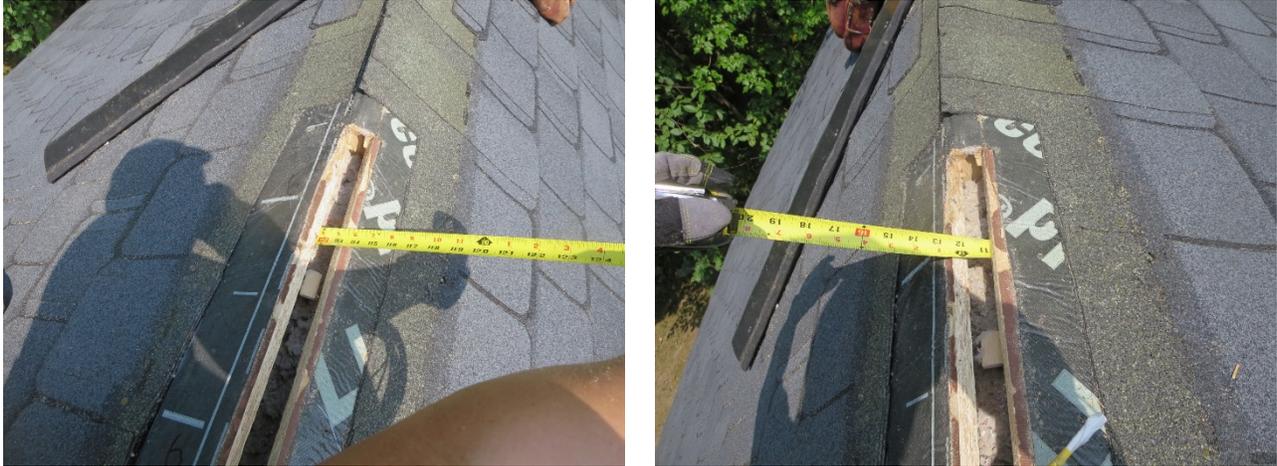
Figure 146. Settling of cellulose insulation on north (left) and south (right) slopes, Roof 6

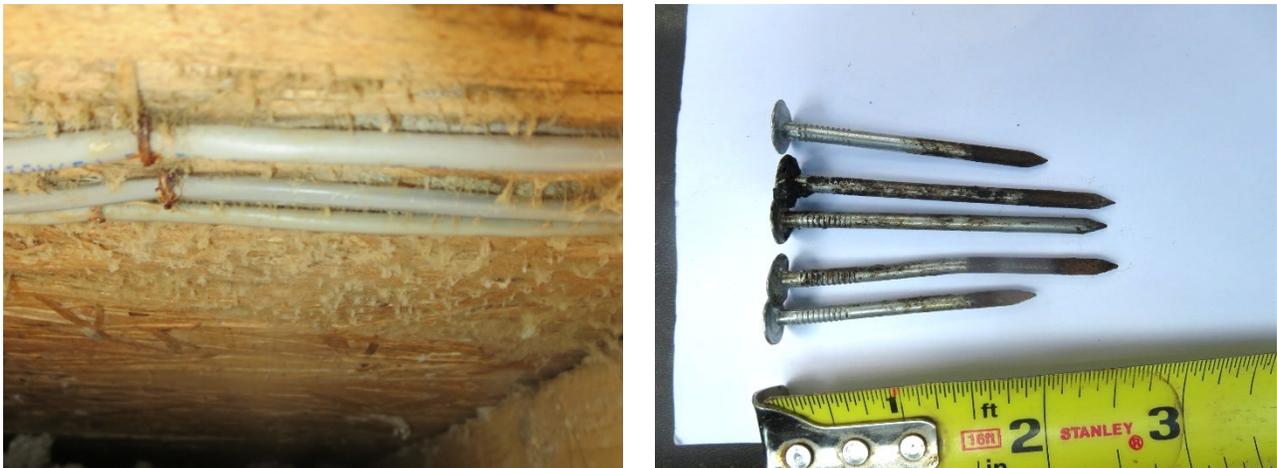
Figure 147. Corrosion of wire staples (left) and corrosion of roofing nails (right)

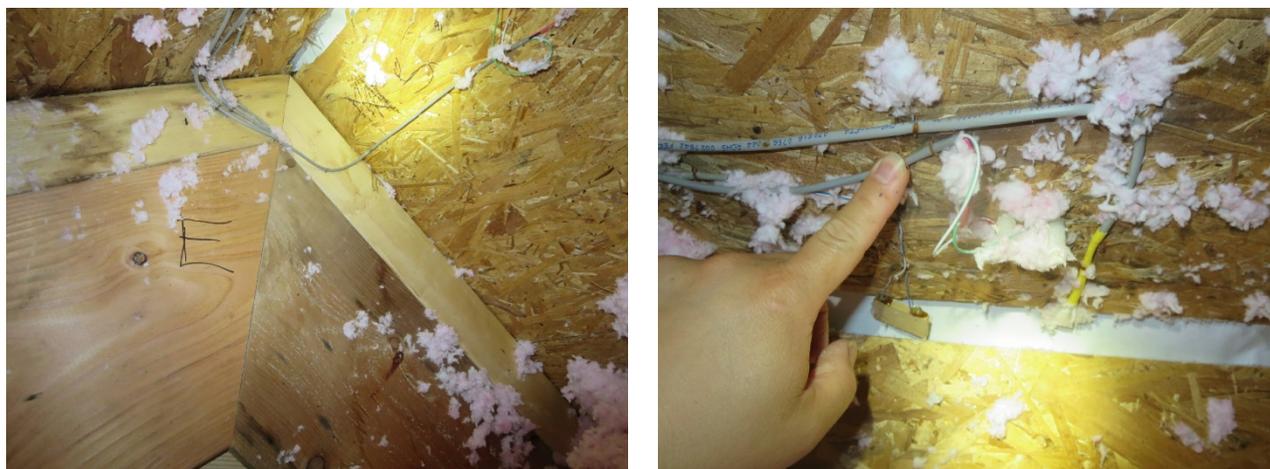
Figure 154. Roof 3 mold and staining on east rafter (left); sheathing damage and rusted staples (right)

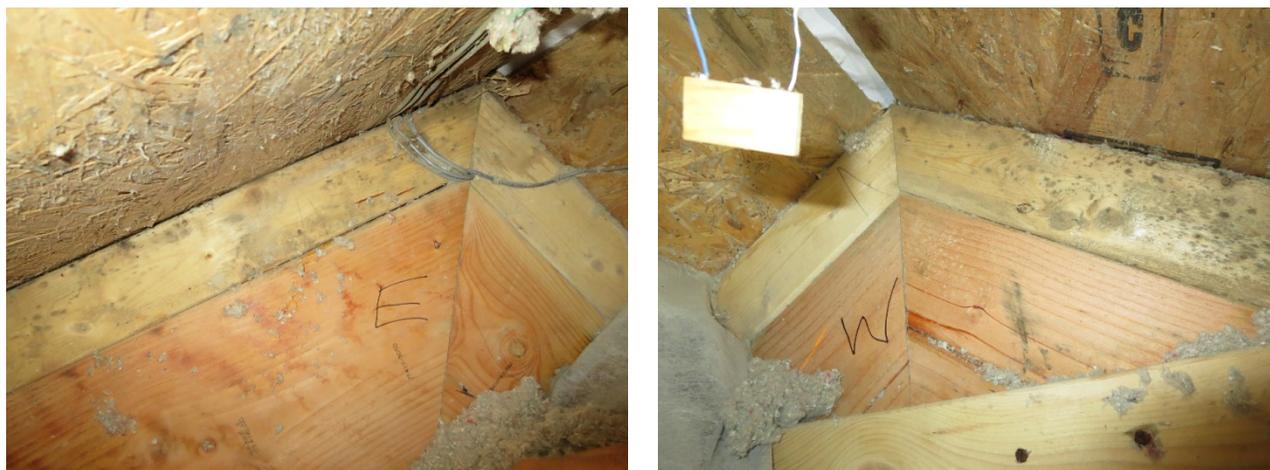
Figure 158. Roof 5 significant mold spotting on both east rafter (left) and west rafter (right)

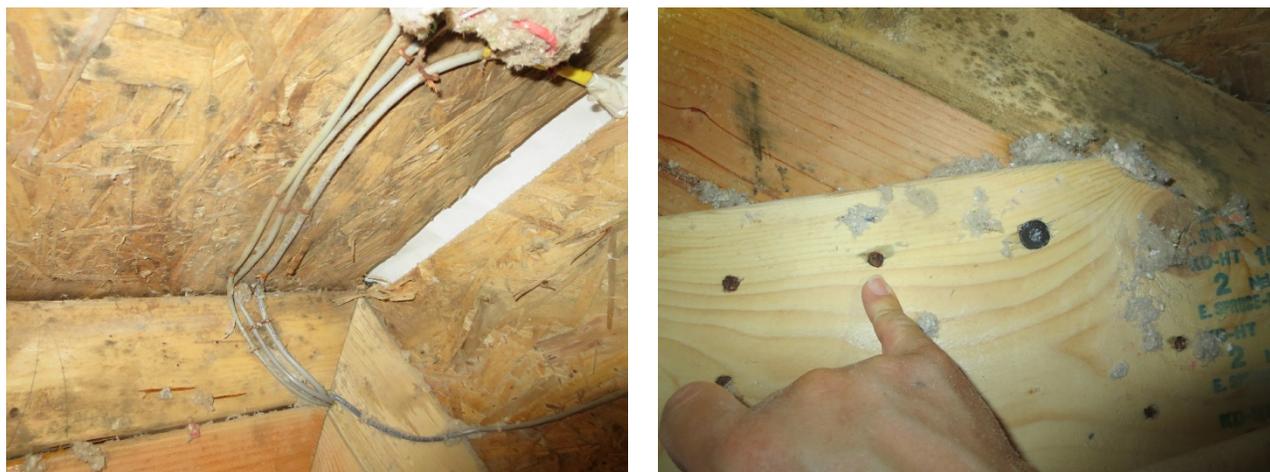
Figure 159. Roof 5 sheathing damage, east-side (left) collar tie rusted nails, rafter mold (right)

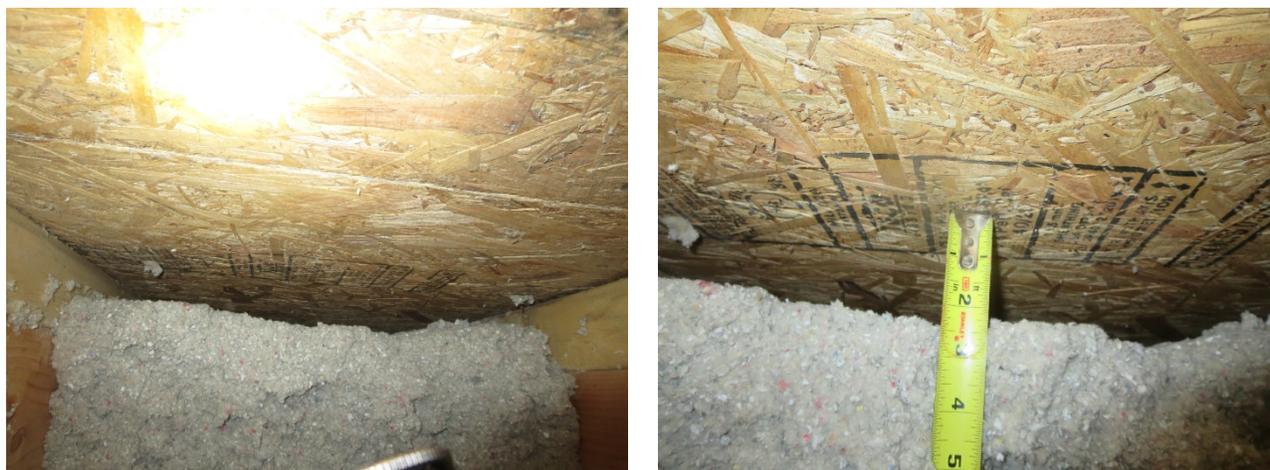
Figure 160. Roof 5 north-side cellulose settling (left); gap size 2 to 2.5 in. (right)

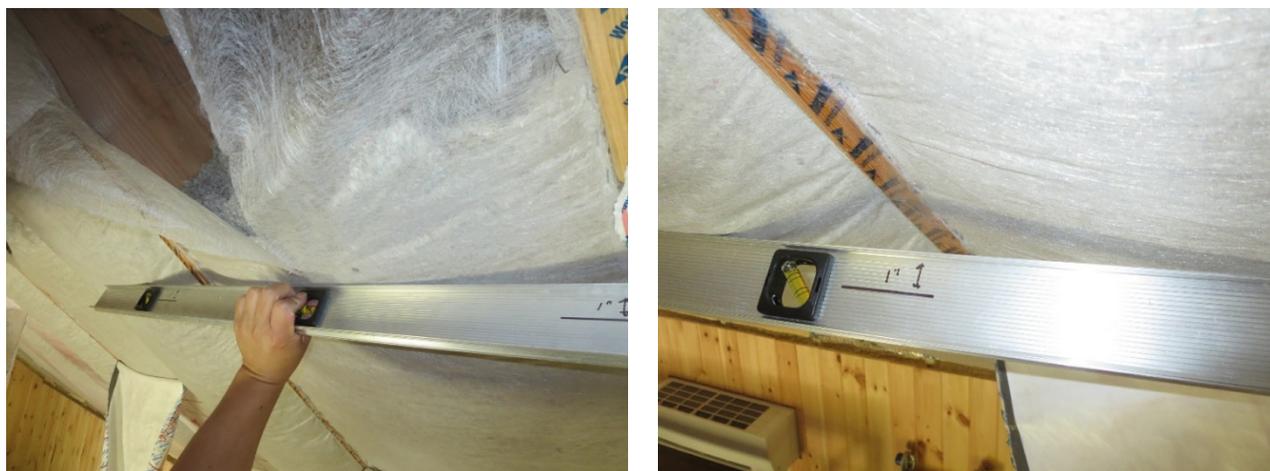
Figure 161. Cellulose netting belly (left); belly depth ~1 to 1.5 in. (right)

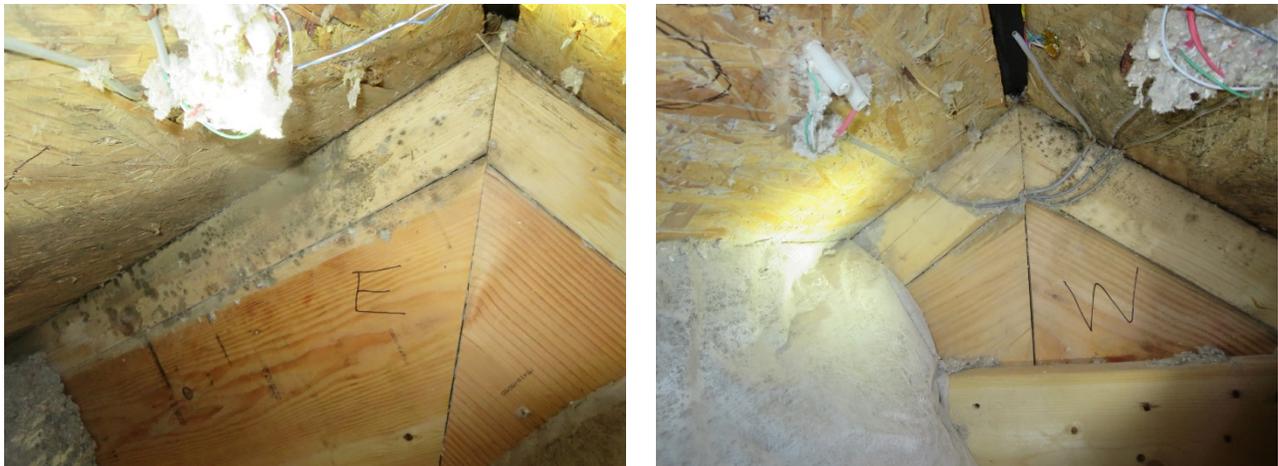
Figure 163. Roof 6 mold and staining on east rafter (left) and west rafter (right)

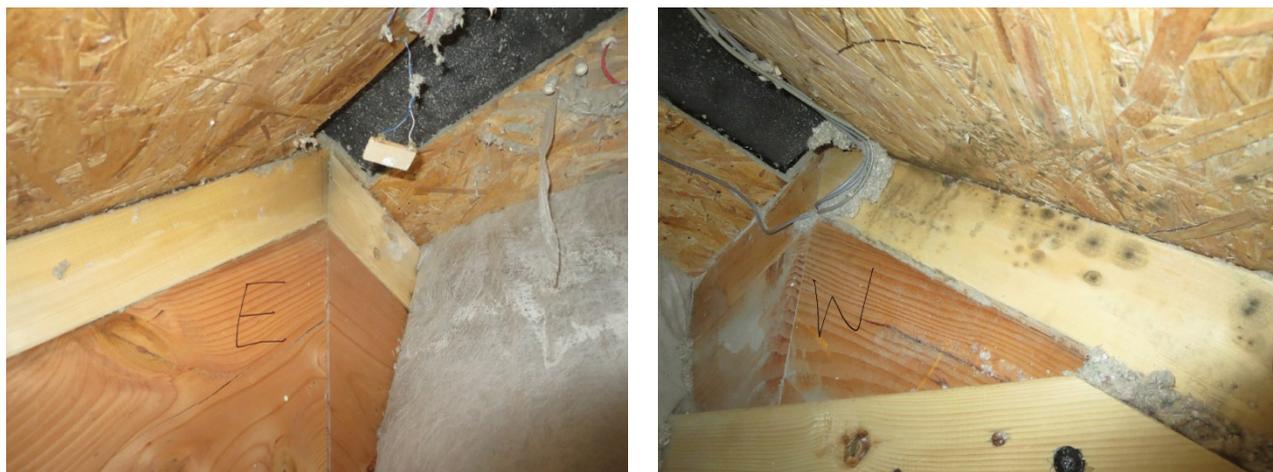
Figure 165. Roof 7 minimal damage to east rafter (left); mold and staining on west rafter (right)

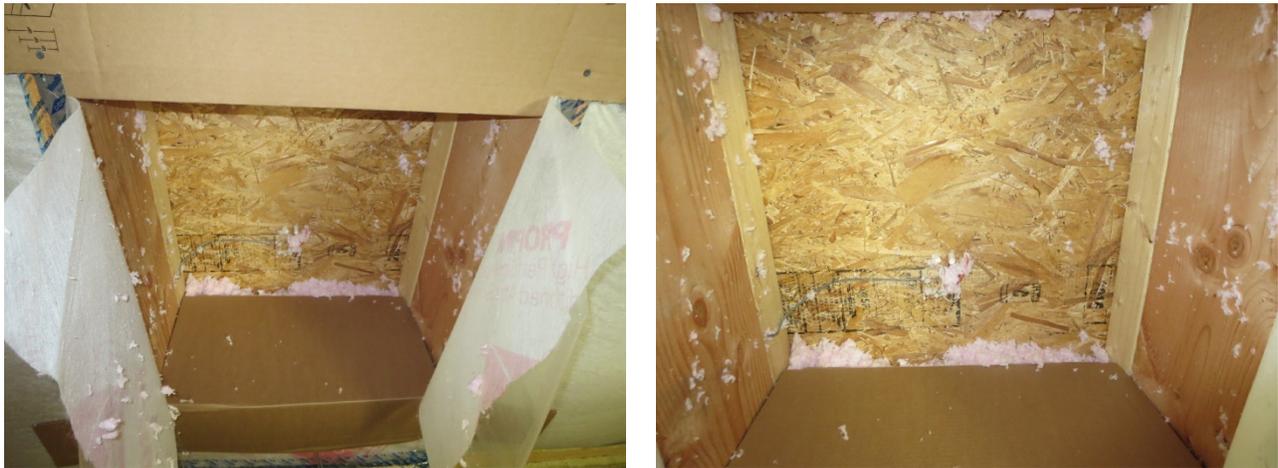
Figure 195. Opening at north-side roof sheathing and OSB conditions (Roof 2 fiberglass)

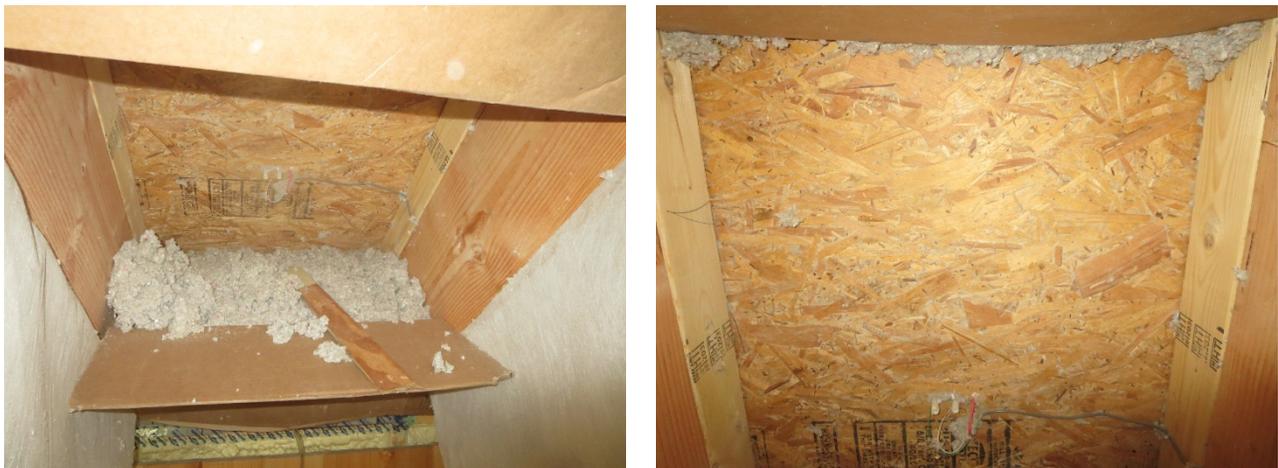
Figure 196. Opening at north-side roof sheathing and OSB conditions (Roof 5 cellulose)
