Field Testing Unvented Roofs with Asphalt Shingles in Cold and Hot-Humid Climates

Building America Report - 1409

Kohta Ueno and Joseph Lstiburek

K. Ueno, J.W. Lstiburek
Building Science Corporation

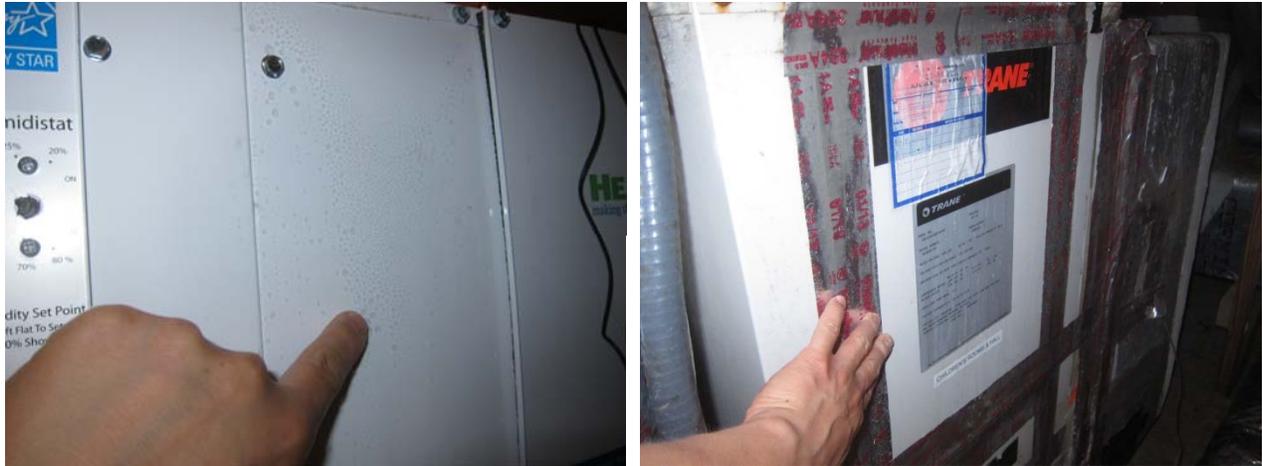
Figure 3: Condensation on HVAC equipment located in vented attic (Zone 2A)

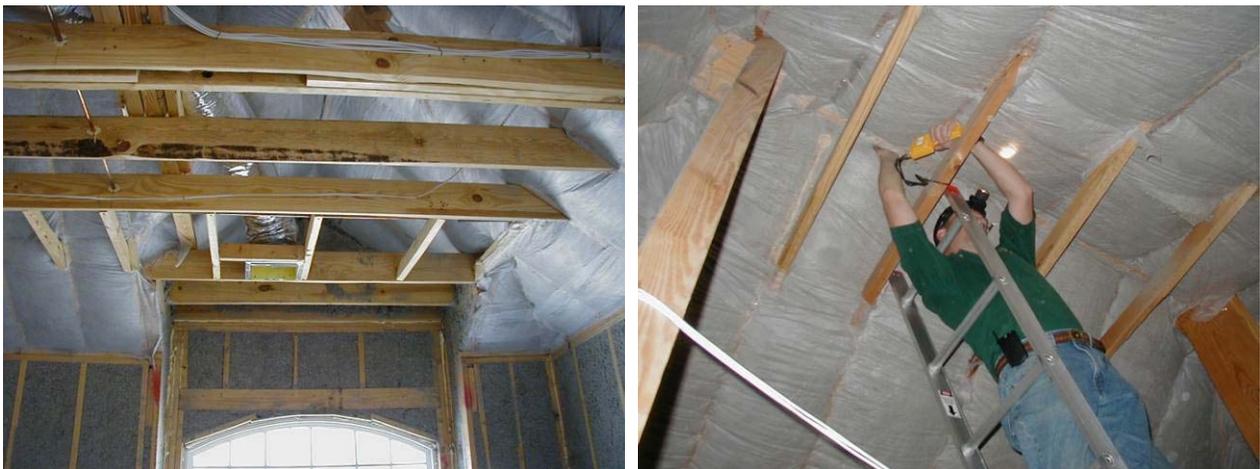
However, during the first fall of operation, the homeowner reported seeing reflections of moisture condensation and dripping from the ridge of the unvented attic, from the interior. Site investigations (see Figure 7 right) revealed that at the ridge, there were elevated wood moisture contents, and evidence of previous condensation (such as rusted staples).

Figure 7: Netted and blown cellulose roof insulation in Houston; moisture content at roof ridge

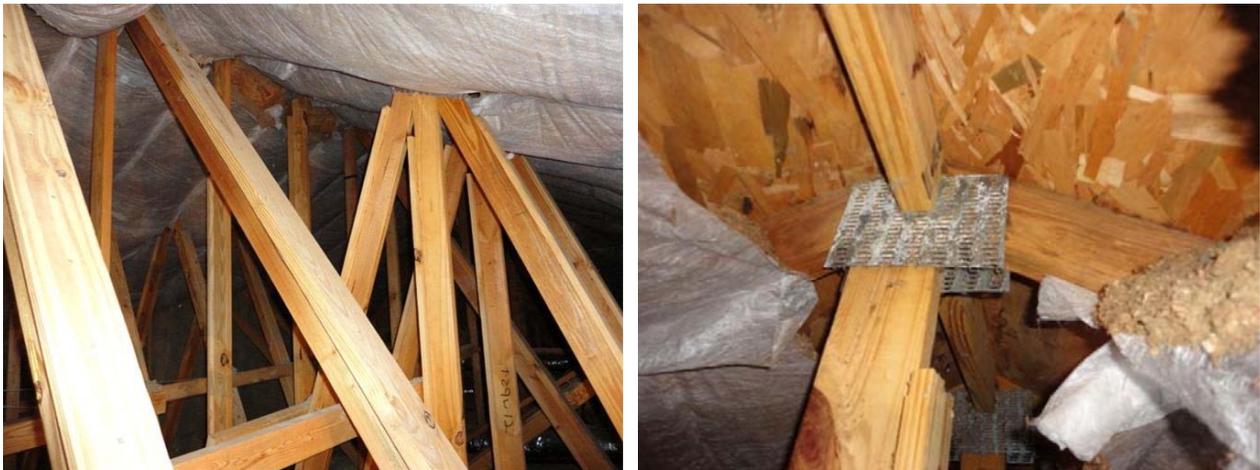
During a site visit, the cellulose and roof sheathing above were wet to the touch, and the steel truss plate was corroded; however, there was no wood decay. In response, the insulation was removed near the ridge (roughly two feet, per Figure 8, right), to increase surface temperatures at the condensing roof sheathing surface. This roof has been rechecked over time (circa 2003, and as recently as March 2014); roof sheathing conditions remain dry with this assembly.

Figure 8: Netted and blown cellulose roof insulation in Jacksonville; corrosion of ridge truss plate

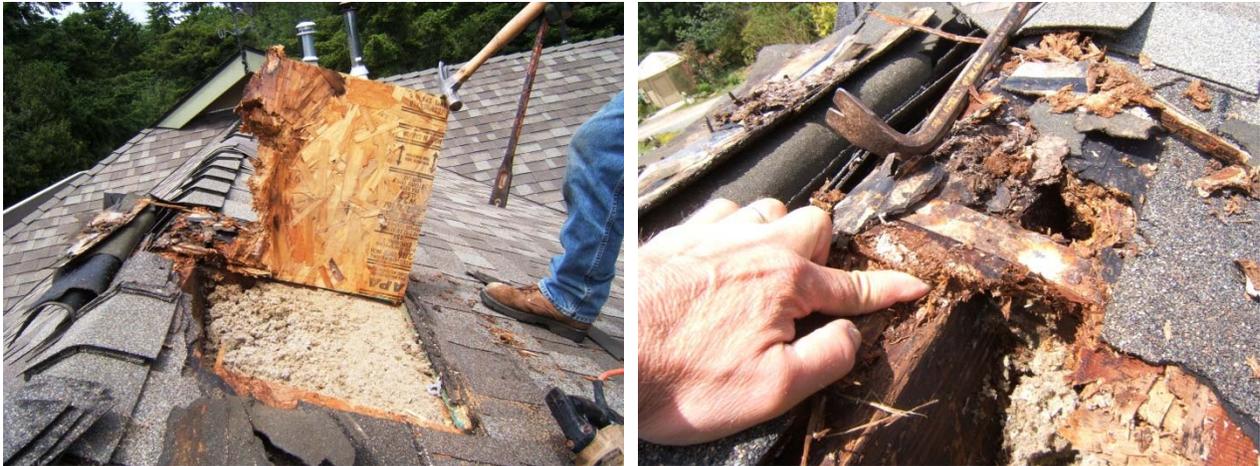
Moisture issues in unvented roof assemblies often manifest in the form of damage to the sheathing at the ridge of a sloped roof, colloquially known as “ridge rot.” An example is shown in Figure 9, which was a dense pack cellulose roof in a northern California location (CZ 3C Marine).

Figure 9: Ridge sheathing degradation with dense pack cellulose in northern California

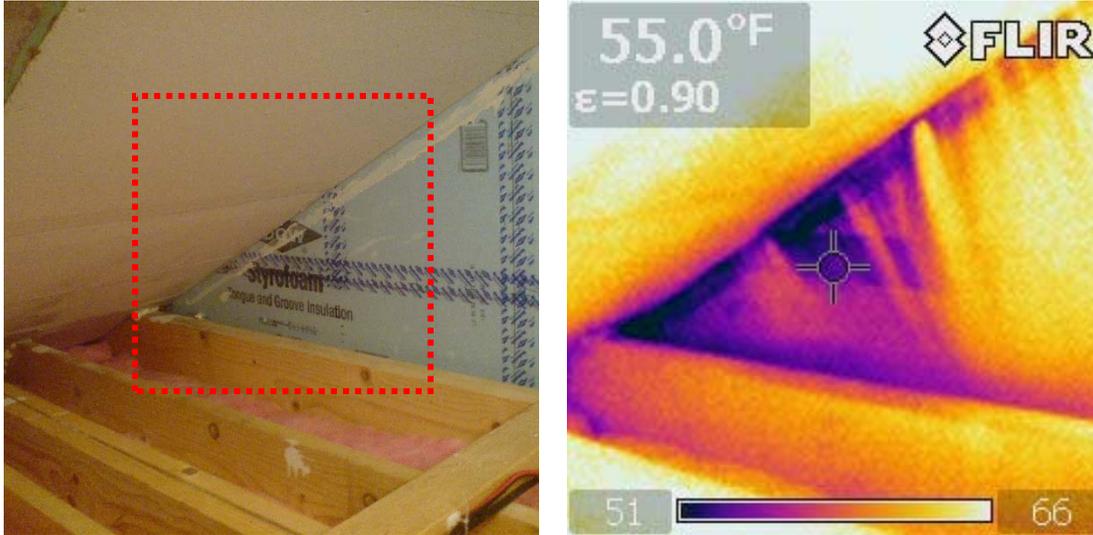
Figure 36: Air leakage at roof connection to main house (XPS sheathed wall)

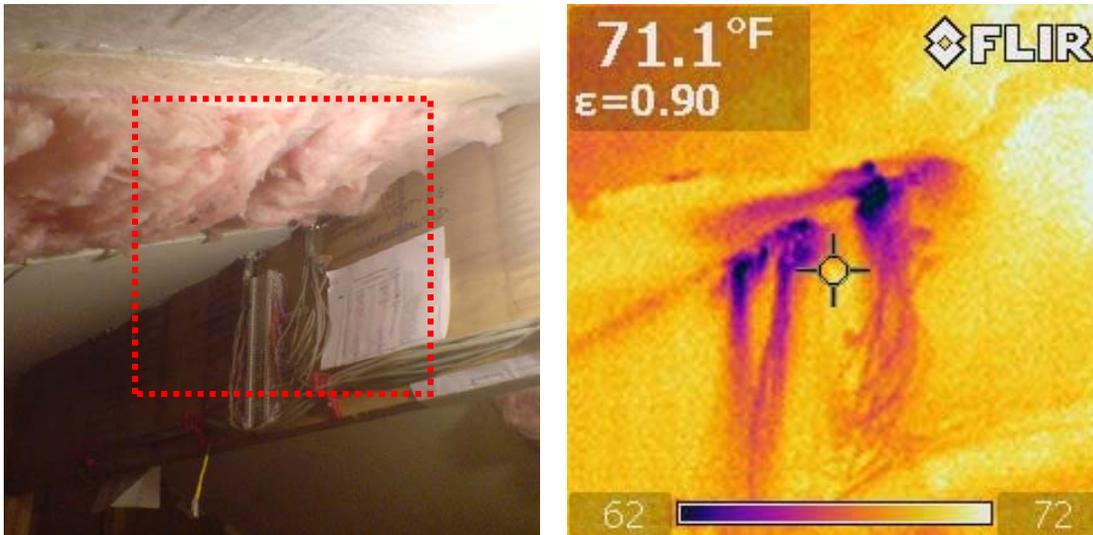
Figure 37: Air leakage at ridge and instrumentation wire penetrations

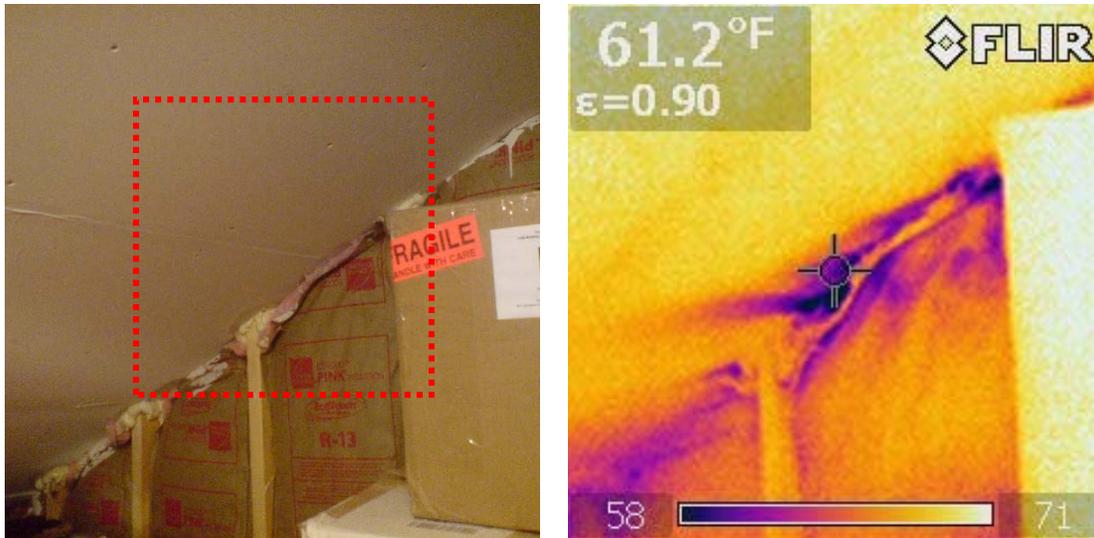
Figure 38: Air leakage at gable end rake wall (connects to unvented cellulose Roof 7)

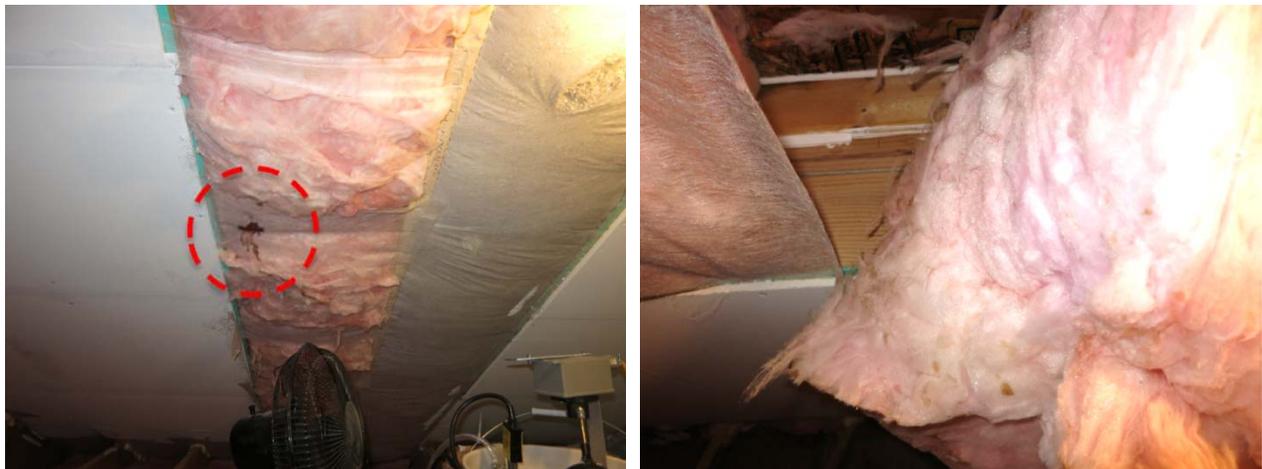
A mid-December site visit allowed verification that the monitoring data reasonably reflected reality. The top vent fiberglass assembly without gypsum board (Roof 4) was examined from the interior. A brown stain indicating water leakage (Figure 53, left) was found; when the batt was removed, very wet/saturated roof sheathing and fiberglass were observed (Figure 53, right).

Figure 53: Top vent fiberglass, no GWB (4) water leak (L) and wet fiberglass batt (R)

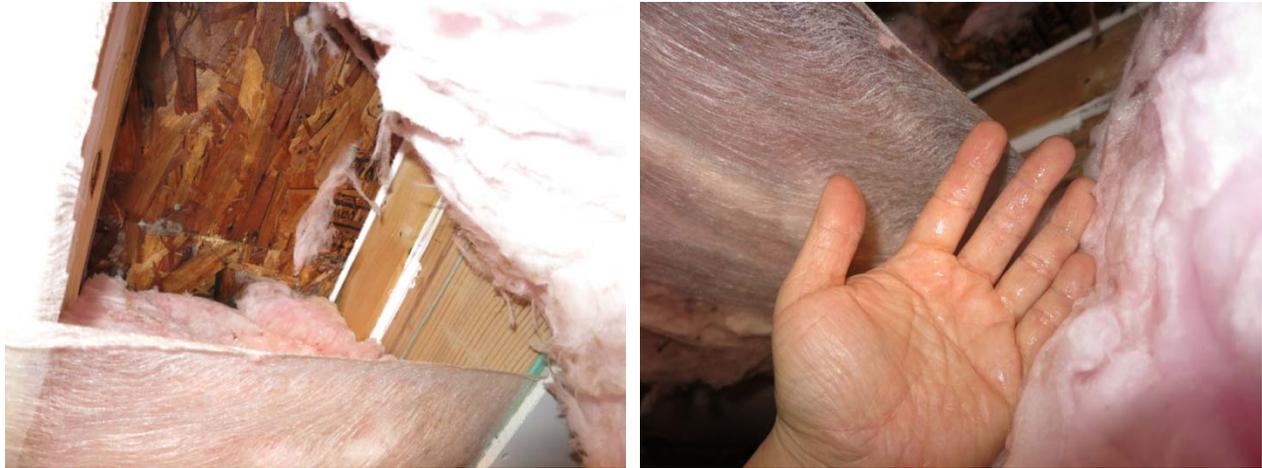
The sheathing was saturated with liquid water/condensation (Figure 54, left), and the fiberglass was saturated with condensation at the exterior surface as well (Figure 54, right).

Figure 54: Top vent fiberglass, no GWB (4) wet sheathing (L) and wet batt (R)

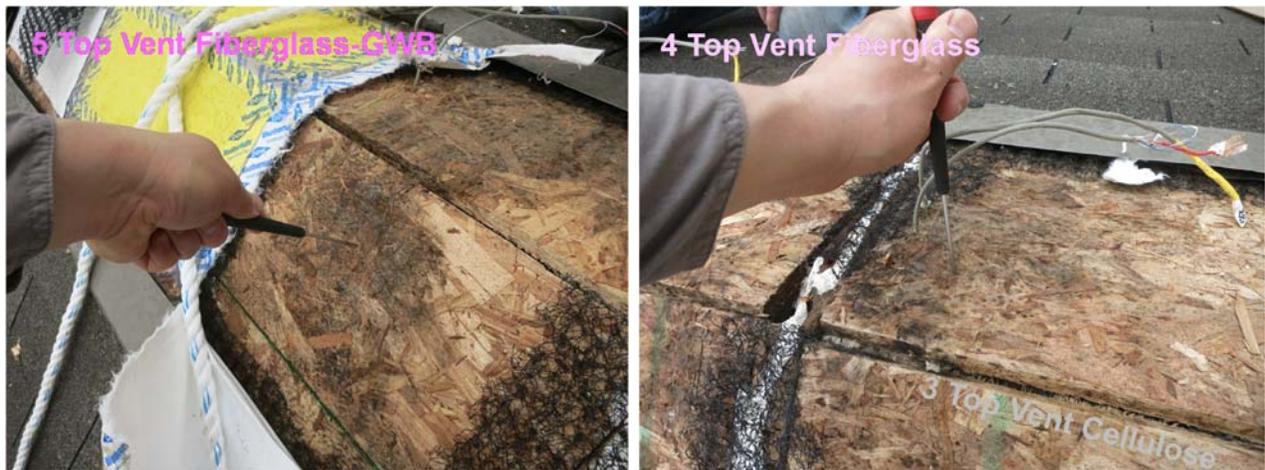
Figure 68: Ridge sheathing conditions (“screwdriver test”) for Roofs 4 and 5

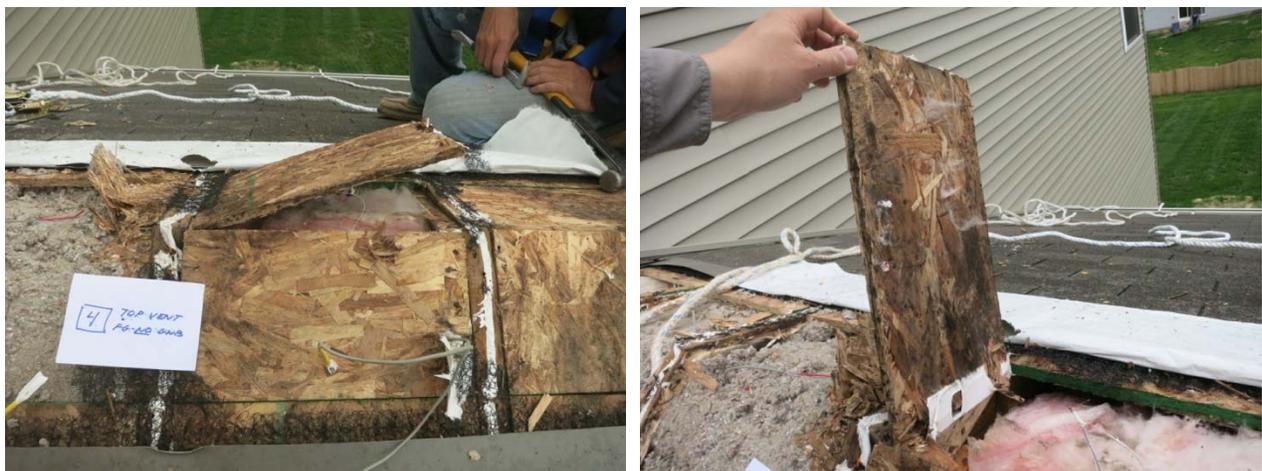
Figure 72: Ridge sheathing top (L) and bottom (R) conditions, Roof 4

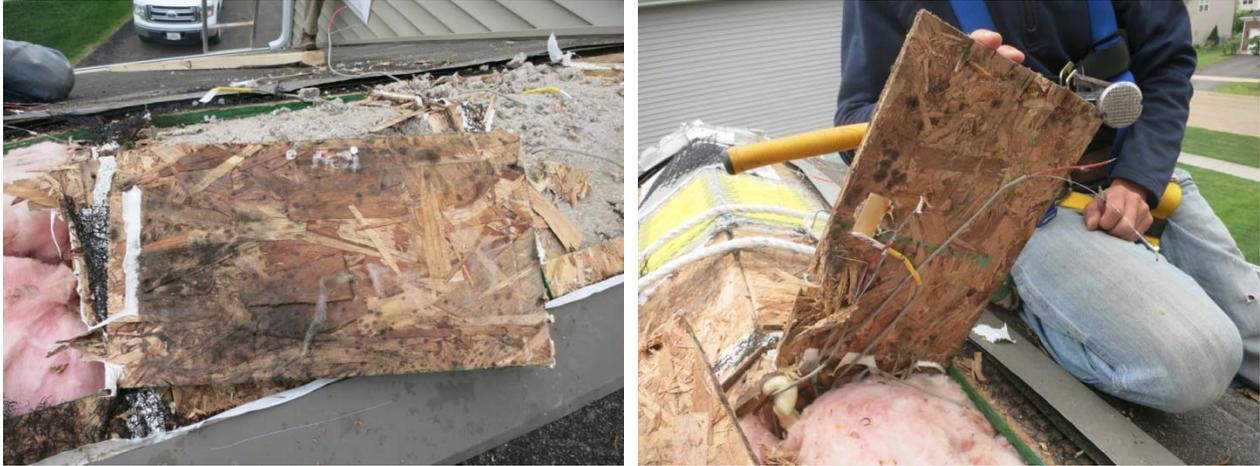
Figure 73: Ridge sheathing bottom conditions, Roof 4

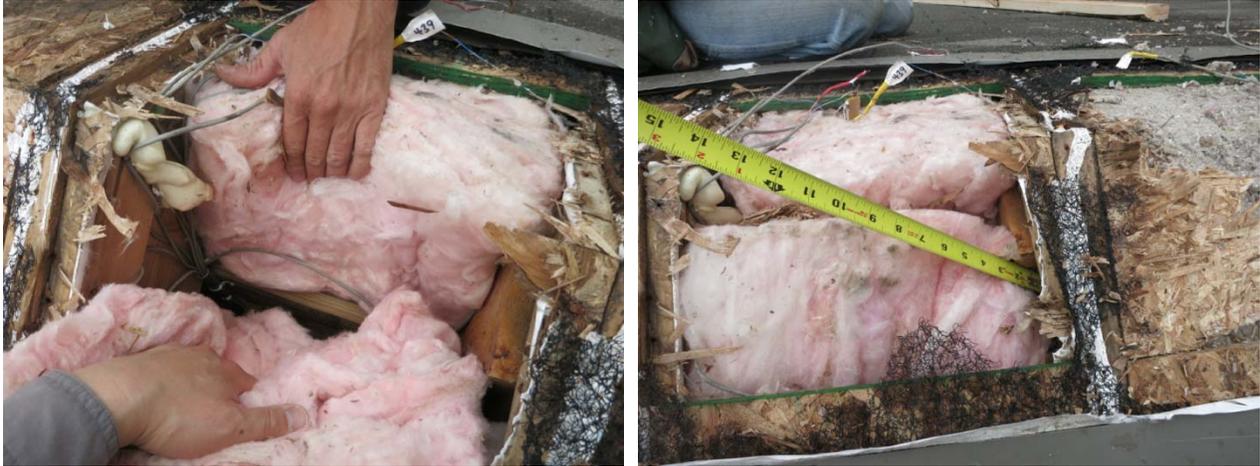
Figure 75: Fiberglass batt conditions at ridge, Roof 4

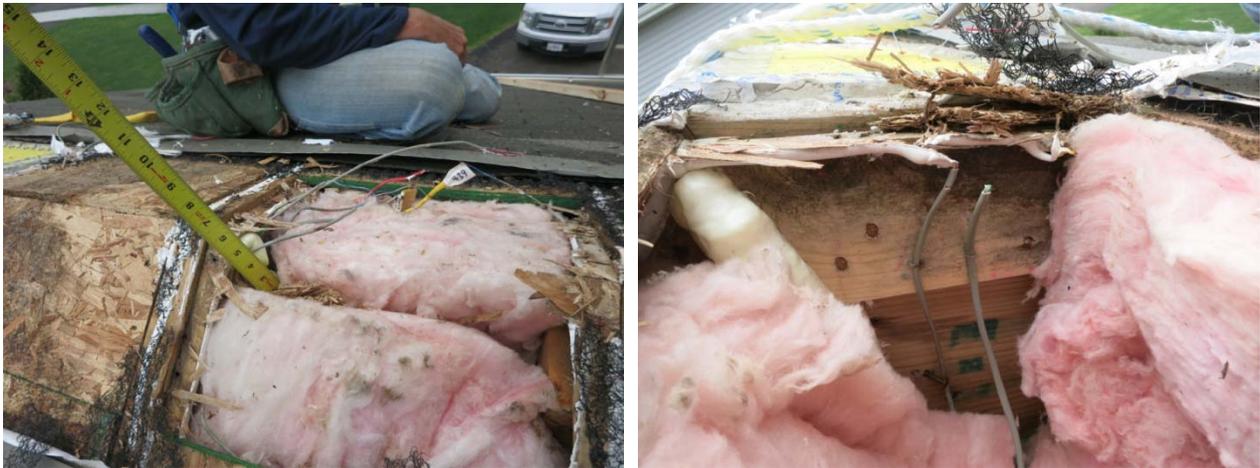
Figure 76: Fiberglass batt and framing conditions at ridge, Roof 4 (L) and Roof 5 (R)

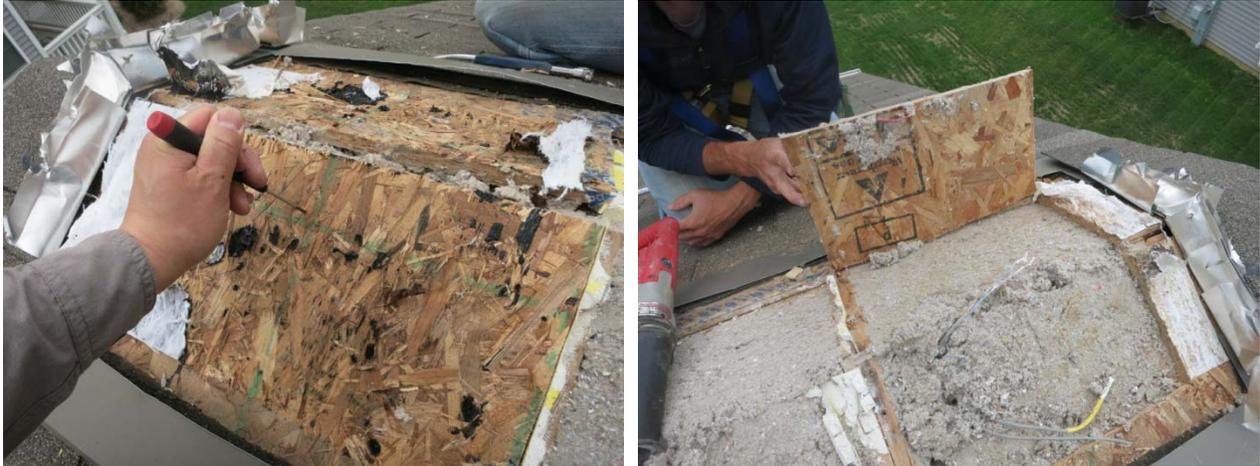
Figure 78: Ridge sheathing top and bottom; cellulose conditions, Roof 7

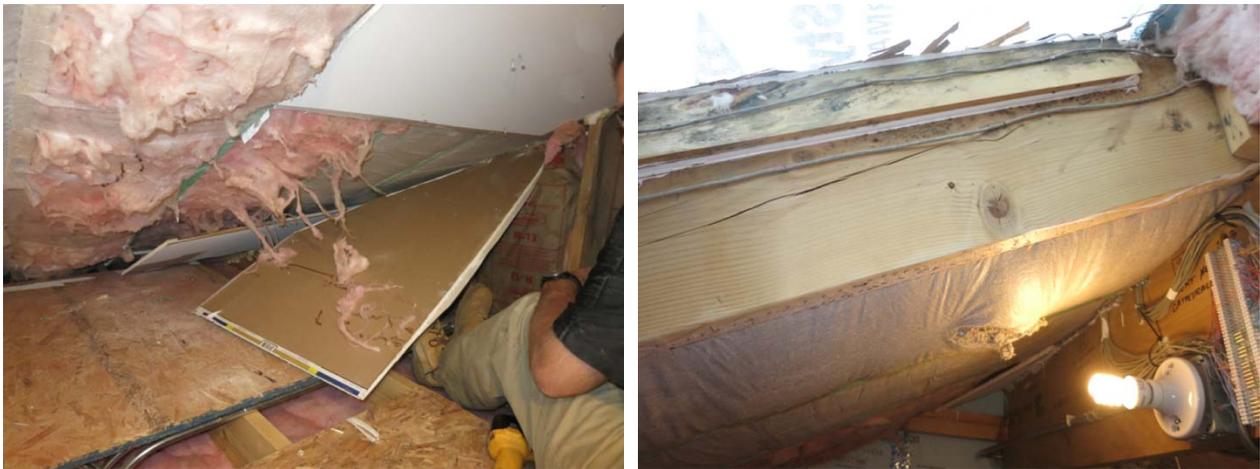
Figure 83: Staining of ceiling gypsum board at (L); mold on framing (R), Roof 5

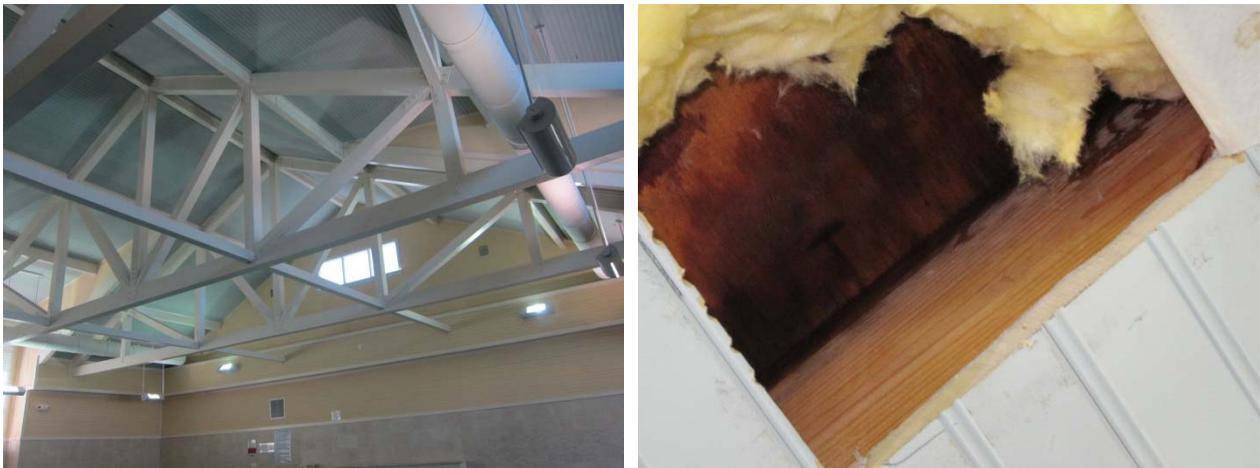
Figure 89: Ridge condensation issues; Zone 3A pool with interior polyethylene vapor barrier

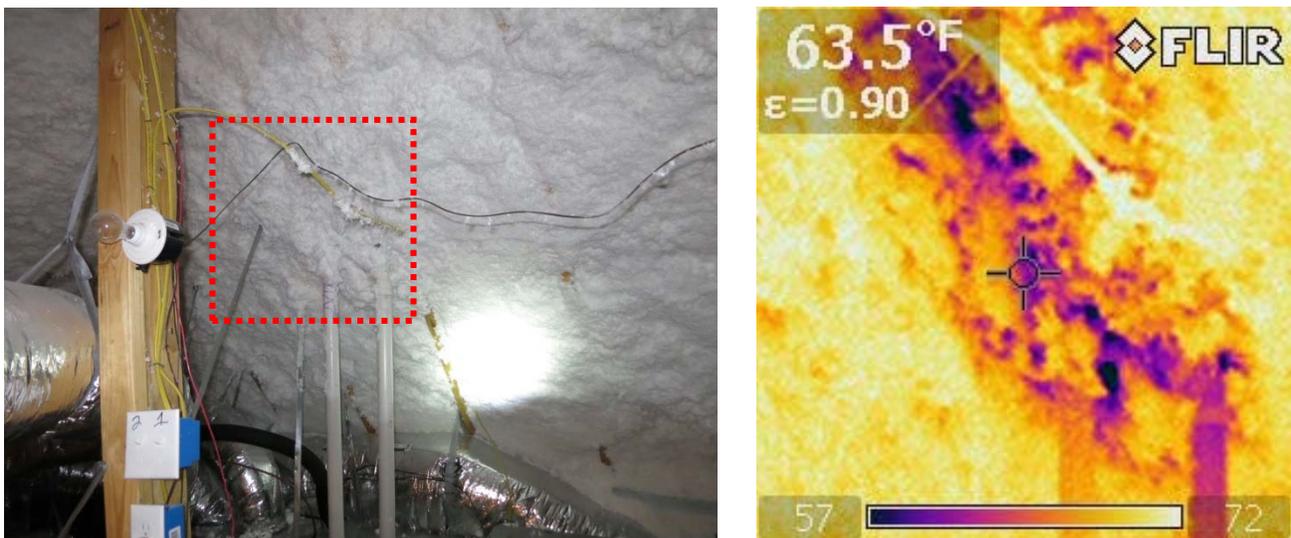
Figure 107: Unsealed gas appliance exhaust/intake, with evidence of air leakage
