## **BSC Information** Sheet 707

What's Wrong With This Project?

# **Non-Load Bearing Framing**

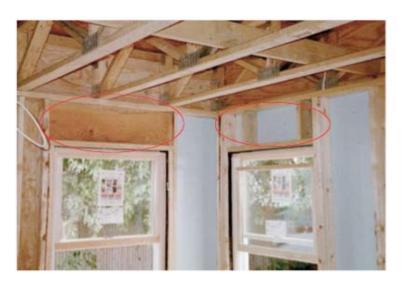
Identify a load bearing header (left) vs. non-load bearing header (right)

Excessive framing in a non-load bearing wall above a sliding glass door (above left), in a non-load bearing door opening (above right), in a non-load bearing wall above a window (below left) and in a non-load bearing wall above a bay window (below right)

Extra framing used around non-load bearing windows and doors throughout building.

Incorporating Advanced Framing techniques around the windows would greatly reduce the wood required below the top plate of the upper story, and it's estimated that between \$500 and \$750 in material costs could be saved in this example alone had a single beam been used directly under the roof trusses.

Identify non-load bearing walls and use Advanced Framing techniques to reduce the amount of wood required around windows and doors.
