BSC Information Sheet 708

What's Wrong With This Project?

Interior Wall at Exterior Wall

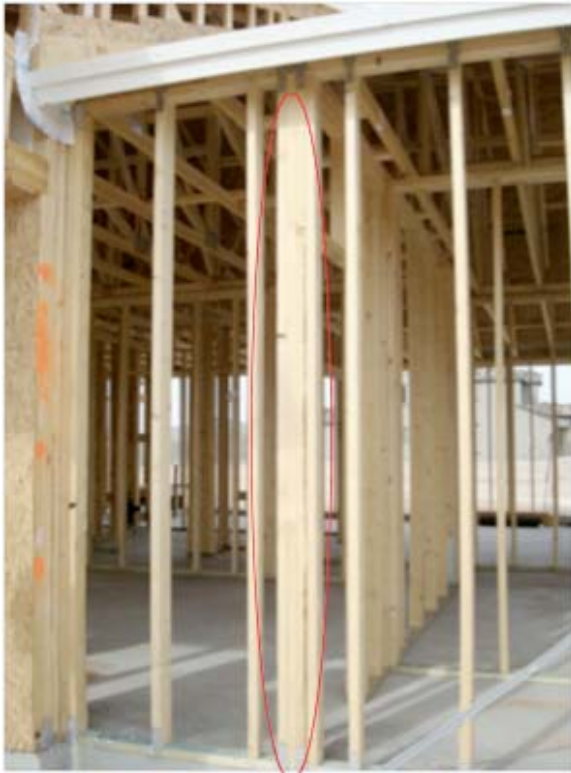
- Interior wall at exterior wall connection

Six unnecessary studs are used to provide this connection.

Had Advanced Framing techniques been used an overall savings of approximately \$2,000 per building would have been realized. The money could have been available to improve other building components to make them more energy efficient in addition to increasing the builder's profit margin and improving the marketability of the product.

A ladder blocking strategy should have been used for the interior and exterior wall connection.

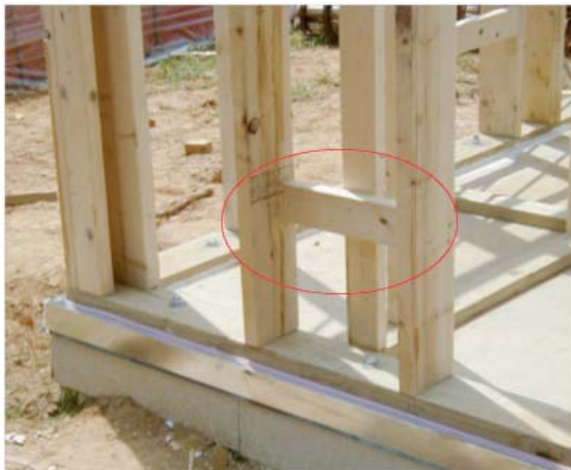
- Ladder blocking should have been used at the interior wall at exterior wall connection
