Mold Control in **Publicly Funded** Housing Developments

Building Science Corporation/Peregrine Group/Bugs, Mold, and Rot III

Case Studies Mold Complaints in Public Housing 1989-1999

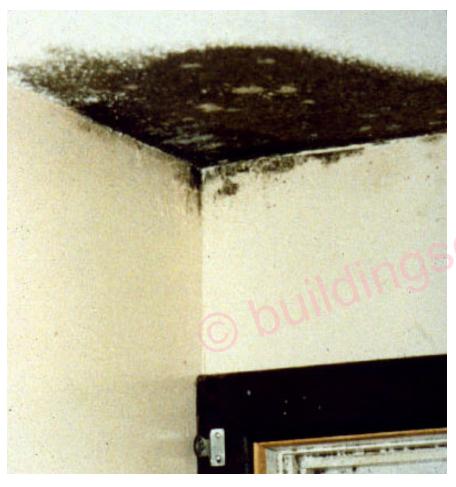
NATURE OF COMPLAINT

Staining of exterior wall corners in living spaces, presence of condensed moisture on windows and mold

- Conclusions: The problems are a result of:
 - High levels of interior generated moisture
 - Cold building enclosure interior surface temperatures
 - Lack of air change

- Recommendations
 - 1. Reduce the interior vapor pressure/moisture
 - This can be accomplished by:
 - Reducing the rate of moisture generation by venting cooking appliances and clothes dryers.
 - Increasing the rate of moisture removal by installing a controlled ventilation system, based on occupancy, limiting rh to 30 percent at 70° during the winter months.
 - Both of the above strategies are recommended.

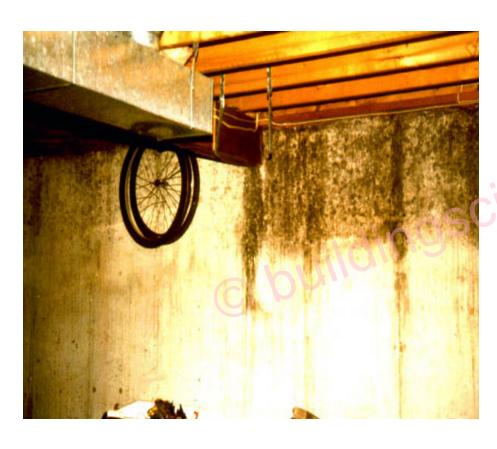
NATURE OF COMPLAINT

> Staining of concrete basement walls with moisture and mold

- Recommendations (con't)
 - 2. Increase the temperature of the cold surfaces.
 - This can be accomplished by:
 - Adding thermal insulation to the interior surfaces of the perimeter concrete basement walls. Rigid insulation should be installed from the basement floor slab level to the underside of the main floor plywood sub floor.
 - Taping vertical joints in the rigid insulation.
 - Blocking basement window openings with rigid sheet insulation and masonry).
 - All of the above strategies are recommended.

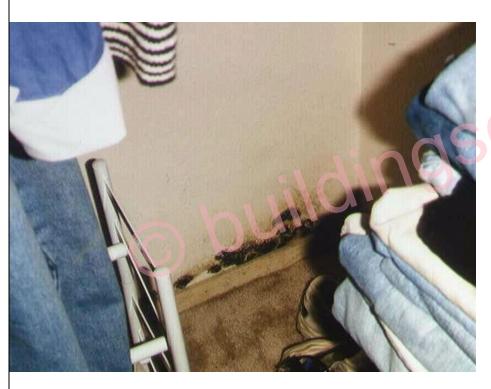
Nature of Complaint

- Sensations of dampness
- Mold and window condensation,
- Window deterioration
- Interior paint and gypsum wall board damage

- Conclusions: The problems are a result of:
 - High levels of interior generated moisture due to high occupant loading
 - Lack of air change due to absence of controlled ventilation

- Recommendations
 - Reduce the interior vapor pressure/moisture by installing a controlled mechanical ventilation system
 - Exhaust fans of 100 to 150 cfm capacity should be installed, extracting air from the washrooms, and basement area.
 - The fans should be operated continuously

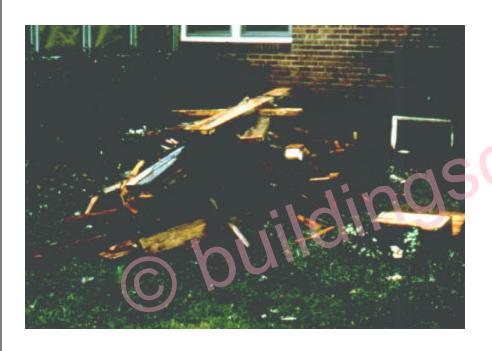
- Nature of Complaint
 - Rotting floor joists
 - Complaints of condensation on windows
 - Mold on interior walls at corners

- Conclusions: Problems are a result of:
 - High moisture entry rate due to wet crawlspaces
 - Lack of air change due to absence of controlled ventilation

- Recommendations
 - Repace rotted framing members
 - Install continuous ground cover in crawl space
 - Install individual exhaust fans in each unit

- Follow-up
 - Rotted framing members were replace
 - Ground cover was installed
 - Fans were installed
 - No more complaints of rotting floors and mold

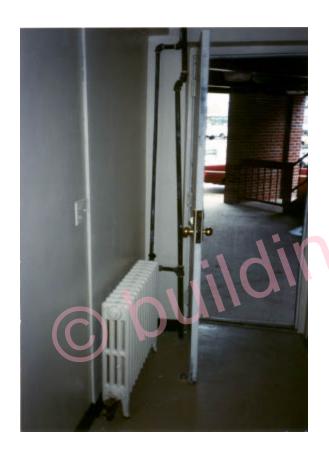
- Nature of Complaint
 - Complaints of condensation on windows and mold growth

- Conclusions: The problems are a result of:
 - High levels of interior generated moisture due to high occupant loading, dirt crawlspaces, condensation on cold water pipes, cold exterior wall surfaces, and city storm drain backups.
 - Lack of air change

- Recommendations
 - Install central, continuous operation exhaust fans in each building.

- Follow-up
 - Owner installed bathroom and crawlspace fans
 - City repaired storm drains
 - Mold and condensation complaints eliminated
 - \$34 per apartment per year additional energy cost (\$85 per apartment per year if low efficiency heating)

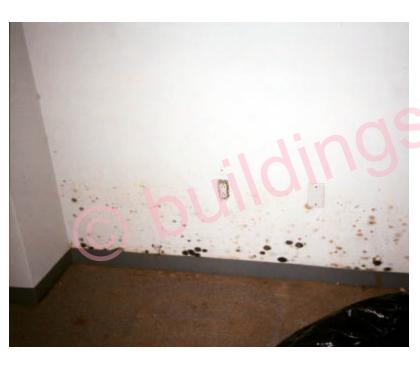
Nature of Complaint

- Complaints of mold
 - Lower units at the interior surfaces of exterior walls near basement floor slab locations;
 - Lower units at the interior surfaces of interior walls near basements floor slab locations;
 - Stairwells at interior surfaces near basement floor slab locations

- Conclusions: The problems are a result of:
 - Summer condensation due to cold surfaces in lower level garden style apartments
 - Warm, humid exterior air "sees" a cooled surface (especially at metal studs)
 - Moisture is deposited at the cooled surface leading to a rise in surface relative humidity and mold
 - Basement level units experience substantial heat loss to the ground at the below grade portions of the perimeter walls and bottom plates of interior walls
 - Warm, humid air enters and is cooled by the concrete foundation assembly
 - The mold growth is occurring as a result of thermal bridging leading to a rise in local surface relative humidity

- Install thermal breaks under bottom plates of interior and exterior walls
- Reconstruct the lower units to eliminate the thermal bridging at the exterior walls
- Strip the damaged gypsum board and place rigid insulation between the metal framing and concrete foundations at perimeter
- Install individual exhaust fans in each unit

- Follow-up
 - Fans were installed, thermal bridging was eliminated, and walls were insulated and sealed
 - No more complaints of mold

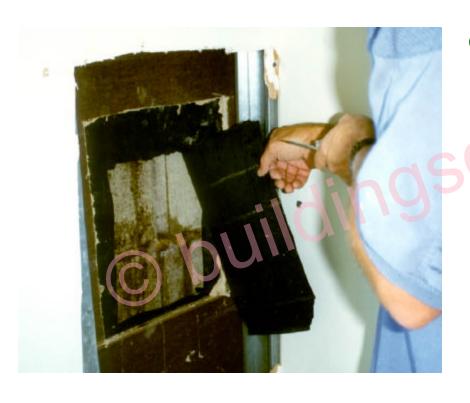
- Nature of Complaint
 - Water infiltration
 - Mold and window condensation
 - Window deterioration
 - Interior paint and gypsum wall board damage

- Conclusions
 - Rain water entry is occurring at the slab edge locations under the fabric flashings
 - Discoloration at the ceiling/exterior wall intersections is due to mold growth as a result of thermal bridging

- Create a "water dam" and drainage path at locations where water is entering the building
- Eliminate the existing thermal bridge affect of the concrete frame

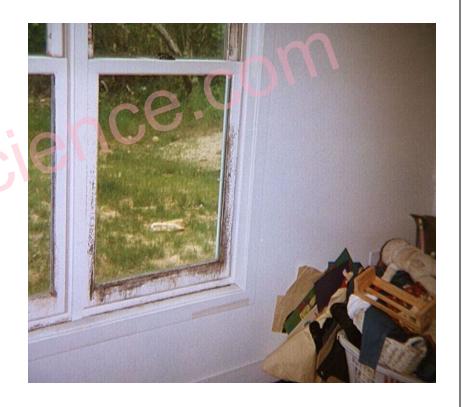
- Nature of Complaint
 - sensations of dampness
 - mold
 - window condensation and window deterioration
 - interior paint and gypsum wall board damage

- Conclusions: The problems are a result of:
 - Lack of air change

- Reduce the interior vapor pressure/moisture by installing a controlled mechanical ventilation system:
 - Exhaust only ventilation strategy
 - A single exhaust fan of 100 to 150 cfm capacity should be installed in each unit, ducted from each bedroom resulting in air extraction from each bedroom

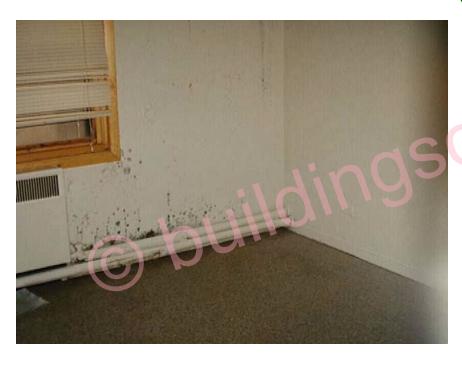
- Nature of complaint
 - Sensations of dampness
 - Mold
 - Window condensation and window deterioration
 - Interior paint and plaster board damage

- Observations and Test Results
 - High occupant loading in relatively small units
 - Occupant lifestyles also inferred high moisture generation (hanging interior laundry, cooking, cleaning, etc.)
 - Mold was observed at exterior corners
 - Condensed water and water stains on window frames indicated significant current and past condensation on the window glass

- Conclusions
 - Sensations of dampness occur as a result of high interior moisture levels due to
 - inadequate air change (ventilation) and
 - a high moisture source strength (high occupant loading and lifestyle);
 - The mold and mildew, window condensation, interior paint and plaster board damage occur as a result of
 - high interior moisture levels due to inadequate air change (ventilation) and
 - a high moisture source strength (high occupant loading and lifestyle)
 combined with cool surfaces

- Reduce the interior vapor pressure/moisture by installing controlled mechanical ventilation :
 - Operate ventilation continuously
 - Maintain interior moisture levels between 30 and 45 percent relative humidity at 70 degrees Fahrenheit
 - Exhaust only ventilation fans of 150 cfm capacity should be installed, extracting air from the washrooms and stairwell/hallway areas and exhaust this air to the exterior via a duct
 - To promote air change in the secondary rooms, all interior doors should be undercut 2.5 inches (from top of floor covering to underside of door) or install transfer grills
