Vancouver Field Exposure Facility: Phase III Exterior Insulation Analysis

Research Report - 1207

17 February 2012

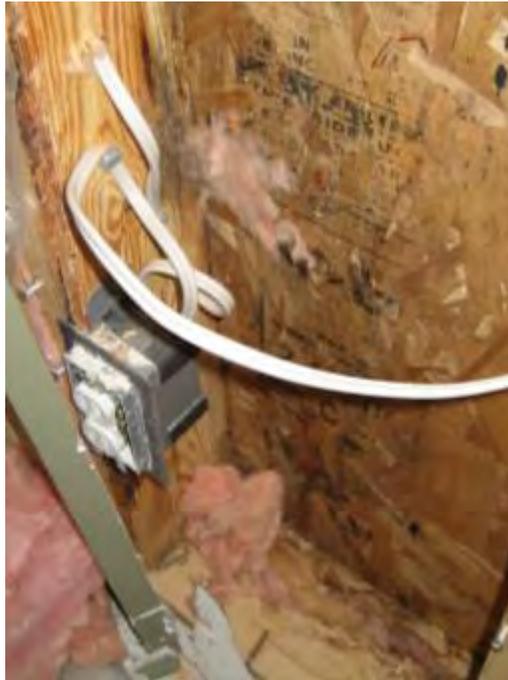
Field experience with air tightness and blower door testing has demonstrated that the enclosure will always have some air leaks, and their location and size depends on the type and quality of construction. It is not uncommon to find air leakage pathways through electrical outlets, switches, and other interior finish penetrations. This means that with air permeable cavity filled insulation, which is the most commonly used, it is not uncommon to find evidence of moisture condensation on the interior surface of the exterior OSB behind penetrations. Figure 29 shows an example of an air leakage condensation problem behind an electrical outlet in a six year old house with an interior poly vapor barrier. The OSB and framing are stained and dark with surface mold and the nails are corroding.

Figure 29 : Example of air leakage condensation durability issues.

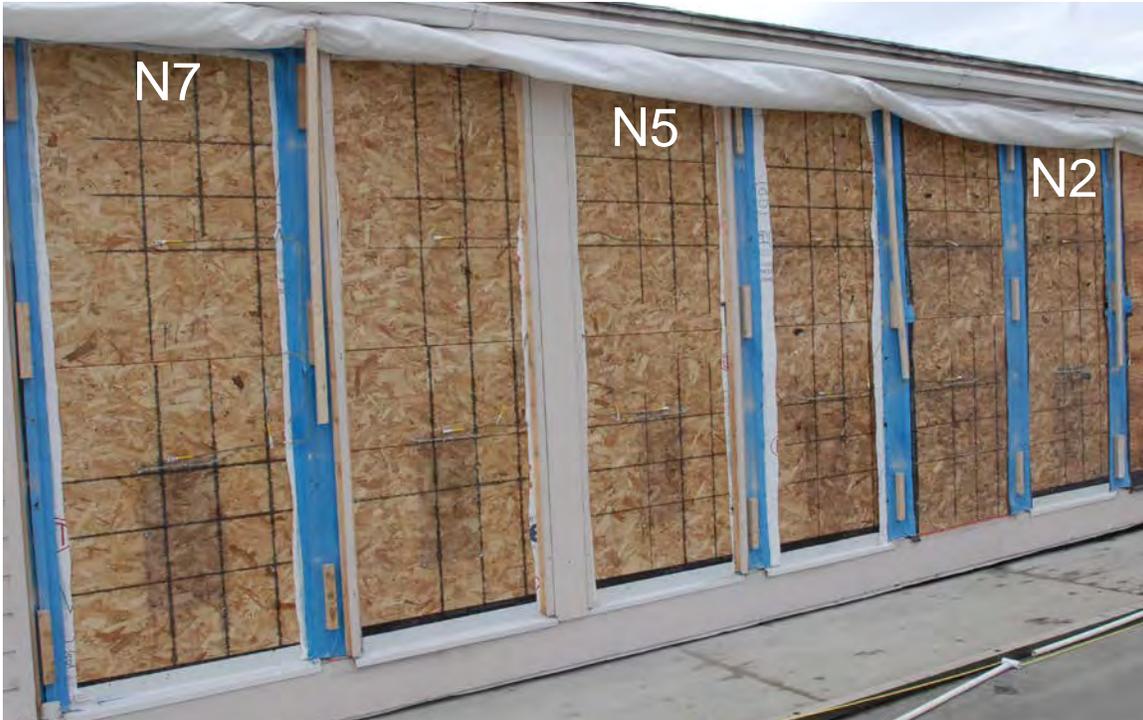
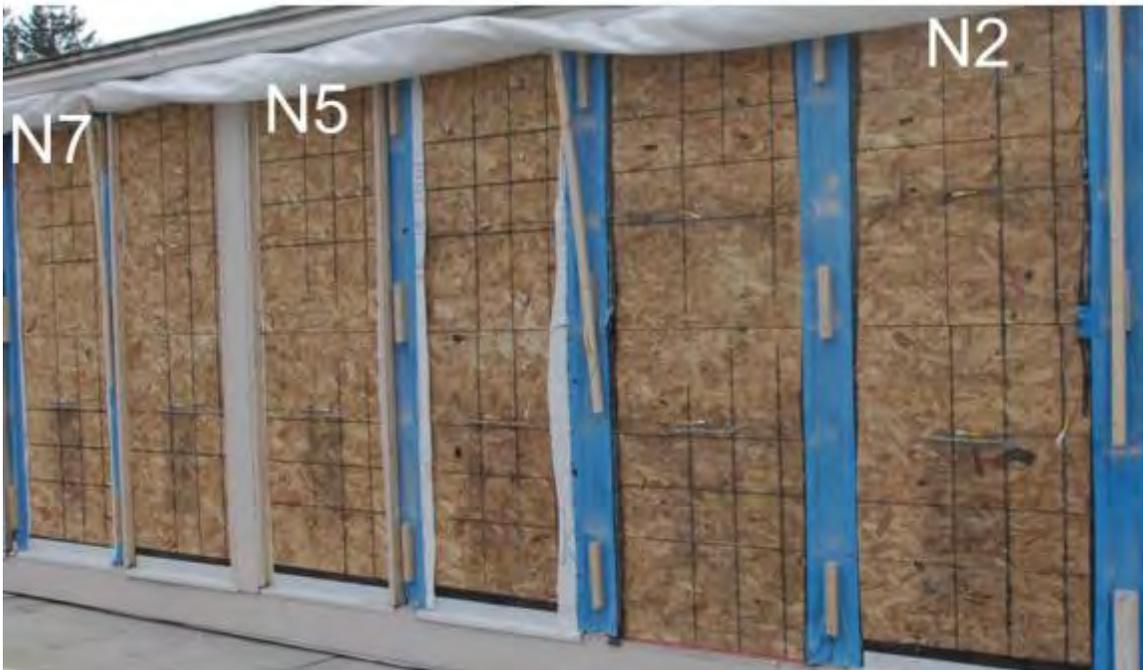
On the north orientation, the exterior of the OSB on Wall 2 was quite dark and stained, particularly in the vicinity of the wetting apparatus (Figure 38 and Figure 39). Both Walls 5 and 7 on the north orientation appeared to be in pristine/good condition. The area immediately behind the wetting apparatus was a little darker on Wall 7 than Wall 5, corresponding to the measured quicker drying rate of Wall 5, likely due to ventilation drying. Overall, the rest of the North Wall 7 was marginally better than North Wall 5.

On the interior surface of the OSB, Wall 2 had the most staining, again, surrounding the wetting apparatus. Walls 5 and 7 looked undamaged on the interior of the OSB.

Figure 38 : Exterior OSB sheathing on the north orientation immediately following deconstruction

Figure 39 : Exterior OSB sheathing on the north orientation immediately following deconstruction (photo taken from the opposite direction of Figure 38)

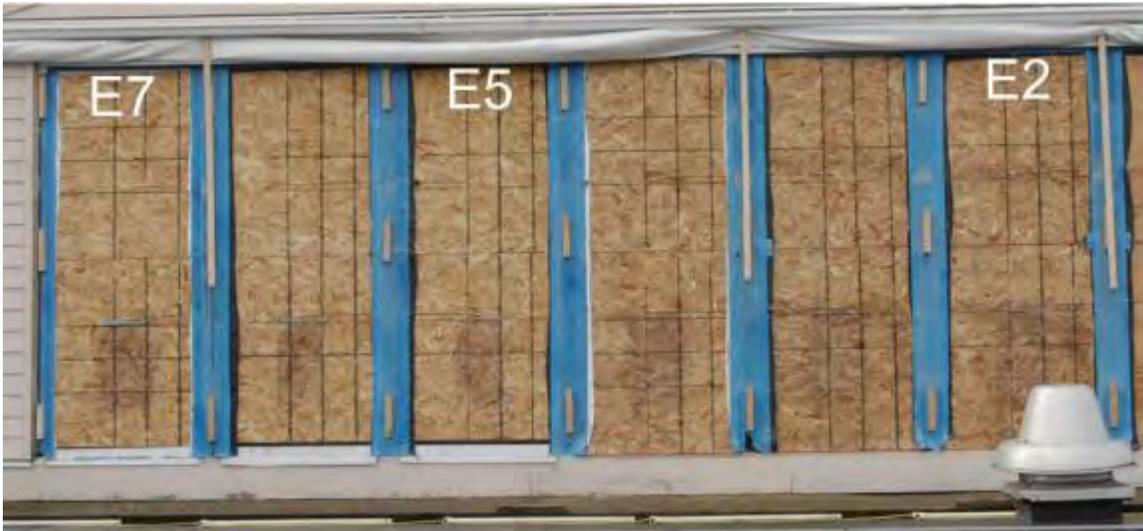
Of the three comparison walls on the east orientation (Figure 40), Wall 2 is the most stained in the area surrounding the wetting apparatus and on the upper portion of OSB. There are no visual

differences in the photo between Walls 5 and 7. Overall, Wall 7 looked the best of all east walls, but both Wall 5 and Wall 7 looked like new over most of the surface of the OSB.

Figure 40 : Exterior OSB sheathing on the east orientation immediately following deconstruction

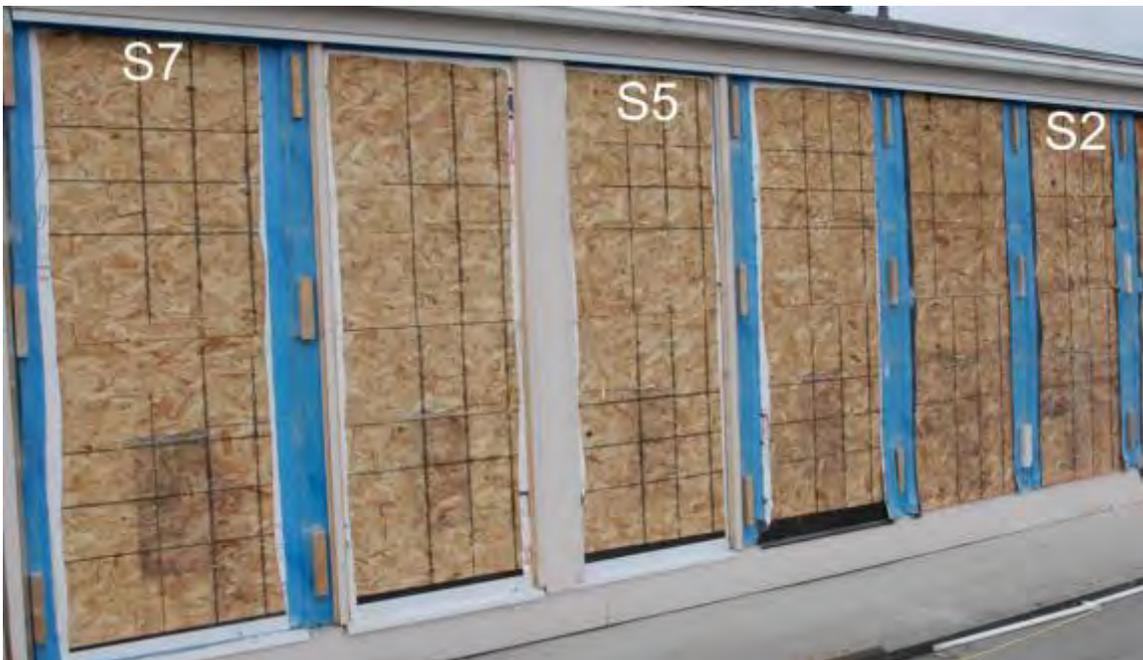
The exterior surface of the OSB on South Wall 2 is clearly the darkest and most stained of the three comparison walls (Figure 41). There was some staining in the vicinity of the wetting apparatus on both Walls 5 and 7, but overall, the exterior surface of the sheathing showed no signs of moisture related damage on Wall 5, and looked like new on Wall 7.

Figure 41 : Exterior OSB sheathing on the south orientation immediately following deconstruction
