### **Rainwater Management Performance of Newly Constructed Residential Building Enclosures During August and September 2004**

Prepared for the Home Builders Association of Metro Orlando and the Florida Home Builders Association By:

Joseph William Lstiburek, Ph.D., P.Eng. Building Science Corporation 70 Main Street Westford, MA 01886

January 11, 2005

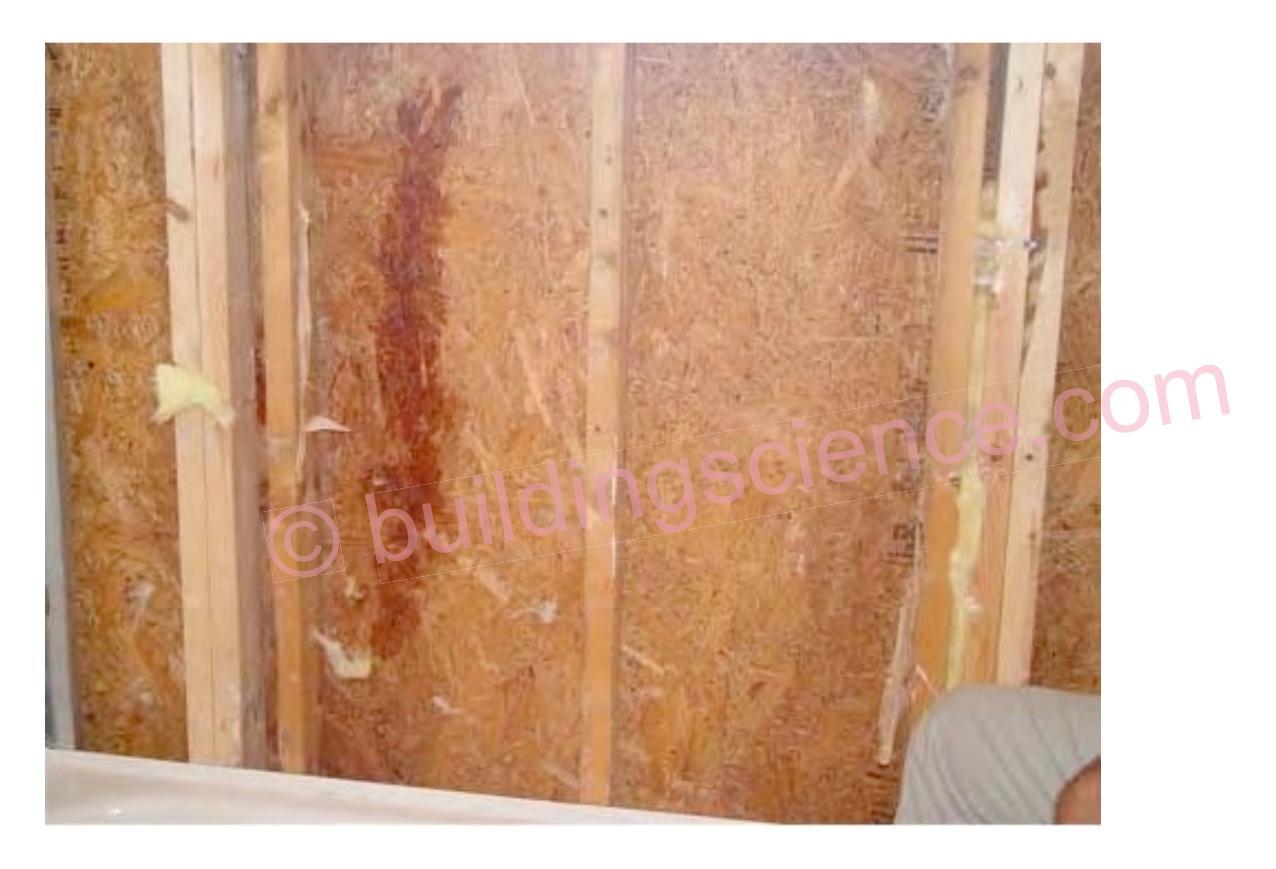
Photograph 2: Rainwater Entry into Second Floor Frame Assembly

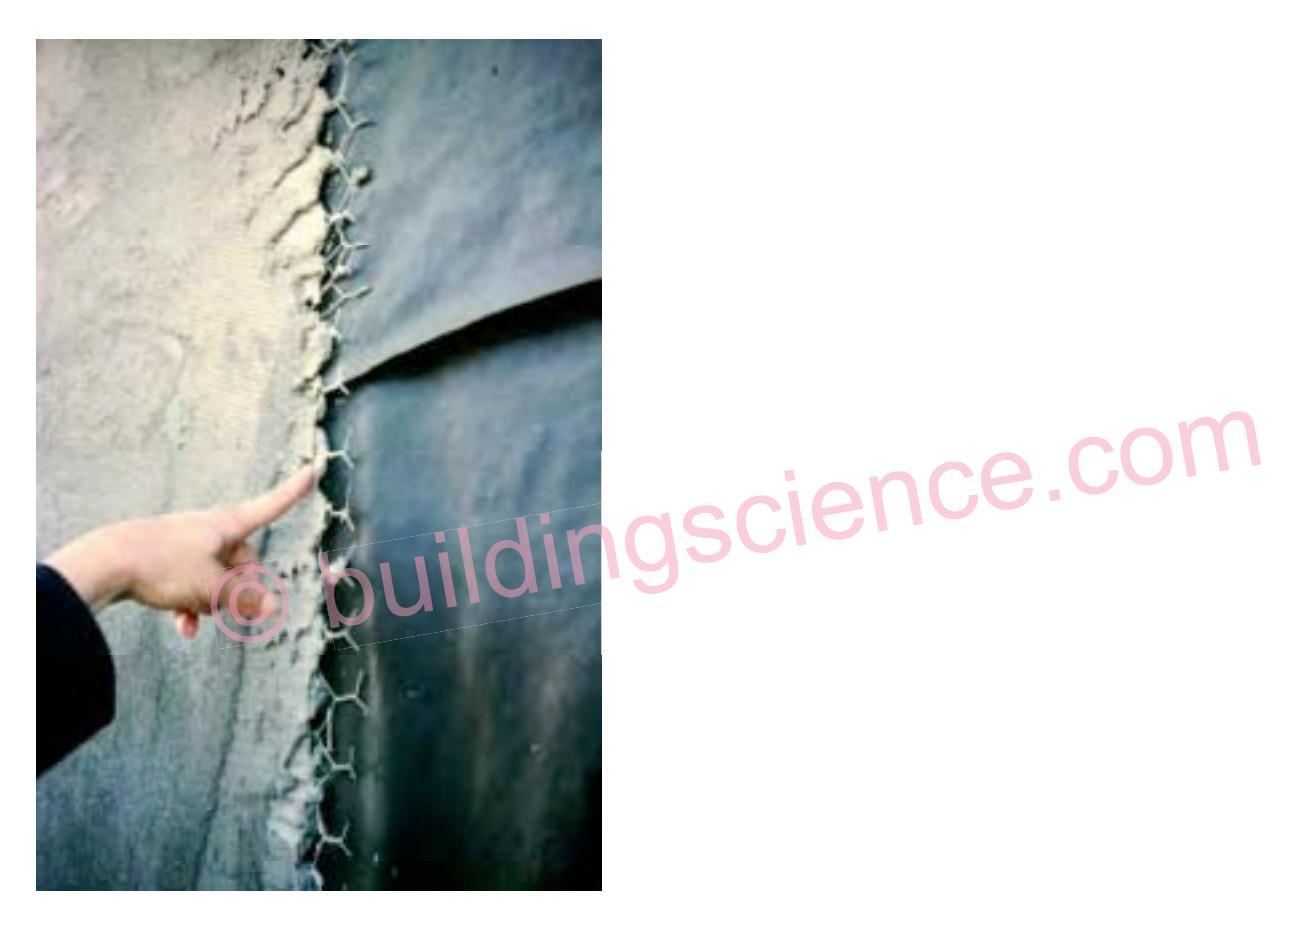
There appear to be significant performance issues with WRB's relating to manufacture, testing and approval. All plastic housewraps and some building papers tend to bond to stucco renderings thereby negating drainage (Photograph 3). Additionally, many plastic housewraps loose their water repellency (Figure 9) when in contact with sheathing and stucco renderings (Photograph 4).

Photograph 4: Stucco Rendering Bonding to Plastic Housewrap

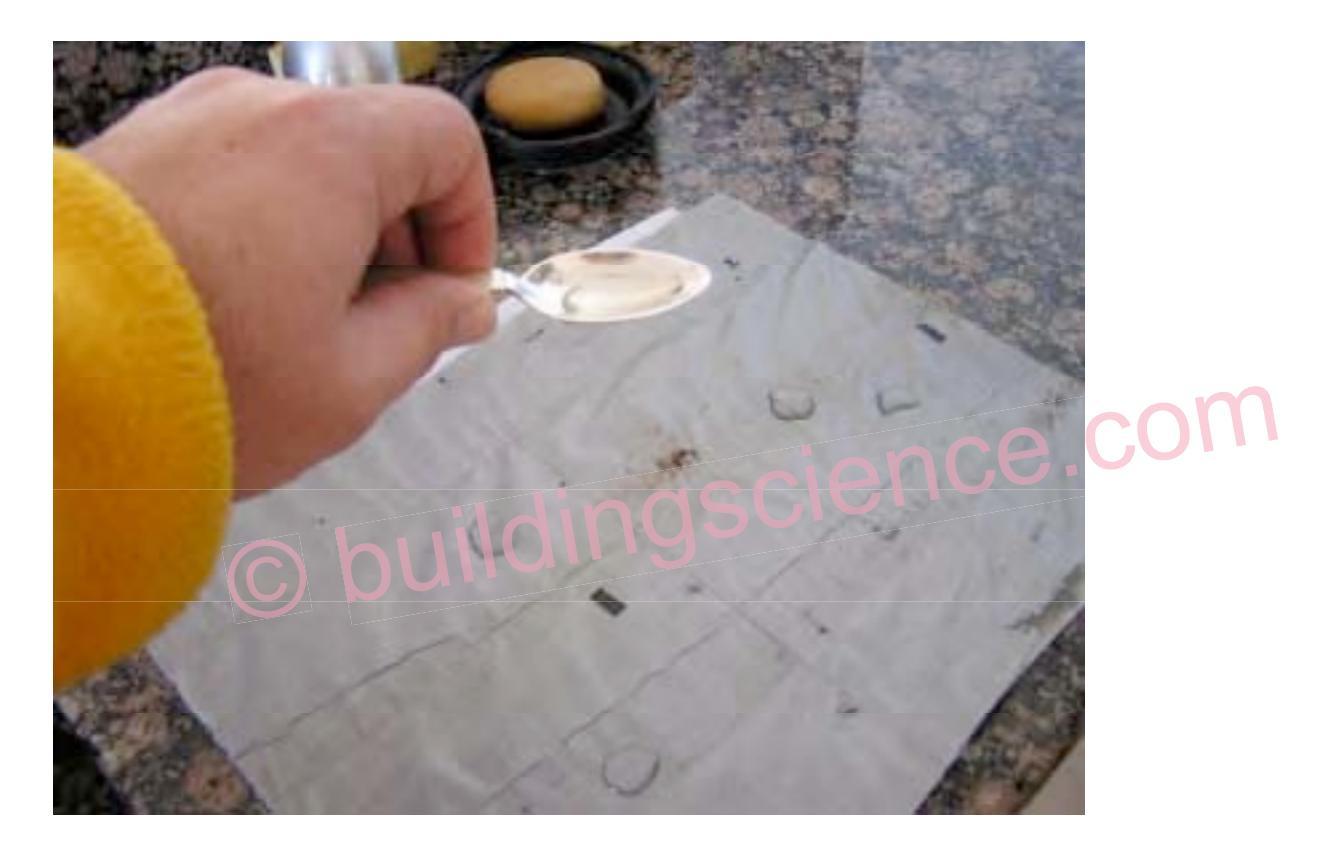
All perforated plastic housewraps fail a simple test for water repellency and water holdout (Photograph 5 and Photograph 6). Many non perforated housewraps fail a similar test when exposed to surfactants (Photograph 7, Photograph 8 and Photograph 9).

Photograph 6: Plastic Housewrap Failing Water Drop Test

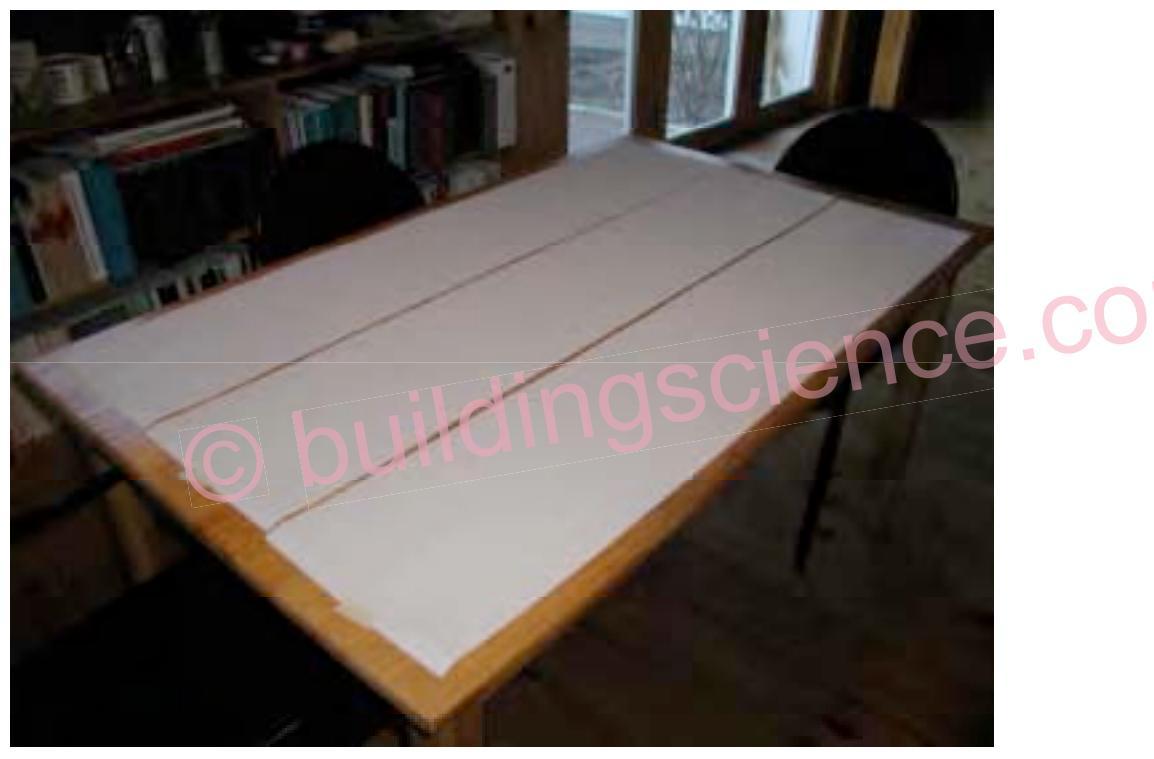
Photograph 8: Plastic Housewrap Undergoing Water Drop Test

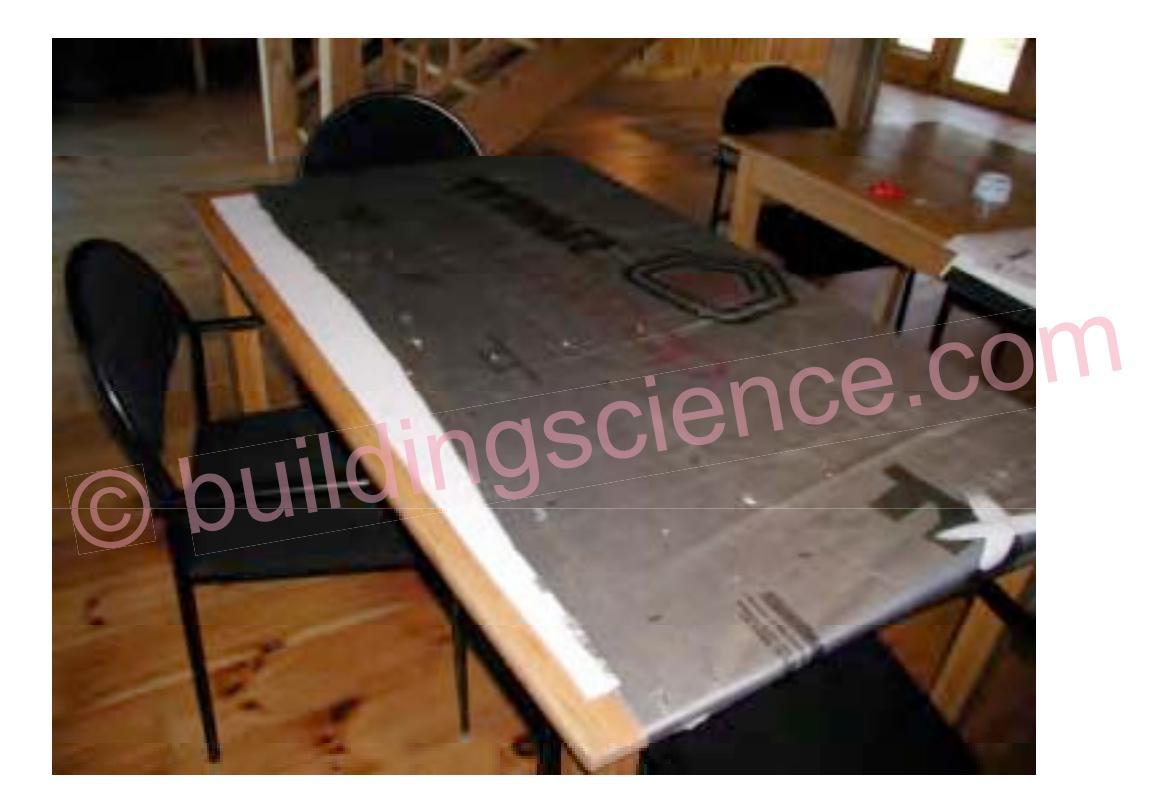
Photograph 9: Extensive Failure of Plastic Housewrap During Water Drop Test

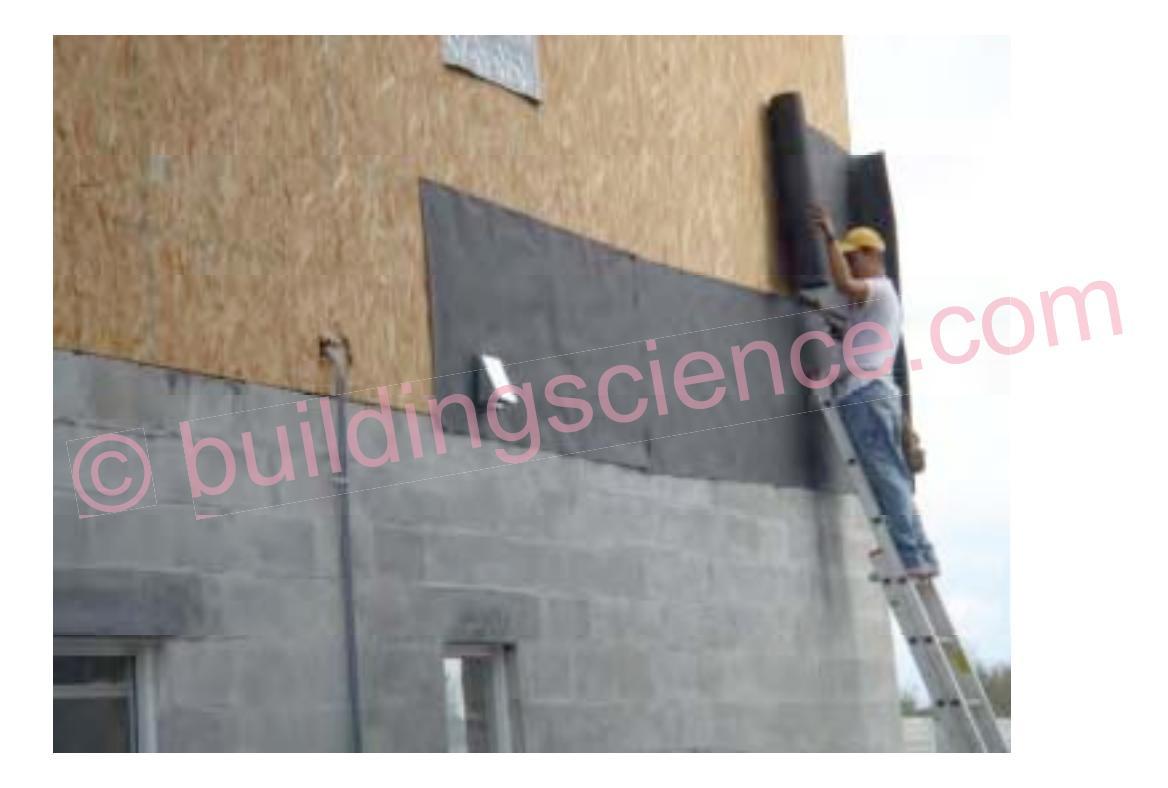
Photograph 14: Building Paper As Bridge Flashing

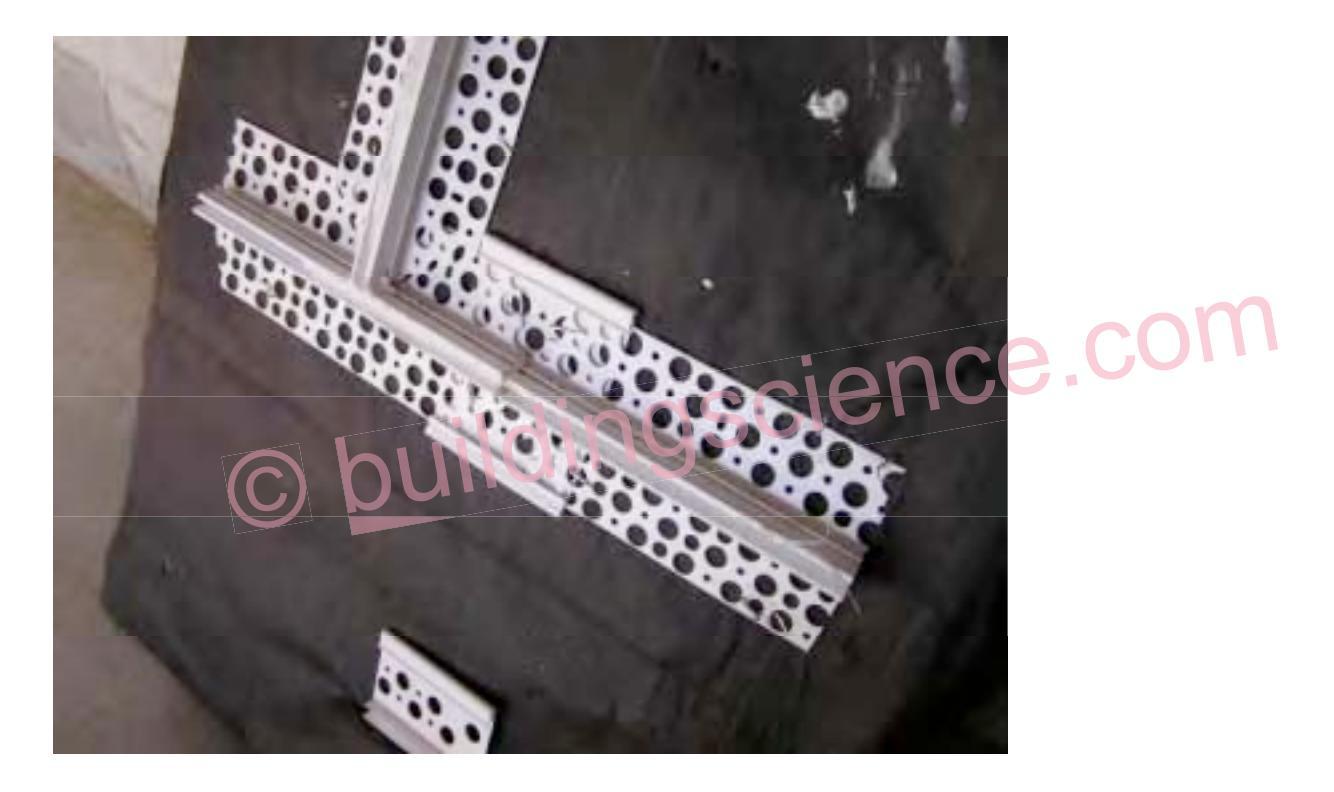
Photograph 15: Control Joint Accessories Installed Over Top of Drainage Plane

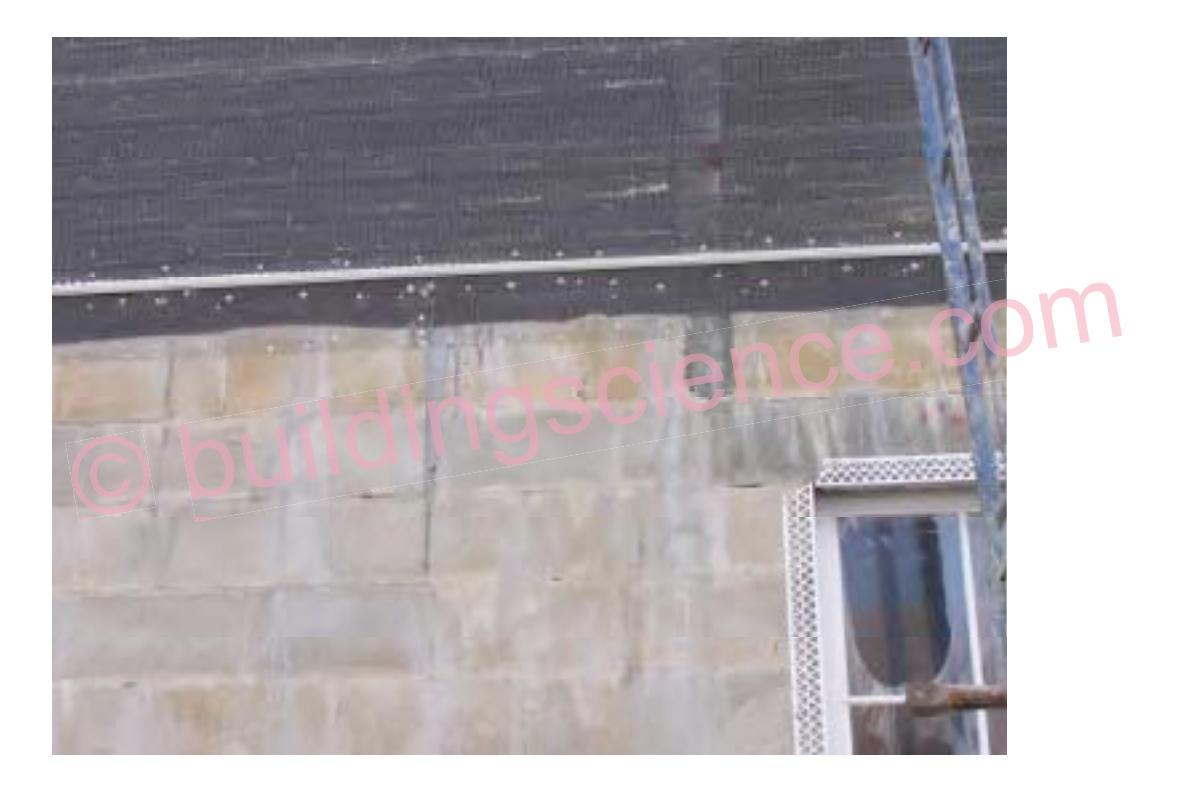
There are significant code enforcement issues regarding the construction of flashing at the base of the second floor frame assemblies. Code officials are enforcing a provision of ASTM C1063 (Standard Specification for Installation of Lathing and Furring to Receive Interior and Exterior Portland Cement-Based Plaster) that is not intended to apply where second floor frame assemblies intersect first floor mass assemblies. For reasons that are not explicable or defensible "reverse flashing" is mandated rather than drainage to the exterior at this location.

Photograph 16: Reverse Flashing Between Floors

The appropriate practice is to use a flashing between floors that effectively drains the water to the exterior (Figure 12). This detail is described in detail in Photograph 18, Photograph 19, Photograph 20, Photograph 21 and Photograph 22.

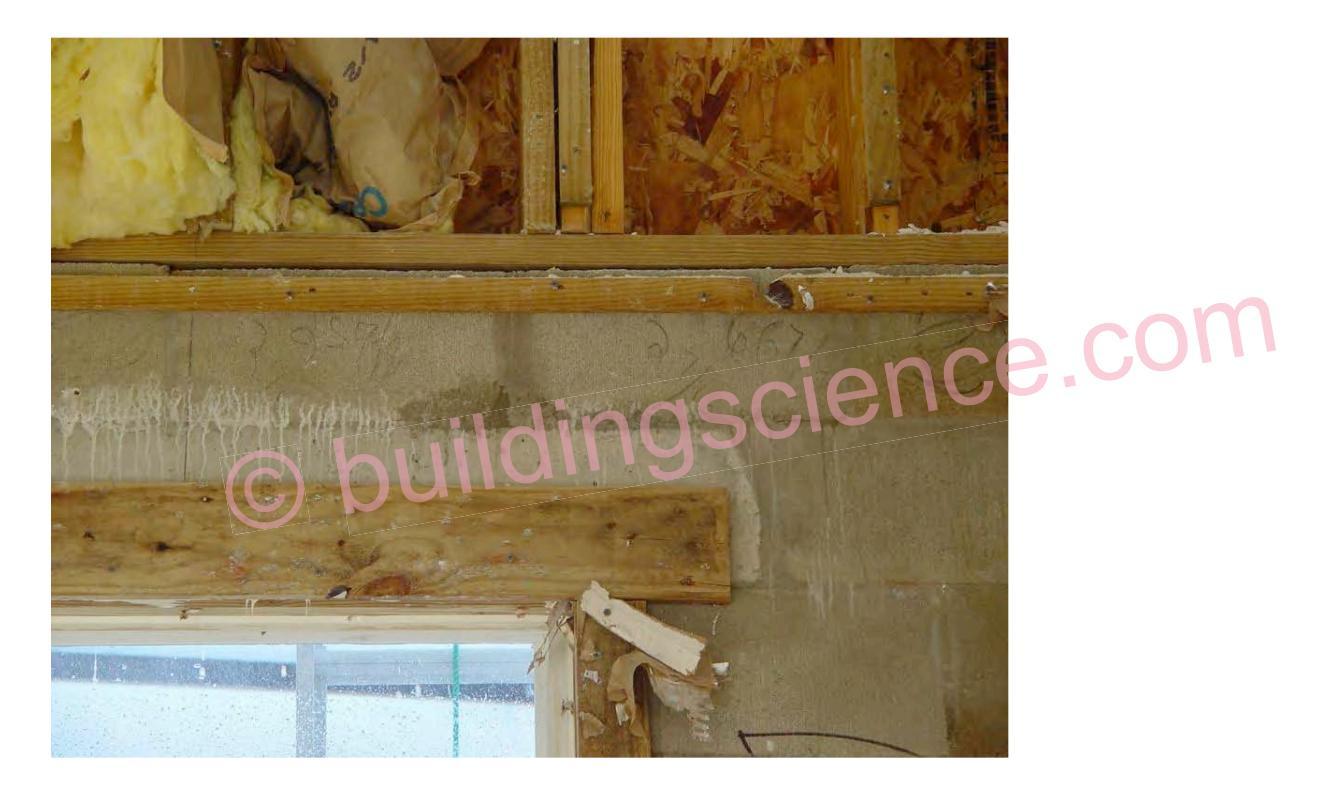
This practice results in leaks during wind driven rain events (Photograph 17) as the moisture storage capacity of the frame wall assembly is easily overwhelmed in the absence of drainage. The second floor frame assembly, which is a drained assembly is effectively unable to drain anywhere except to the interior.

Photograph 17: Water Entry Between Floors

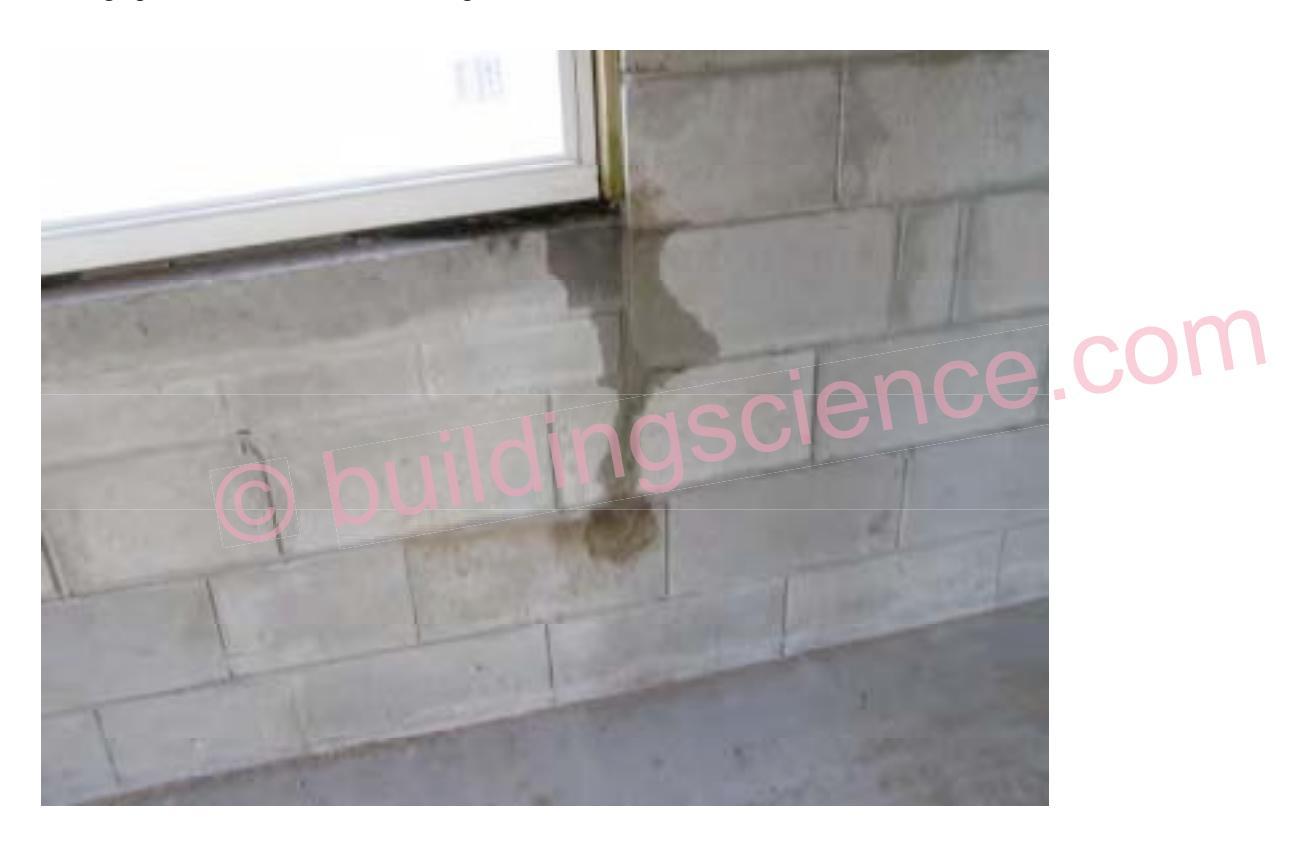
However, our testing indicates that many windows leaked at conditions well below their rated value -i.e. under no wind condition (Photograph 24 and Photograph 25).

Photograph 24: Window Corner Leakage

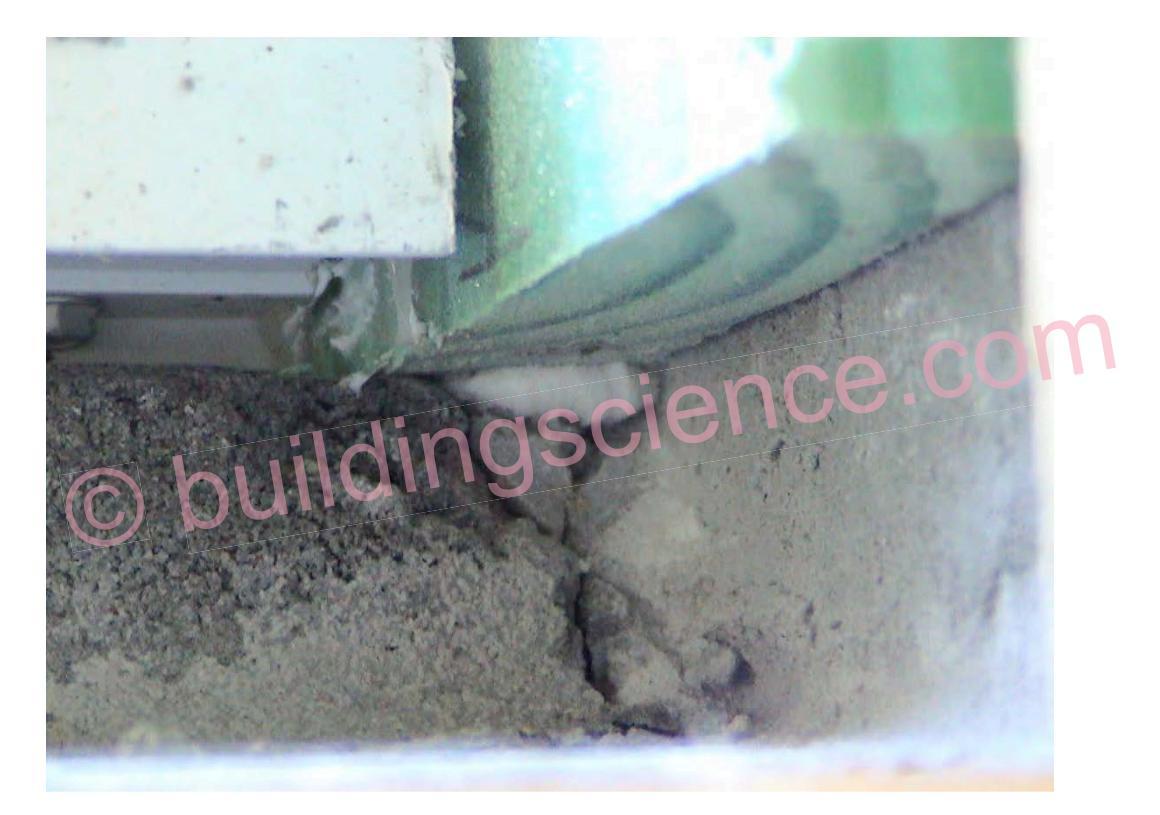
Photograph 25: Window Unit Leaking Inboard of Precast Attachment Rib

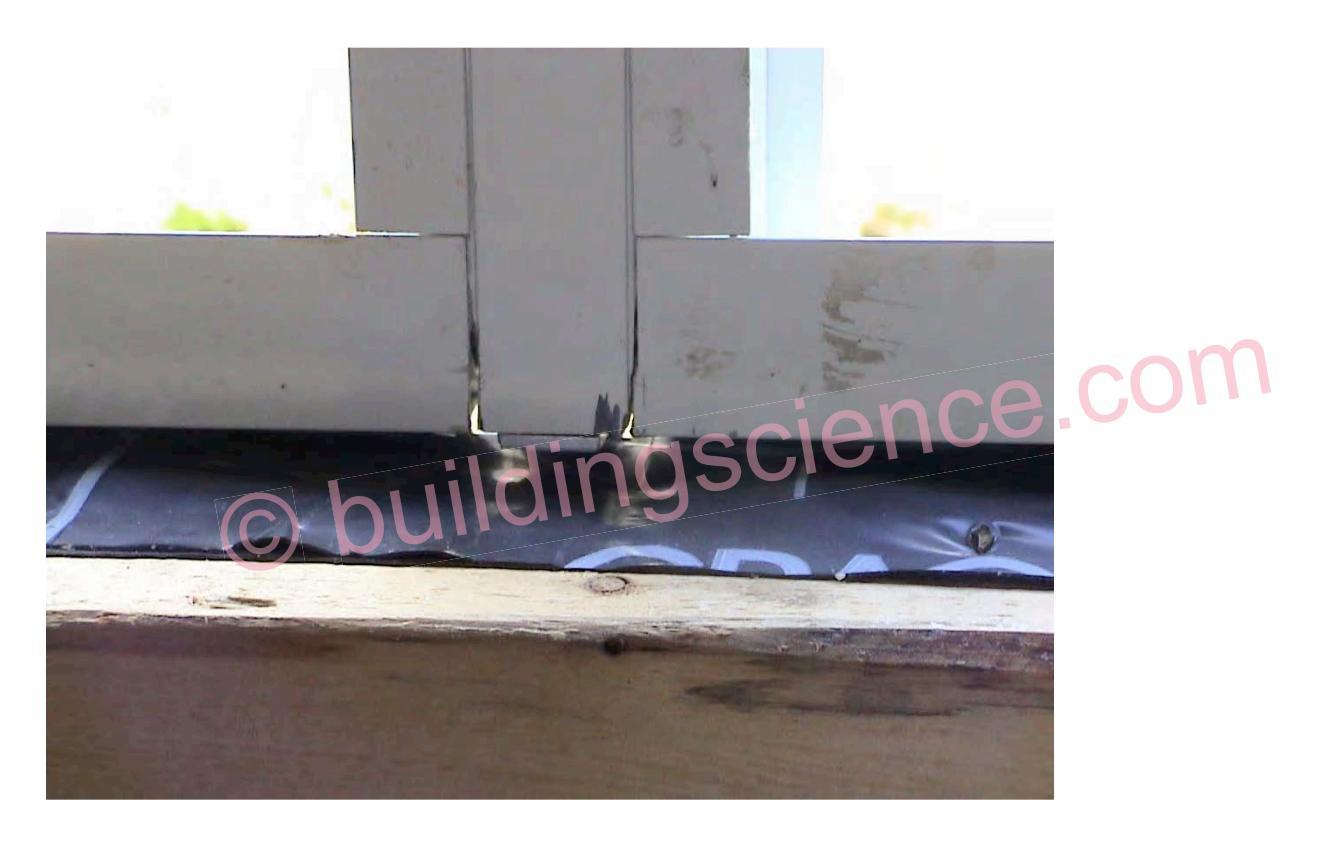
Additionally, many windows are sold as "mulled" or double windows or composite windows. However, they are tested as single units. Every mulled window unit tested leaked with no applied wind load (Photograph 26).

Photograph 26: Mulled Window Unit Leakage Paths

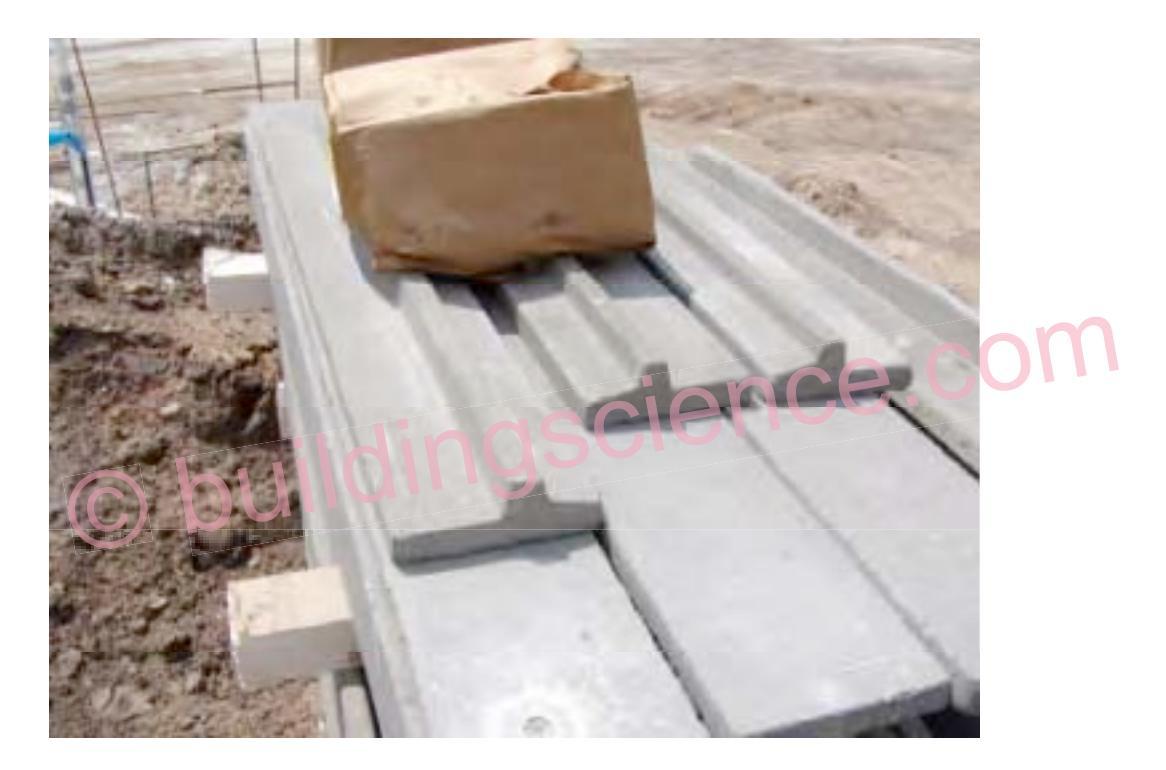
Many mass wall assembly window openings are constructed with precast sill units that have a raised rib attachment that directs window water leakage inwards rather than outwards (Photograph 27, Photograph 28, and Figure 13).

Photograph 27: Precast Sill With Illogical Attachment Rib

Figure 14 illustrates a precast sill profile that directs window water leakage outward. A similar approach is recommended for window openings in frame wall assemblies (Photograph 29).

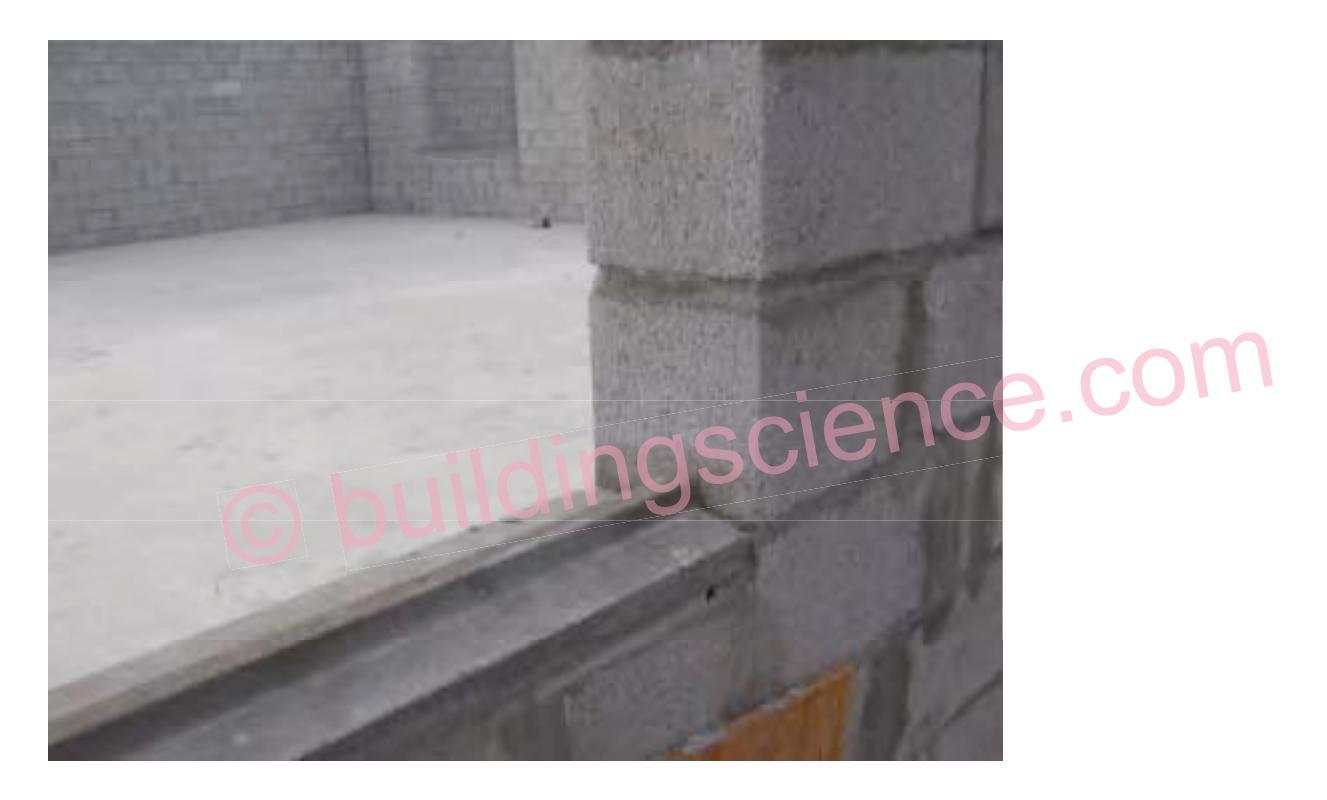
Photograph 28: Precast Sill That Channels Window Leakage Inward

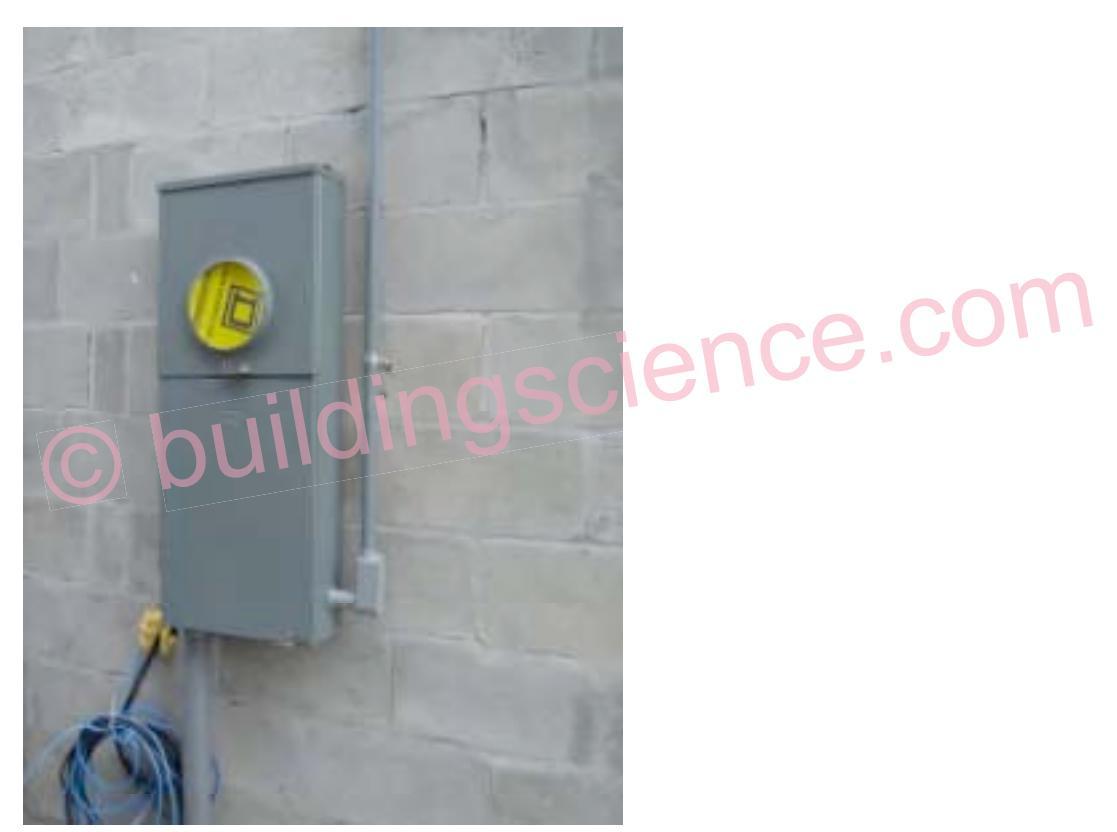
Electrical panel boxes are typically installed without water protection behind them (Photograph 31). This is typically not a major issue as these panel boxes are located on garage walls. However, it is recommended that the stucco rendering be applied prior to the installation of the electrical panel box.

Photograph 31: Electrical Service Panel – No Water Control Behind Panel

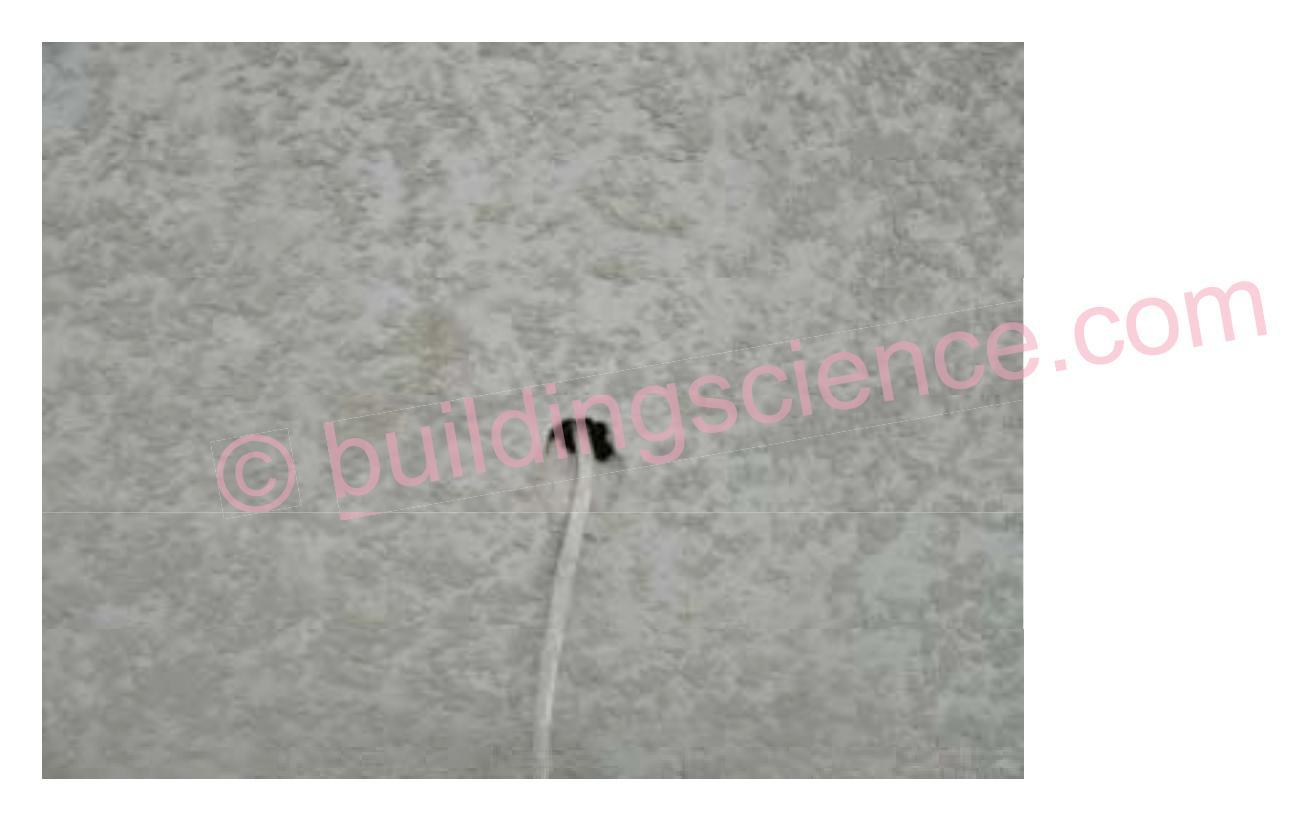
Photograph 32: Typical Maintenance Intensive Service Opening

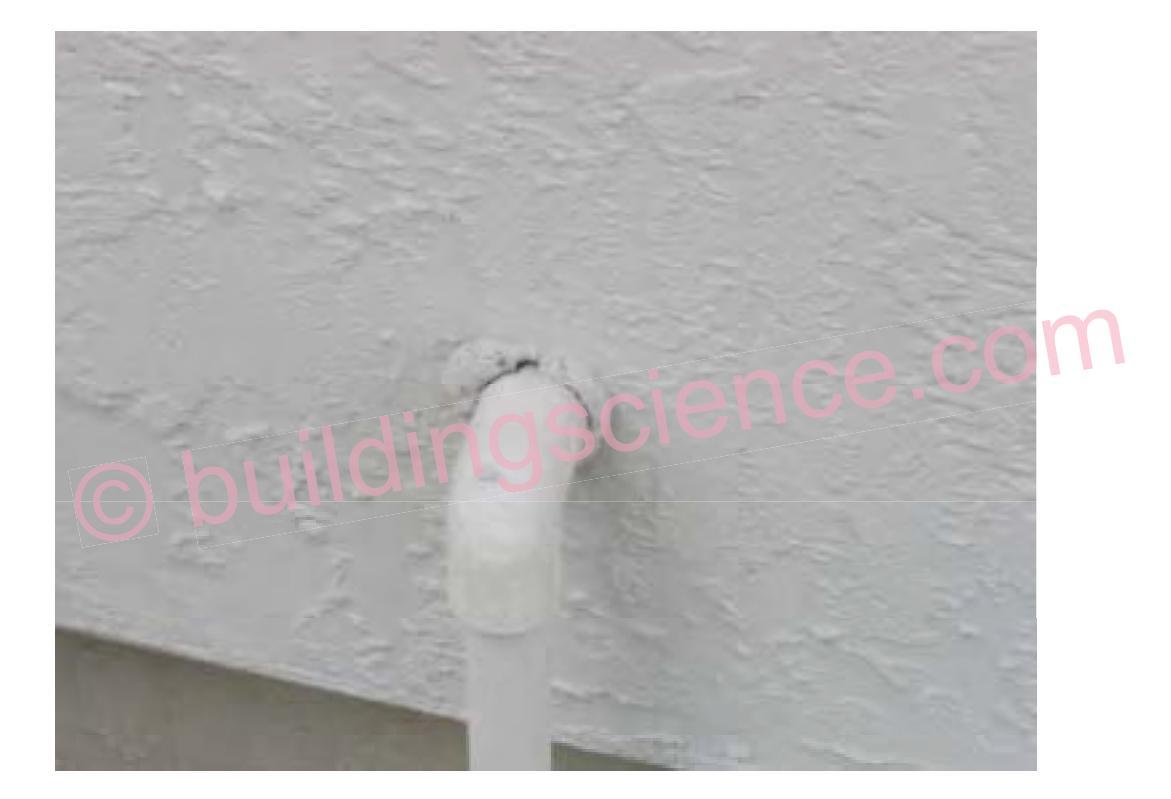
Photograph 33: Maintenance Intensive Service Opening

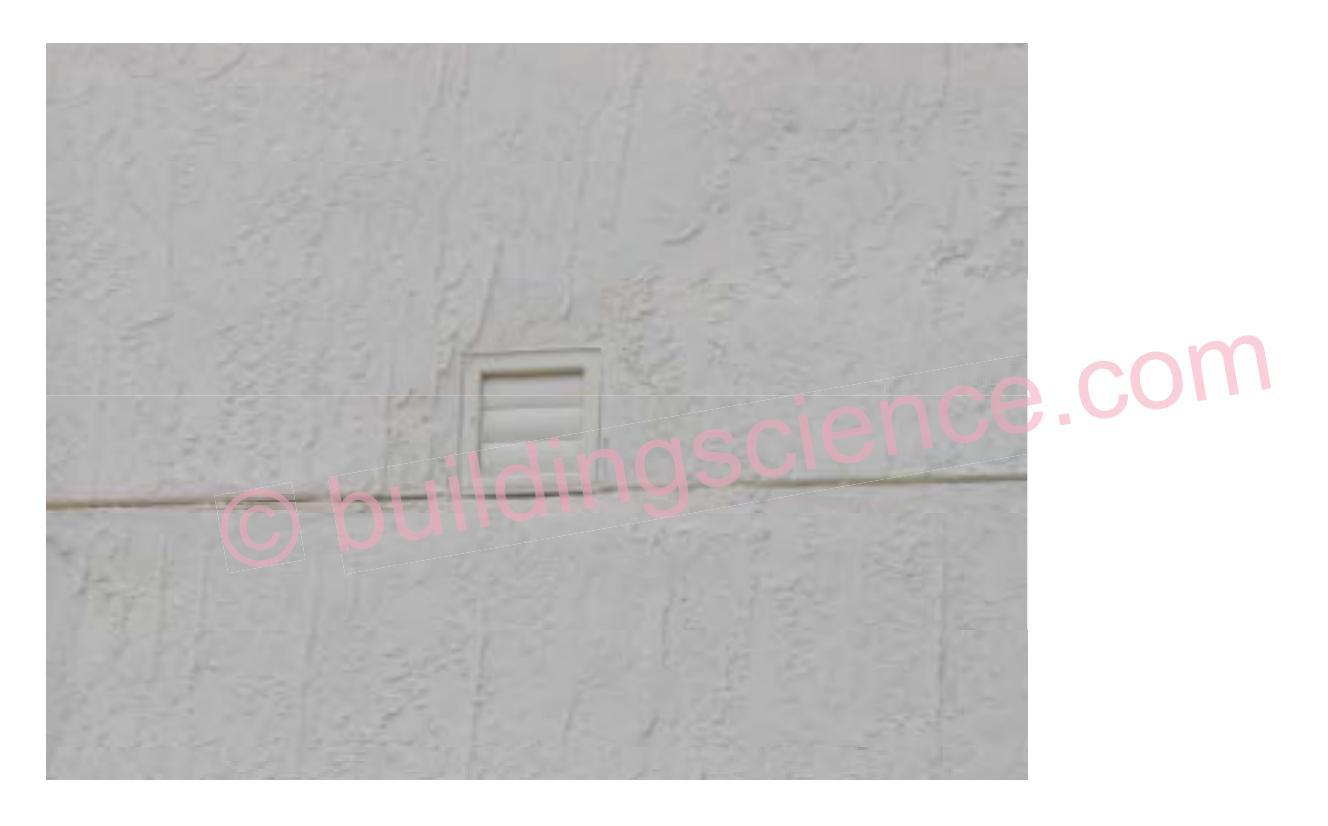
Photograph 34: Dryer Vent Opening
