National Grid Deep Energy Retrofit Pilot Program

Millbury Cape
Millbury, Massachusetts

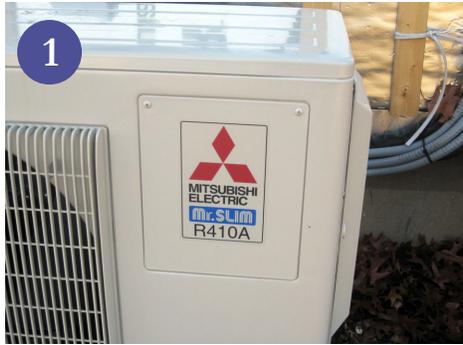
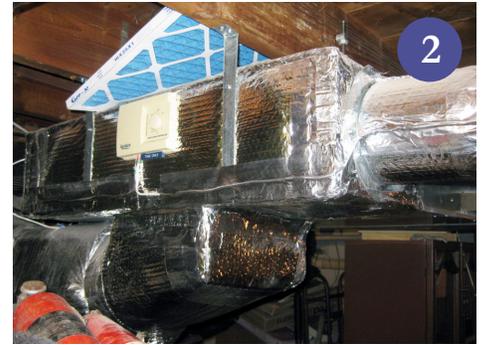
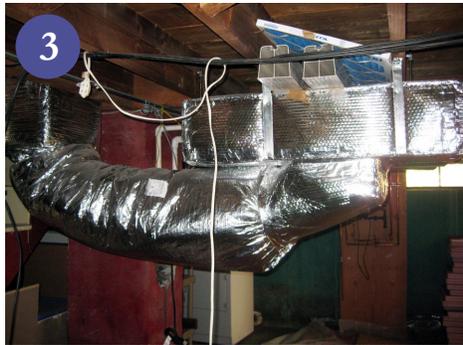
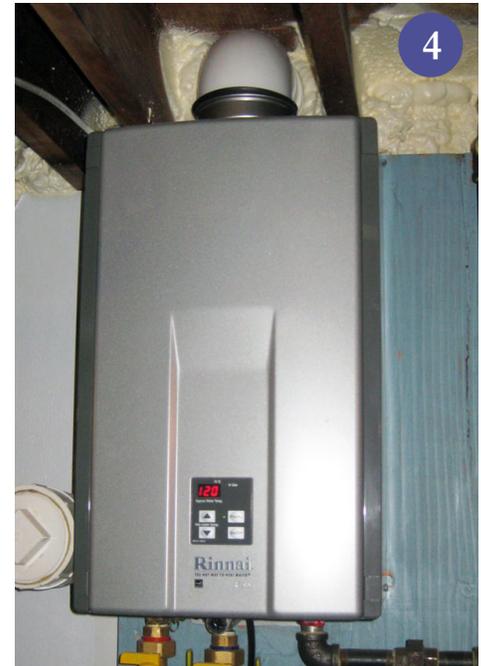
4 DHW: Instantaneous propane water heater.

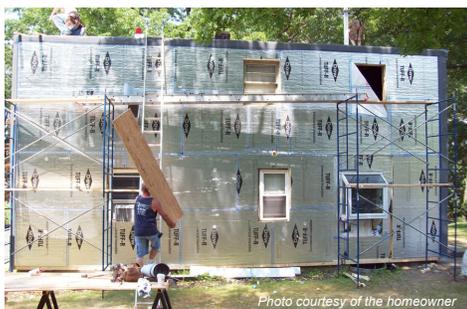
Photo courtesy of the homeowner

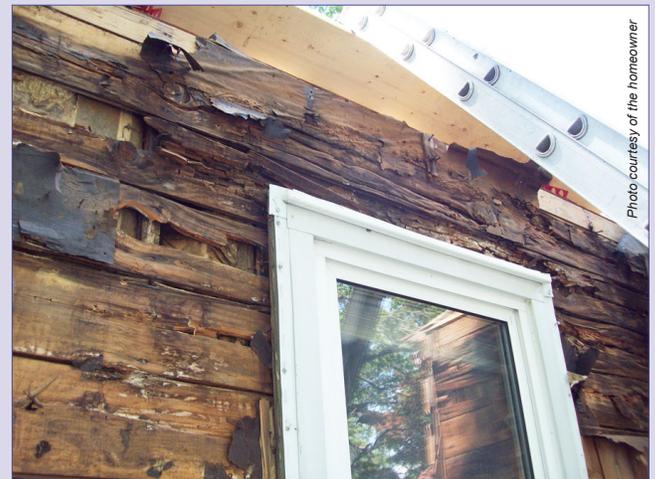
Addition of overhangs, ventilation/drainage gap behind the siding, carefully flashed windows, insulated roof—each of these measures reduces the risk of future water intrusion problems.
