First Canadian Place

Renewal From The Outside In

16th Annual Symposium
on Building Science
July 30, 2012

Halsall (A Parsons Brinckerhoff Company)

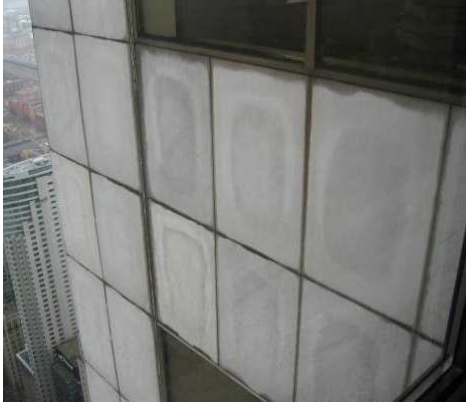
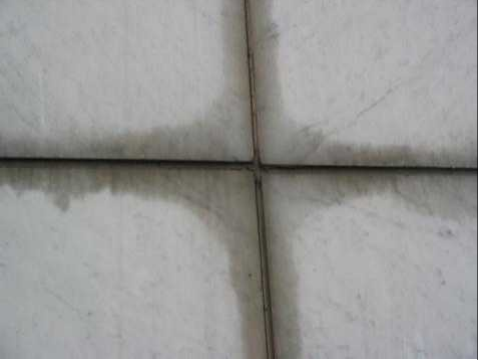
Staining from Silicone Sealant

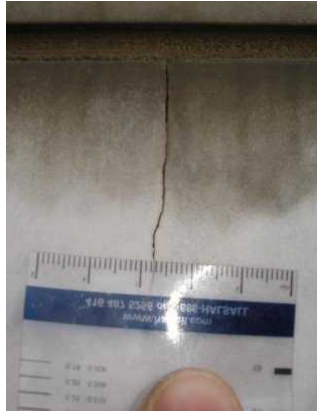
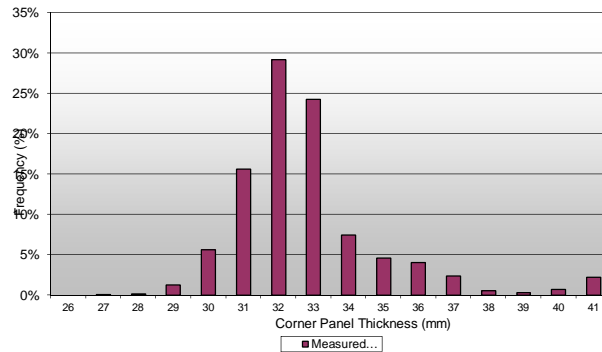
Cracks & Panel Thickness Variations

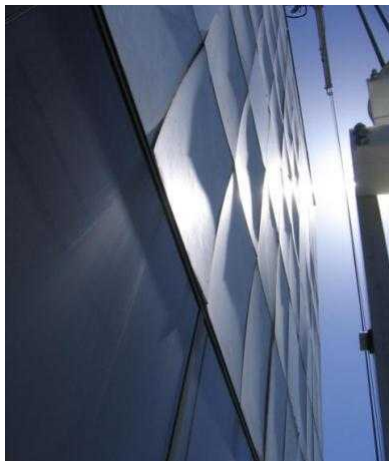
Thermal Hysteresis & Strength Loss

- Anisotropic behavior with thin marble & heat/moisture
- Volumetric expansion and bowing
- Reduced density and strength loss
- Cracking

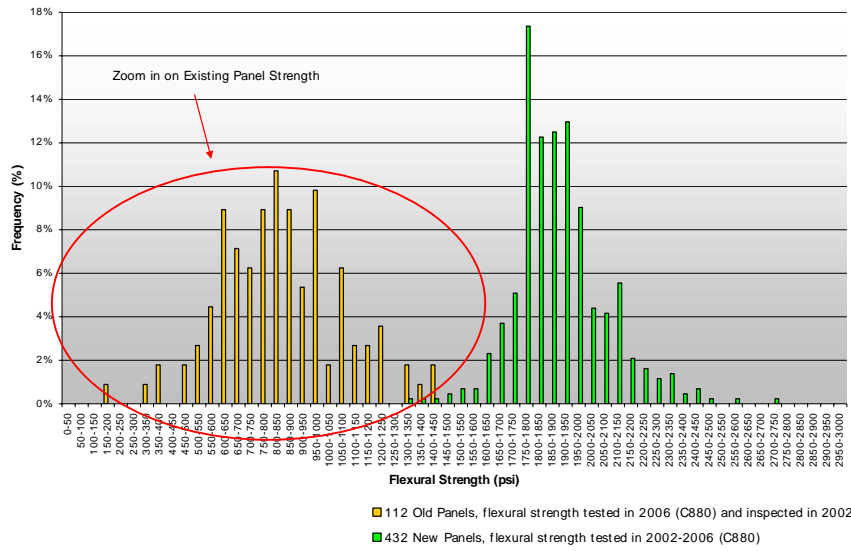
Old vs New Marble Strength

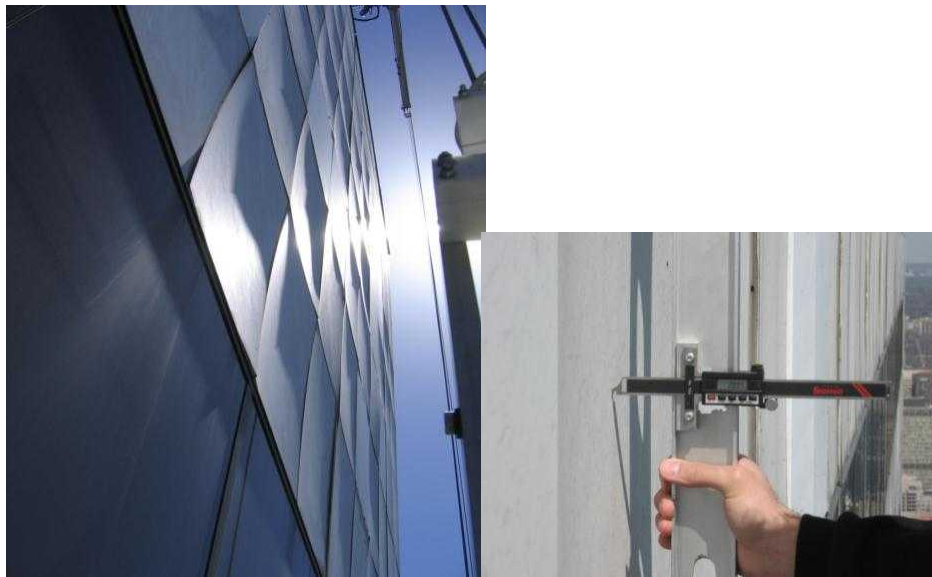
Bow Measurements

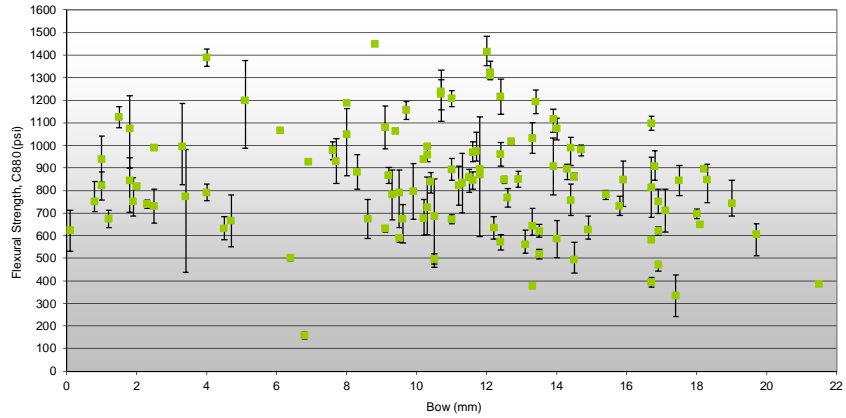
Bow vs. Strength Analysis

First Canadian Place - Marble Cladding
Bow vs C880 Flexural Strength of Panel Populations Tested in 2005/2006

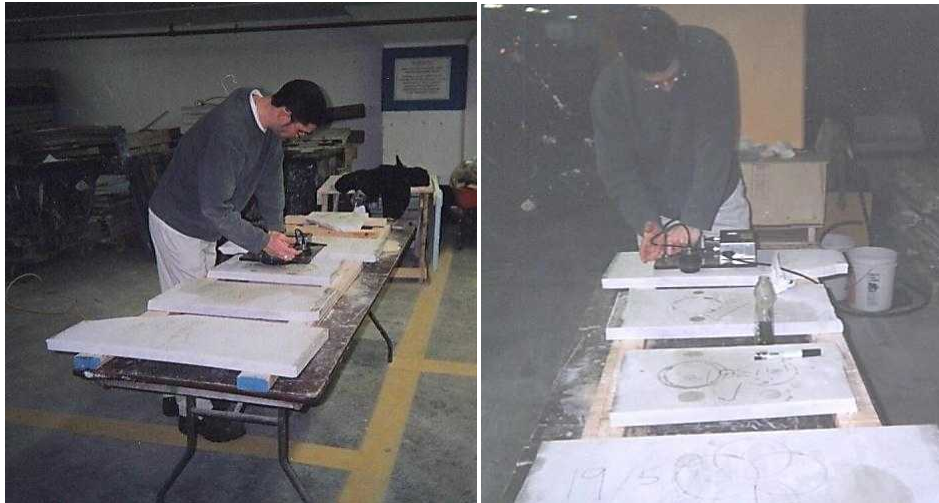
Acoustic Testing

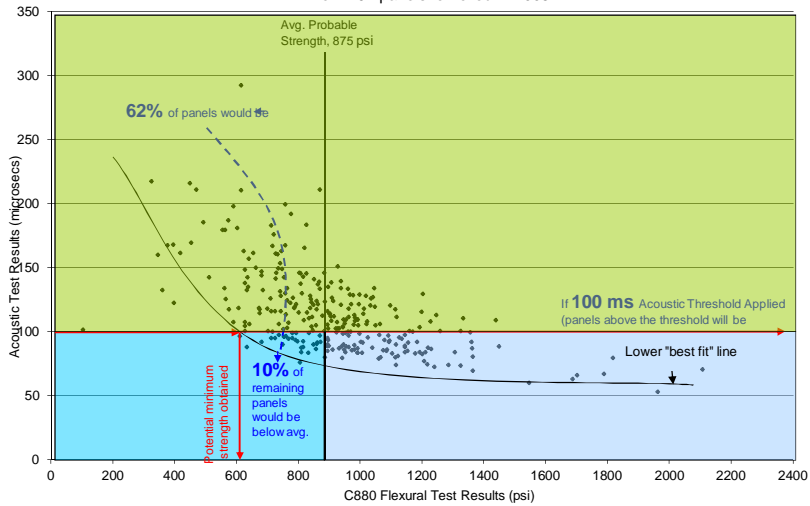
Acoustic Testing vs Strength

First Canadian Place - 100 King St., Toronto
 100 microsec Acoustic Threshold Applied to Acoustic and Flexural Test Data
 from 291 panels removed in 2005

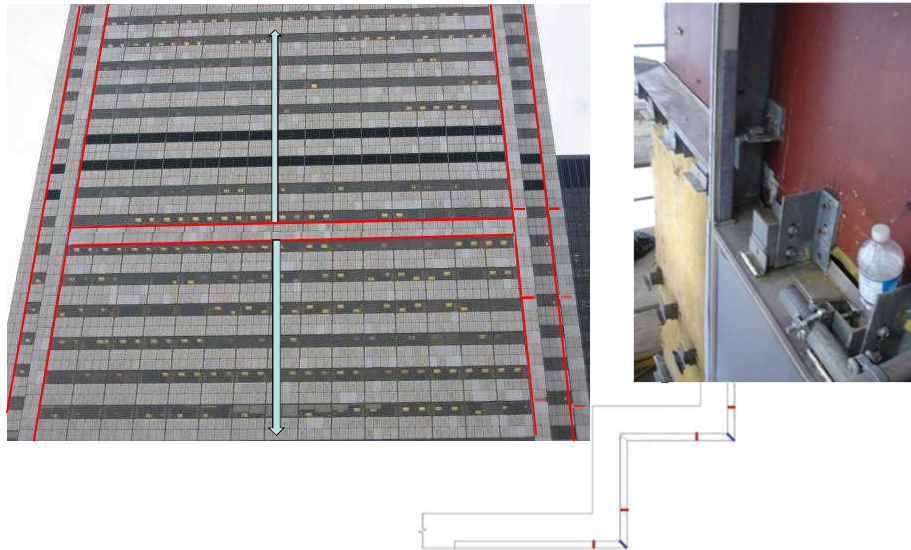
Original FCP Compartment Layout (Red)

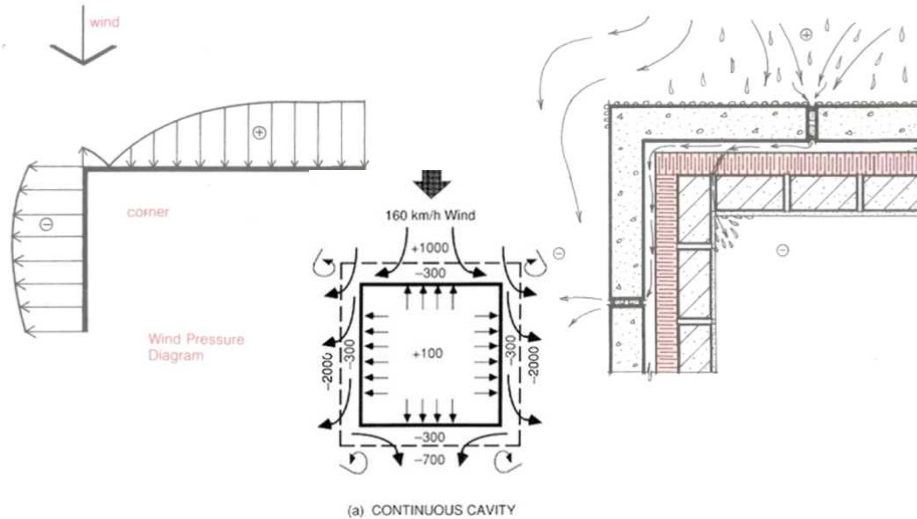
Corner Closure Influence

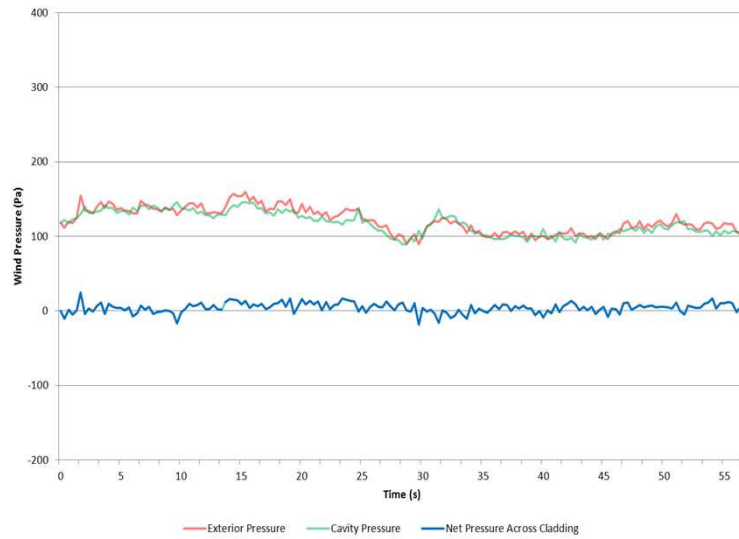
Pressures at Middle of Wall

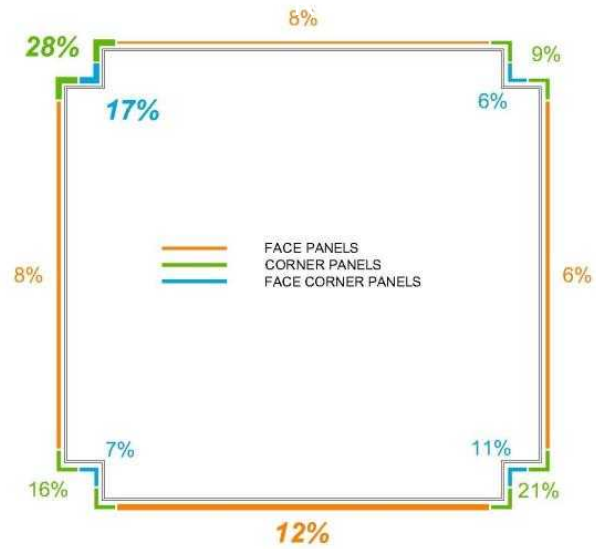
Percent Replacement

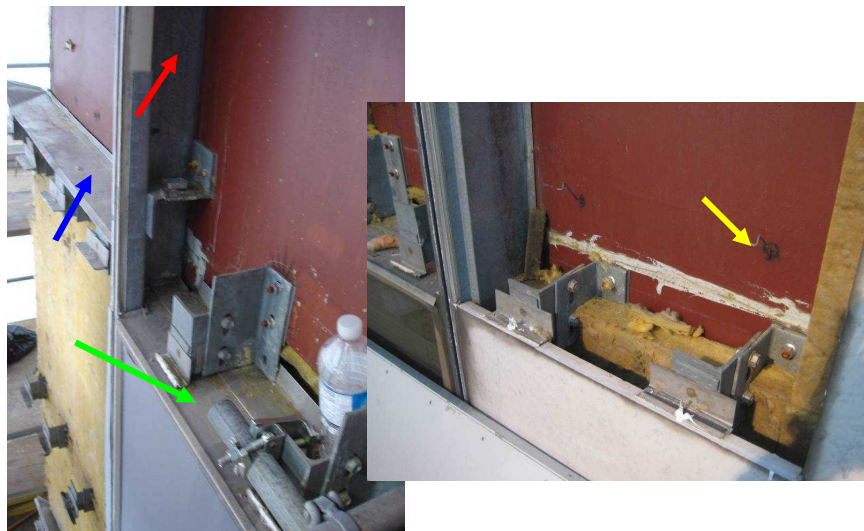
Typ. Section

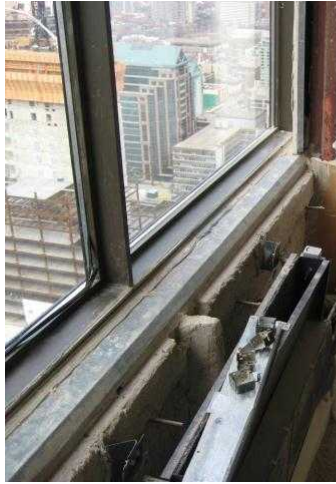
Air Seals Generally in Good Condition

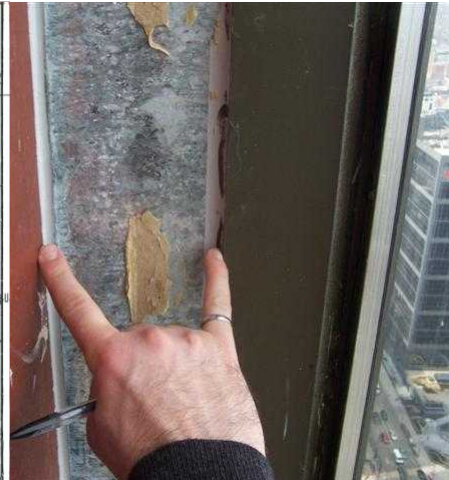
Air Seals Generally in Good Condition

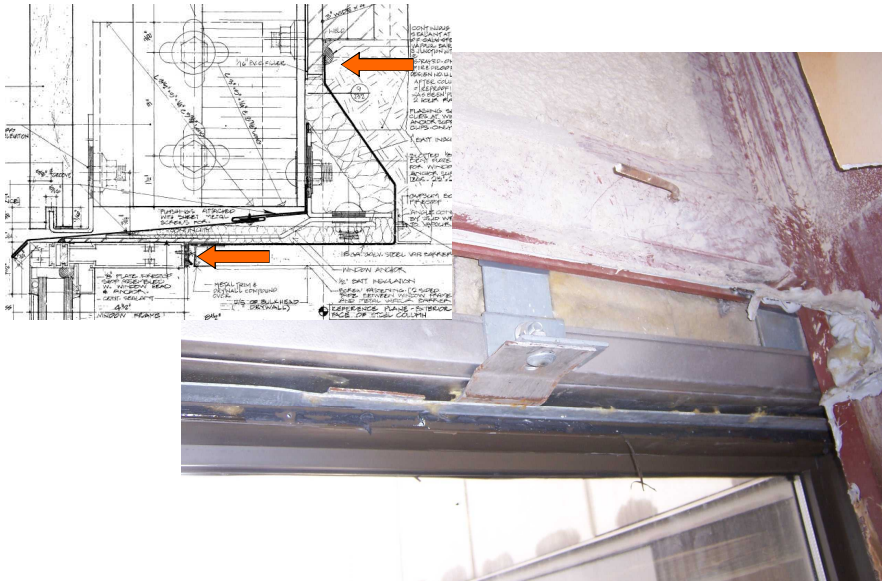
Air Seals Generally in Good Condition

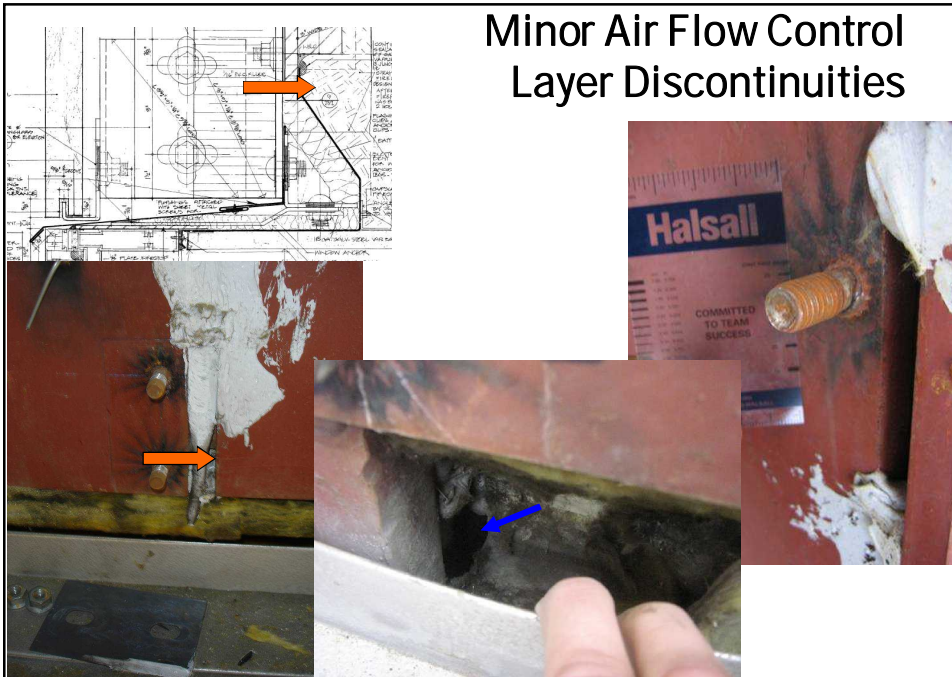
Minor Air Flow Control Layer Discontinuities

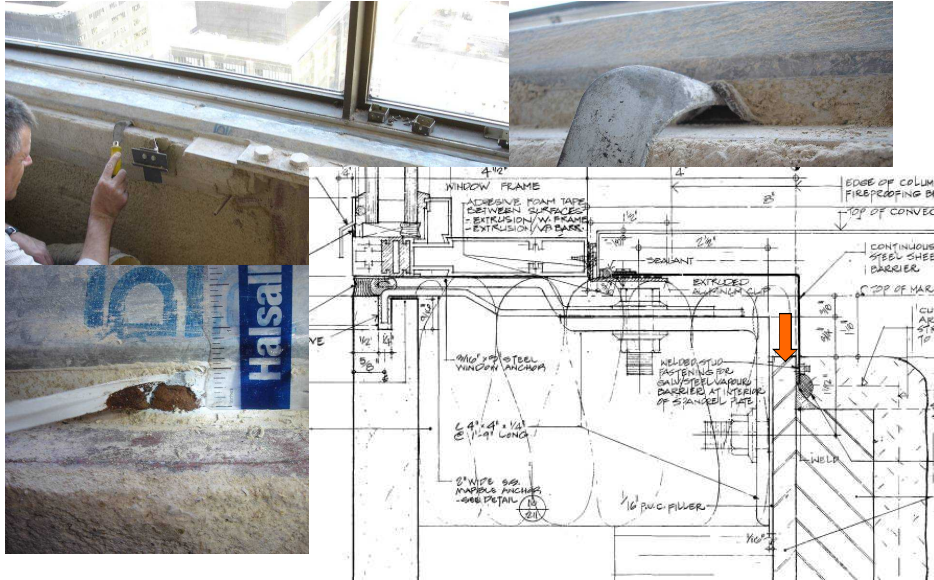
Corrosion Impacting Air Seal Durability

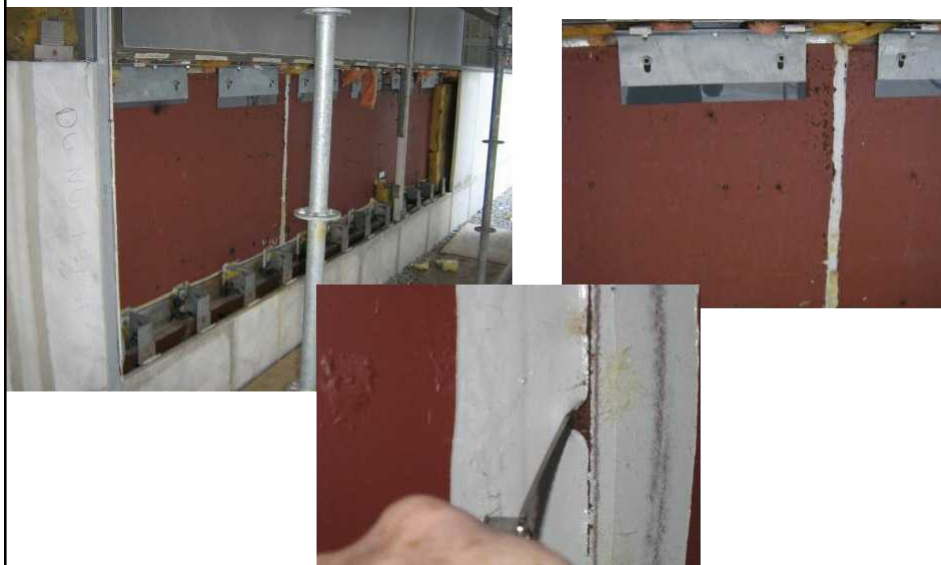
Corrosion Impacting Air Seal Durability

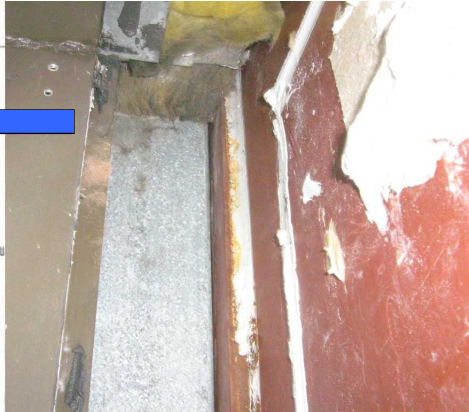
Missing Fire Separation (window term. at full height marble)

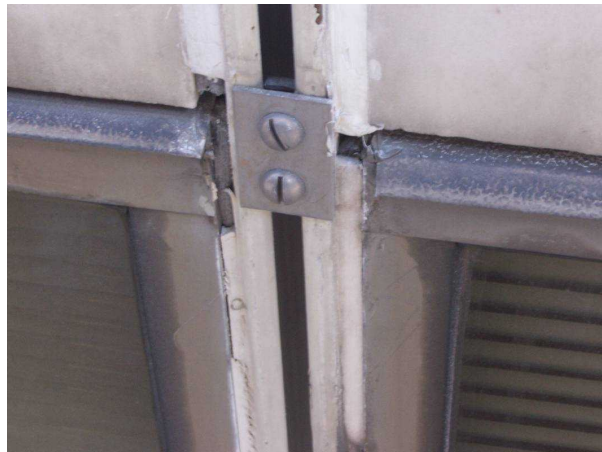
Exterior Window Frame and Metal Flashing Finish Faded/Stained

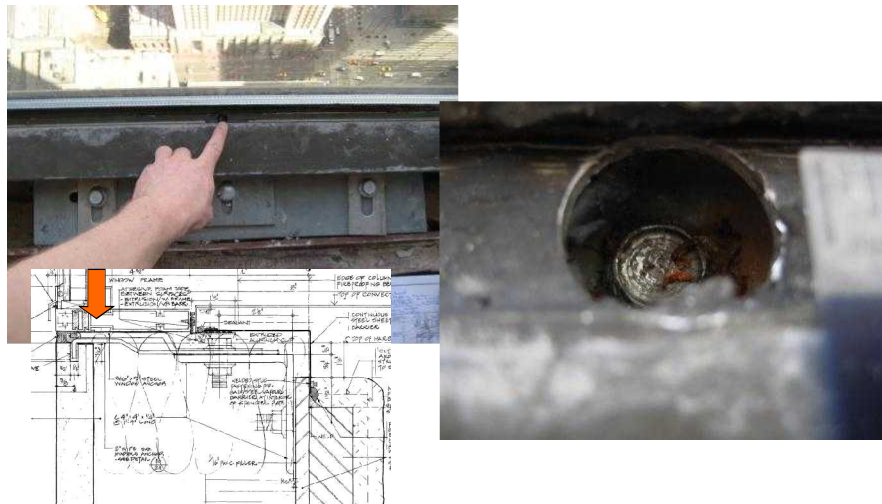
Window Sill Connection Required Reinforcement

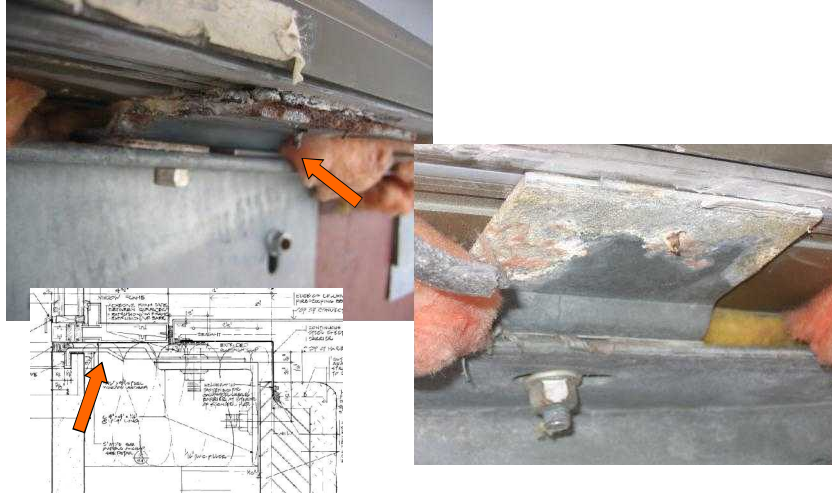
Corrosion at Window Sill Connection

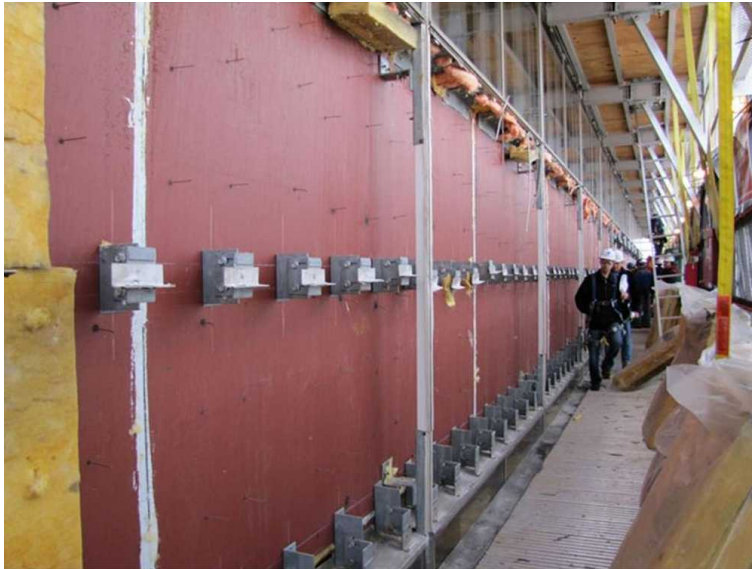
Removals

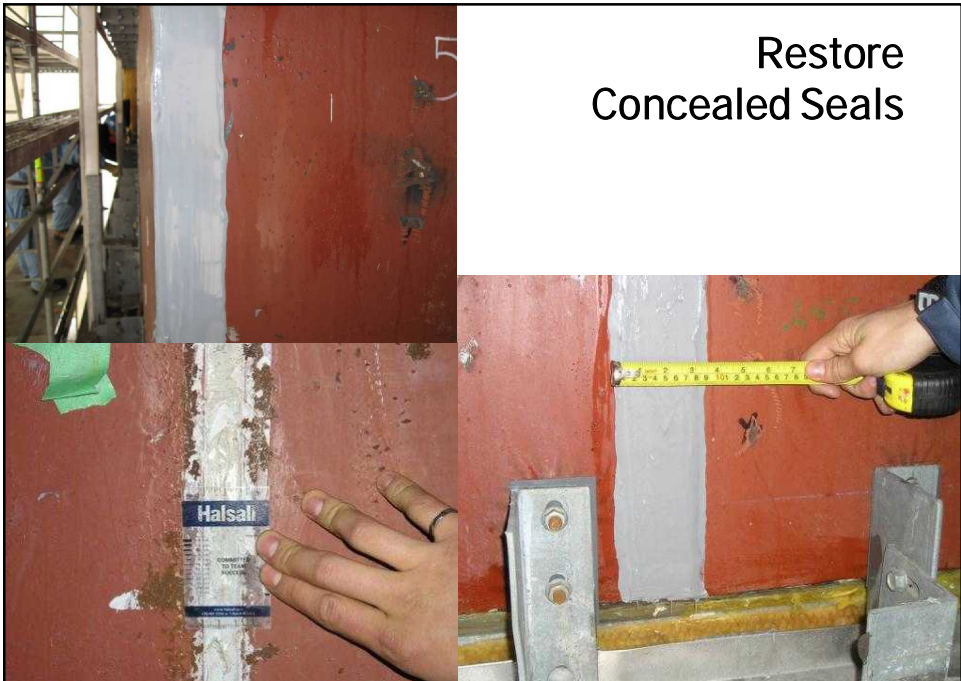
Restore Concealed Seals

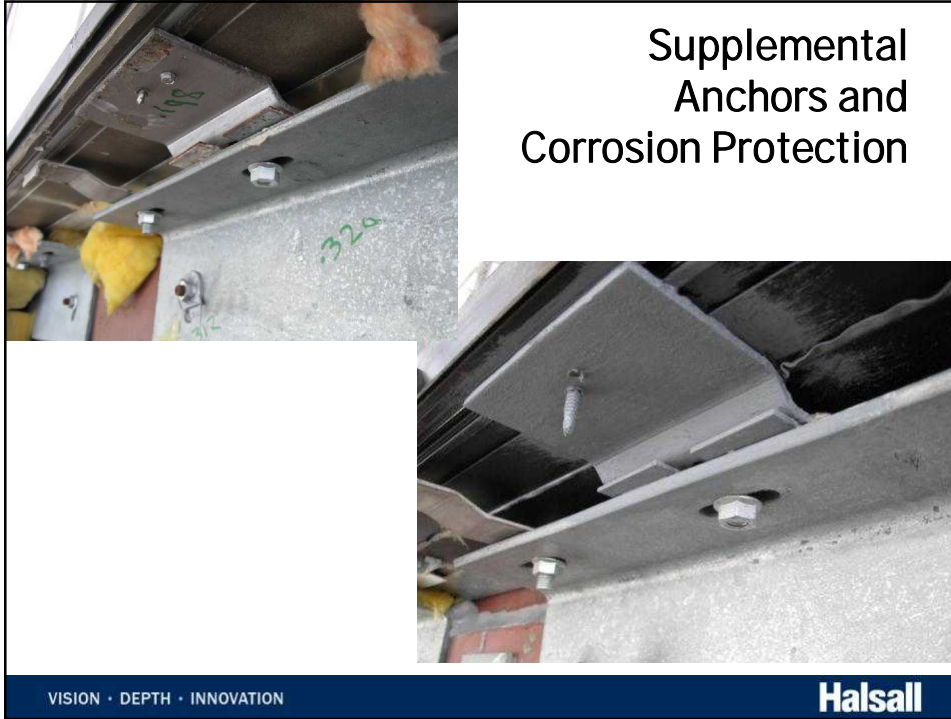
Supplemental Anchors and Corrosion Protection

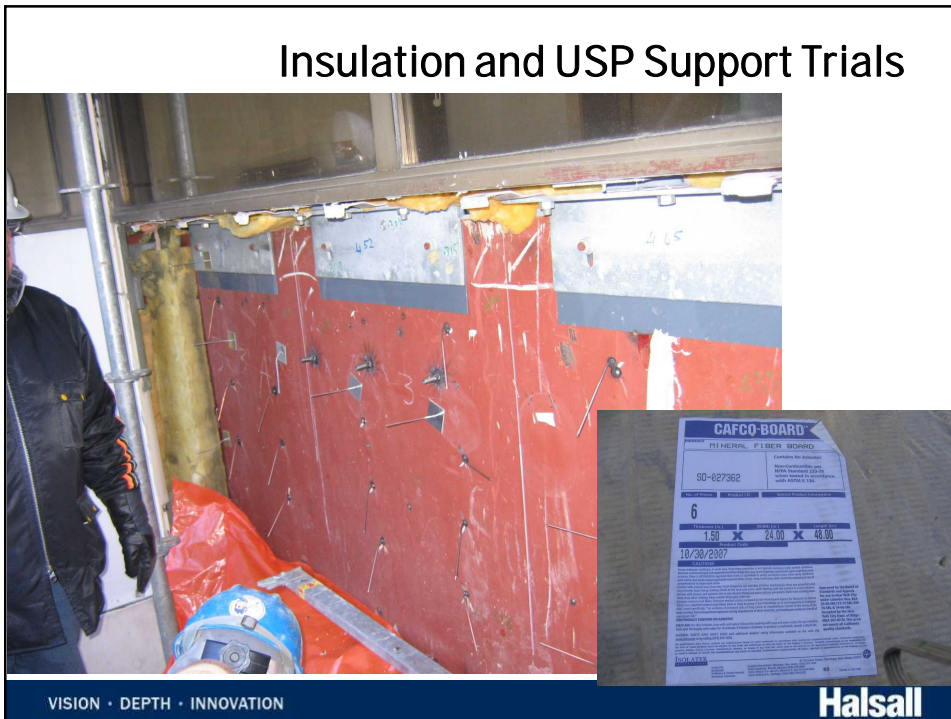
Insulation and USP Support Trials

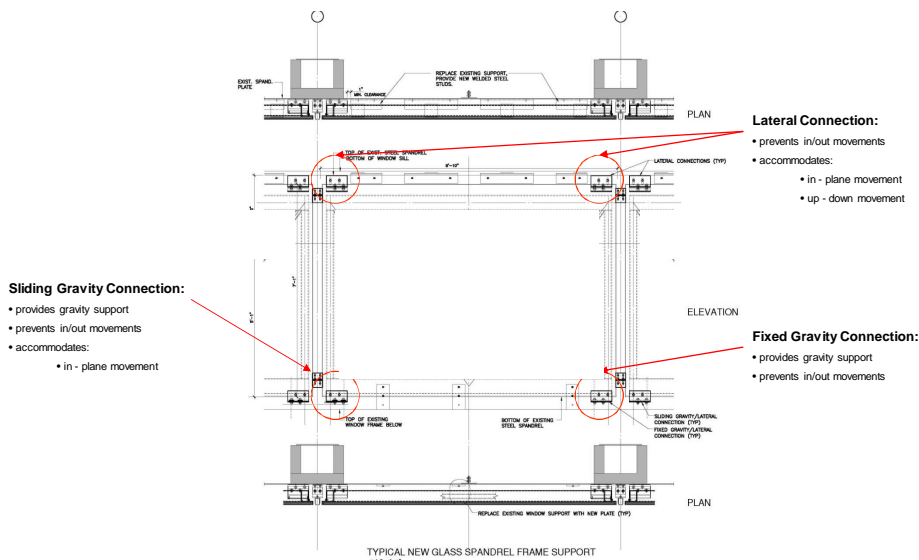
Unitized Spandrel Frame and Support

Sliding Gravity Connection:

- provides gravity support
- prevents in/out movements
- accommodates:
 - in - plane movement

Lateral Connection:

- prevents in/out movements
- accommodates:
 - in - plane movement
 - up - down movement

Fixed Gravity Connection:

- provides gravity support
- prevents in/out movements

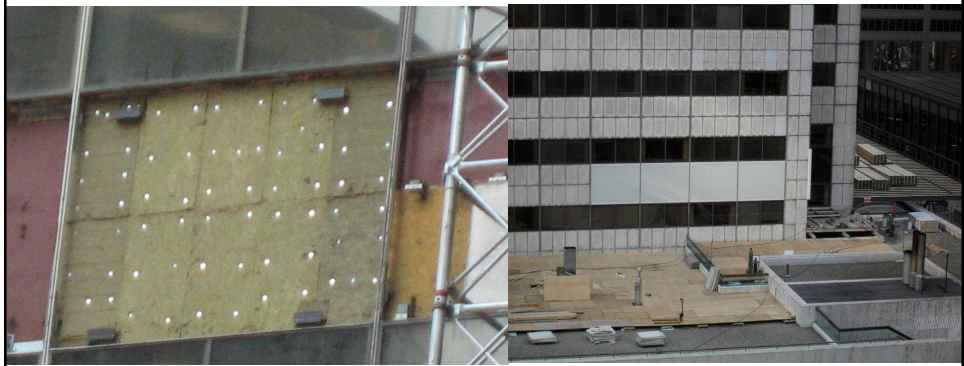
On-Site Mockups

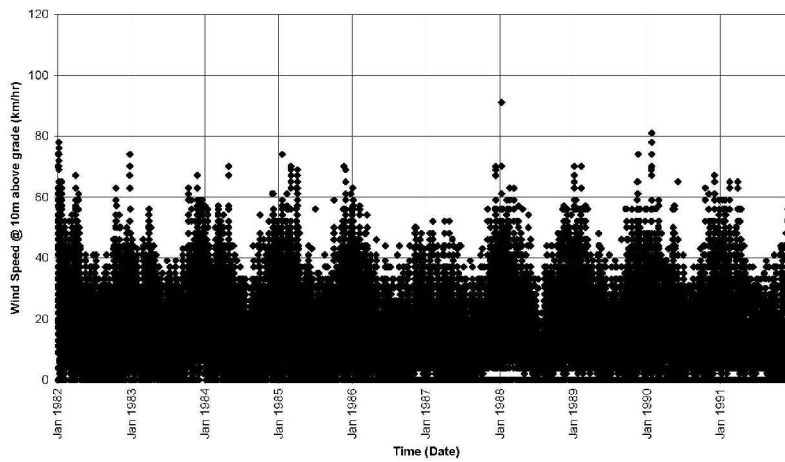
Wind vs. Temp

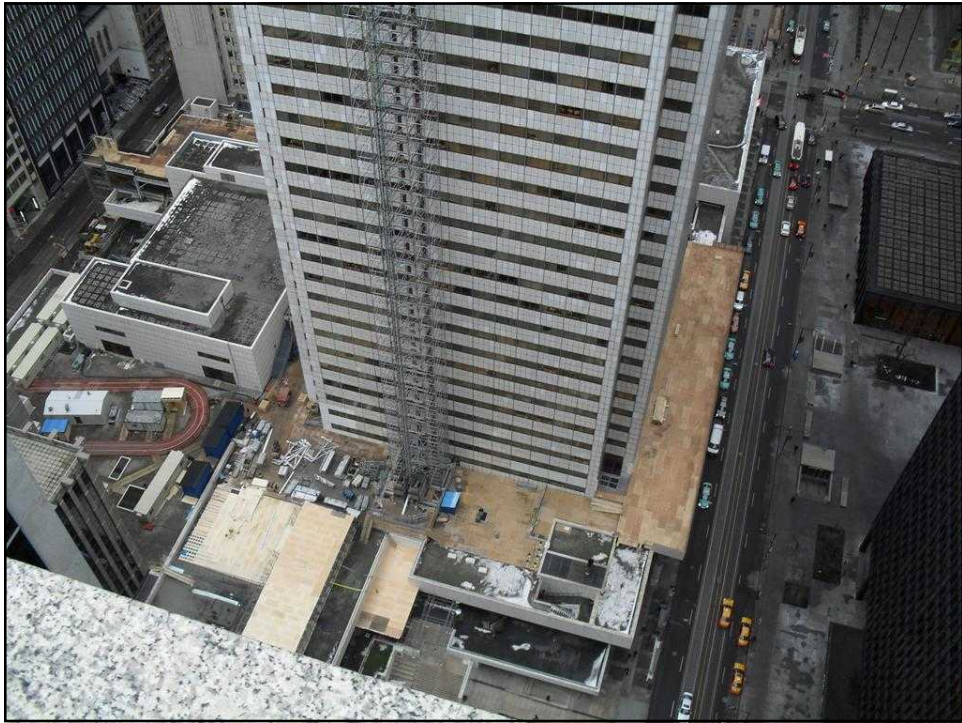
Access

- 1. SUSPENDED ELEVATED PLATFORM**
Platform attaches to the building at the middle level via tie-in struts bolted to temporary brackets. The S.E.P. is suspended for movement by cables to winches on the roof.
- 2. MARBLE REMOVAL**
Marble is removed from the building on the bottom level of the platform. Workers remove the sealant and stone, as well as the panel support brackets. Carts are used to wheel the panels to the elevator hoist.
- 3. GLASS INSTALLATION**
On the top level, glass is installed where the marble used to be. The 450-kilogram panels of glass are transported by elevator hoist and then across by monorail.
- 4. PLATFORM DESCENT**
The tie-in struts are removed and the entire structure moves down one floor. Each step of the whole process takes about four days.

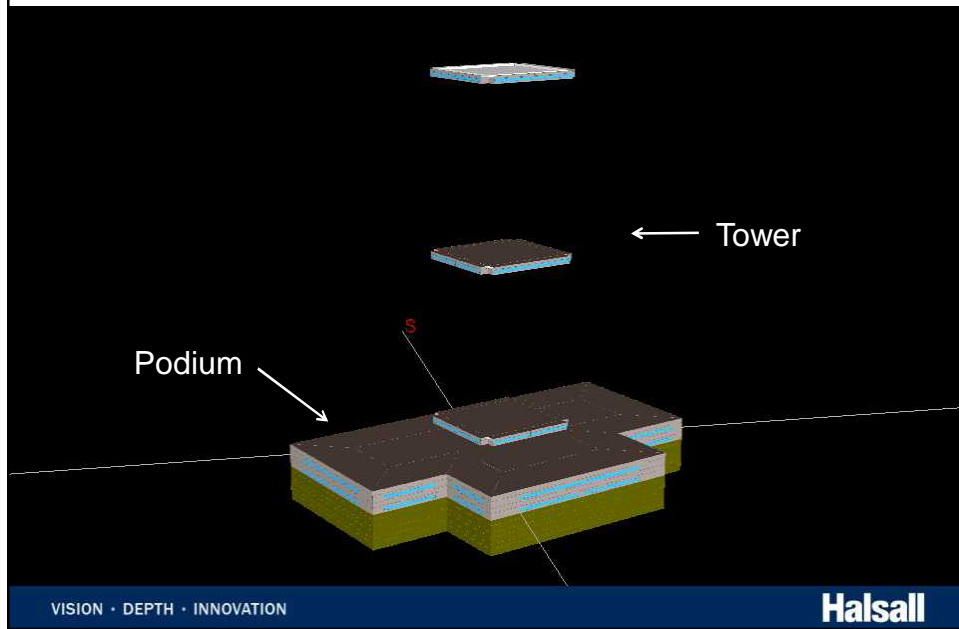
Energy Modelling

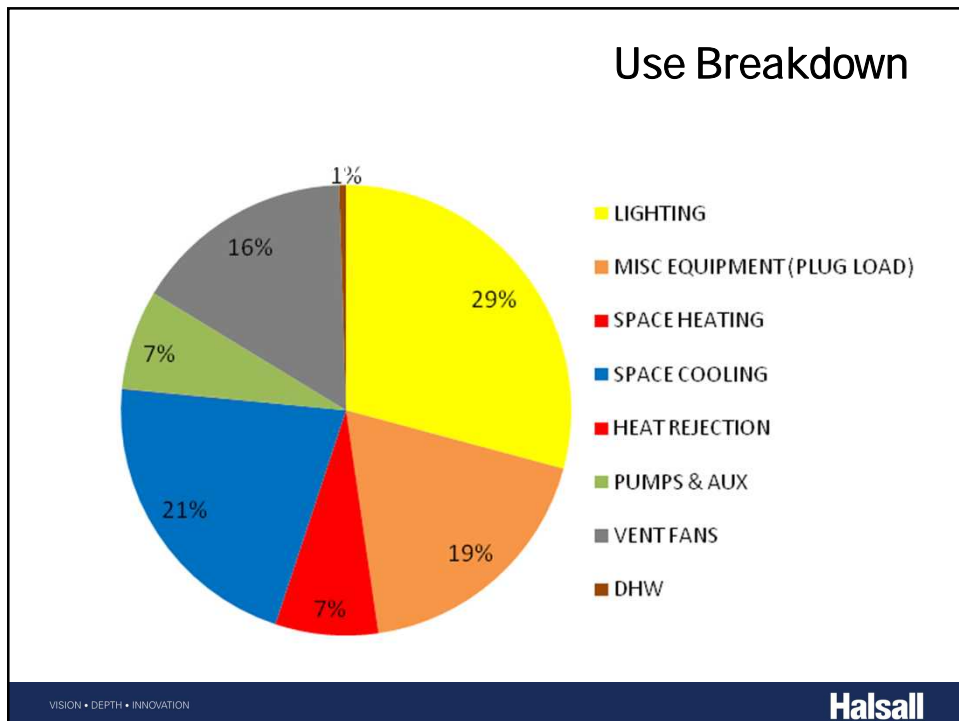
Use Breakdown
