Insight

Over-roofing: Don't Do Stupid Things

By Joseph W. Lstiburek, Ph.D., P.Eng., Fellow ASHRAE

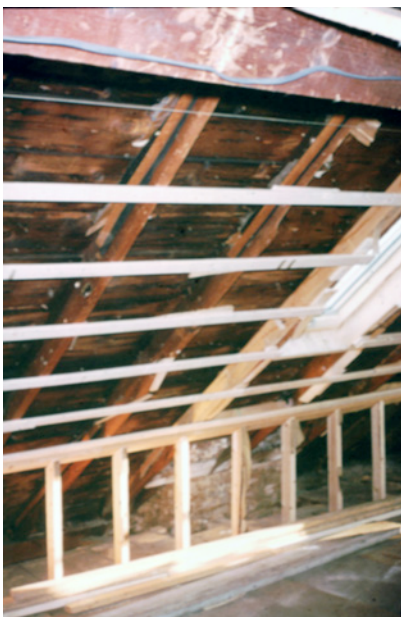
What was the original roof construction? It was a completely uninsulated and unvented roof. The attic had windows at the gable ends but the attic was unfinished.

Photograph 1 (above left): Original Roof – Uninsulated rafter framing with board roof deck. Furring straightens out rafter plane for smooth plaster finish. Yes, skylights went in. Yes, they are big thermal holes. But a space needs to be a space or what is the point. It took us many millennia to get out of caves. Kind of dumb to build one on the top of your house. Let the light shine in. Dormers were considered but we didn't want to change the appearance that drastically.

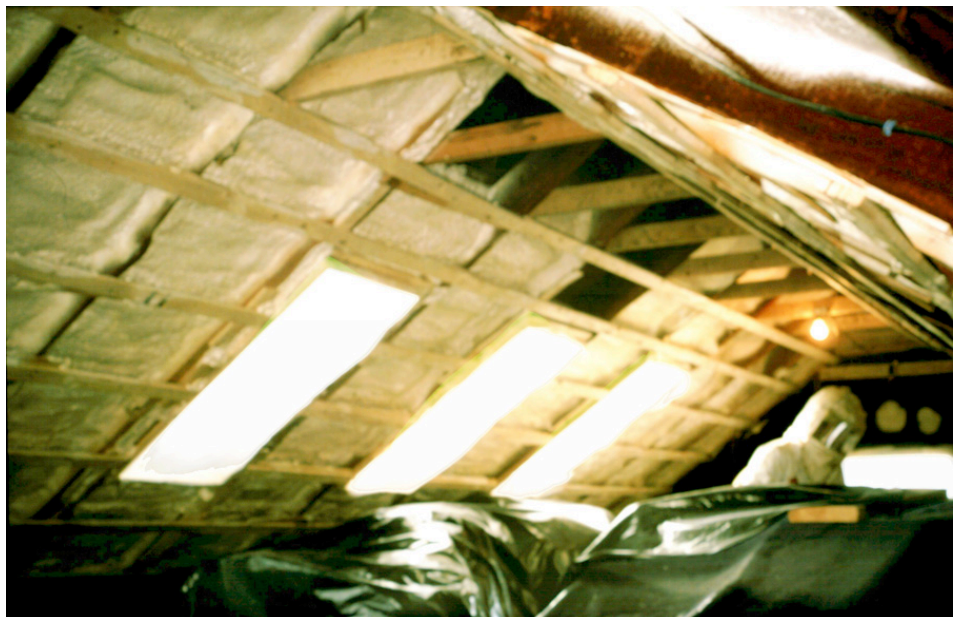
Photograph 2 (above right): Rafter Cavity Insulation – high-density spray polyurethane foam fills rafter cavity (2 lb/ft³ density).

In went some skylights on the back-side (**Photograph 1**) and the rafters got sprayed full of 2 lb/ft³ density spray polyurethane foam (SPF) (**Photograph 2**). The attic was turned into living space. Got two bedrooms and a bathroom, a place to store old ASHRAE Journals and a place for mechanicals. Got ourselves a kinda R-35 roof assembly when you factor in the thermal bridging. In 1995 that seemed pretty good. Installed new shingles over a fully adhered membrane and the house looked pretty darn good (**Photograph 3**). I felt pretty clever. Life was good.

¹ Because I phased the work, I had to use spray polyurethane foam—the 2 lb/ft³ density stuff—in the cavities during the original renovation. If I had done the over-roofing at the same time I probably would have used cellulose in the rafter cavities. The rigid insulation over-roof would have controlled the temperature of the condensing surface—the underside of the roof deck—so that I would not have had to use the spray foam except at the perimeter to provide the air seal to the tops of the walls.

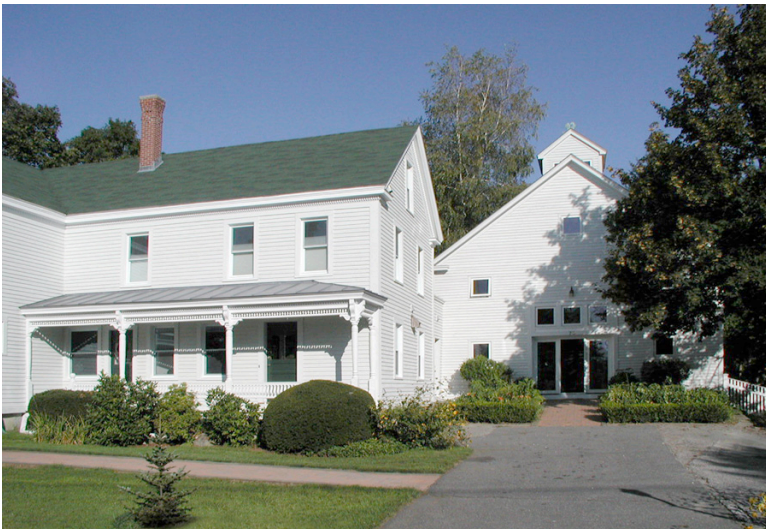
Photograph 3: Finished Roof Back Then – Looked pretty good seventeen years ago. New shingles were installed over a fully adhered membrane applied directly to the original roof decking.

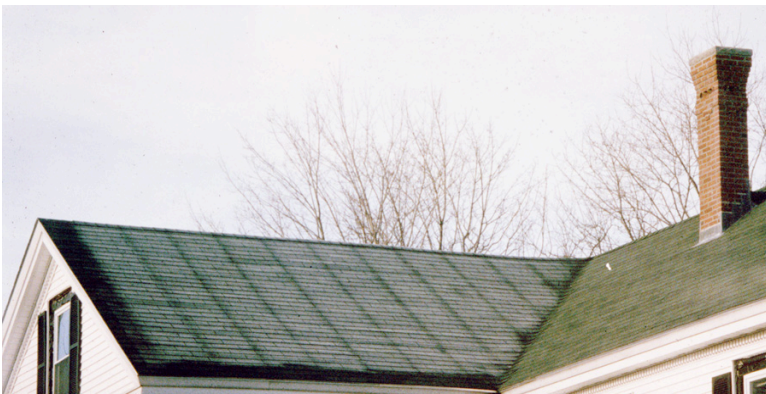
Photograph 4: Thermal Bridging – Don't need no stinkin infra-red camera. Ouch. Only invited friends over at night so I wouldn't be embarrassed.

Then the first winter came (**Photograph 4**). Ouch. What to do? Easy. Just don't tell anyone and don't invite anyone who knows anything about this stuff over during the day during the winter. That didn't work. I was a marked man. Folks knew where I lived and wondered what kinda house the self proclaimed building guru lived in. Double ouch. It got worse.

The attic was cold in the winter. Then the summer came. The attic was hot in the summer. That was not a surprise after the attic being cold in the winter.

I am real good at fixing stuff—especially stuff that I break. Air conditioning went into the attic for the summer and portable heaters went into the attic for the winter and I was done. Throw some energy at it - that will fix it. And it did. I am after all, first and foremost a mechanical engineer. We mechanical engineers can heat and cool anything. And we are good at blaming the architect for the lousy building enclosure that we are stuck dealing with. Except this time the enclosure was my fault. Not enough insulation. One day I was going to come clean and get it done right. When the shingles needed replacing it was time (**Photograph 5**).

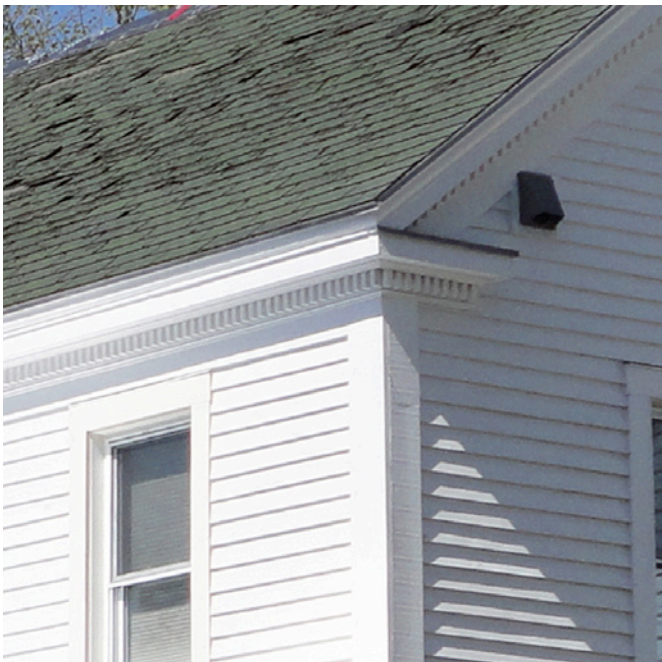
Photograph 5: Time To Replace Shingles—Note the condition of the shingles. Yes, it was time to replace them. Now check out the original roof trim details. Note the dentil molding, the fascia, the crown molding and the depth of the overhangs.

What was the strategy? Actually, it was the original strategy, just fully executed. I did the first part right. The spray foam in the cavities 17 years ago and the fully adhered membrane over the top. I just didn't get around to doing the second part - rigid insulation over the top of the existing roof deck.¹ Strip the shingles, expose the deck, install a fully adhered membrane and go to town with rigid insulation. How much rigid insulation? By this time I had it figured out. Nothing like two more decades of experience to draw on. I needed at least R-50 just to control the ice damming in my climate zone. Oh, yeah, forgot to tell you about ice damming. Wrote about the ice damming thing already as well (*BSI-046: Dam Ice Dam*). We didn't actually get ice dams, but I think it was more due to luck than skill. Simple roofs don't collect and hold snow. We had a simple roof. Anyway, to do

If I already had R-35 I would need another R-25 which is about 4 inches of polyisocyanurate. So I added 6 inches. You all knew that is where this was going. I added another R-36 getting around R-70.³ Plus, I needed to prove something. Not what you think. Aesthetics. Huh? Read on. Besides, the cost of adding the extra 2 inches was nothing compared to the cost of the trim details and framing necessary to over-roof.

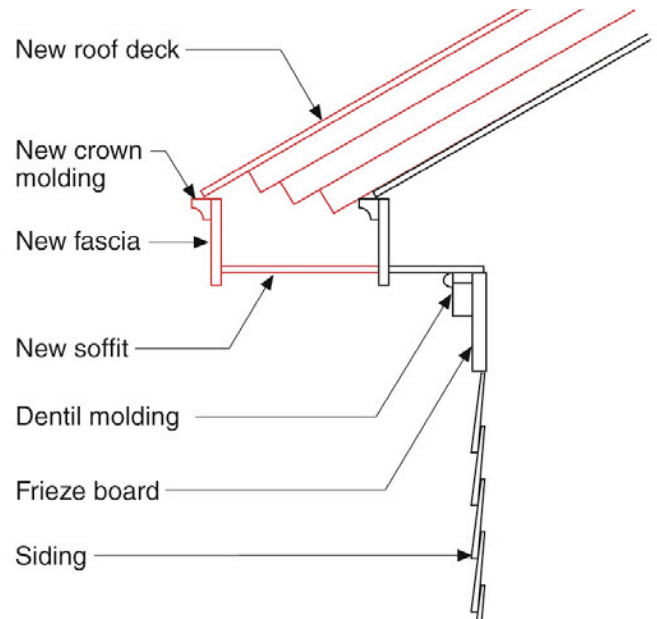
Figure 1: Roof Edge Detail—Overhang extended to hide the thickness of the over-roofing rigid insulation.

had to look like they “belonged”. They had to look “original”. Don't believe me? Ask an architect. Trust me on this. I didn't get it at first. I get it now. If it does not look “right” it is not “right”. Don't do ugly things. **Figure 1** and **Figure 2** show the general approach. The overhangs on the gable ends were cut off, rigid insulation added to the top (**Photograph 6**) and then the overhangs rebuilt as box beams (**Photograph 7**). Then the box beams were trimmed out (**Photograph 8**) and a double frieze board installed to hide the increase in roof thickness without requiring redoing the gable end siding (**Photograph 9**).

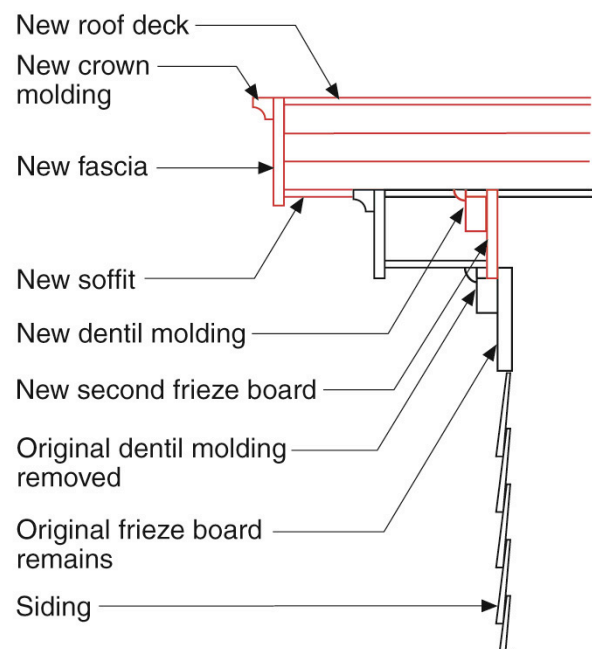
Figure 2: Gable End Detail—Overhang cut and then rebuilt to hide the thickness of the over-roofing rigid insulation.

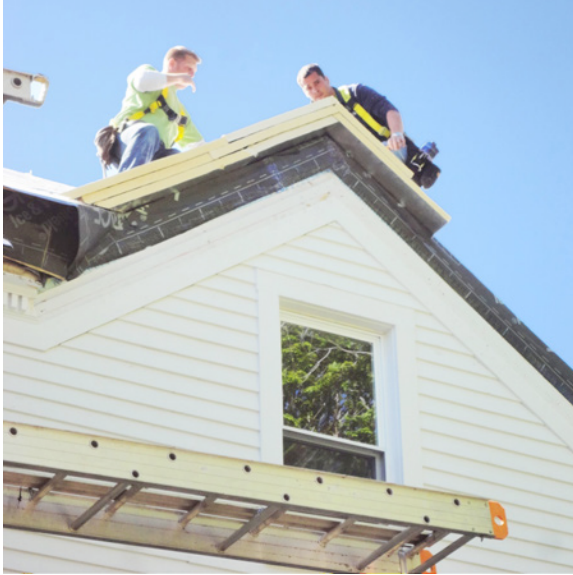
Photograph 6 (above left): Over-Roof Insulation—The gable overhang has been cut flush with the wall sheathing. Also note that a new fully adhered membrane is installed on the original roof deck replacing the one installed 17 years ago is folded down to catch the top edge of the wall water control layer. Further note that the 3 layers of 2-inch rigid insulation are cantilevered over the wall to take into account the likely possibility of retrofitting exterior continuous insulation on exterior wall framing in the future. The exposed edges of the 3 layers of rigid insulation are to be sealed with another layer of membrane.

So the journey started—again. Stripped the old trashed shingles, stripped the old fully adhered membrane exposing the original boards once again. Guess what? The old board sheathing was in great shape. I had all that closed-cell spray polyurethane foam underneath the deck for 17 years and nothing rotted. No surprise there. No roof leaks, no problems. No air leaks from underneath,

no problems. Installed a new fully adhered membrane to the top of the old board sheathing prior to adding all that rigid insulation.⁴

⁴ The fully adhered membrane on the original roof deck boards is for air control not for water control. The fully adhered membrane over the top surface of the upper layer of plywood directly under the roof shingles is for water control.

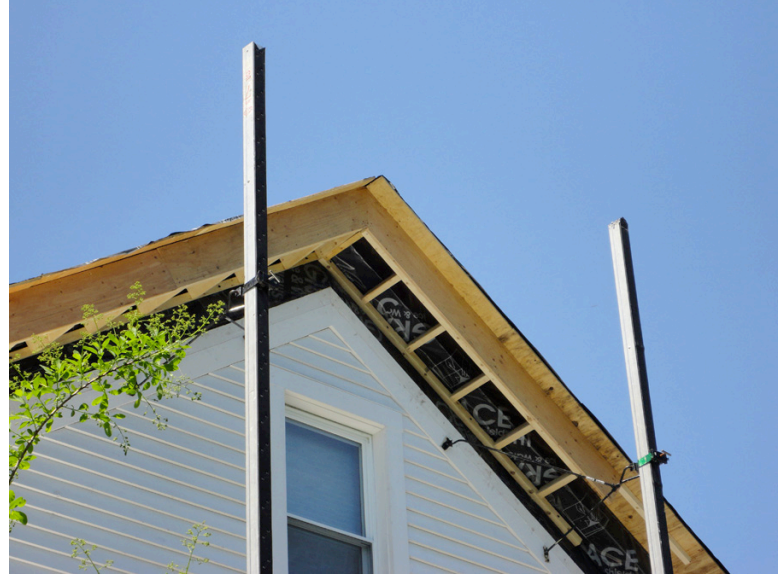
Photograph 7 (above right): Box Beam Gable Framing—New gable overhang is framed in the form of a box beam hanging off of a new layer of roof plywood roof sheathing cantilevered over the top of the 3 layers of rigid insulation. The exposed edges of the 3 layers of rigid insulation are no longer exposed.

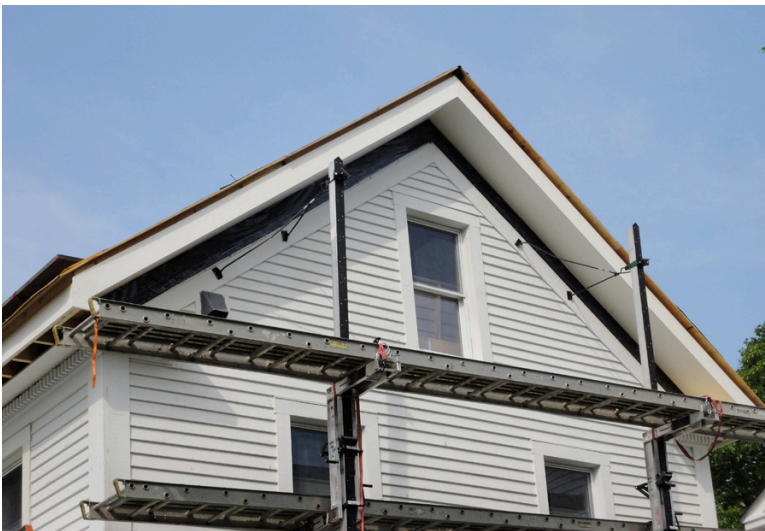
Photograph 8: Cellular PVC Trim—Trim fascia and soffit installed. Dentil molding and crown molding and frieze board to come.

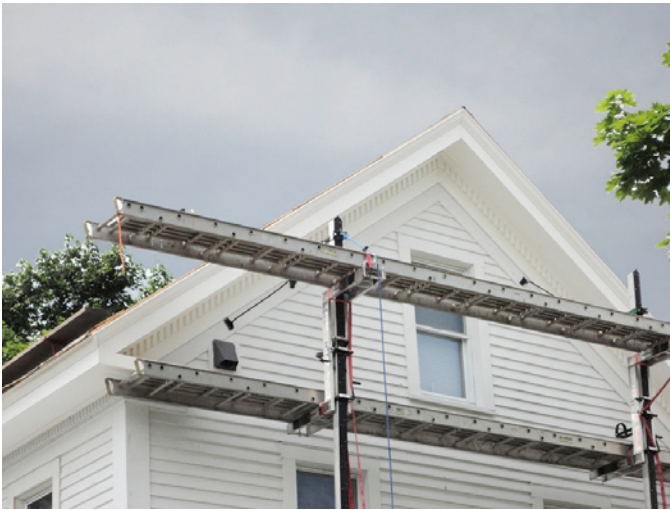
Photograph 9 (above left): Trim Installed—Dentil molding, crown molding and double frieze board done. Note that a second frieze board is installed catching the top edge of the original frieze board. Double frieze boards are not uncommon in New England so that the second frieze board does not look out of place. This approach allows us to leave the original frieze boards in place along with not having to remove and reconstruct the gable siding. Next step stainless steel drip edges and shingles.

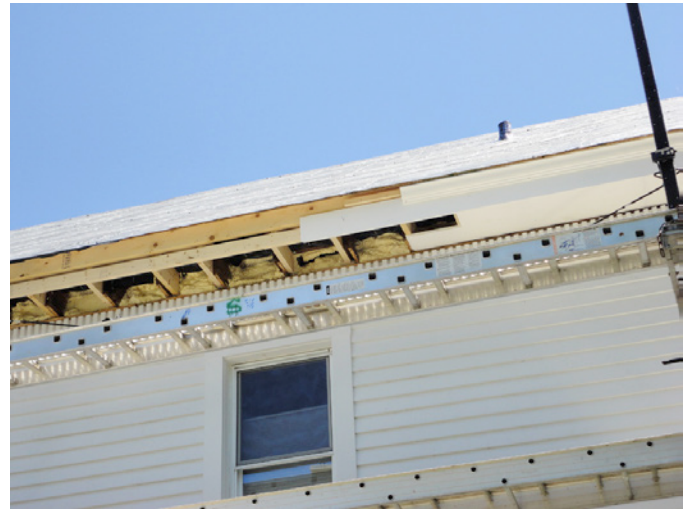
Photograph 10 (above right): Roof Edge Framing and Trim—Original rafters are extended – but original roof deck sheathing cut back to be flush with the original wall sheathing. This allows the new roof membrane installed on the original roof deck to run down and catch the wall water control and air control layer. Original dentil molding and frieze board are left in place. New cellular PVC fascia, crown molding and soffit installed. Note the 2 lb/ft³ spray polyurethane foam enhancing the air seal around the extended rafters. This foam is applied over the top of the membrane that came down from the roof deck catching the wall control layers.

On the front of the roof edges of the roofs, the overhangs were extended to hide the thickness of the roof insulation (**Photograph 10**). The original rafters are extended—but original roof deck sheathing cut back to be flush with the original wall sheathing. This allows the new roof membrane installed on the original roof deck to run down and catch the wall water control and air control layer. Why not just cut the original rafters flush with the wall as well and do the box beam thing on the front similar to what was done on the gable ends? Good question. I felt the overhang would have been a bit too large for that treatment on the front. Had I added a bunch of insulation to the walls as well at the same time

back roof deck to tie into the wall water control layer and air control layer (**Photograph 11**). On the front of the roof edges the original roof deck sheathing was cut back flush with the wall and the fully adhered membrane folded down around the rafter tails to catch the wall water control layer and air control layer. This was then “foamed” to complete the air seal. Go back and check out **Photograph 10**.

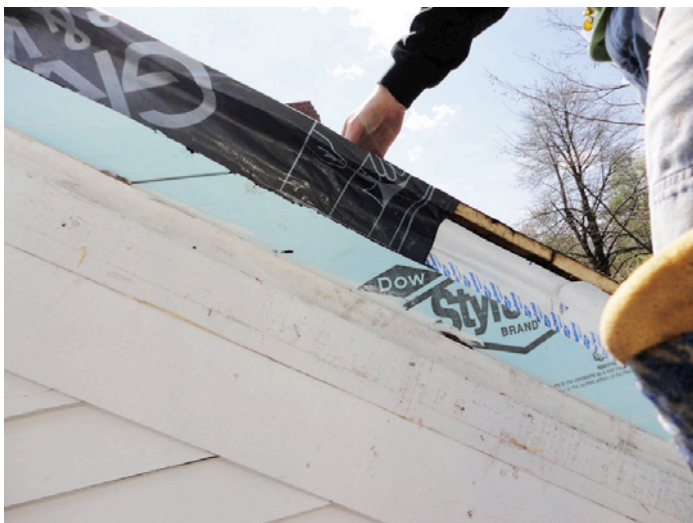
Photograph 11: Roof to Wall Air Seal—Note the connection of the new roof deck membrane overlapping the trimmed back original gable overhang and catching the “white” housewrap water control layer and air control layer behind the wall exterior insulation (the “blue” layer of foam). The three layers of rigid insulation have yet to be installed over the top of the roof decking at this point. This air seal is pretty darn good. Note that there was no air seal at this location originally. Dumb. I have to come clean here as well. I resided 17 years ago over one layer of continuous rigid insulation. Not enough. Dumb. Should have installed much more. I will get around to fixing this eventually as well. Yes, I will share the experience. I can point out just how dumb I was on the walls as well 17 years ago. But the real mistake was not making the air seal at the top of the walls 17 years ago. No excuse, I knew better then. Got sloppy, careless. It happens, even to self proclaimed gurus.

One of the keys to over-roofing is to tie the air control layer of the roof assembly to the air control layer of the wall assembly. On the gable ends this was pretty easy. The fully adhered membrane wrapped down over the cut

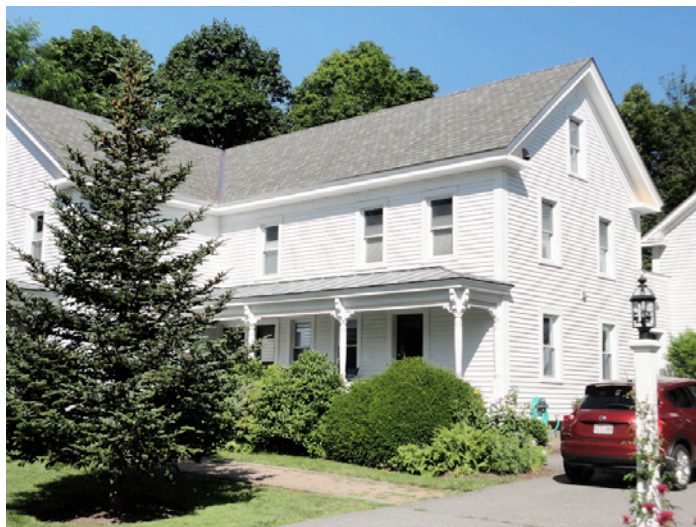
Photograph 12: New Shingles Installed—Neighbors were pretty nervous until the shingles got installed. What is the crazy guy up to this year? I sure hope it does not end up looking dumb. I heard he had ants. Sheesh. Talk, talk, talk. Neighbors are such a pain.

The finished roof hides the insulation over-roofing (**Photograph 12** and **Photograph 13**). Compare the trim details of **Photograph 13** with the original trim details of **Photograph 5**. Not bad eh? This stuff needs to be

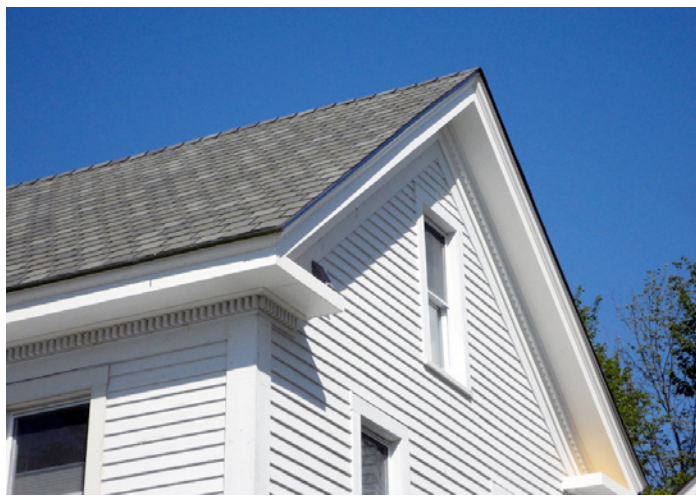
Photograph 13: Finished Trim Details—Hah! Can't tell this roof is a super insulated over-roof – which was the whole point. This stuff needs to be “invisible” or it will not happen. Find yourself an architect who gets it and helps make it invisible.

Notice the increase in overhang dimension on the gable ends. This is not just to match the overhang on the front. Apparently, I did not add enough insulation to the walls 17 years ago either. The increased overhang sets the stage for my next project, over cladding the walls.⁵ Later. Maybe much later. Just remember, whatever you do, don't do ugly things.
