# Overview of Med/Ed Challenges

#### Failures and Best Practices in Medical/Educational Bldgs © buildingscience.com

#### Medical/Educational Challenges

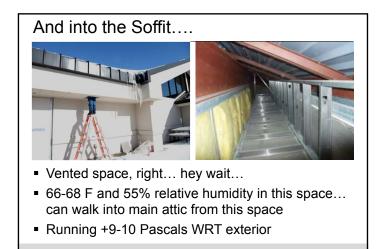
## Case Study: Cold Climate Air Leakage

- Eastern Nebraska Location (Design T -5.4° F)
- Climate Zone 5A (Cold)
- Icicles coming out of soffit in wintertime
- Pressurized & humidified interior conditions

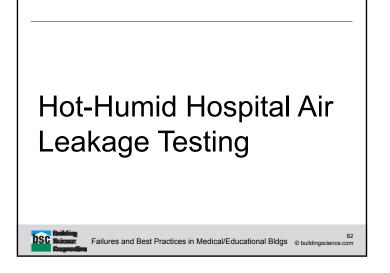
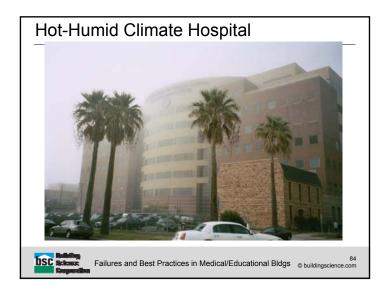
- Gulf Coast (DOE Zone 2A)
- Complaints of mold on interior finishes, especially vapor-impermeable surfaces (frames)
- Complaints of general interior humidity issues

- Gulf Coast (DOE Zone 2A)
- Complaints of mold on interior finishes, especially vapor-impermeable surfaces (frames)
- Complaints of general interior humidity issues
- Real problem: unbalanced HVAC system, negative pressures
- Other side contends: air leaky building causing problem
- Windows were leaking water, but not air...
- Testing the building for air leakage
