Buildings XV Conference

Deep Energy Retrofit of a Sears Roebuck House: A Home for the Next 100 Years* **13 Years Later**

*published by HIGH PERFORMING BUILDINGS Spring 2009

Betsy Pettit, FAIA, President
Building Science Corporation
betsy@buildingscience.com

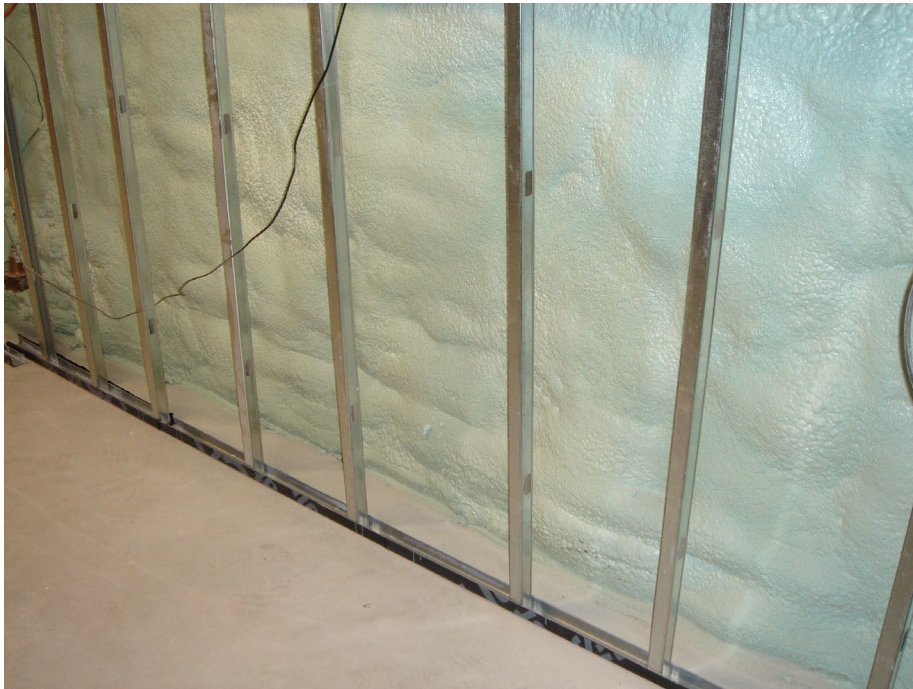
Air Control Layer Continuity

Continuity of the air barrier is maintained at the wall to foundation connection by the sprayed polyurethane foam

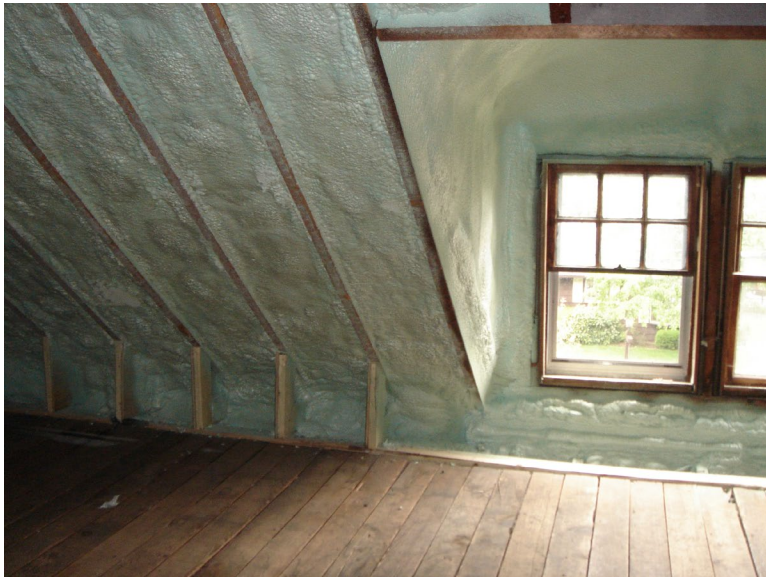
Thermal Control Layer Continuity

Thermal resistance of the roof assembly is made up of the two layers of 2-inch polyisocyanurate insulation and the sprayed polyurethane foam

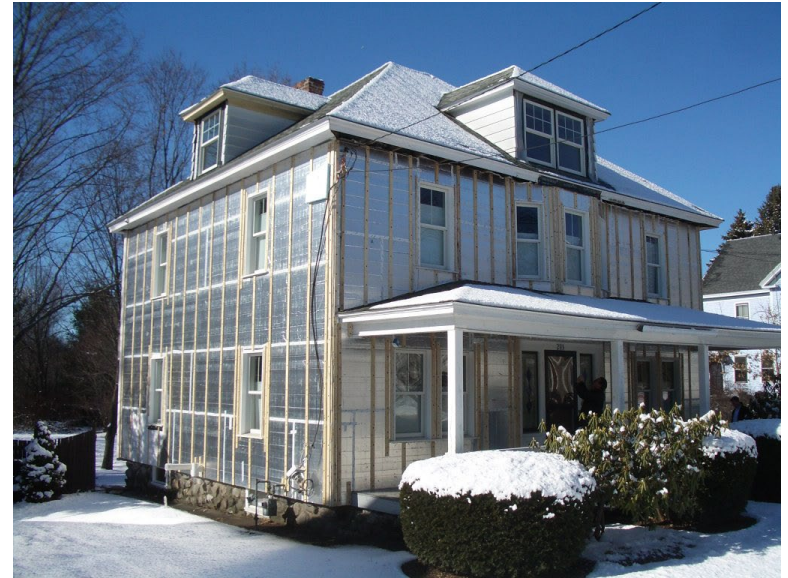
Thermal Control Layer Continuity

The thermal resistance of the wall assembly is made up of the blown cellulose cavity insulation and the two layers of 2-inch rigid polyisocyanurate insulating sheathing

New windows with low-E squared glazing maintain the thermal continuity of the wall

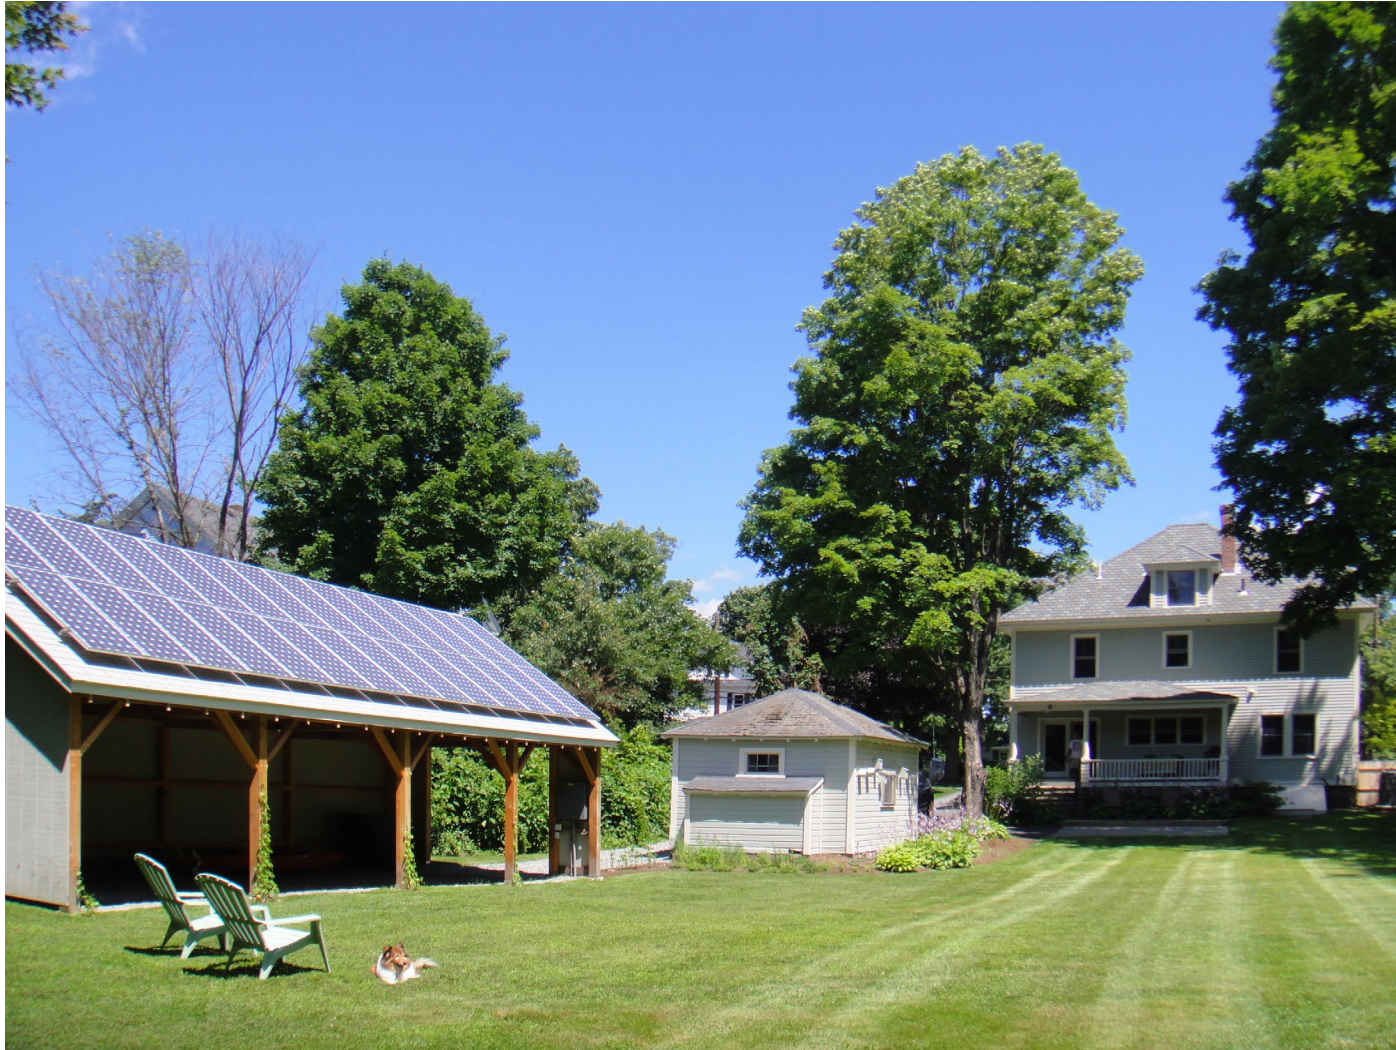
2010 - 4.9 kW PV System – 28 @ 175w panels with microinverters

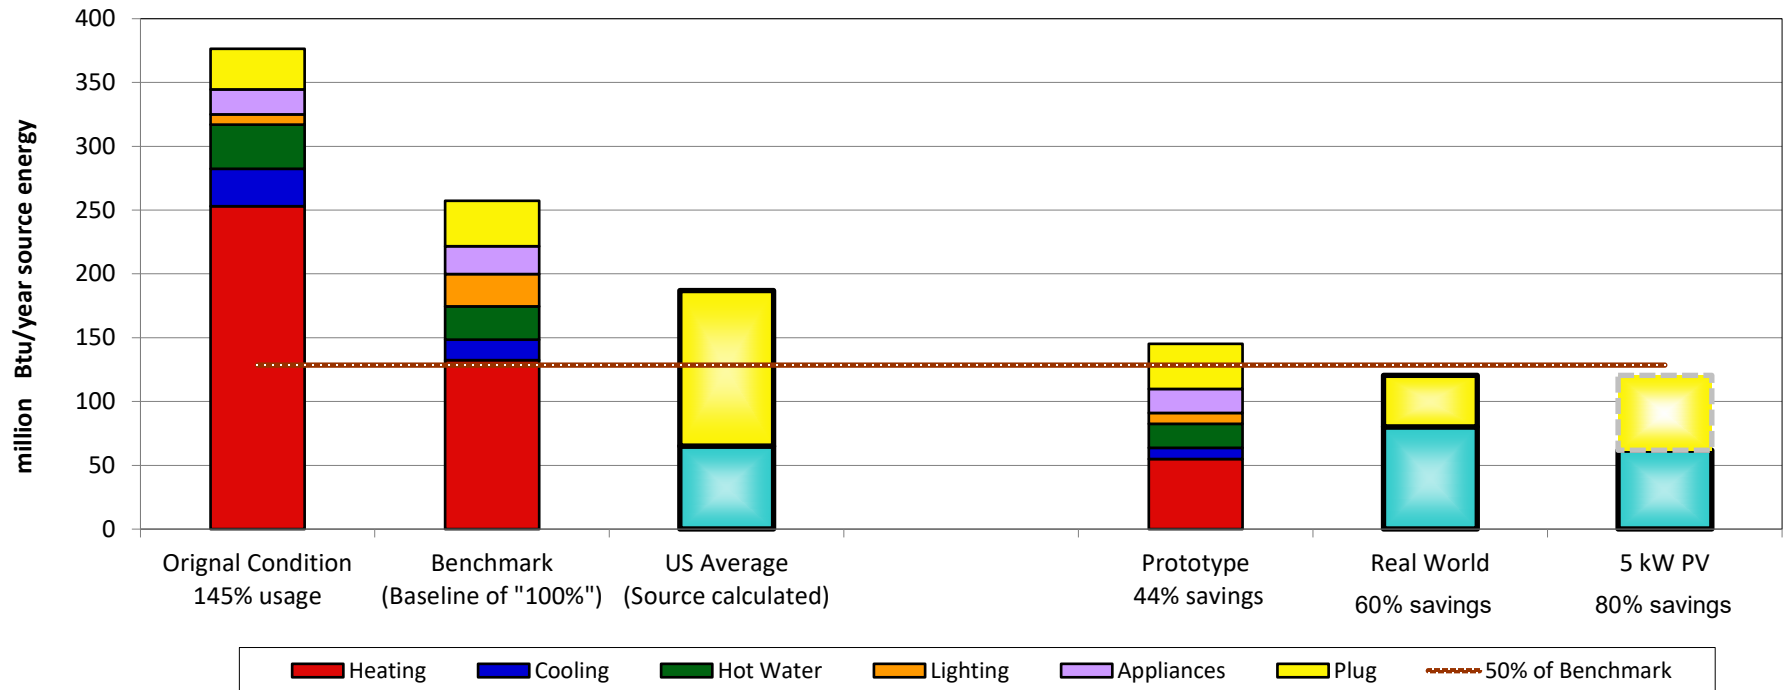
Actual Performance

- Without the PV's, the house had a 75% reduction with respect to its original energy use.
- Without the PV's, the house had a 60% reduction with respect to the national average.
- With the PV's, the house had an 80% reduction with respect to the national average.

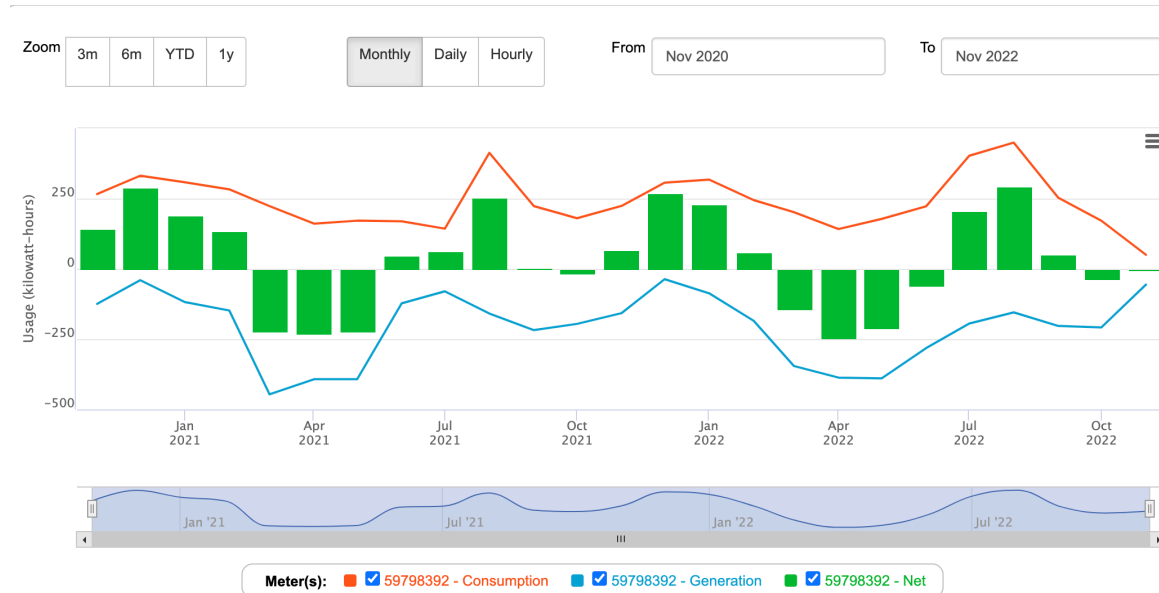
Why is the Net Electric Use 450 kWh's?*

Usage	
Meter:	59798392 - Consumption
High Usage:	449.09
Low Usage:	50.13
Average Usage:	241.35
Total Usage:	6,033.73

Usage	
Meter:	59798392 - Generation
High Usage:	-36.73
Low Usage:	-446.13
Average Usage:	-204.92
Total Usage:	-5,122.99

Usage	
Meter:	59798392 - Net
High Usage:	294.39
Low Usage:	-245.07
Average Usage:	26.49
Total Usage:	910.77

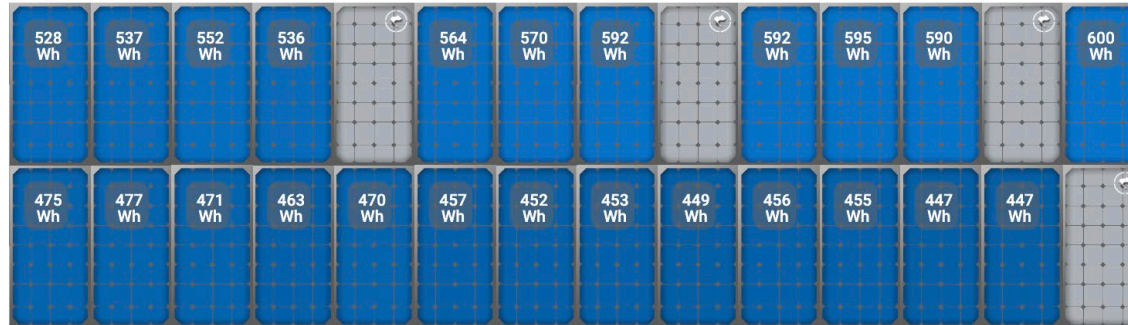
Micro - Inverter Failure

Over 12 years should have been 73,000 MWh

System Energy
13.8 kWh

54 Microinverters
1 Gateway Ethernet
West Concord, MA

Microinverters Not Reporting
