Hybrid Foundation Insulation Retrofits: Measure Guideline

Building America Report - 1108

K. Ueno and J. Lstiburek, Ph.D., P.Eng.
Building Science Corporation (BSC)

April 2012

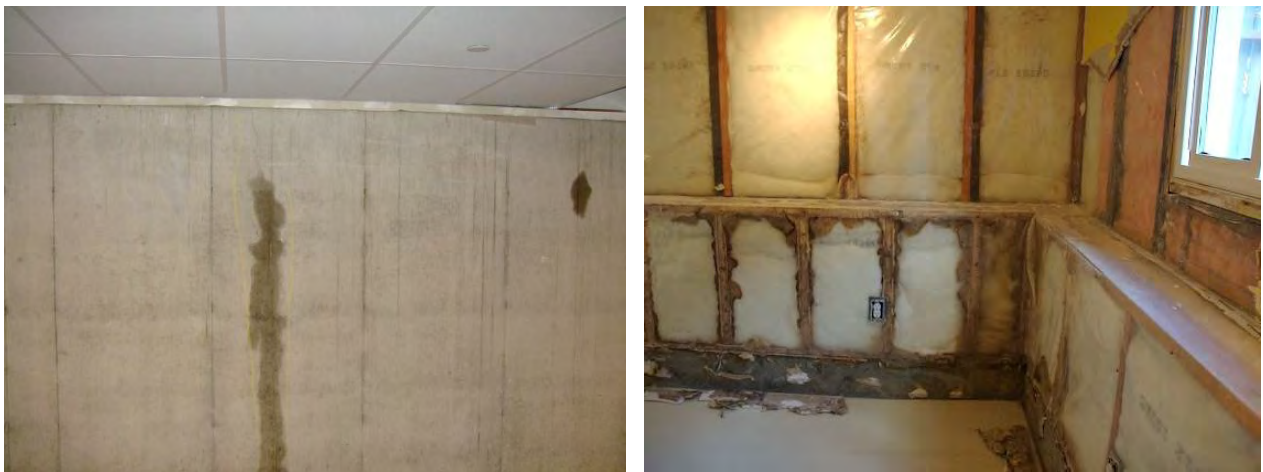
Figure 1. Active seepage through cast concrete (L); water damage concealed behind finishes (R)

However, many foundations are damp (either due to bulk water or capillary “wicking” of moisture) or of a type of construction that is not easy or straightforward to insulate (such as rubble foundations). Bulk water leakage can cause severe damage to improperly designed interior insulation assemblies (Figure 1). Assemblies that provide insulation (and interior finishes, if desired) and control bulk water leakage are a valuable potential retrofit component.

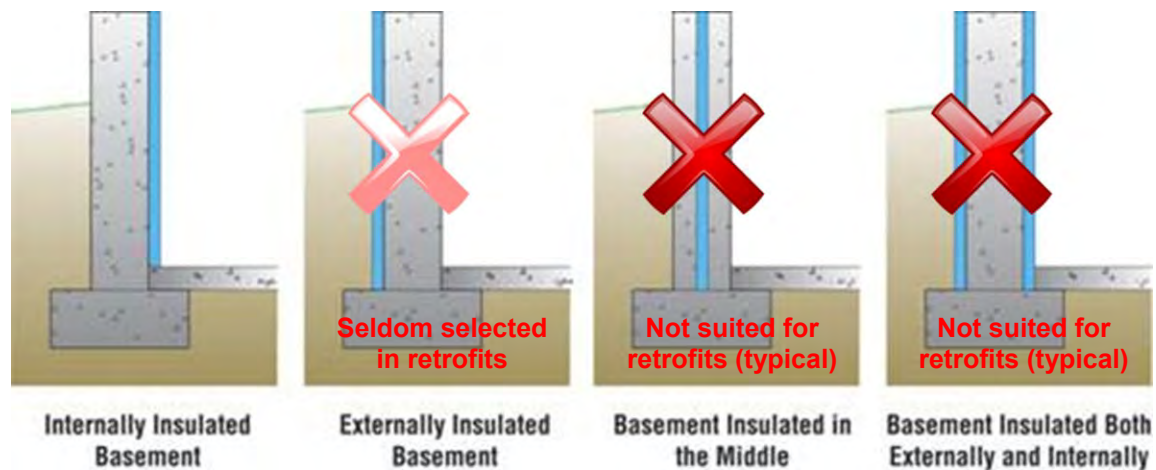
Figure 2. Choices for insulation location in retrofits (adapted from Lstiburek 2006)

Foundation insulation can be accomplished by several methods, as discussed in generic terms by Lstiburek (2006), and shown in Figure 2. These methods of insulation include:

- Interior: most common, least expensive, most moisture problems
- Exterior: best location from physics perspective, practical problems with protection, thermal bridging and insects;

- Middle: most expensive, fewest moisture and insect problems, but is the most difficult to construct
- Both sides: similar problems to the exterior insulation approach with the additional cost of the interior layer.

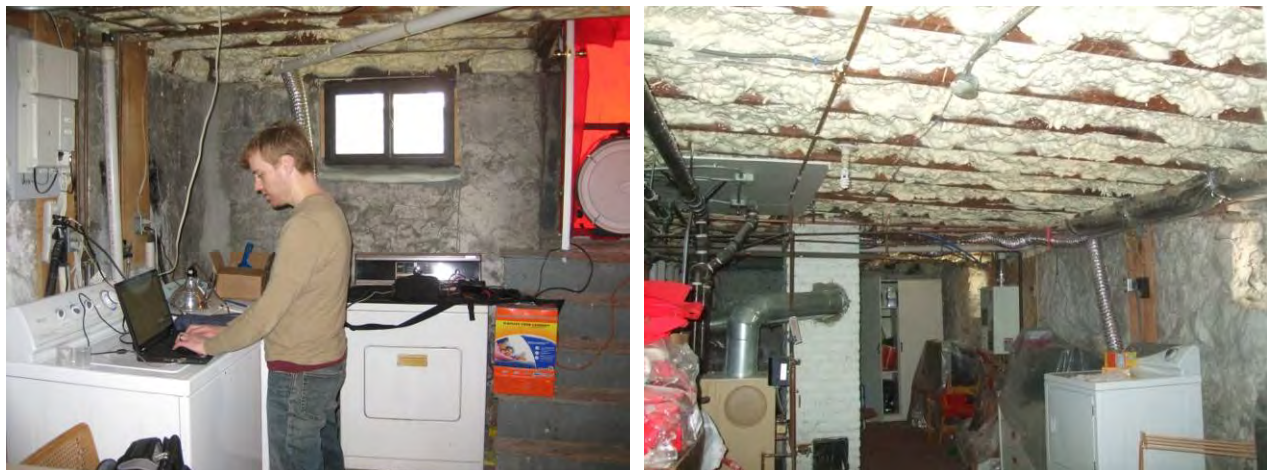
Figure 3. Arlington, MA Duplex basement ceiling spray foam, and nullified air leakage testing

Nullified or guarded blower door air leakage testing was conducted, using multiple blower doors to equalize pressures between the basement and above-grade zones. Afterwards, unguarded tests were run on individual zones (with the adjacent zones open to the exterior); the difference between tests can be used to calculate leakage to adjacent zones. These methods are commonly used in testing multifamily or multizone buildings, and in particular, airtightness of portions of an enclosure (Genge 2009).

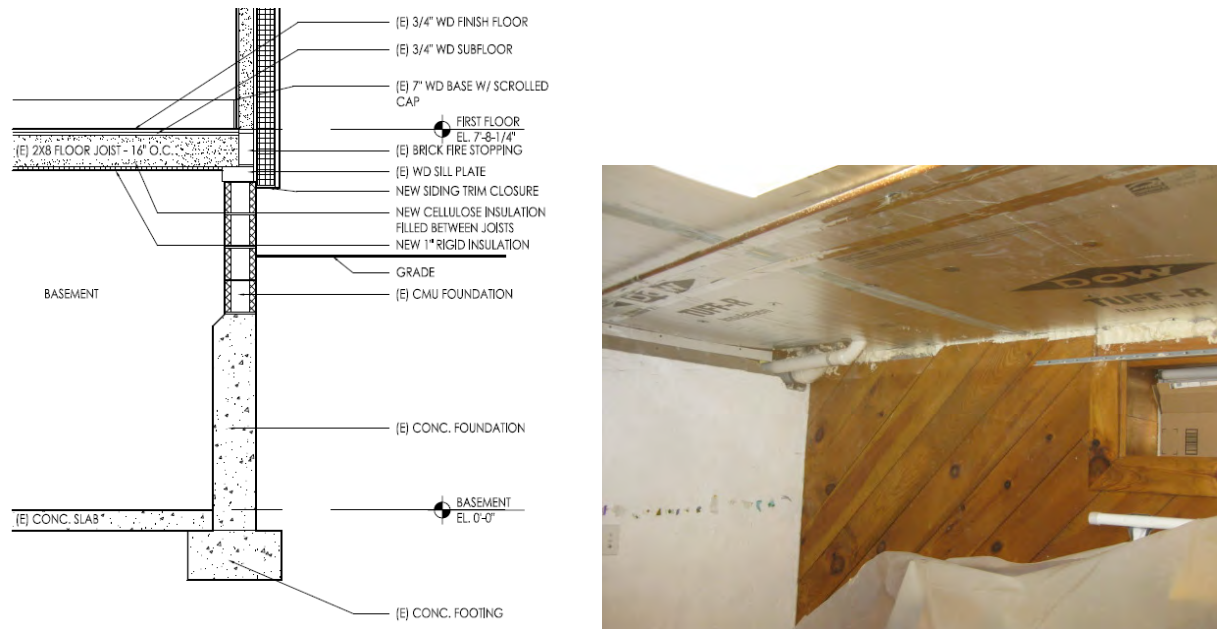
Figure 4. Basement ceiling insulation and air sealing plan and completed image

underside of the framing (see Figure 4). Again, the results were worse than expected, with normalized leakage at 8.5 ACH 50 or 0.54 CFM 50 per square foot of building enclosure. Again, leakage through the floor/ceiling assembly comprised roughly half of the total leakage of the building (1740 CFM 50 out of 3590 CFM 50). This leakage was ascribed to the presence of ductwork systems in the basement, mechanical penetrations, and connections to the above-grade via two stairwells.

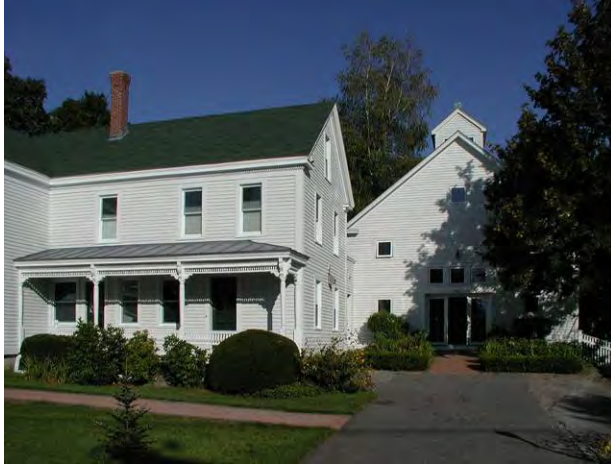
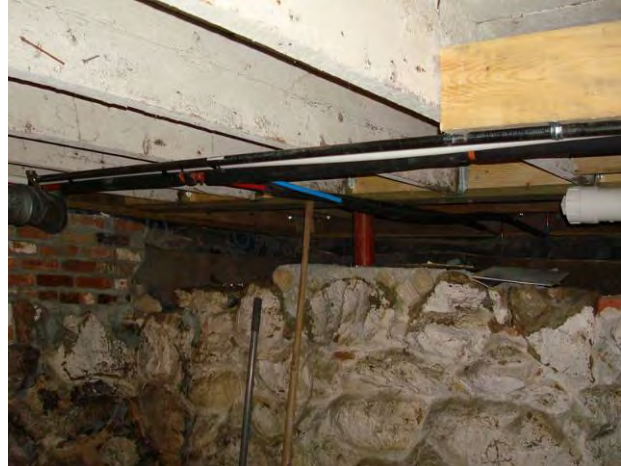
Figure 18. Overview of Westford House/Barn, existing foundation conditions (Lstiburek 2010a)

The steps of implementation are shown below. The test case is the Westford House/Barn (see Section 7 “Field Survey Work”, and Lstiburek 2010a). Both buildings were on rubble stone basements with severe seasonal bulk water infiltration problems and generally high moisture levels.

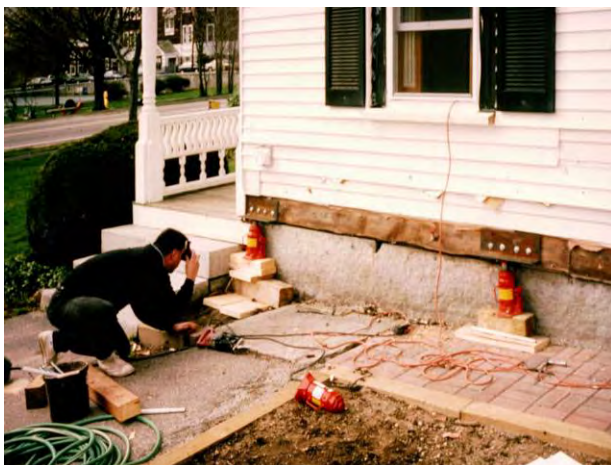
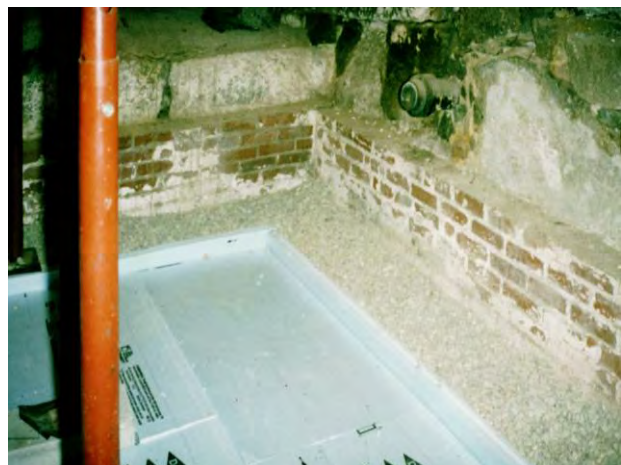
Figure 19. Sill beam lift and slab insulation and drainage (Lstiburek 2010a)

Granular fill and interior perimeter drainage were installed on top of the existing earth/slab floor, an XPS “bathtub” of insulation was placed, and a new concrete slab was cast. Perimeter drainage was connected to an interior sump. Note that Figure 17 shows a case of an uninsulated slab, with excavation and demolition only at the perimeter, to receive the interior perimeter drain. In the case of an uninsulated slab with no capillary control, some type of coating is required to control water vapor transmission from the slab surface.

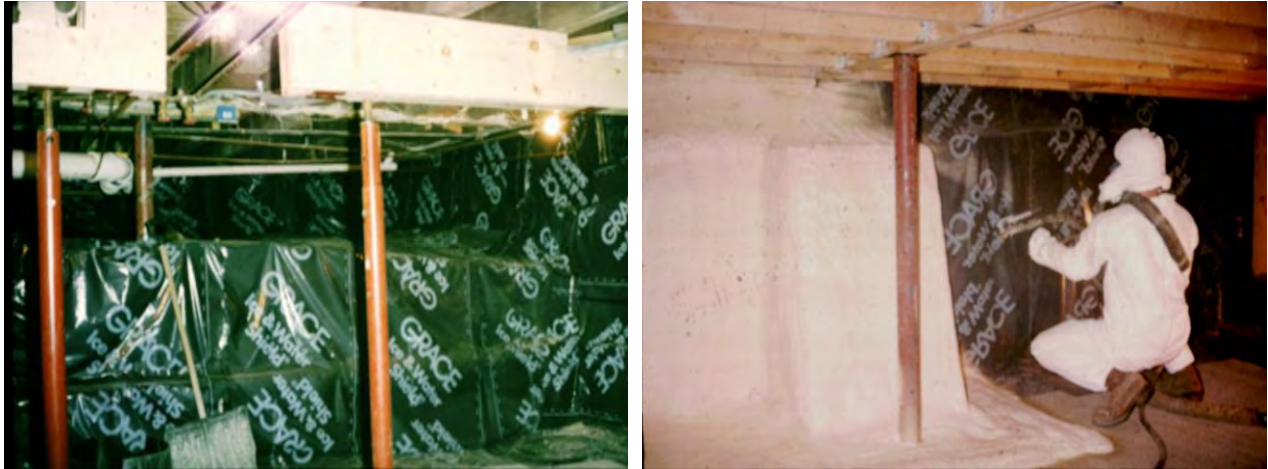
Figure 20. Self-adhered membrane and spray foam installation (Lstiburek 2010a)

of the rubble stone wall and the rigidity of the self-adhered membrane resulted in large gaps for drainage behind the membrane (see Figure 53). This drainage membrane is connected to the capillary break membrane under the sill. Closed cell spray foam was applied to the interior of the membrane, lapping onto the slab to provide air barrier continuity. The spray foam was left exposed.

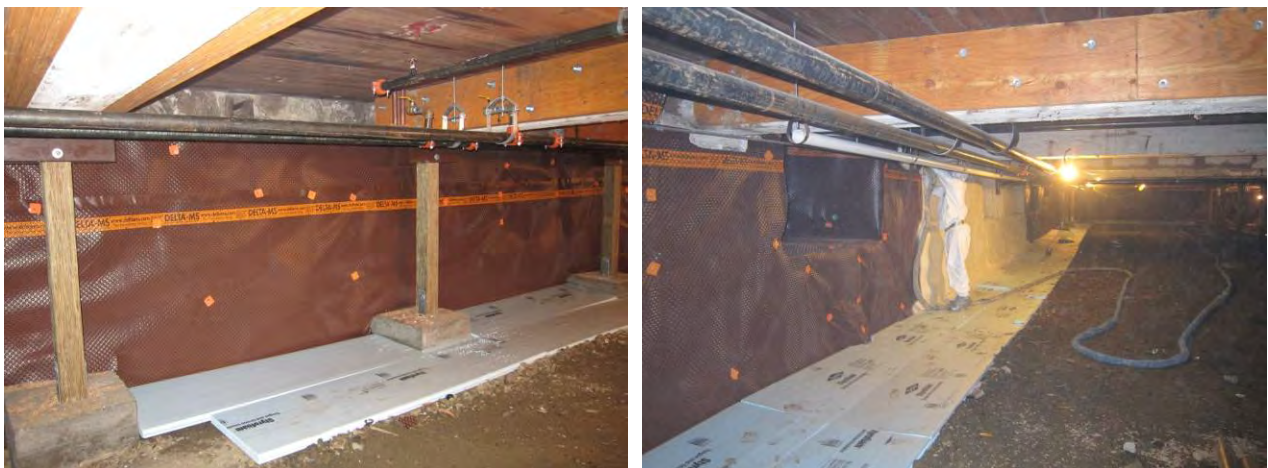
Figure 21. Air gap membrane under spray foam installation; 4’ basement slab edge insulation

The air gap membrane was mechanically fastened to the wall, extending from slightly above grade level to the existing earth floor of the crawl space. Perimeter drainage was installed, and perimeter slab insulation (2”/51 mm XPS, 4’/1.2 m from the edge) was laid on top of the assembly. Note that the slab is only partially insulated. Closed cell spray foam was then sprayed against the air gap membrane, extending from the bottom of the first floor deck to the XPS perimeter insulation.

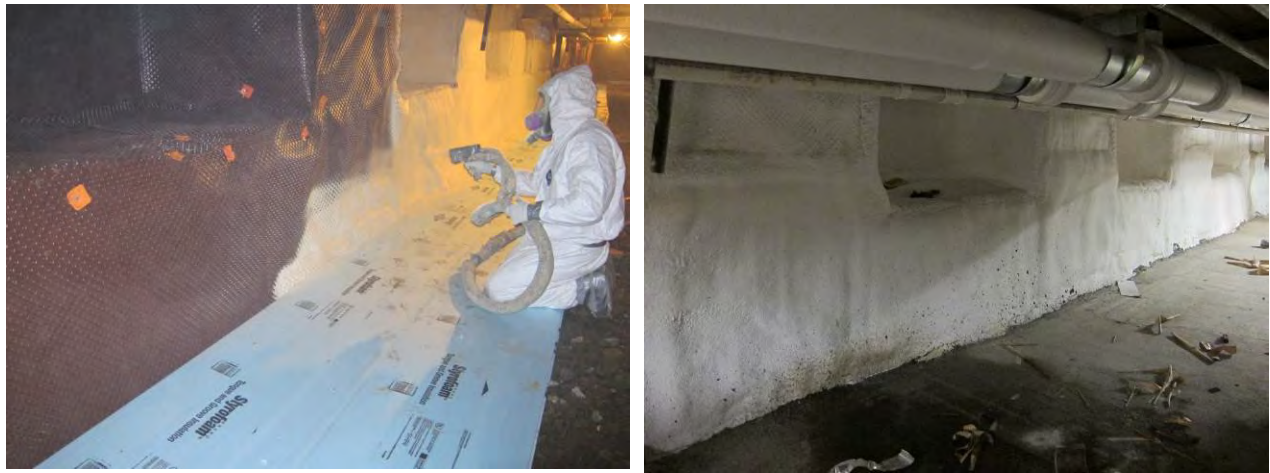
Figure 22. Spray foam slab edge insulation detail; completed installation of spray foam

A polyethylene ground cover was installed over the exposed earth and lapped onto the XPS insulation, and a 2”/51 mm “rat slab” was cast on top, to provide vapor control, air barrier continuity, and a durable walking surface for maintenance access.

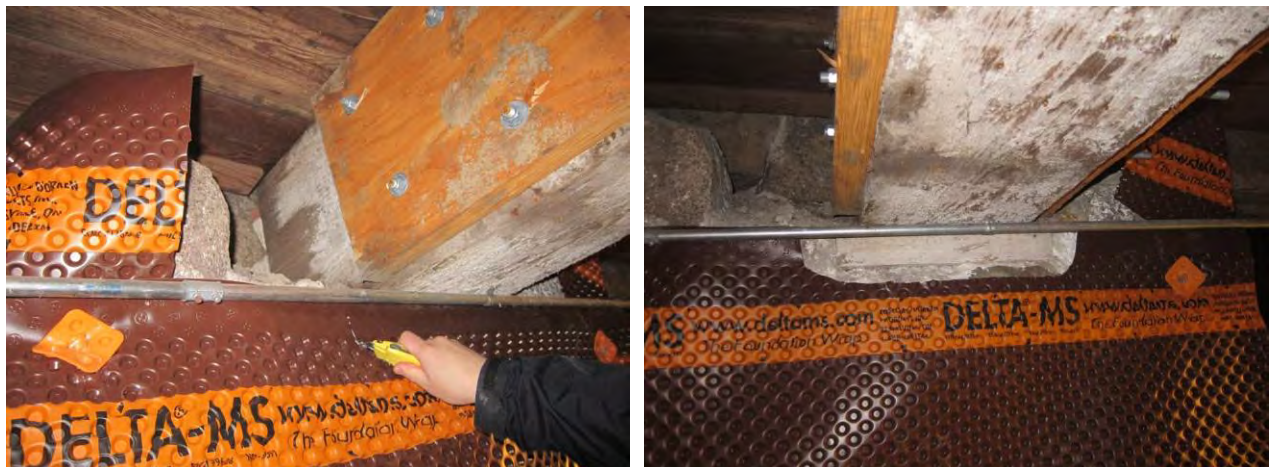
Figure 23. Air gap membrane venting to underside of beam (L); retrofitted detail (R)

One particular detail was the termination of the air gap membrane at embedded wood beams, as shown in Figure 23. This as-installed detail was a risky installation, because high relative humidity air (which will collect behind the air gap membrane) will be connected to moisture-sensitive materials such as the wood beam. Instead, the air gap membrane was cut with a “pocket” around the beam, thus resulting in no air connection. Note that this air gap membrane must be sealed from the interior, to avoid venting of soil gases and high humidity air into the interior (now conditioned) space.

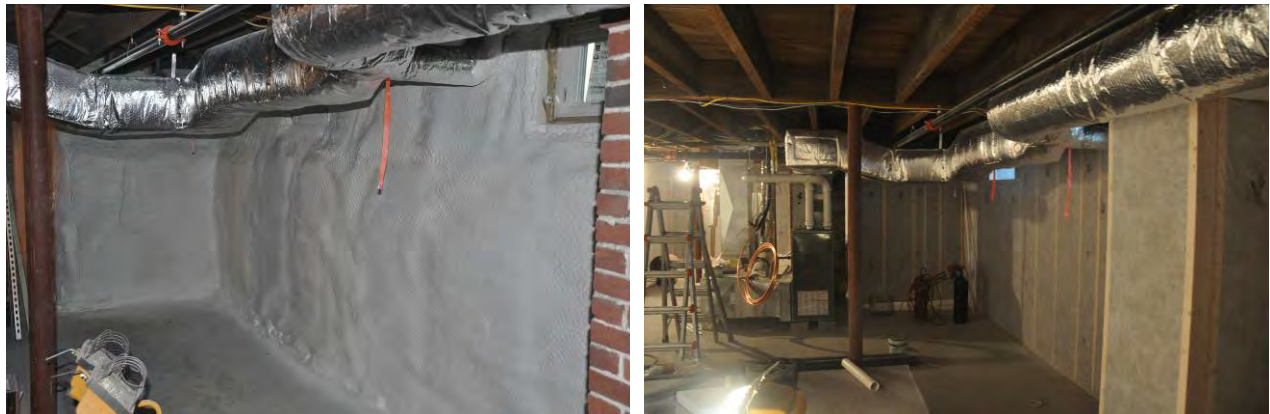
Figure 25. Basement with spray foam (L); and added cellulose in framed wall (R)

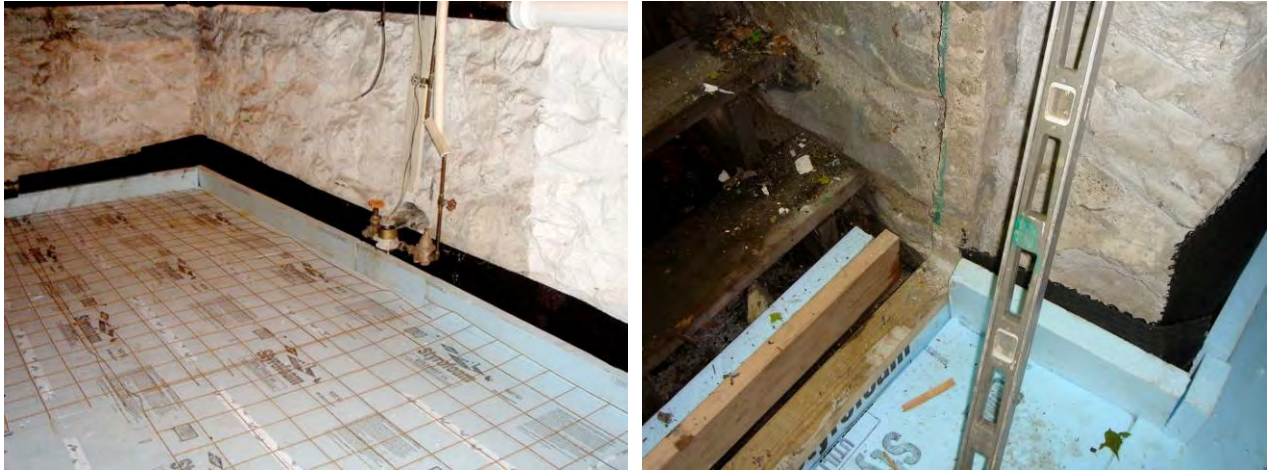
Figure 29. Basement slab insulation, and edge drainage mat detail continuing under slab

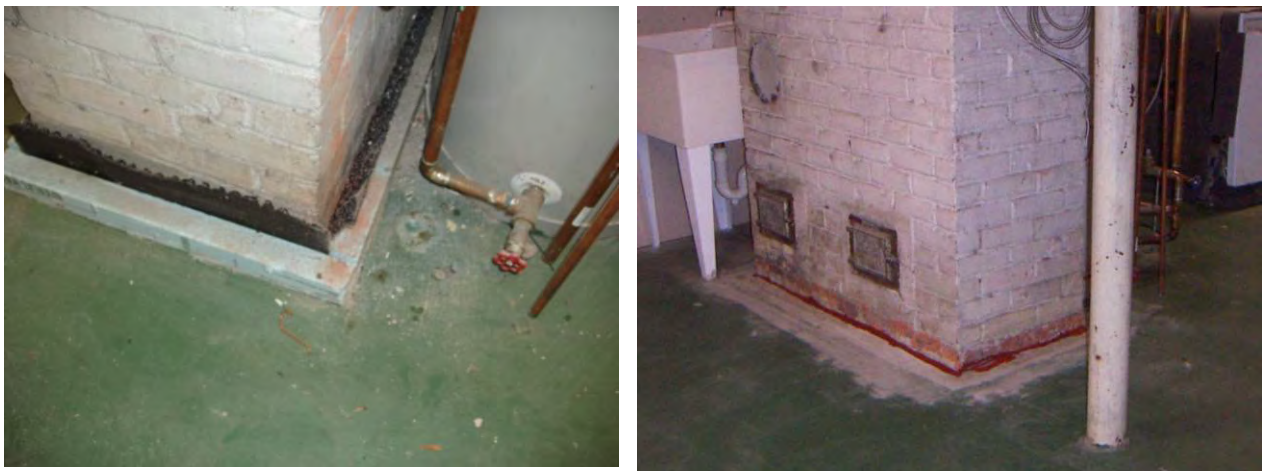
Figure 30. Drainage mat penetration at chimney; retrofit sealing of drainage mat

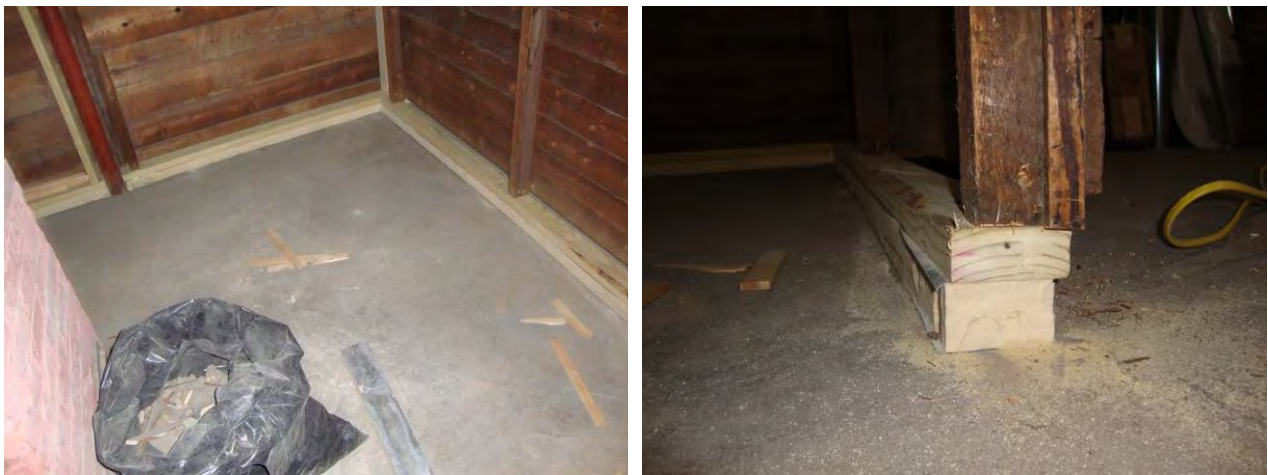
Figure 32. Modification of existing partitions (© 2011 by Byggmeister; reprinted with permission)

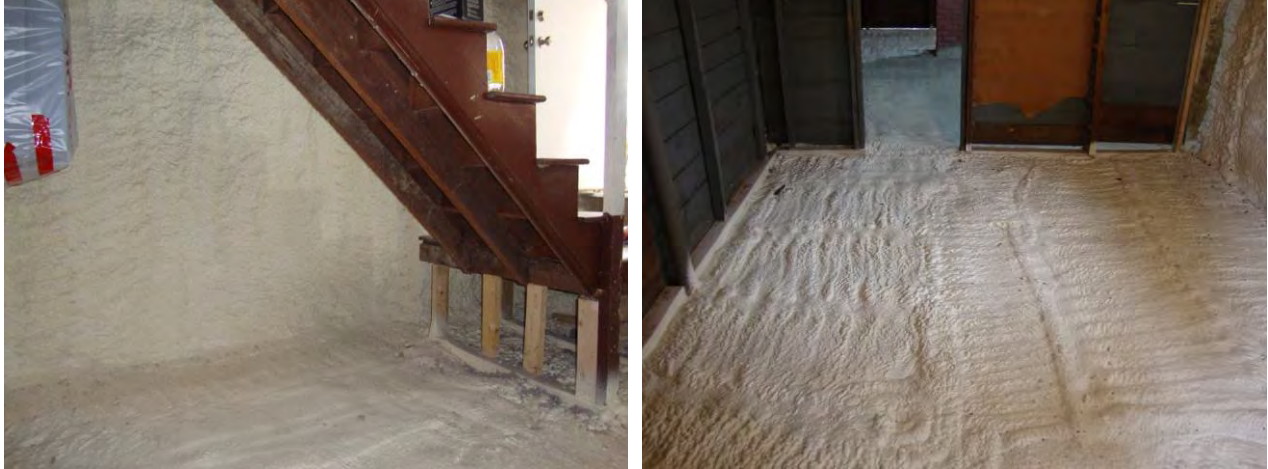
Figure 33. Spray foam applied to walls and slab (© 2011 by Byggmeister; reprinted with permission)

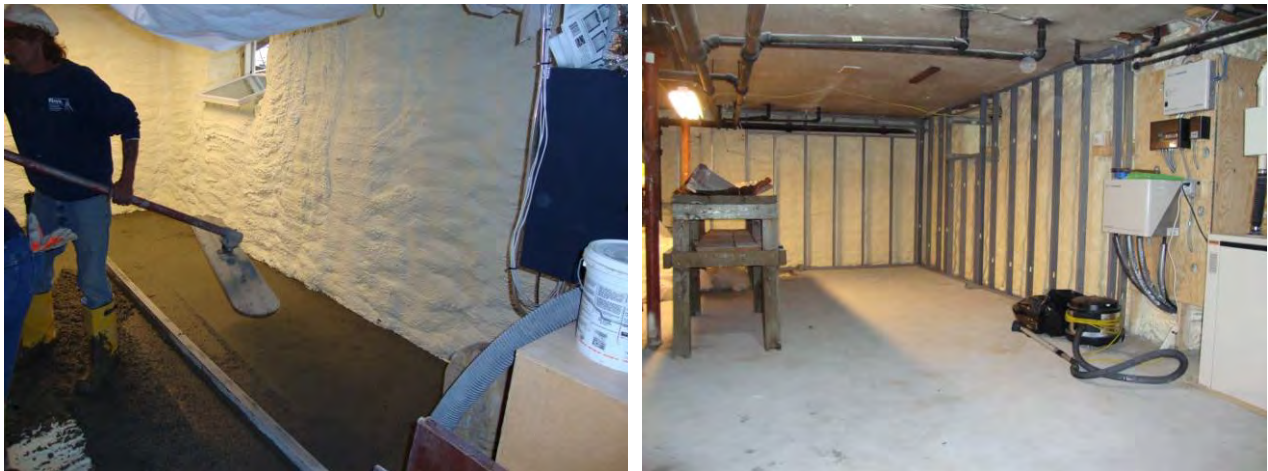
Figure 34. Casting of slab; wall framing (© 2011 by Byggmeister; reprinted with permission)

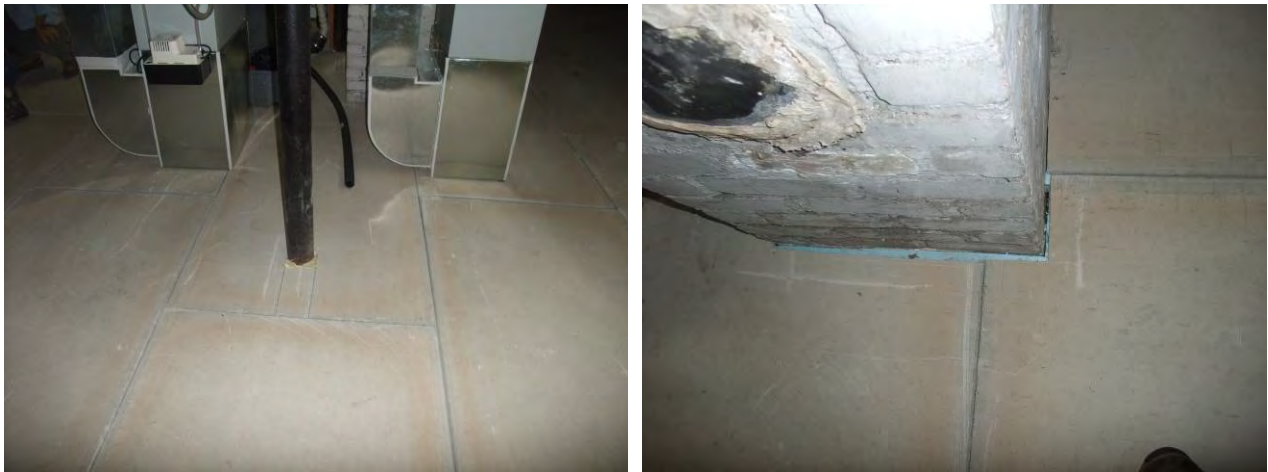
Figure 35. Storage use basement slab insulation/moisture control retrofit; cement board surface

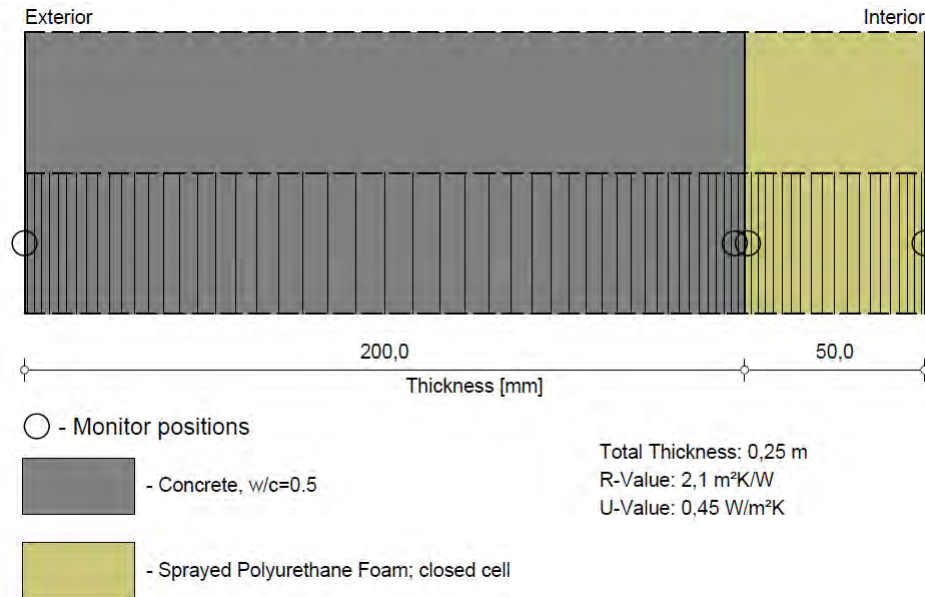
Figure 38. WUFI insulated model setup, showing layers and monitor positions

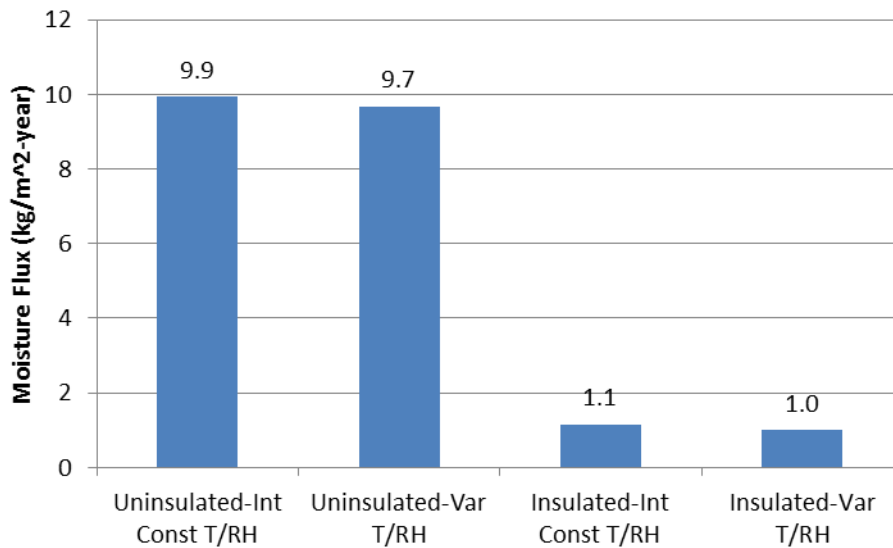
Figure 39. Moisture flux through concrete (and insulation), kg/m²-year

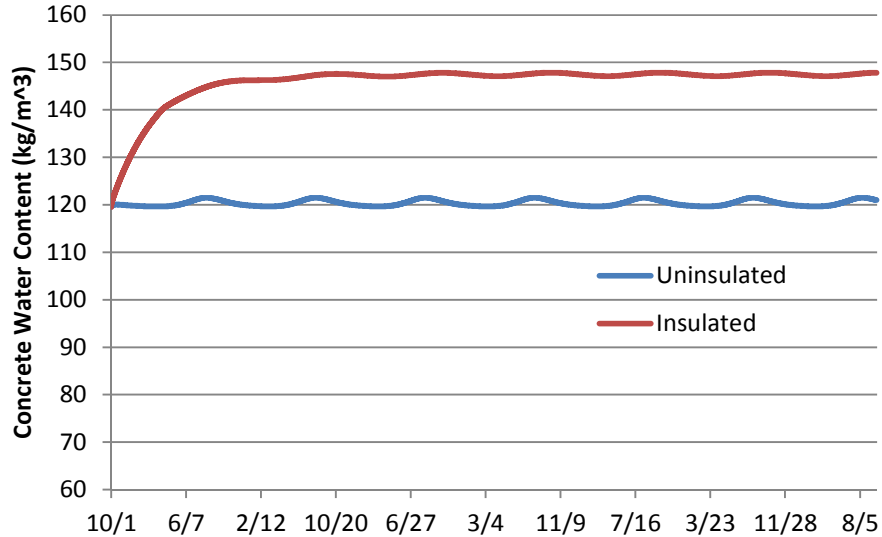
Figure 40. Concrete layer moisture content, kg/m³, pre- and post-insulation

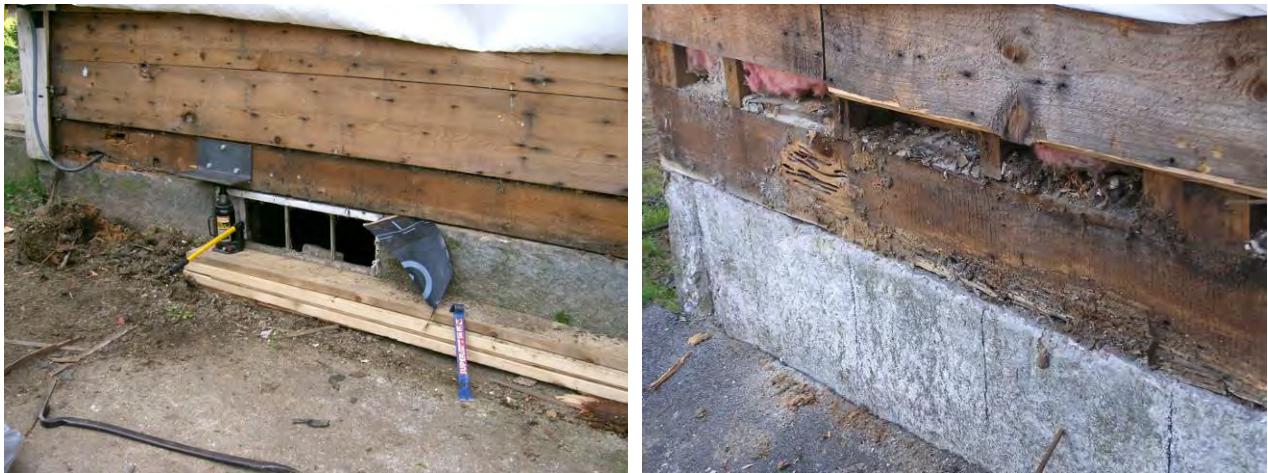
Figure 42. Sill lift and pre-retrofit sill beam condition at Bedford Farmhouse

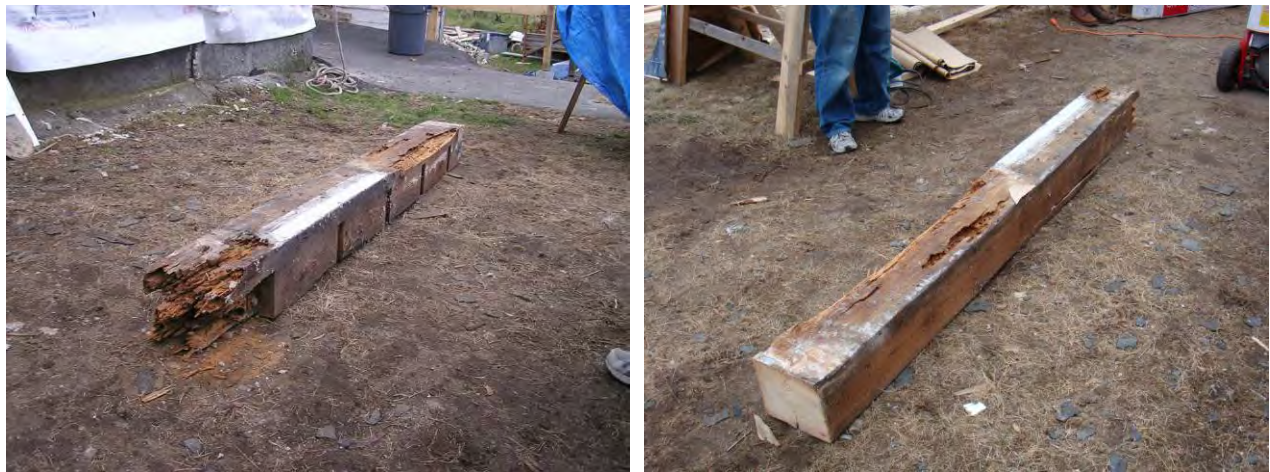
Figure 43. Damaged sill beams from Bedford Farmhouse

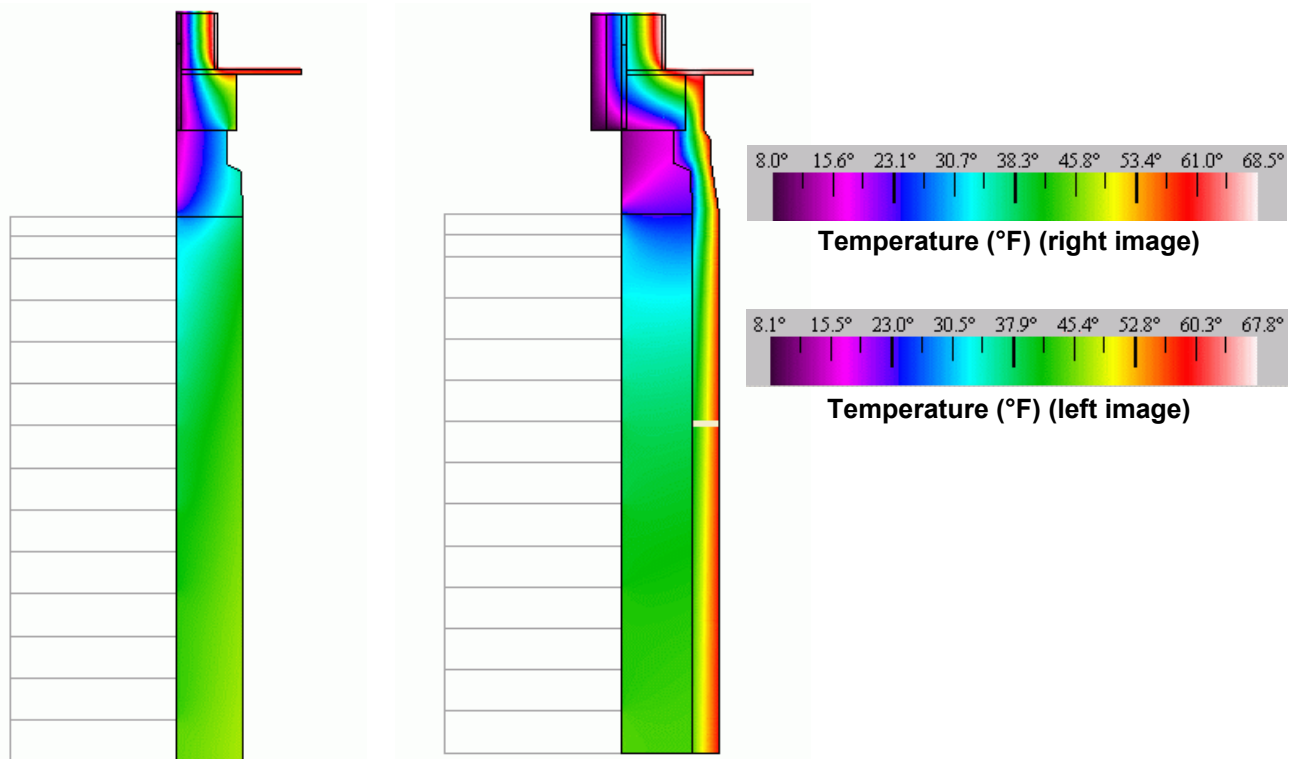
Figure 45. Pre- and post-retrofit basement wall and sill beam temperatures

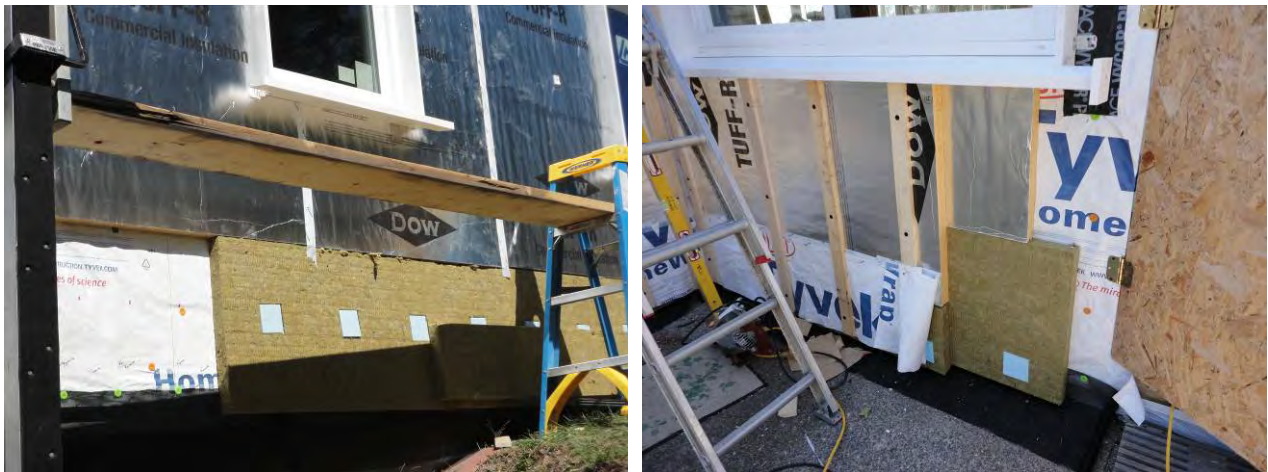
Figure 46. Sill beam insulated with vapor-permeable mineral fiber insulation overlaid

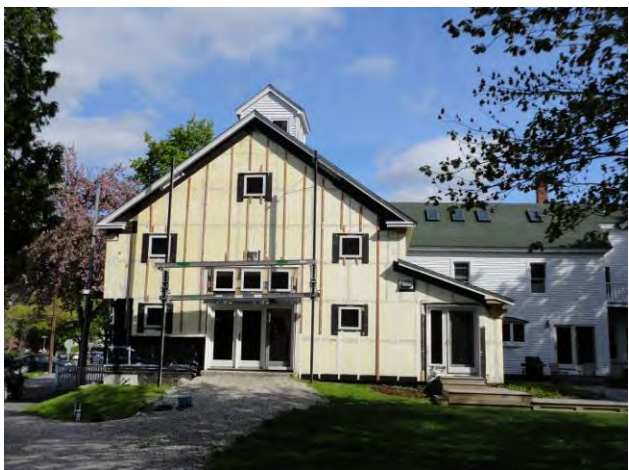
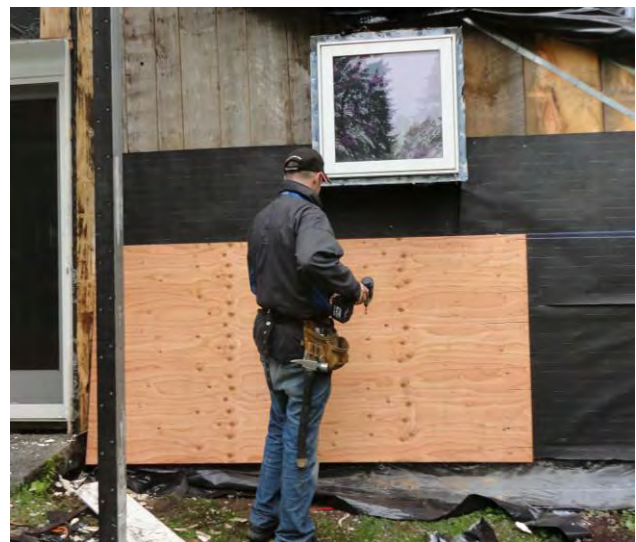
Figure 47. Westford House/Barn recladding and sill beam inspection

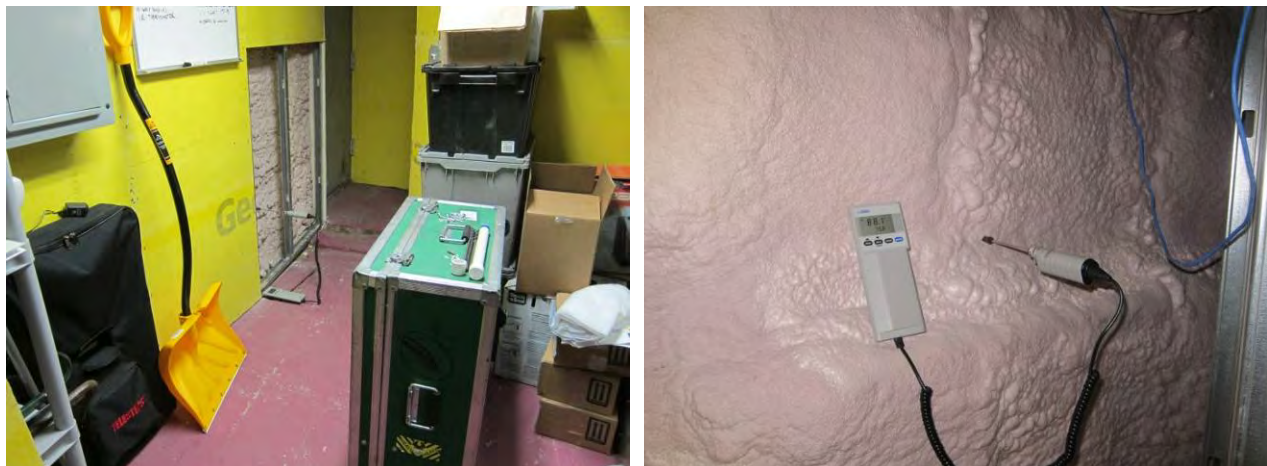
Figure 48. Measurement of T/RH conditions behind ccSPF insulation, Somerville Office

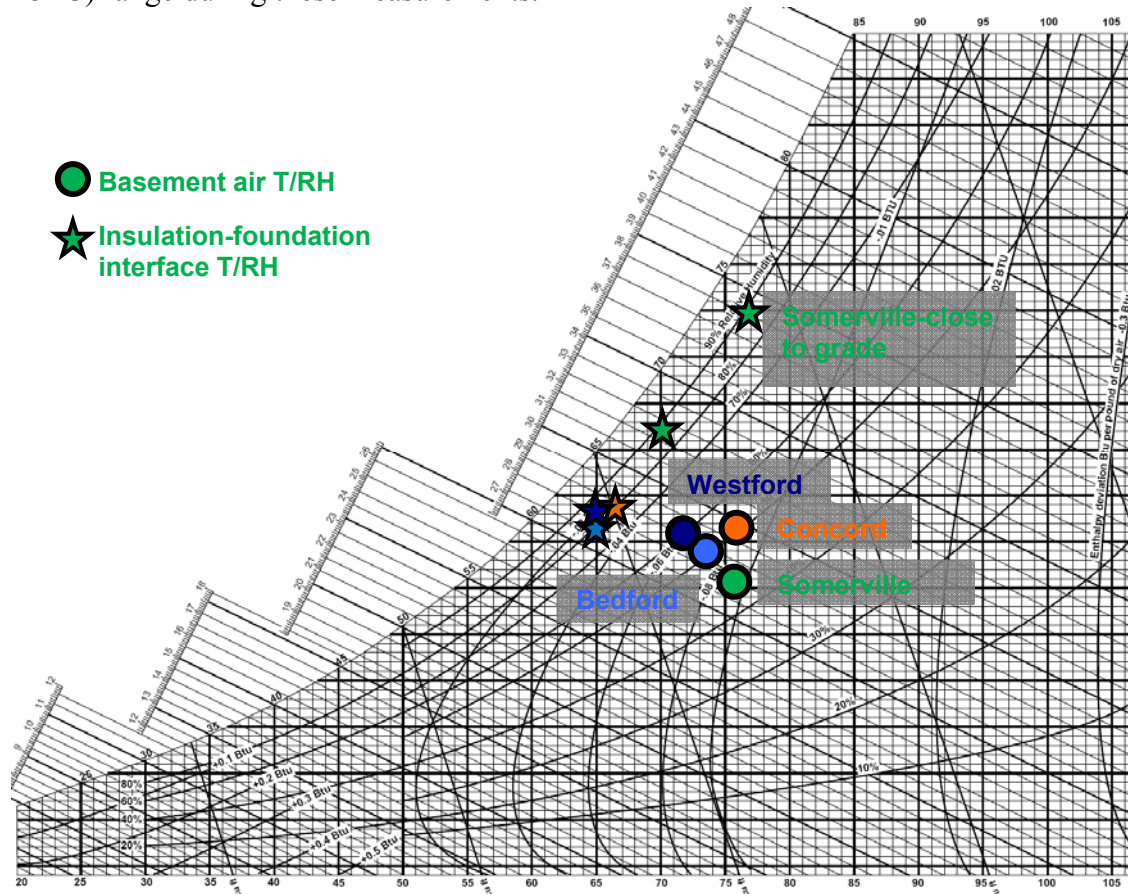
Figure 49. Psychrometric comparison of survey site conditions (basement and exterior to foam)

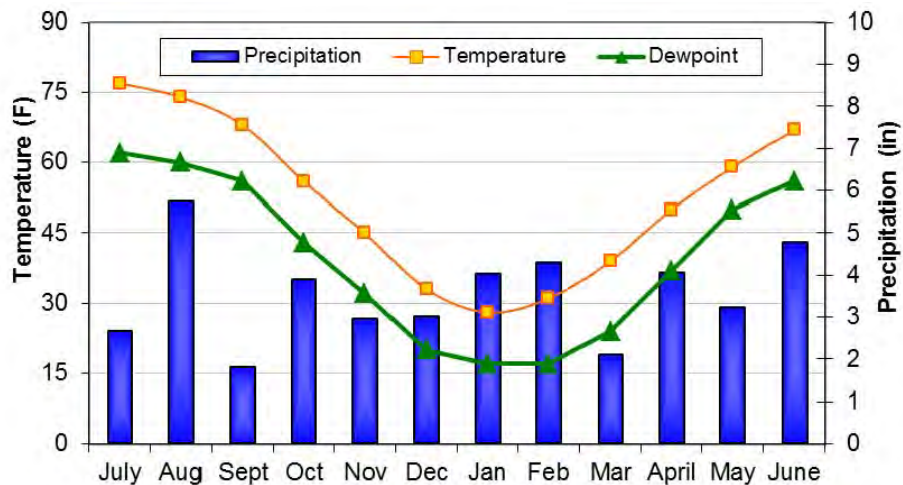
Figure 50. Boston area monthly temperature, dewpoint, and precipitation, 2010-2011

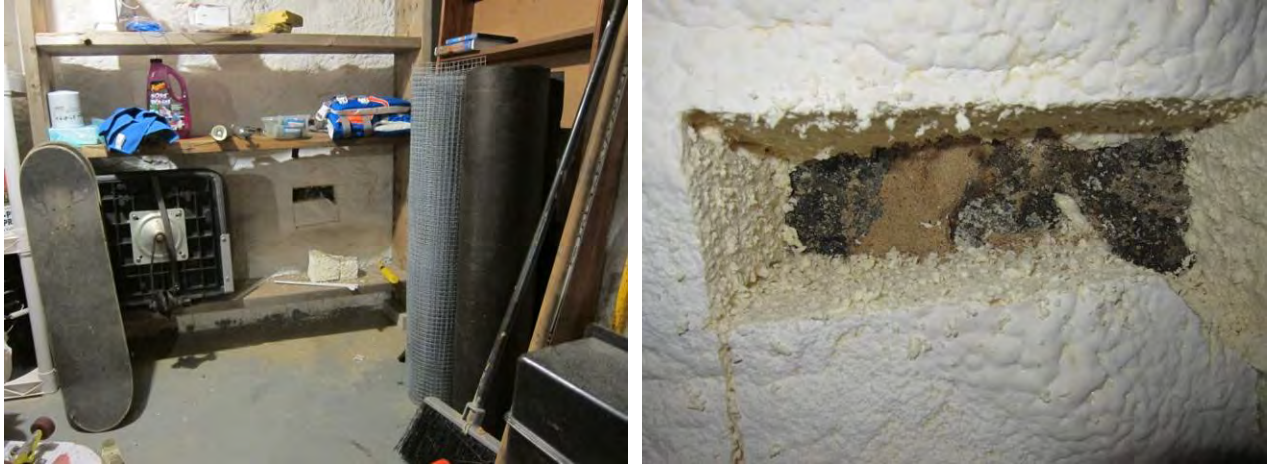
Figure 51. Test port cut into wall ccSPF, Bedford Farmhouse Renovation

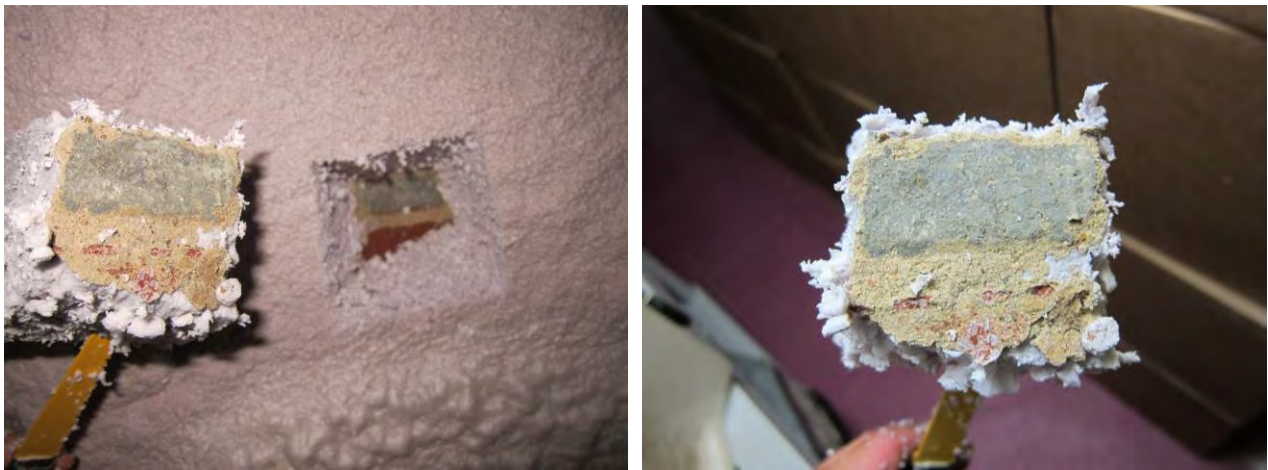
Figure 52. Test port cut into wall ccSPF, Somerville Office

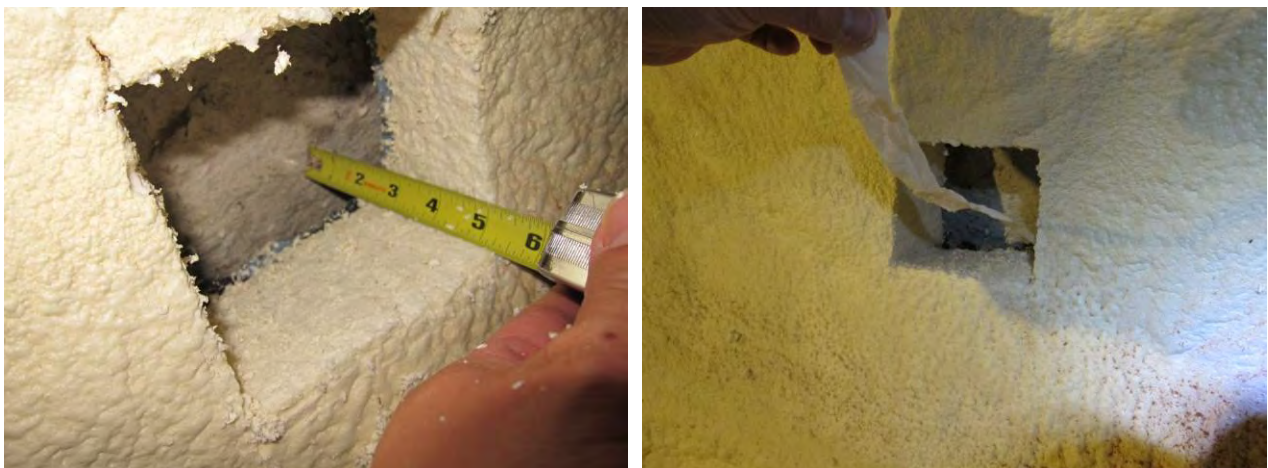
Figure 53. Air gap behind membrane; demonstration of airflow behind foam, Westford Barn/House

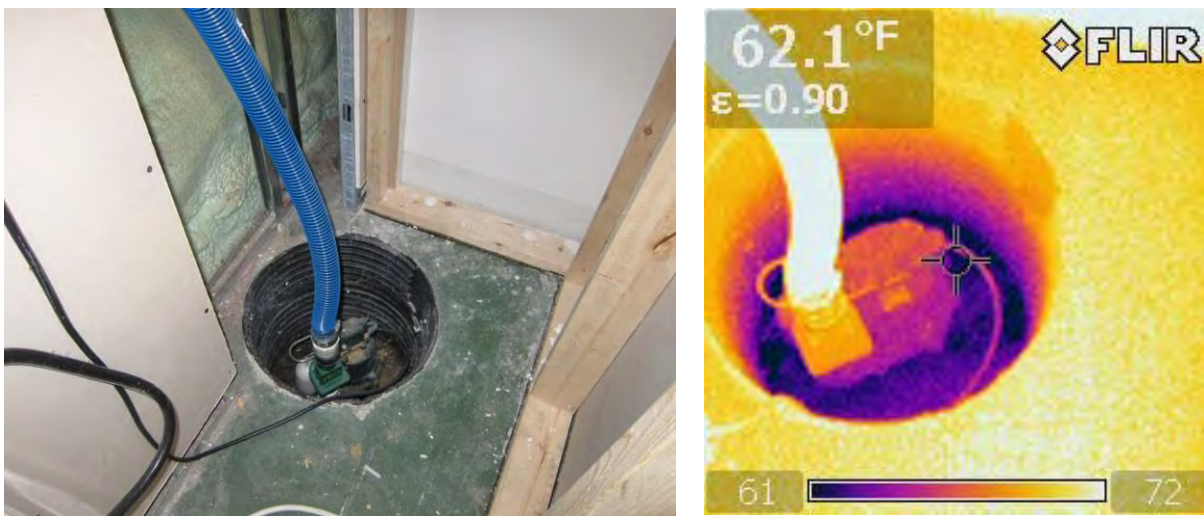
Figure 56. Sump pit temperatures, Concord House

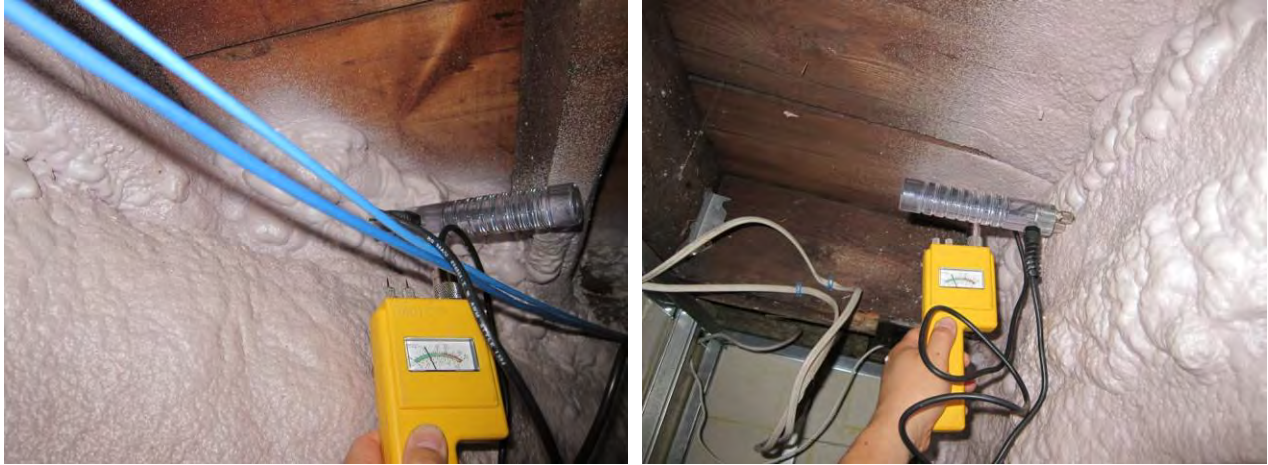
Figure 59. Sill beam moisture content measurement, Somerville Office

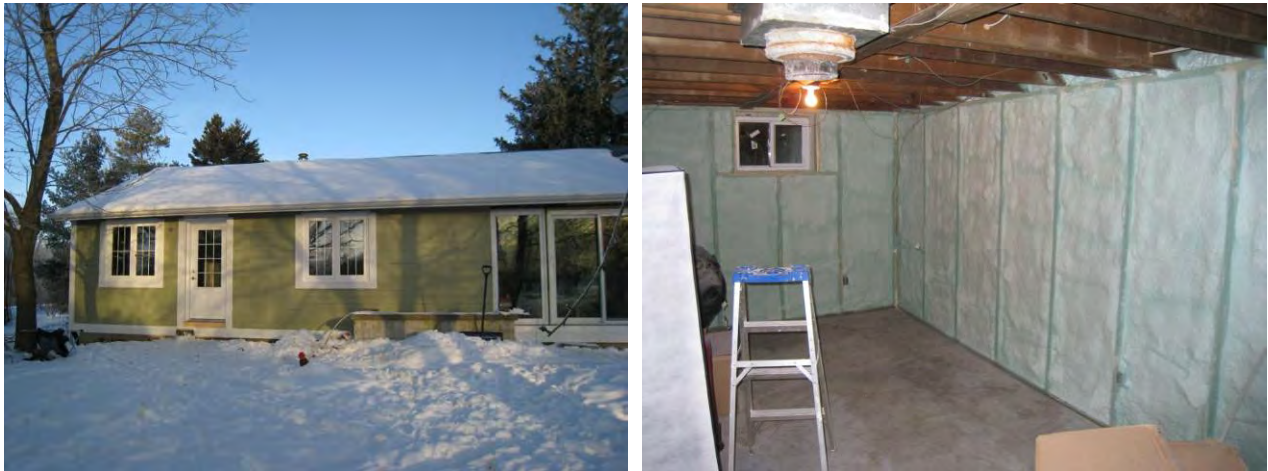
Figure 60. Exterior view of St. Agatha site; completed basement ccSPF retrofit
