Hybrid Foundation Insulation Retrofits: Measure Guideline

Building America Report - 1108

K. Ueno and J. Lstiburek, Ph.D., P.Eng.
Building Science Corporation (BSC)

April 2012

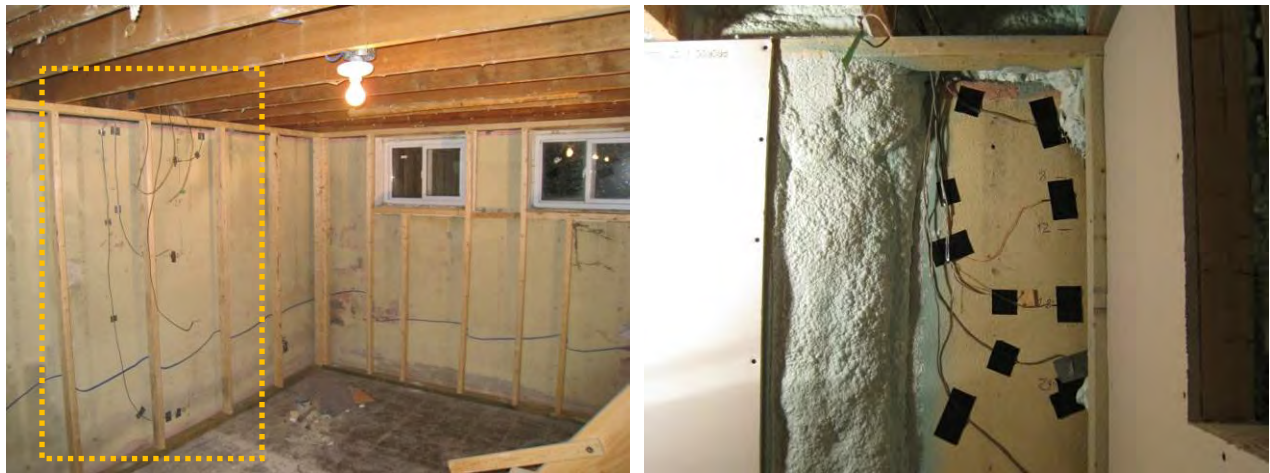
Figure 62. Overview and close-up of instrumentation in ccSPF retrofit basement

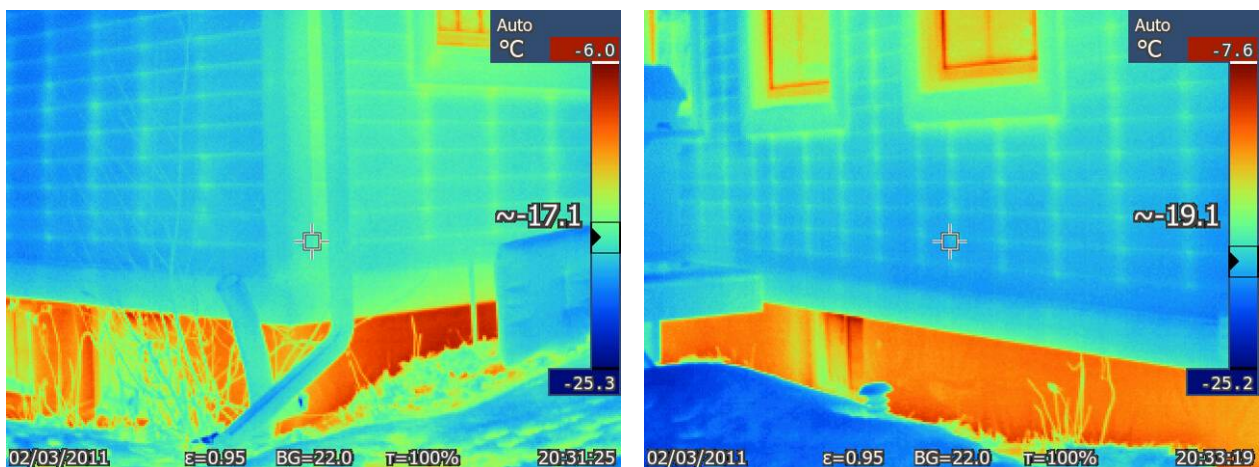
Figure 63. Infrared images of basement wall in wintertime (February) conditions

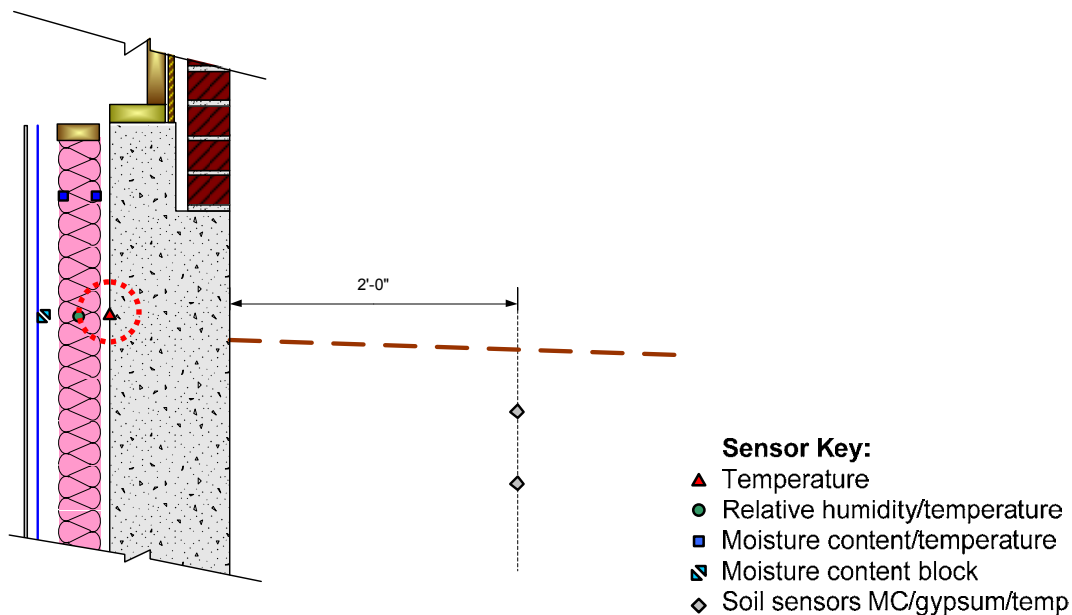
Figure 64. Sensor locations and types in basement wall monitoring (Ueno 2007)

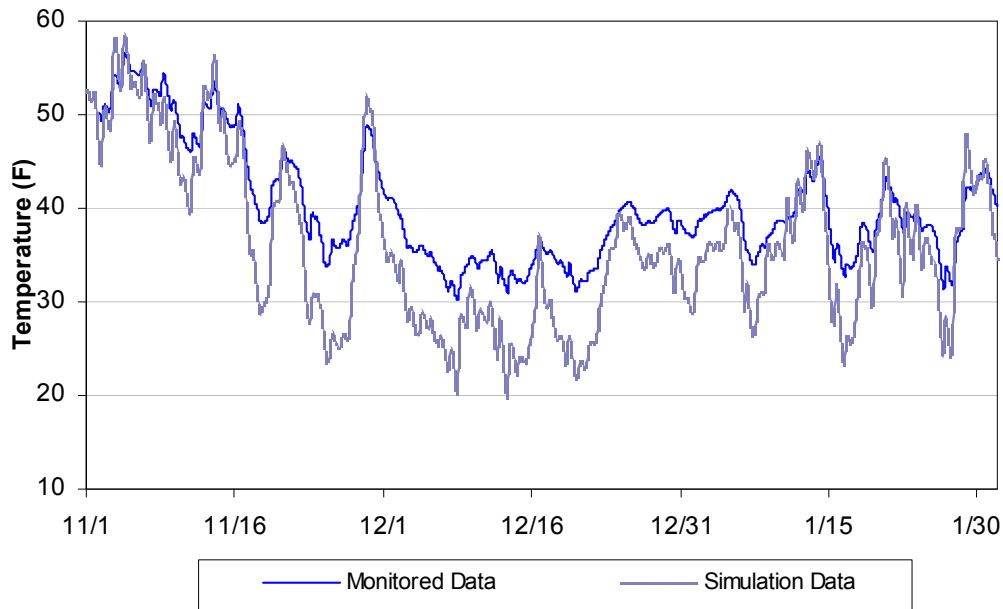
Figure 65. Concrete-insulation interface temperature, monitored vs. simulation (Ueno 2007)
