# Interior Insulation of Mass Masonry Walls: Joist Monitoring, Material Test Optimization, Salt Effects

Building America Report - 1307

May 2013

K. Ueno, R. Van Straaten, C. Schumacher  
*Building Science Corporation*  
May 2013

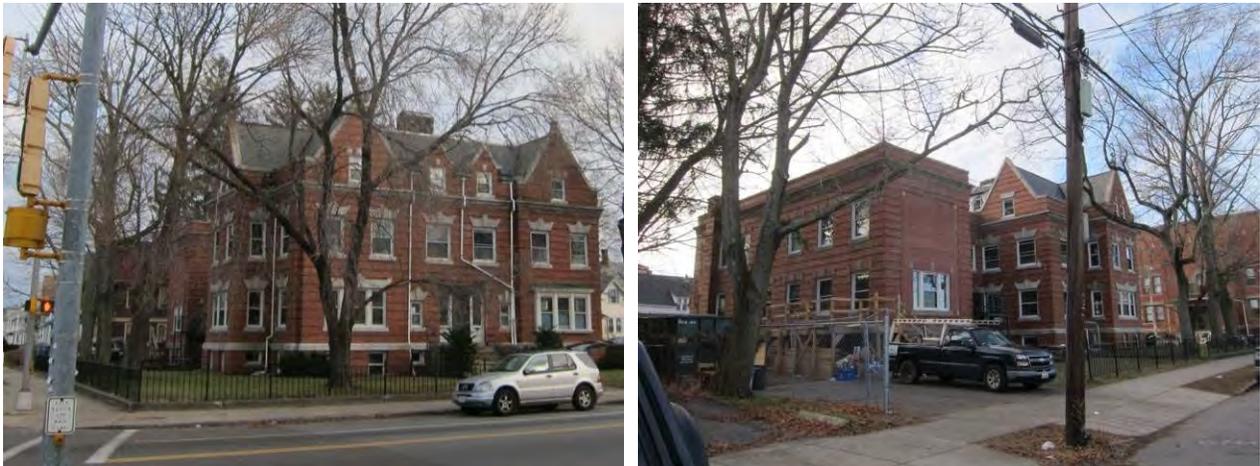
This field monitoring work was done at an existing brick mass masonry building in Lawrence, MA, which is being renovated by the Merrimack Valley Habitat for Humanity (MVHfH) into ten condominium units (Figure 1).

Figure 1: Merrimack Valley Habitat for Humanity retrofit building from west (left) and north (right)

The construction of the masonry walls at this project include both multi-wythe solid brick walls, and exterior brick with a hollow clay block infill/backup wall, as shown in Figure 4. These photos show conditions after demolition of the interior furring, lath, and plaster. Solid multi-wythe brick is used at the original portion of the building (west-facing front elevation; circa 1906 construction; see Figure 1, left); clay block is used at the east-facing rear addition (circa 1930 construction; Figure 1, right).

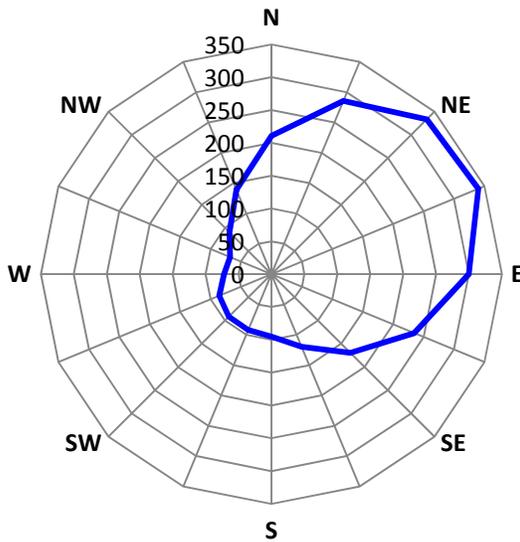
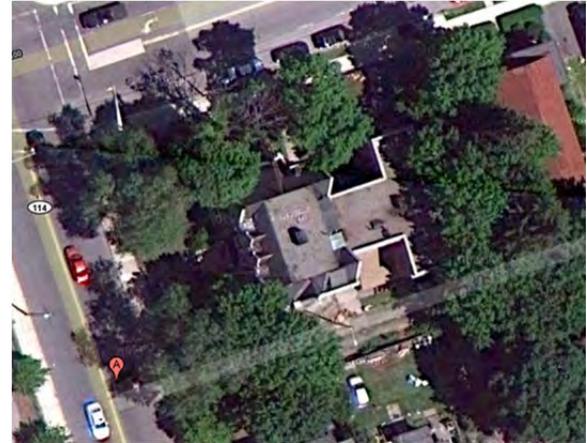
The past year’s weather data (May 2012-May 2013) for the nearest station (Lawrence Municipal Airport/KLWM) was used to create a driving rain rosette (Figure 3), using methods described in Straube and Burnett (2005). It shows that the greatest driving rain deposition occurs on the rear face of the building (project East). There is some shielding of the building due to adjacent trees during non-winter conditions.

**Figure 3: Driving rain rosette for KLWM, rain in mm/year (left) and overhead view (right)**

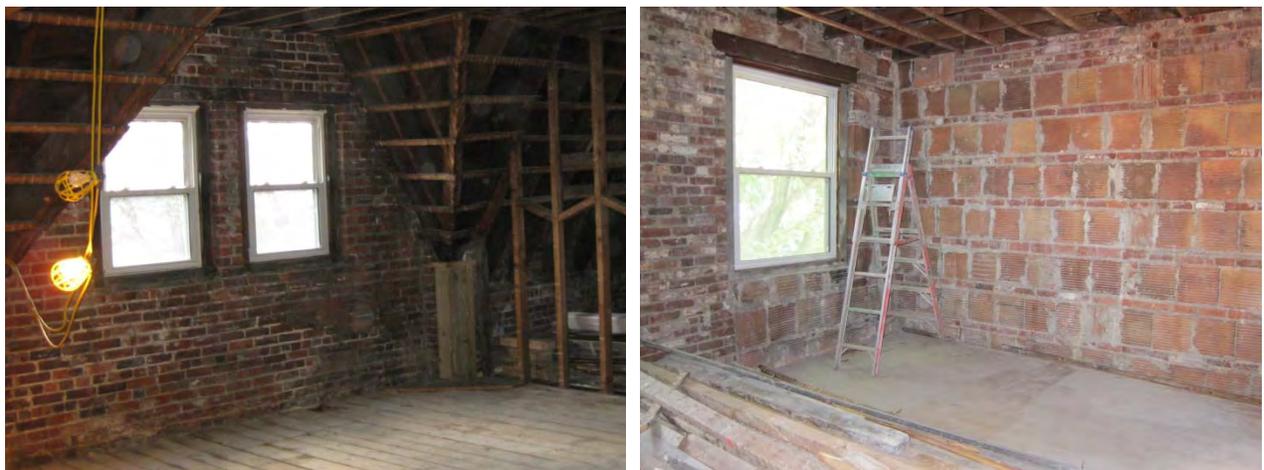
**Figure 4: Exterior wall conditions at solid brick (left) and hollow clay block infill (right) conditions**

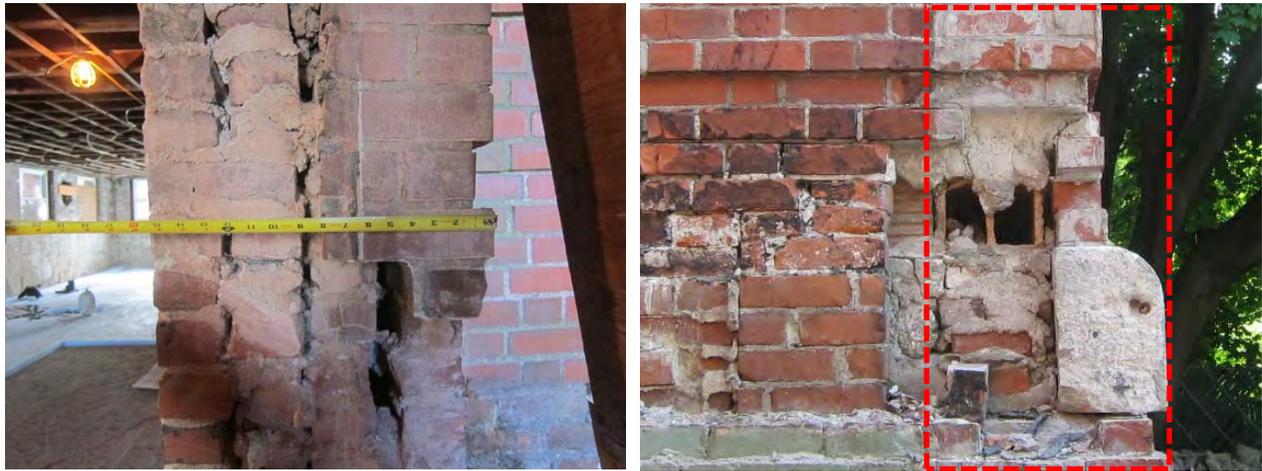
Although these assemblies appear to be monolithic from the interior and exterior, there are a variety of interconnected spaces, such as the incompletely filled collar joints between brick wythes (Figure 5, left), or the hollow cores of the clay blocks (Figure 5, right).

**Figure 5: Wall section at solid brick (left) and at hollow clay block infill (right) conditions**

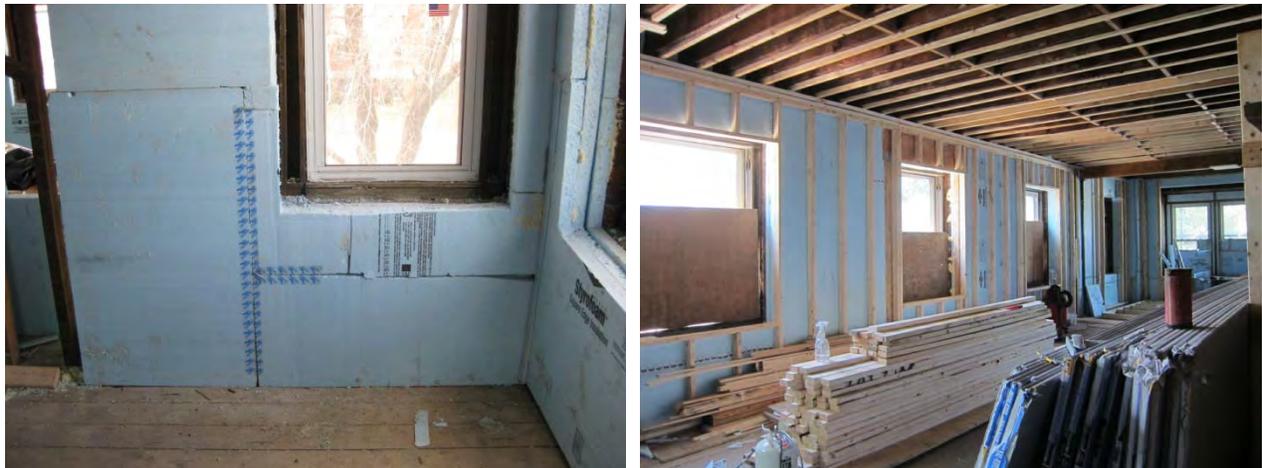
The building is being retrofitted with interior insulation, which consists of three 2” layers of extruded polystyrene (XPS) insulation adhered to the existing masonry with polyurethane adhesive (Figure 6, left). The seams are staggered, and are taped on the innermost and outermost layers, to improve air barrier performance. Wood 2x4 framing is installed inboard of the XPS insulation for mechanical systems and services (Figure 6, right); the cavity is left uninsulated.

**Figure 6: Multiple layers of insulation (left) and framing installed inboard of insulation (right)**

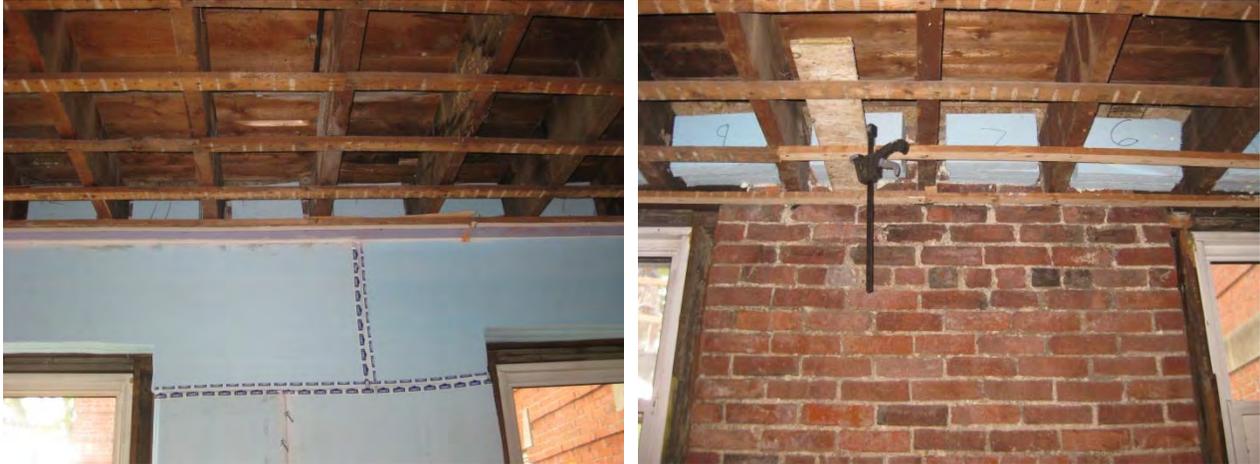
The embedded wood structure consists of dimension lumber (roughly 2” thickness) joists at a close spacing (16” on center typical), as opposed to large, widely-spaced timbers or beams. Typical conditions are shown in Figure 7 (left). The insulation approach at the embedded beams is to use scraps of rigid XPS foam insulation, installed with polyurethane adhesive. This approach consumes available scrap; note that there is a generous space at the perimeter of each block, which allows effective air sealing with a spray foam kit.

**Figure 7: Embedded joist foam blocks (left); close-up showing clamping jig (right)**

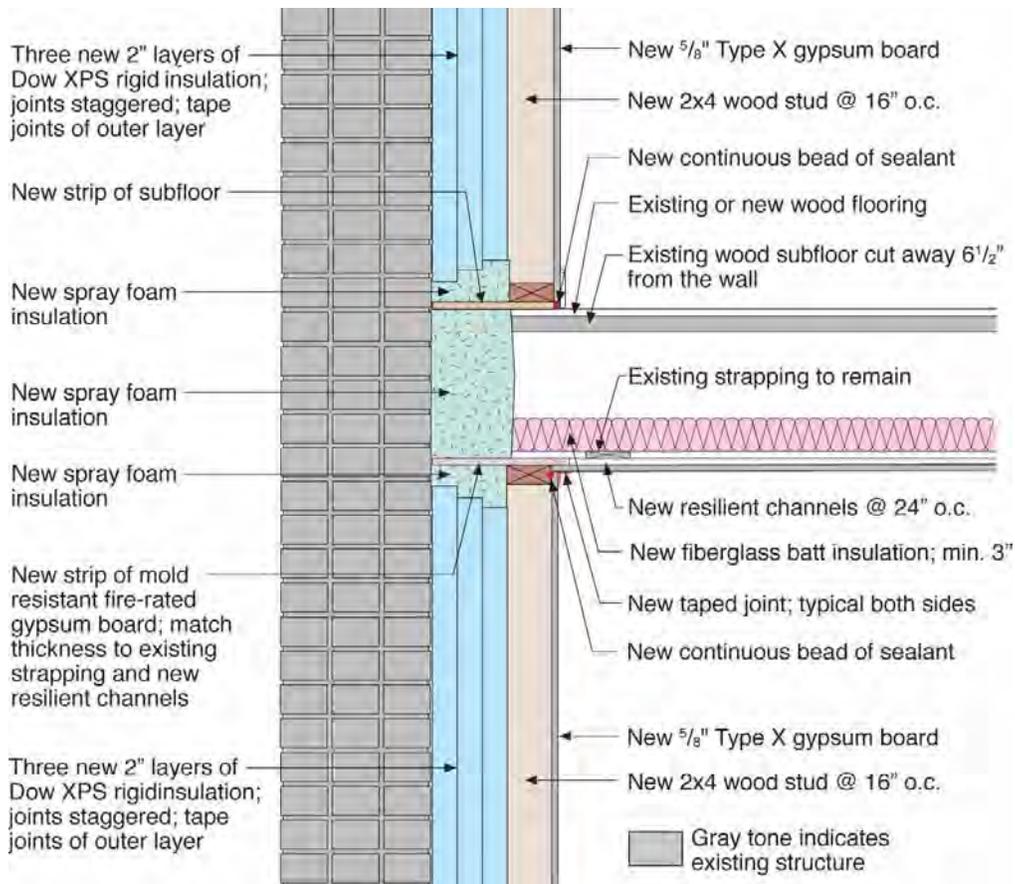
The typical floor-to-floor detail is shown in Figure 8, showing spray foam at the joist space. This floor-to-floor separation detail also needs to meet fire separation requirements, which is the reason for the discontinuities in the insulation (see “New strip of mold resistant fire-rated gypsum board”).

**Figure 8: Unit-to-unit floor/ceiling assembly at exterior wall; joists perpendicular to wall**

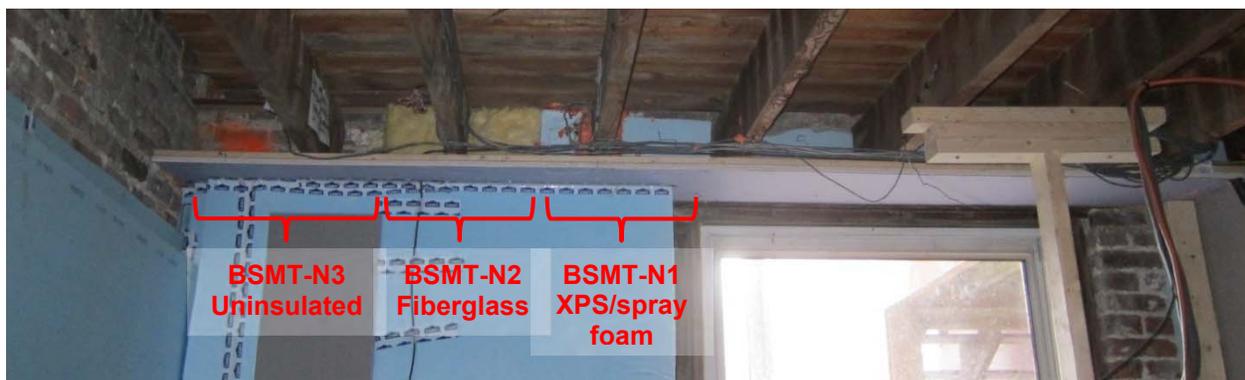
- BSMT-N1 is insulated as per the remainder of this project, insulated and air sealed with rigid foam and urethane spray foam
- BSMT-N2 is insulated with air-permeable insulation (two R-13 layers of fiberglass batt, or R-26), which captures the effect of insulating, while still allowing airflow.
- BSMT-N3 is left uninsulated, similar to assemblies described in Morelli's research (2010).

**Figure 9: Comparison of insulation strategies for joist ends BSMT-N-1/2/3, pre-drywall**

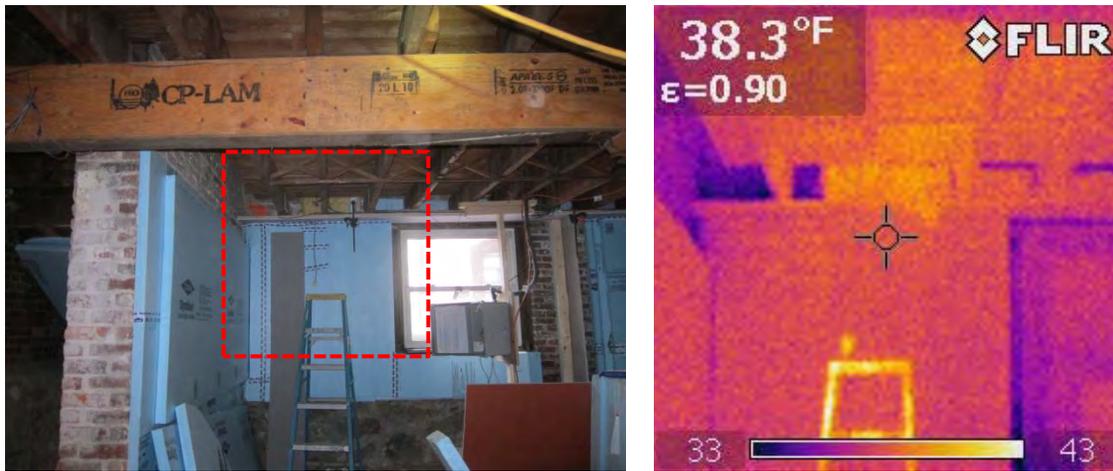
**Figure 10: Infrared comparison of BSMT-N1/N2/N3 joist ends (interior unheated)**

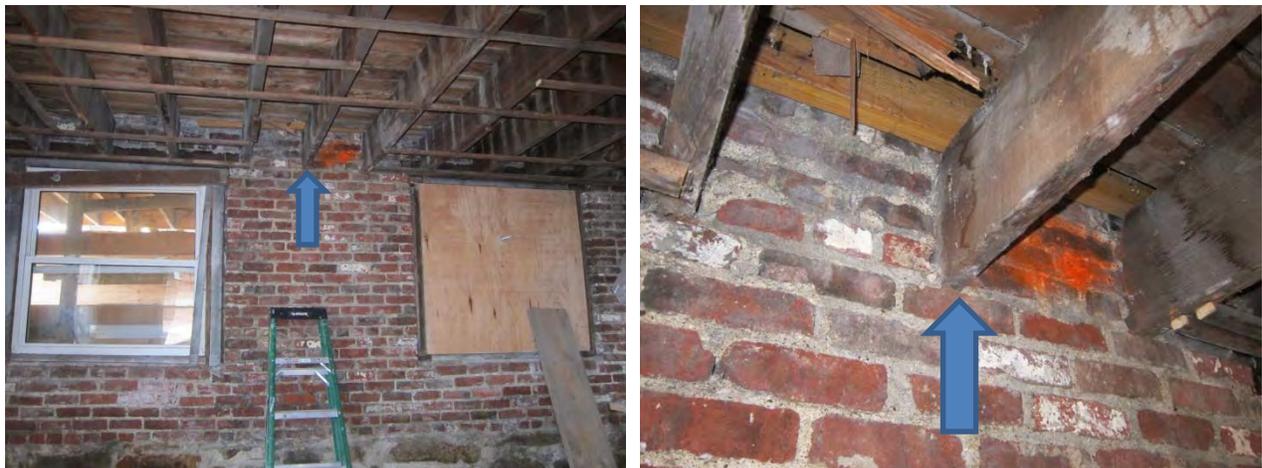
BSMT-E2 is of particular interest because it shows evidence of previous water penetration (staining of the beam end). The east orientation at the rear of the building also has the highest exposure for driving rain. It is unknown whether these bulk water issues have been solved in previous renovations, or if there might be some unknown hidden leakage path.

**Figure 11: BSMT-E-2 joist, showing existing water staining**

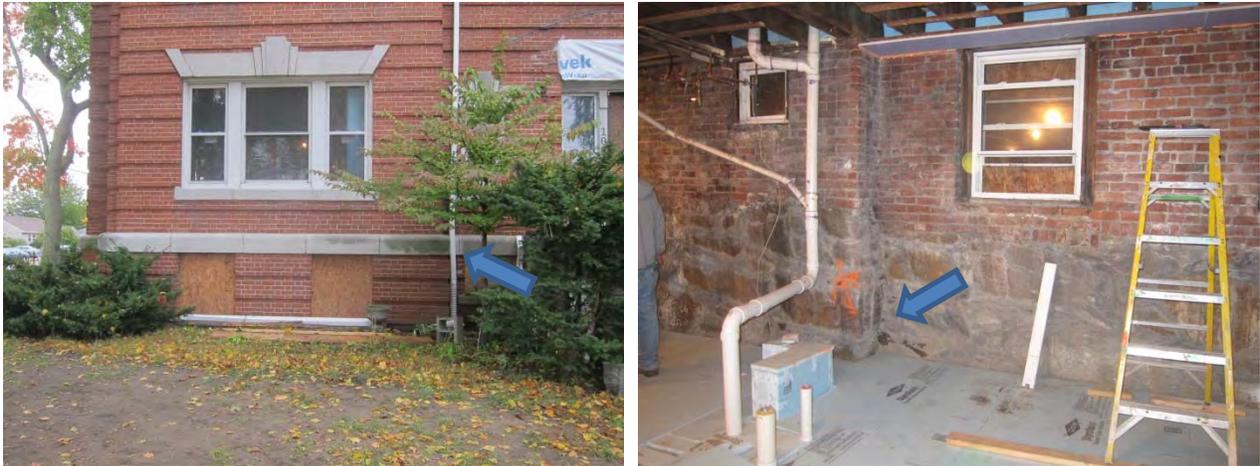
BSMT-W1 and BSMT-W2 are of interest because during the site inspection, it was noted that rainwater was being deposited on the wall at the “jog.” BSMT-W1 was set up to capture the mostly-dry field of the wall, while BSMT-W2 was located close to the jog, to determine whether this bulk water was sufficient to cause issues with the embedded joist end moisture behavior. This orientation has low driving rain exposure.

**Figure 12: BSMT-W1 and BSMT-W2 joists, showing water deposition at wall jog**

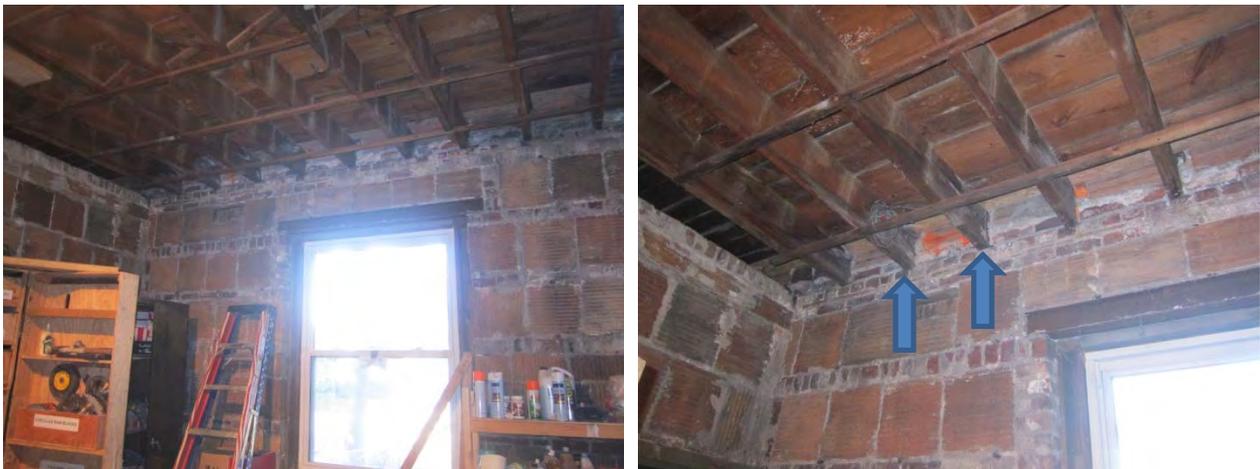
On the first floor, joists were only monitored in the addition (hollow clay block) walls, due to a lack of access to joists in the first floor original wing. The hollow clay block backup walls are actually constructed with alternating layers of block and brick, as shown in Figure 13, which shows the FIRST-N monitoring locations.

**Figure 13: FIRST-N joists, showing brick and clay block wall construction**

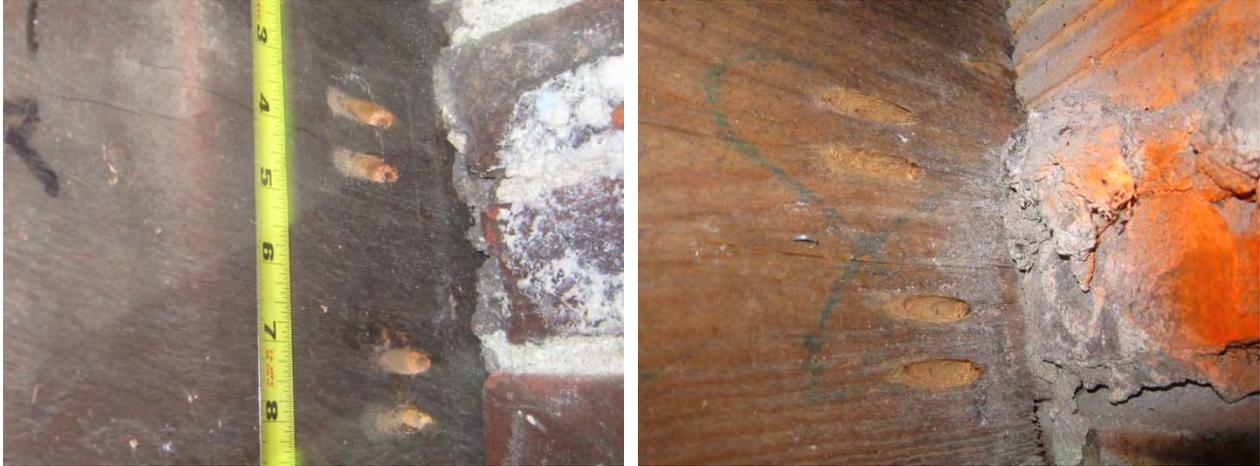
Monitoring was installed in north, south, and east-facing joists. The east-facing joist appears to be a different species: the wood is noticeably softer, and is a different color (see Figure 14). This difference in wood species may have an effect on moisture content measurements via electrical resistance.

**Figure 14: Wood color comparison at BSMT-E-1 and FIRST-E joists**

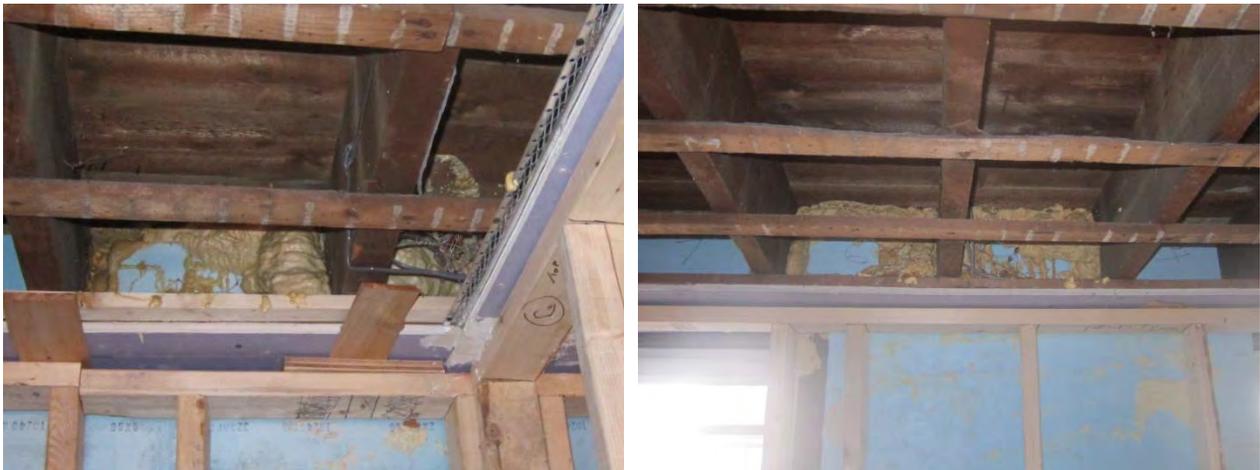
The insulation blocks have been installed between the floor joists at the front (west) wing, which contains BSMT-W1, BSMT-W2, and BSMT-E1. These joists have been insulated and air sealed to the perimeter of the foam blocks with a two-component spray foam pack, as shown in Figure 15. The remaining joists are running at close to ambient conditions, and have not yet been insulated.

**Figure 15: Two-component spray foam air seal at joists BSMT-W1 and BSMT-E1**

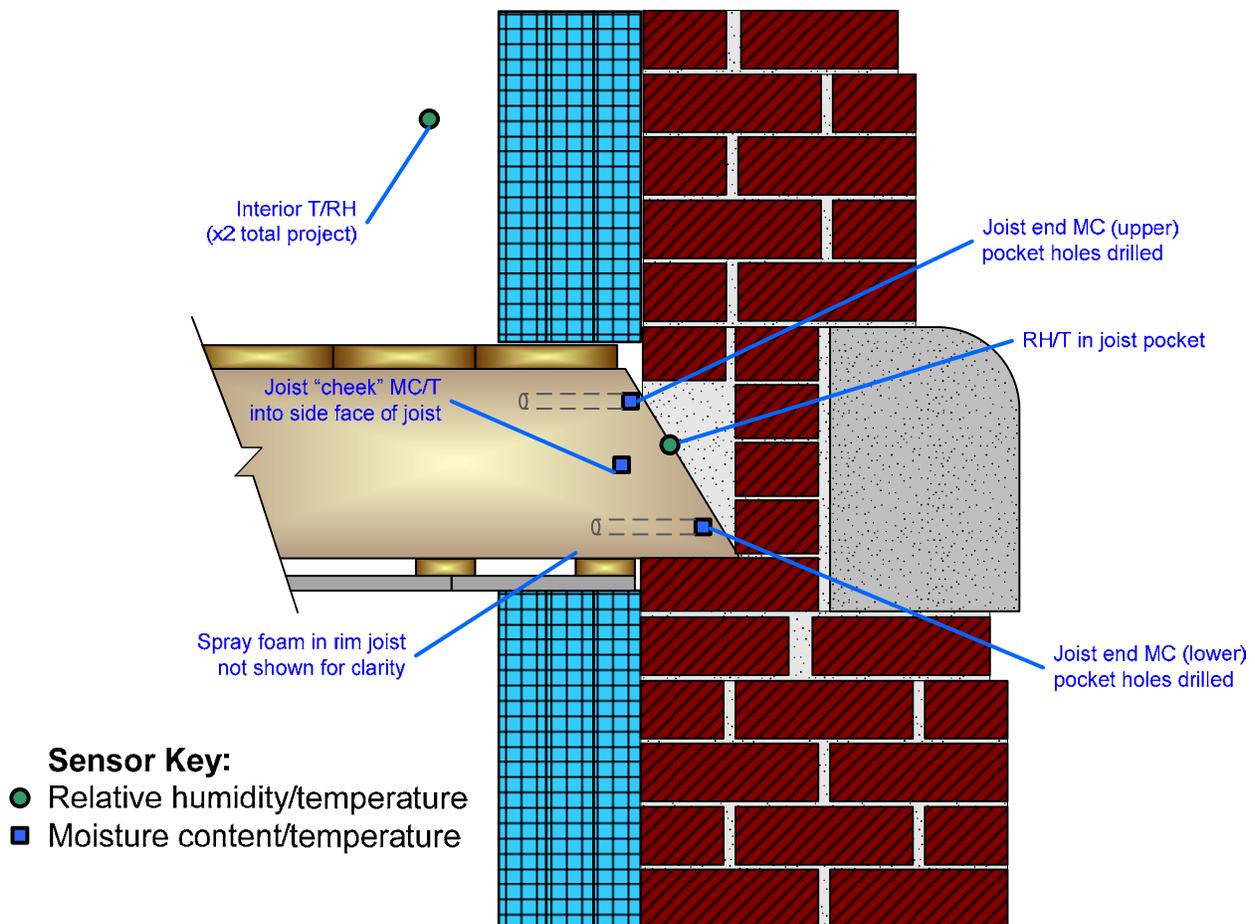
The specifics of these sensors are covered in detail by Straube et al. (2002). The sensor package installed at each joist is shown schematically in Figure 18. Note that the ends of the joists are “fire cut,” or cut at an angle so that a fire which burns through a joist will not collapse the masonry wall by “levering” the structure upward and outward.

**Figure 18: Schematic of typical joist end sensor monitoring package**

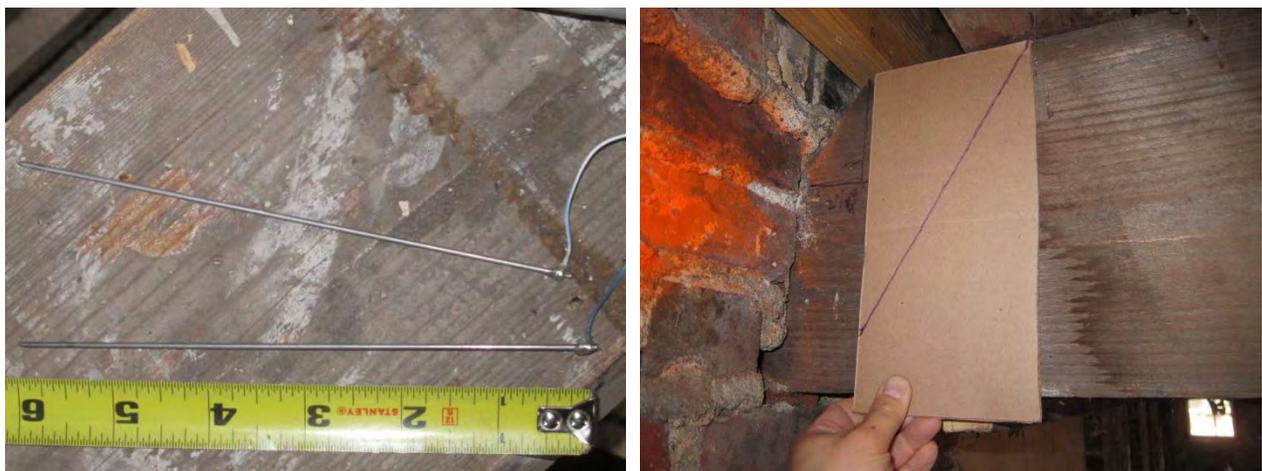
The joist ends were monitored using 6” long sharpened stainless steel pins attached to wire leads, as shown in Figure 19 (left). First, the end of the joist was examined, to determine the angle of its fire cut, and the location of the end of the joist (Figure 19 right).

**Figure 19: 6” extended moisture content pins (left) and determining drilling depth (right)**

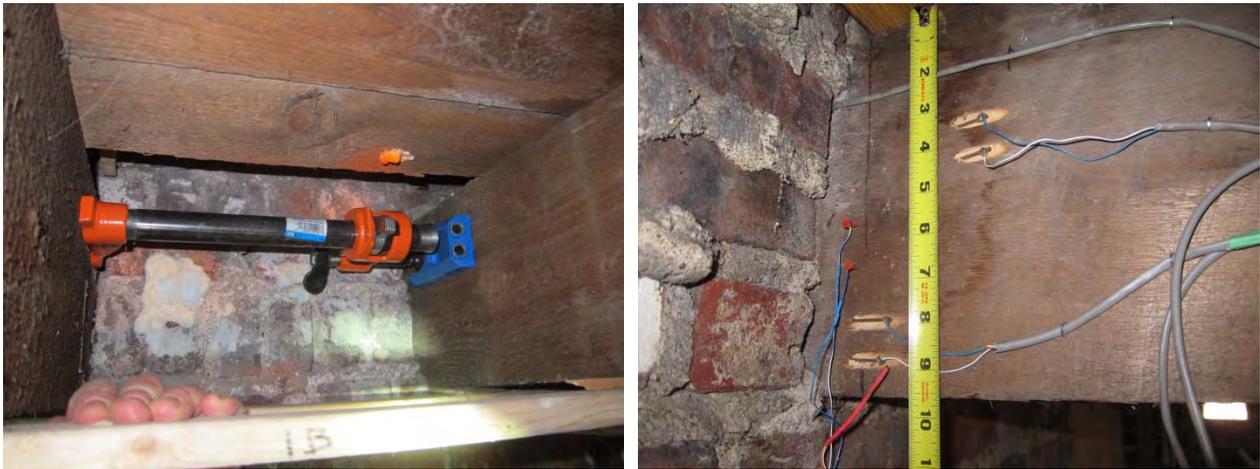
undisturbed, so that the pin would be driven directly into wood fibers with frictional contact. Figure 20 (right) shows the upper and lower joist end moisture content measurements and the “cheek” moisture content/temperature measurement.

**Figure 20: Pocket hole jig (left) and installed moisture content pins (right)**

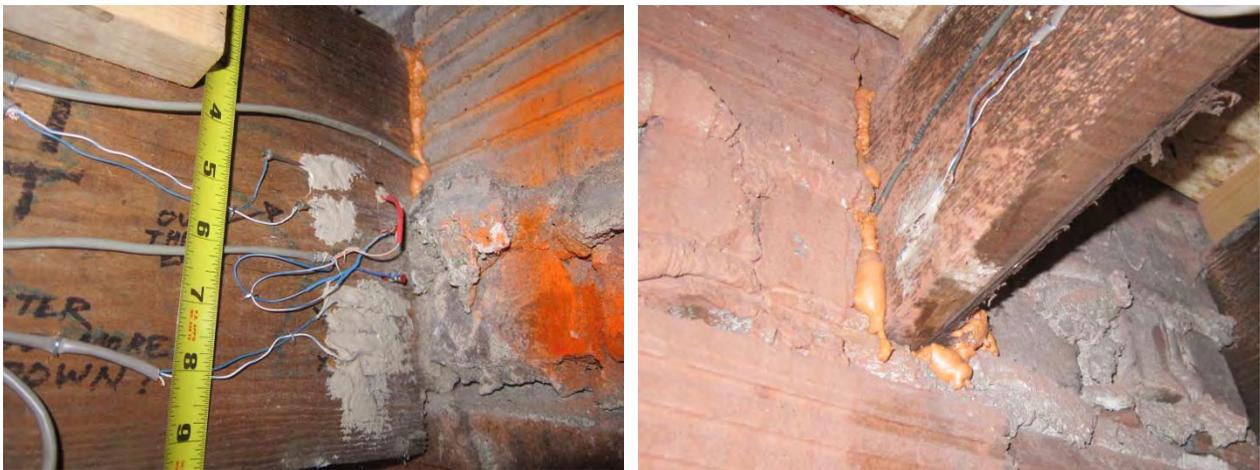
The pocket holes for the joist end moisture contents were sealed from interior air and water vapor with a vapor-impermeable synthetic rubber caulk (Figure 21 left). The joist pockets were air sealed from the interior with a combination of can-based expanding foam (Figure 21), and the spray foam kit used around the rigid blocks of foam mentioned earlier (Figure 15).

**Figure 21: Caulked pocket holes (left) and air seal at joist pocket (right)**

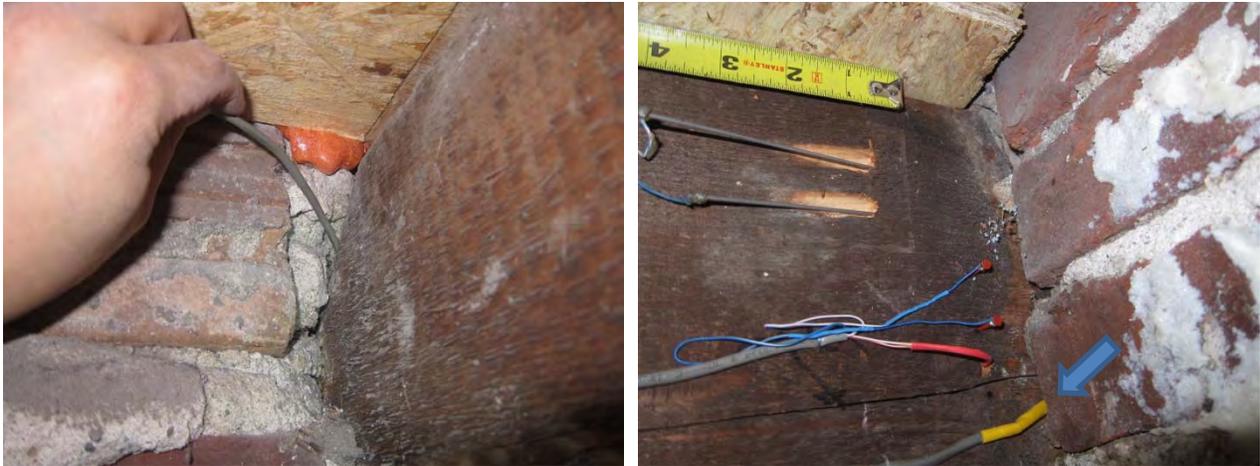
The temperature and relative humidity sensors were installed at any air space available between the joist and the masonry. In some cases, space was readily available to insert the sensor, as shown in Figure 22. In other cases, some demolition of the mortar around the beam was required to install the sensor.

**Figure 22: Installation of pocket RH sensor (left) and installed RH sensor (right)**

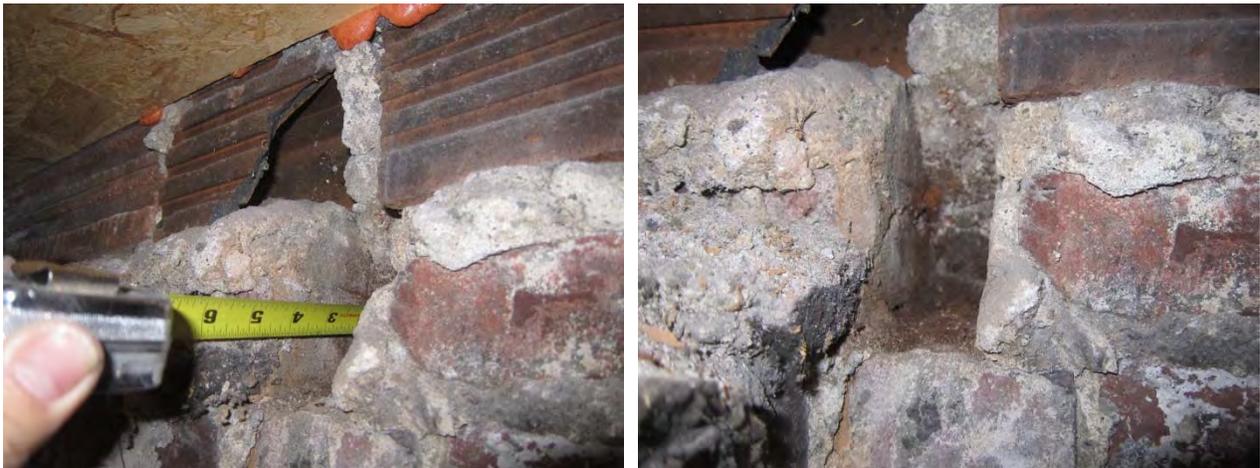
The condition of the masonry joist pocket could be observed directly at several north-facing openings in the addition portion of the building, where a beam had been removed (Figure 23). It appears that mortar or grout was packed in between the brick and the wood joist during installation; in addition, mortar was packed in at the angled space behind the fire cut. However, at the hollow clay block, there would be an air space adjacent to the joist, which would likely increase drying.

**Figure 23: Conditions in joist pocket at north-facing building at addition**

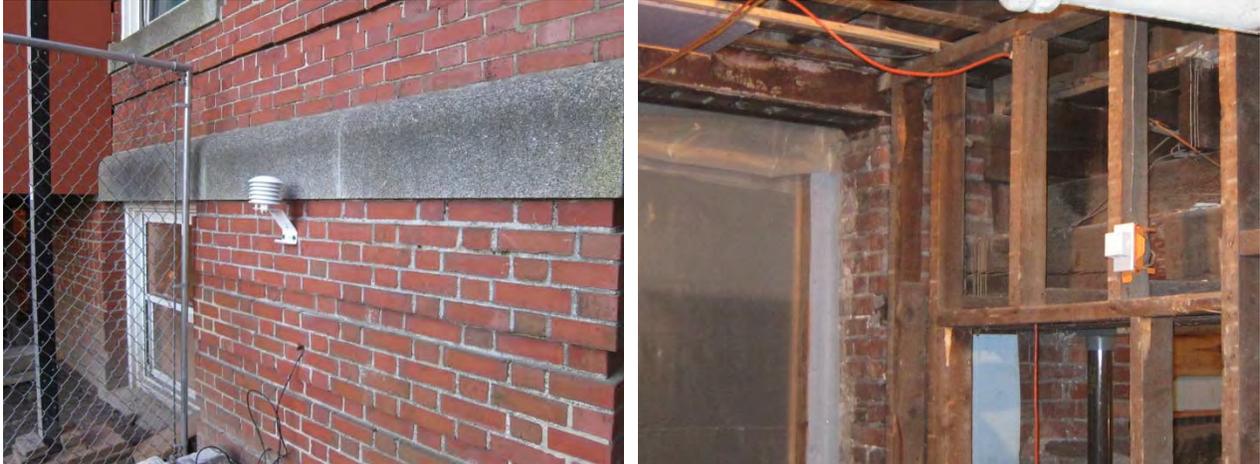
An exterior temperature and relative humidity sensor (Campbell Scientific HMP60 Temperature and Relative Humidity probe; Figure 24, left) provides outdoor conditions synchronized to the

joist end measurements; it is located within a solar radiation shield on the north side ground floor of the building. Additional outdoor weather conditions (including precipitation, and wind speed and direction) are being collected from online sources for comparison; the nearest weather station is Lawrence Municipal Airport (KLWM).

**Figure 24: Exterior (left) and interior hallway (right) temperature/relative humidity sensors**

Interior temperature and relative humidity conditions are measured at two locations, as shown in Figure 16. One interior T/RH measurement is directly below the data acquisition system (data logger), and the other is in the common hallway at the front of the building (Figure 24, right), both on the basement level. The basement level was chosen because the majority of the sensors are located on this floor. In addition, the front of the building is currently heated with temporary construction heat, while the rear portion is operating near ambient conditions. The two interior sensors measure these two disparate conditions.

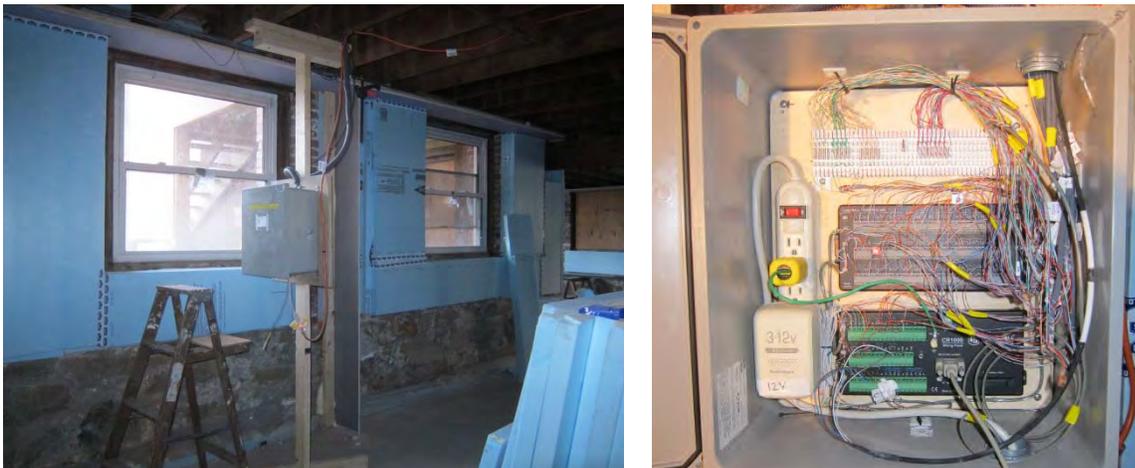
Data are being collected by a Campbell Scientific CR1000 measurement and control system, installed in a basement storage room (Figure 25). Extension cables were run from the sensor locations to the data collection system before the application of interior finishes. Data are being measured at five minute intervals, and average values are recorded hourly. No battery backup for the data logger is provided; however, the unit has non-volatile memory, and will resume data collection after a power failure. Data will be downloaded during site visits, by direct connection (as opposed to remote downloads).

**Figure 25: Data acquisition system, showing placement (left) and wiring connections (right)**

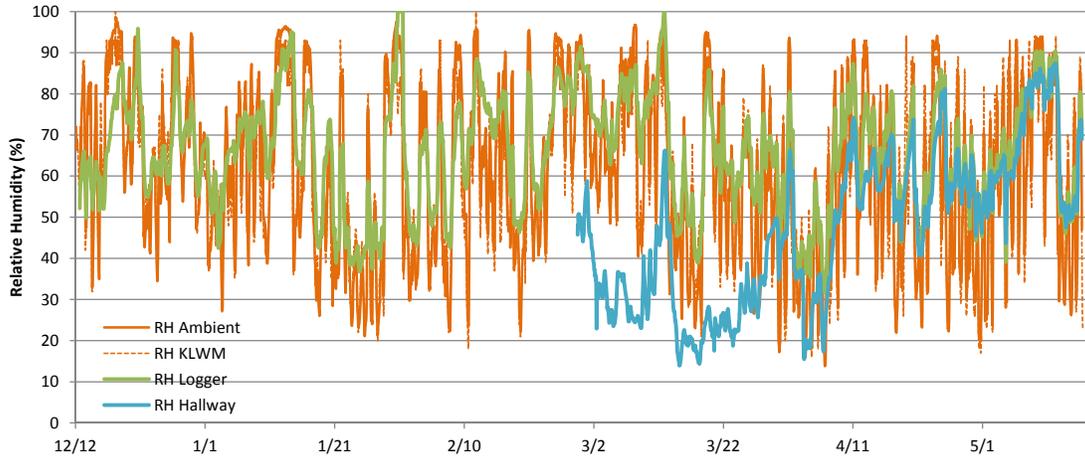
Exterior and interior relative humidity measurements are shown in Figure 27.

**Figure 27: Interior and exterior relative humidity measurements (KLWM data for comparison)**

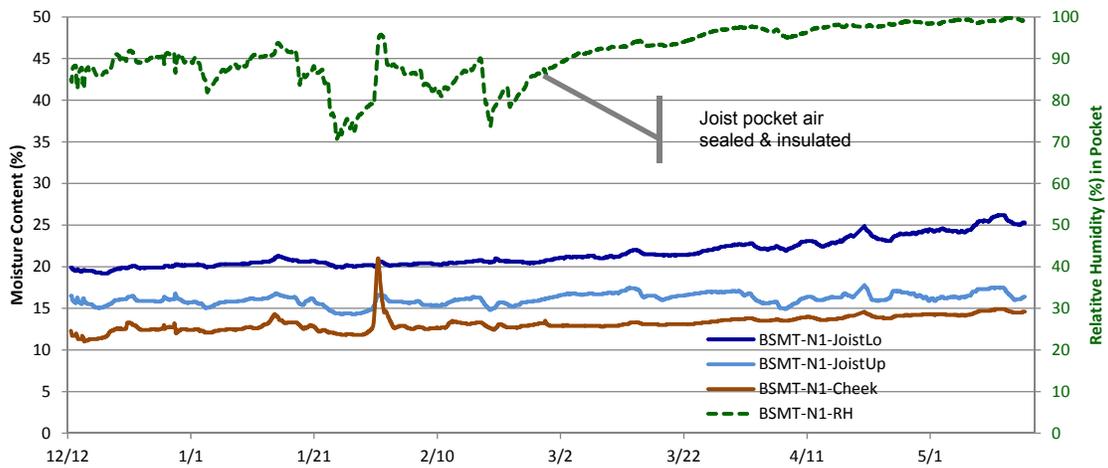
**Figure 30: Basement North 1 (insulated) joist end moisture contents and relative humidity**

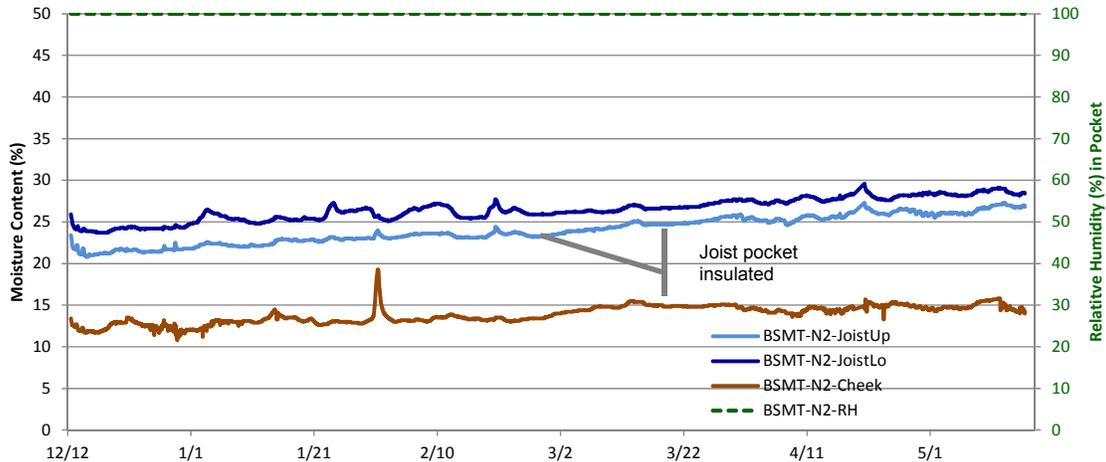
**Figure 31: Basement North 2 (fiberglass) joist end moisture contents and relative humidity**

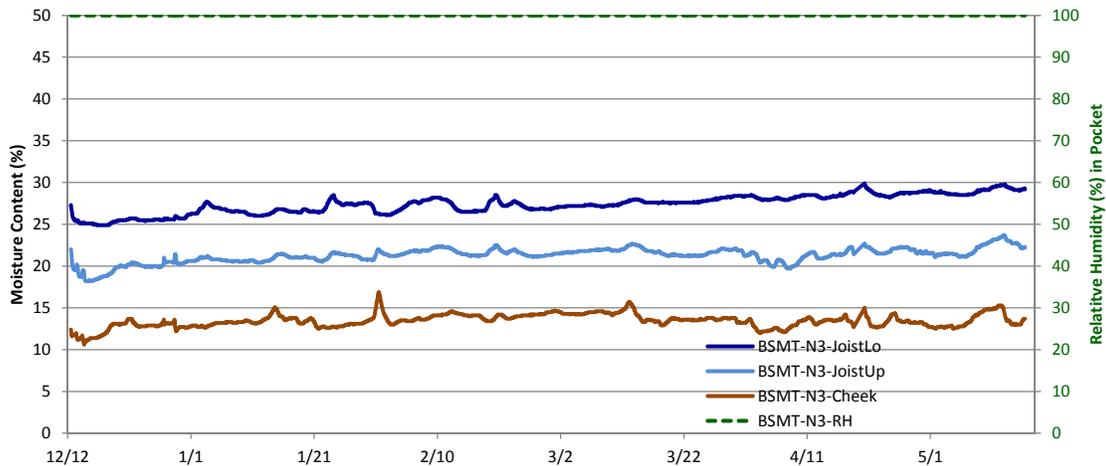
**Figure 32: Basement North 3 (uninsulated) joist end moisture contents and relative humidity**

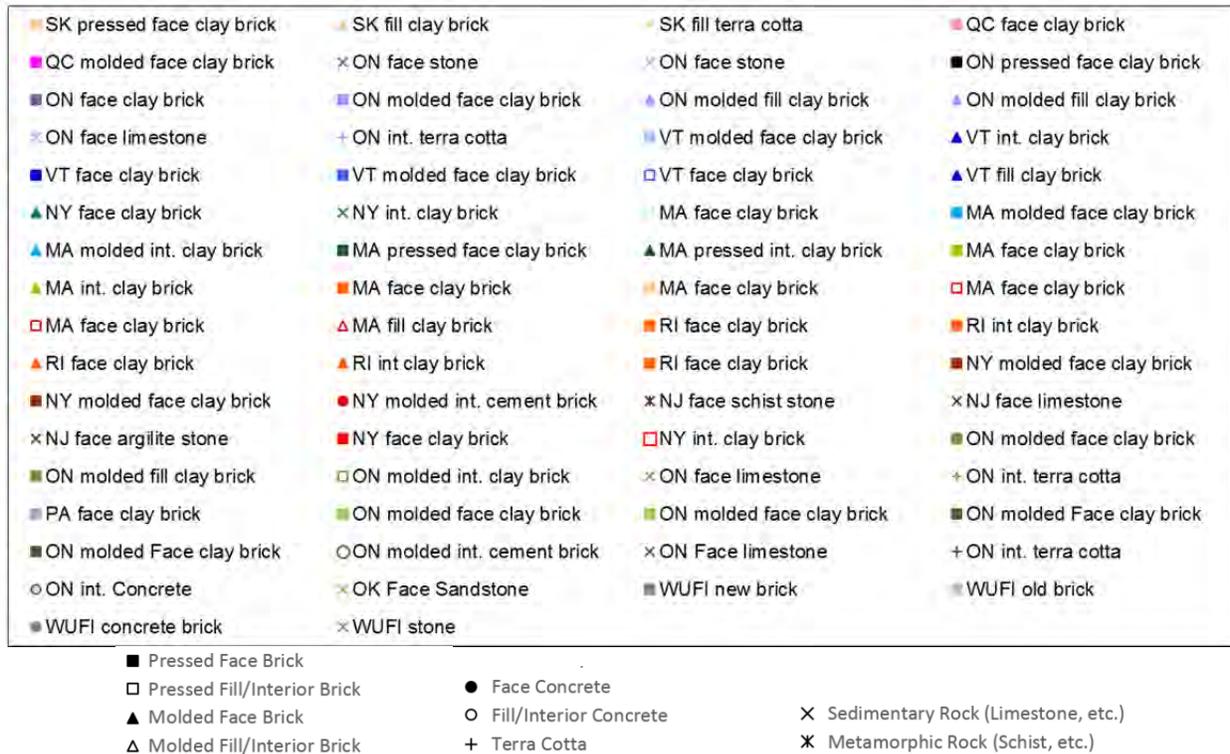
The dataset is drawn from results of 24 previous projects involving testing at some level. Each project listing shows the state or province (as an abbreviation), brick manufacturing type (pressed or molded), and the masonry type.

Figure 46: Sample set legend

Most of the plots are given with vintage as the horizontal axis, providing a separation between projects and even building wings within projects. Some projects contain several types of masonry materials. The legend provided in Figure 46 illustrates the marker coding, and shows the geographic range of collected samples.

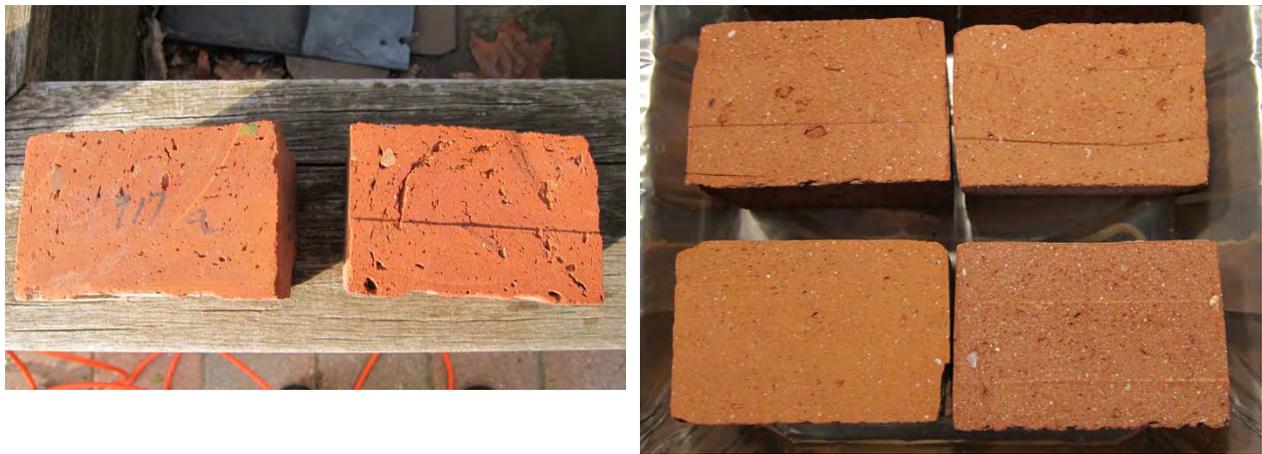
**Figure 49: Highly porous c. 1917 (left) and less porous c. 1940 (right) brick samples**

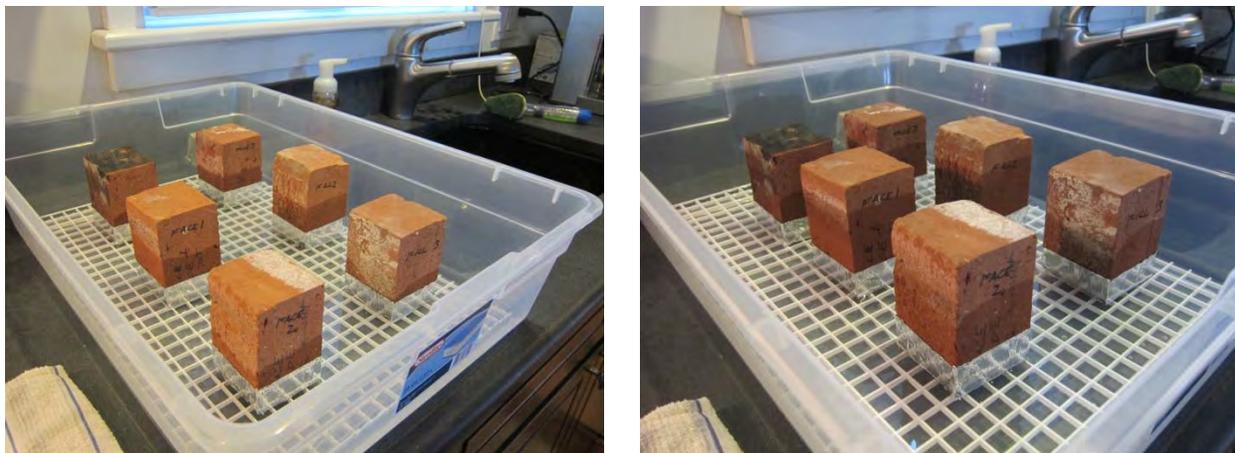
Figure 51: Brick water uptake coefficient (A-value) testing

Free water saturation (or capillary saturation) is a measure of how much water the material absorbs under normal pressure (without additional pressure forcing water into the pores). The test method is similar to a water uptake test (Figure 51), except it is done in a closed container to limit evaporation. The sample will reach a maximum weight/water content, which is equal to the free water saturation.

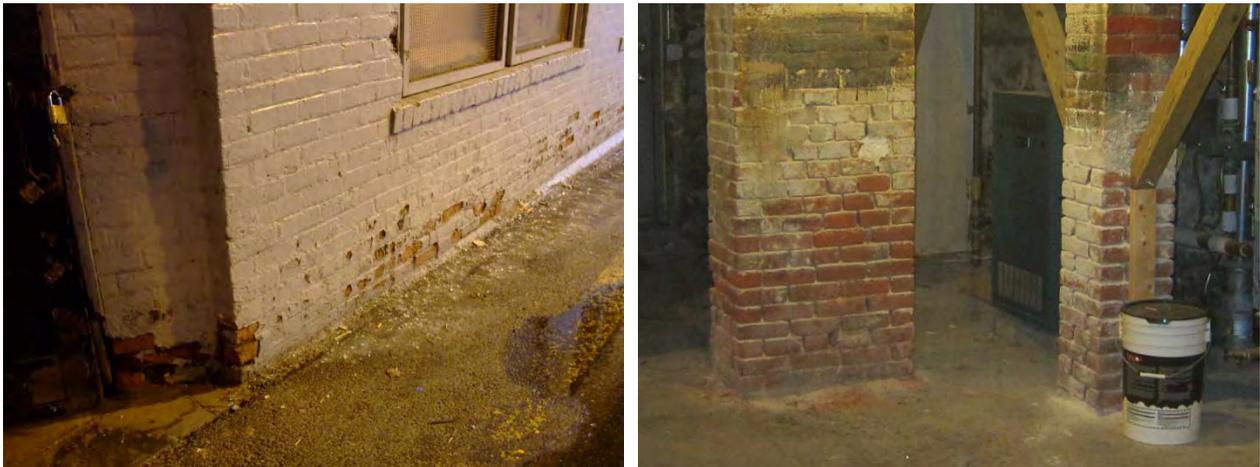
**Figure 55: Suspected de-icer salt damage (left) and basement capillary rise damage (right)**

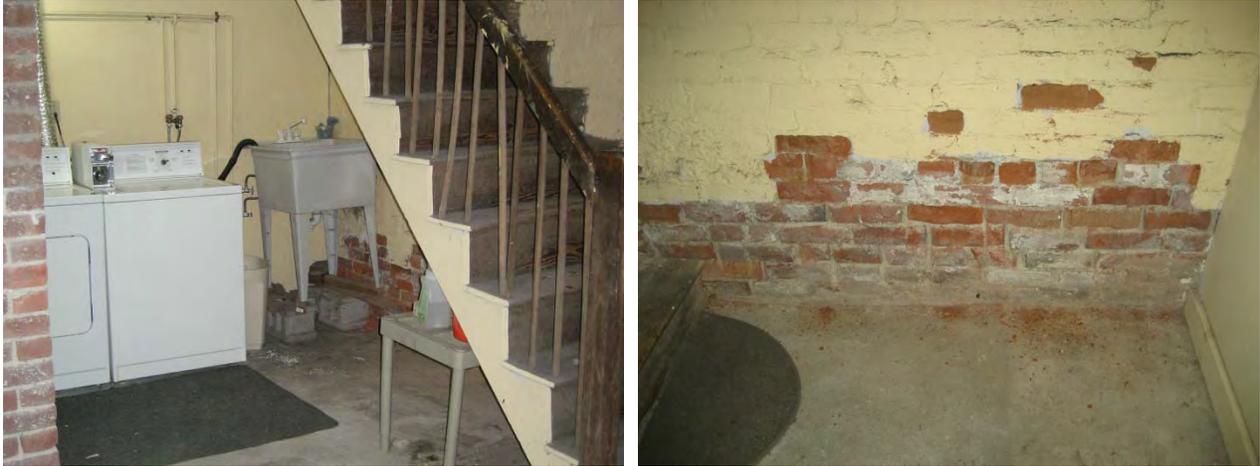
**Figure 56: Brick spalling and paint blow-off basement party wall due to capillary rise**

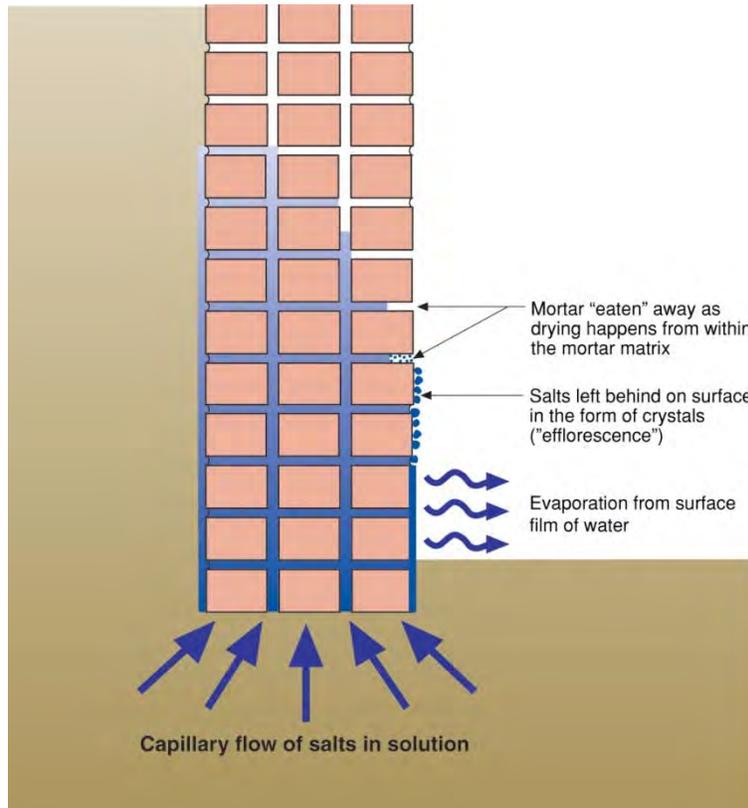
**Figure 57: Capillarity (“rising damp”) transport of salts, causing efflorescence (Lstiburek 2007b)**
