# Interior Insulation of Mass Masonry Walls: Joist Monitoring, Material Test Optimization, Salt Effects

Building America Report - 1307

May 2013

K. Ueno, R. Van Straaten, C. Schumacher  
*Building Science Corporation*  
May 2013

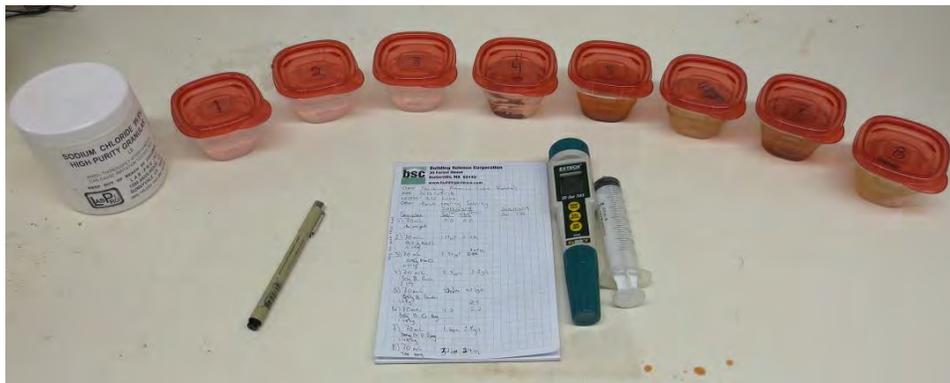
This research team’s current protocols currently do not measure salt content as part of frost dilatometry measurement. However, this measurement is being added to the test protocol in future work; initial testing will include overall salinity measurements of ground masonry samples dissolved in water. Further lab testing would be required to determine specific salt chemistry, if this is considered useful information.

**Figure 58: Preliminary masonry sample salinity testing, with deionized water control samples**

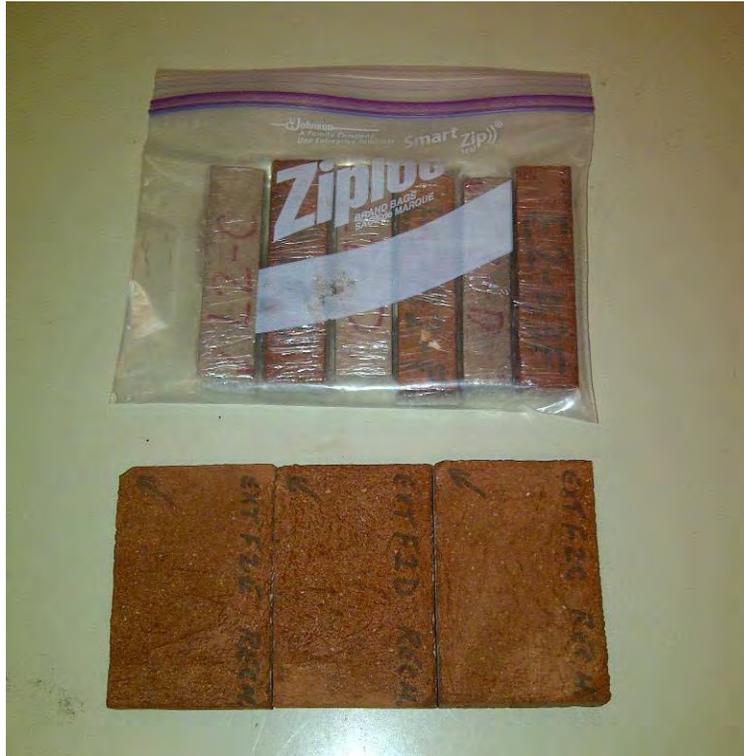
As part of this exercise, the width was identified as a non-critical dimension. An opportunity was identified to reduce this dimension to 1” (25 mm) without negatively affecting the testing. A photo of the old and new samples is provided in Figure 59. This allowed twice as many slices to fit into the controlled temperature bath for freeze thaw cycling, thus doubling the throughput.

It also allows twice as many samples to be taken from sample bricks, which is useful in some cases due to sample availability.

**Figure 59: New (top) and old (bottom) brick slice samples**

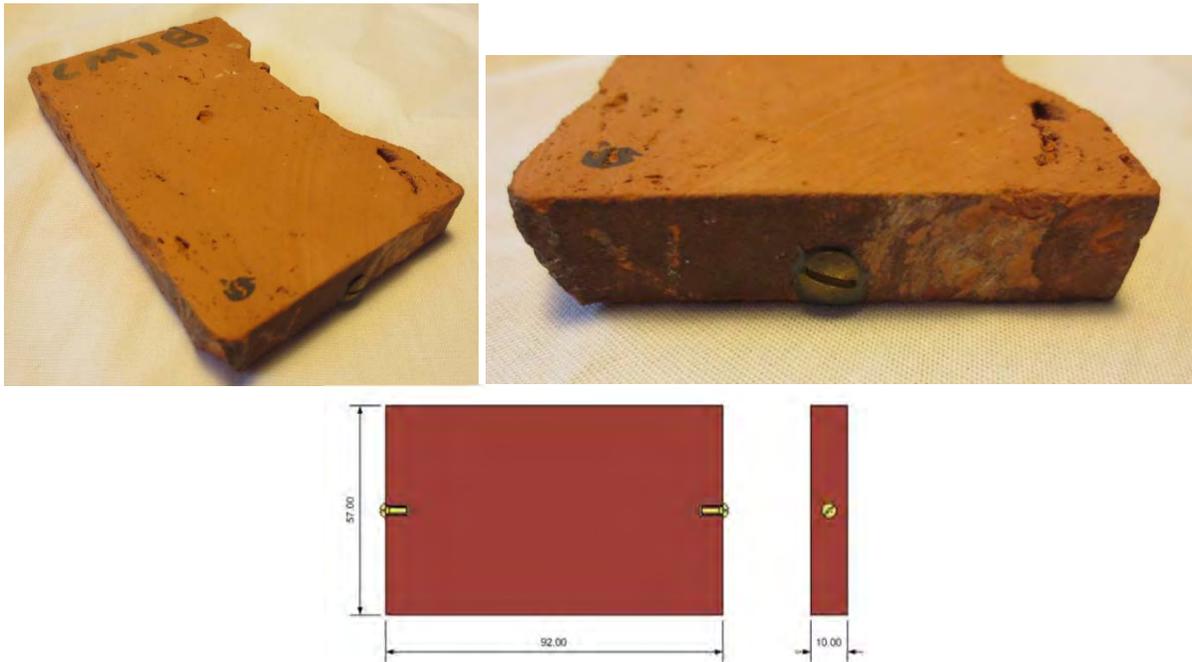
**Figure 61: Photo and illustration of sample brick slice with metal screw targets**

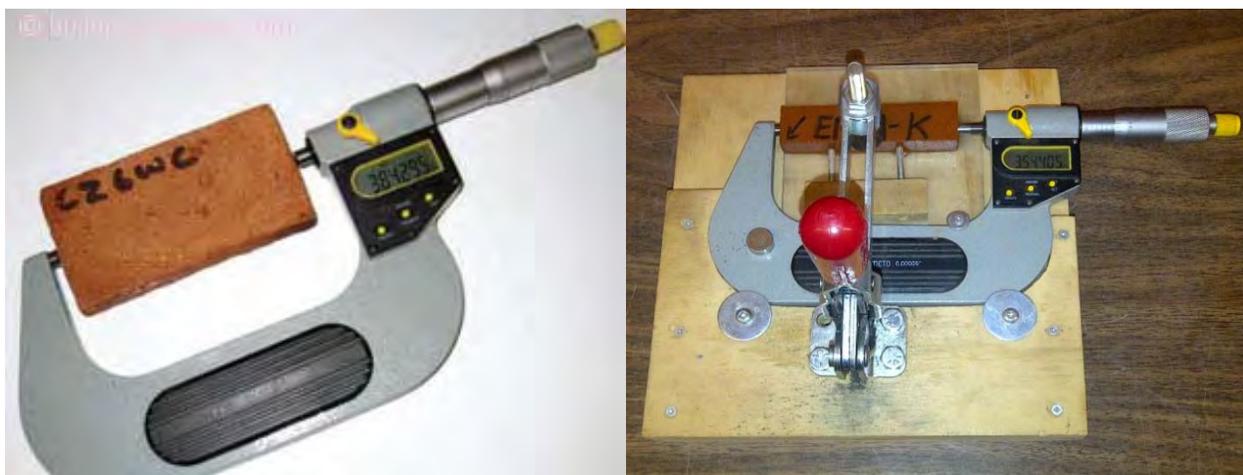
**Figure 62: Strain measurements with (right) and without jig (left)**

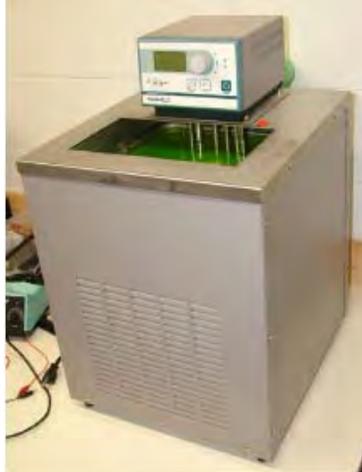
**Figure 65: Chilled bath (Schumacher 2011)**

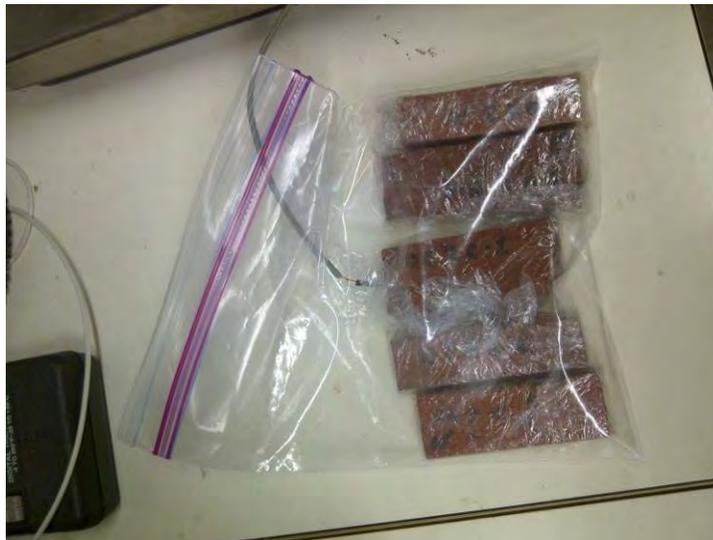
The 1 hour hold times were originally set to ensure that the sample was completely thawed or frozen to -15°C/5°F. In order to ensure that the target temperatures was reached at the brick samples core, a thermistor was installed within the core of a sample slice (Figure 70).

**Figure 70: Thermistor installed within brick slice**

In order to measure the temperature accurately at the core of the slice, a hole was drilled in the end of the slice reaching the center. The hole was drilled along the longest axis to minimize

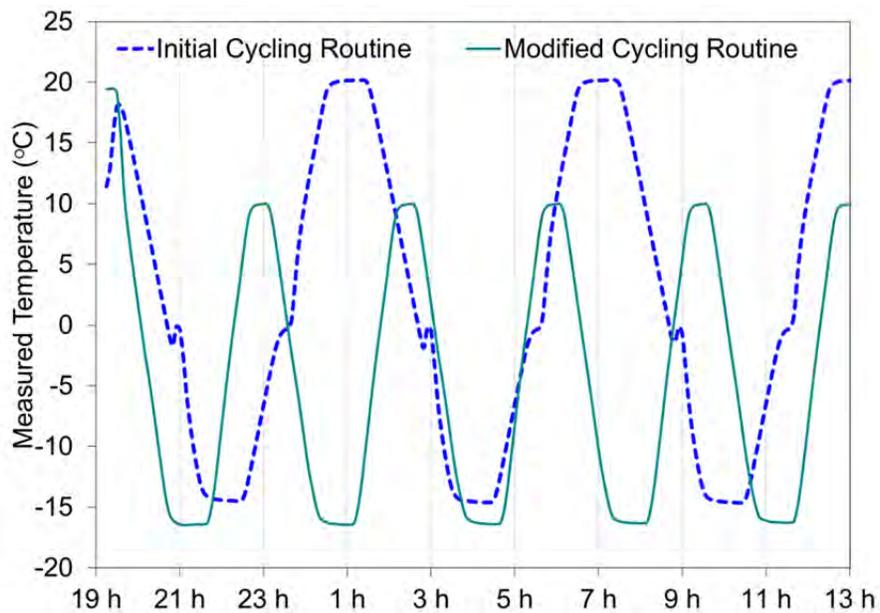
**Figure 71: Measured slice core temperature with initial and modified cycling routine**
