Evaluation of Cladding and Water-Resistive Barrier Performance in Hot-Humid Climates Using a Real-Weather, Real-Time Test Facility

Conference Paper - 1011

15 December 2010

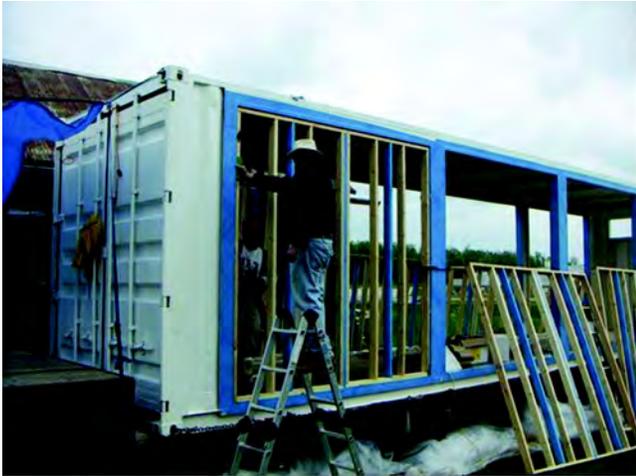
Figure 1 Installation of specimen wall framing in container.

of the chamber. Figure 1 shows the installation of the stud walls in the sides of the container. The RBETS was placed in its test location in June 2006 and was orientated such that the opposing wall sections were exposed directly to the east and the west. This was done in order to take advantage of the local weather patterns. Once the unit was placed on site, construction of the wall assemblies was completed.

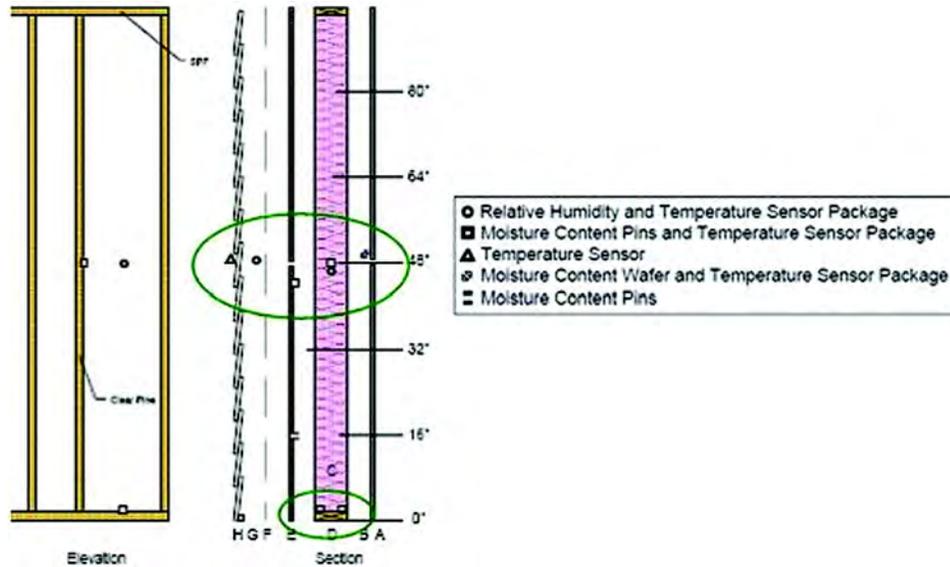
Figure 2 Location of temperature sensors.

Temperature Sensors. Each wall section possessed eight temperature sensors. See Figure 2 for details. The majority of these sensors were placed 48 in. from the bottom of the wall. These sensors were located on the outside of the cladding, in the drainage gap or plane, behind the OSB sheathing, in the stud space, and on the exterior face of the gypsum wallboard. This grouping of sensors allowed for a temperature profile from the interior temperature of the unit to the exterior climate to be observed (as shown in Figure 3). Two temperature sensors were also located at the base plate or bottom of the wall framing: one on the exterior face and the other on the interior face. In many cases, the readings from the temperature sensors were applied to create correction factors for the readings from the moisture wafers and pins. The error for the temperature sensors used in this study was approximately $\pm 0.2^{\circ}\text{C}$.

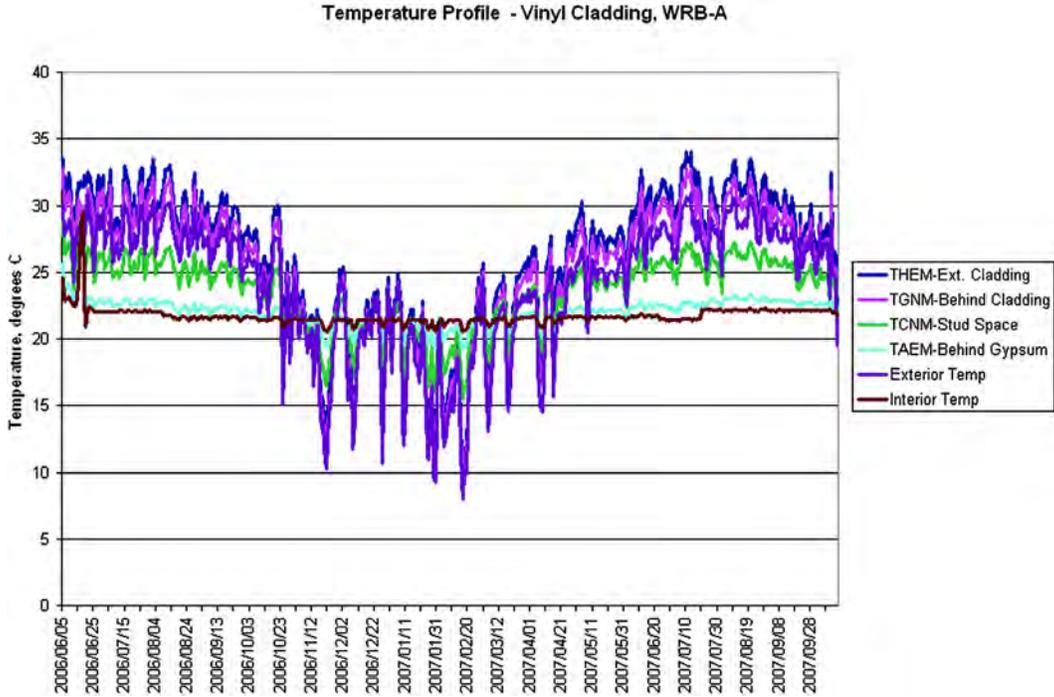
Figure 3 Temperature profile: vinyl cladding.

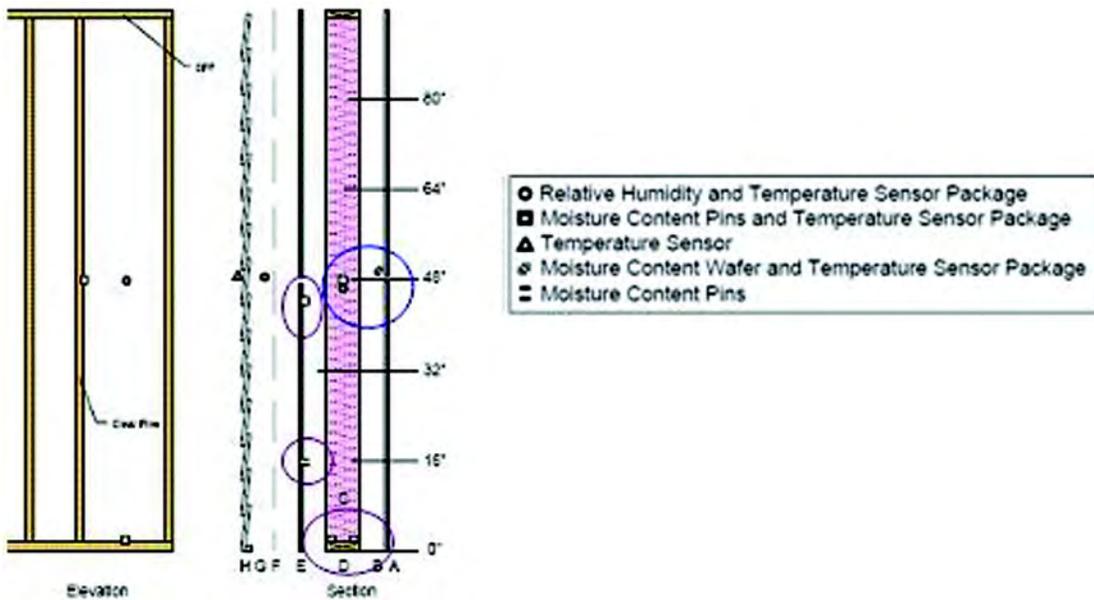
Figure 4 Location of moisture content pins and wafers (blue = wafers; purple = pins).

Moisture Content: Pins and Wafers. Moisture content was measured using two different methods. The first used a small pair of nails (pins) placed in layers that contained wood (i.e., OSB sheathing, wood framing). The pins were driven into the wood substrate to a depth of approximately 1/4 in. at a spacing of approximately 1 in. apart and were often paired with a temperature sensor. When the moisture content was

measured at a location where no wood was available (e.g., gypsum, stud space), a moisture wafer was used. A moisture wafer consists of a small piece of eastern white pine with two moisture pins embedded in it. Moisture content is not measured directly; rather, the pins and wafers measure electrical resistance. Moisture content was found by a calculation involving the measured electrical resistance and temperature. Like the temperature sensors, moisture content sensors were mainly located 48 in. from the bottom of the wall. However, there was also a pair of moisture pins located 16 in. from the bottom of the wall and behind the water injection system. Additionally, there were also two sets of moisture pins at the base of the wall system: one pair close to the exterior face of the wall and the other close to the interior side of the unit. For details, refer to Figure 4. The approximate error for moisture content pins and wafers was dependent on whether the pins were embedded in OSB or a homogeneous wood substrate. Since OSB is a variable material and contains many different species of wood, the moisture content readings from OSB contain a larger error. The associated error of moisture pins in OSB was approximately $\pm 4\%$. Pins inserted into a homogeneous wood specimen (i.e., pins embedded in the framing, as well as the moisture wafers) result in readings with slightly less error (about $\pm 2\%$).

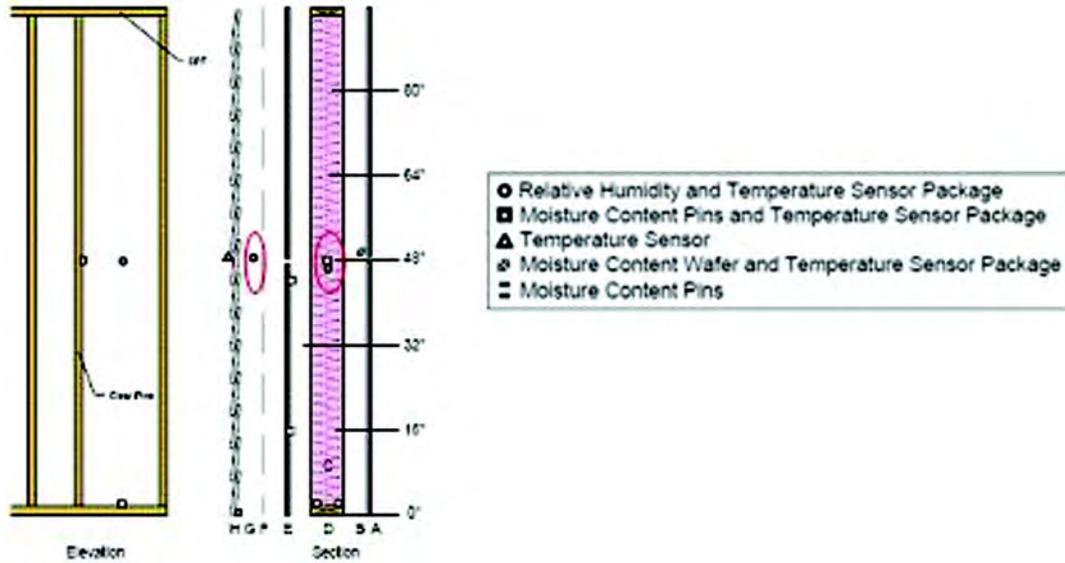
Figure 5 Location of relative humidity sensors.

Relative Humidity. Each wall section contained two sensors for monitoring relative humidity. Both sensors were located 48 in. from the bottom of the wall. One of the two relative humidity sensors was located just behind the cladding in the drainage gap, while the other was located inside the stud cavity. See Figure 5.

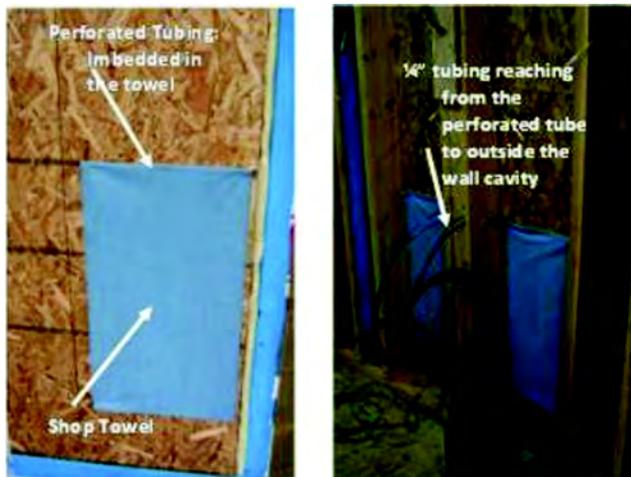
Figure 6 Internal and external view of soaker hose, distribution media, and 1/4 in. tubing.

The water injection system used was based on that originally developed during ASHRAE Research Project RP-1091 (Burnett et al. 2004). Each wall section apparatus consisted of a shop towel that was attached to each side of the OSB sheathing (i.e., exterior and interior faces). A perforated tube was placed at the top of the towel and was connected to a regular, unperforated vinyl hose. The vinyl hose was passed through either the exterior or the interior face of the wall. The shop towel was used as a distribution medium, which could hold on to the water long enough to allow it to be wicked into the OSB sheathing (see Figure 6). The wetting apparatus was located centered approximately 16 in. above the bottom of the wall. The wetting apparatus location in the wall specimen was

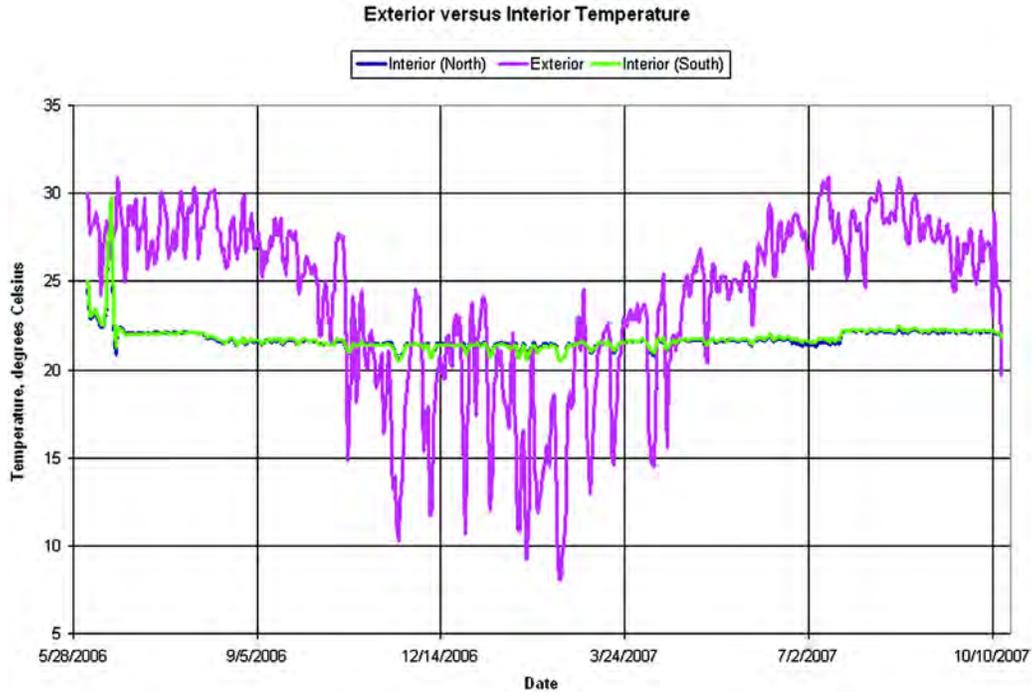
Figure 7 Measured exterior and interior temperature.

The weather conditions experienced during the 18-month test period were recorded by an on-site weather station. Interior temperature and humidity were controlled, with targets of 22°C and 60% RH. The interior temperature conditions were monitored at both the north and south ends of the chamber. The sensors were located approximately 10 ft from the north and south walls of the container. Monitored temperature and humidity results are summarized in Table 5. After an initial break-in period (when the equipment was equilibrating), the temperature remained basically constant throughout the test 18-month test period. The north and south temperature sensor measurements tracked each other almost exactly. The interior humidity was less controlled than the interior temperature. After the initial settling in period, the humidity was more controlled but drifted down. In the last portion of the test period, the humidity exhibited a short uncontrolled period followed by a drop to 50% RH as measured by the south sensor. The north sensor during this period exhibited instability, which may indicate sensor failure. This unstable period caused an increase in the overall measurement standard deviation, as seen in Table 5. Exterior and interior temperatures are shown in Figure 7. Exterior and interior humidity is shown in Figure 8.

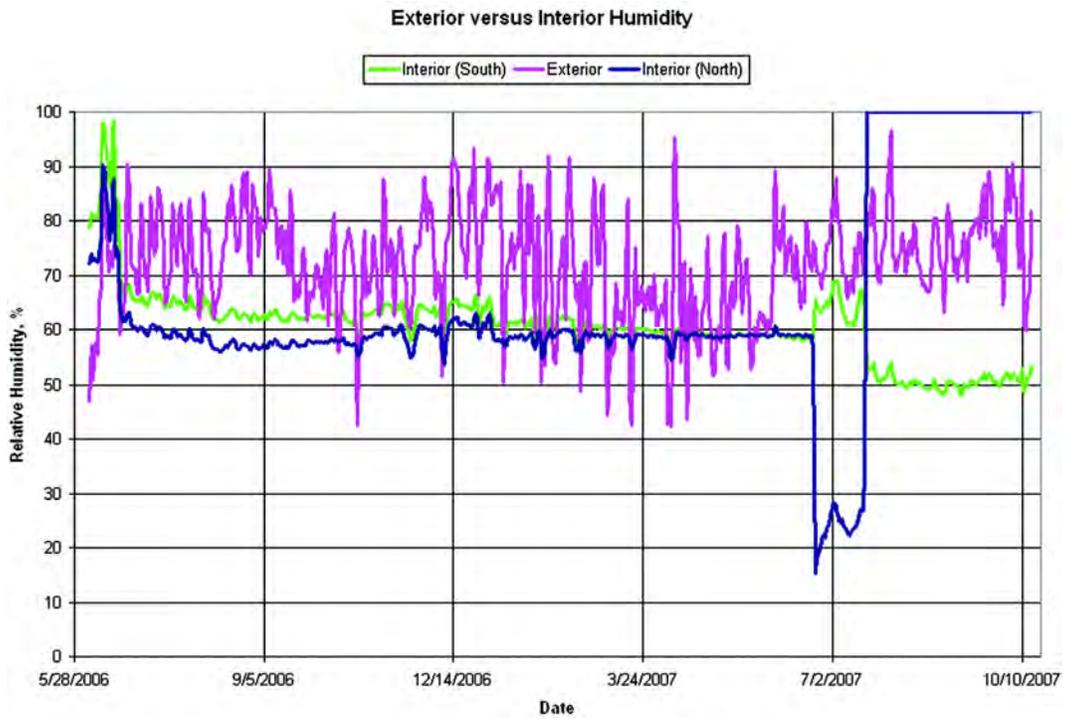
Figure 8 Measured exterior and interior humidity.

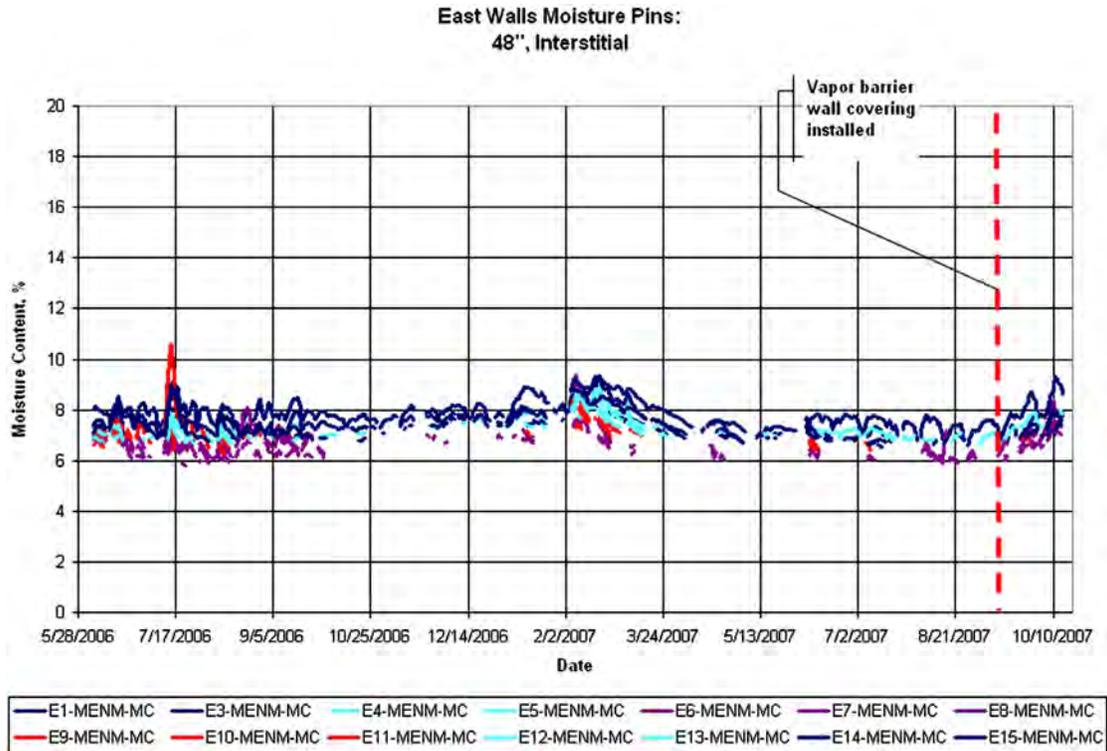
Figure 9 OSB moisture content at 48 in.: east walls.

Figures 9 and 10 show the moisture content of the OSB (interior face) at 48 in. (above the water injection site) for all the walls. All the east- and west-facing walls show the same general behavior at this OSB site. The OSB moisture content stays below 10% with few exceptions during the experimental period. Several of the walls experienced periods in which the moisture content was below the sensor detection limits, and the walls have no reading for those periods. Slightly higher moisture contents appear initially and during the cooler winter months. In general, there does not appear to be a response to the water injected using the water injection system located below this area on the wall. The walls show an increase in moisture content at the end of the experimental period after the internal surface of the walls were covered with vapor barrier film.

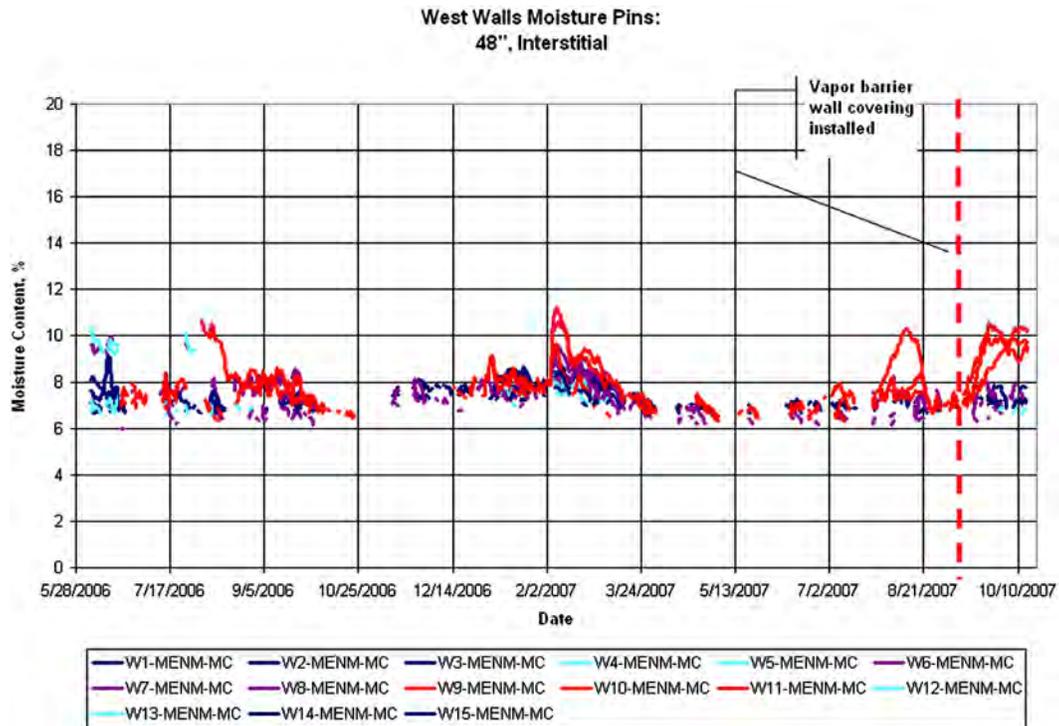
Figure 10 OSB moisture content at 48 in.: west walls.

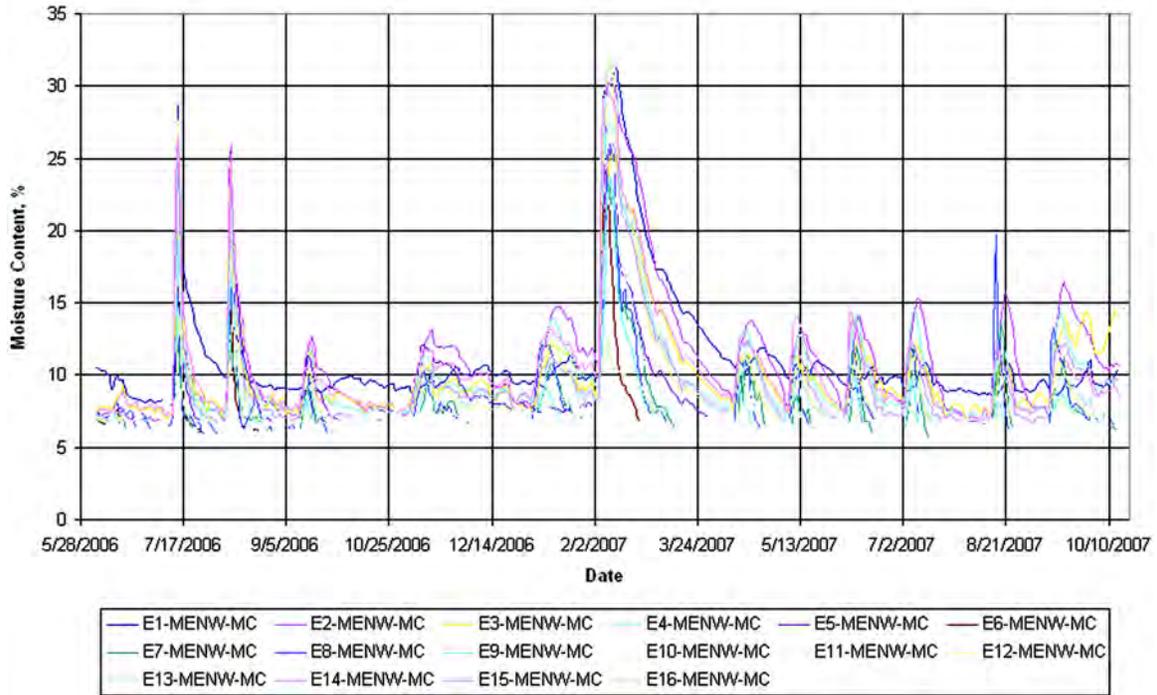
Figure 11 OSB moisture content behind water injection system: east walls.

Figures 11 and 12 show the moisture content in the OSB behind the water injection system. Water injection peaks are

clearly visible. When water was injected in the interior or in both the interior and exterior, the peaks are substantially higher and sharper than when the injection was in the exterior side only. The OSB moisture content appeared to return to the baseline level between water injection events.

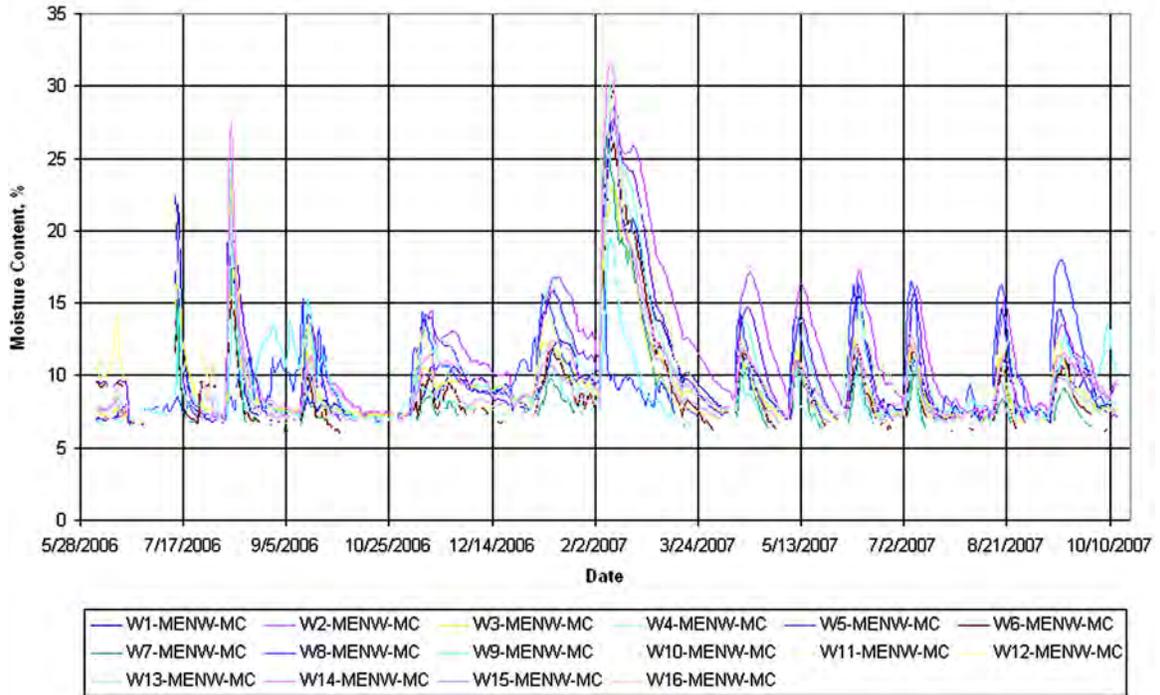
Figure 12 OSB moisture content behind water injection system: west walls.

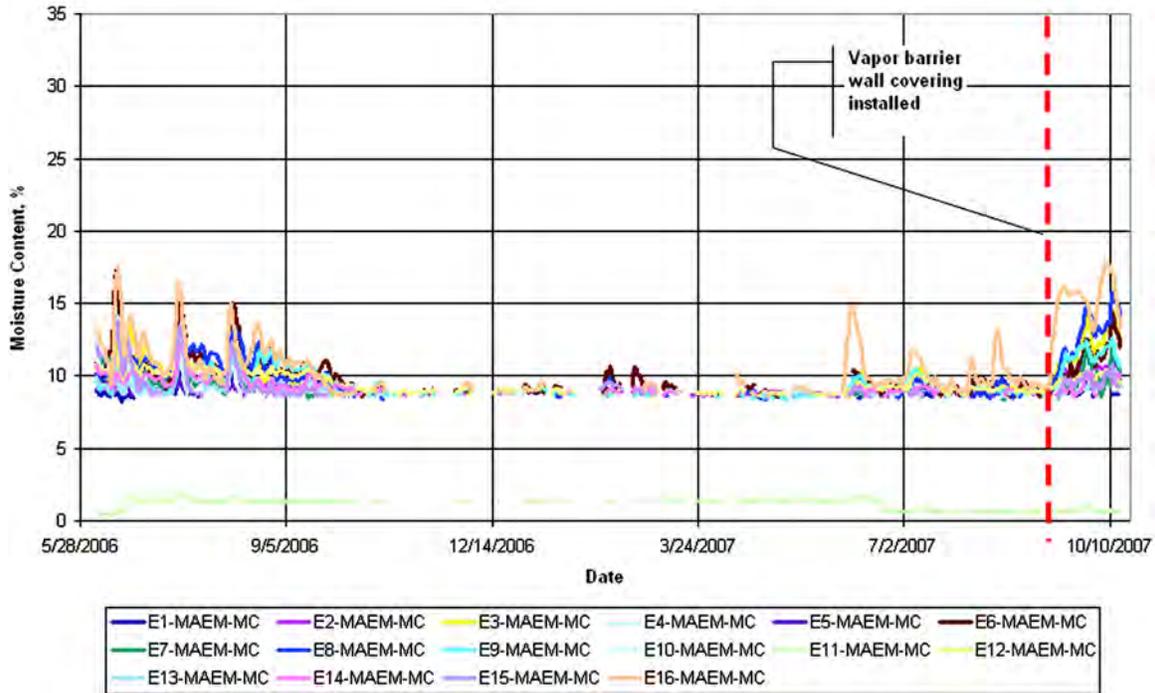
Figure 13 Moisture content of gypsum wallboard wafer: east walls.

Figures 13 and 14 show the moisture content of this wafer. The sensor in wall E11 failed. Although the moisture contents remain at modest levels throughout the experimental period, higher contents are seen in the warmer summer months, indicating moisture drive to the interior of the assembly. Water injection events are reflected in moisture content peaks, which return to the baseline level. This indicates drying to the inside is occurring, and the moisture appears to be handled well by all of the walls until the vapor barrier wall covering was installed. Once the vapor barrier interior covering was installed and water was injected through the system, the moisture content continued to increase. The experiment was terminated before the wallboard completely dried out. Wafer moisture content of all walls were in the same general level, except for the west-facing brick veneer walls (W9, W10, W11), which exhibited higher moisture content.

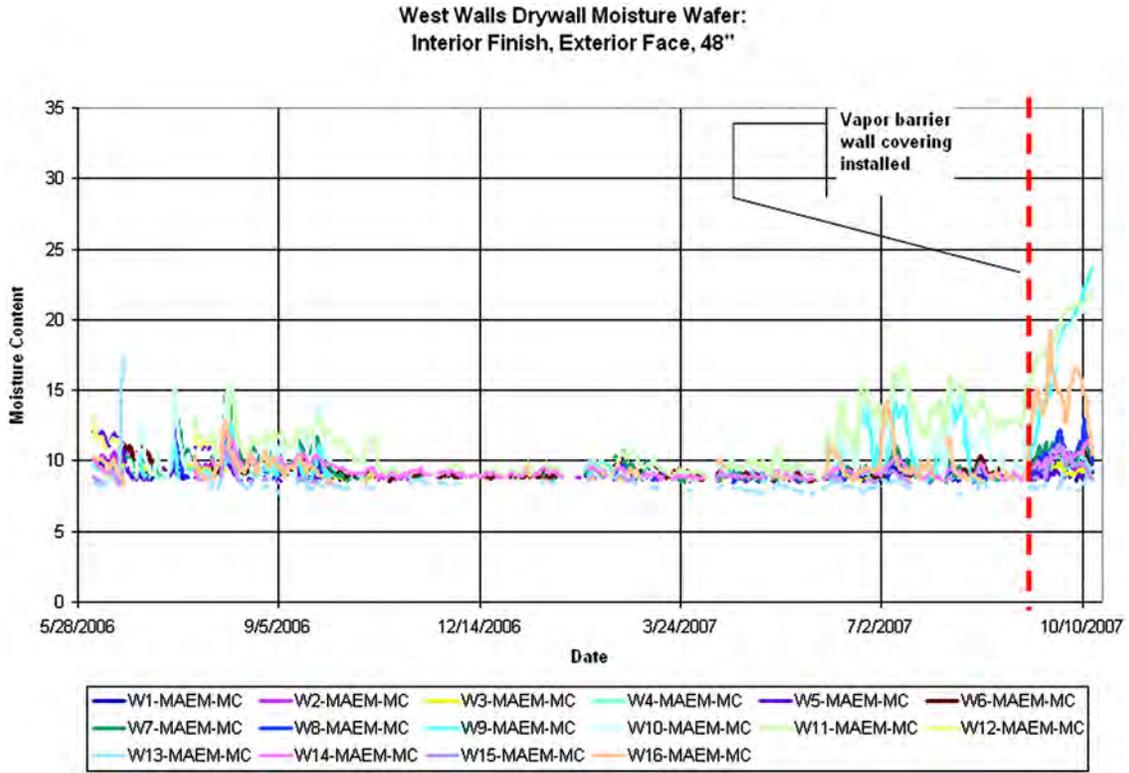
Figure 14 Moisture content of gypsum wallboard wafer: west walls.

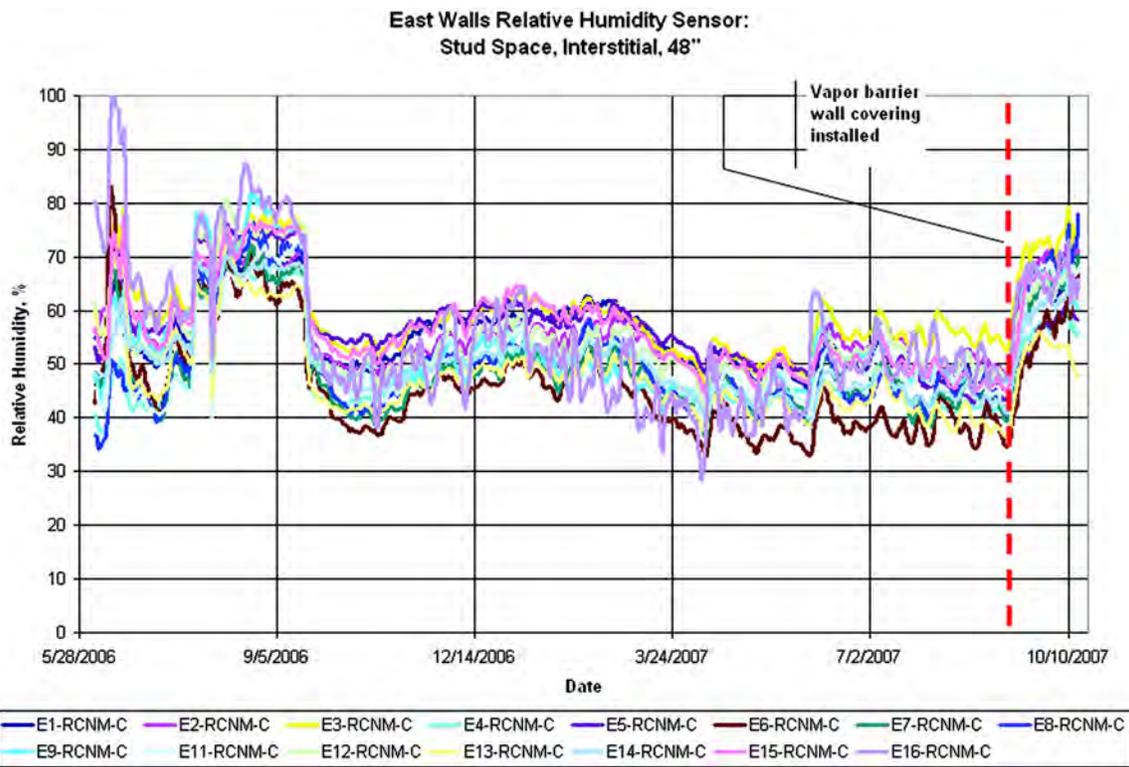
Figure 15 Relative humidity: east walls.

Figures 15 and 16 show the relative humidity of the insulation cavity. As previously discussed, the measurements should not be considered quantitatively, due to their calibration issues and drift of the sensors. Qualitatively, all the walls except for the west brick walls seemed to behave the same

way, showing a fairly constant RH. RH in the cavity increased after the installation of the vapor barrier covering on the interior walls.

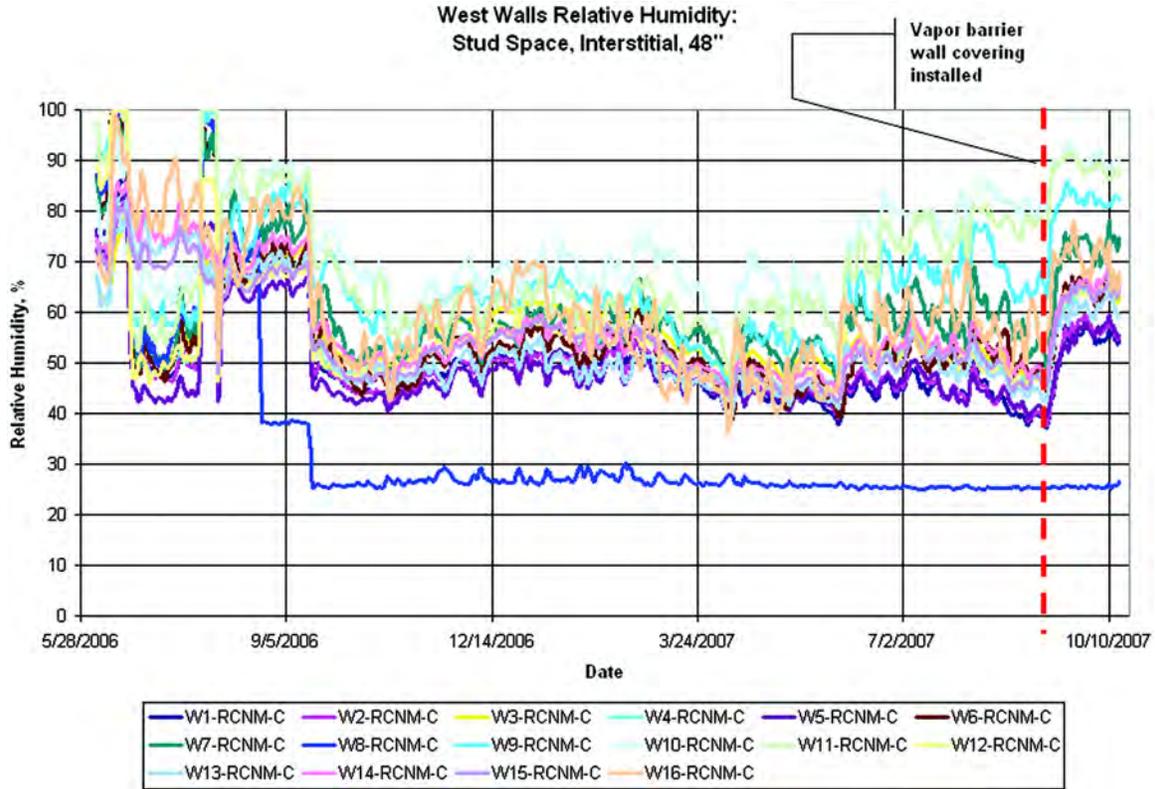
Figure 16 Relative humidity: west walls.

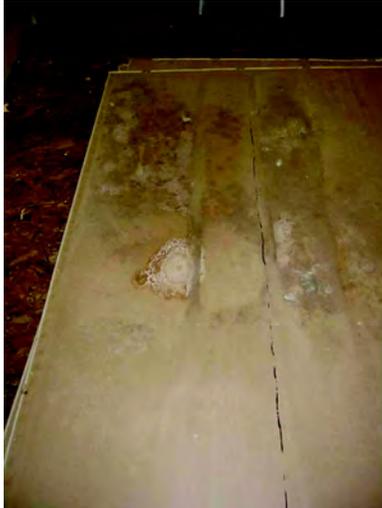
Figure 17 *Mold on brick west wall gypsum wallboard.*

At the end of the experimental period, the walls were disassembled and examined for moisture and/or mold. The only significant moisture damage was seen in the west-facing brick walls (Figure 17). It was discovered that these had a leak at the top of the wall–roof interface and had seen a much higher moisture load throughout the experimental period. Indications of moisture was observed at the sill plates of several walls, and appeared to be associated with water runoff variations from the water injection devices (Figure 18). The water injection apparatus had worked well throughout the test period, but a few of the wall sections developed plugged tubes, and some degradation of the shop-towel distribution medium was seen (Figure 19).

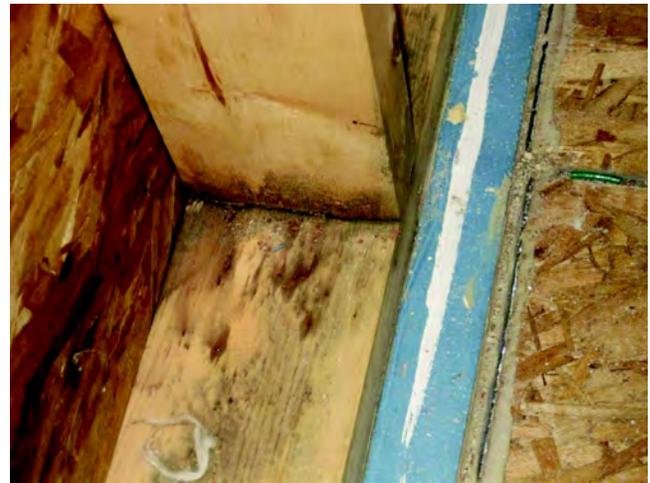
Figure 18 *Moisture on bottom plate.*

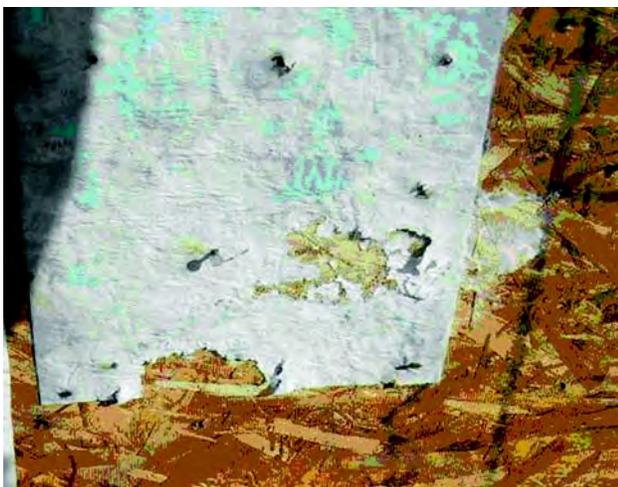
Figure 19 *Water injection system shop towel degradation.*

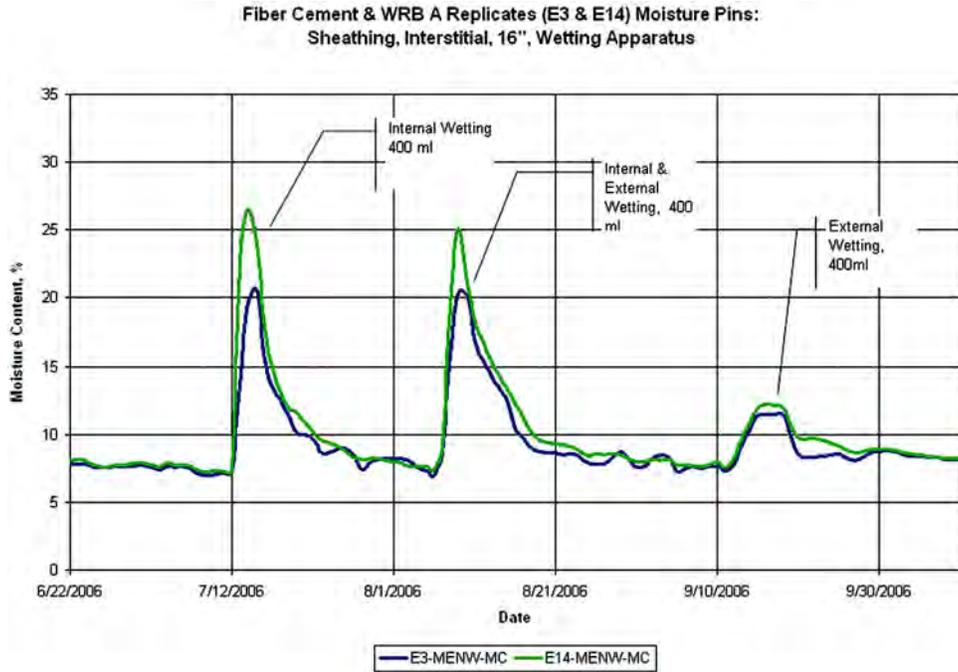
Figure 20 Moisture content at water injection system; July, August, and September 2006 wetting events: fiber-cement siding and WRB A.

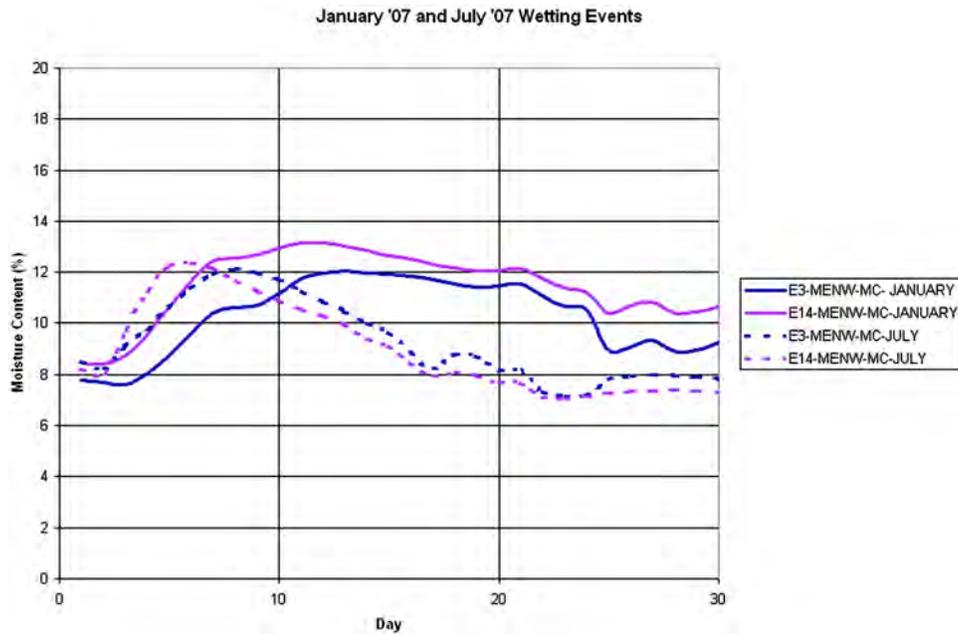
Figure 21 Moisture content at water injection system; January and July wetting events: fiber-cement siding and WRB A.

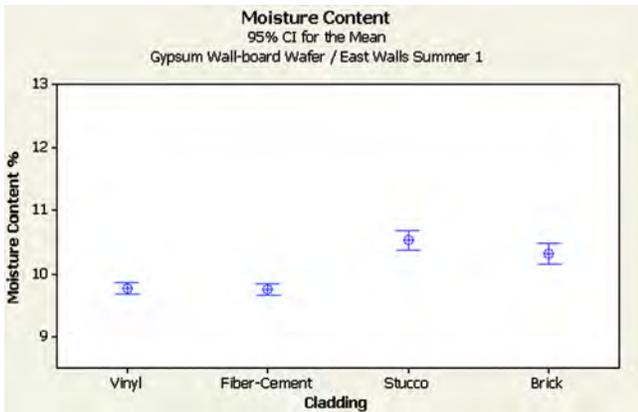
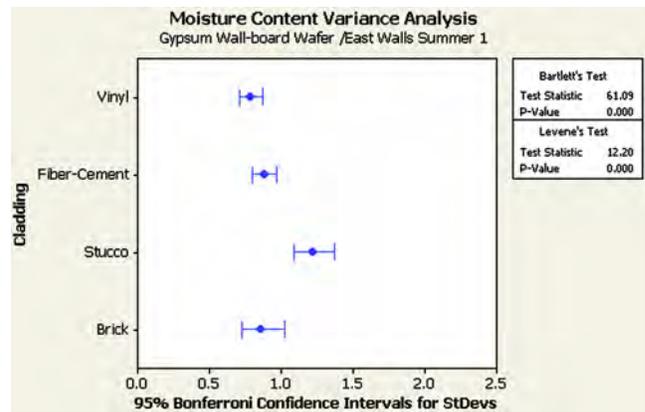
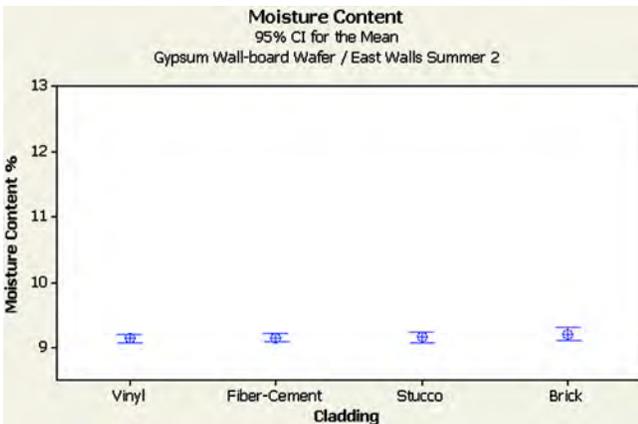
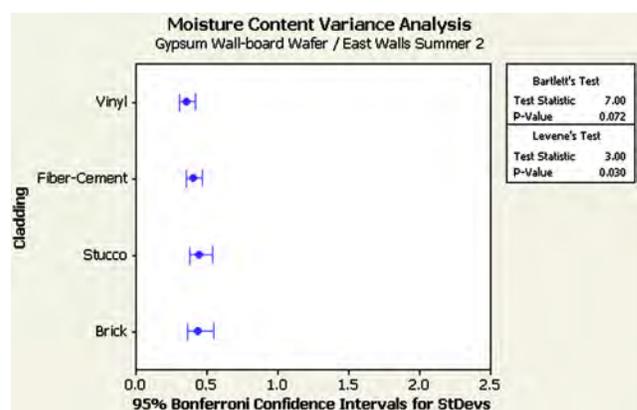
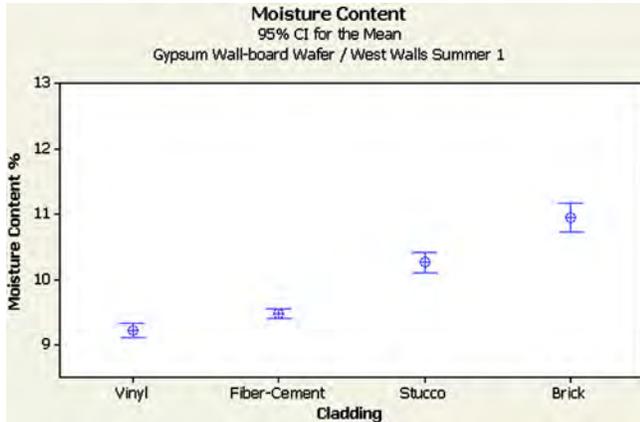
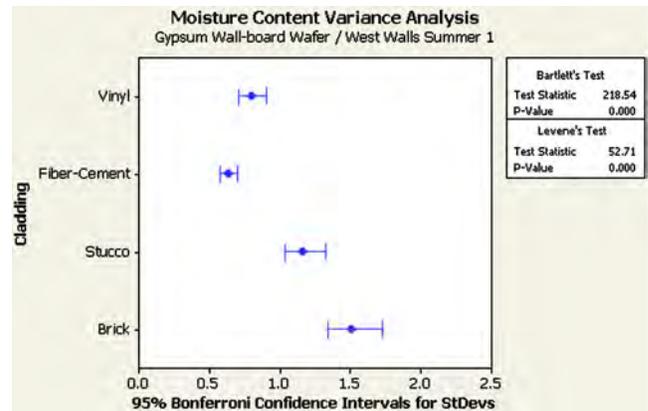
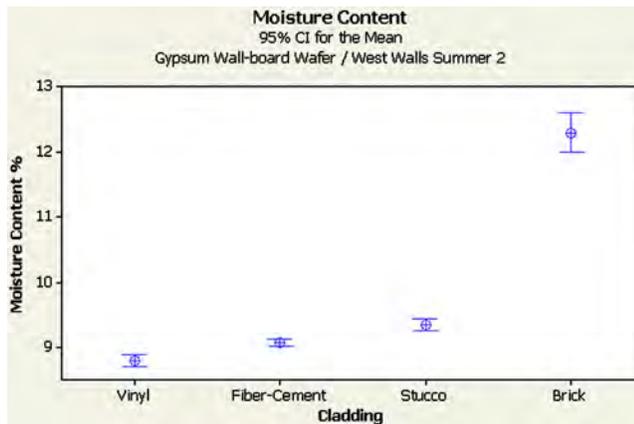
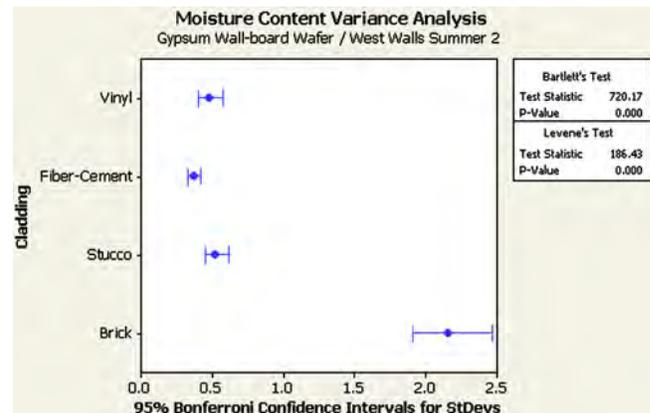
Figure 22 Gypsum wallboard wafer moisture content: east exposure, summer season 1.

Figure 23 Gypsum wallboard wafer moisture content variance analysis: east exposure, summer season 1.

Figure 24 Gypsum wall-board wafer moisture content: east exposure, summer season 2.

Figure 25 Gypsum wallboard wafer moisture content variance analysis: east exposure, summer season 2.

Figure 26 Gypsum wallboard wafer moisture content: west exposure, summer season 1.

Figure 27 Gypsum wallboard wafer moisture content variance analysis: west exposure, summer season 1.

Figure 28 Gypsum wallboard wafer moisture content: west exposure, summer season 2.

Figure 29 Gypsum wallboard wafer moisture content variance analysis: west exposure, summer season 2.

from construction of the wall assemblies elevating the moisture content during the first summer or because of differences in the water injections during these two periods. The first summer period had 600 mL injected at the internal side and 600 mL injected at the external side of the OSB. The second summer had 1400 mL injected at the external side of the OSB. The difference in the water injection site may have caused a difference in the direction of the drying, internal injections causing more moisture to move to the interior side of the wall and dry through the gypsum wall-board. Means and variances of gypsum board wafer moisture content are compared in Figures 22 to 29.
