# National Grid Deep Energy Retrofit Pilot Program

## Cape Basement Renovation Turned Comprehensive DER

Newton, Massachusetts

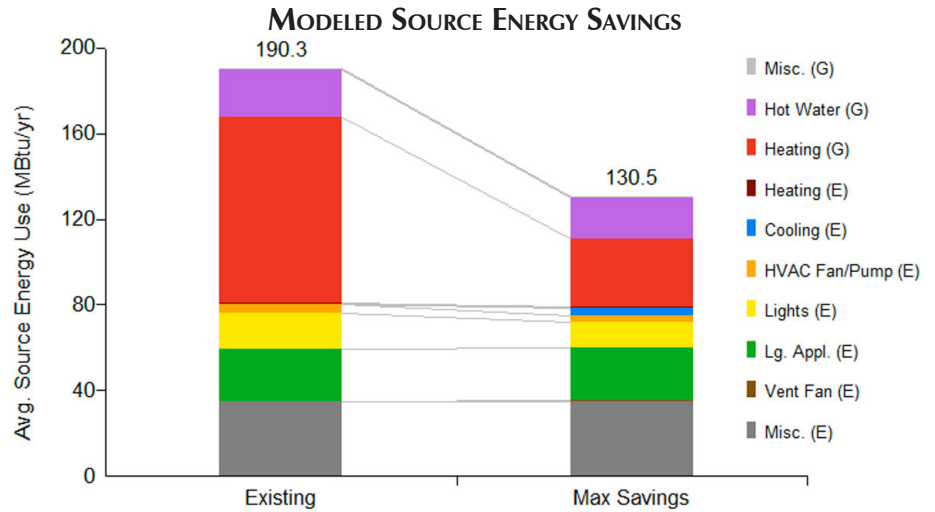
Image from BSC generated by NREL's BEOpt 1.1 for retrofits

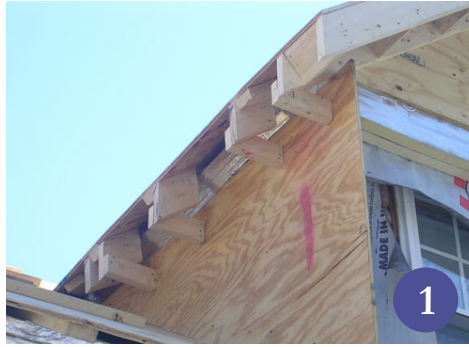
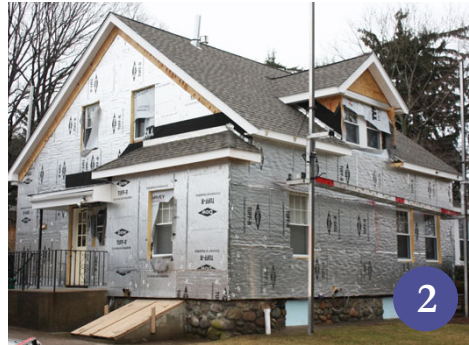
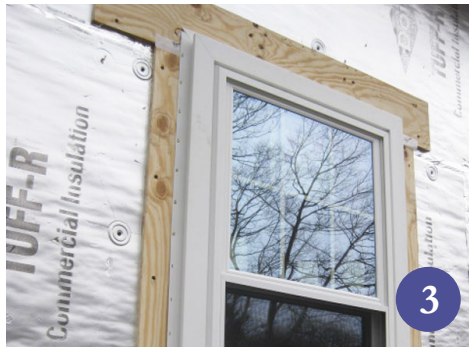
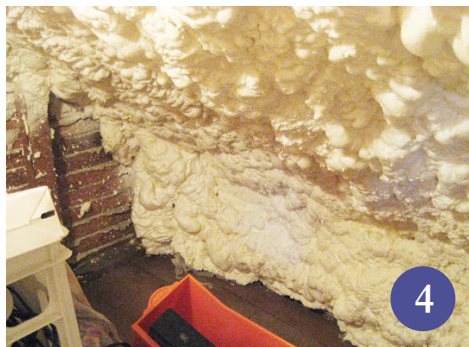
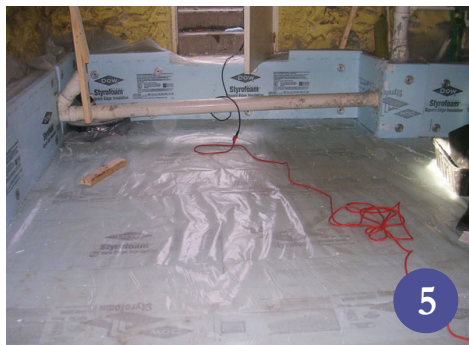
**1 Roof Assembly:** R-56 (nominal) Unvented roof assembly with vented over-roof: rafter cavities at eave space filled with existing fiberglass batts encapsulated with open-cell spray foam, cellulose insulation at cathedral ceilings, open-cell spray foam above flat ceiling; housewrap over existing sheathing, two layers of 2" foil-faced polyisocyanurate insulating sheathing, 2x4 purlins, 1/2" plywood, underlayment and asphalt shingles.

**2 Wall Assembly:** R-39 (nominal): Existing 2x4 wall framing cavities with fiberglass insulation supplemented with dense-packed cellulose where needed, housewrap, two layers of 2" foil-faced polyisocyanurate insulating sheathing, 3/4" furring strips, fiber cement siding.

**3 Window Specifications:** New Harvey Tribute triple-glazed, argon gas, low-E vinyl windows, U=0.2, SHGC=0.21; six Harvey Majesty, double-glazed, argon, low-E wood windows, U=0.3, SHGC=0.24; windows installed proud of drainage plane on blocking.

**4 Infiltration:** "Chain saw" retrofit approach; housewrap, air control layer wraps directly from roof to wall; open-cell spray foam at framing sill, closed-cell over rubble stone foundation wall, taped rigid insulation at concrete underpinning wall; new concrete slab.

**5 Foundation Assembly:** Conditioned basement with 3" closed-cell spray foam applied to rubble stone foundation wall in new 2x6 stud walls finished with drywall, 12" of open-cell spray foam extending up the mud sill, 2" XPS at interior of concrete underpinning wall; gravel drainage pad, 2" of XPS insulation and polyethylene vapor retarder beneath new concrete slab; radiant subfloor finished with hardwood flooring.

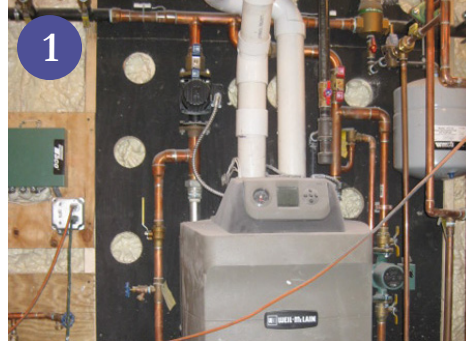
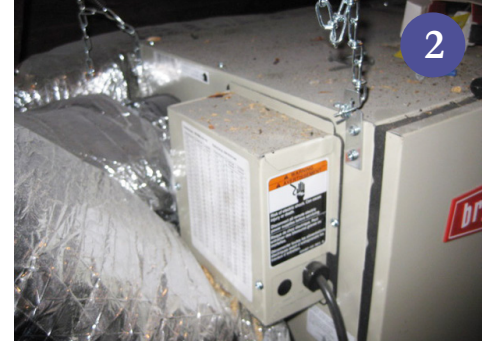
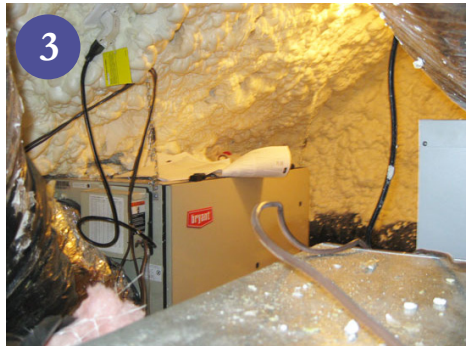
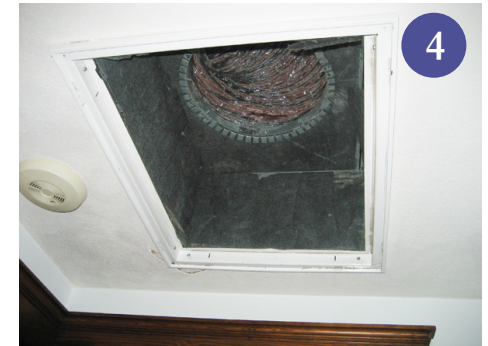
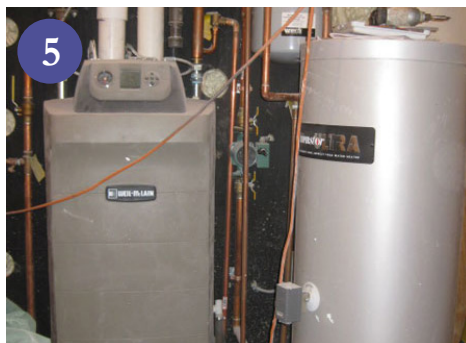
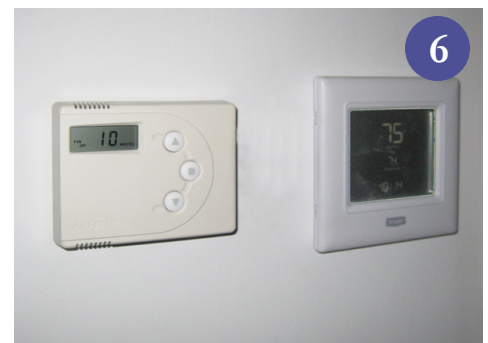
Condensing boiler located in the basement mechanical room for existing hot water baseboards and new Warmboard radiant heating in the basement; high efficiency air-source heat pump using expanded central A/C ductwork.

2 3 Ventilation: Bryant Energy Recovery Ventilator (ERV) ducted to central air handler located in the attic.

Distribution: Ductwork entirely inside the conditioned space.

5 6 DHW: SuperStor® Ultra storage hot water heater supplied by boiler located in the basement mechanical room.

During the course of construction, the builder devised solutions for conditions of continuous exterior insulation. A strip of plywood was used at the top of the gables to support a rake overhang that was otherwise aligned with exterior insulation of the roof. The added thickness of the roof would have brought the roof surface too close to the sill of dormer windows. The insulation was thickened at the

face of the dormer to align the face with the wall below and to allow the eave overhang to break at the dormer.

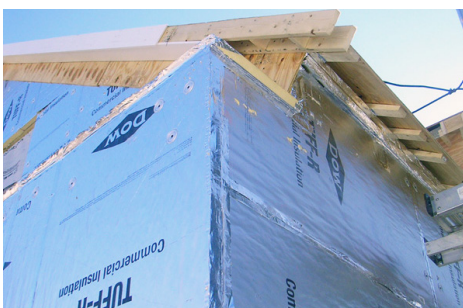
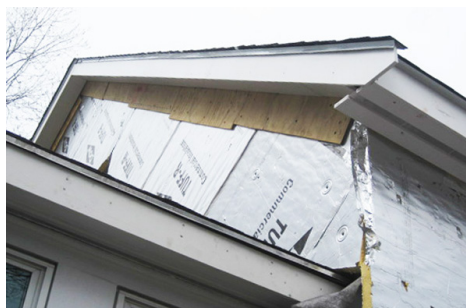
A common mistake with exterior insulating sheathing used as the drainage plane is to place step flashing at the plane of the existing sheathing rather than at the face of the insulating sheathing. In the photo on the left, the roof-wall flashing is not at the face of the drainage plane and the drip edge creates a condition where water may be directed in behind the drainage plane. This situation was corrected for this home.

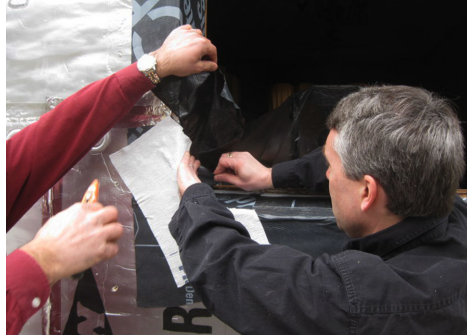
additional site visit to identify major sources of air leakage. With the house alternately depressurized and pressurized, BSC inspected the enclosure with a both a small handheld smoke generator and a larger theatrical smoke machine. While no significant problems were observed in the enclosure construction, BSC did find a problem with outside air dampers on the ERV that requires remediation.

BSC performed a post-retrofit air leakage testing to assess the air leakage reduction relative to pre-retrofit conditions. The pre-retrofit air leakage measurement was 11.2 ACH50 and the post-retrofit measure was 4.9 ACH50.

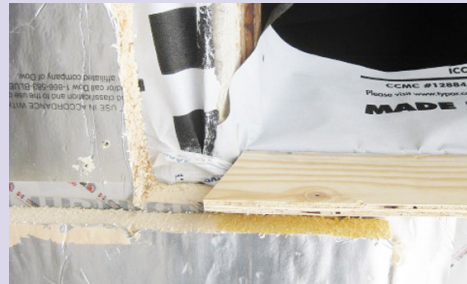
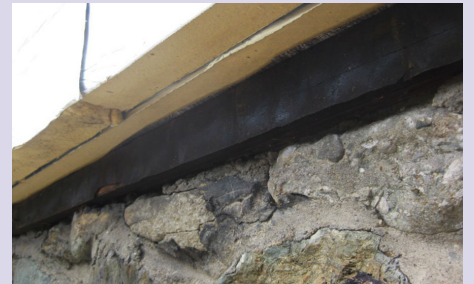
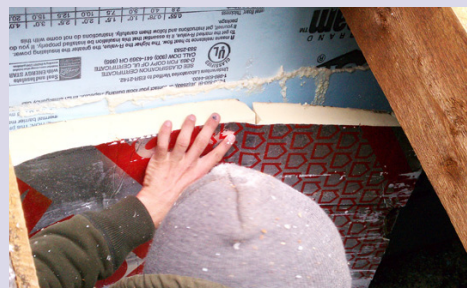
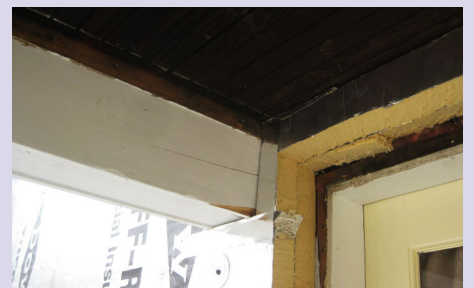
Implementation sequence was a critical factor in air flow control. The housewrap – intended to be the primary airflow control – and exterior insulation had been installed prior to removing the existing windows. This made it difficult to transition the air flow control layer into the window opening and to provide connection to the new window. To make the connections, sections of insulating sheathing around the windows had to be removed to allow pieces of air control membrane (house wrap or adhered membrane) to attach to in-place housewrap. Also, the housewrap had not been sealed to the base of the wall prior to installation of exterior insulation leaving limited options for a robust connection there.

While the builder pursued a “chain saw” approach at the roof-wall interface, porches were left attached thus precluding continuous air control and insulation layers at these locations. Sealing around the intervening framing and roof decks proved challenging.

In other areas the application of exterior insulation presented challenges. Installation of exterior insulation over the housewrap, before making critical airflow control connections complicated many of the airsealing details (see Design Challenge). The builder purchased windows with an integral trim channel

designed to receive lapped siding. Windows were installed to blocking on top of the exterior insulation in order to align the window's receiving channel with the siding (which is installed over furring strips to create a ventilation/drainage space as well as for attachment). Installing the windows this way created significant challenges to the implementation of proper flashing and airflow control.
