Insight

Stucco Woes: The Perfect Storm

By Joseph W. Lstiburek, Ph.D., P.Eng., Fellow ASHRAE

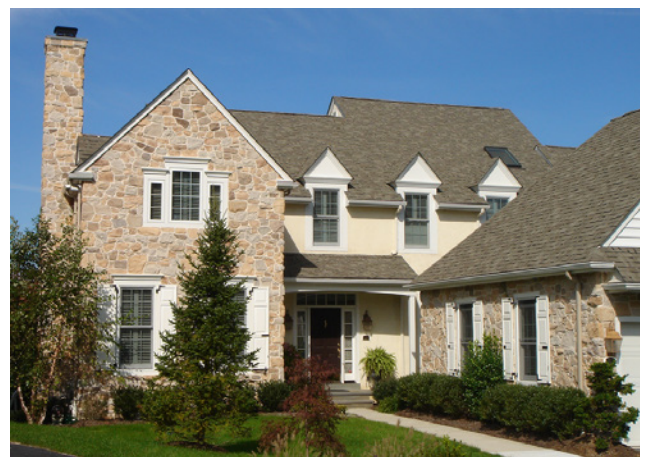
Photograph 1: Pennsylvania Stucco “Shack”—Eastern Pennsylvania is the stucco failure capital of the United States. Note the manufactured stone veneer—or “lumpy” stucco on the front façade.

We are seeing problems with stucco claddings in field of the wall—away from windows and “other architectural features.” And the buildings affected are not shacks (**Photograph 1**). And the problems are not limited to

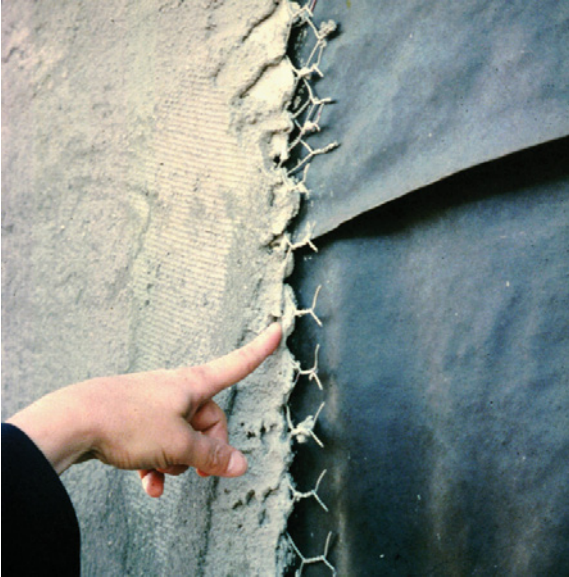
Photograph 2: Hardcoat Stucco—Three coats have been traditionally applied directly over a single layer of impregnated felt or asphalt saturated kraft paper. Today, this results in a bond between the stucco rendering and the outer layer of the felt or paper compromising drainage.

Hardcoat stucco is typically a three layer cementitious rendering (scratch coat, brown coat and top coat) applied over a building paper, metal lath and sheathing (**Photograph 2**). Manufactured stone veneer is a version of hardcoat stucco where the top coat is replaced with an embedded thin stone veneer (**Photograph 3**). Stucco claddings coupled with manufactured stone veneers are hugely popular because of their beauty—among other things. Unfortunately, the beauty is often only skin deep, as they are also commonly linked with moisture problems (**Photograph 4**). This was not always the case and the reasons for the change in performance are due to several seemingly small factors that add up to a huge factor:

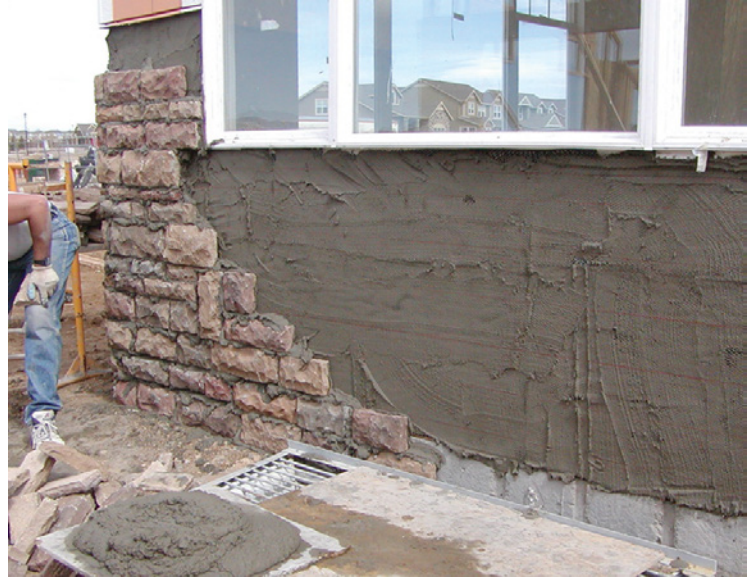
Photograph 3: Manufactured Stone Veneer—Manufactured stone veneer claddings are very similar to hardcoat stucco and perform in a similar manner. In a manufactured stone veneer the outer coat of stucco is replaced with a thin stone layer.

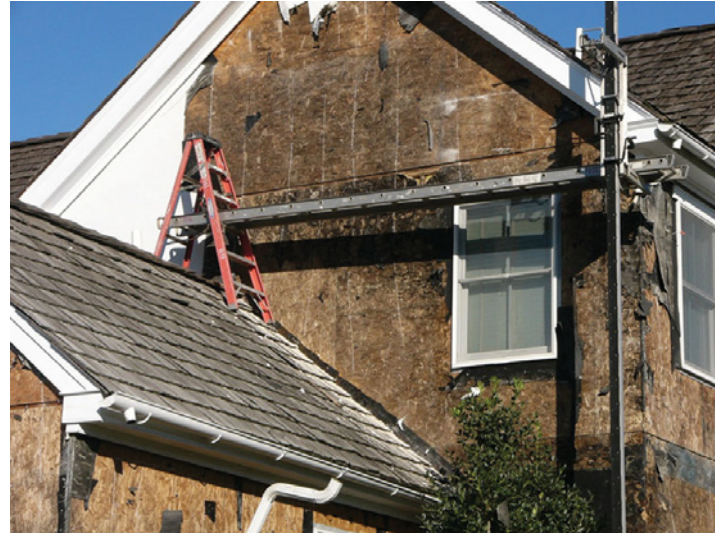
Photograph 4: Hardcoat Stucco Failures—Note that the damage is in the field of the wall away from windows.

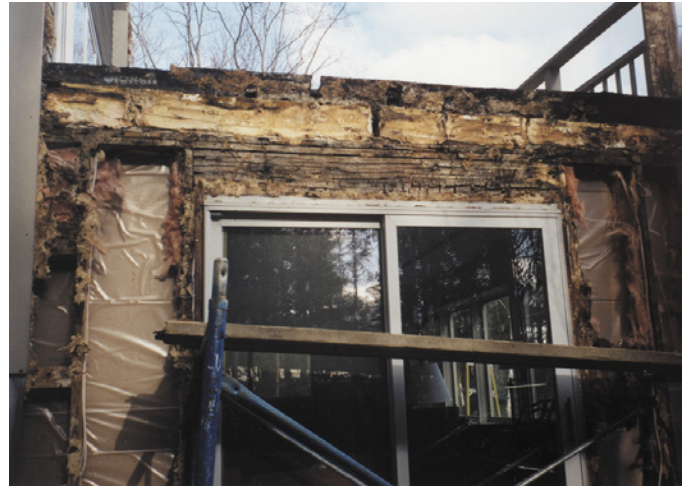
Photograph 5: Failure on Steroids—Note the plastic vapor barrier “accelerant” in this Vancouver, Canada building.

assemblies. In many cases even two of these changes combined do not lead to grief. But three, any three, and problems begin to raise their heads. And with four or all five, it gets ugly, very ugly—we call this type of ugly—Vancouver ugly (**Photograph 5**). Let's look at each of these small factors individually at first.

Now, to the plastic vapor barrier thing. What can I say that I haven't said about this earlier. The interior plastic vapor barrier prevents inward drying during cooling periods. Except in extreme heating climates plastic vapor barriers are unnecessary. The reduction of inward drying is often enough to push the wall over the edge if it is borderline to begin with (go back and look at **Photograph 5**).

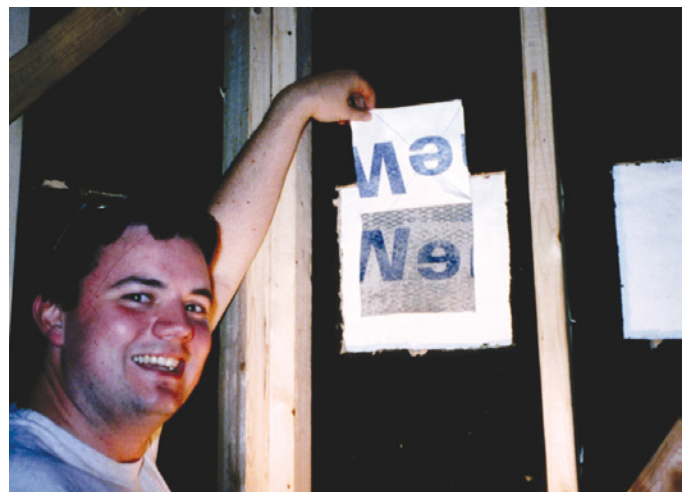
Photograph 6: Hardcoat Stucco Bonding to Plastic Building Paper—A young, happy engineer, discovers that stucco does indeed bond to plastic building papers preventing drainage. The engineer is my friend Chris Schumacher—may he remain this happy when he gets older.

Building paper manufacturing changes and the introduction of plastic building papers (also referred to as “building wraps” or “housewraps”) led to a change in the water management attributes of stucco renderings installed directly over these materials. Older building papers were more “robust” than more recently manufactured products—they weighed more and had more cellulose content. As a result when stuccos were applied directly over them a bond between the stucco and the building paper did not develop due to the dimensional instability of the cellulose. The absence of a bond permitted a modest degree of drainage to occur between the building paper and the stucco. With more recently manufactured building papers a bond develops between the building paper and the stucco—preventing drainage between the building paper and the stucco. The bond between plastic building papers and stucco is even greater (**Photograph 6**).

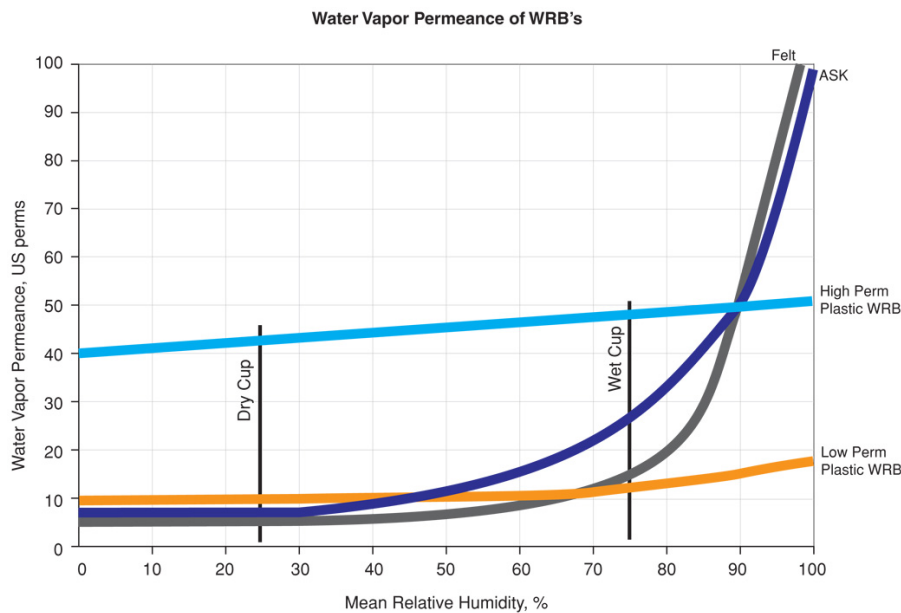
Figure 2: Permeance of Water Resistive Barriers (WRB's)—Debate rages within the building science community as to what the curves mean. The old guy in me intuitively believes that the shape of the curve describing the traditional building papers (WRB's) is “good.” And that the curve describing the “high perm” WRB is “not so good” and the curve describing the “low perm” WRB is “better but not as good as” the curve describing traditional building papers. I believe that if we could get a plastic building paper with a curve that mirrors the shape of the traditional building papers the product would “kick building science butt.”

Another attribute that changed was the water vapor transmission of the plastic building papers versus the traditional building papers (impregnated felts and asphalt saturated kraft paper) (Figure 2). What is the big deal with the shape of the curves? Well, it’s a “Goldilocks” thing—the materials should not be too vapor open or too vapor closed—but “just right.” With materials that are too vapor open—too much moisture stored/absorbed in the stucco layer can be driven inwards through the material under solar induced drive causing damage in the sheathing layer. With materials that are too vapor closed—not enough moisture will be able to exit the sheathing layer and dry outwards during drying events.

The stucco problem seems to be worse with “high perm” plastic WRB’s than with “low perm” materials. As the “dwell” time for moisture in the stucco and WRB layers goes up, inward vapor transmission also goes up with “high perm” plastic WRB’s. The “low perm” plastic building papers appear to do a better job of “throttling” the inward vapor drive protecting the sheathing.

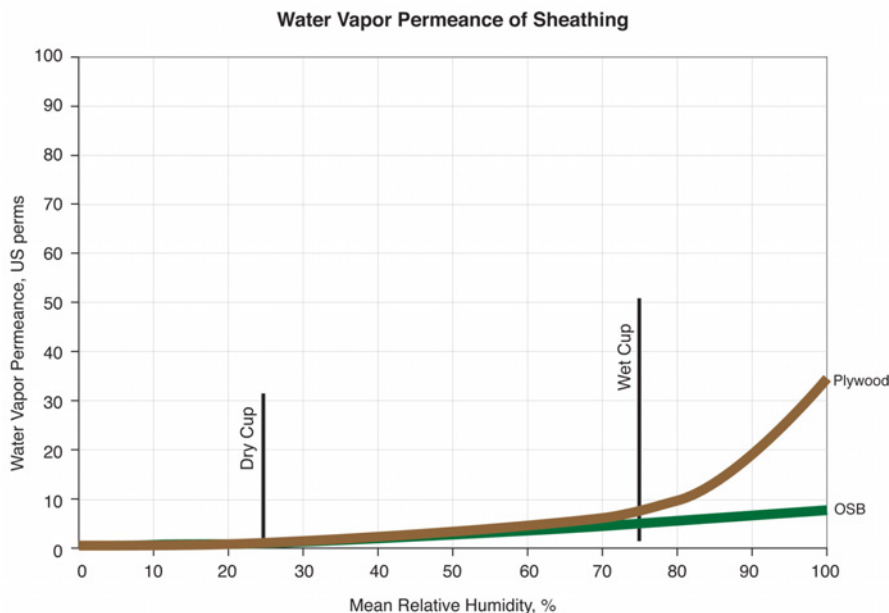
Figure 3: Permeance of Plywood vs OSB Sheathing—Note the “hockey stick” shape of the plywood curve. Hockey is good—remember that and life will be good. The upward rise allows the plywood to dry more readily than OSB when it gets wet.

On to the plywood versus oriented strand board (OSB) change. Folks, this is a big deal. No matter how many times manufacturers say that OSB is just like plywood it just isn’t so. Check out **Figure 3** and the relative differences in water vapor transmission between plywood and OSB. Plywood becomes vapor permeable as it becomes wet—OSB does not. Did I mention that this is a big deal? When plywood gets wet it dries a lot easier (and faster) than when OSB gets wet because it becomes vapor open. Moisture also migrates laterally

within a plywood sheet a lot easier than OSB. The lateral movement and vapor openness when wet allows the plywood to more easily redistribute moisture than OSB. This means that with OSB moisture becomes concentrated at OSB/building paper interfaces—whereas with plywood the moisture is released into the cavity as well as allowed to migrate laterally reducing concentrations and localized moisture stresses.
