Case Study

National Grid Deep Energy Retrofit Pilot Program: 18th Century Cape Comprehensive Retrofit

Belchertown, Massachusetts

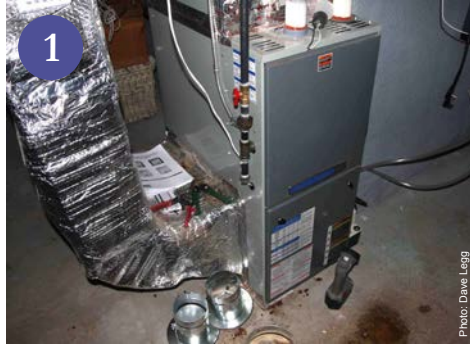
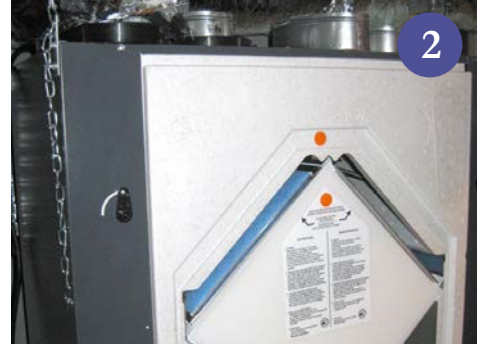
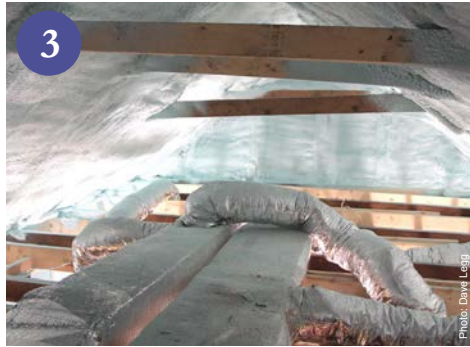
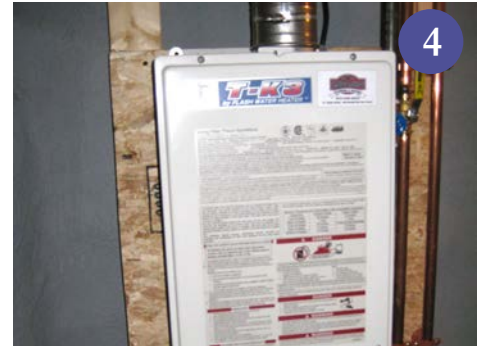
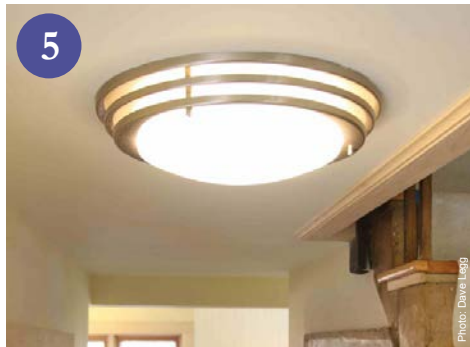
MECHANICAL DESIGN

- 1 Heating:** 96.7% AFUE sealed combustion propane furnace in conditioned space. High SEER coil installed for future connection to air-source heat pump.
- 2 Ventilation:** High efficiency heat recovery ventilator (HRV) with dual ECM motors and 74% recovery efficiency. Outside air supply ducted to heating system distribution, exhaust air taken from bathroom.
- 3 Space Conditioning Distribution:** Insulated sheet metal trunks with insulated flex run-outs. Ducted return in each bedroom plus two additional returns in first floor areas. Entire distribution system within thermal enclosure.
- 4 DHW:** 0.86 EF on-demand propane-fired water heater.
- 5 Lighting:** Hard wired ENERGY STAR® CFL lighting plus high efficacy (60 lumen/Watt) LED lighting.
- 6 Appliances:** ENERGY STAR® dishwasher, refrigerator and clothes washer.

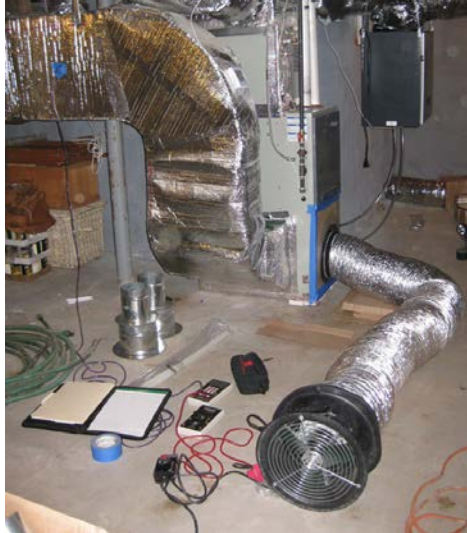
The target air tightness of the closure in BSC's Building America work is 2.5 in² of effective leakage area per 100 ft² of building enclosure area. For this home the target corresponds to ~925 cfm at 50 Pascals (cfm50) or 0.25 cfm50 per ft² of enclosure. The National Grid Deep Energy Retrofit Pilot set an even more aggressive air leakage target of 0.1 cfm50 per ft² of enclosure. BSC measured air leakage of 468 cfm50 or 0.13 cfm50 per ft² of enclosure. While falling just short of the Pilot target, these results are, nonetheless impressive and

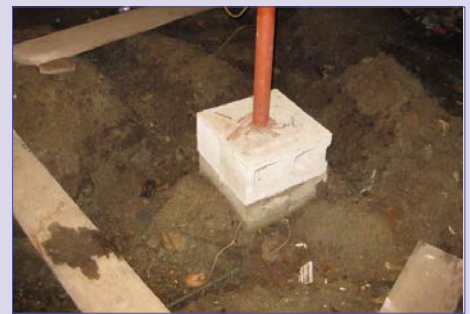
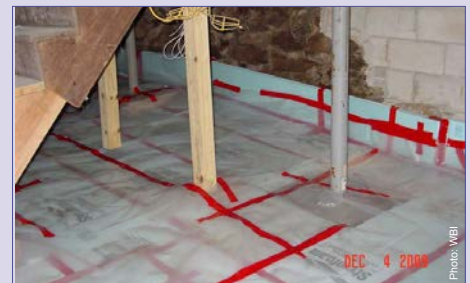
DESIGN CHALLENGE: CONVERTING A COLD, WET CELLAR INTO A USEABLE SPACE

Prior to the renovation project, the basement was a cold and damp space. It often contained standing (sometime flowing) water. The homeowner and builder combined efforts to dig trenches in the basement, install drainage piping draining to daylight, and load several cubic yards of gravel into the basement. To supplement these liquid water control measures, BSC recommended an insulated concrete slab in contact with a polyethylene sheet to provide condensation control, vapor diffusion control and to control convective (air flow) transfer of moisture and soil gases into the space. BSC also provided a detail to ensure that, after spray foam insulation is installed against the foundation walls, any water that leaks through the walls is able to drain into the sub-slab drainage system.
