Insight Uplifting Moments— Roof Failures

By Joseph W. Lstiburek, Ph.D., P.Eng., Fellow ASHRAE

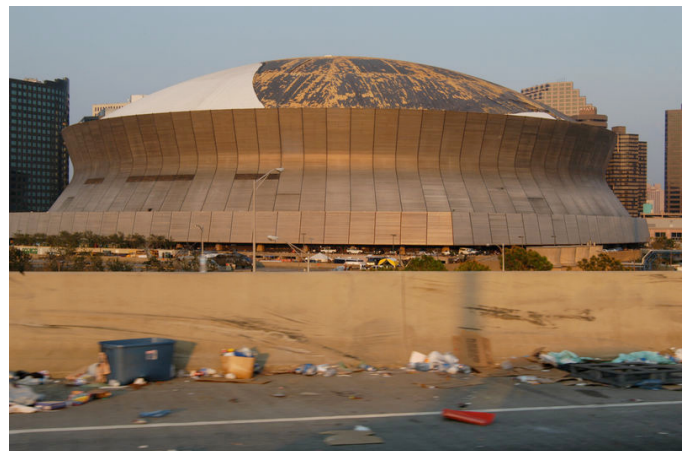
I remind everyone that the roof of the Superdome experienced one of the more spectacular failures in enclosure history. It unzipped during Katrina like a cheap prom dress on a Saturday night in less than catastrophic wind conditions (**Photograph 1**). Let's toy with this memorable failure a little – just hypothetically of course because there is litigation.¹

Photograph 1: Should Have Never Happened—The Superdome roof membrane is missing after Hurricane Katrina.

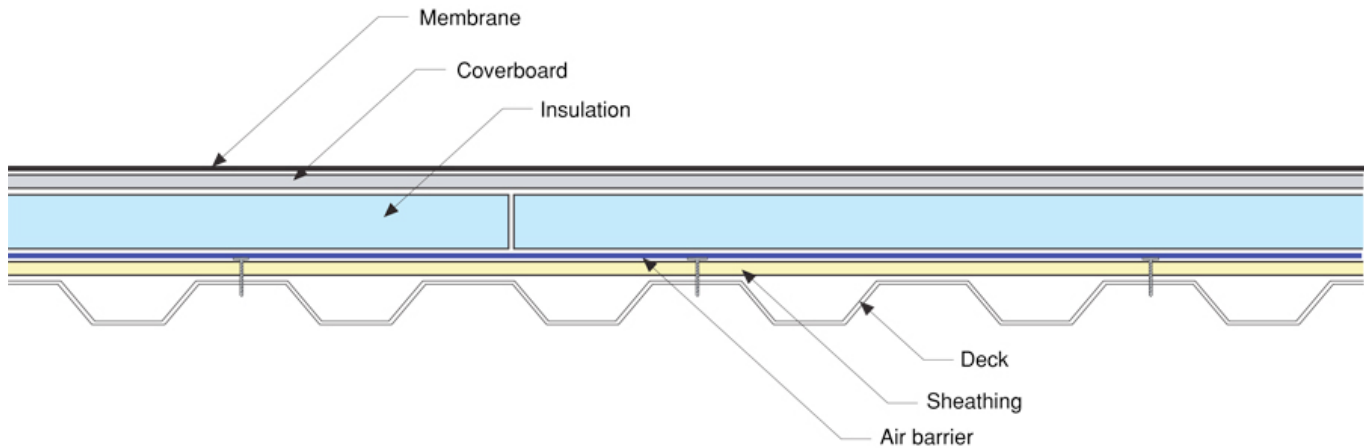
Figure 1: Multiple Layer Compact Roof

- Mechanically attached sheathing supports fully adhered air barrier.
- Fully adhered insulation boards – best performance when split into two layers with joints staggered to further limit three dimensional air flow paths.
- Fully adhered coverboard protects insulation and facilitates lateral migration of water vapor and other off-gassing products to control blisters.
- Fully adhered membrane.
- (It is becoming increasingly common to mechanically attach the insulation layers and membrane while also omitting the coverboard – an unfortunate development. Some insurance policies require mechanically attached layers because they don't trust the workmanship necessary for fully adhesion of layers – old timers roll their eyes at this and the crotchety ones do both – they fully adhere the layers to get the performance and add the mechanical attachment to shut the insurance folks up.)

We seem to have forgotten how to build roofs. Back in the day compact roofs required multiple layers – and one of the most important was the air barrier (**Figure 1**). Air barriers were originally an artifact of cold climate construction and often misnamed as vapor barriers. In Canada, where there are only two seasons, this winter and last winter, architects and engineers learned about the importance of air barriers in controlling roof assembly moisture induced deterioration from interior sources. However, early on, one of the most important lessons of utilizing air barriers, was the huge improvement in uplift performance. The air barrier helped to transfer the wind load to the structural deck. And this proved to be important in all climates besides those dominated by hockey players.

With an air barrier a significant portion of the wind pressure is transferred to the air barrier and its attachment to the deck. The tighter the air barrier, the greater the load transfer. The greater the load transfer to the air barrier, the less stress on the membrane. **Figure 1** rocks, **Figure 3** sucks—literally—wind suction.

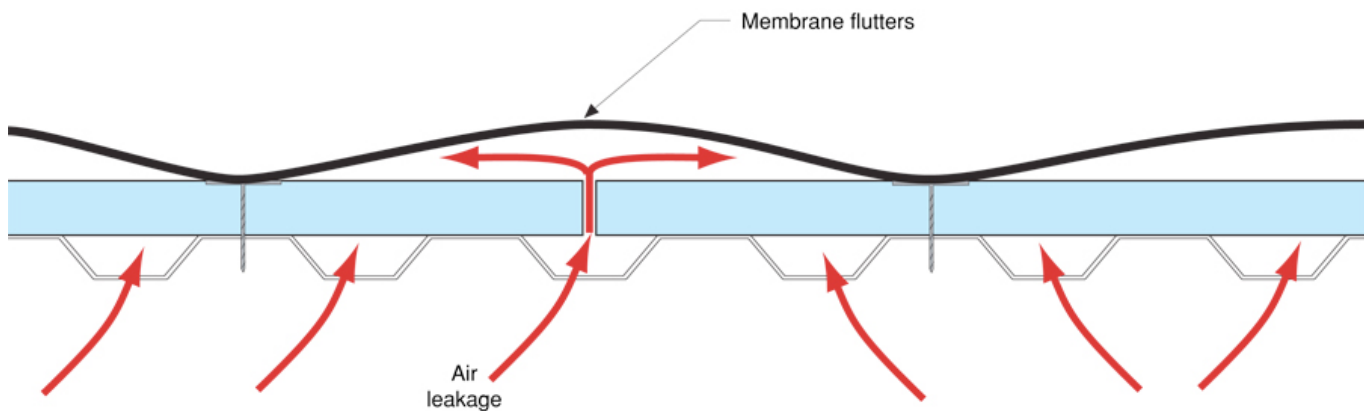
When mechanically attached membranes became common – a bad idea in my humble opinion – the lack of an air barrier lead to fluttering of membranes (**Figure 2**) and some interesting failures (**Photograph 2**) and some interesting solutions (**Photograph 3**).

Fluttering, besides stressing the membrane, leads to the pumping transfer of airborne moisture from the interior into the roof assembly. This has typically been a cold climate phenomenon but the problems are migrating south as membranes become white rather than black. Dark membranes get very hot – duh – and the heat drives the moisture back down into the building. In the south mechanically attached dark membranes roofs typically dodged the moisture bullet because the moisture

Figure 2: Fluttering Membrane—Mechanically attached membrane flutters due to air leakage from interior when air barrier is omitted.

Air barriers make fluttering go away and make the world safe for mechanically attached light colored membranes. The fluttering is controlled since any attempt by the

membrane to lift off the insulation layer is resisted by suction - air from the interior is not able to enter the roof assembly due to the presence of the air barrier. The lack of an air barrier and a leaky deck will allow replacement air to enter the roof assembly from the interior and the suction resistance is lost.

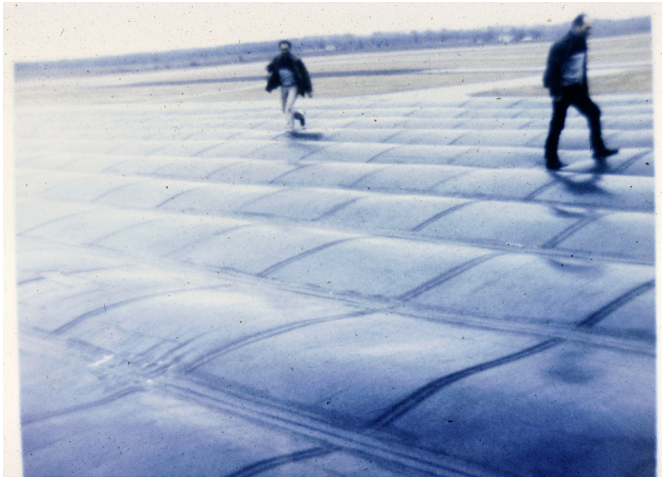
Photograph 2: Fluttering Membrane—No air barrier at deck leads to an idea for a Disney World ride...

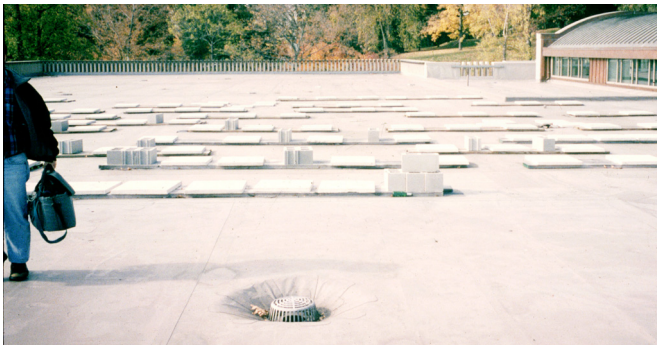
Photograph 3: Fluttering Membrane Fix—“I’ll fix that darn moving membrane, Bubba get me some pavers and blocks...”

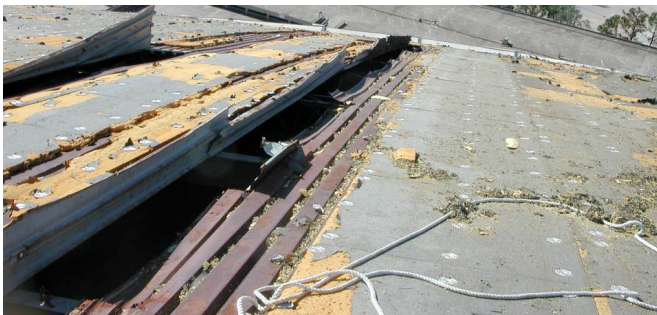
Photograph 4: Superdome Roof Damage—Missing membrane and exposed rigid sheet insulation - note the mechanical connectors. The membrane was adhered to the top of the sheet insulation boards and to the mechanical connectors. Also note the metal deck and the flutes that allowed lateral airflow and lateral water migration.

Here is a trick question – what is the tightest element of a roof? That would be the element without any holes. That would be the membrane since it can’t have holes because if it does it leaks. Duh. If I have a tight membrane, rigid insulation installed in boards/sheets with gaps over a fluted steel deck with seams and holes the majority of the wind load is taken by the membrane. That was the case in the Superdome roof (**Figure 3**). We know that how? Well, the membrane is gone and the insulation was left behind– double duh (**Photograph 4**).

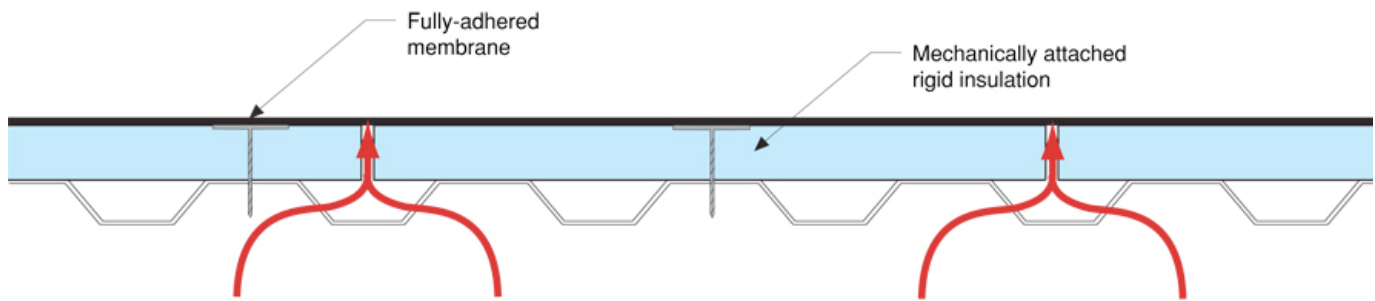
The Superdome roof did not have an air barrier – at least not the replacement roof installed in 2002 – the one that failed during Katrina. It was reported that the smoke dampers at the top of the roof were sucked off during Katrina and that allowed the wind to enter exacerbating building pressurization and stressing the roof assembly. The membrane took the majority of the load, unzipped and traveled to a neighboring parish.

Figure 3: Failed Superdome Roof Section—Mechanically attached rigid insulation boards on fluted metal deck with fully adhered membrane. Note the absence of an air barrier. Membrane takes full wind load.

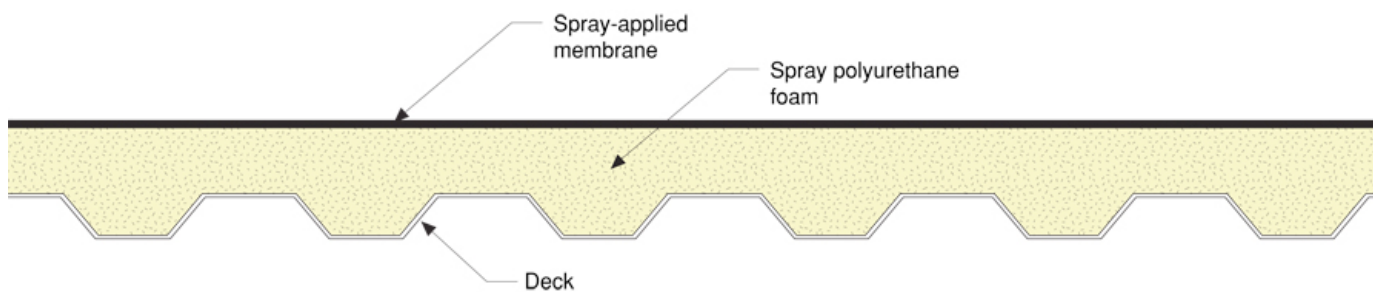
Figure 4: New Superdome Roof Section—Fully adhered spray-applied membrane over fully adhered spray polyurethane foam insulation layer and integral air barrier.

The good news is that the post Katrina repair is both bulletproof² and has an air barrier. The new roof is similar to the original roof. It is spray polyurethane insulation system applied directly to the roof deck (**Figure 4** and **Photograph 5**). A spray applied fully adhered membrane is installed over the top of the insulation (**Photograph 6**). The spray polyurethane insulation also acts as the air barrier.

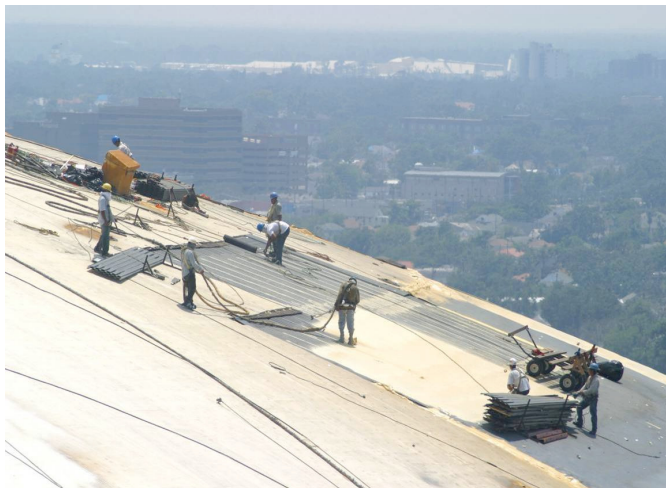
Photograph 5: Spray Foam Application—New, fully adhered roof insulation and integral air barrier.

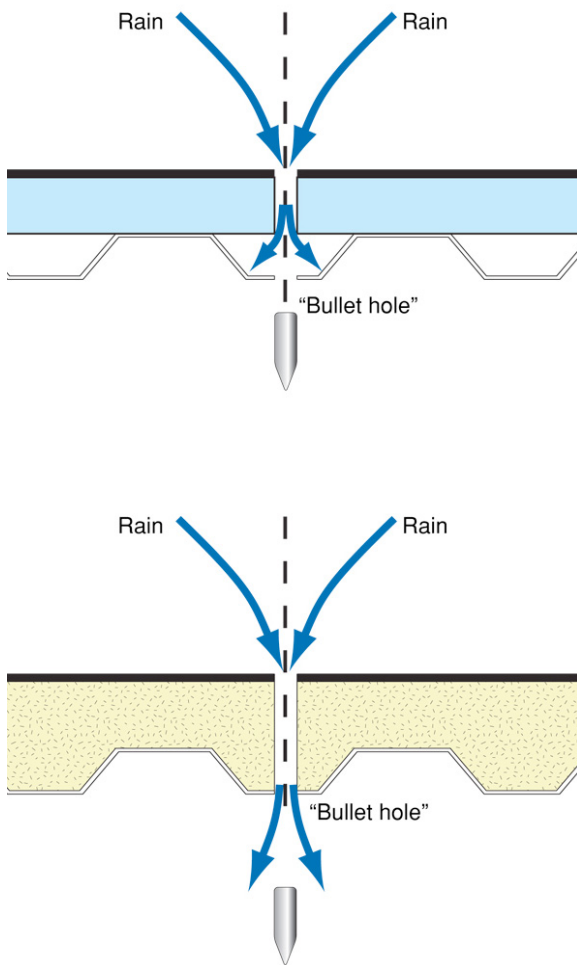
So how are bullets handled in the new roof? The bullet goes right through the roof system providing a “straight-through-the-assembly” water path. The spray foam does not allow the lateral migration of water that occurred in the 2002 roof (**Figure 5**). OK, so the roof isn't really bullet proof, but bullets don't cause anything besides a minor annoyance. The bullet holes are easy to fix – the

hole and the leak are coincident – and corrosion is limited and controlled.

Figure 5: Bullet Proof—Bullet holes in upper roof section allow for lateral migration of rainwater due to the gaps in the roof system layers and the channels provided by the fluted steel deck. In the lower roof section bullet holes result in a “straight-through-the-assembly” flow path for water thereby limiting damage to the hole only.

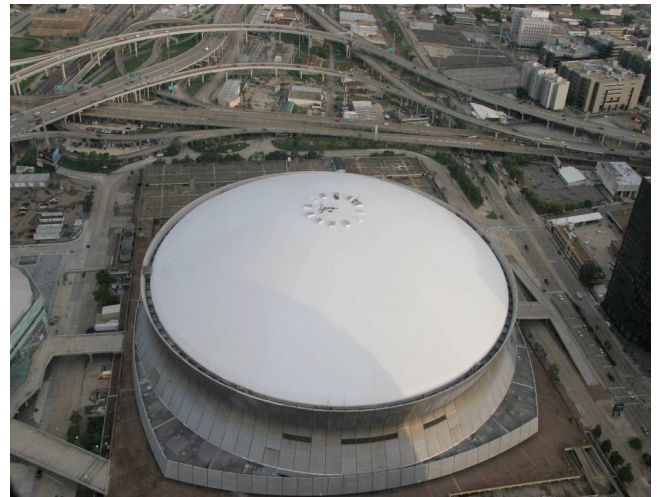
Photograph 6: Better than Before—Welcome back Saints...
