Interior Insulation of Mass Masonry Walls: A Pittsburgh-Area PH Case Study

8th Annual North American Passive
House Conference

McKeesport, PA YMCA Building

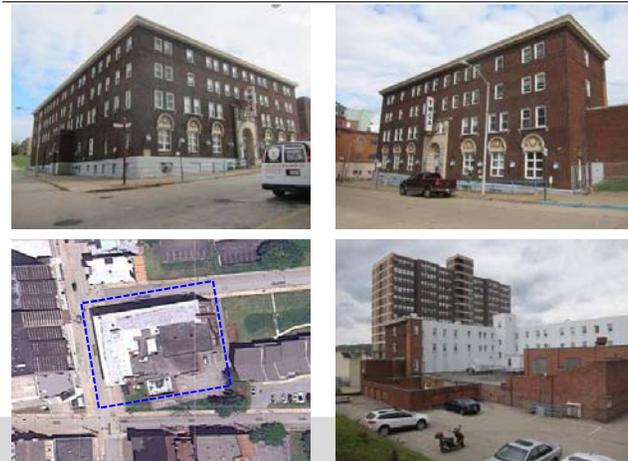
McKeesport, PA YMCA Building

- Former YMCA building, circa 1923 construction
- Action Housing Inc. - Downtown Housing facility
- ~65,000 sf; ~75 units (rental, shelter rooms)
- Major energy efficiency retrofit project underway
 - PH target; occupied rehab project
- Thoughtful Balance Inc. (architecture firm)
 - Laura Nettleton, Michael Whartnaby
- BSC acting as sub-consultant
 - Masonry interior insulation retrofit; other energy issues

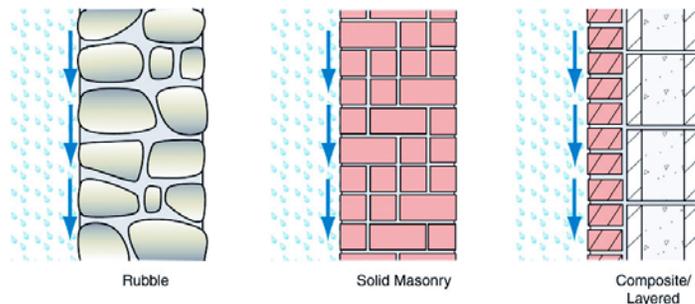
Mass Walls (Rain Control)

- Moisture is absorbed/safely stored during rain
- Moisture re-evaporates/dries while warmer
- No “drainage plane”

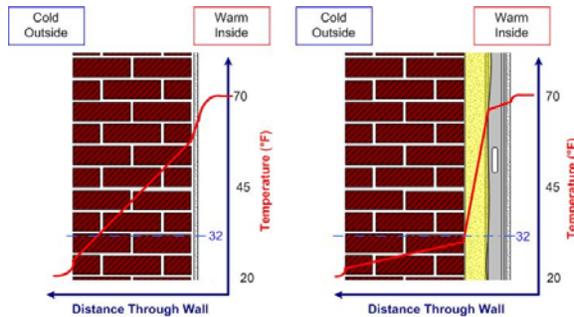
Cold Climate Risks

1. Freeze-thaw (reduced drying)
2. Air leakage condensation on interior face of masonry
3. Rot / corrosion of embedded elements

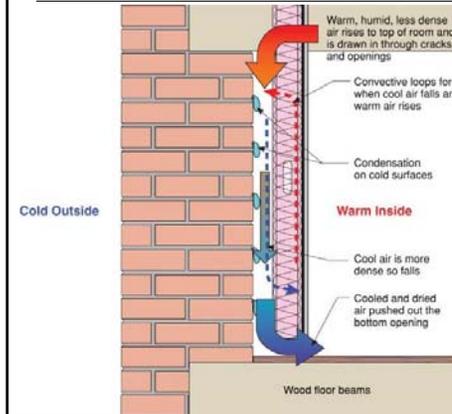
Cold Climate Risks: Condensation

- Requires perfect workmanship at air barrier—around penetrations, etc.
- Made worse by air gap behind insulation
- NOT RECOMMENDED**

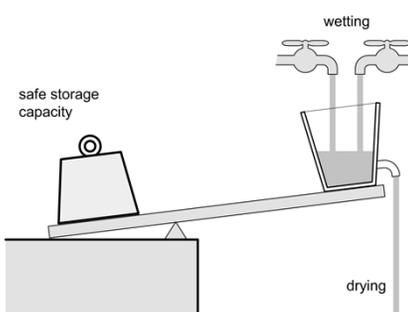
The Moisture Balance

- Large storage capacity (mass wall)
- Drying decreases with insulation
- Design should reduce/control wetting to compensate

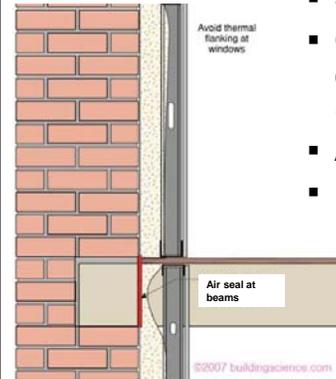
Recommended Approaches

- Spray foam against masonry
- Open cell (0.5 PCF)? Closed cell (2.0 PCF)? Intermediate (1.0 PCF)?
- Air seal at joist pockets
- Montreal experience

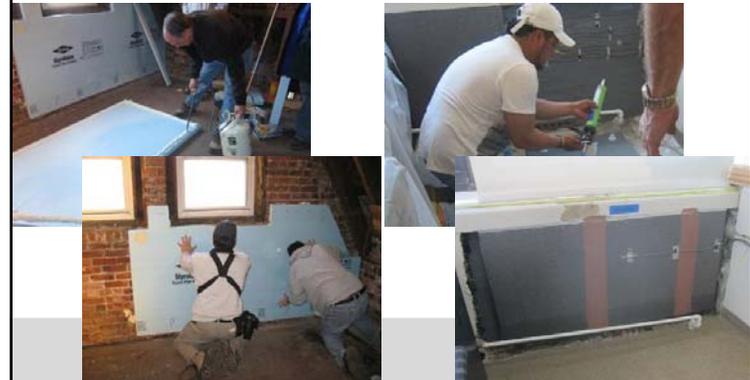
Non Spray Foams Options

- Rigid board foams, adhered to wall—air barrier
- Expanded polystyrene/EPS (non-GWP foam)

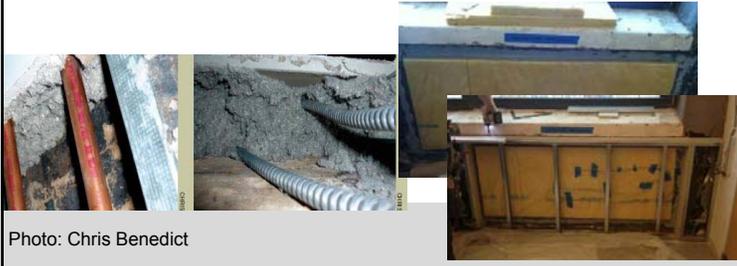
Non-Foam Options?

- Dense pack cellulose against brick
- High-density mineral fiber/glass fiber & variable permeability vapor retarder
- Requires meticulous workmanship/air barrier—air barrier outboard of framing & services

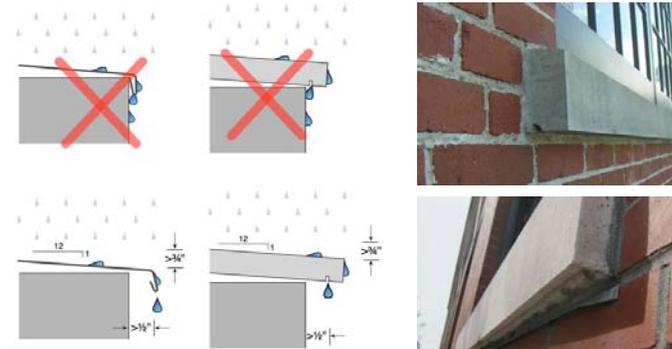
Drip Edges

- Minimum projection of drip edge

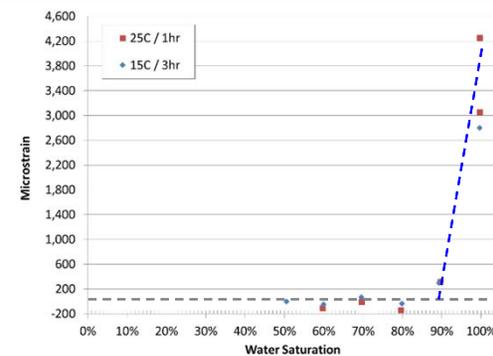
Dilation (Growth) of Samples

- “Hook” in graph signifies S_{crit}

- Critical Degree of Saturation (S_{crit})
 - European research on stone and masonry
 - Below this moisture content: no damage w. F/T
 - Above this moisture content: damage occurs quickly
- Cut brick samples; measurements
- Vacuum saturate to range of moisture contents
- Subject to freeze-thaw cycles
- Measure dilation (growth) of samples (very small!)
- “Hook” in graph signifies S_{crit}
