Four Square Revisited Toward Zero Energy Renovation

Betsy Pettit, FAIA
Building Science Corporation
www.buildingscience.com

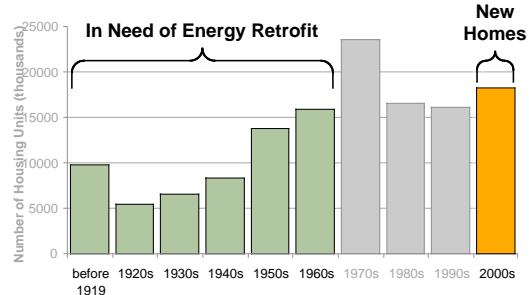
Age of US Housing Stock (all unit types)

Number of Housing Units (thousands)

before 1919 1920s 1930s 1940s 1950s 1960s 1970s 1980s 1990s 2000s

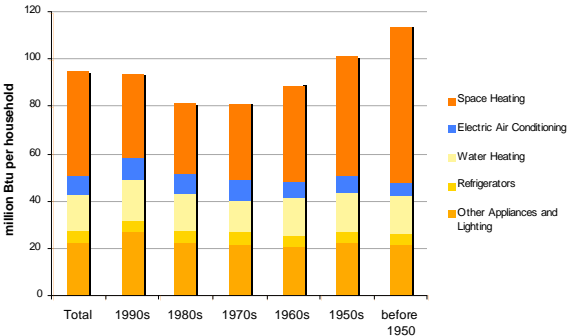
Total Btu Consumption per Household, 2001

million Btu per household

Total 1990s 1980s 1970s 1960s 1950s before 1950

- Space Heating
- Electric Air Conditioning
- Water Heating
- Refrigerators
- Other Appliances and Lighting

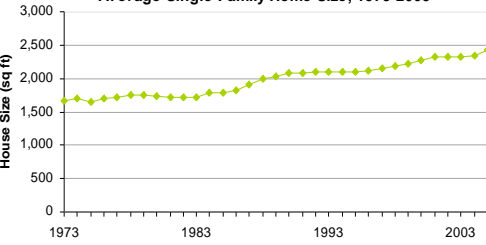
Average Single Family Home Size, 1973-2005

House Size (sq ft)

1973 1983 1993 2003

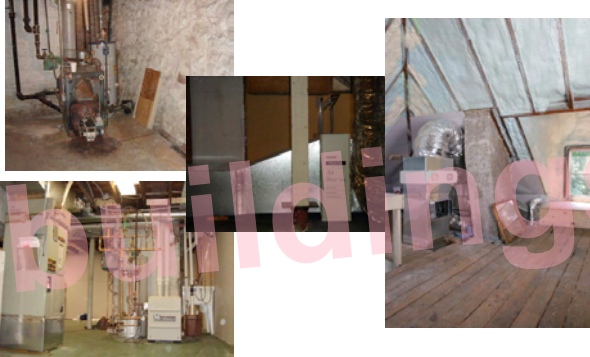
Old Boiler to New Boiler plus air handlers,
outside air intake, filtration, and exhaust at
baths and kitchen
