Revised January 2007

## Building Science Corporation

## Water Management Details

### Housewraps/Flashings/Windows

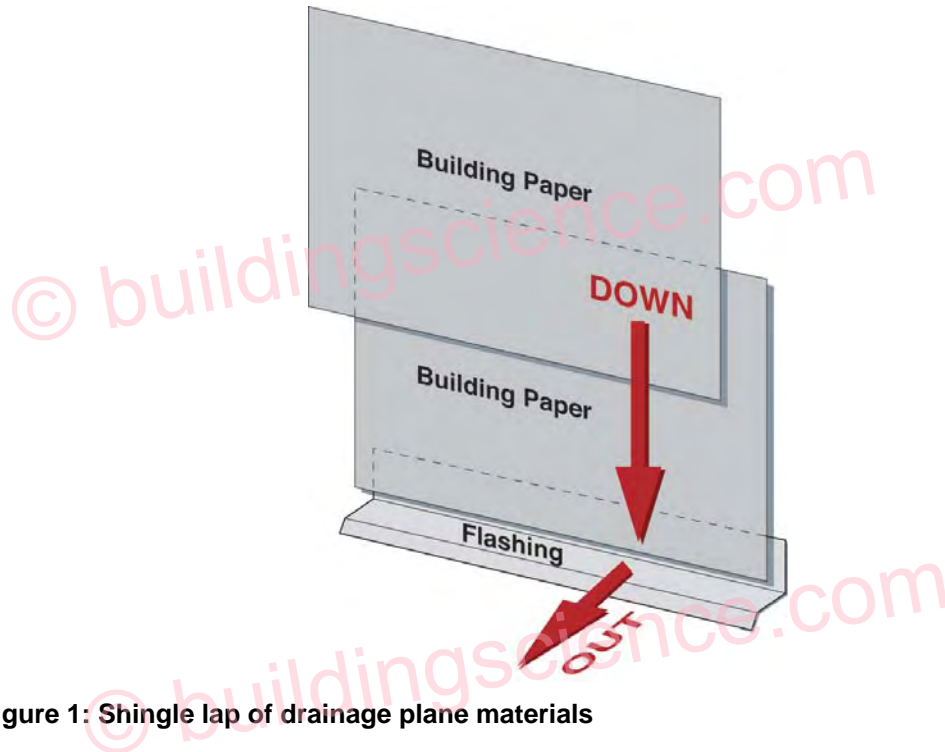
Figure 1: Shingle lap of drainage plane materials

An integral part of many water management systems is the use of building paper or housewraps as the drainage plane in the wall system. The basic concepts with these products are that they should always be installed in a shingle lap fashion and have enough space to drain moisture down and out to the exterior. With house wraps, the joints are often also taped to provide increased protection from water entry and to increase the air tightness of the assembly. With no other factors to consider, following these basic ideas should result in long-term performance of the material. While the concept is simple, certain construction methods and details have interfered with the performance of the house wraps and building papers.

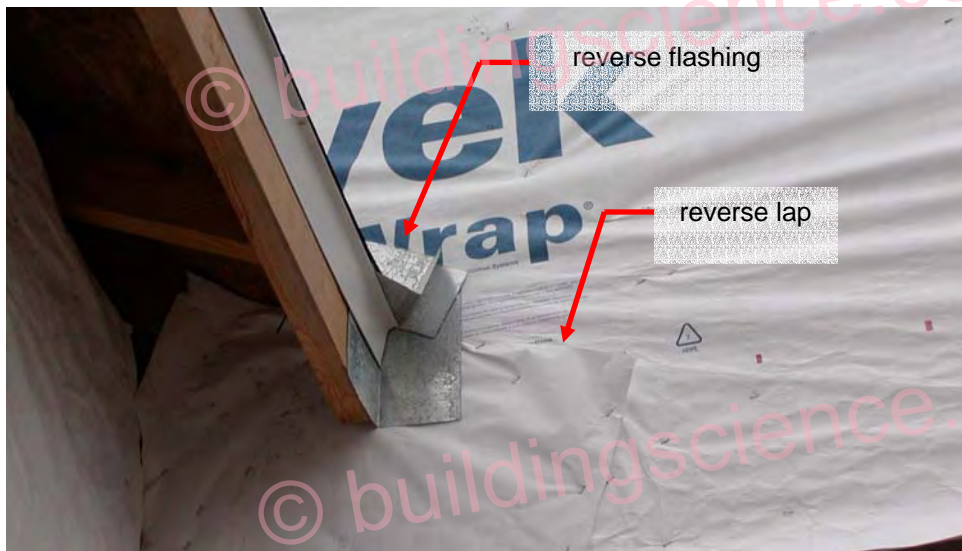
Figure 2: Improper installation of drainage plane materials

Maintaining the shingle lap of the building paper or housewrap is generally pretty easy for the field of the wall. Problems usually appear at areas where there is a change in construction, specifically at window intersections and at roof wall connections. These are also often areas of higher liquid water concentration which further exacerbate the problem.

This occurs due to improper sequencing of the construction, or though the difficulty in installing the products at areas of more complicated geometry. Often at these locations the shingle installation ideal is exchanged for coverage (As long as we get the housewrap everywhere it should be fine, right? Wrong.). When roof overhangs, or other kick outs in construction occur, the installation of the house wrap must be considered carefully to ensure that a reverse flashing is not created. While taping the joints of housewraps can reduce the risk of water entry, it is no substitute for proper shingle lapping of the product.

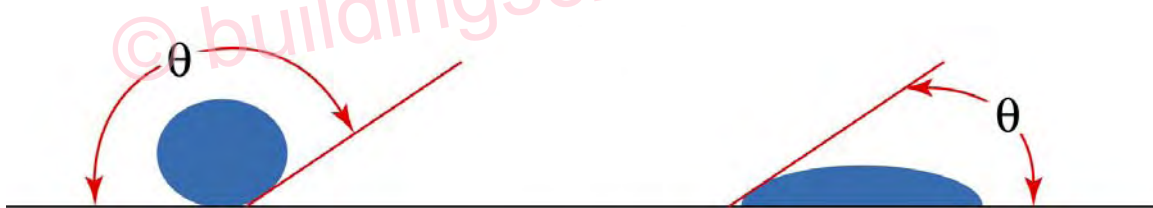
- "non-wetable" surface
- water repellent surface
- hydrophobic surface
- water more attracted to itself than to surface
- surface energy of water greater than surface energy of surface
- water "beads up"
- "greasy" surface
- high contact angle " $\theta$ "

- "wetable" surface
- non-water repellent surface
- hygroscopic surface
- water more attracted to surface than itself
- surface energy of surface greater than surface energy of water
- water "spreads up"
- "non-greasy" surface
- low contact angle " $\theta$ "

Figure 3: Hydrophobic and hydroscopic properties

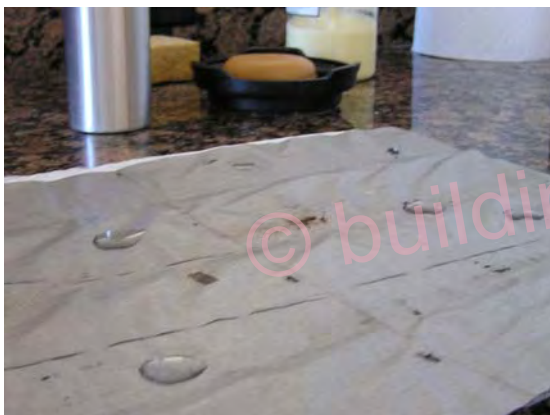
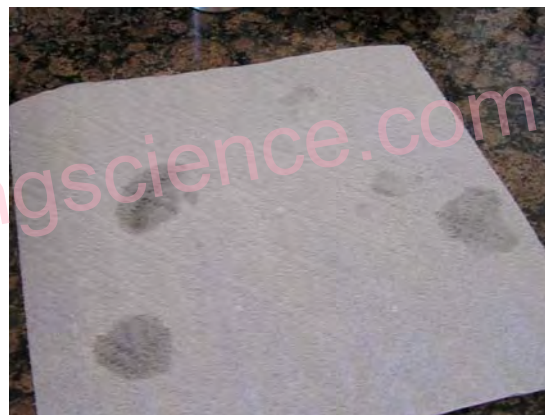
#### Figure 4: Failed water drop test of a housewrap

Similarly to masonry veneers, some sidings installed directly against building paper or housewrap will also hold water up against them. The problem can be even worse with housewraps and wood claddings such as cedar or redwood, due to some water-soluble extractives in wood being a type of surfactant that can contaminate the surface of the housewrap. As the surfactants migrate into the house wrap, the house wrap loses its hydrophobic properties and begins to absorb moisture. This loss of water repellency of the house wrap constitutes a fundamental failure in its role as a drainage plane.

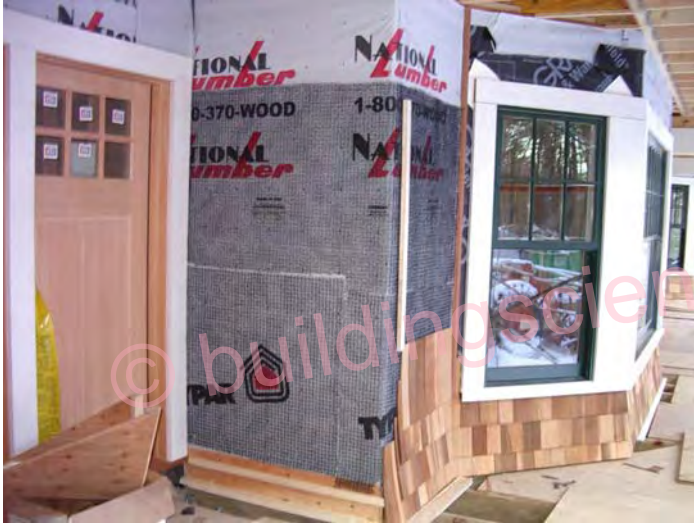
Figure 5: Drainage matt installed behind wood shingles

For all sidings (except vinyl) it is recommended that they be installed over some form of drainage matt or furring strips in order deal with the problems of water retention and potential surfactant contamination. This spaces the siding off of the housewrap to prevent surfactant contamination, increases drainage, and often increases drying by ventilation as well. Furring strips are a more traditional method of moving the siding off of the back up wall construction, however from past experience both methods have been very successful at managing the moisture problems with board sidings and house wraps.

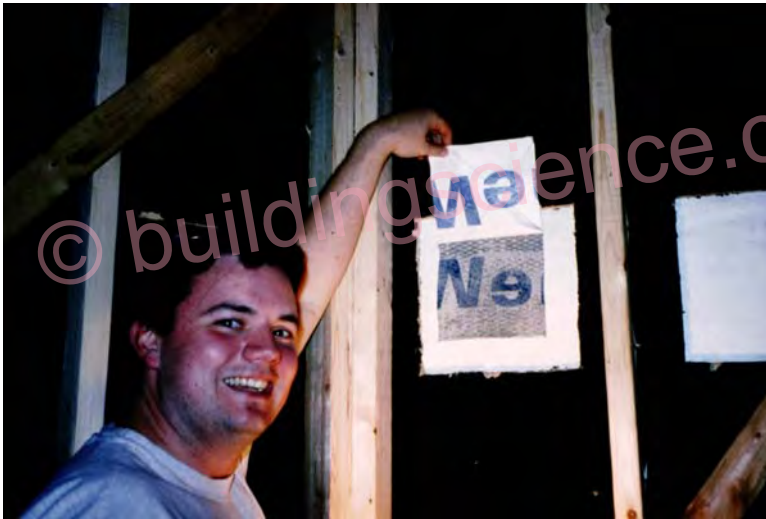
**Figure 6: Stucco renderings bonded to house wrap**

In the case of stucco, thin brick, and manufactured stone veneer, renderings tend to bond to all plastic housewraps and some building papers. This reduces or eliminates the ability of the assembly to drain.

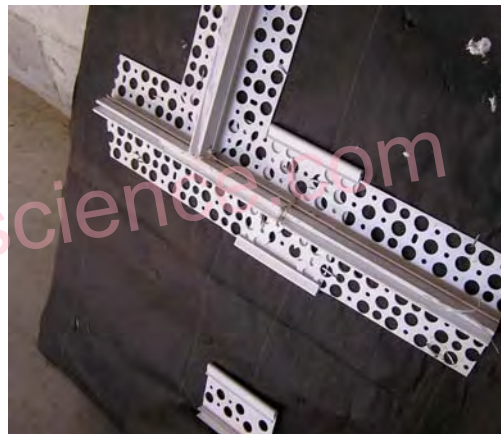
**Figure 7: Control joint over top of building paper (not recommended)**

Other drainage plane concerns with stucco can be created when there is a change in the back up wall construction. In Florida it is common for the main floor of the house construction to be concrete block while the top floor is wood frame. Stucco is commonly installed directly onto the concrete block with no building paper installed behind the stucco. This barrier cladding approach can be used successfully due to the capacity of concrete block to absorb water and dry out under more favorable conditions. The problem occurs at the transition between the drained and barrier cladding approach. Standard stucco installation practices have created a reverse flashing at this location. The stucco control joint is traditionally installed over top of the building paper. This directs the water towards the interior at the top of the masonry block.

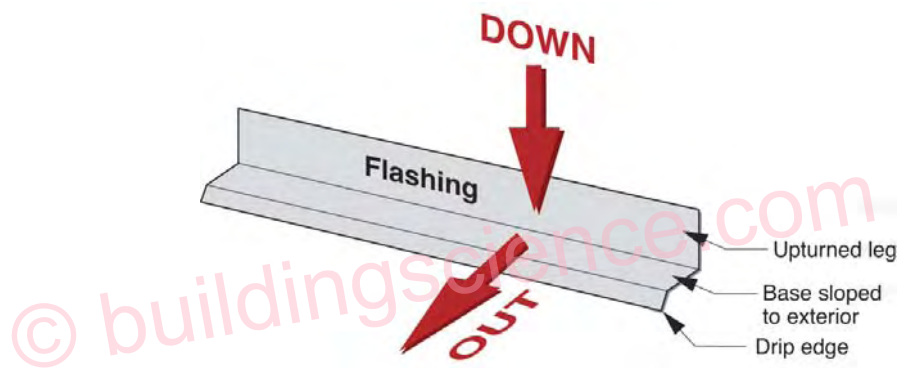
**Figure 9: Basic flashing principles**

Flashings should all be sloped in the direction of drainage. This may seem like a simple enough concept to incorporate into the design, however, surprisingly the most fundamental failure mechanism for a flashing installation is through installing the flashing with a reverse slope. With reversed sloped flashings water is held by the flashing and drains to the side and off the ends of the flashing back into the assembly. This can also hold water up against claddings and other materials, potentially reducing the service life of the products. All flashings should be installed with a positive slope to drain to the exterior.

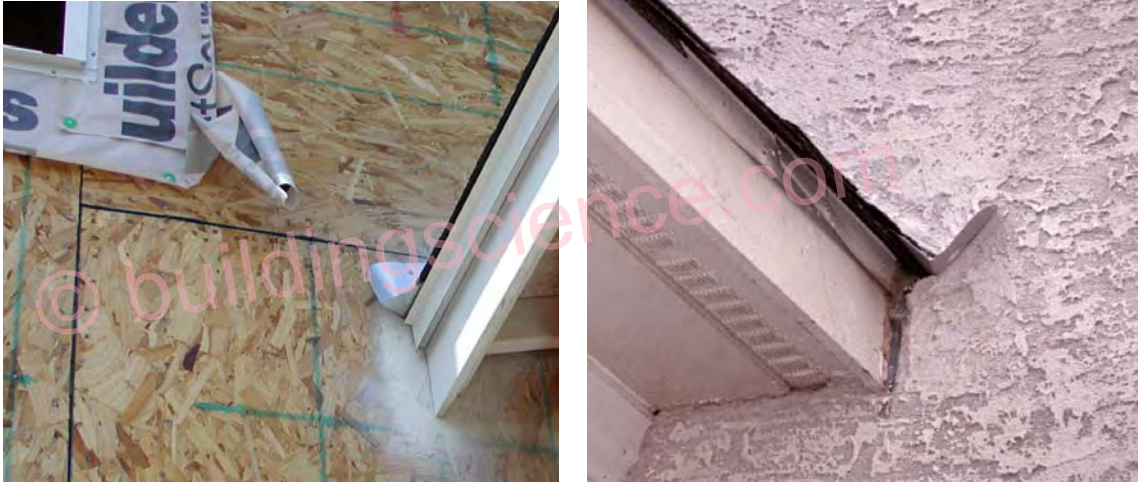
**Figure 12: Kick out flashing installations**

In order for the kick out flashing to be effective, the bottom seam must be properly sealed or folded to ensure that water does not leak through the joint. Improperly folded or sealed kick out flashings will cause a high water concentration to be poured behind the cladding.

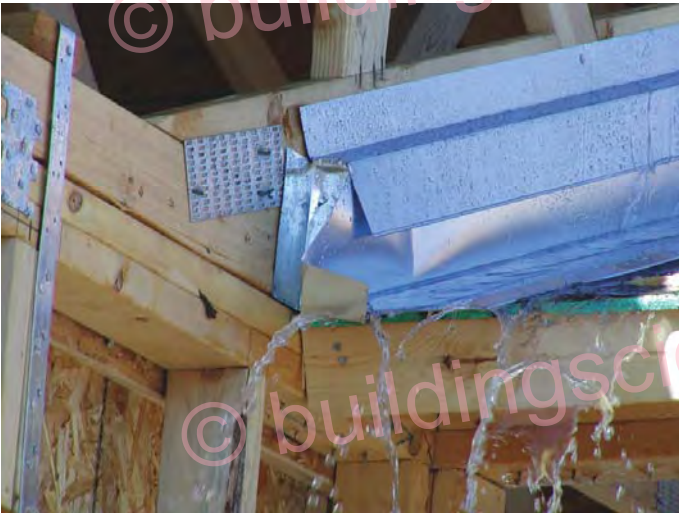
**Figure 13: Poorly folded kick out flashing**

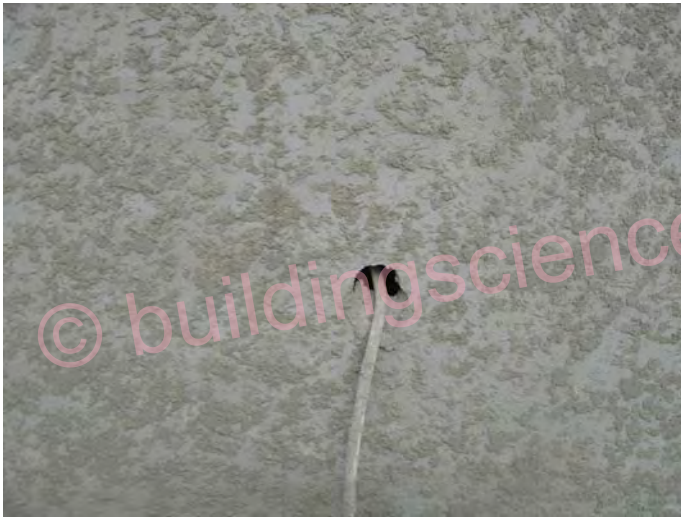
**Figure 14: Electrical utility installed after water management system**

Often miscellaneous penetrations such as mechanical penetrations, balcony railings, and or porch framing attachment are improperly integrated into the design and construction of the water management system of the building. Being less common than many other details they can be overlooked or improperly sequenced.

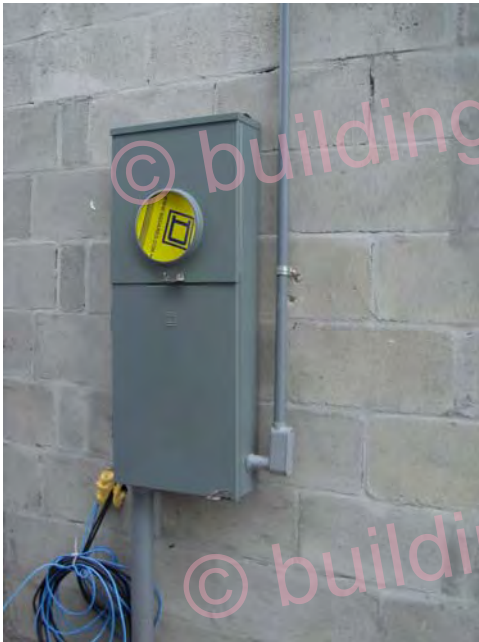
**Figure 15: Panel installed before installation of the drainage plane**

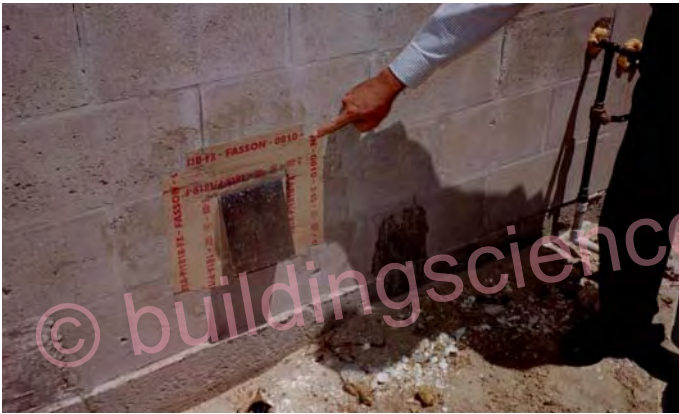
**Figure 16: Membrane flashed exhaust vent**

Mechanical penetrations, including exterior lighting, electrical boxes, dryer vents, gas utility penetrations etc. need to be properly flashed and integrated into the design of the water management system. This can often be achieved through the use of self adhered membrane flashings. Some products are also available that provide flanges that can be sealed and shingled lapped into the drainage plane permitting these penetrations to be more easily incorporated into the water management system.

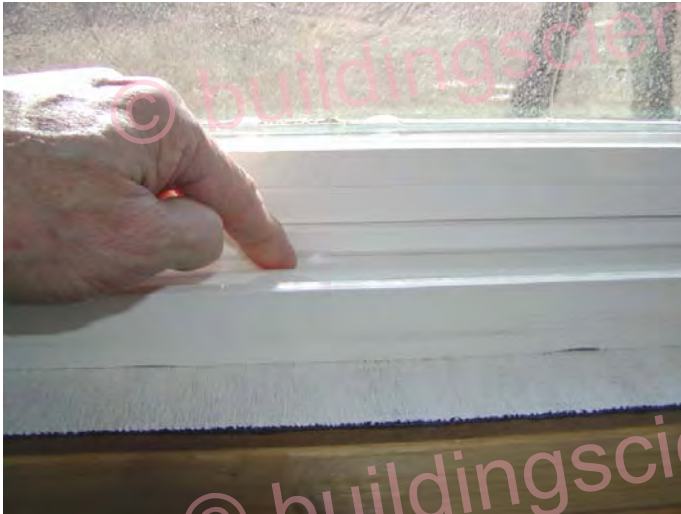
**Figure 19: Water intrusion through the window frame**

Leaks from windows have existed as long as windows have existed. Water not only leaked through the windows themselves, but also around the windows at the interface between the rough opening and the window frame. In many older solid masonry buildings this was not a problem due to the capacity of the construction to absorb moisture and dry out under more favorable conditions. As the construction industry changed, materials and assemblies began to be used that had less of a capacity to manage moisture. The absorption capacity and the drying potential of assemblies were significantly reduced. This led to serious building enclosure failures related to window leakage.

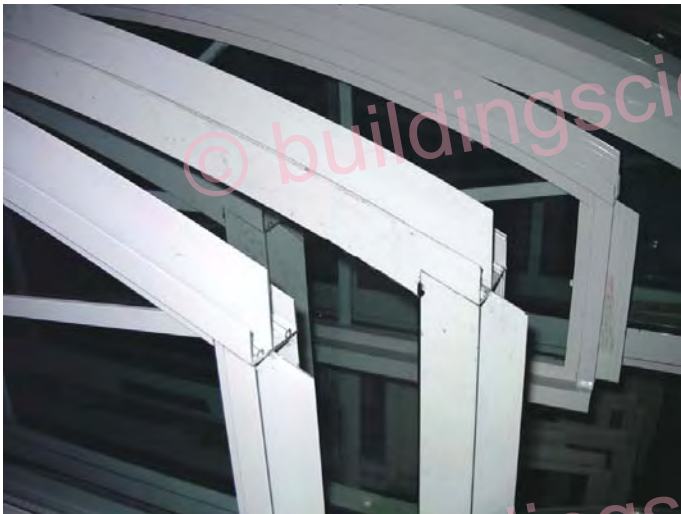
**Figure 20: Discontinuity of the nailing flange at the corners**

The nailing flange is usually a thin PVC or metal fin that is part of the frame extrusion and generally not very strong. These flanges can be damaged, bent or broken during the delivery or installation of the window system into the wall assembly, or may not be continuous around the window depending on the assembly at the corner joints of the frame. Damaged and broken nailing fins can lead to fundamental failures in the integrity of the drainage plane of the wall assembly as membrane tapes and building papers/housewraps no longer have adequate area of material to adhere to or cover over the flange.

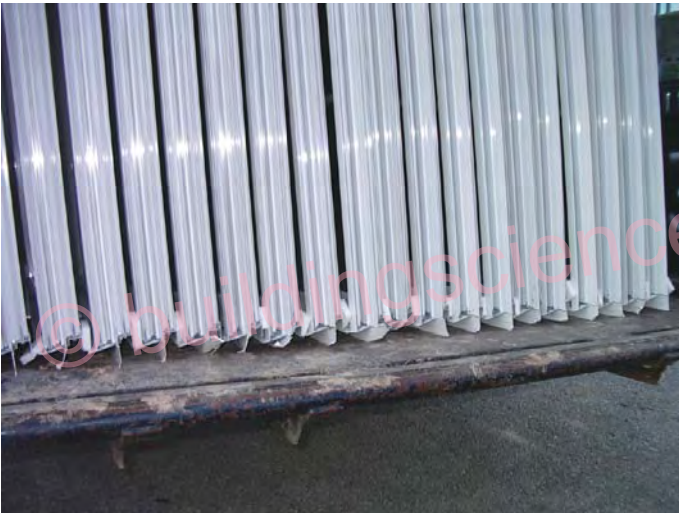
**Figure 21: Bent and damaged nailing flanges being delivered to site**

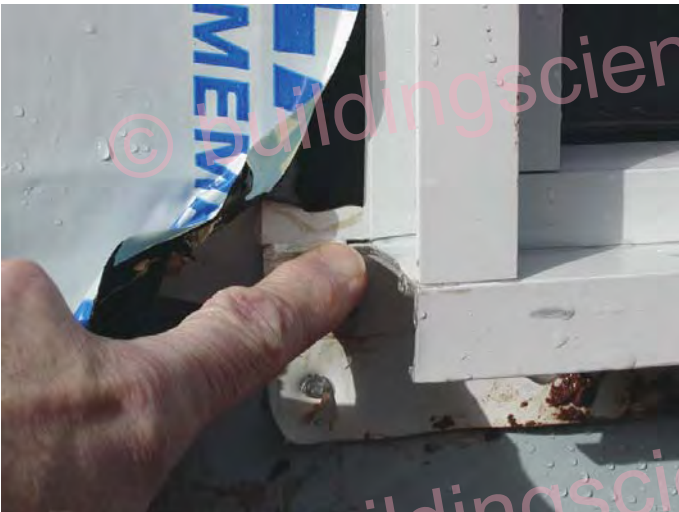
**Figure 22: Cracked nailing flange at corner connection**

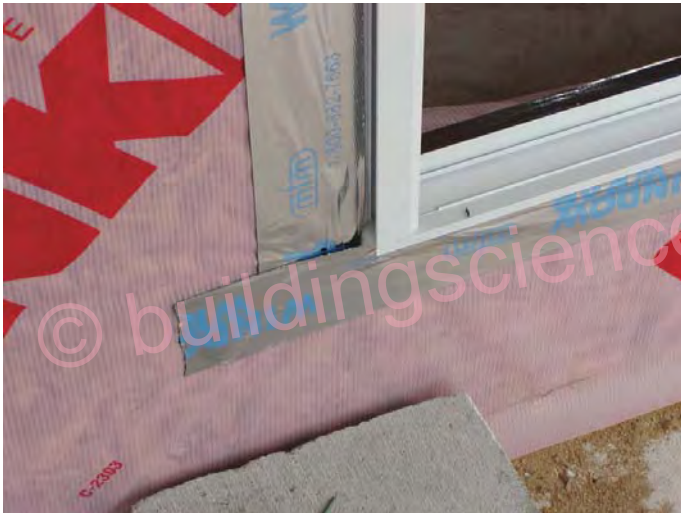
**Figure 23: Reverse lap of self adhered membrane at window sill in a barrier installation**

As long as the nailing flange is continuous and undamaged it can be effectively integrated into the moisture management of the wall assembly. Self adhered membranes are often used to integrate the nailing flange into the drainage plane of the water management system of the wall assembly. Self adhered membranes used to seal to the nailing flange must be installed, as with other water management concepts, in a shingle lap fashion to prevent reverse laps that can create paths for water intrusion. While this concept is generally understood, repetitive installations and requirements to complete the installations in a timely manner, has led to poor installations and problems with installation.

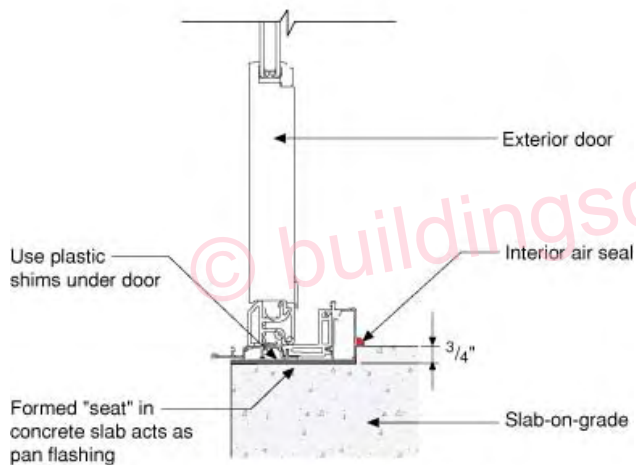
Forming a depression in a cast-in-place floor slab creates a built-in drainage pan for mulled entry doors and sliders, which are prone to leakage at joints.

**Figure 24: Sill and backdam options**

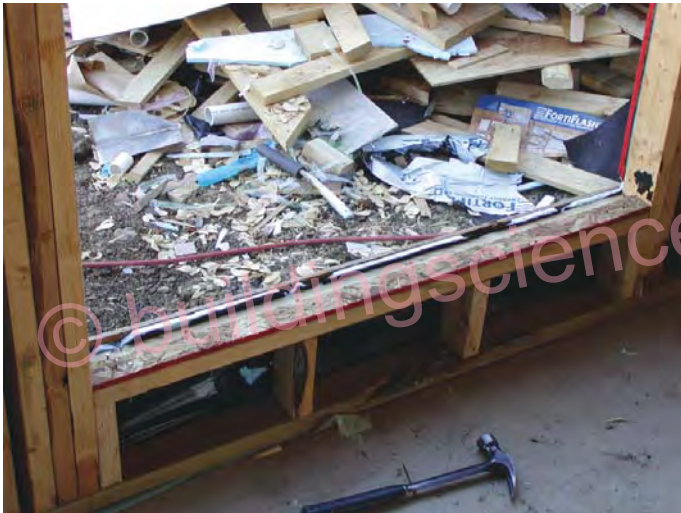
**Figure 25: Drainage blocked due to exterior sheathing above the sill framing**

The condition of the rough opening can affect the performance of the drainage of the pan flashing. The exterior sheathing must not extend higher than the sill framing. In this situation, even with a perfectly installed pan flashing, the drainage of the system will be compromised.

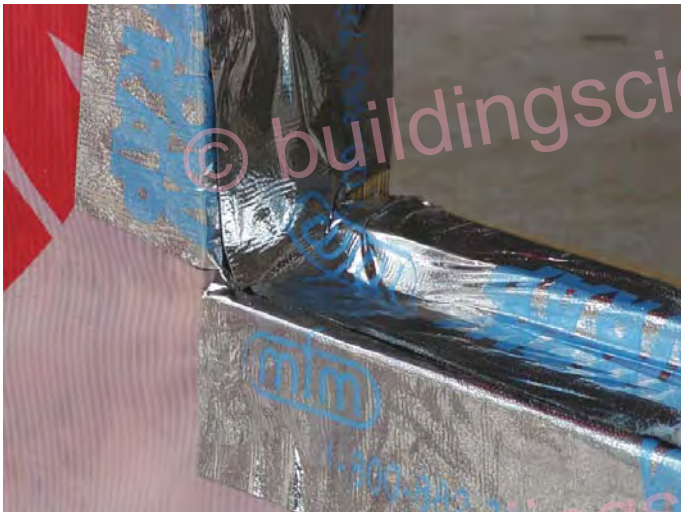
**Figure 26: Tenting of the membrane pan flashing in the corner**

Tenting of the membranes occurs when the membrane pieces are not seated properly into the corners of the sill rough opening. The result is a curved fillet, placing the flashing in tension with a void beneath. Because of this tearing of the membrane can occur during the installation of the pan flashing, or the sharp corners of the window frame can cut or damage the reinforcing of the membrane leading to failures in the integrity of the pan flashing.

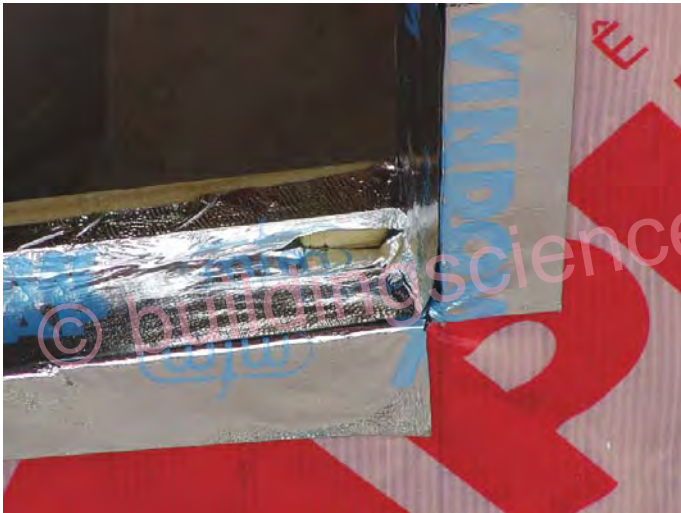
**Figure 27: Torn membrane pan flashing**

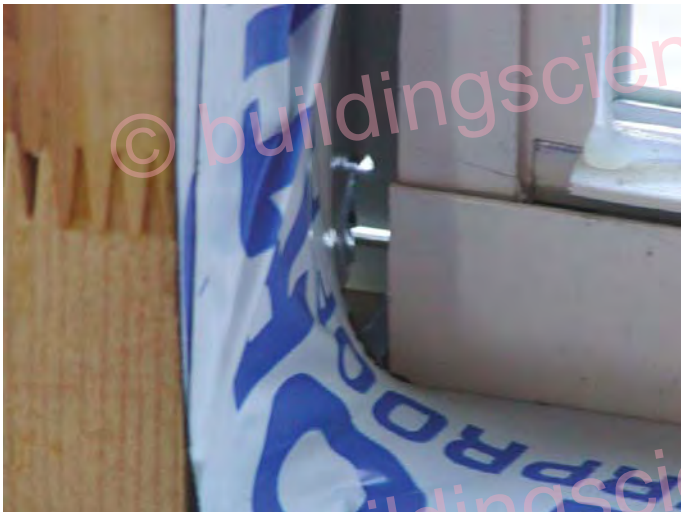
**Figure 28: Window corner cutting into improperly seated pan flashing**

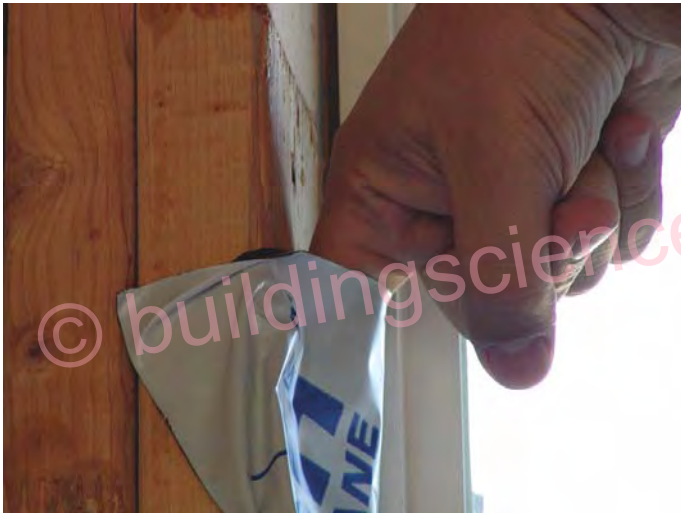
**Figure 29: "Fishmouthing" of the membrane**

Rushed installations also lead to problems with poor membrane installations and “fishmouths”. “Fishmouths” act as a funnel to direct water into the construction.

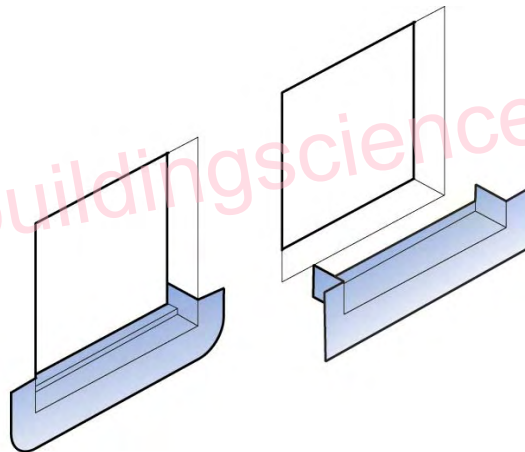
**Figure 30: Moldable membrane and preformed plastic pan flashings**

As a means to correct some of these concerns, other products available on the market such as moldable membrane flashings and preformed plastics can be used for the installation of the pan flashing. Moldable membrane flashings allow for a single piece of membrane to be installed at the corner of the sill as the membrane can stretch to fan out and curve around corners.

Preformed plastic pan flashings have also been developed to address this problem of time consuming and finicky work of creating pan flashings with membranes. The preformed plastic sections usually have integrated backdams as well. With these products the jambs and sill joint between the two pieces must still be sealed with membrane to prevent water intrusion below the pan flashing.

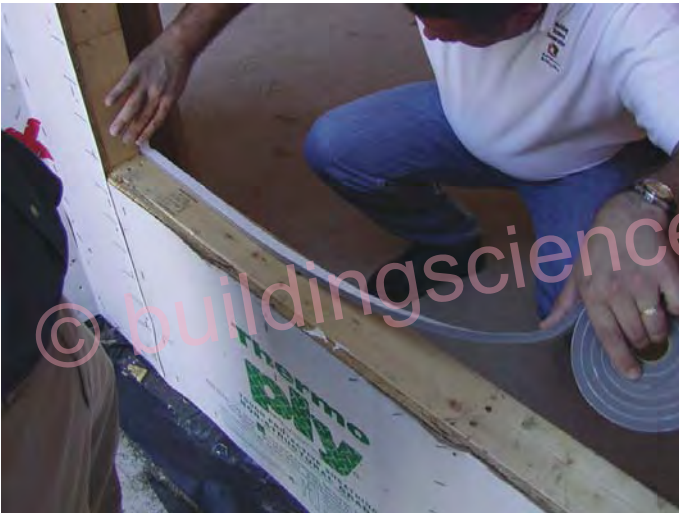
**Figure 31: Weather seal gasket used as a backdam**

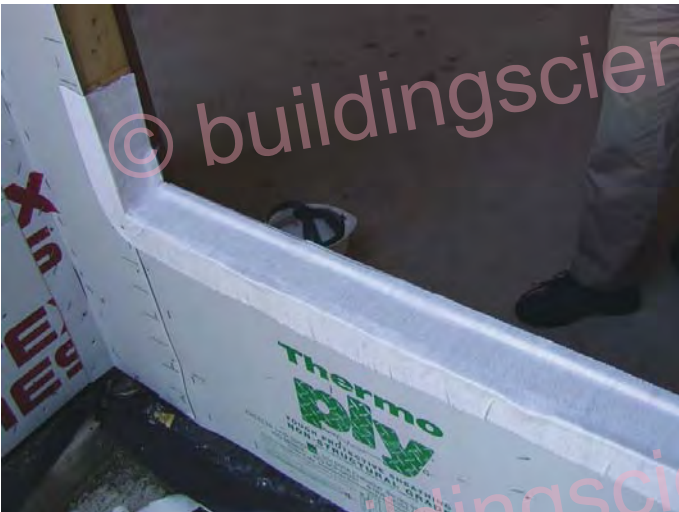
**Figure 32: Single piece moldable membrane pan flashing with backdam**

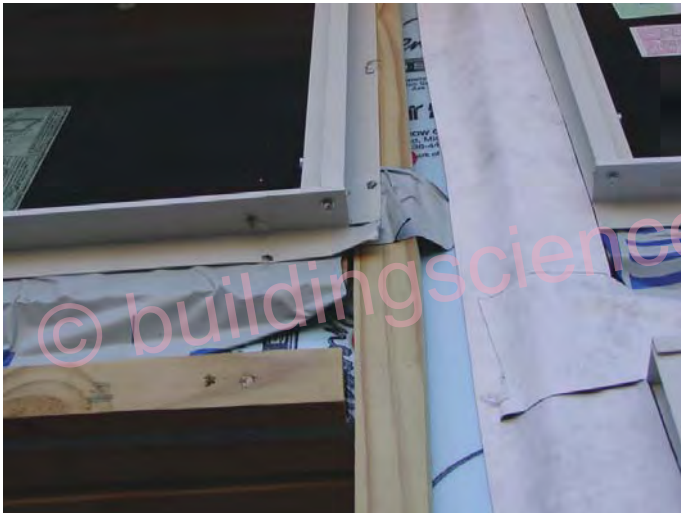
**Figure 33: Window furred out from the drainage plane (not recommended)**

Many architectural designs attempt to push the window frame further to the exterior of the wall assembly for aesthetic reasons. While it is possible to design the water management system to function adequately with this type of window installation, the difficulties associated with trying to move the window further to the exterior generally do not make this a recommended approach.

The furring strips move the window out of the drainage plane of the wall assembly. This adds more three dimensional complexity to the window, flashing, and housewrap installation details. Clearance requirements between adjoining assemblies can also become an issue. Most sheet good products become difficult to install in locations where there are multiple changes in plane in a relatively small location, often leading to poor installations and discontinuities in the drainage plane.
