Vancouver Field Exposure Facility: Phase IV Construction and Instrumentation Report

Research Report - 1305

April 2013

Phase IV Construction and Instrumentation Report

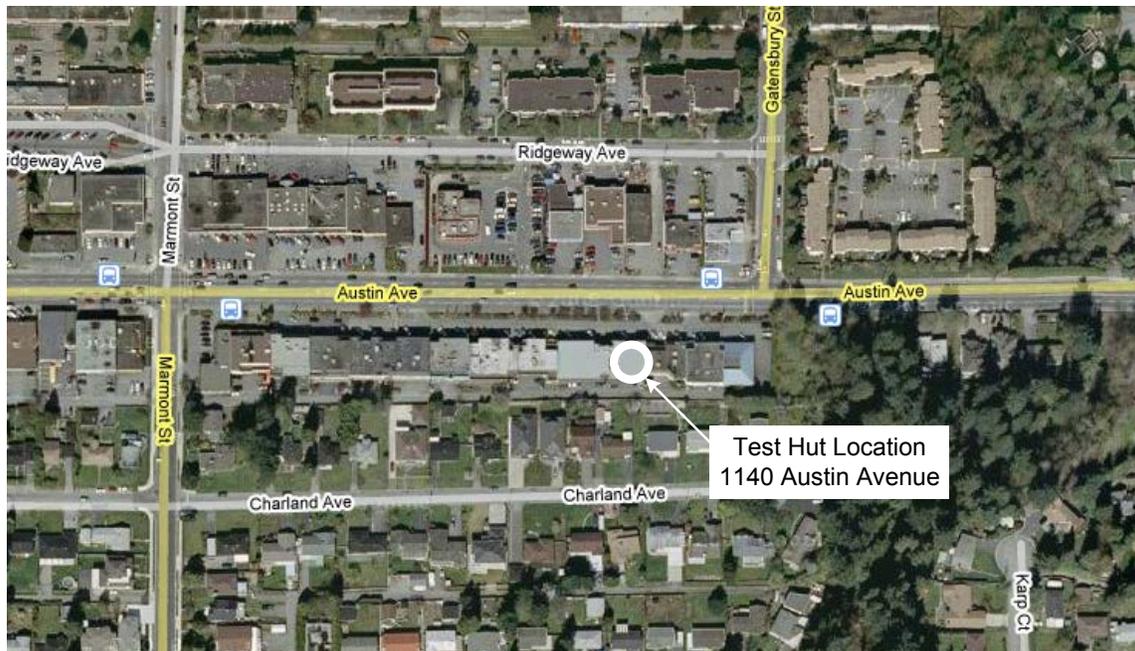
Figure 2 – Test Facility and Immediate Surroundings

The test facility was constructed on the roof of a low-rise office building that is owned by Gauvin 2000 Construction Ltd. (a British Columbia builder who is a co-sponsor of this research project). This eliminated the need to buy or rent a large empty site (with free wind approach) in the expensive real estate market of greater Vancouver. The location also affords the test facility some protection from potential vandalism. Figure 2 shows the location of the test facility

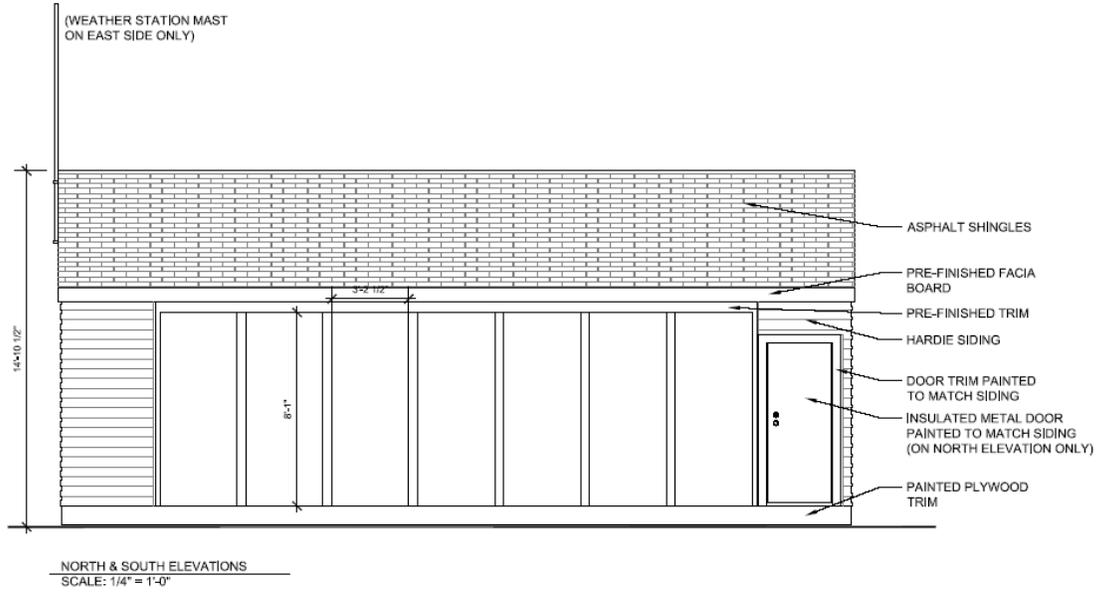
Figure 3 - North & South Elevation

relative to other buildings. Figure 3 and Figure 4 provide elevation drawings showing the facility's basic components.

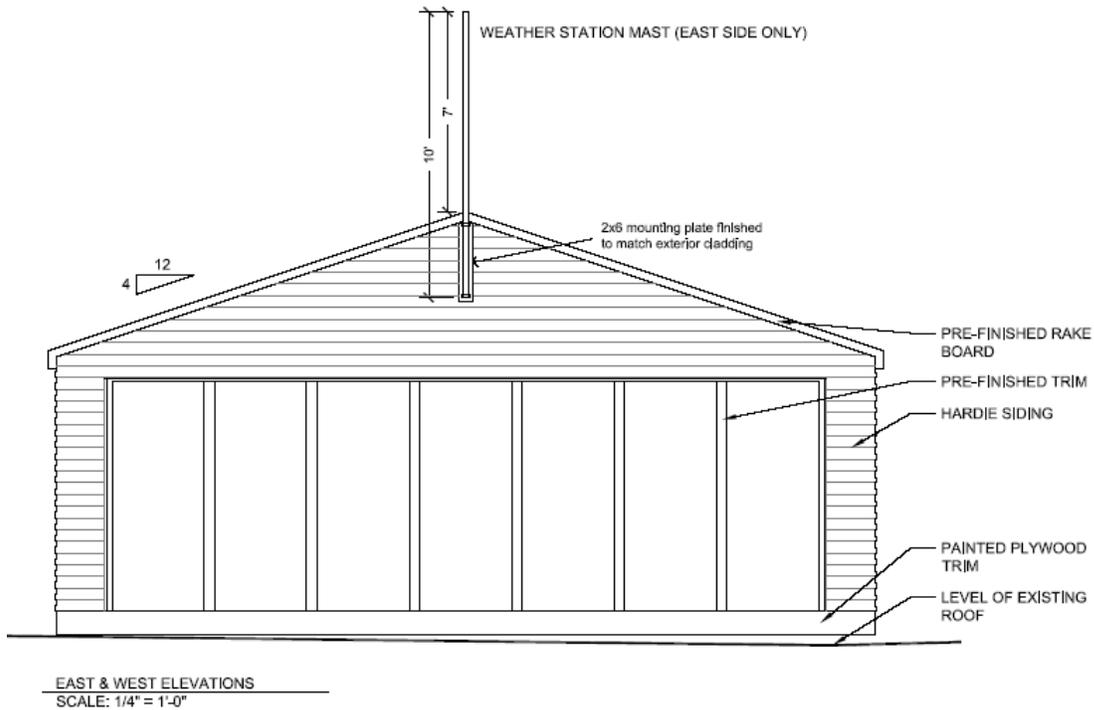
Figure 4 - East & West Elevation

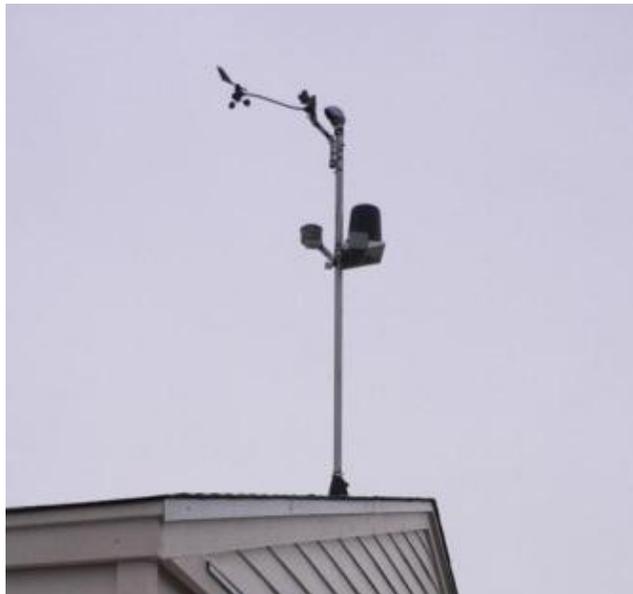
Figure 5 : Weather station on the roof of the Coquitlam Test Hut

A steel mast on the roof of the test facility supports a weather station at a height of 22 ft (6.7 m) above the roof of the office building and 50 ft (15.24 m) above ground level. The monitoring system continuously collects weather data, including: temperature, relative humidity, wind speed and direction, rain, and solar energy.

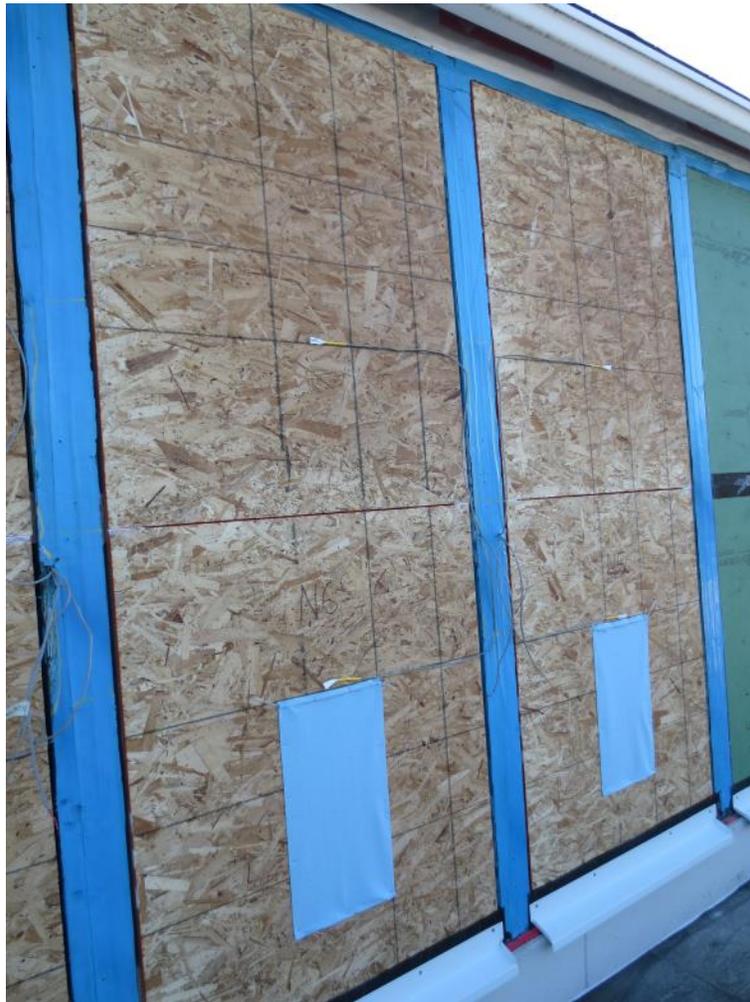
Figure 6 : Exterior wetting apparatus

The main objective of Phase IV is to determine how various configurations of exterior low vapor permeance insulation affect the moisture durability risk of structural wood-based sheathing. To assist with this analysis, the walls will be exposed to intentional wetting events of a known volume at a known time, using a water-storage medium directly in contact with the interior or exterior of the sheathing. Figure 6 shows examples of the exterior wetting storage media. These media are connected to the interior conditioned space with a tube so that water can be injected after all components of the wall assembly are in place.

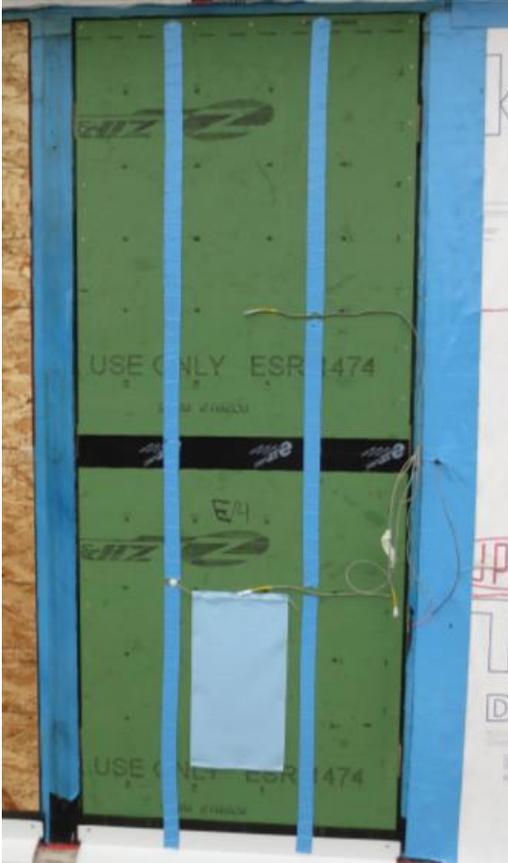
Figure 7 : Wall 4 - Huber ZIP sheathing with vertical Blueskin spacers

Wall 4 was constructed with 1.5" (3.8 cm) of taped exterior XPS insulation over Huber Zip sheathing. Zip sheathing is specially designed structural sheathing with the sheathing membrane laminated to the surface of the OSB panel so the exterior surface can act as a drainage plane (WRB); to ensure a drainage plane, taping of the joints with Zip tape is required. In this test, the Huber ZIP sheathing was taped to provide an air barrier and secondary drainage plane, but the primary drainage plane is the exterior taped surface of the XPS insulation. A small drainage gap (approx. 1/8"[3.2 mm]) was formed by installing 2" (5.1 cm) wide strips of blueskin flashing over the Zip.

On the interior, standard fiberglass batt (without Kraft facing) was used, so the latex paint was the only interior vapor control. Using a Class III latex paint as the vapor control layer should allow more water vapor to move through the interior of the wall system, either from the interior environment during elevated interior relative humidities, or from the wall stud cavity to the interior environment during intentional wetting events. This wall will be compared to other test walls to determine what moisture performance differences resulted from using a latex paint vapor control layer. The taped ZIP sheathing with the vertical blueskin peel and stick prior to installing the exterior insulation can be seen in Figure 7.

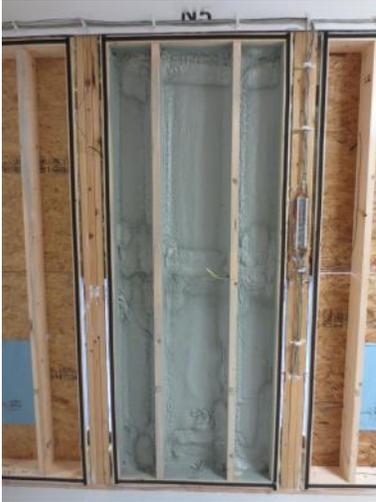
Figure 8 : North Wall 5 with approximately 2" of closed cell 2pcf spray foam

Wall 5 was constructed with 1.5" (3.8 cm) of exterior foil-faced polyisocyanurate insulation (PIR). There is a 1/8" (3.2 mm) drained/vented cavity² between the OSB sheathing and foil-faced polyisocyanurate. On the interior of the OSB sheathing, 2" (5.1 cm) of 2 pound per cubic foot (pcf) closed cell spray polyurethane foam (SPUF) was installed. It should be noted that inspection of the spray foam following installation showed that the thickness of the spray foam ranged from approximately 1" to 1.75". The spray foam significantly decreases drying and redistribution to the interior of any water in the OSB sheathing. The interior wetting system was partially protected against direct contact with the spray foam to ensure that water would still distribute against the sheathing for wetting comparison purposes. Closed cell spray foam in the stud cavity is a worst case scenario for inward drying and water redistribution. R13 fiberglass batt was installed in the remaining cavity space to the interior of the spray foam. The performance of Wall 5 will be compared to Wall 7, which is also constructed of vented PIR but without spray foam in the cavity. Wall 5 is shown in Figure 8 and Figure 9.

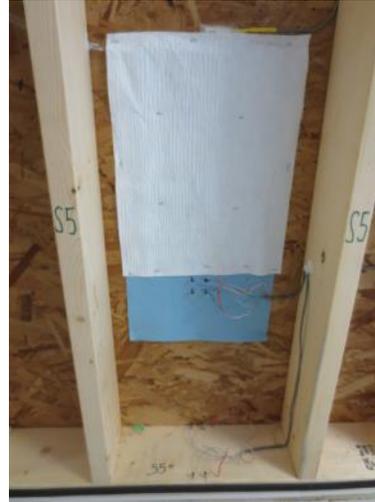
Figure 9 : South Wall 5 – Interior Wetting system protected from spray foam

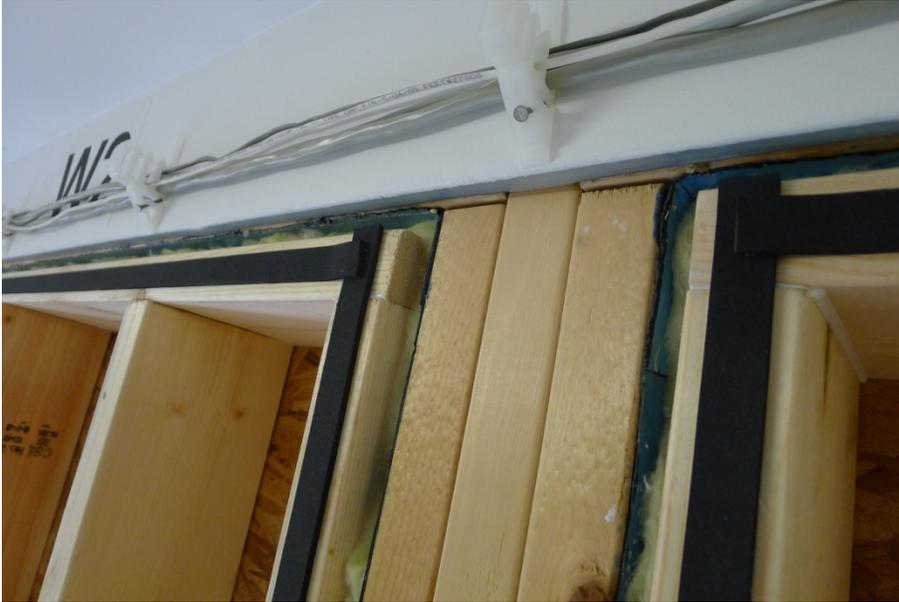
Figure 10 : Gasket installed on the interior edge of the framing as airseal

Based on our experience, it is critical with full scale wall testing to eliminate air movement between the interior conditioned space and the interior of the test wall. This is achieved with a gasket installed around the perimeter of the wood framing (Figure 10).

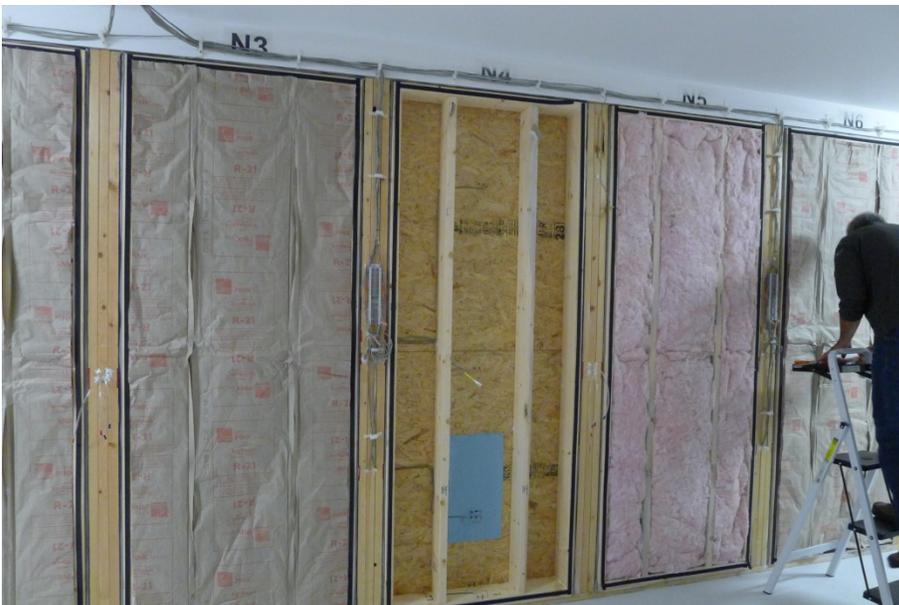
Figure 11 : Interior of test wall panels on the north orientation

Figure 11 shows the interior of test wall panels on the North orientation including the foam gaskets and installation of most fiberglass batt insulation. Walls 4 and 5 were constructed with unfaced fiberglass batt, but all other walls were constructed with a kraft facing vapor control layer.

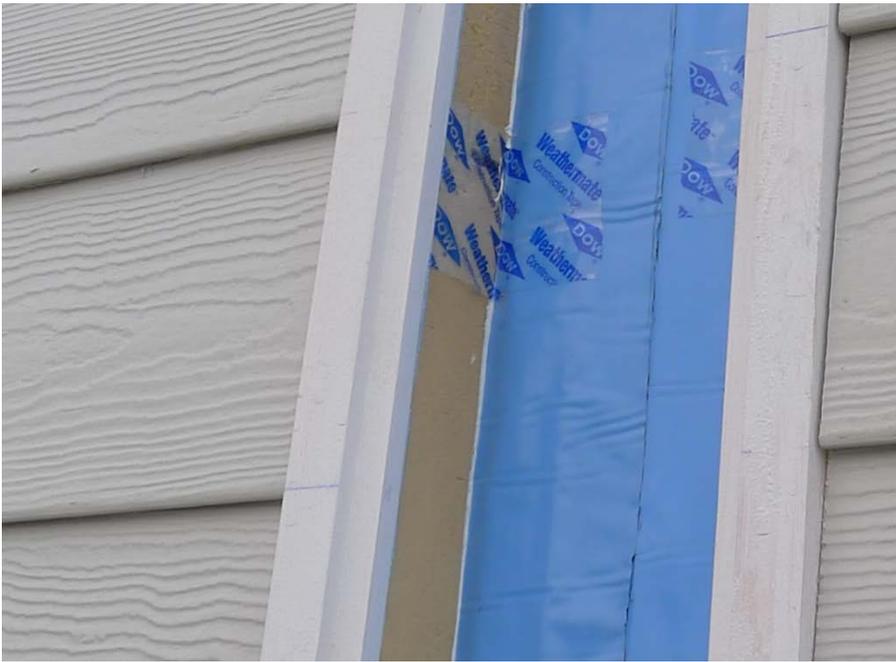
Figure 12 : Sealant installed at the interior surface of exterior insulation

Sealant was used to eliminate any airflow between the wall panel and the adjacent cavity at the interface of the sheathing and exterior insulation (Figure 12). Sealant was also used at the top of the exterior insulation to eliminate any ventilation of the cavity. This is particularly critical on the two walls with a 1/8" drained and ventilated cavity to the interior of the foil-faced

polyisocyanurate exterior insulation so that we do not encourage ventilation and outside air bypass of the insulation. Figure 12 also shows the peel and stick used to seal the sheathing of the wall panel to the structure, to ensure an air tight seal between the test wall and structure.

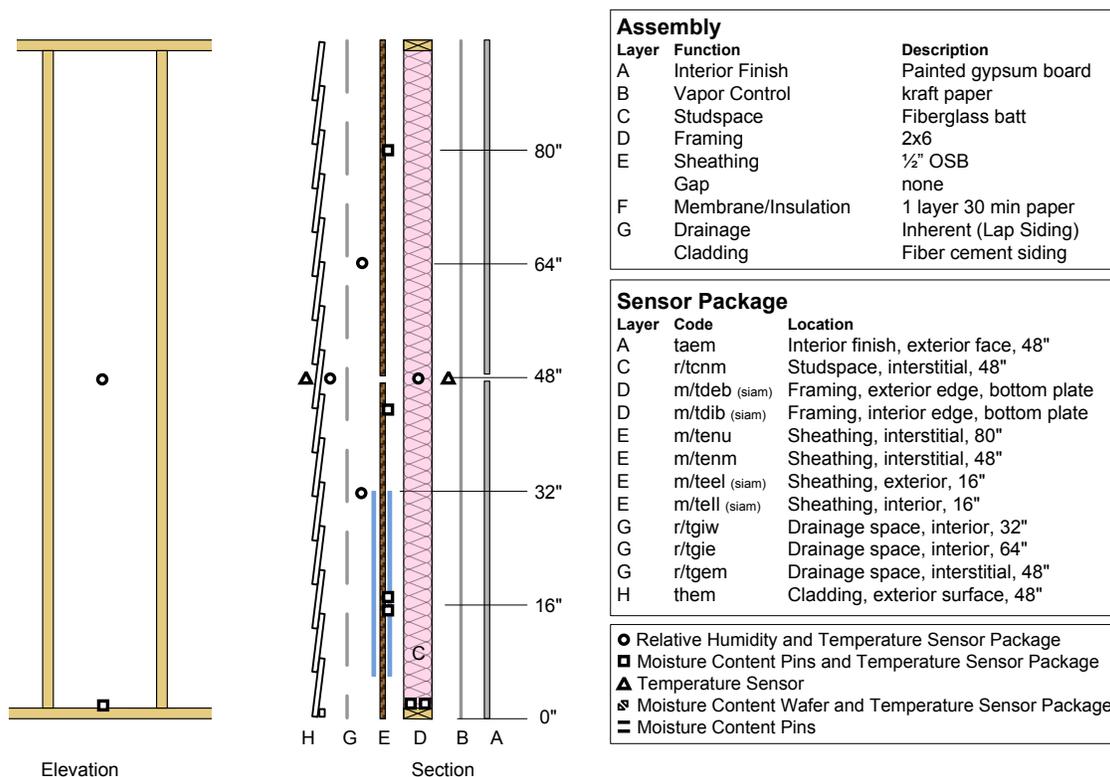
Wall 1 FC Siding, 1 x 30 min paper, OSB, 2x6, kraft faced batt, latex paint (Base Wall)

Figure 13 - Typical Instrumentation Package

Each of the test walls was outfitted with a series of temperature (T), relative humidity (RH) and wood moisture content (MC) sensors. These sensors will continuously monitor the test walls and record to the data acquisition system throughout the testing period. All walls received a similar sensor package. This package is illustrated in Figure 13.

Moisture content pins were installed in the framing lumber and the sheathing (from the interior) in all wall systems. Wood moisture contents can be determined from electrical resistance of wood based on the Garrahan equation^{3,4}. These pins can be used to measure moisture content at any depth chosen because the pins are electrically insulated except for the tips. Measurements are most commonly taken at ¼" (6mm) tip depth. In this study, moisture contents were taken at two depths on the lower OSB near the wetting system. The wood moisture content pins were installed in combination with a temperature sensor in all locations. To correct the moisture content readings for temperature effects, a hole was drilled to the same depth as the moisture content pins and a temperature sensor was installed inside.

Relative humidity sensors were always installed in combination with temperature sensors, both of which were protected by a vapor permeable, water resistant cover. Relative humidity and temperature sensors were installed at the midpoint of the stud space, between the drywall and the sheathing, behind the drainage material at two heights and outboard of the drainage material at mid height.

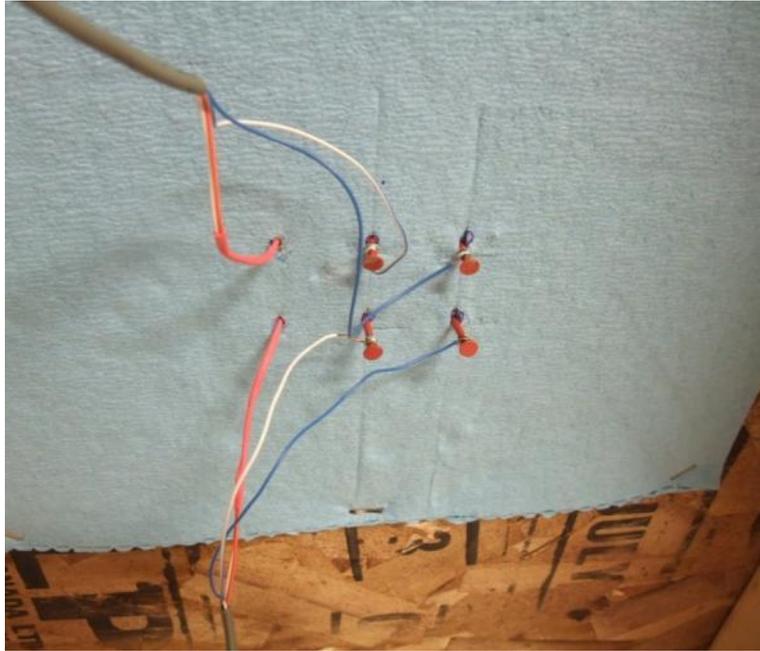
Figure 14 - Interior and Exterior Sheathing MC/T Sensors

Example photographs of the individual sensors are shown below in Figure 14 to Figure 18.

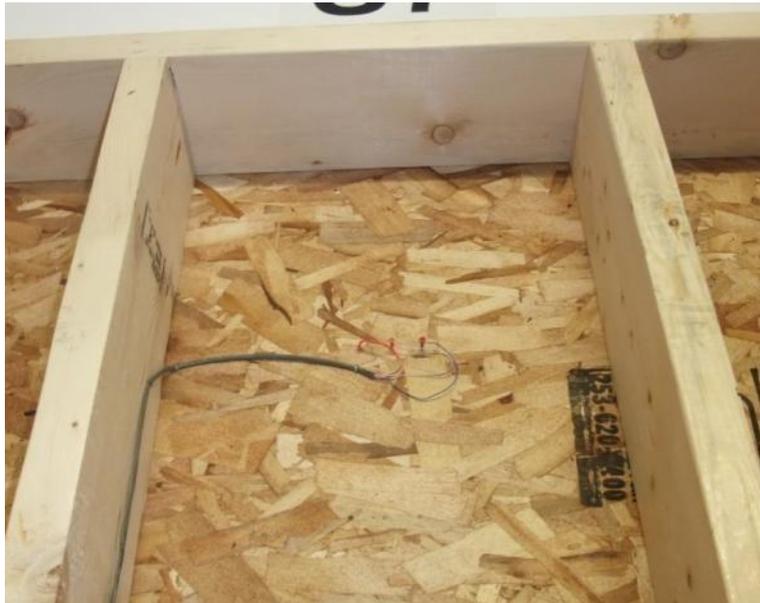
Figure 15 - Upper Interior Sheathing MC/T Sensors

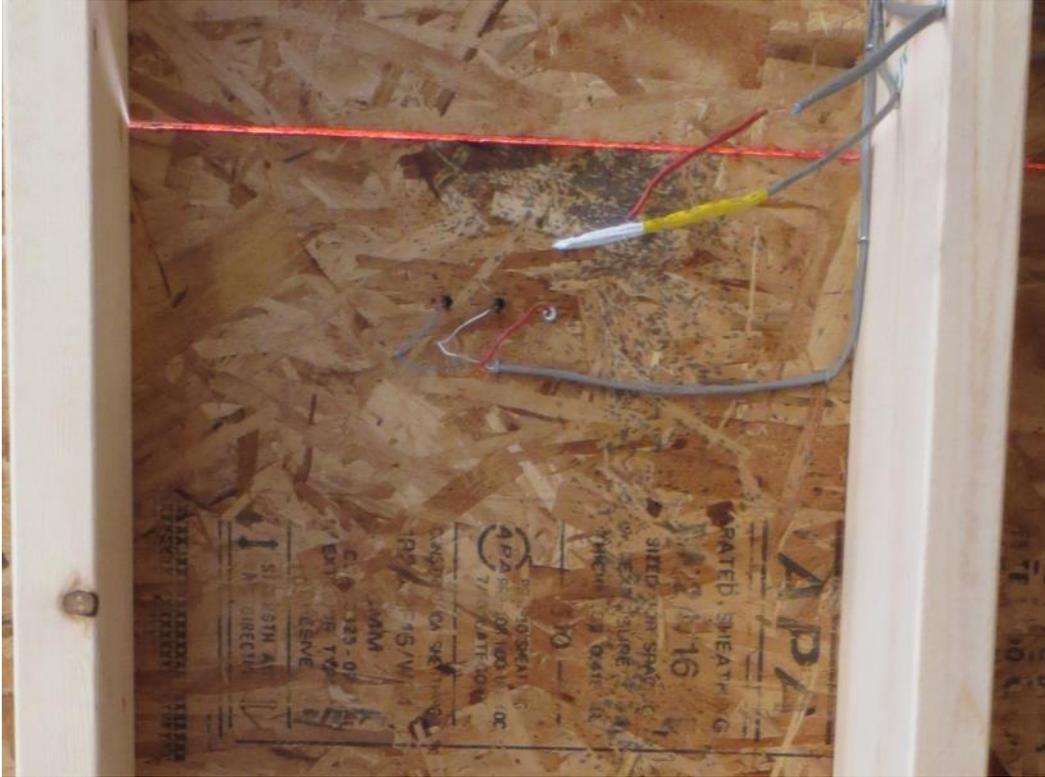
Figure 16 - Interior Mid-Height T, T/RH and MC/T sensors

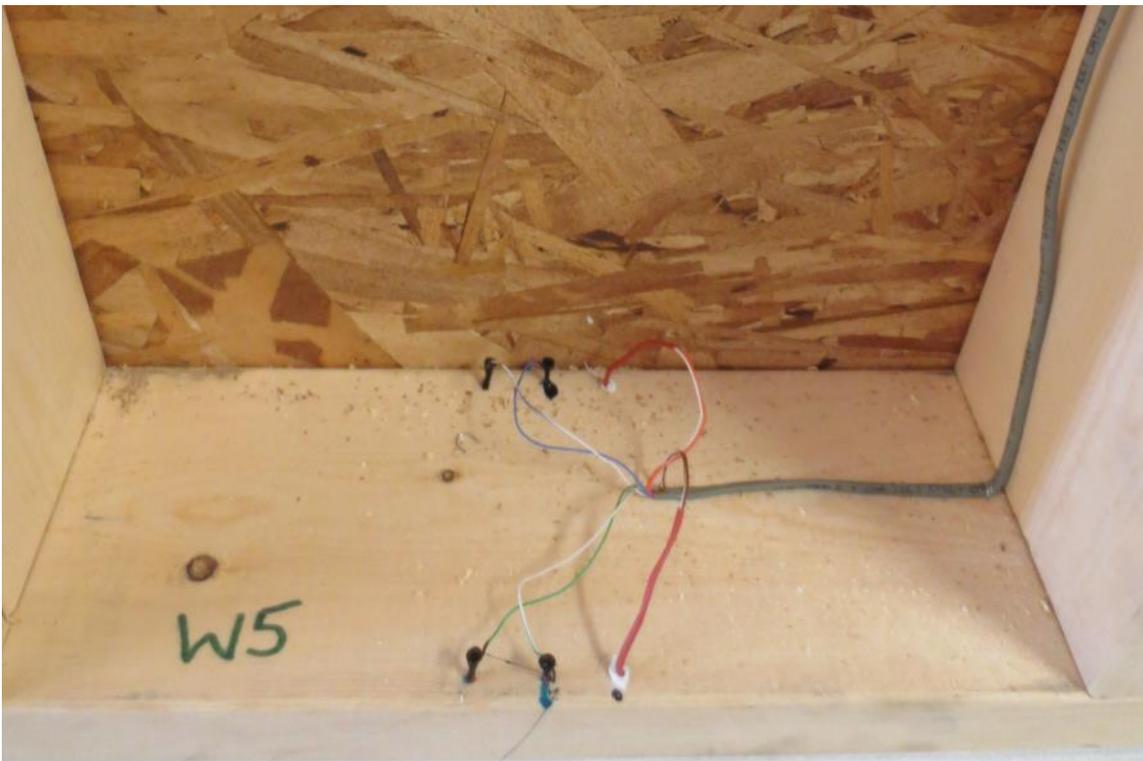
Figure 17 - Bottom Plate MC/T Sensors

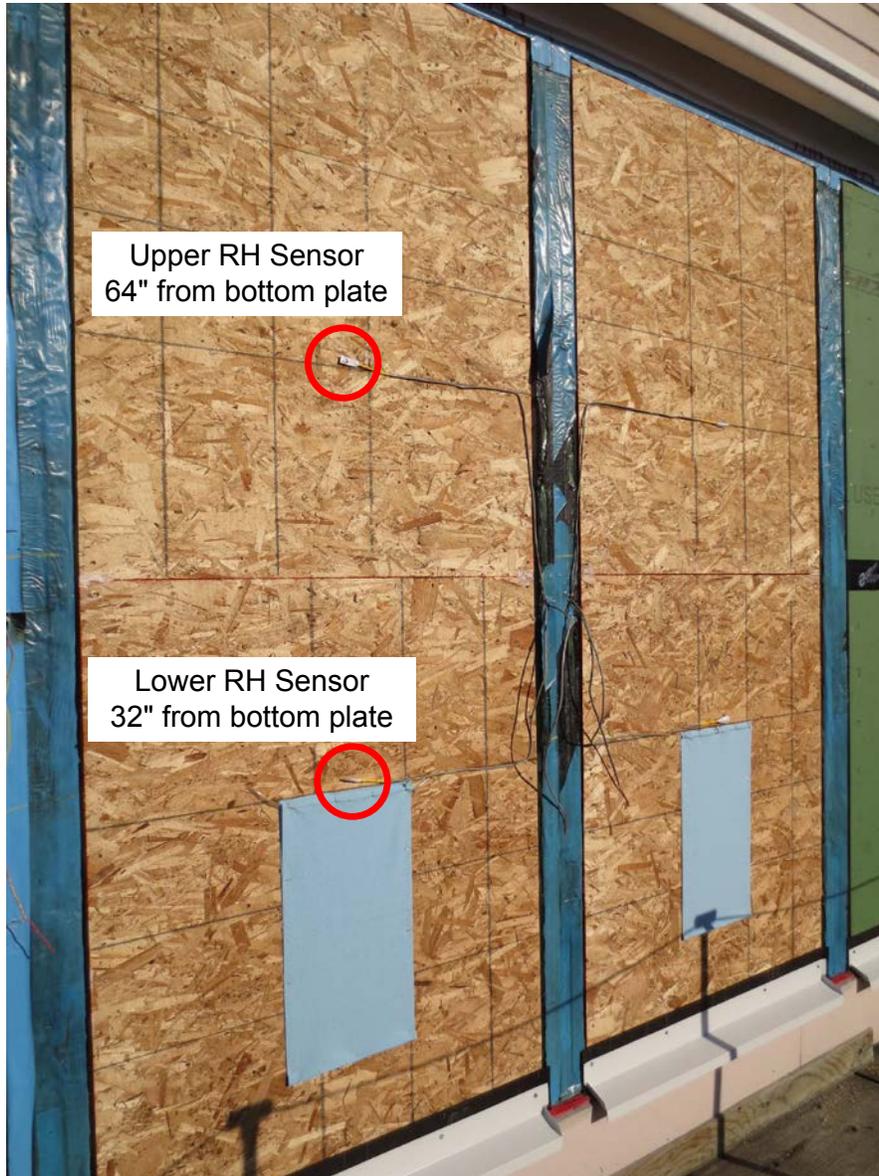
Figure 18 - Exterior Upper and Lower T/RH Sensors

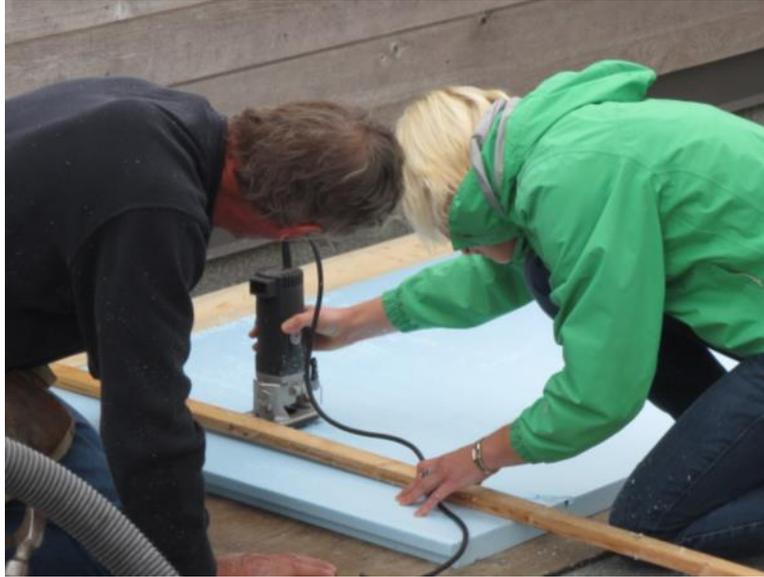
Figure 19 – Creating small grooves on the interior surface of board foam insulation

The sensors and wetting apparatus tube on the exterior of the OSB interfered with the direct applied exterior insulation that is typically in contact with the sheathing. Small grooves were carefully cut into the exterior surface of the exterior insulation (Figure 19) where necessary, so that the sensors and wetting apparatus tube did not affect the gap between the sheathing and the insulation. The grooves are shown in detail in Figure 20 with the corresponding tube and RH/T sensor.

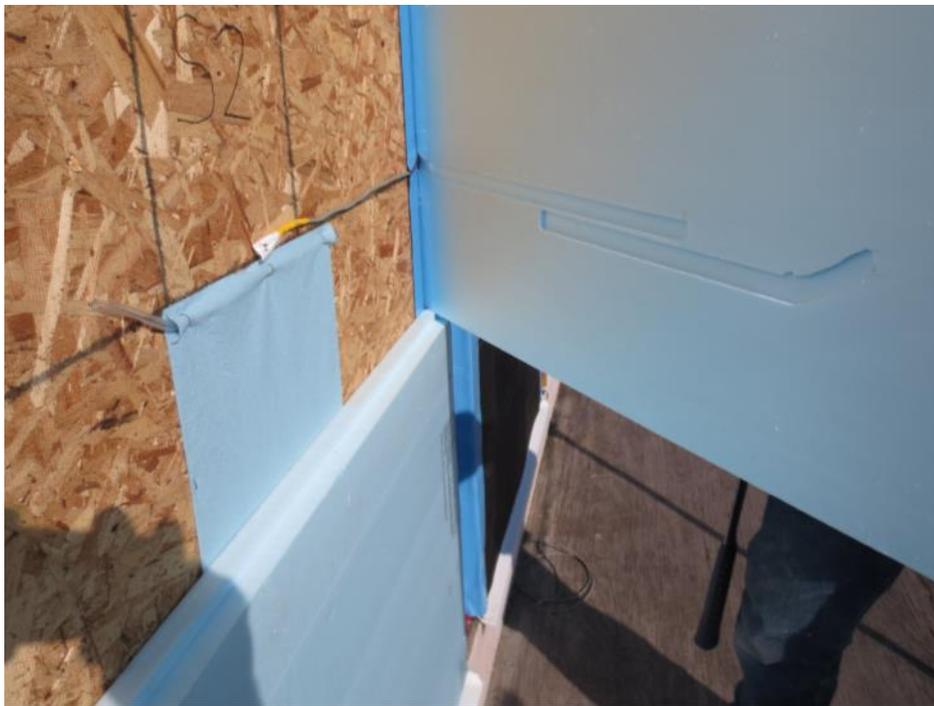
Figure 20 – Sensor and wetting apparatus tube pockets in XPS Insulation

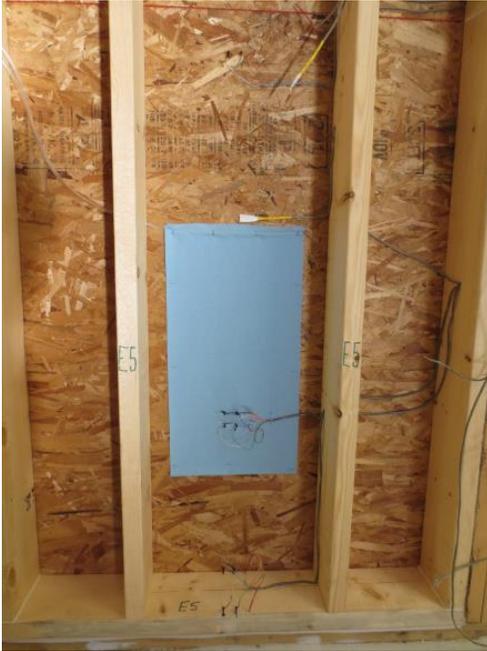
Figure 21 - Interior Wetting Apparatus

For Phase IV, wetting systems were installed on both the interior and the exterior of the exterior sheathing at locations similar to those in Phase III. These systems were used to help determine the drying potential of specific wall assemblies by allowing a known amount of water to be injected at a controlled time, simulating a window leak. The wetting apparatus consists of a storage medium and a tube connecting the medium to the interior of the test hut to enable wetting without opening the wall system. Photographs of the installed wetting systems are shown in Figure 21 to Figure 23.

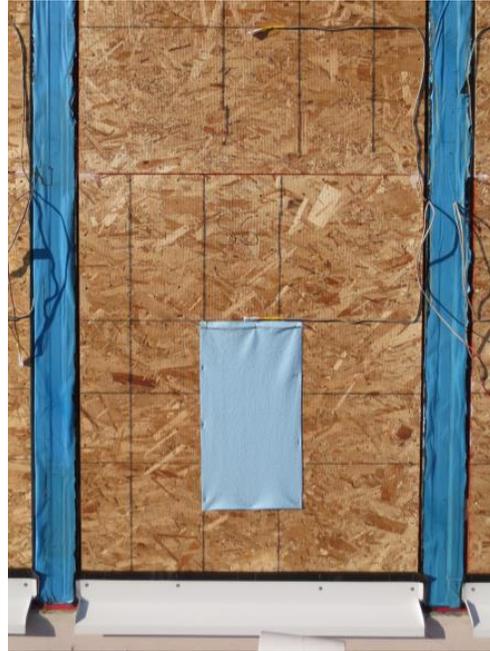
Figure 22 - Exterior Wetting Apparatus

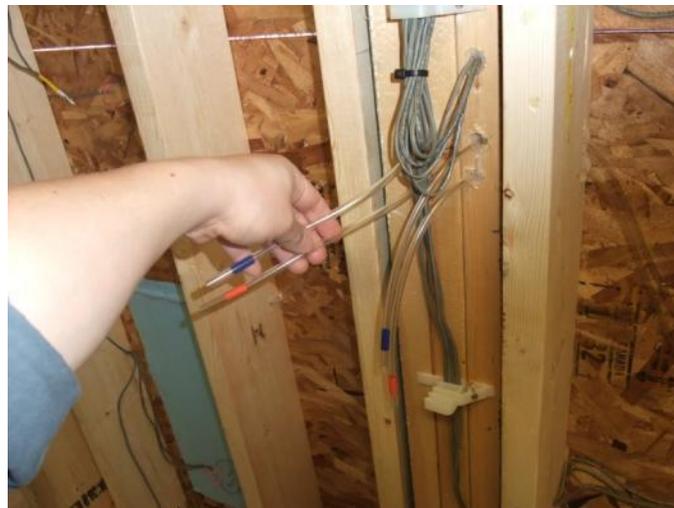
Figure 23 - Wetting Apparatus Injection Tubes

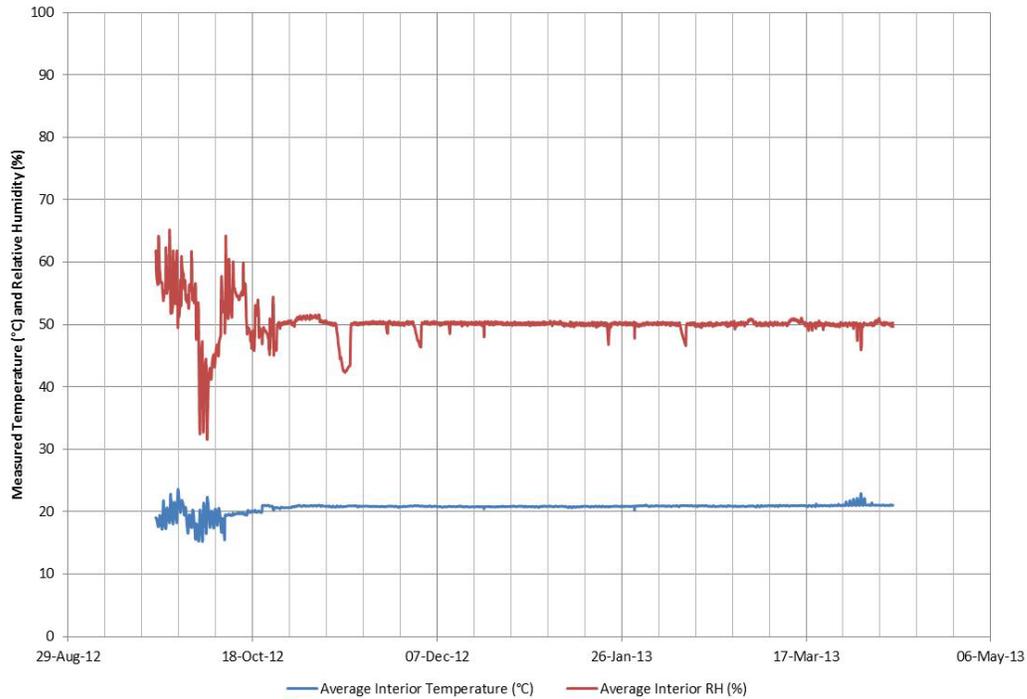
Figure 25 : Measured interior temperature and relative humidity

The following figures show the measured interior and ambient temperature and relative humidity since testing began.

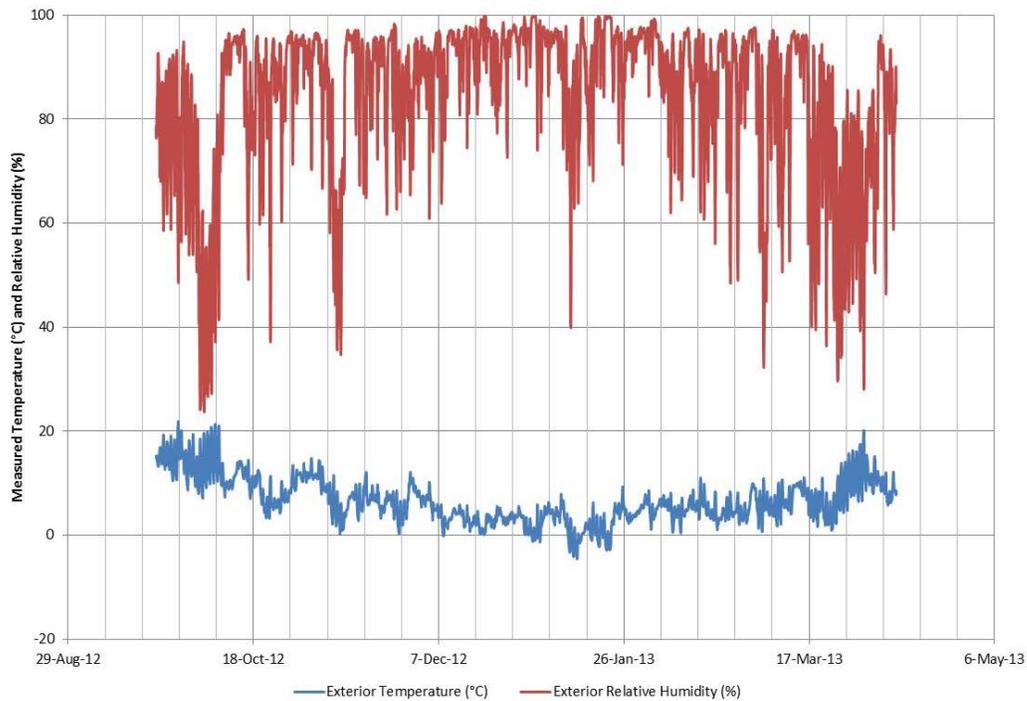
Figure 26 : Measured exterior temperature and relative humidity

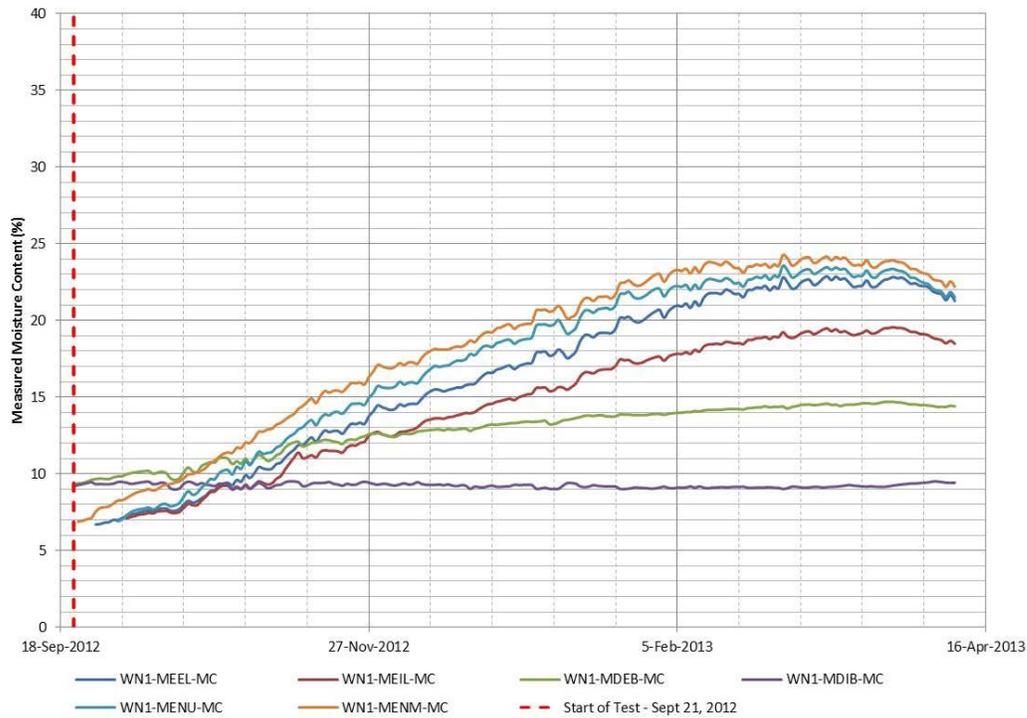
Figure 27 : North Wall 1 measured moisture contents

The following seven figures show the measured moisture contents for every wall on the North orientation as an example of the moisture content data that has been collected since testing began.

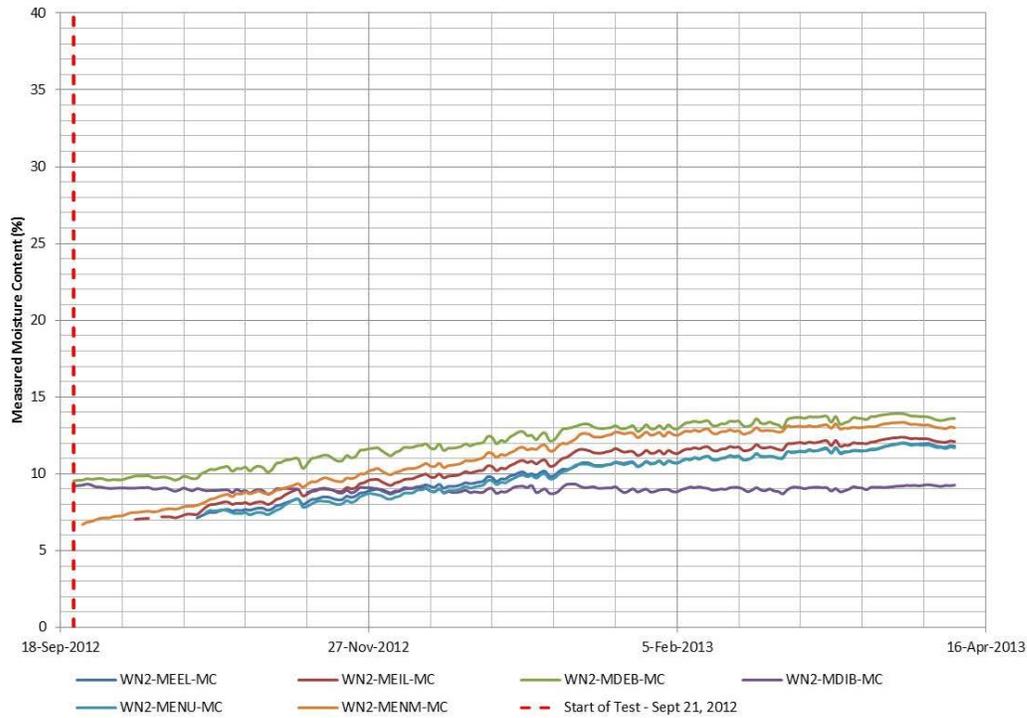
Figure 28 : North Wall 2 measured moisture contents

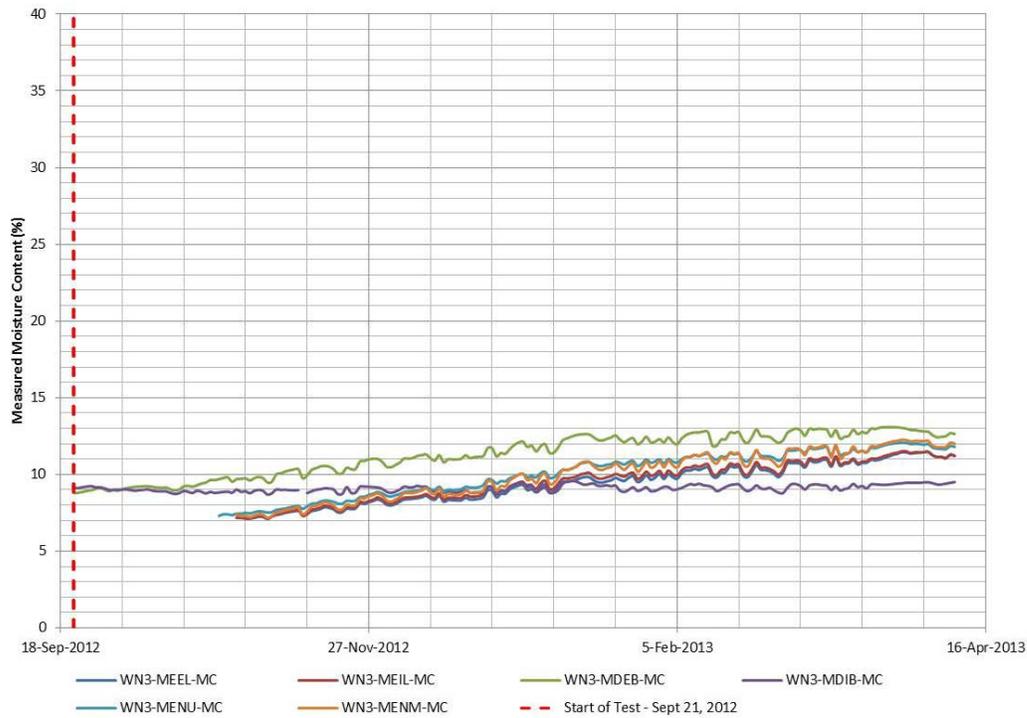
Figure 29 : North Wall 3 measured moisture contents

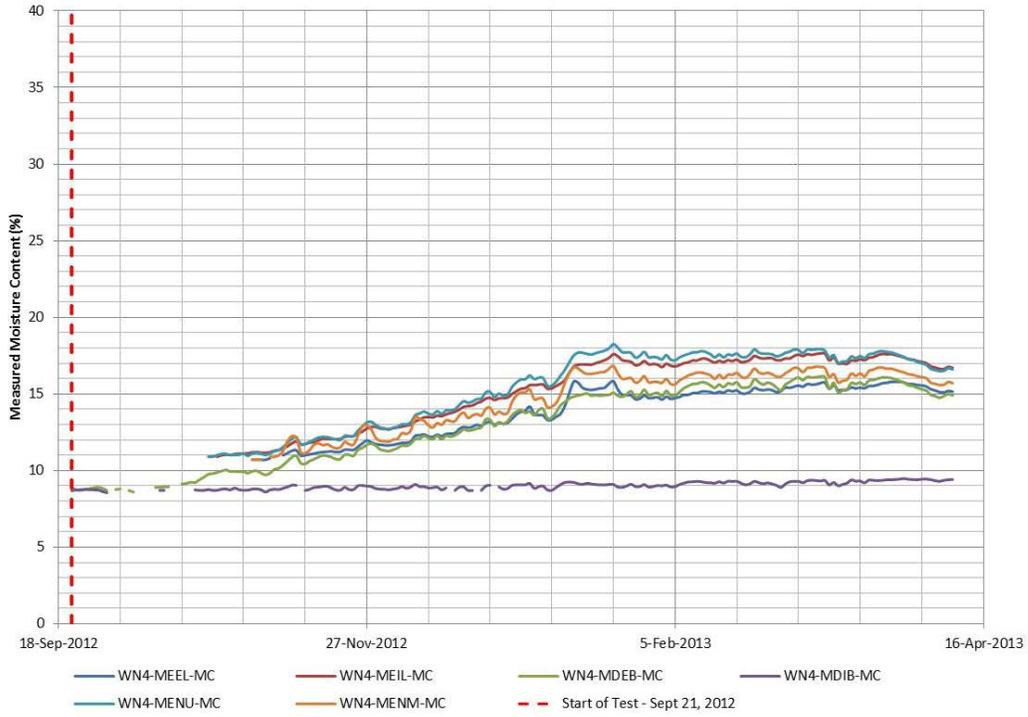
Figure 30 : North Wall 4 measured moisture contents

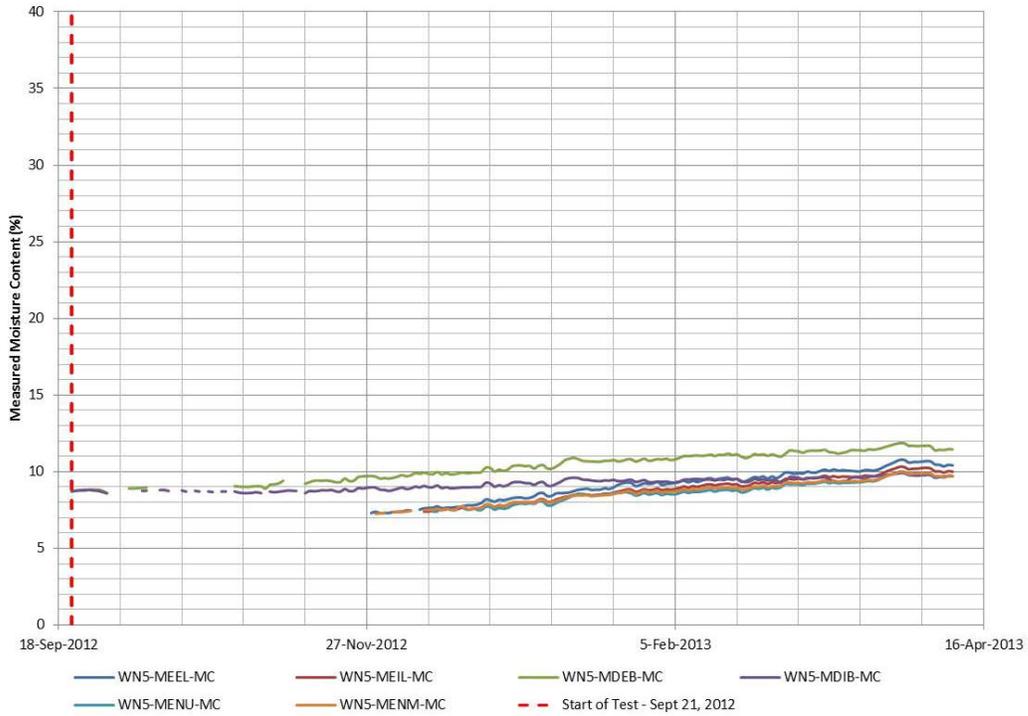
Figure 31 : North Wall 5 measured moisture contents

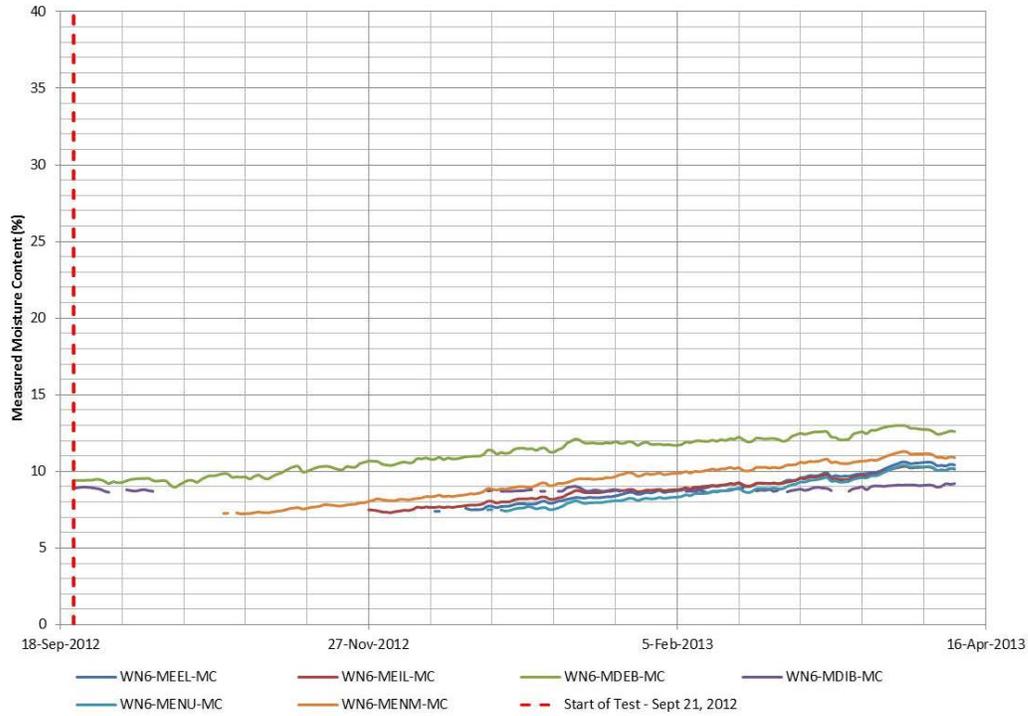
Figure 32 : North Wall 6 measured moisture contents

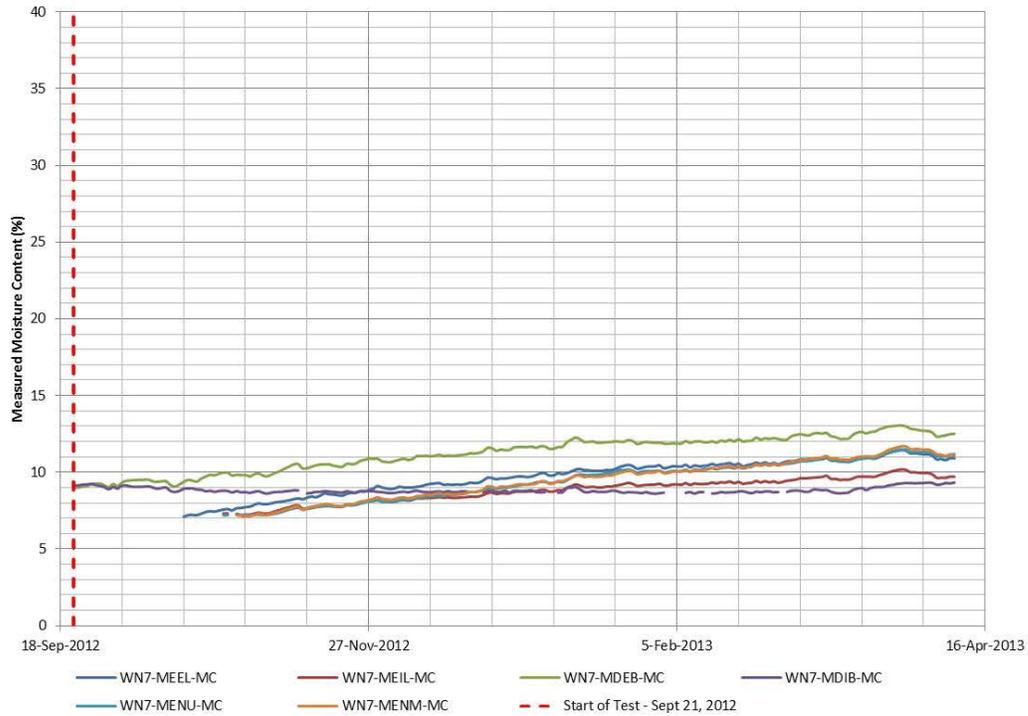
Figure 33 : North Wall 7 measured moisture contents

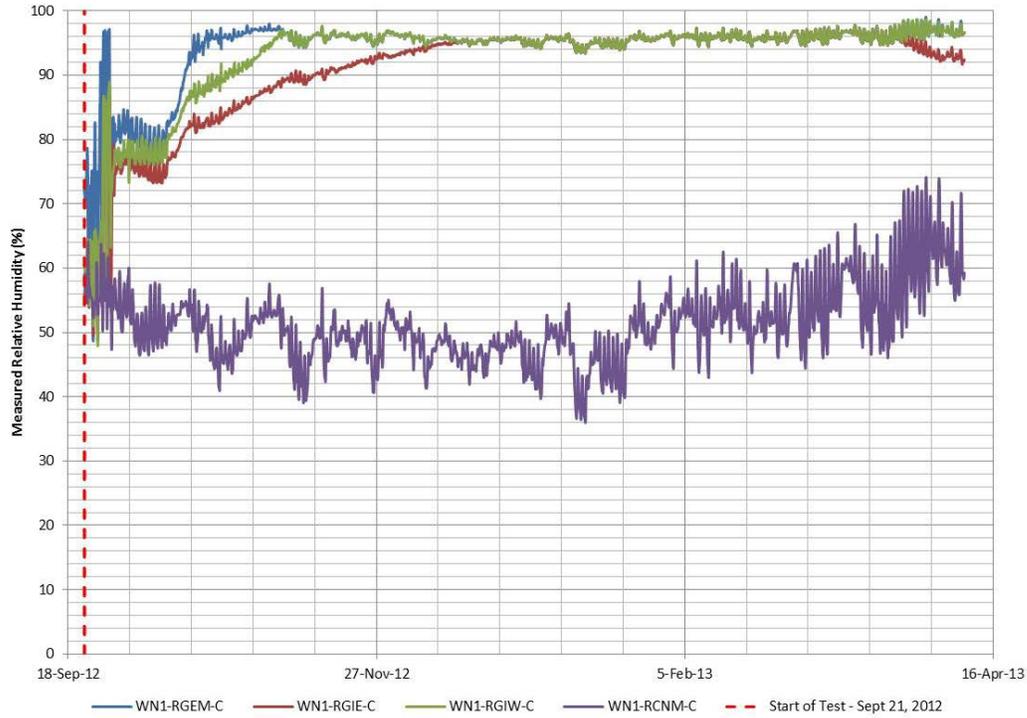
Figure 34 : North Wall 1 measured relative humidity

The following seven figures show the measured relative humidity in each wall on the North orientation as an example of the relative humidity data that has been collected since testing began.
