Vancouver Field Exposure Facility: Phase IV Construction and Instrumentation Report

Research Report - 1305

April 2013

Phase IV Construction and Instrumentation Report

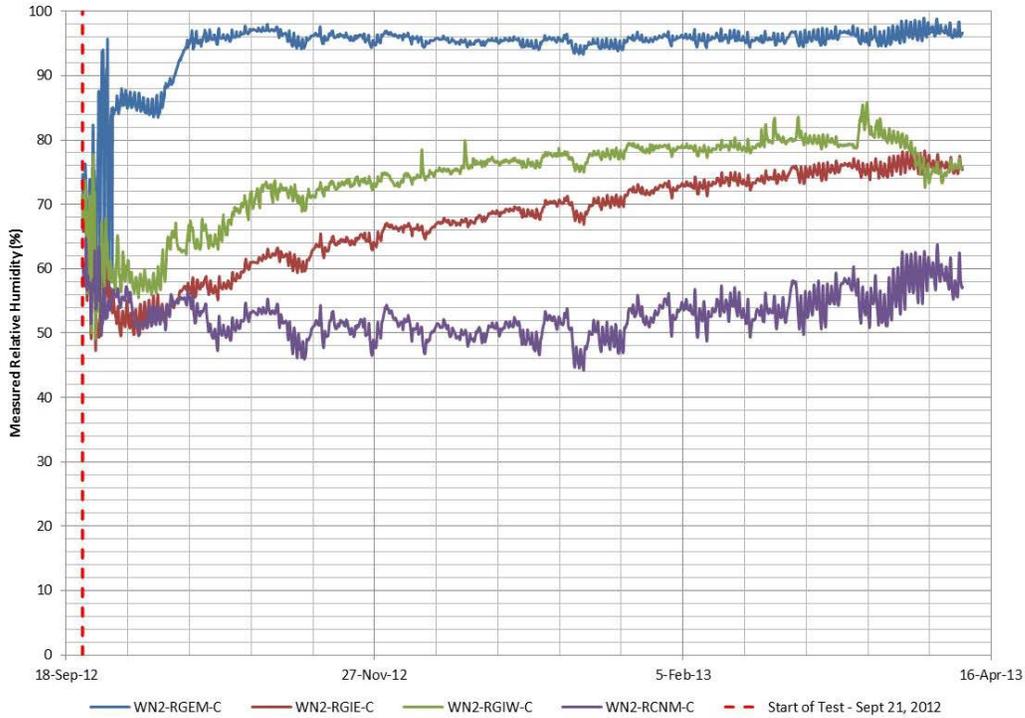
Figure 35 : North Wall 2 measured relative humidity

The following seven figures show the measured relative humidity in each wall on the North orientation as an example of the relative humidity data that has been collected since testing began.

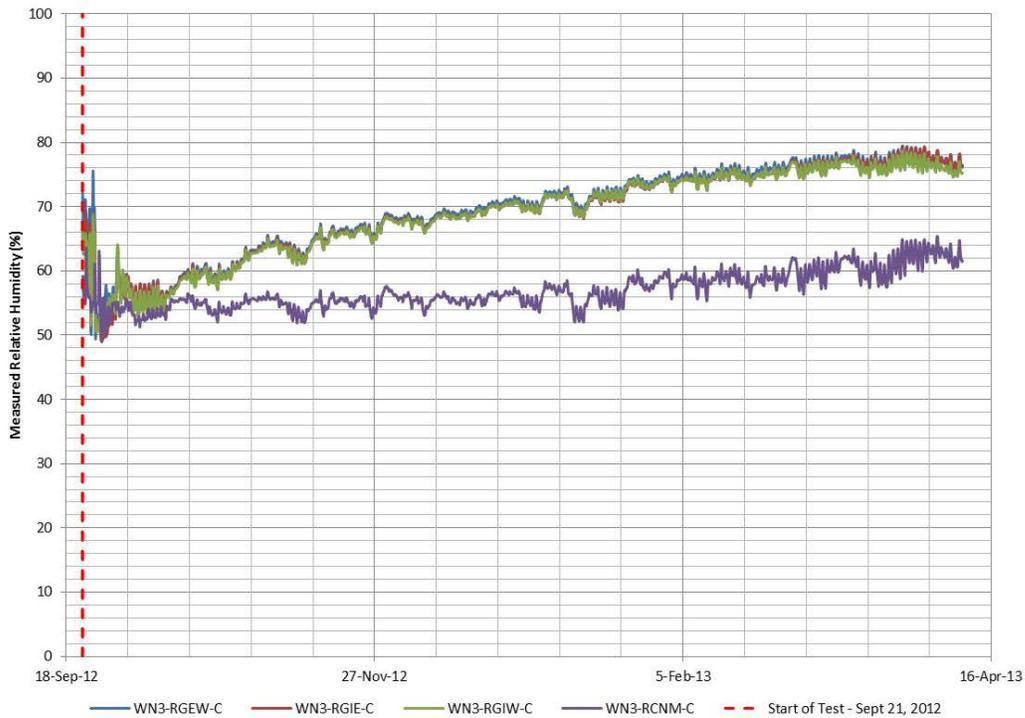
Figure 36 : North Wall 3 measured relative humidity

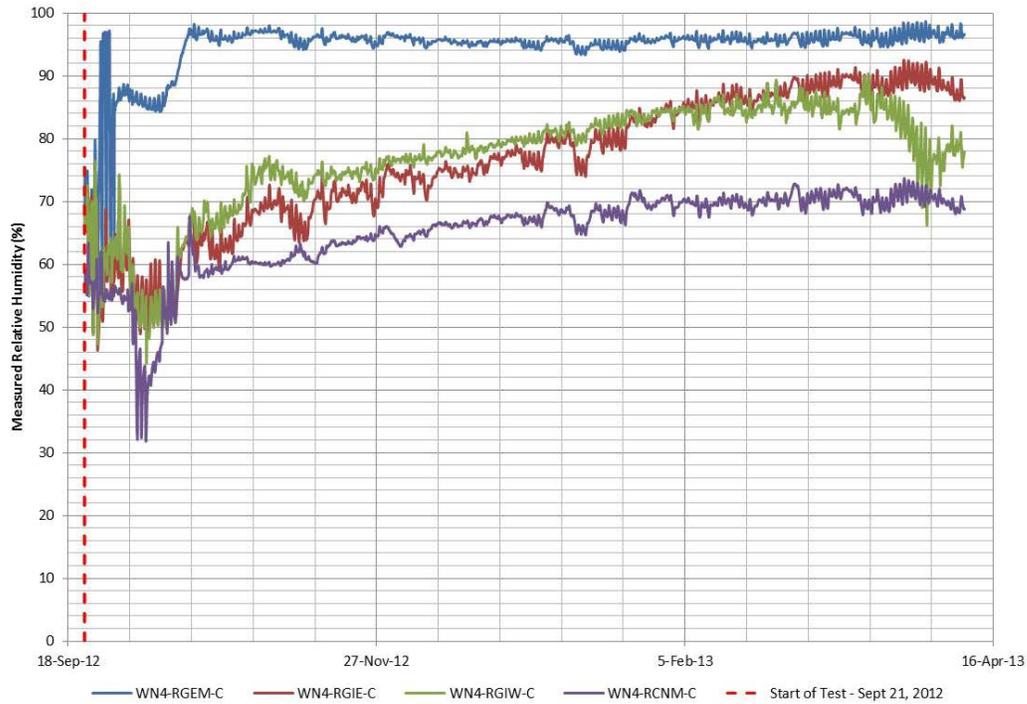
Figure 37 : North Wall 4 measured relative humidity

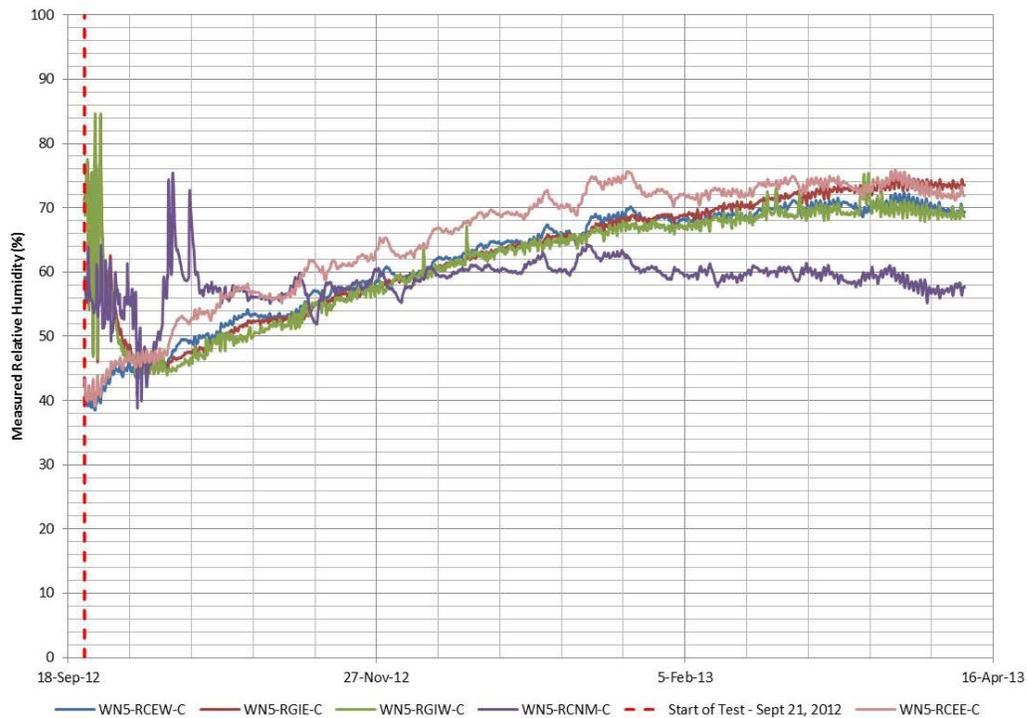
Figure 38 : North Wall 5 measured relative humidity

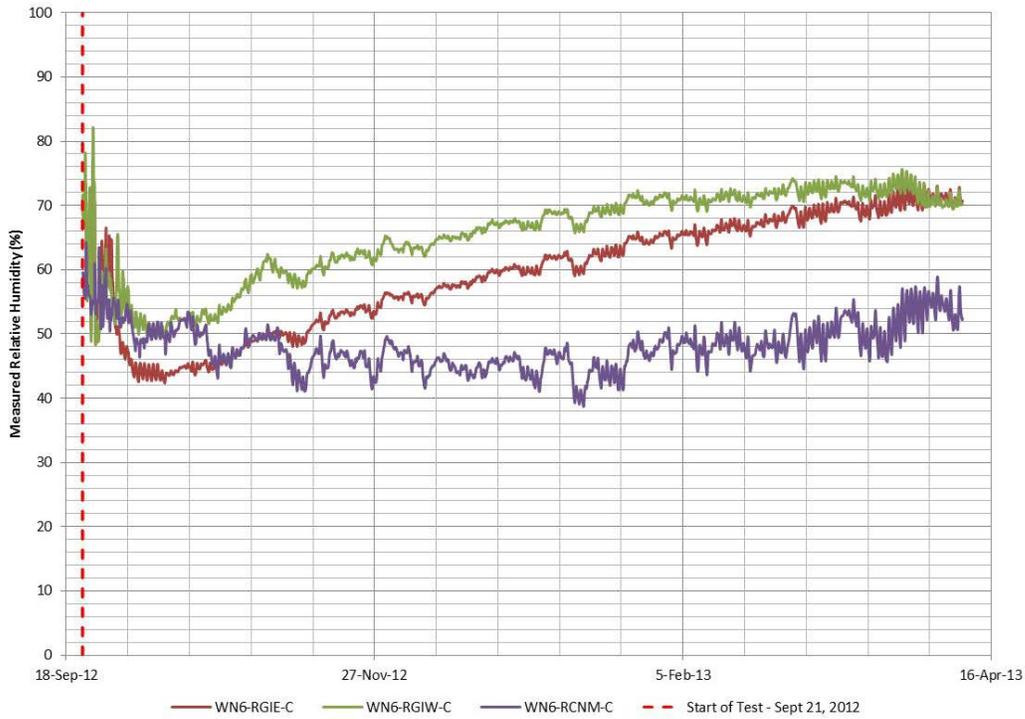
Figure 39 : North Wall 6 measured relative humidity

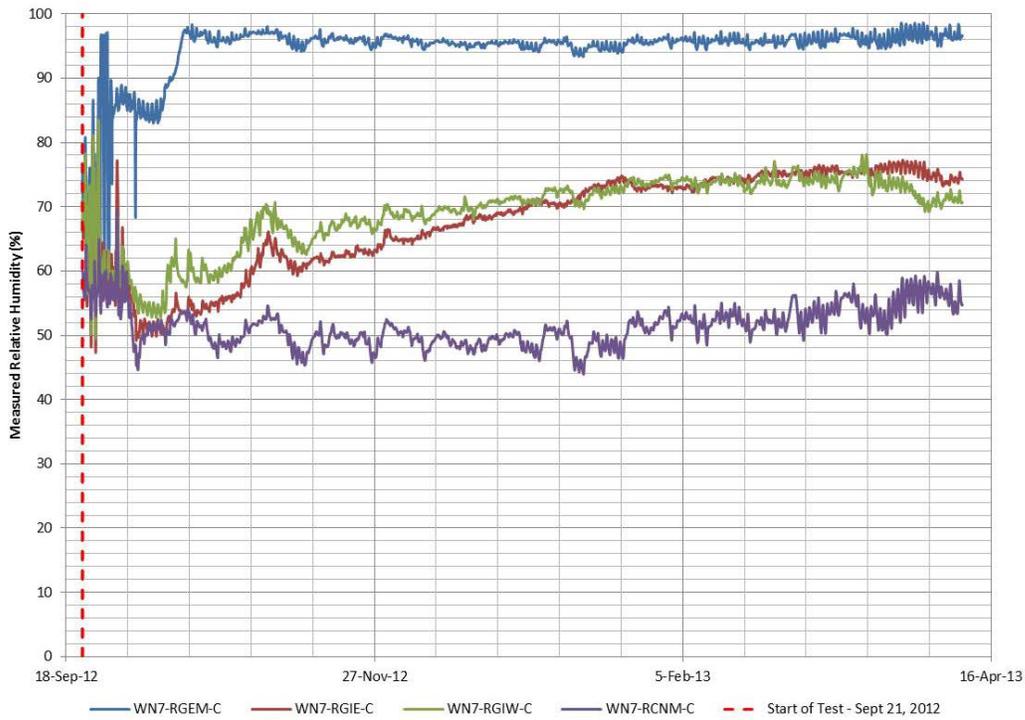
Figure 40 : North Wall 7 measured relative humidity
