Vancouver Field Exposure Facility: Phase III Construction and Instrumentation Report

Research Report - 1304

May 2010 (posted April 2013)

Phase III Construction and Instrumentation Report

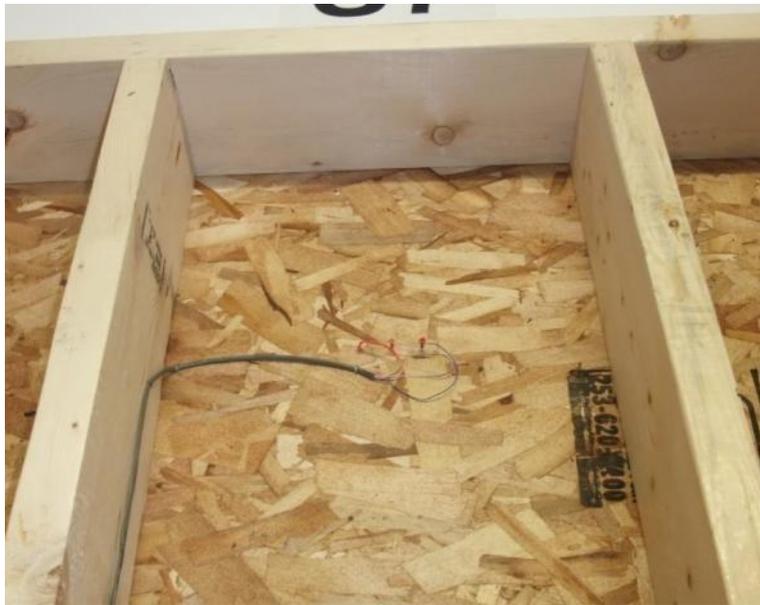
Figure 7 - Upper Interior Sheathing MC/T Sensors

Example photographs of the individual sensors are shown below in Figure 6 to Figure 11.

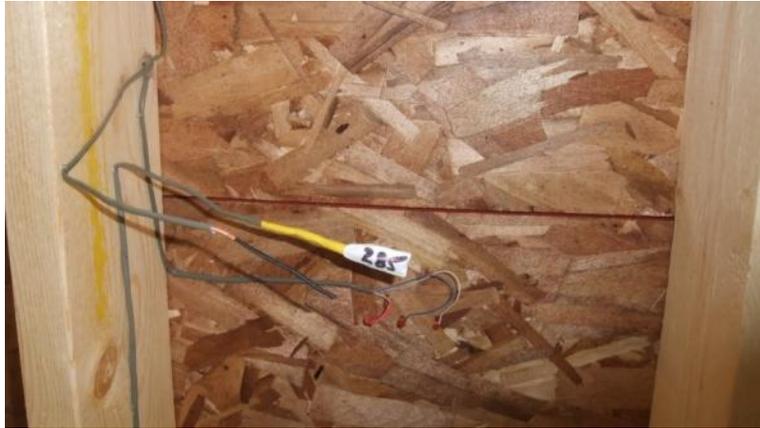
Figure 8 - Interior Mid-Height T, T/RH and MC/T sensors

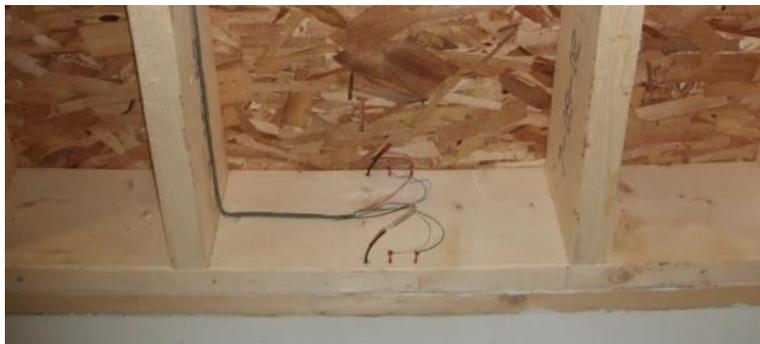
Figure 9 - Bottom Plate MC/T Sensors

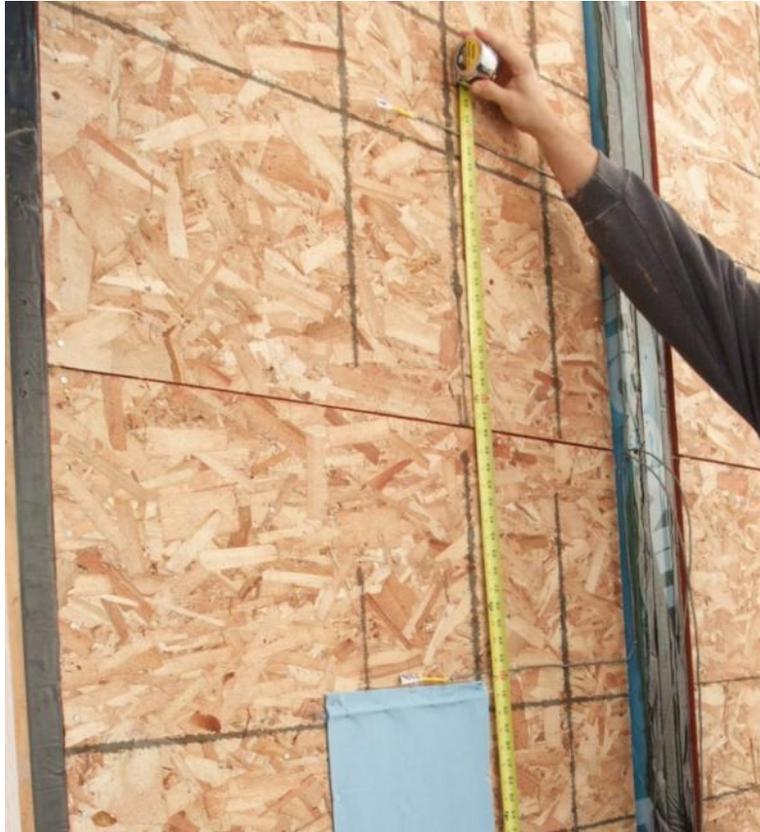
Figure 11 - Exterior Upper and Lower T/RH Sensors

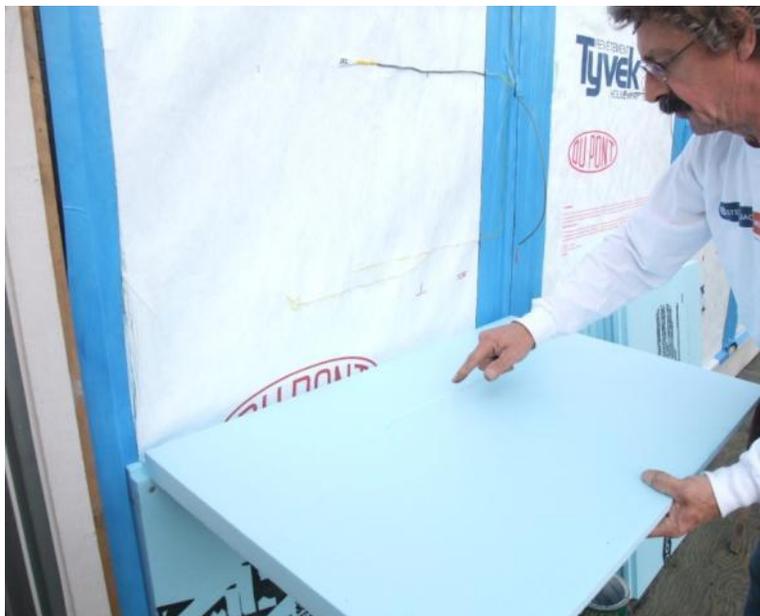
Figure 12 - Installation of Dow XPS 1.5" Insulation

Figure 12 shows the installation of the 1.5" exterior XPS over housewrap. A small pocket approximately 3/8" (10 mm) wide and 1/4" (6 mm) deep was cut out of the back of the XPS to allow the T/RH sensor and wire to fit behind the XPS and not create a gap between the XPS and the housewrap. The pocket is shown in more detail in Figure 13.

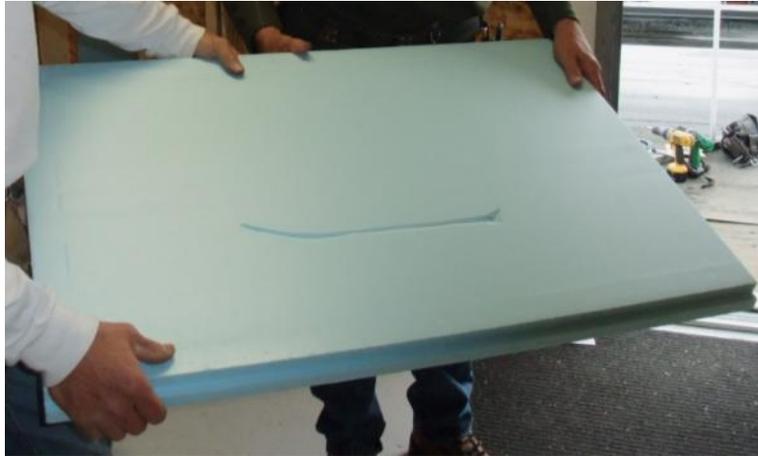
Figure 13 - Sensor Pocket in XPS Insulation

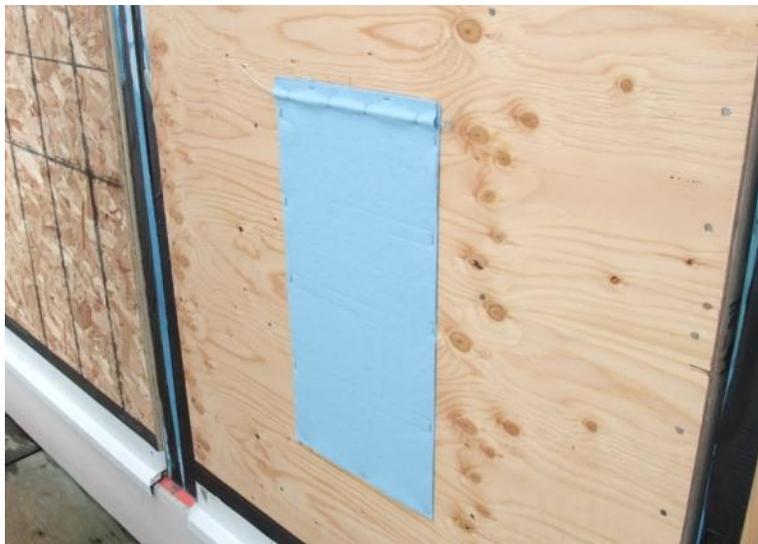
Figure 14 - Exterior Wetting Apparatus

For Phase III, wetting systems were installed on both the interior and the exterior of the exterior sheathing to allow a known amount of water to be injected at a controlled time and location. The wetting apparatus consists of a storage media and a tube connecting the storage media to the interior of the test hut to enable wetting without opening the wall system. The wetting system was designed to simulate a window leak, and was used to help determine the drying potential of specific wall assemblies. Photographs of the installed wetting systems are shown in Figure 14 to Figure 16.

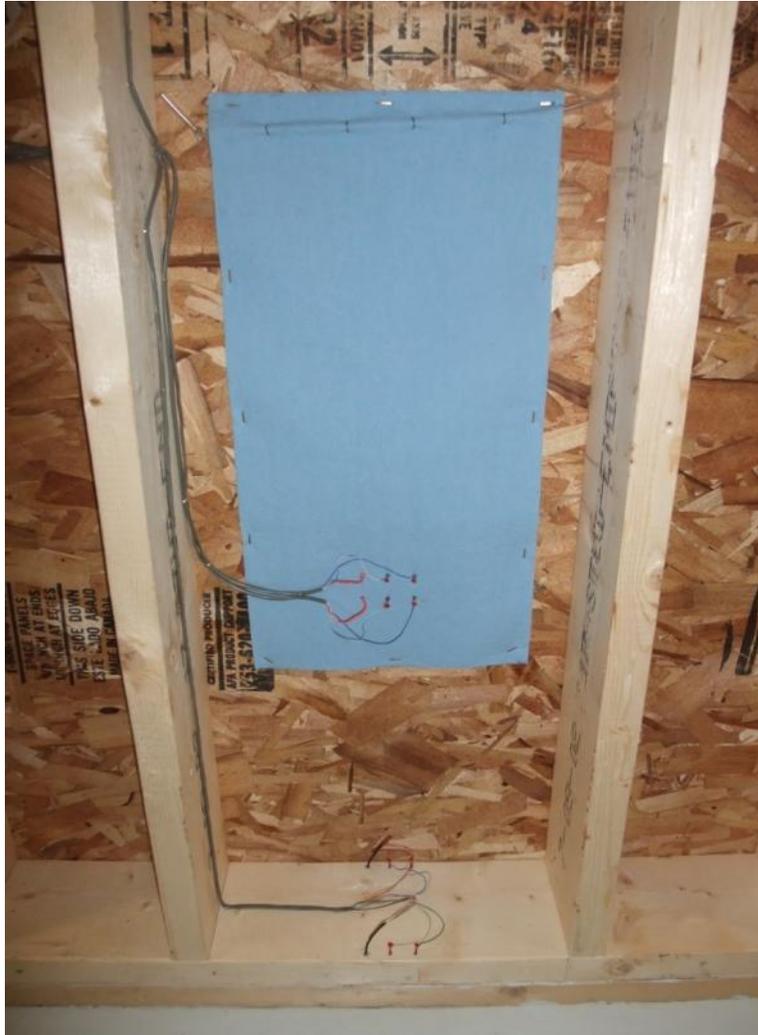
Figure 15 - Interior Wetting Apparatus

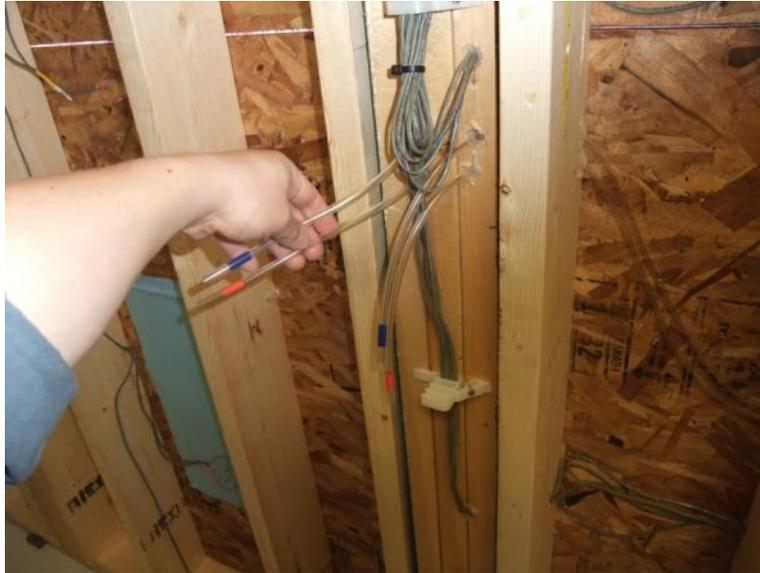
Figure 16 - Wetting Apparatus Injection Tubes

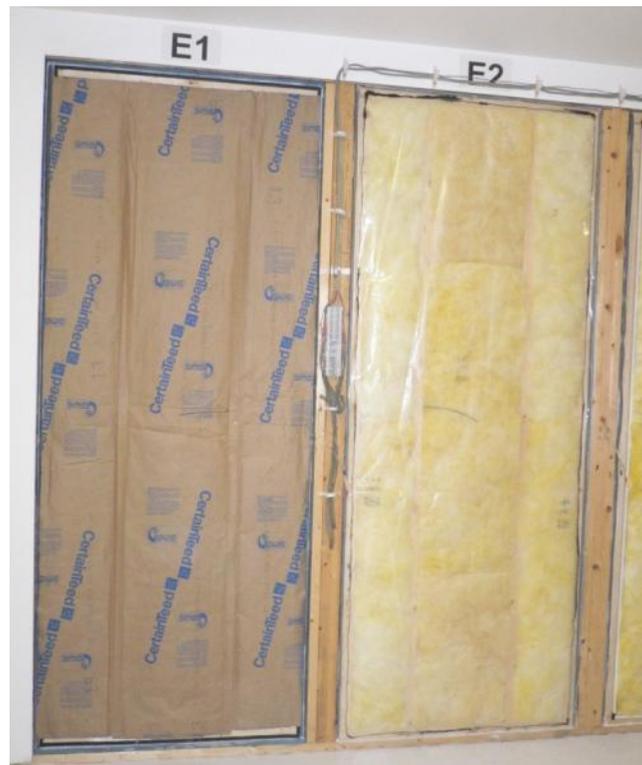
Figure 17 - Interior Vapor Control and Stud Space Insulation

Upon completion of the sensor installation, the stud space insulation and interior and exterior finishes were applied by Gauvin 2000 Construction sub-contractors. These tasks took approximately three weeks to complete. Figure 17 and Figure 18 show a few of the final phases of construction.

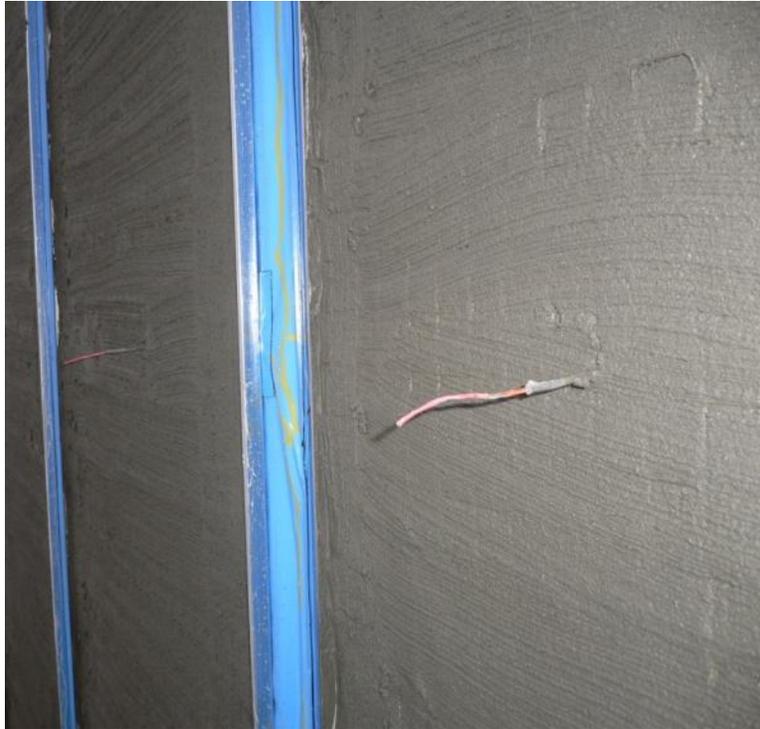
Figure 18 - Stucco Base Coat and Mid-Height T Sensor
