Rainwater Management Performance of Newly Constructed Residential Building Enclosures During August and September 2004

Research Report - 0503
2005 January by Joseph Lstiburek

Prepared for the Home Builders Association of Metro Orlando and the Florida Home Builders Association By:

Joseph William Lstiburek, Ph.D., P.Eng.
Building Science Corporation
70 Main Street
Westford, MA
01886

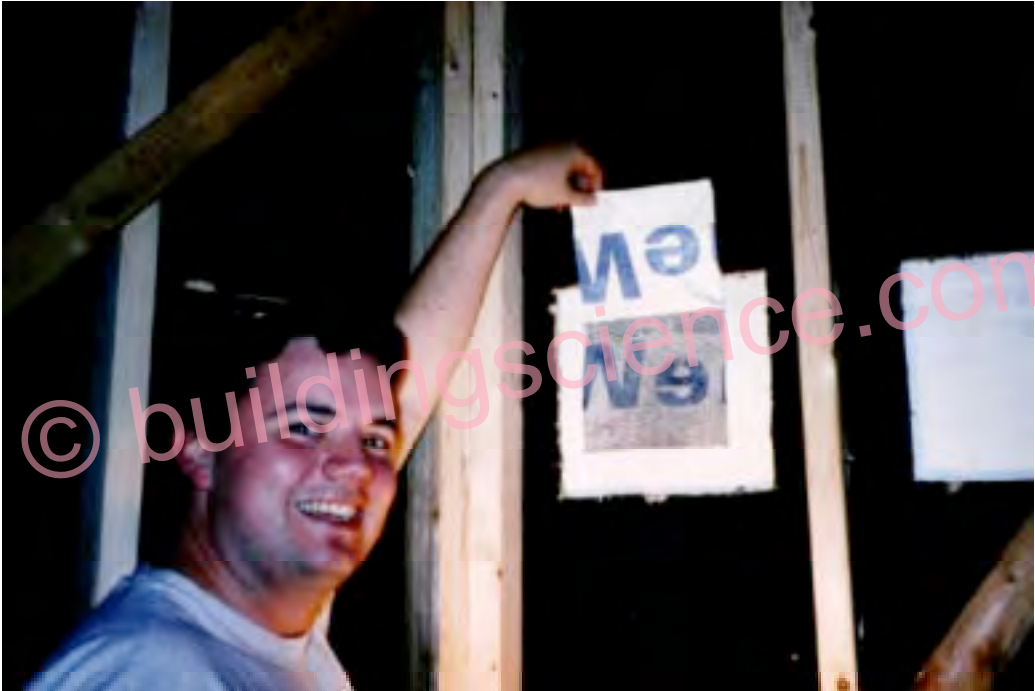
Photograph 4: Stucco Rendering Bonding to Plastic Housewrap

There appear to be significant performance issues with WRB's relating to manufacture, testing and approval. All plastic housewraps and some building papers tend to bond to stucco renderings thereby negating drainage (Photograph 3). Additionally, many plastic housewraps lose their water repellency (Figure 9) when in contact with sheathing and stucco renderings (Photograph 4).

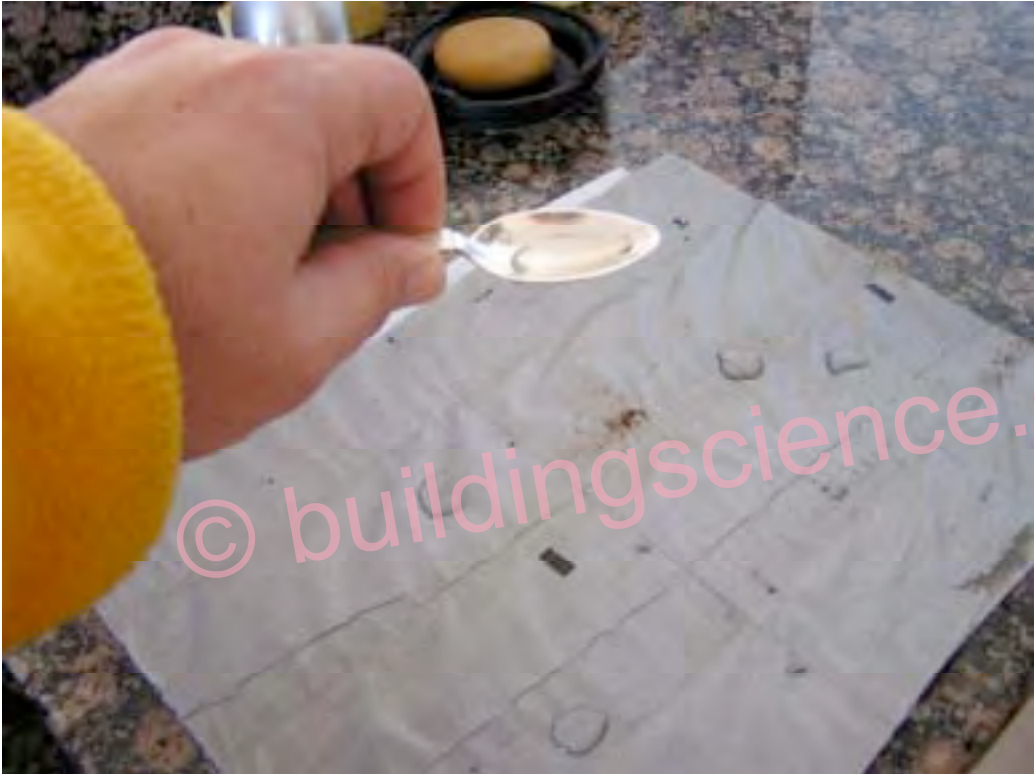
Photograph 5: Water Drop Test For Water Repellency

All perforated plastic housewraps fail a simple test for water repellency and water holdout (Photograph 5 and Photograph 6). Many non perforated housewraps fail a similar test when exposed to surfactants (Photograph 7, Photograph 8 and Photograph 9).

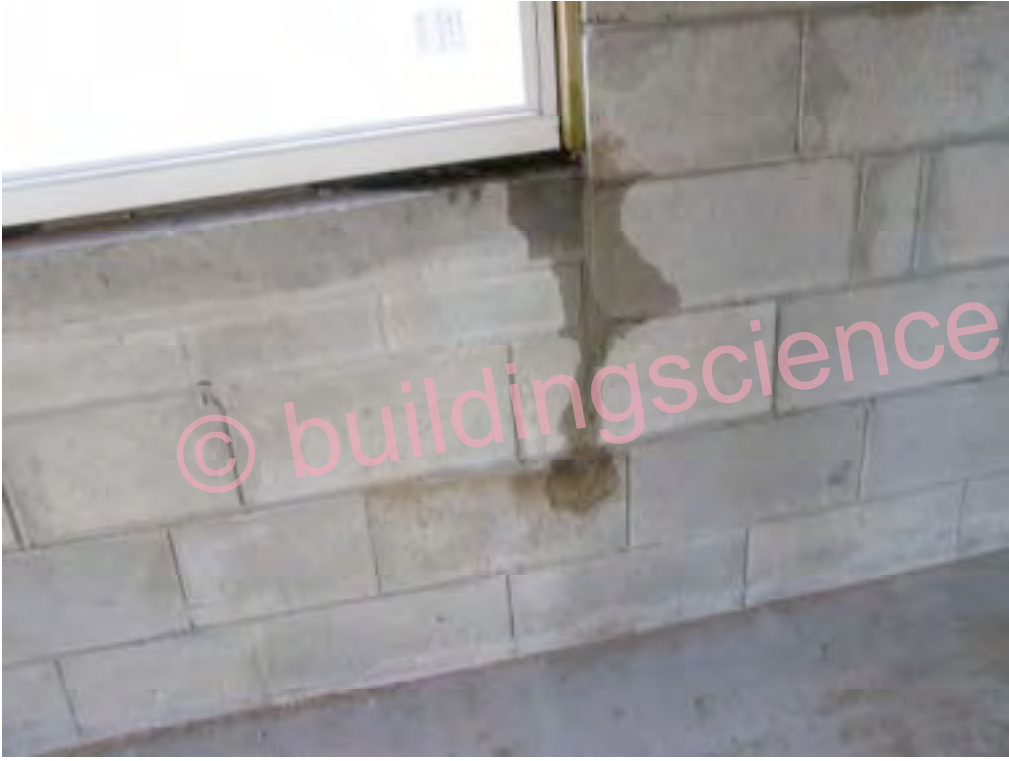
Photograph 24: Window Corner Leakage

However, our testing indicates that many windows leaked at conditions well below their rated value – i.e. under no wind condition (Photograph 24 and Photograph 25).

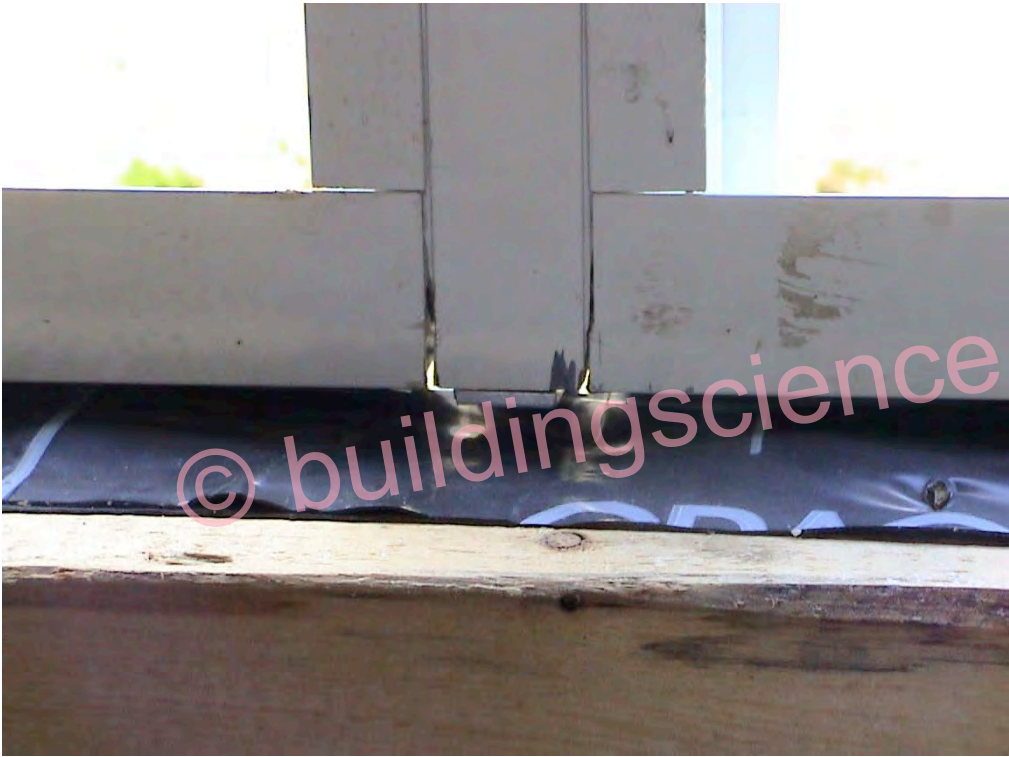
Photograph 26: Mulled Window Unit Leakage Paths

Additionally, many windows are sold as “mulled” or double windows or composite windows. However, they are tested as single units. Every mulled window unit tested leaked with no applied wind load (Photograph 26).

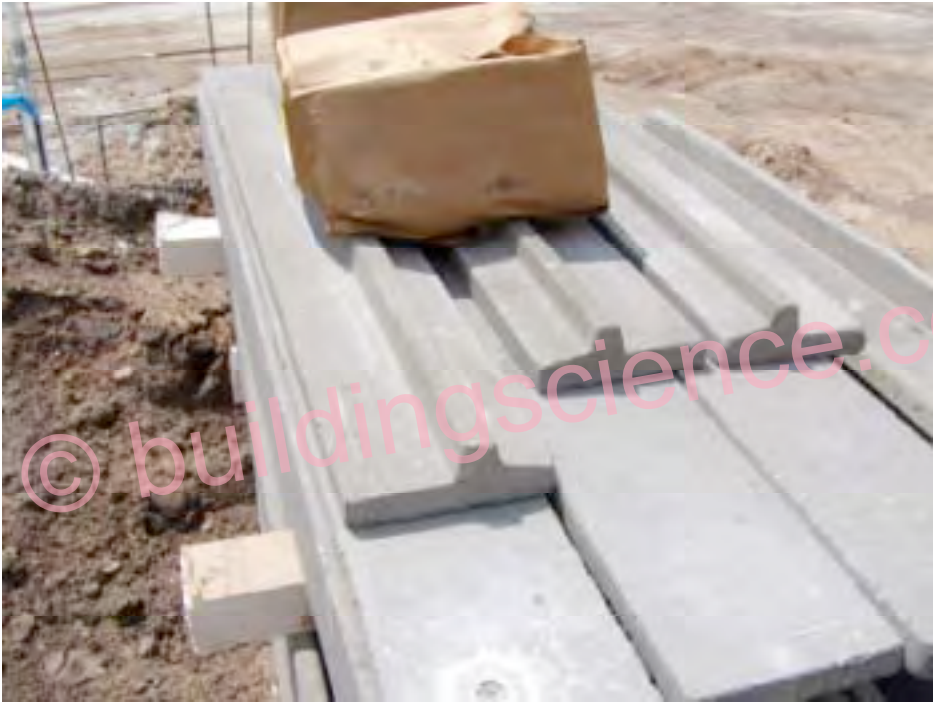
Photograph 27: Precast Sill With Illogical Attachment Rib

Many mass wall assembly window openings are constructed with precast sill units that have a raised rib attachment that directs window water leakage inwards rather than outwards (Photograph 27, Photograph 28, and Figure 13).

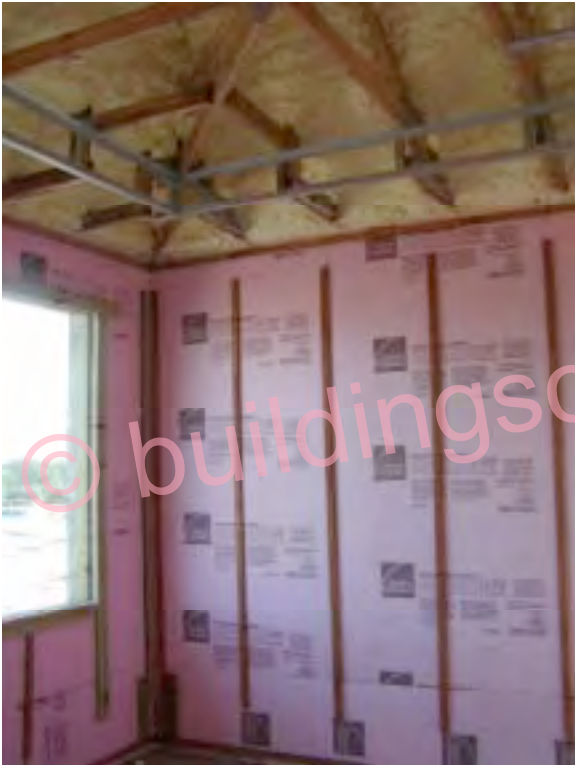
Photograph 41: Spray Foam Insulation In Unvented Conditioned Attic Assembly

Photograph 41, Figure 17, Figure 18 and Figure 19 illustrate unvented conditioned attic construction. This technology has significant advantages in the Florida climate with respect to rainwater control, energy conservation, moisture, and humidity control, wind uplift and fire performance over standard vented attic roof technology.

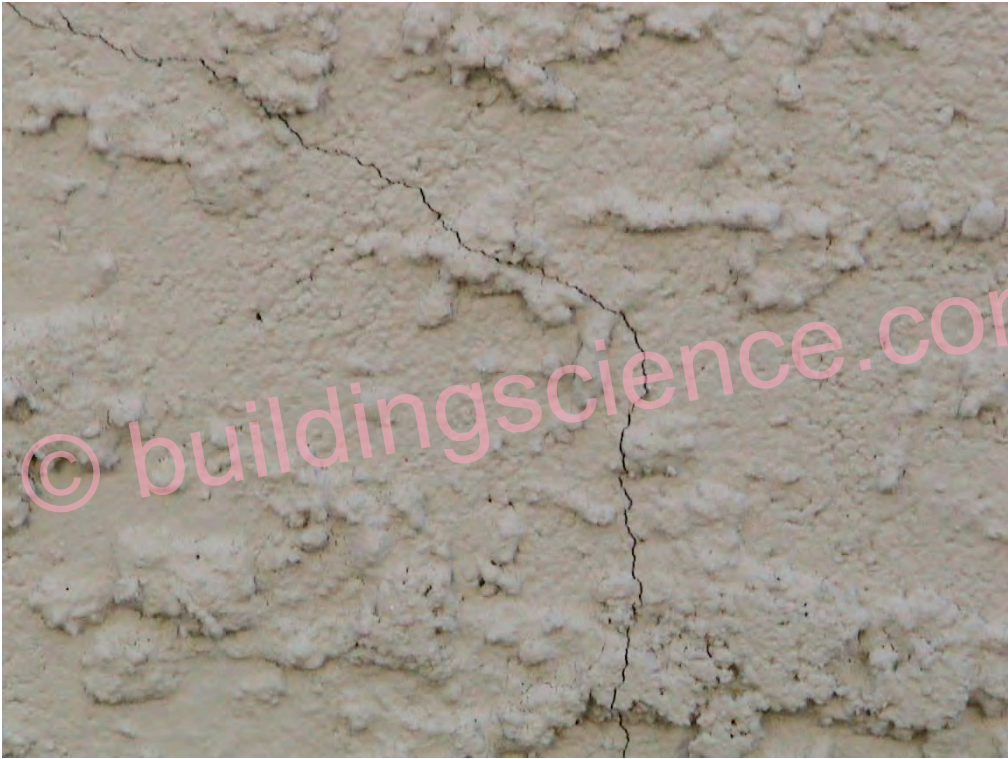
Photograph 60: Typical Crack In Stucco Rendering

However, the presence of cracks (Photograph 60 and Photograph 61) caused all mass wall assemblies to pass water.

The type of crack shown in Photograph 60 is indicative of typical and expected stucco rendering crackage. Workmanship, quality control and cure impact the number and extent of shrinkage cracking. Soil conditions, the nature of the materials, geometry and aspect ratio of mass wall assemblies impact the number and extent of settlement cracking. However, the nature of stucco application, materials and substrates make it impossible to construct crack free monolithic stucco renderings – in other words shrinkage cracks and settlement cracks are to be expected.

These shrinkage cracks and settlement cracks traditionally are handled through ongoing maintenance. At present, technology offers no other practical approach.

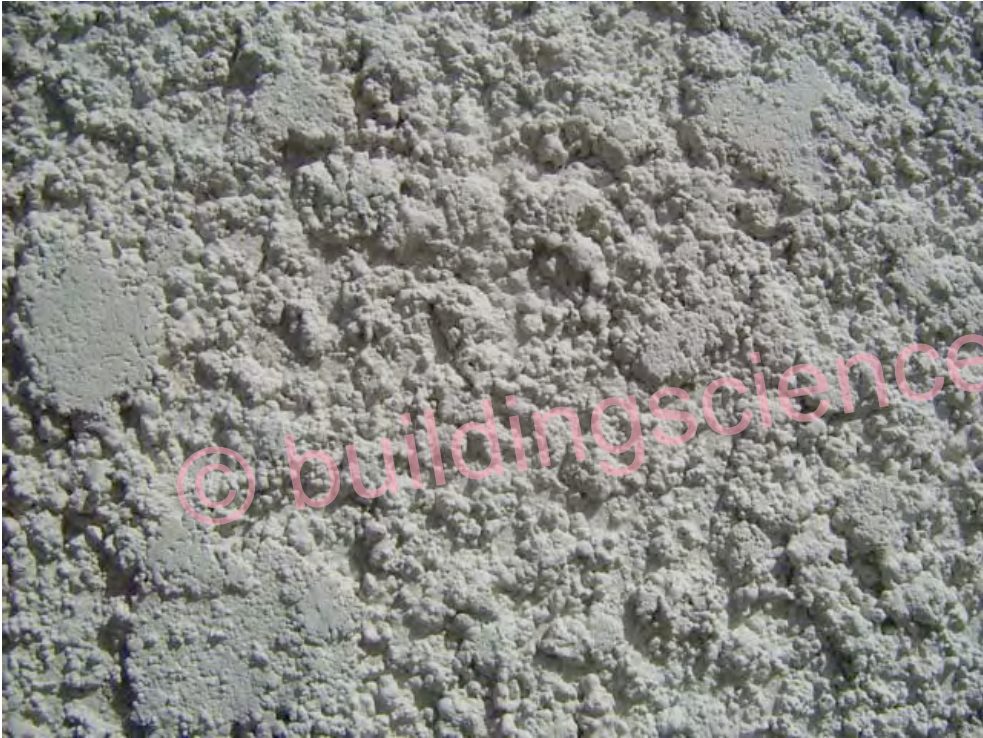
Photograph 66: Paint Coating Over Rough Surface

Low build and high build paint system on both smooth and textured surfaces were carefully examined (Photograph 66, Photograph 67 and Photograph 68) and it is our conclusion that almost no coating or painting system is able to span settlement cracks (Photograph 69). Only small hairline cracks on relatively smooth, and relatively untextured surfaces are there likely to be significant performance benefits of high build systems.
