BY JOSEPH LSTIBUREK

# Foam Shrinks, and Other Lessons

What we learned from updating a 16-year-old deep-energy retrofit

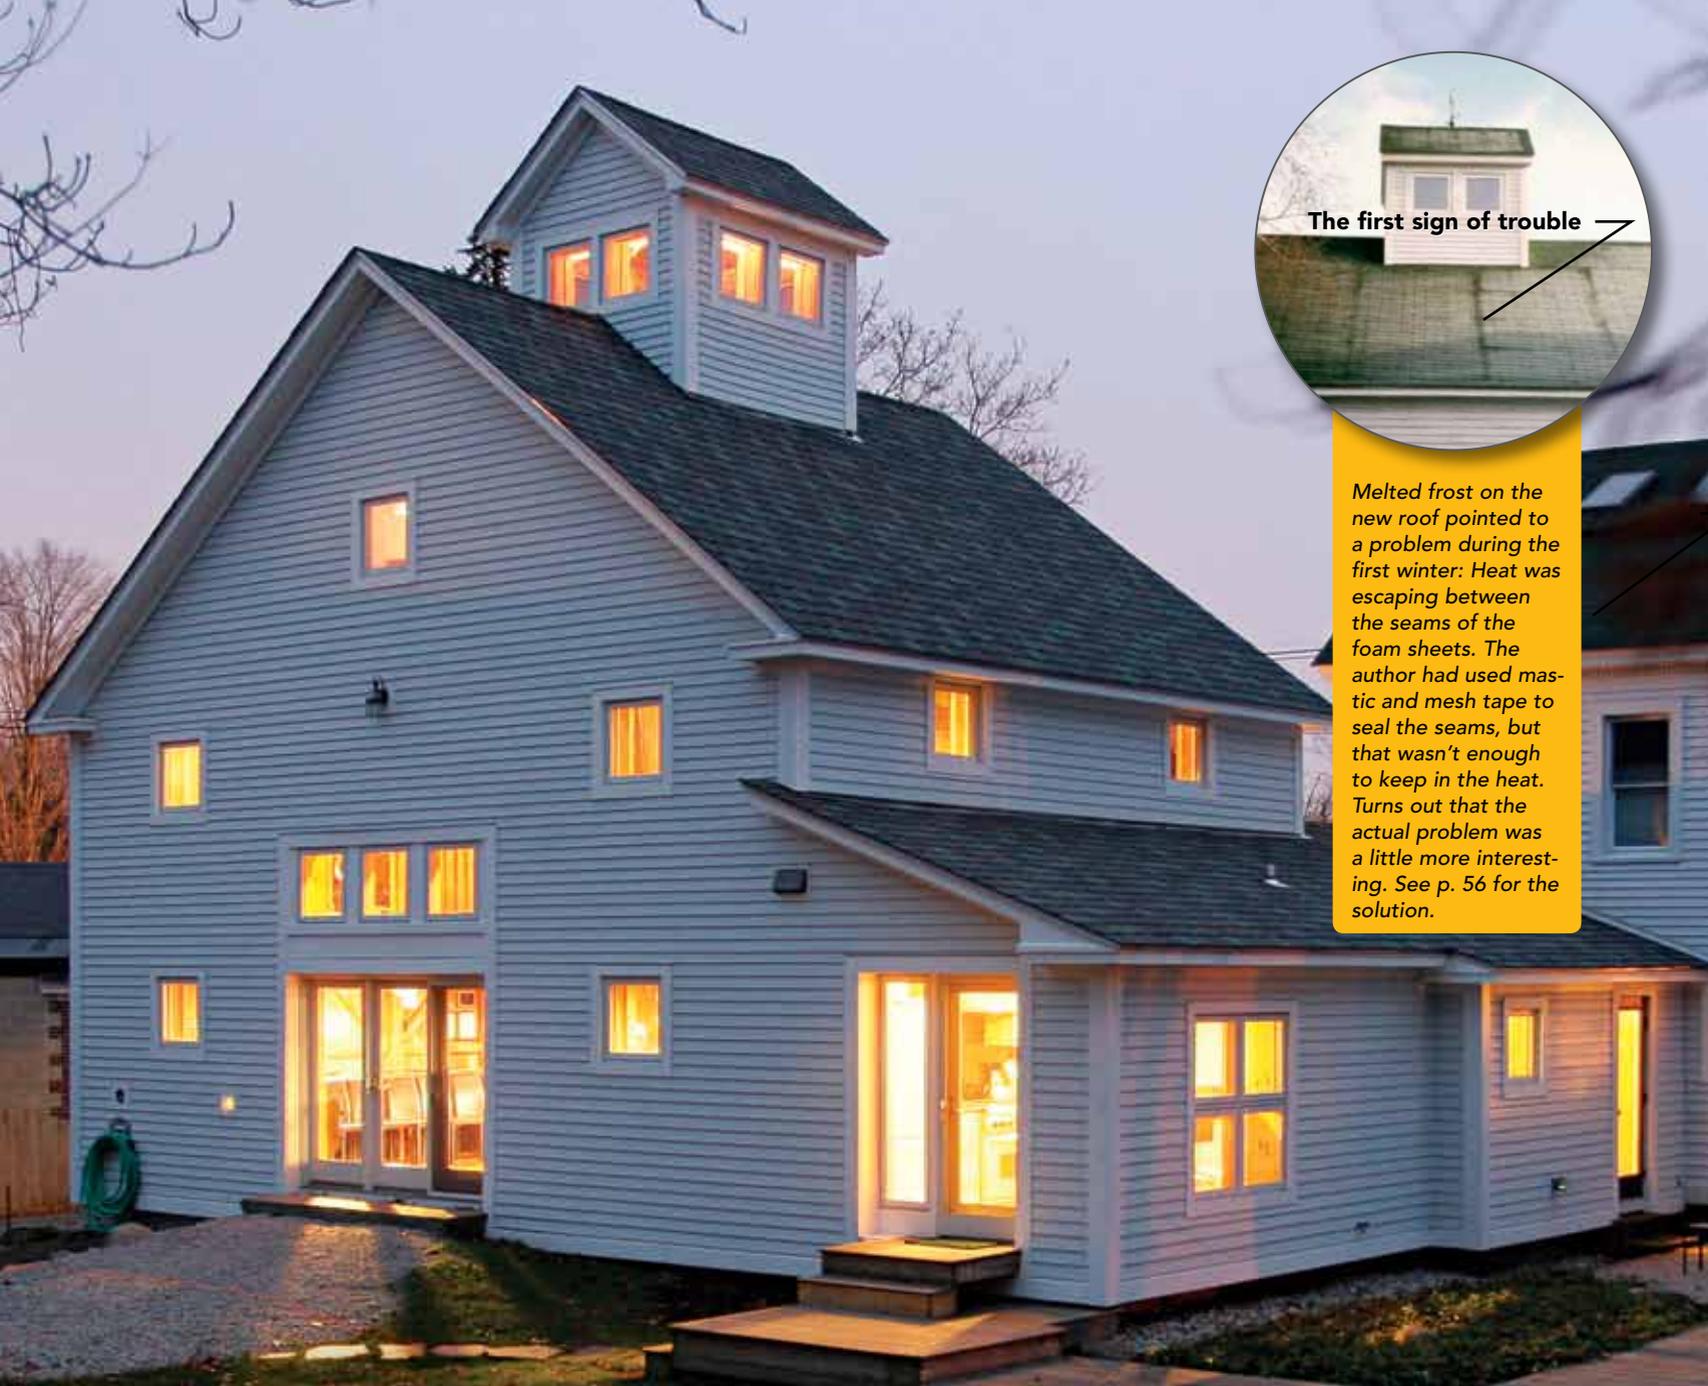
The first sign of trouble

Melted frost on the new roof pointed to a problem during the first winter: Heat was escaping between the seams of the foam sheets. The author had used mastic and mesh tape to seal the seams, but that wasn't enough to keep in the heat. Turns out that the actual problem was a little more interesting. See p. 56 for the solution.

Our first lesson came about four months after the retrofit was complete: When the first frost hit the roof, I discovered an obvious melting pattern. At the seams between the foam panels, warm air was escaping and melting the frost. Rather than installing one thick layer of foam, I should have installed multiple layers, offsetting the joints and staggering the seams. I decided to fix that when I replaced the shingles.

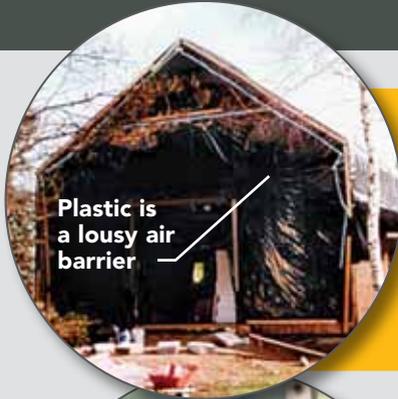
Peel-and-stick membrane was available when the author completed this retrofit, but it seemed like an excessive step when the air-control layer would be covered with foam anyway. Turns out that plastic, with its many holes, and a single layer of foam (that shrunk) didn't work so well at controlling air movement.

**Solution:** The author covered the entire barn with peel-and-stick membrane.

In the 1980s, I was preaching all over Canada about plastic being a dumb air barrier. What did I choose to wrap my barn with? Plastic. It was cheap, and I was overconfident. The blower-door test years later didn't specify where, but it told me that there were a lot of holes. Rather than try to figure out where all the holes were and detail the plastic layer better, I switched to covering the barn in peel-and-stick membrane as the first line of defense in my air-barrier system.

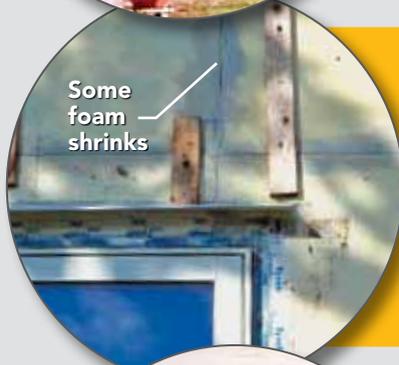
The biggest surprise was not that heat escaped between the joints of a single layer of foam, but that the gaps got bigger. Gaps are clearly visible above this window where the EPS foam panels shrunk, opening cracks in the mastic. On the house, where the author used XPS (drawing right), the panels stayed put, and the tape stuck tight.

When we installed this foam, we covered the joints with mesh tape and mastic. Over time, the panels shrunk, and the tape/mastic combination cracked, opening the seams. This is where the heat came through to melt the frost on my roof.

Because we used XPS on parts of the main house, we dug into that siding to compare the EPS with the XPS, which was sealed at the seams with Tyvek tape. After 16 years of service, the XPS and Tyvek tape were in perfect condition (photo p. 56).

**Solution:** The author switched to a more stable type of foam and used multiple layers, offsetting and taping the joints.

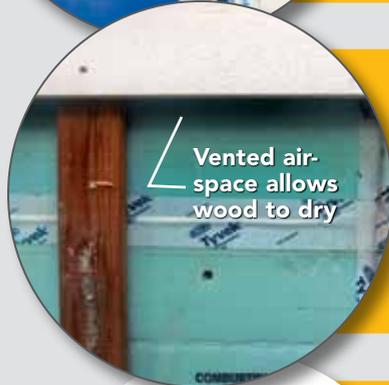
A common criticism of the author's wall assembly was that the furring strips needed to be pressure-treated or they would rot. Because the whole point of a vented airspace behind siding is to allow the siding to dry, the author reasoned that the furring strips ought to dry quickly, too. He was right. Not only did the paint job last 16 years, but the furring strips were in pristine condition as well.

I can't tell you how many times I have heard, "You've got to use pressure-treated furring strips," but it is absolutely untrue. When we took the walls apart, the furring strips looked brand new. Why does this detail work? Because the vent space is designed to dry. That is its whole job.

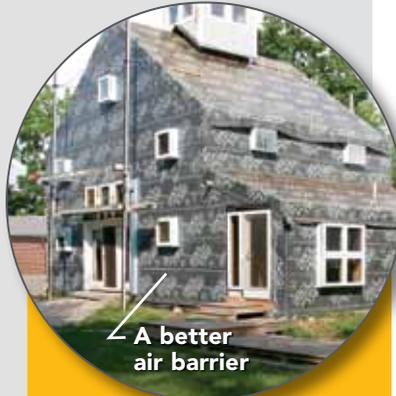
A better air barrier

Rather than wrap the barn in plastic again, the author chose to dig deep into his bank account and spring for peel-and-stick membrane as a first-line air barrier.

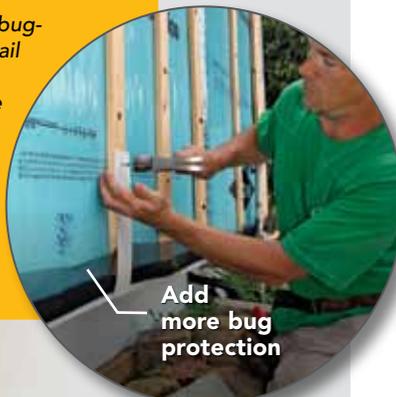
Add more bug protection

The original bug-proofing detail worked well, but builder David Joyce gave it an upgrade. Joyce added bug screen to the mesh and devised a better way to fasten the coil-stock bug barrier.

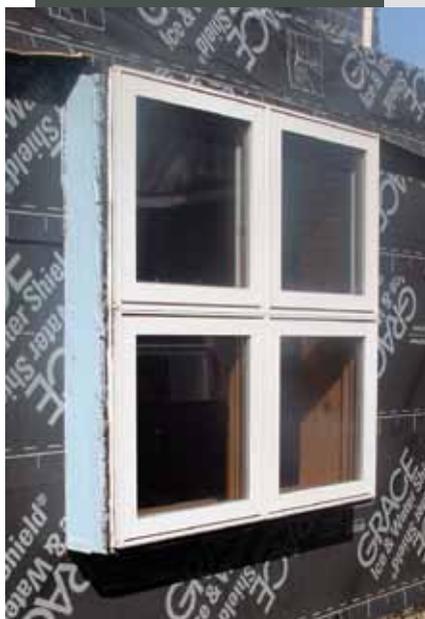
## CANTILEVERED PLYWOOD BOX DID NOT SAG

When thickening walls by 8 in., one of the difficult design details is how to install and trim windows. The author chose to cantilever plywood boxes past the frame and to install the windows with masonry straps. Naysayers cautioned that the boxes would sag under the weight of the windows, but time told a different story.

those window boxes sag? When I talk about this window detail (called *outies* by the energy nerds), I often get questions about whether the boxes will sag under the constant weight of the window. I have always answered this question by saying that the window boxes on my house hadn't seemed to sag so far. Now, after having had the barn stripped of its siding and foam, which gave me the opportunity to measure the deflection, I can say unequivocally, "No, they will not sag." □

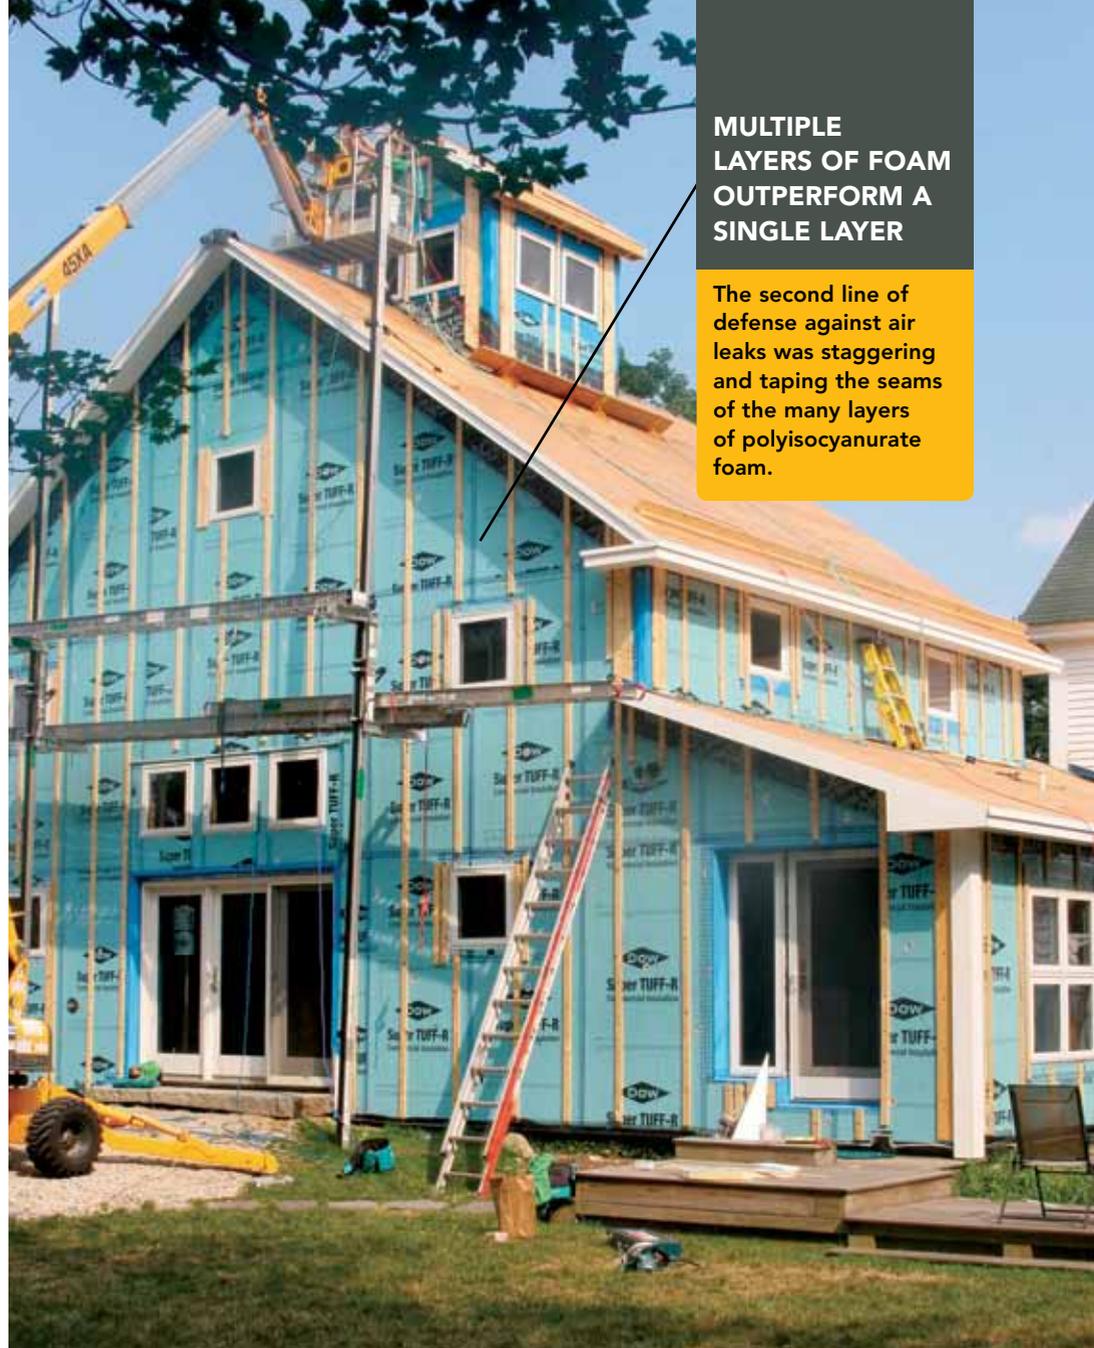
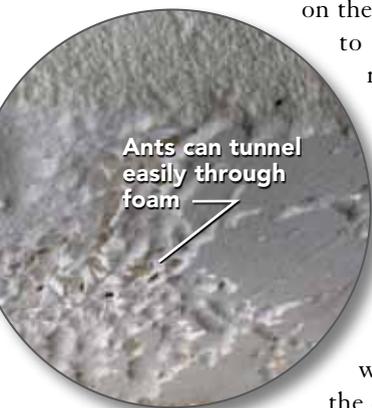
**MULTIPLE LAYERS OF FOAM OUTPERFORM A SINGLE LAYER**

The second line of defense against air leaks was staggering and taping the seams of the many layers of polyisocyanurate foam.
