Evaluation of Two CEDA Weatherization Pilot Implementations of an Exterior Insulation and Over- Clad Retrofit Strategy for Residential Masonry Buildings in Chicago

Building America Report - 1311

August 2013

Ken Neuhauser
Building Science Corporation

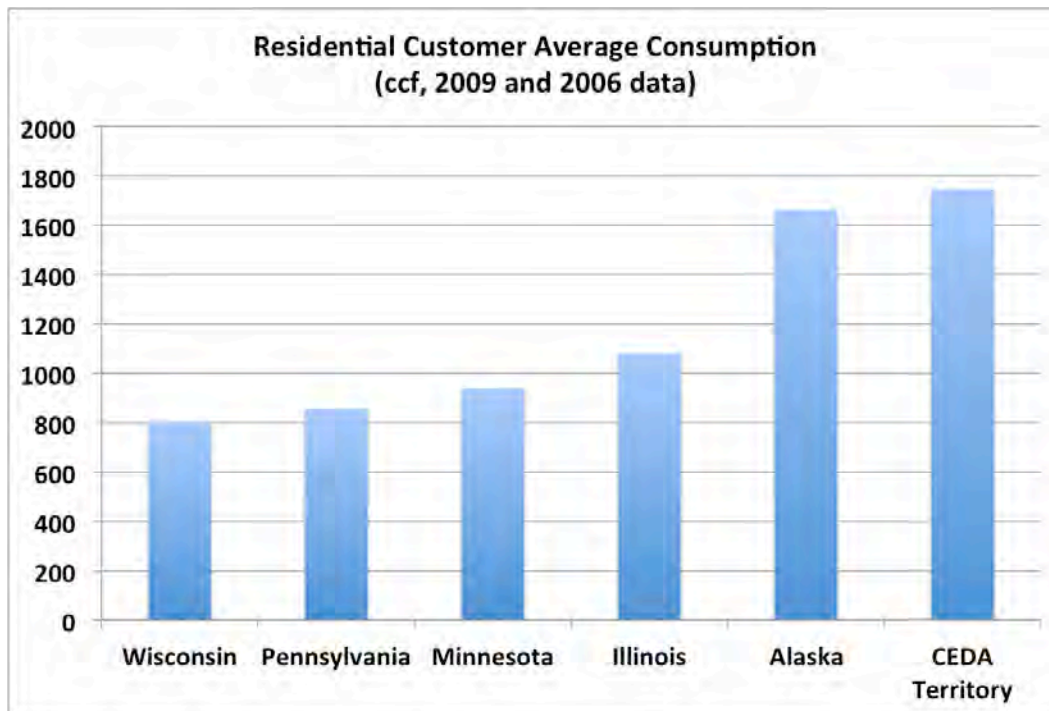
Figure 1. Average gas consumption per residential customer for several cold climate states and the CEDA territory

Compilation of utility data shows Illinois has the second-highest average gas consumption per residential customer for all the United States (AGA 2010). Only residential gas customers in Alaska use more, on average, than residential gas customers in Illinois (see Figure 1). Homes within the CEDA service territory are using even more on average than the rest of the state, surpassing the residential customer average for Alaska and using nearly twice the gas per household as other heating climate areas such as Minnesota.

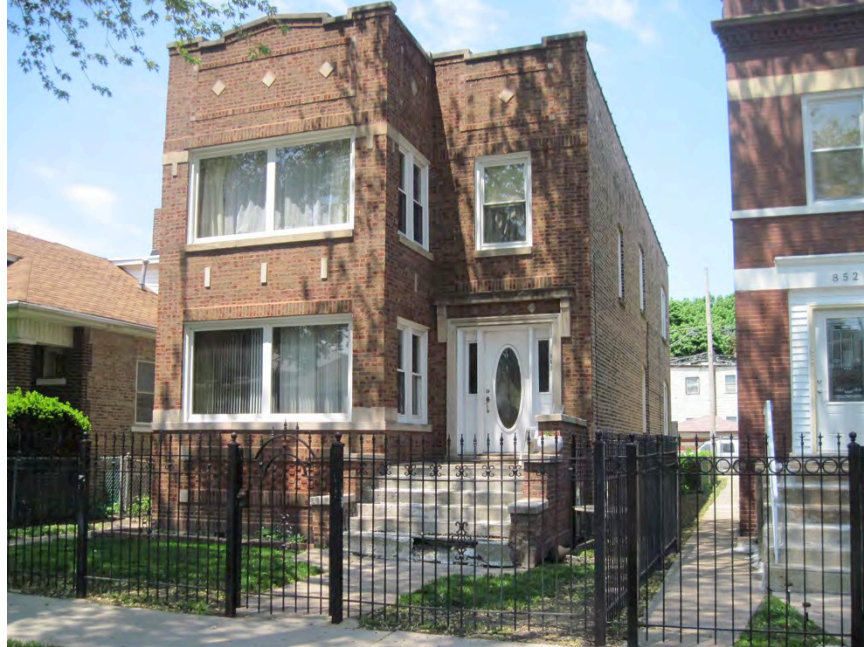
Figure 2. Two-family over-clad candidate
(Credit: Scott Sanders, CEDA)

Although it is a multifamily building, the two-family building represents many characteristics typical of single-family homes. These typical characteristics include the project scale, the spacing between buildings, and a more finely articulated street façade (Figure 2). A very common feature of detached single-family masonry homes that is not represented in this subject building is an intersection between an exterior wall and a roof overhang. Instead the subject building has a low-sloped roof with a parapet at the intersection of the treated wall and roof. This configuration is not uncommon. It required a connection from the wall system, over the parapet to the roof. Subsequent to launching construction on this building, it was found to have another feature apparently common in low-sloped buildings of similar age in the area: a parapet in significant disrepair.

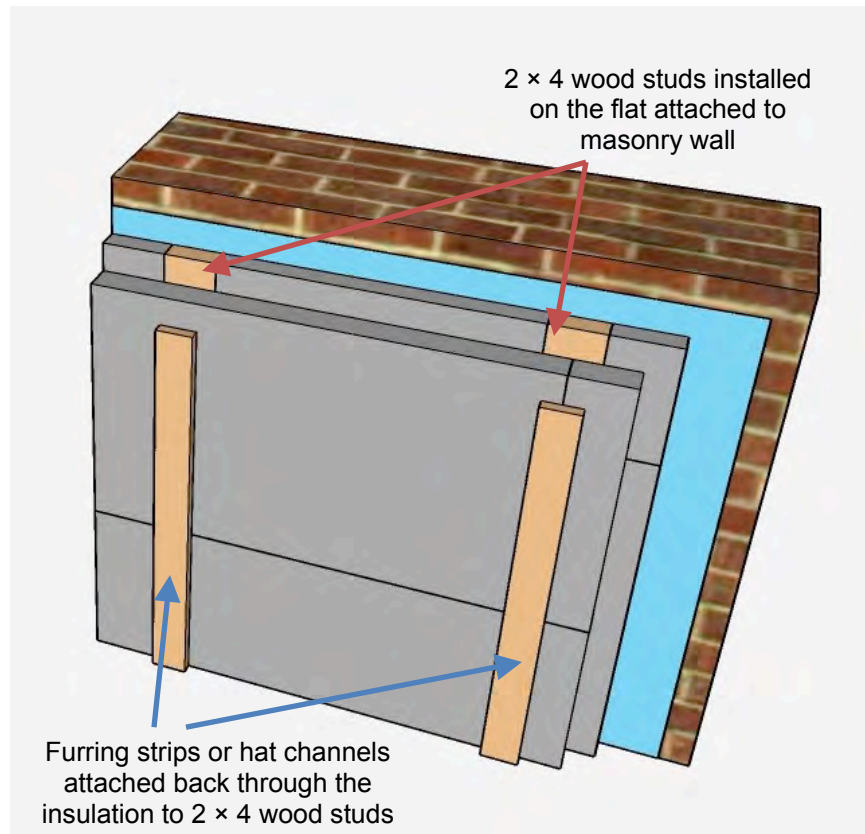
Figure 5. Exterior insulation strategy adopted as the basis for the assembly to be implemented through the research project

Based on the parameters identified for the retrofit assembly, the research partnership determined that the retrofit assembly would include wood furring fastened to the face of masonry, rigid or semirigid board insulation, strapping, and fiber-cement siding attached to the strapping. The assembly would also include a fully adhered air and water control membrane over the face of the masonry. The basic assembly that forms the basis for the retrofit assemblies evaluated in this research project is consistent with the recommended cladding design for masonry walls identified in previous Building America research (see Baker 2012). An illustration from the technical report for this research is reproduced in Figure 5 below. In this assembly, the wood furring or framing is attached to the masonry with standard exterior-grade masonry fasteners, the strapping is attached to this wood framing with long exterior-grade screws, and the fiber cement is attached with fasteners typically used for fiber cement installation.

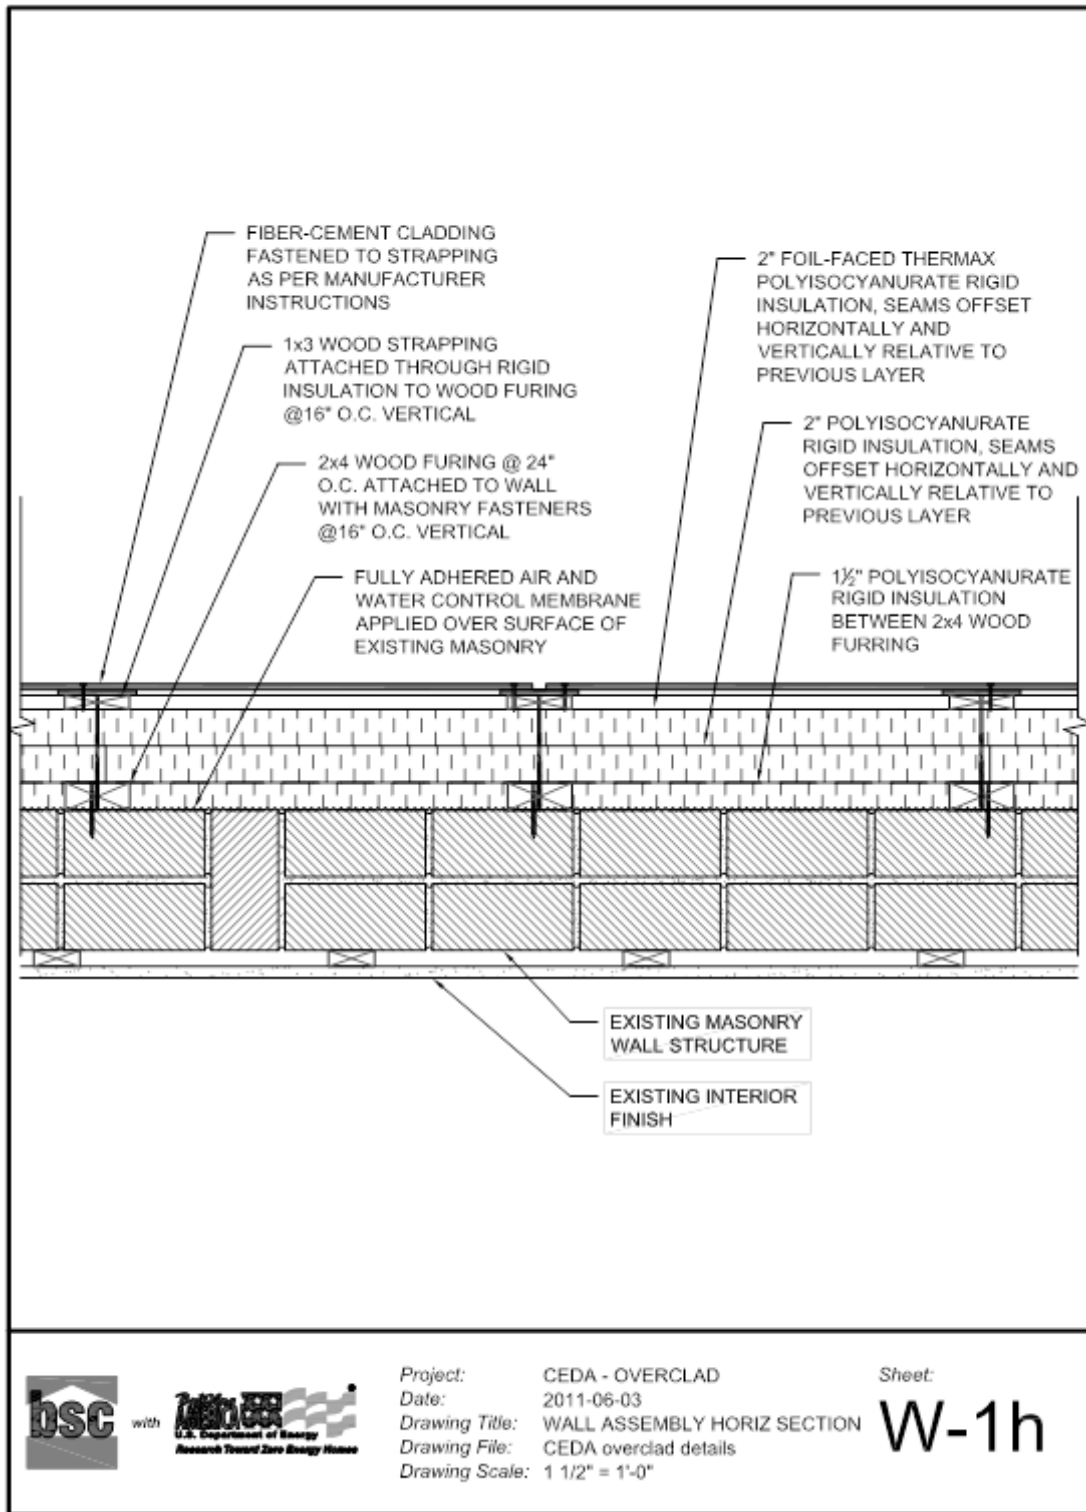
Figure 6. Schematic retrofit assembly, plan view

BSC prepared schematic drawings of the retrofit wall assembly for preliminary discussions with the City of Chicago Building Department. The research team's preferred approach included foil-faced polyisocyanurate insulation, wood framing against the masonry, and wood strapping for attachment of fiber cement cladding (Figure 6 and Figure 7). This assembly demonstrates robust thermal performance and was also deemed by the research team to provide robust fire resistance due to the material nature of fiber cement siding and the fire resistance rating of the specific insulation material.

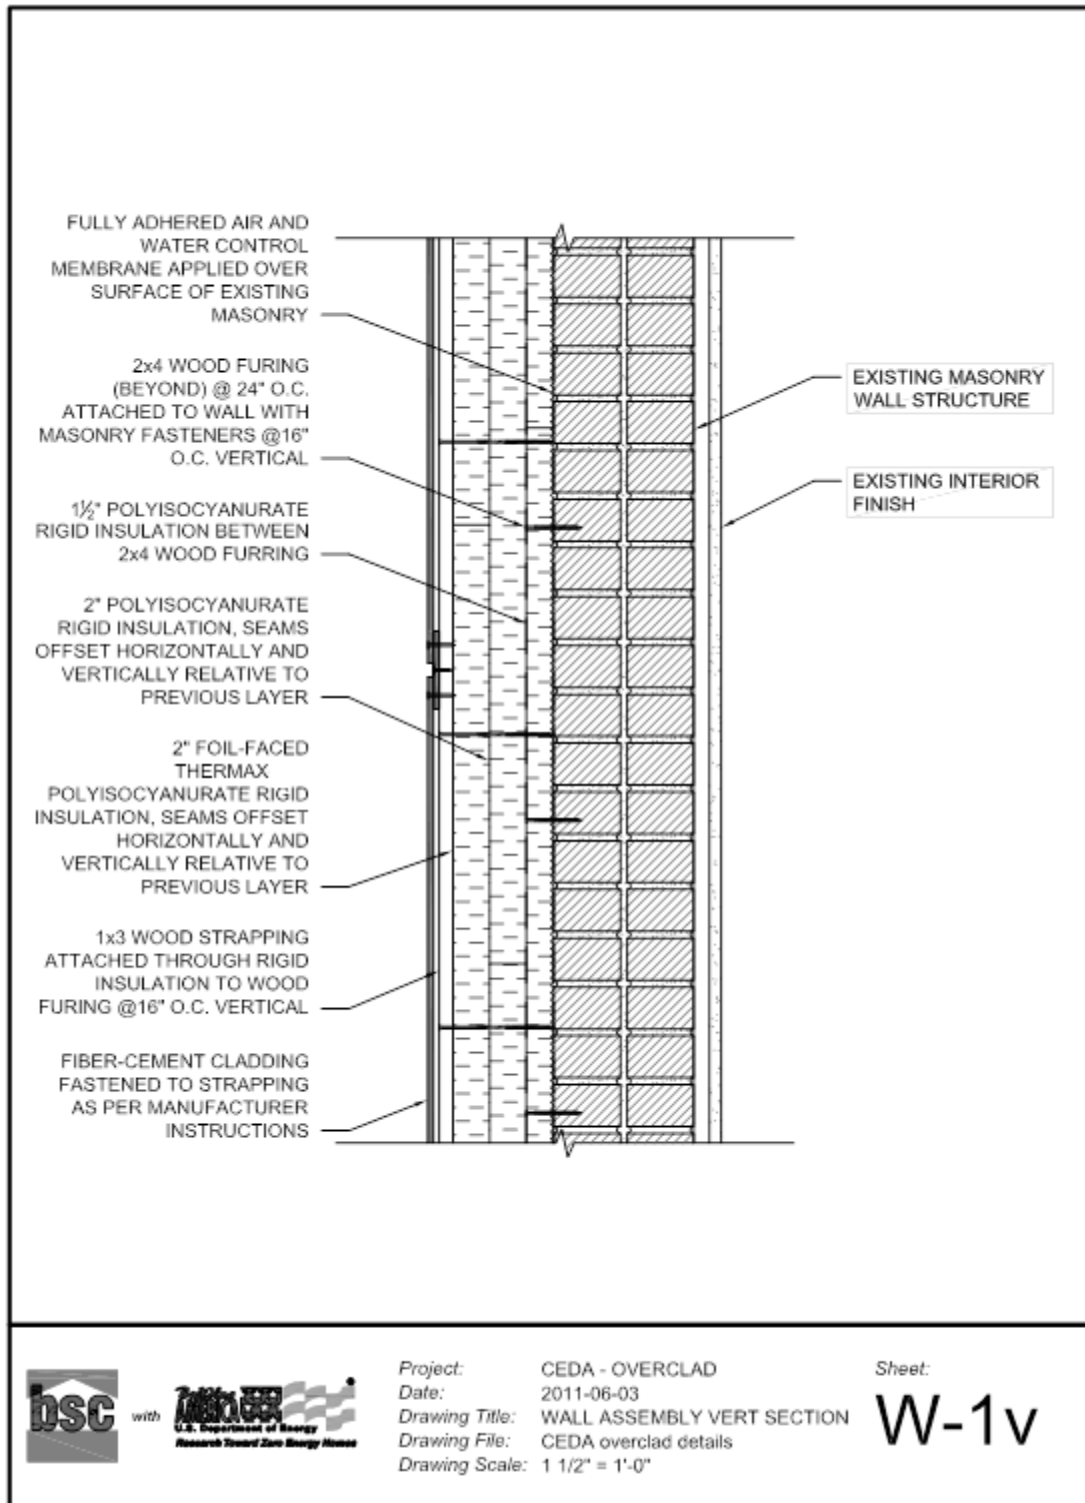
Figure 7. Schematic retrofit assembly, section view

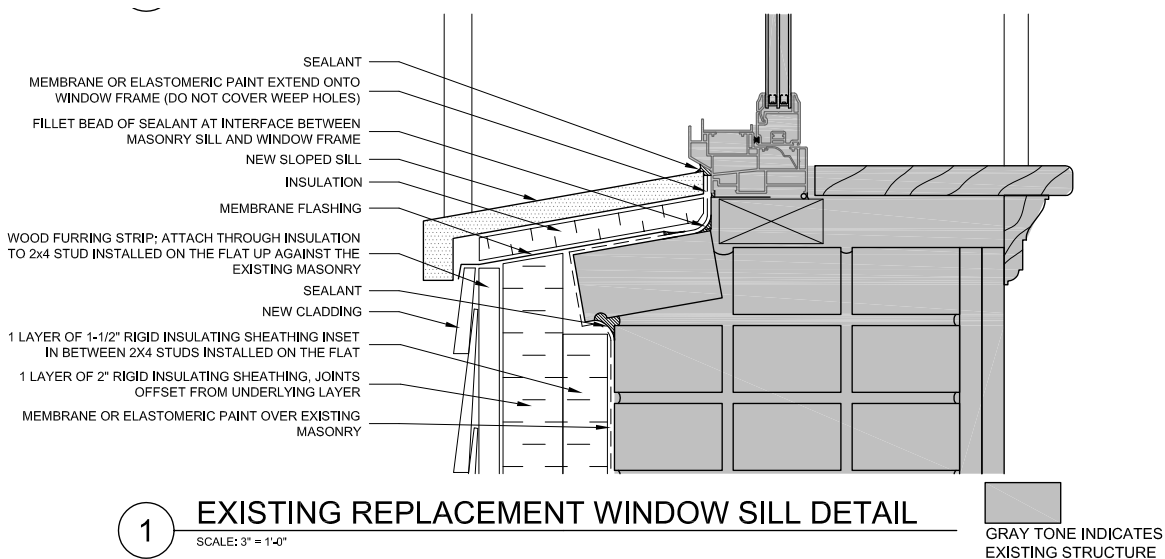
Figure 8. Window sill detail from schematic window details. Note that the water and air control membrane (dashed line at exterior face of brick) returns onto the window frame.

The details also show sealant between the trim and the bottom and sides of the existing window frame (Figure 8). The new window trim butting to the existing window frame provides a measure of protection for the sealant joint that is relied upon for water control (until such time as the window is replaced or reinstalled in a drained opening).

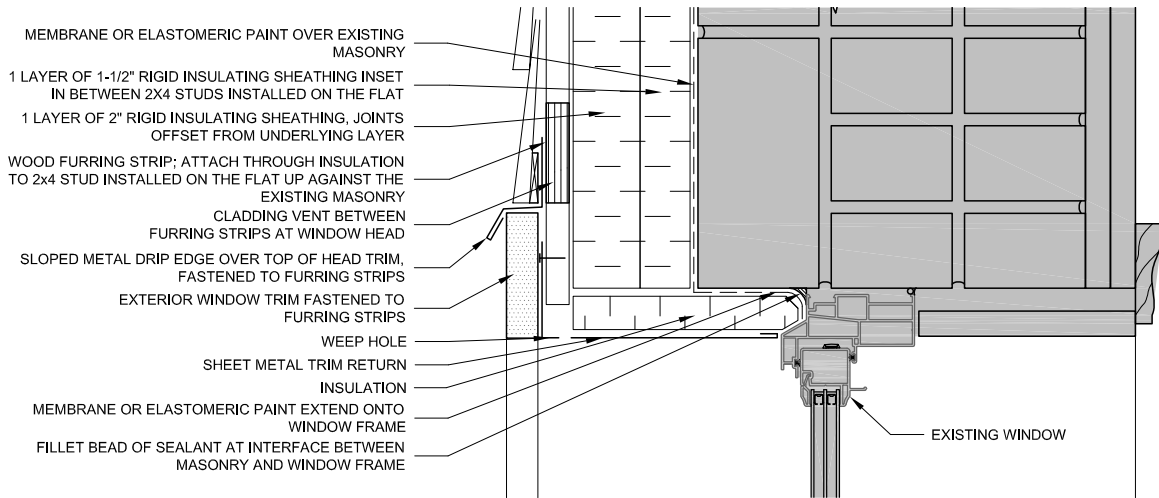
2 EXISTING REPLACEMENT WINDOW HEAD DETAIL
SCALE: 3" = 1'-0"

Figure 9. Window head detail from schematic window details. Note that removing the window trim, trim return, and window return insulation exposes the water and air control membrane (dashed line at exterior face of brick) of the assembly.

Regardless of whether or not leakage through the window frames will require near-term repairs, the expected service life of the window is not nearly as long as that of the wall assembly. The schematic window details anticipate replacement of the window at some point in the future. The window casing trim, window sill trim, trim returns and insulation at window returns are designed to be removed (and subsequently reinstalled) without disrupting the insulation and over-cladding assembly beyond the window opening. Removing these elements around the window opening provides access to the water and airflow control membrane of the insulation and over-cladding assembly. This makes it possible for a future window installation to establish a drained opening by installing pan flashing below the window and jamb flashing at the sides that properly integrate with the water and airflow control of the insulation and over-cladding assembly (Figure 9 and Figure 10).

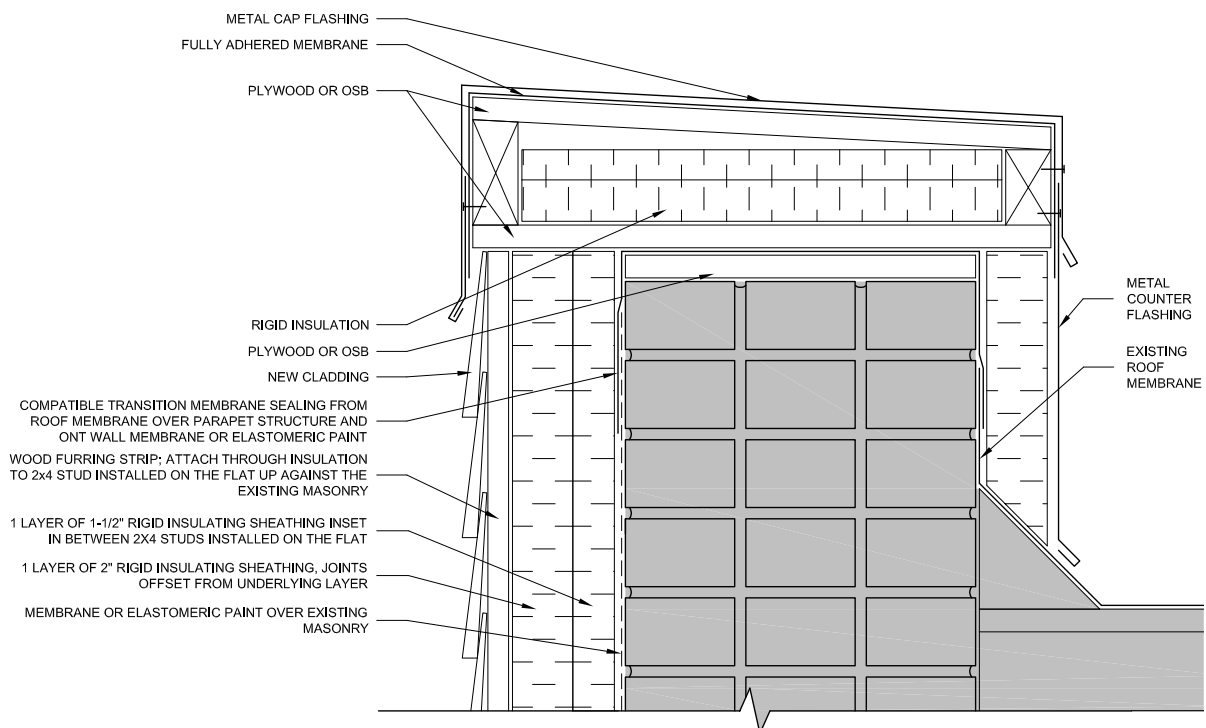
Figure 11. Schematic parapet detail. Note the transition membrane that connects the air control membrane of the wall (dashed line at exterior face of brick) to the existing roof membrane.

For the parapet wall, the details prepared demonstrated a connection between the airflow control of the wall and that of the roof by a transition membrane that wraps over the top of the existing parapet structure and seals to both the membrane or elastomeric paint on the wall and, on the roof side of the parapet, the existing roof membrane. The approach represented in the detail also illustrated the need to remove the existing parapet cap as the existing cap would be inadequate after the wall is thickened with insulating sheathing (Figure 11). Wrapping the parapet with insulation also addresses a major heat loss liability represented by this masonry fin projecting above the surface of the roof (see Lstiburek 2008)

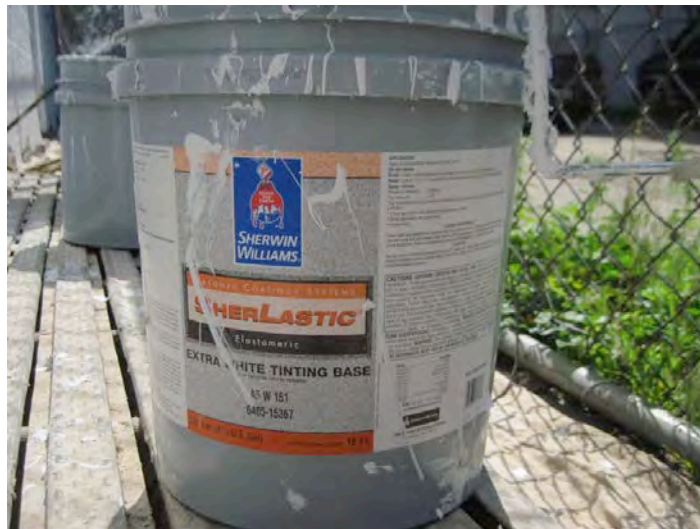
Figure 12. Commercially available elastomeric paint used by over-clad contractor
(Credit: Scott Sanders, CEDA).

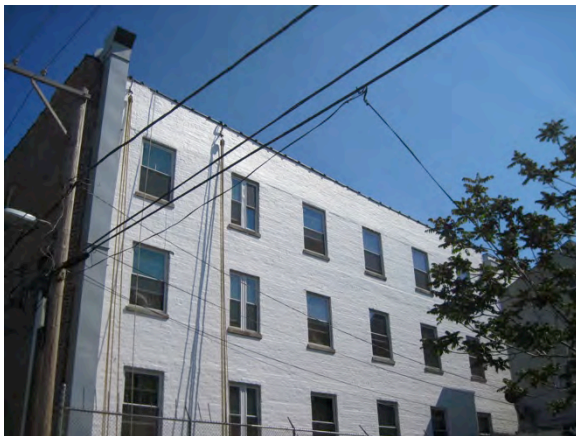
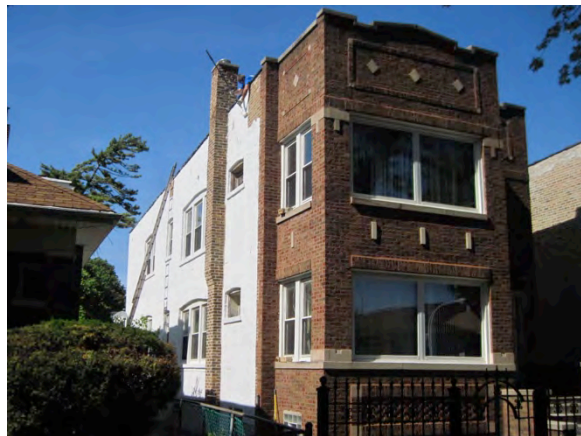
Figure 13. (L) Elastomeric paint application at larger multifamily building. Note that sills of windows are not painted; (R) Elastomeric paint application at two family building.
(Credit: Scott Sanders, CEDA)

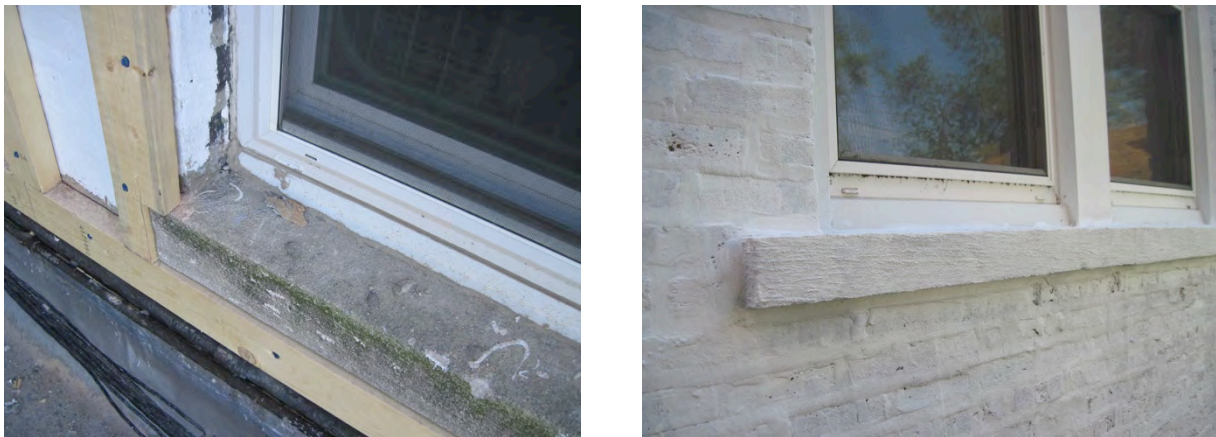
Figure 14. (L) Elastomeric paint application not complete around windows and portions of masonry surface obscured by wood framing; (R) elastomeric paint application at the two-family building covering the window sill and lapping onto the window frame
(Credit: Scott Sanders, CEDA)

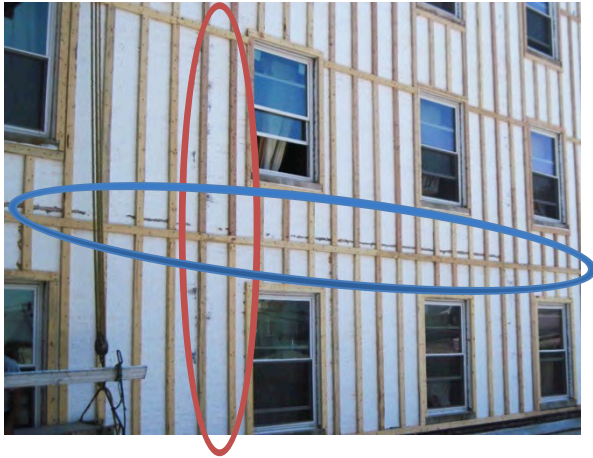
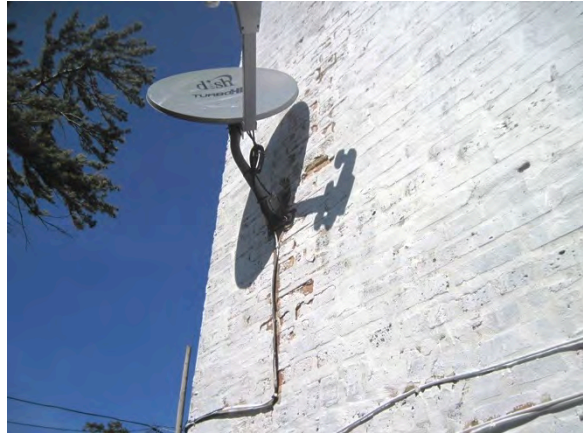
Figure 15. (L) Water and air control layer discontinuous at location of removed electrical conduit (blue circle) and gutter brackets; (R) satellite reception dish and associated cables create areas that will require touch-up to establish a continuous control layer with the elastomeric paint
(Credit: Scott Sanders, CEDA)

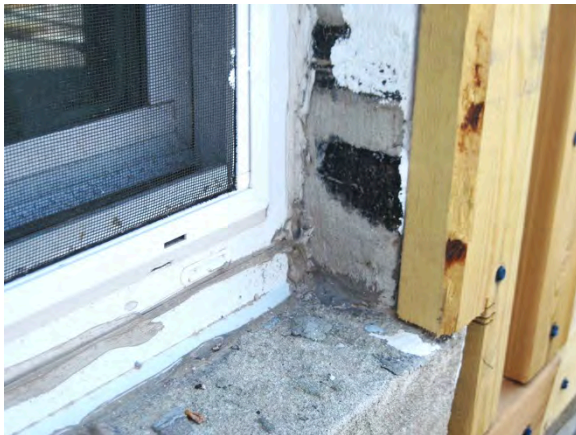
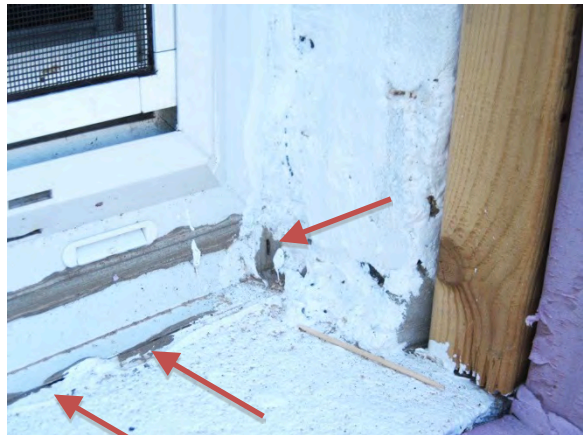
Figure 16. (L) Window in masonry opening with previously applied sealant; (R) new sealant and elastomeric paint applied at window opening. Note persistent gaps at transitions.
(Credit: Scott Sanders, CEDA)

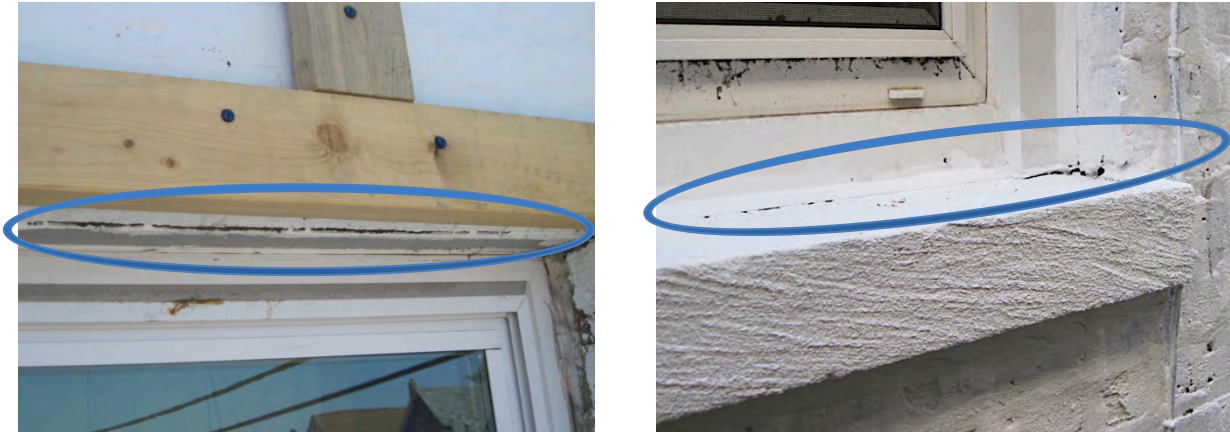
Figure 17. (L) Gap between masonry and lintel; (R) gaps at joints where sealant had not been applied as a substrate for the elastomeric paint
(Credit: Scott Sanders, CEDA)

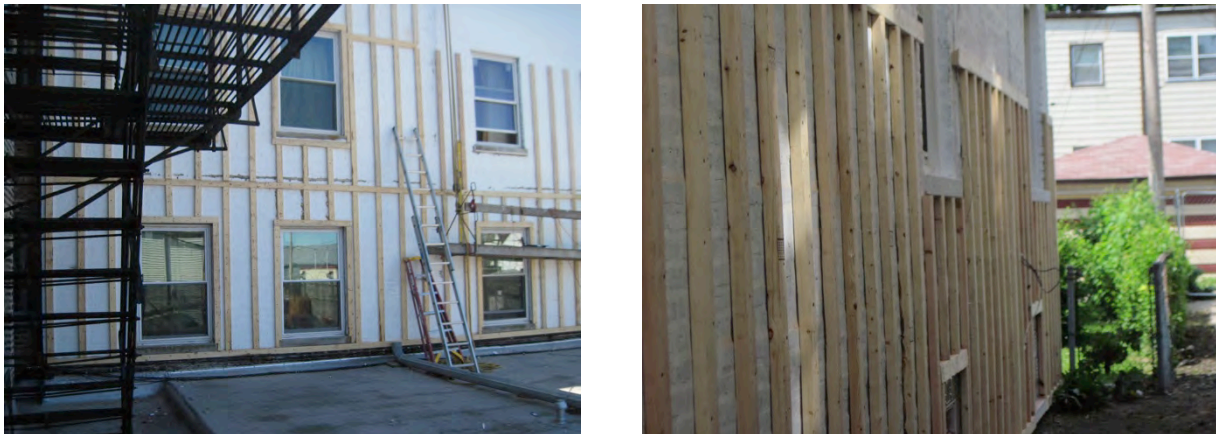
Figure 18. (L) Framing installed in a vertical orientation at 16 in. o.c. as well as horizontally at 8-ft increments in the field of the wall. Each window opening is also picture framed with the framing material; (R) Framing installed against masonry at two-family building with horizontal framing at top of window openings and at 8-ft vertical increments.
(Credit: Scott Sanders, CEDA)

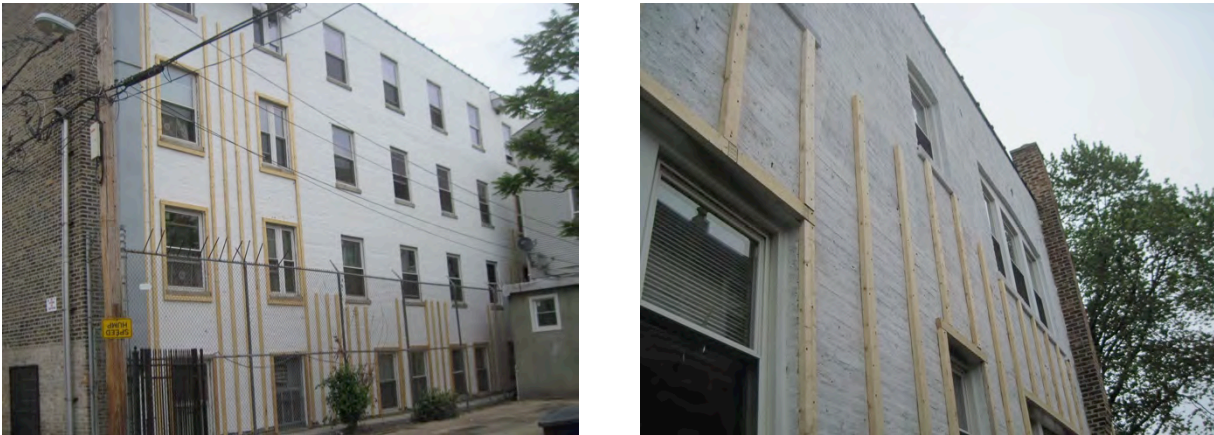
Figure 19. (L) Framing installed at in a vertical orientation only in the field of the wall. Each window opening is picture framed with the framing material. (R) Framing installed against masonry at two-family building with horizontal framing at top of window openings but in a vertical orientation elsewhere.
(Credit: Scott Sanders, CEDA)

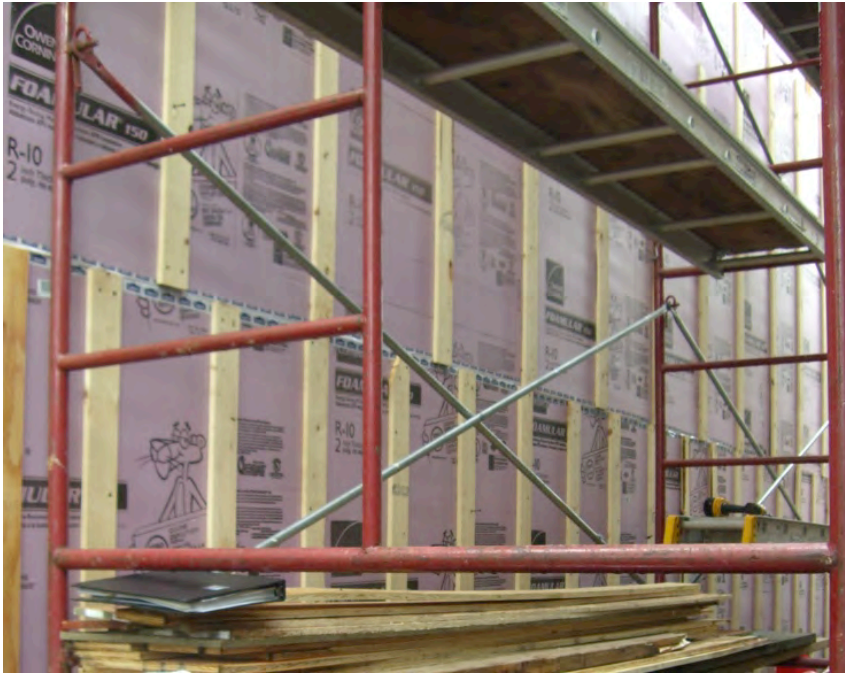
Figure 20. Strapping over insulating sheathing showing switch from 16 in. o.c. to 24 in. o.c. at the two-family building
(Credit: John Yi, CEDA)

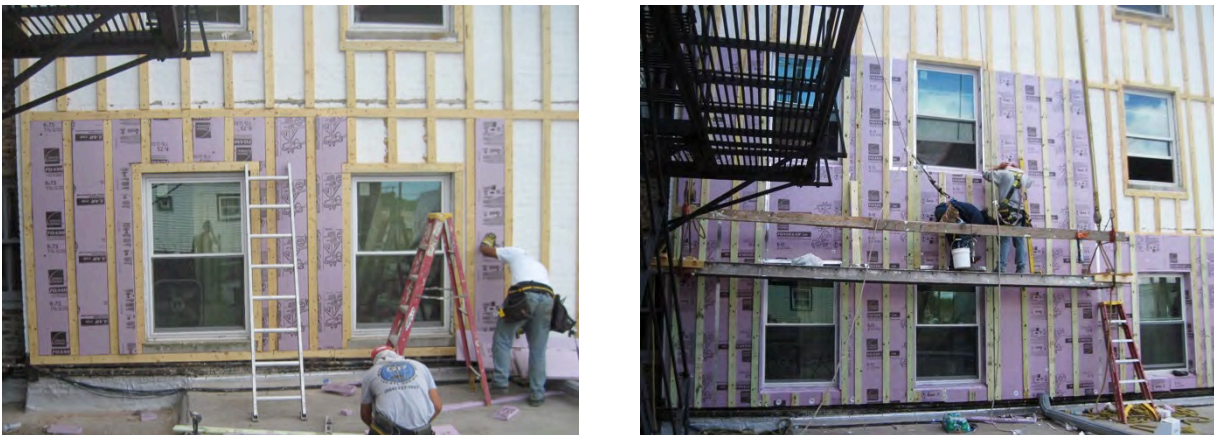
Figure 21. (L) Crews installing rigid insulation between furring; (R) second layer of rigid insulation installed over same section of wall as shown at left. Photo taken 1½ hours after photo at left. Finished first floor insulation extends another three window bays to the right of the image.
(Credit: Scott Sanders, CEDA)

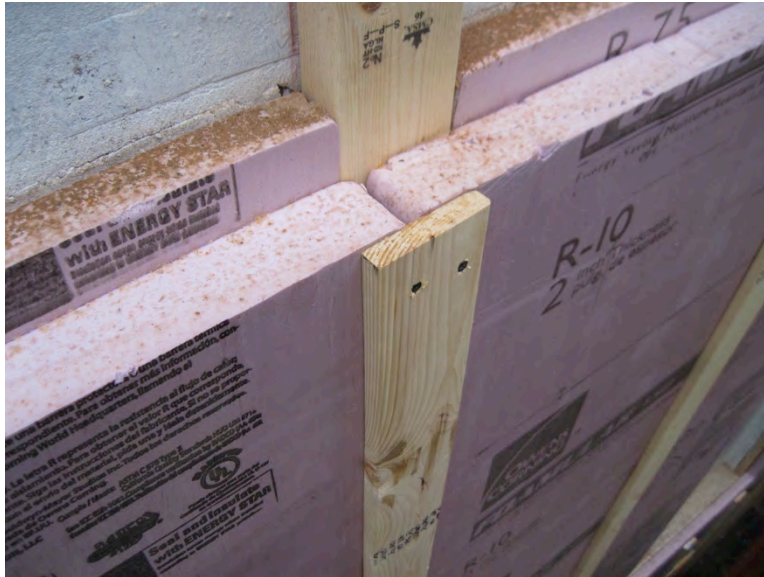
Figure 22. Offset of seams in successive layers of insulating sheathing. Offset for vertical seam is limited by the size of insulation boards and the spacing of framing.
(Credit: Scott Sanders, CEDA)

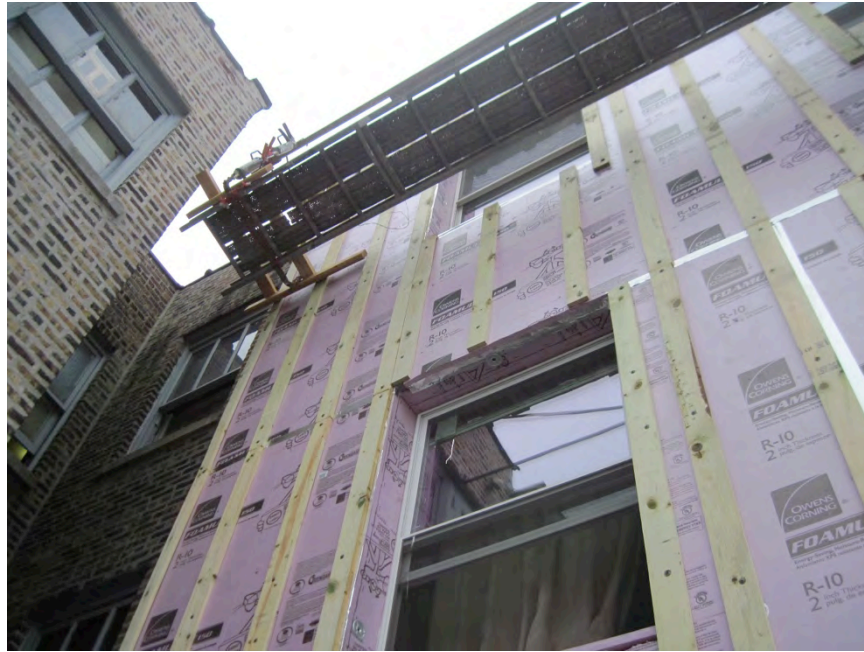
Figure 23. Wood strapping installed in vertical orientation only over face of insulating sheathing
(Credit: Scott Sanders, CEDA)

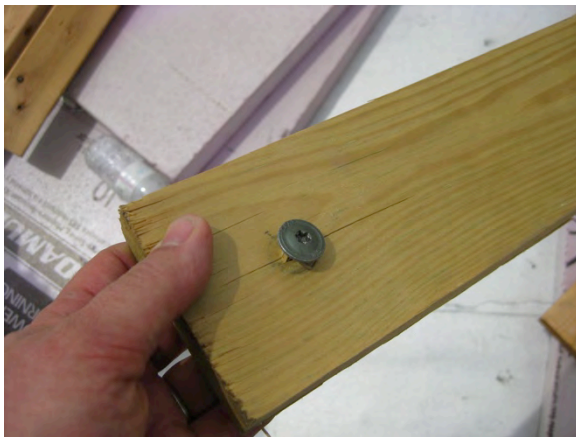
Figure 24. (L) Wood strapping with fastener used for attachment through rigid foam insulation to 2 x 4 framing; (R) longer size fasteners used to attach strapping through thicker rigid foam insulation layer at parapet

Despite exhibiting a reticence to employ framing in a vertical orientation only, during installation of strapping over the insulation, the contractor for the larger building demonstrated comfort with limiting strapping to a vertical orientation (Figure 23 and Figure 24).

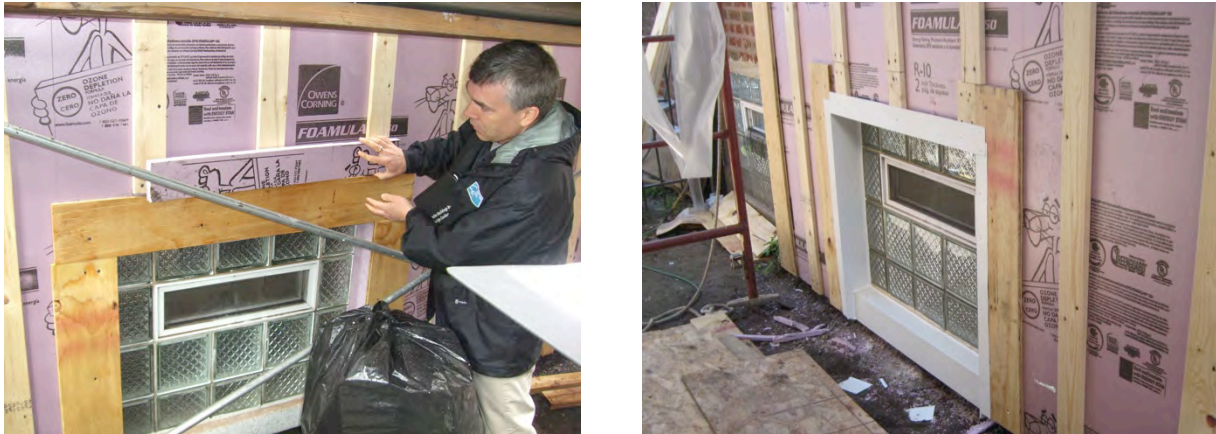
Figure 25. (L) BSC personnel explaining the attachment of trim to vertically oriented strapping; (R) the same window after the contractor reconfigured the strapping
(Credit: John Yi, CEDA [L] and Scott Sanders [R], CEDA).

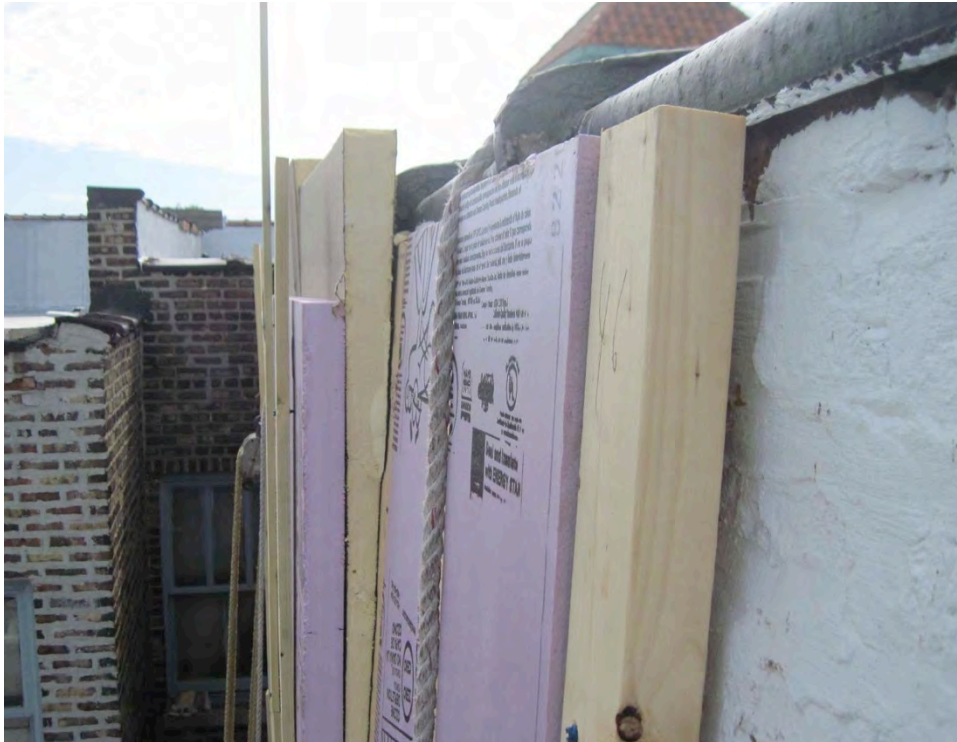
Figure 26. Beveled roof insulation used to true new cladding attachment at top of wall. Note that fasteners are left loose at the time of this photo.

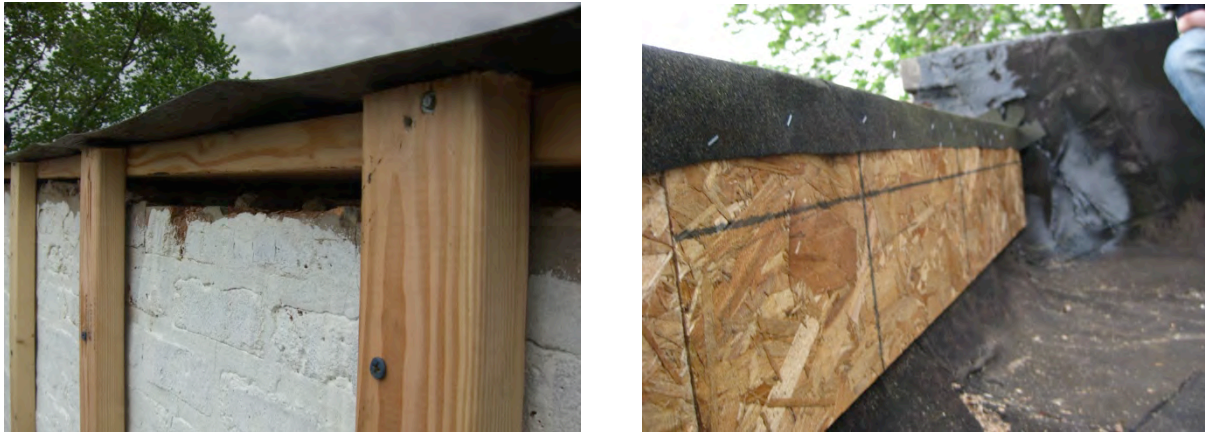
Figure 27. (L) Contractors mock up of frame over parapet using 2 × 12 attached to vertical furring attached to face of wall; (R) OSB attached to 2 × 12 at inside face of parapet.
(Credit: John Yi, CEDA)

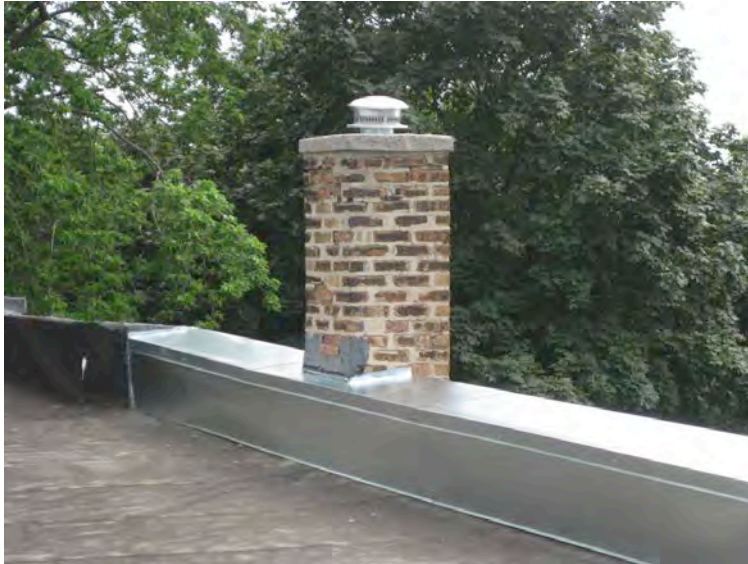
Figure 29. Finished parapet cover at two-family building

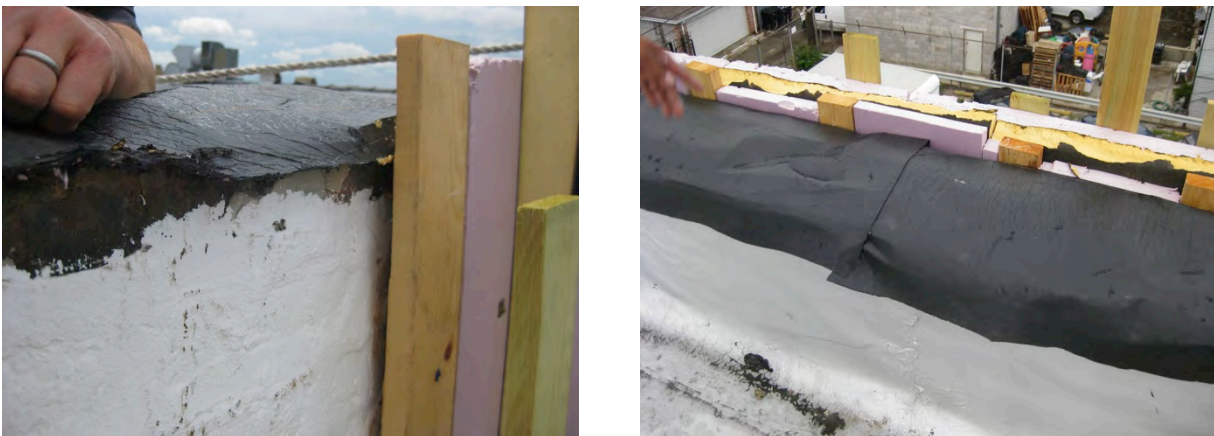
Figure 30. (L) Transition membrane not connected to elastomeric coating at face of wall; (R) transition membrane not adhered to roof membrane at inside face of parapet

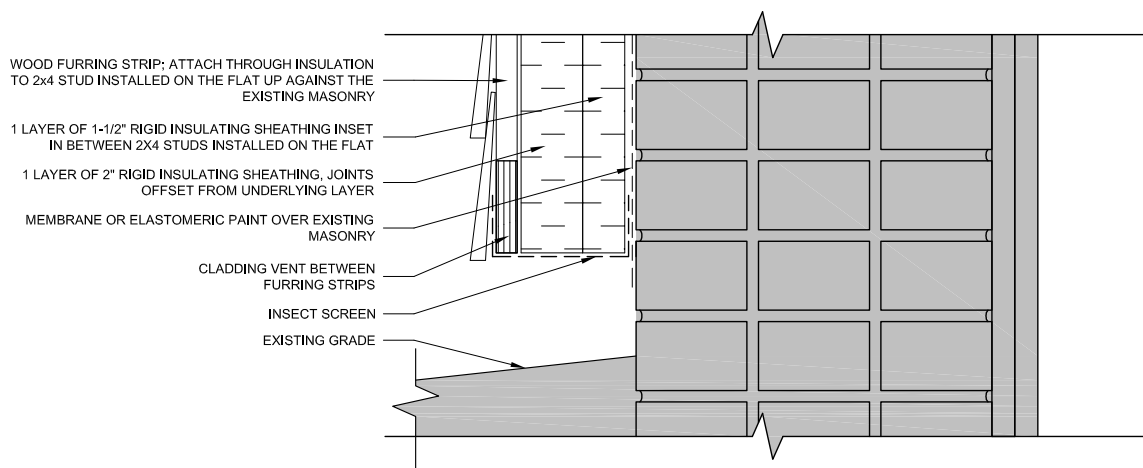
Figure 31. Schematic detail for base of insulation and over-clad assembly

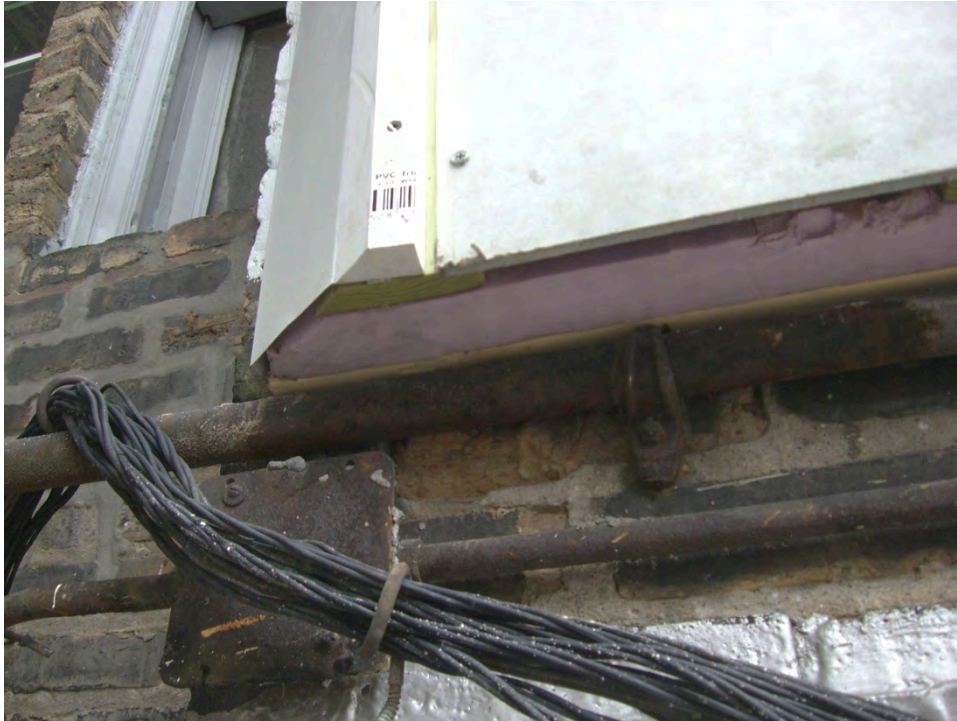
Figure 32. Base of wall with constricted access for attachment of screening
(Credit: John Yi, CEDA)

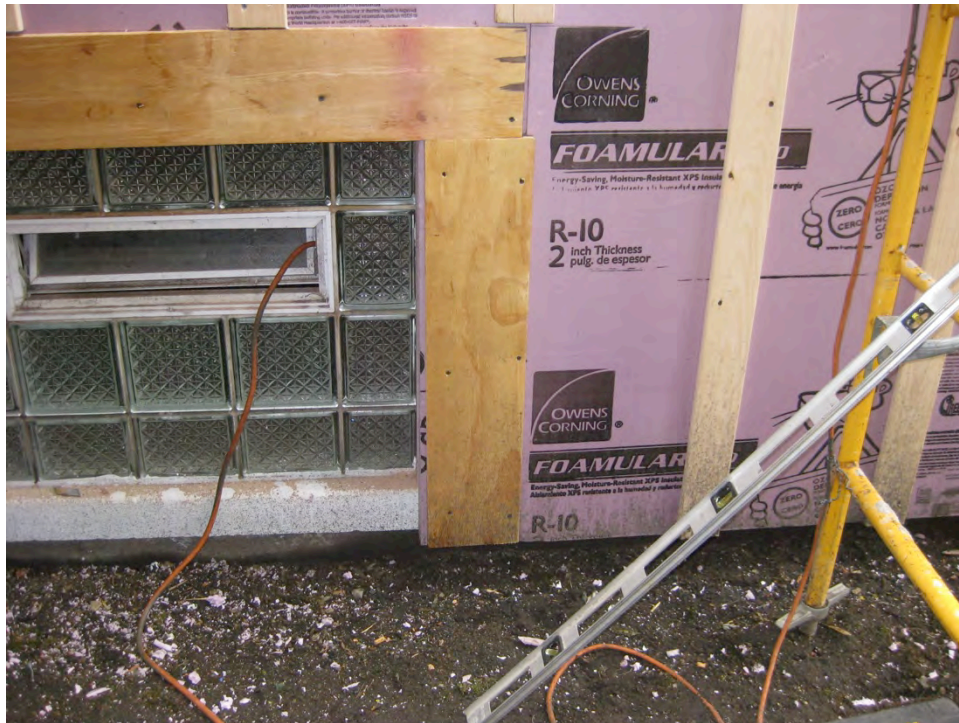
Figure 33. Base of wall insulation and over-clad assembly very close to grade at the two-family building

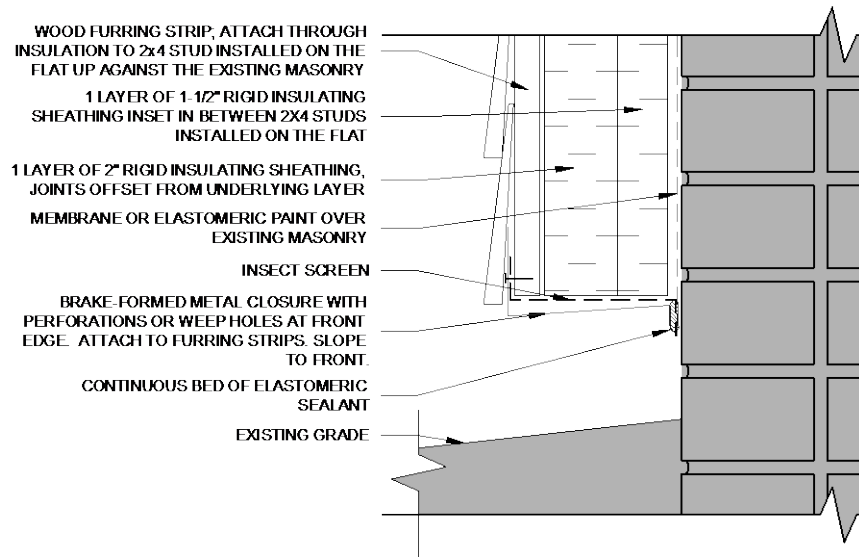
Figure 34. Excerpt of revised detail for protection at base of wall insulation and over-clad assembly

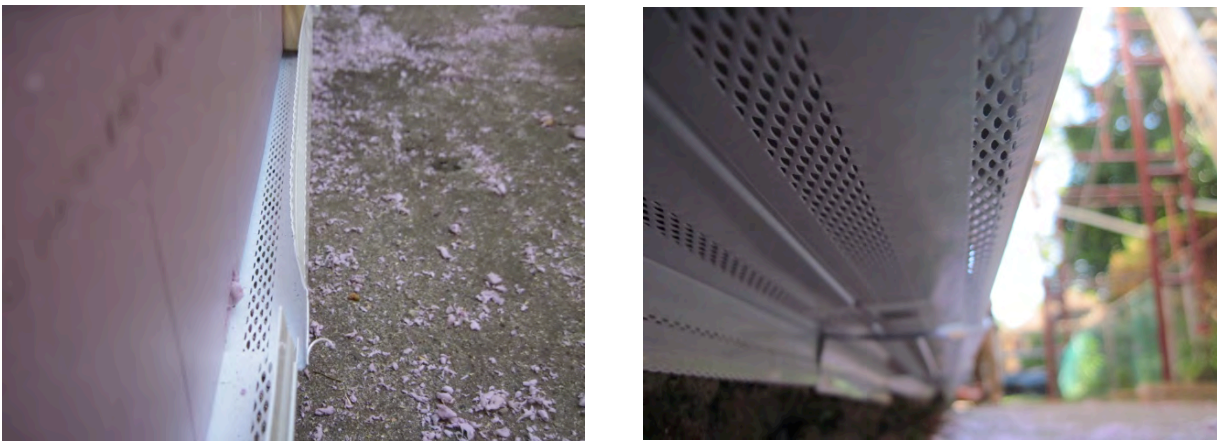
Figure 35. Perforated soffit material use for protection at base of insulation and over-clad assembly
(Credit: Scott Sanders, CEDA).
