Evaluation of Two CEDA Weatherization Pilot Implementations of an Exterior Insulation and Over- Clad Retrofit Strategy for Residential Masonry Buildings in Chicago

Building America Report - 1311

August 2013

Ken Neuhauser
Building Science Corporation

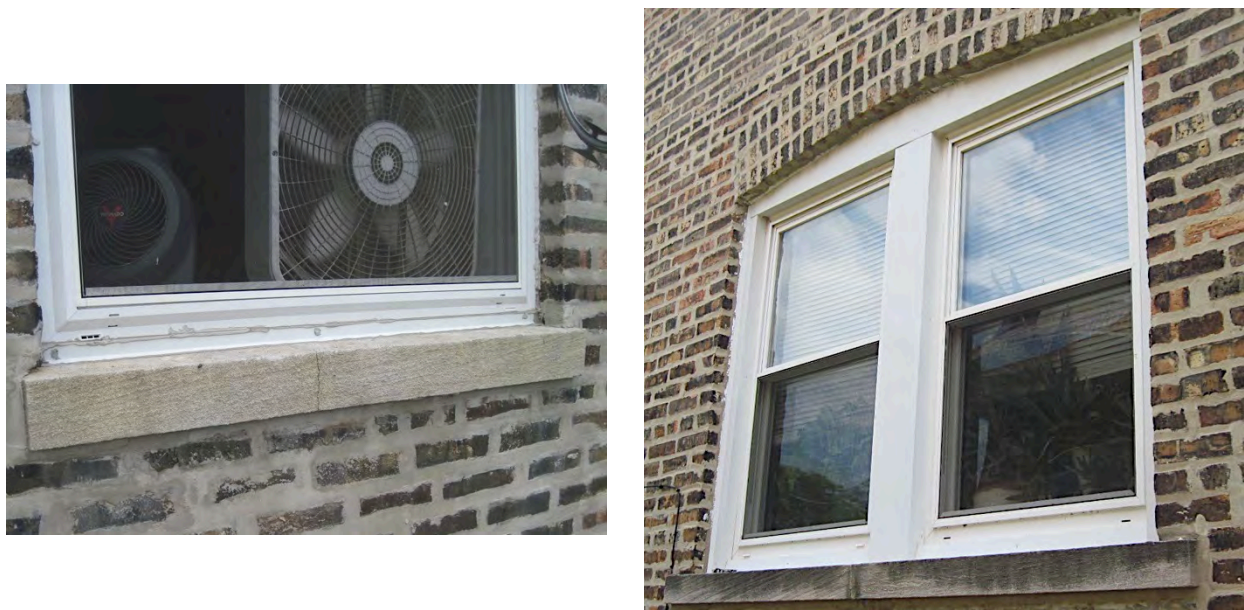
Figure 36. (L) Window set directly in masonry opening at the larger building; (R) windows set in metal-clad trim/frame surround at the two-family building
(Credit: Scott Sanders, CEDA)

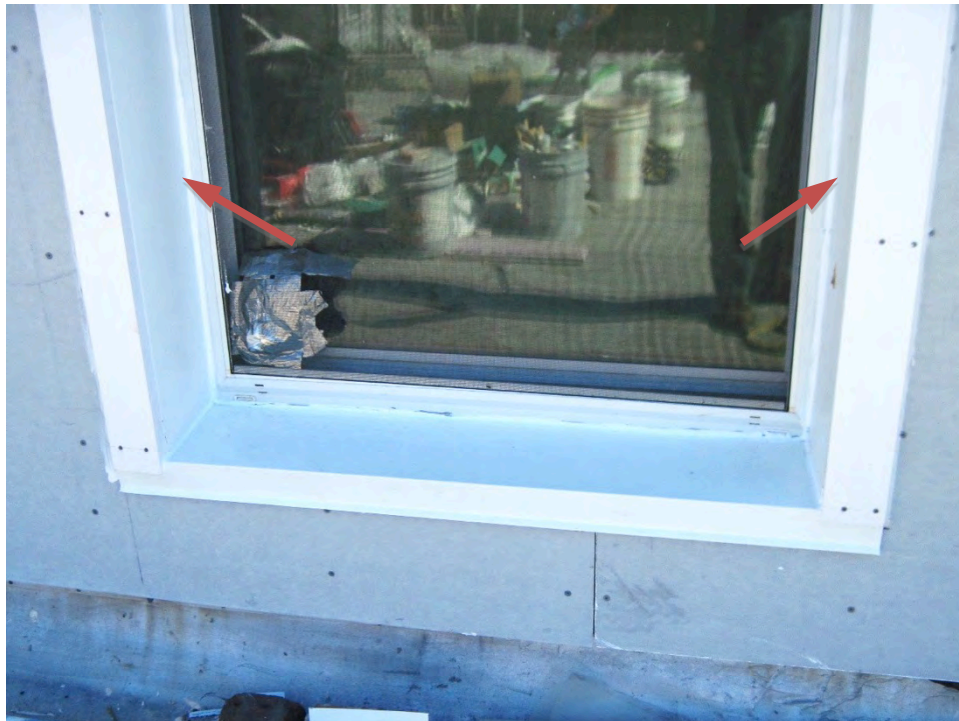
Figure 37. Return trim at the larger building butting into the vinyl window frame

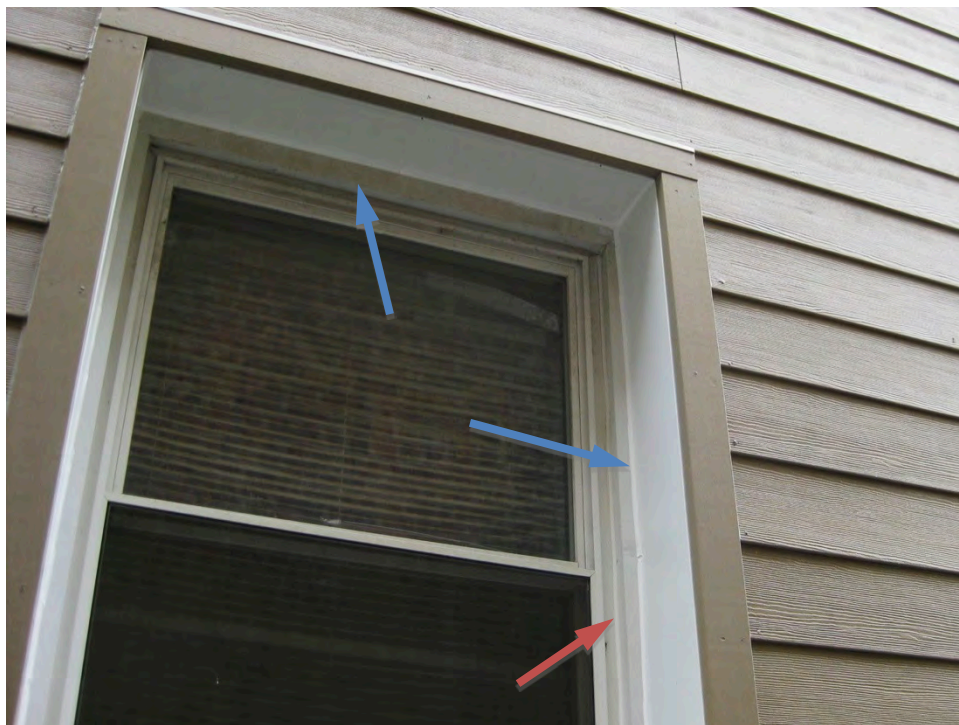
Figure 38. Return trim at the smaller building butting into the metal-clad trim surround (blue arrows) leaving the joint around the vinyl window frame exposed (red arrow)

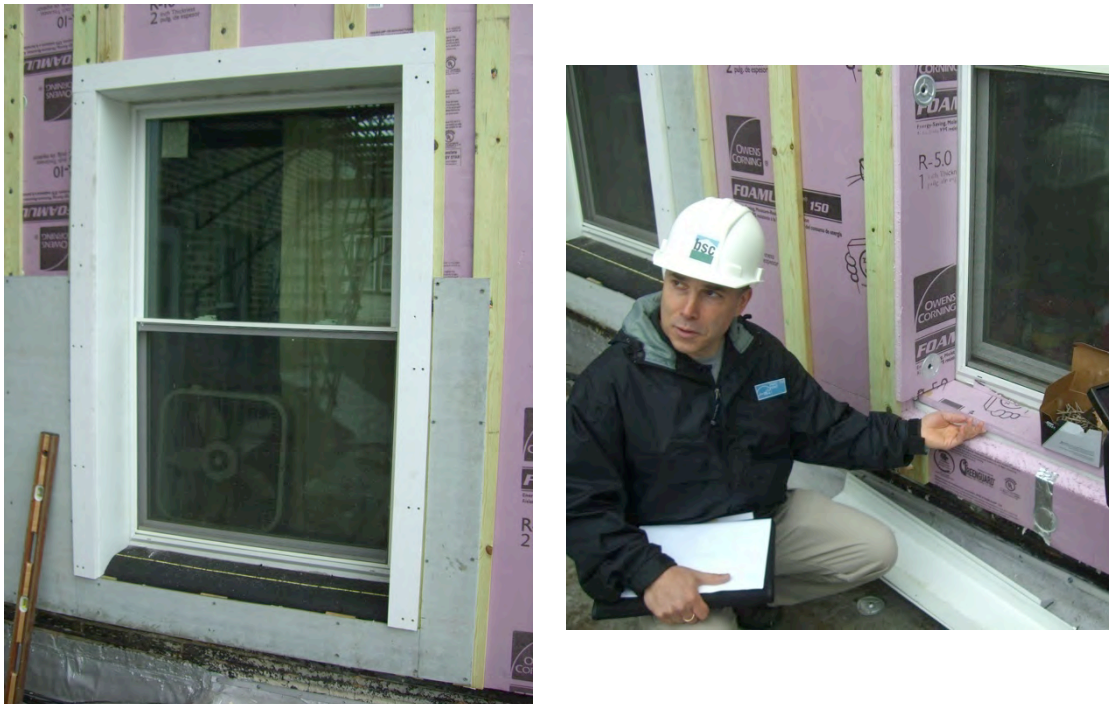
Figure 39. (L) Contractor mockup of window surround; (R) BSC personnel explaining placement of flashing membrane
(Credit: John Yi, CEDA)

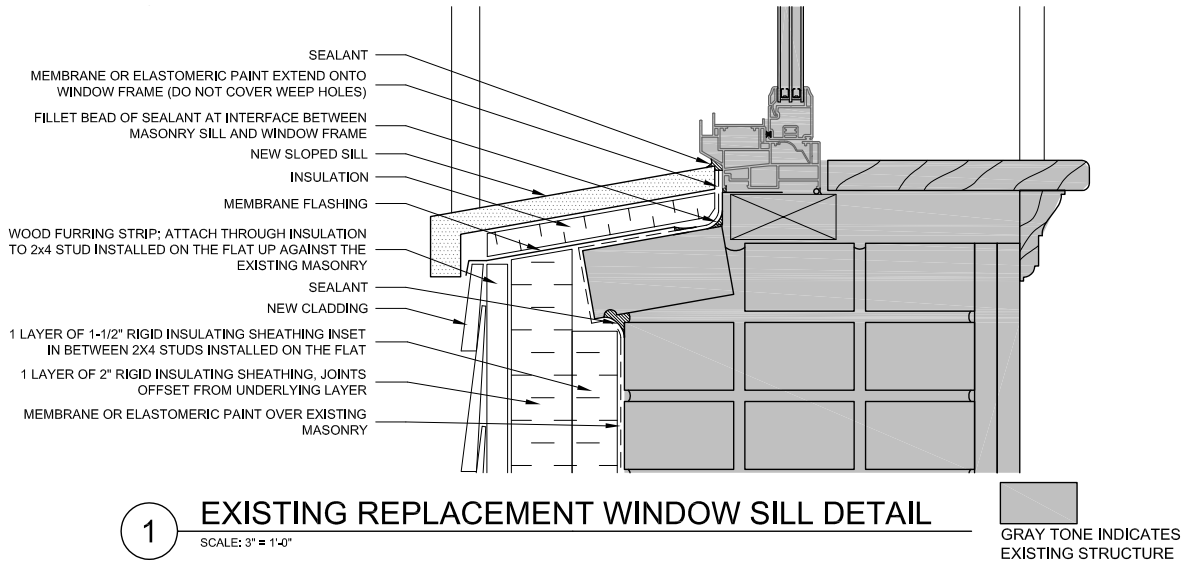
Figure 40. Window sill detail from schematic window details. Note that removing the window sill trim and window sill insulation exposes the water and air control membrane (dashed line at exterior face of brick) of the assembly.

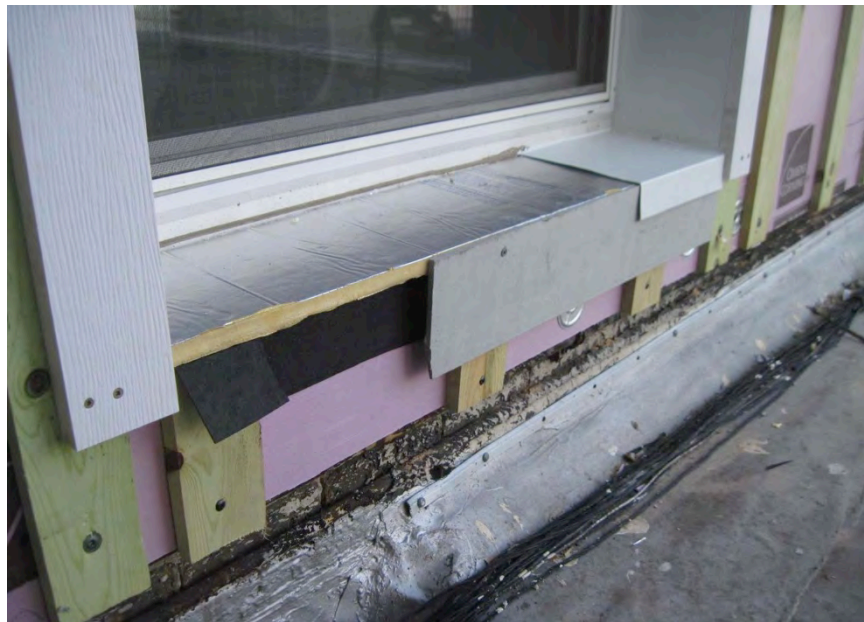
Figure 41. Second mockup of window surround showing the flashing membrane placed beneath the insulation return
(Credit: Scott Sanders, CEDA)

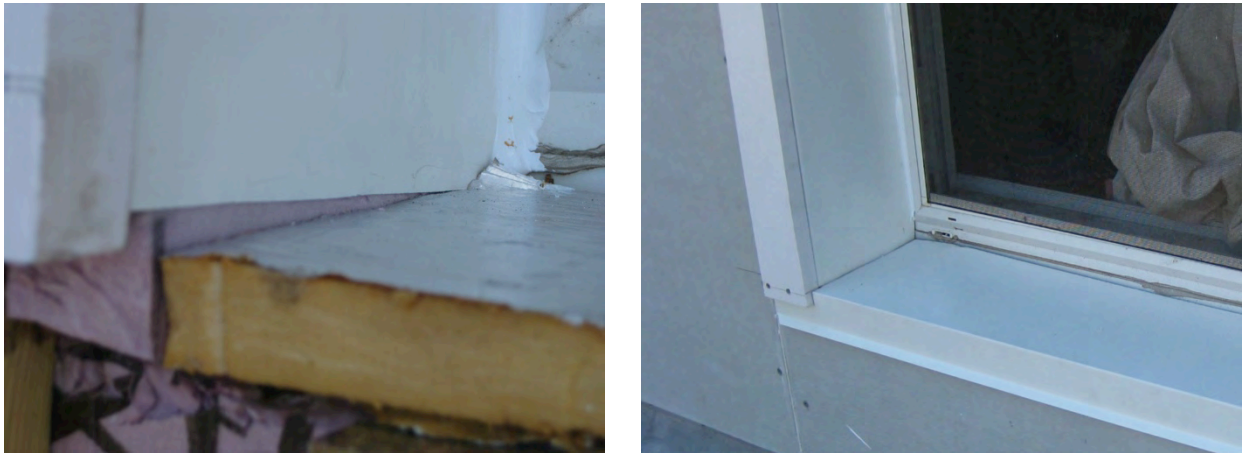
Figure 42. (L) Insulation return at the jamb installed before the insulation return at the sill. Note also that the sill flashing membrane does not extend over the outer face of the insulating sheathing. This was later corrected. (R) Sill trim installed after the jamb return trim. Sill extensions are actually cut around the jamb trim. Note that the window sill trim has a kick-out to direct water away from the face of the building.

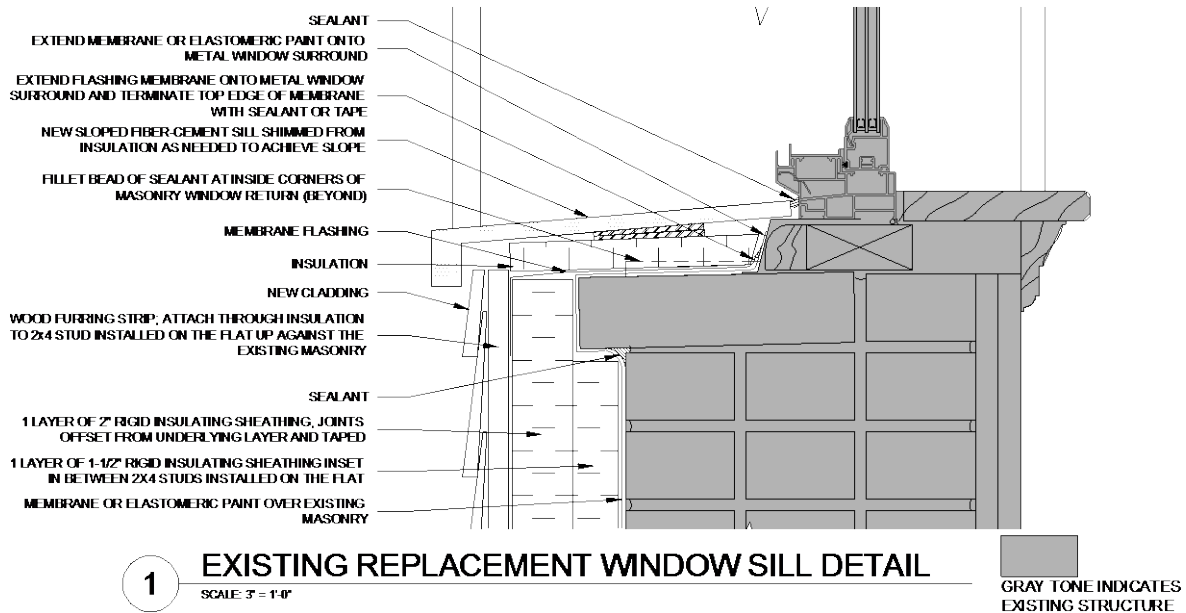
Figure 43. Revised detail for window sill treatment

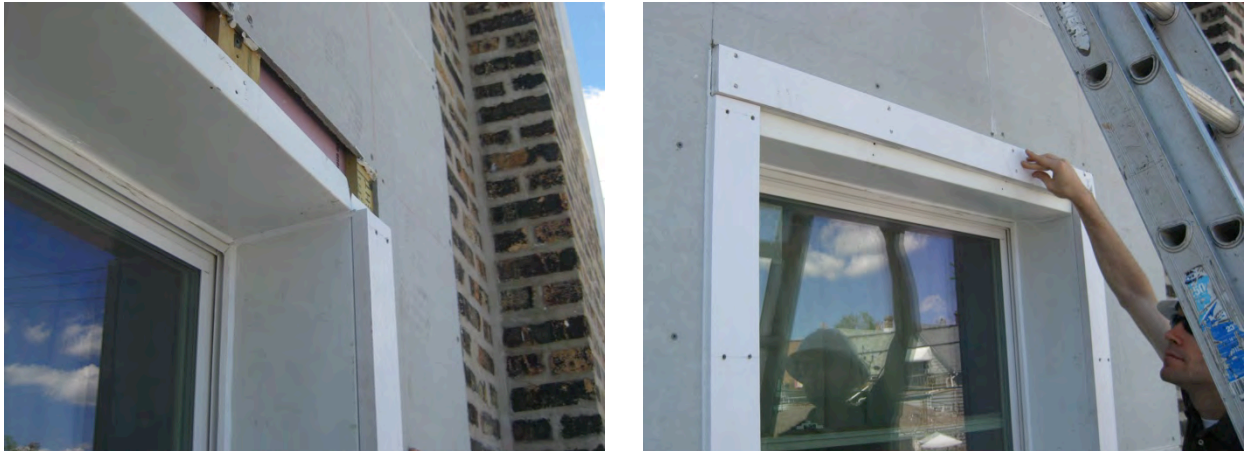
Figure 45. (L) Window head return trim sloping toward the window; (R) CEDA personnel demonstrating the reconfiguration of the window head return trim

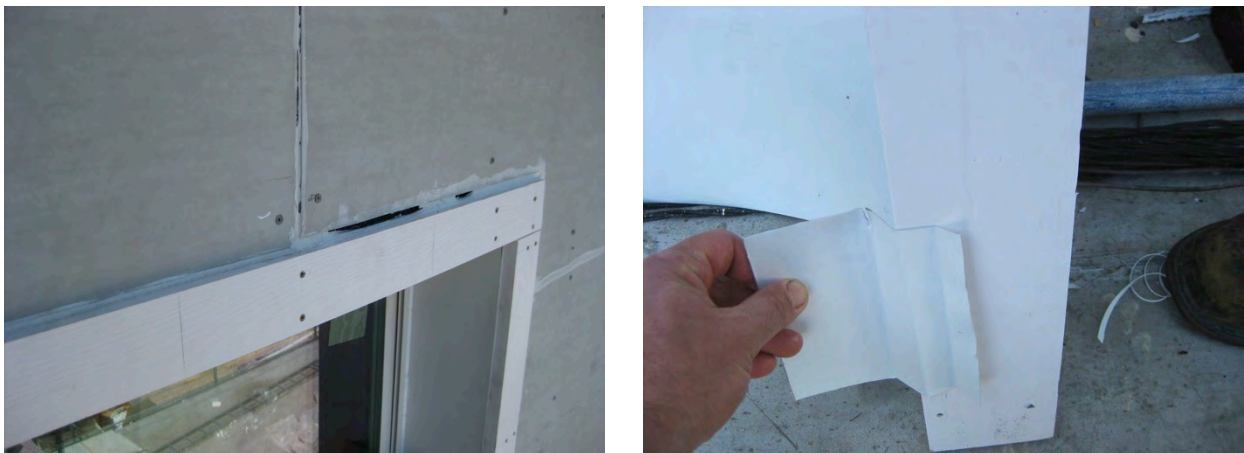
Figure 46. (L) Window head casing with no drip cap and sealant gaps; (R) Contractor project manager reviewing the drip cap flashing with the crew

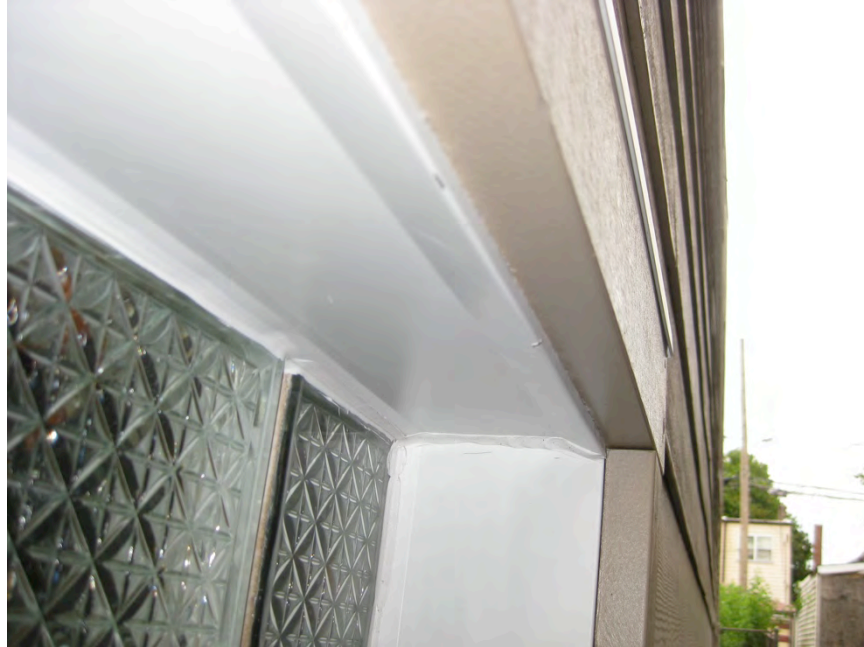
Figure 47. Window head return trim with profile channeling water to weep holes at the front edge

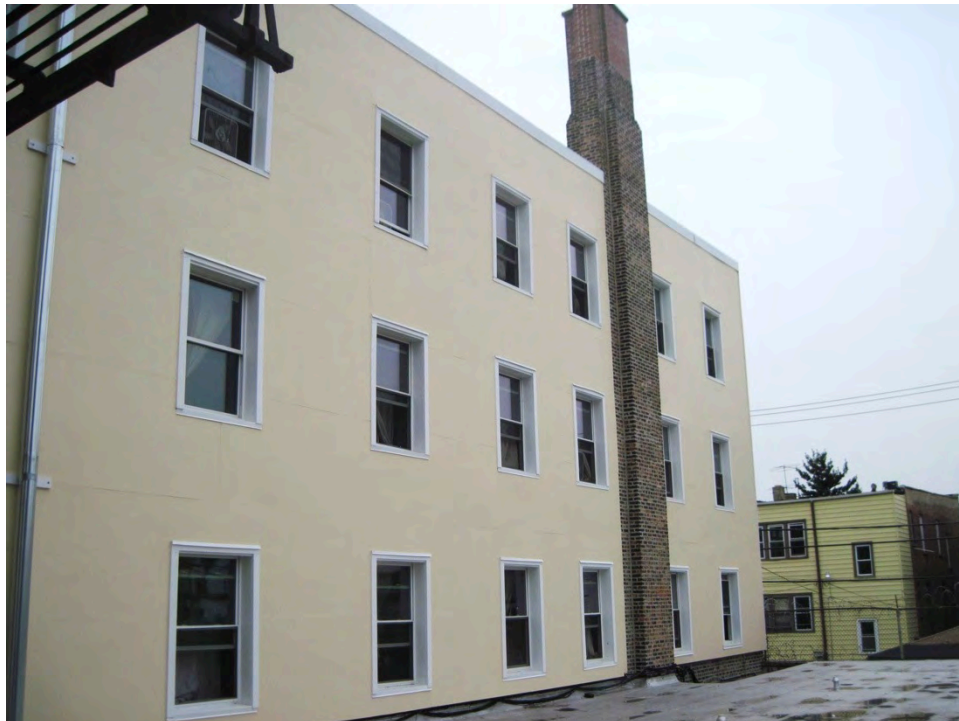
Figure 48. Finished side of the larger building

The treated elevations of both over-clad projects present a clean and finished appearance. The contractor for each project involved the building owner in selection of cladding and trim colors (Figure 48 and Figure 49).

The scope for the larger building employed fiber cement panels (4-ft × 8-ft sheets) for the cladding. The contractor used cellular polyvinyl chloride (PVC) and metal coil stock for the trim. For the smaller building, lapped fiber cement siding was the specified cladding system. The contractor for this project used metal coil stock and color-matched cellular PVC for the trim. Some differences in treatment emerge from the different cladding types used.

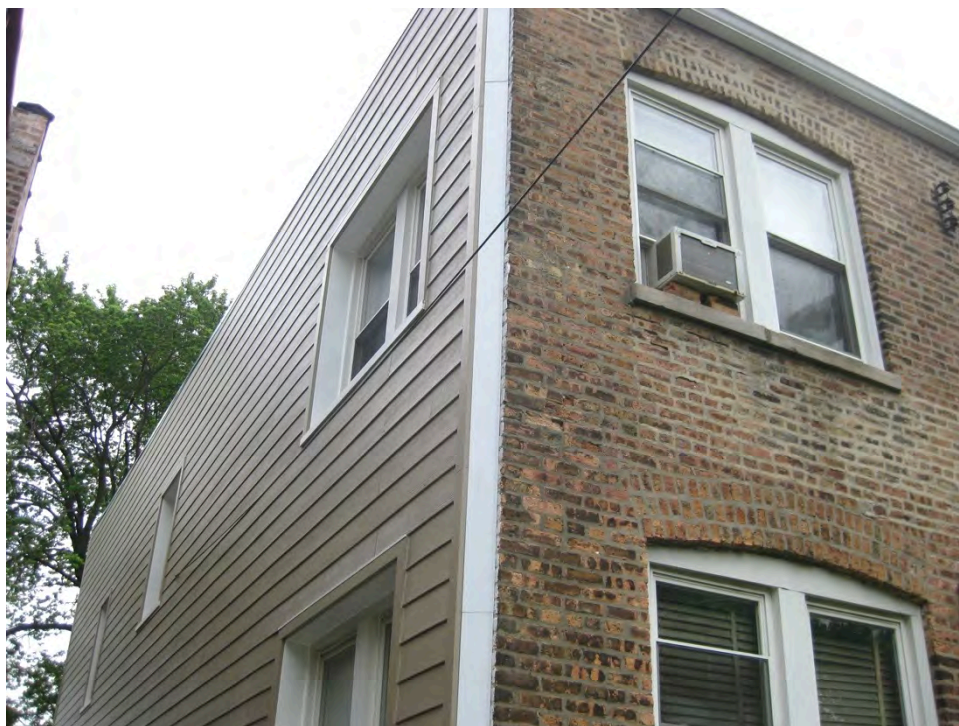
Figure 49. Treated wall at the smaller building striking a contrast with the untreated wall at the rear of the building

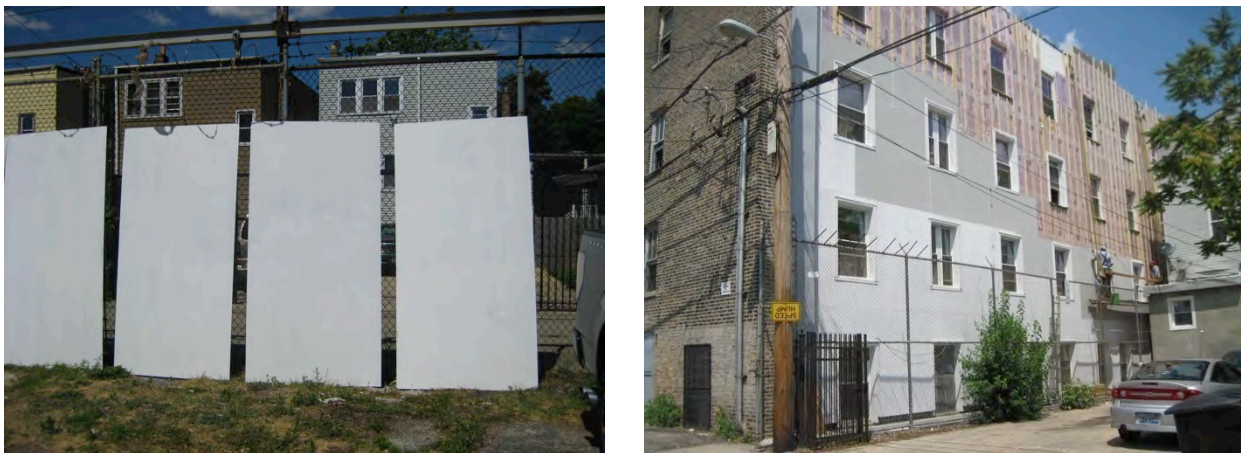
Figure 50. (L) Fiber cement panels back-primed prior to installation; (R) Progression of panel installation and face-priming at the second treated side of the larger building
(Credit: Scott Sanders, CEDA)

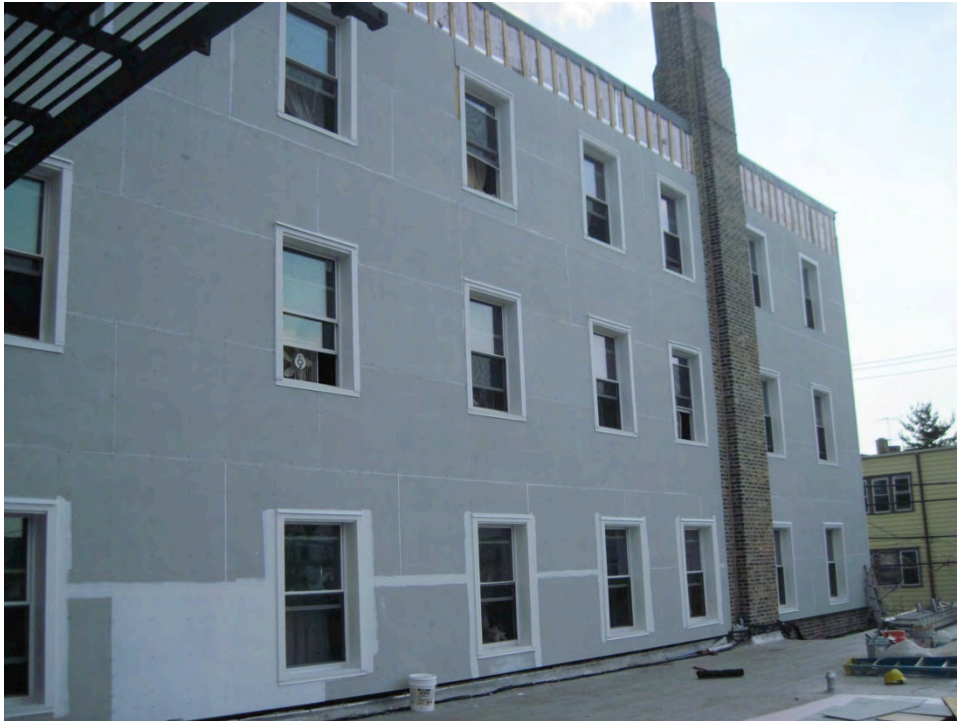
Figure 51. Caulked butt joints between 4 × 8 panels

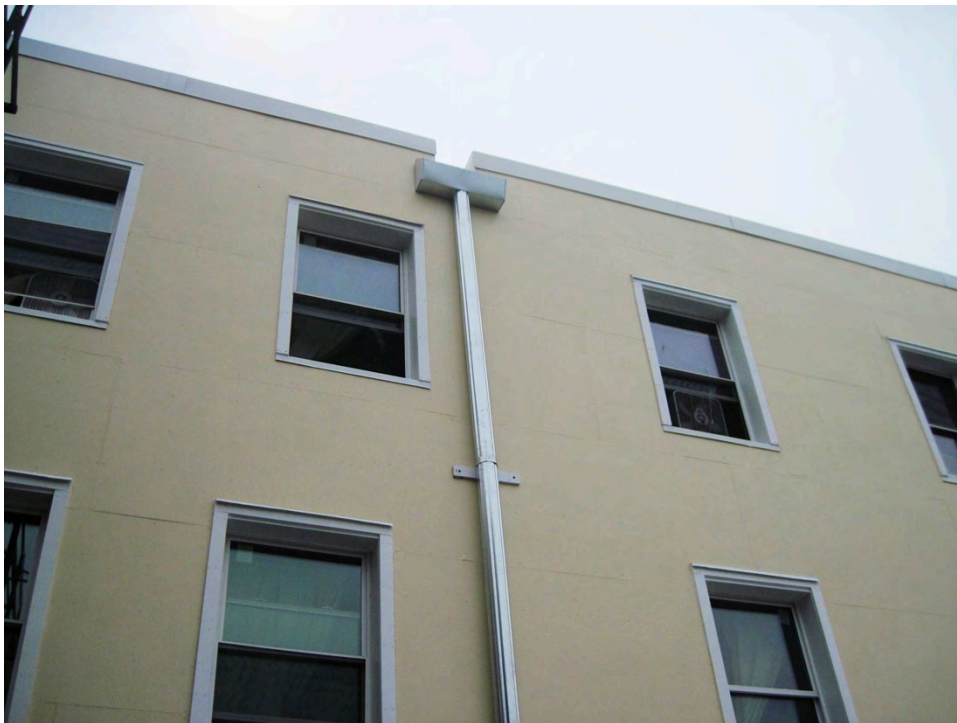
Figure 52. Butt joints between the panels visible in the finished wall

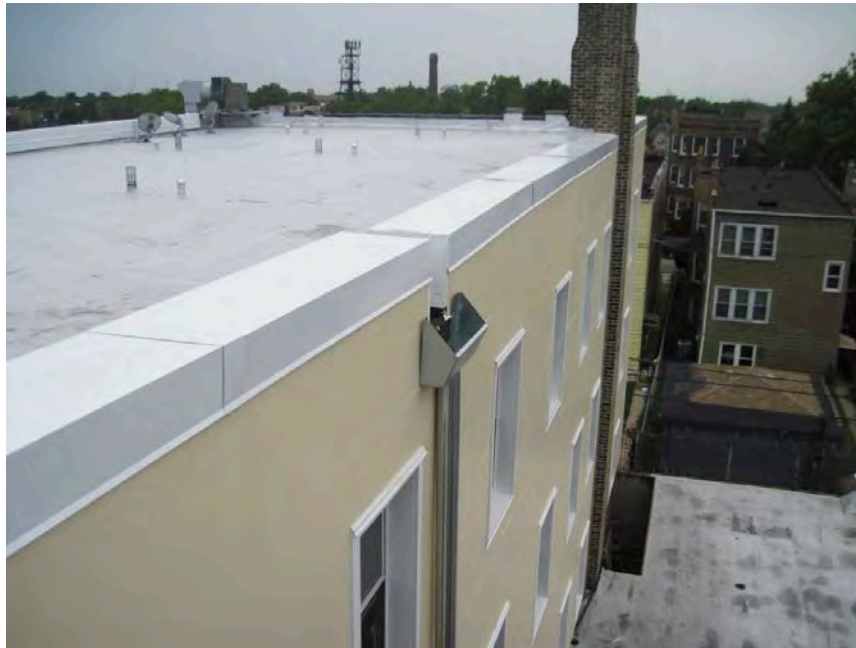
Figure 53. Visible butt joints in the finished wall

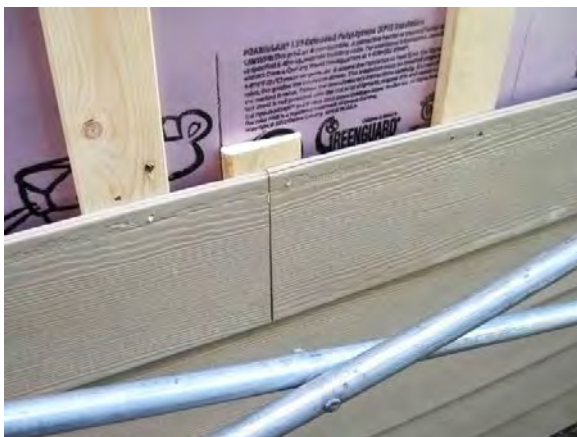
Figure 54. (L) Fiber cement lapped siding with fasteners at the top edge concealed by lap of subsequent piece; (R) fasteners for the panel cladding system exposed
(Credit: Scott Sanders, CEDA)

While the lapped siding system is able to hide fasteners, the panel system installed employs exposed fasteners. The exposed fasteners might also detract from the appearance of the finished system, although this is subjective. The fiber cement panel manufacturer’s installation instructions included in the contractor submittal indicates “Z” flashing as an acceptable option for horizontal joints between panels. The contractor for the larger building where the panels were used elected, instead, to caulk both horizontal and vertical butt joints between panels (Figure 54). With the drainage cavity directly behind the panels, the “Z” flashing is not needed to relieve water behind the panels.

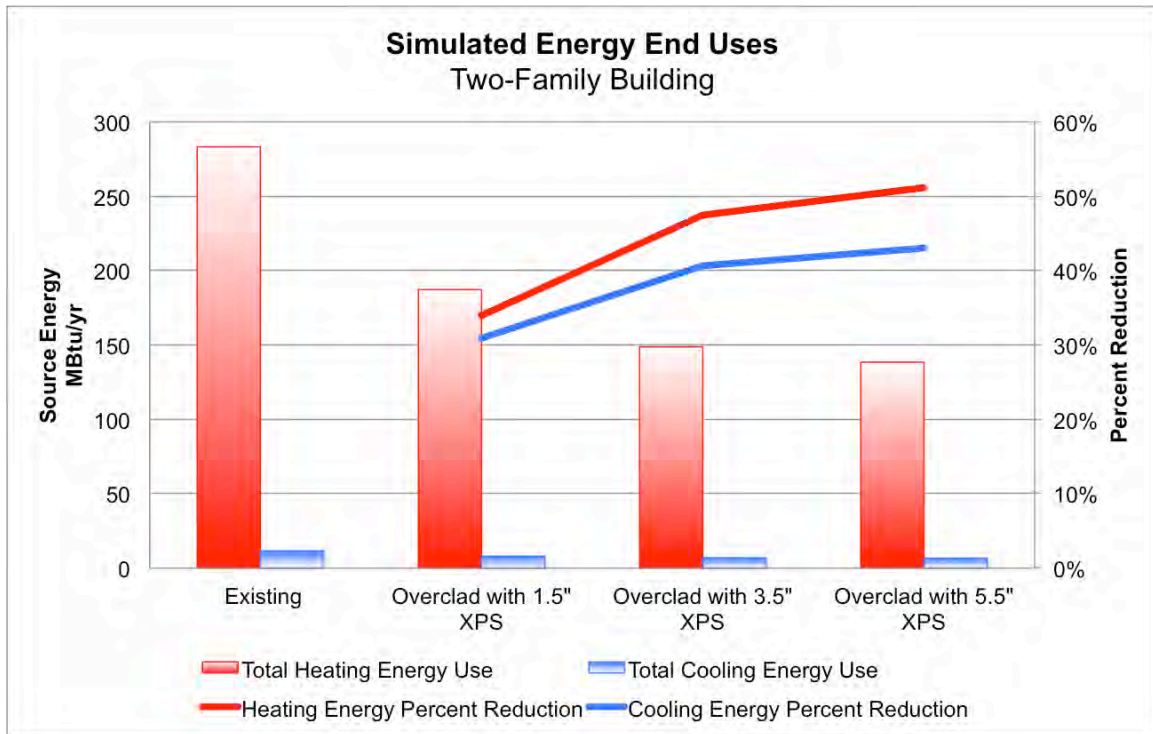
Figure 55. Predicted heating and cooling energy end uses for the two-family building

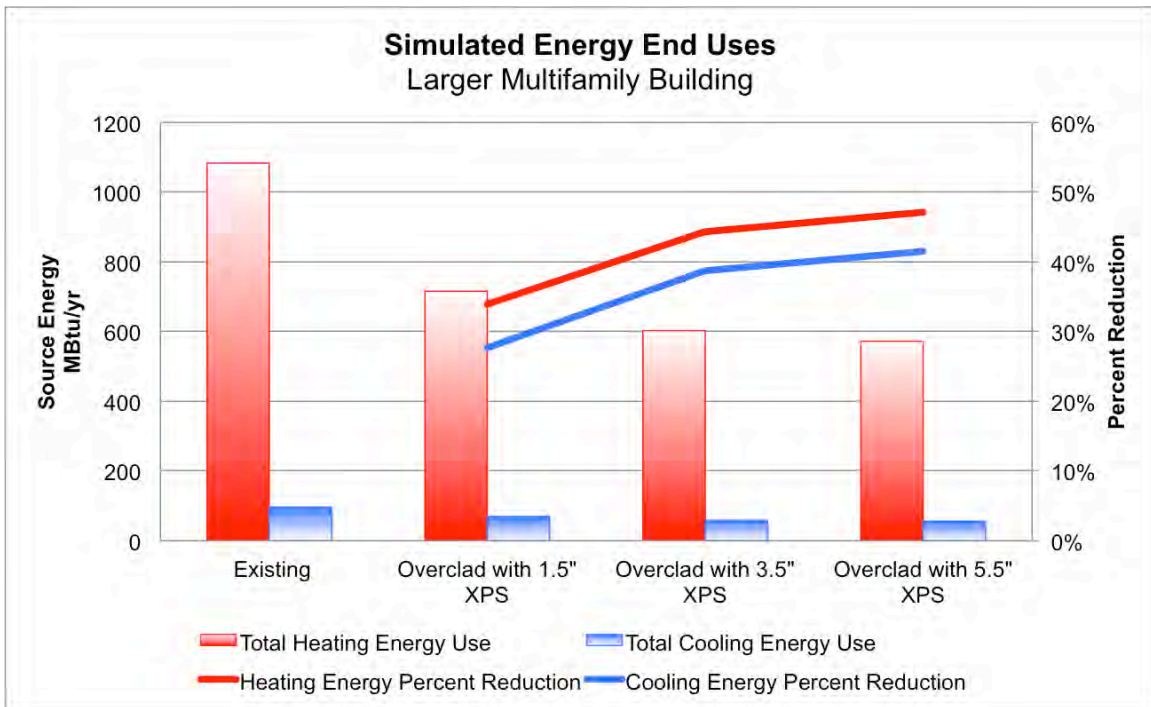
Figure 56. Predicted heating and cooling energy end use for the larger multifamily building

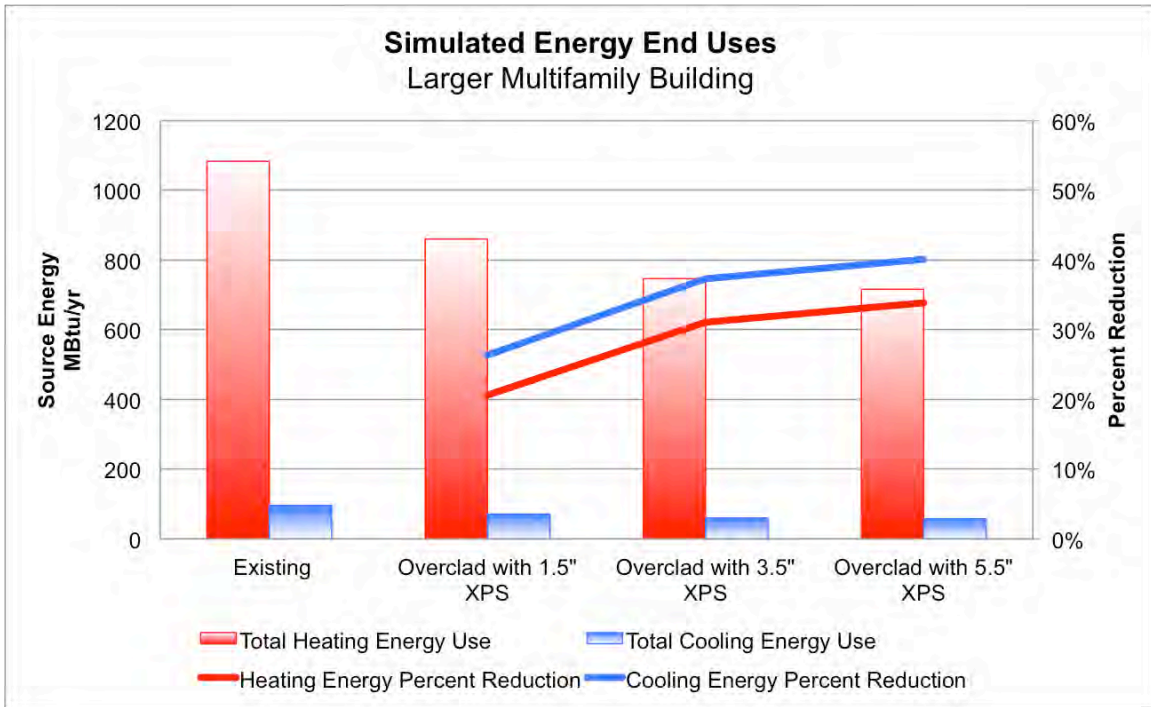
Figure 57. Predicted heating and cooling energy end use for the larger multifamily building without accounting for air leakage reduction

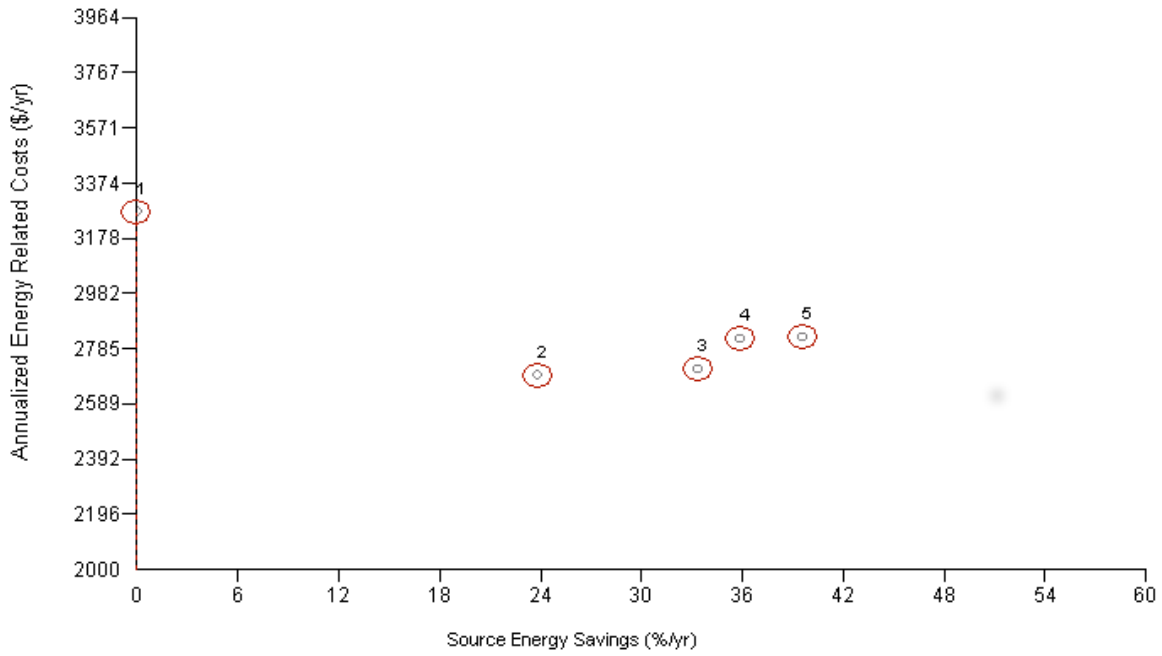
Figure 58. Predicted annualized energy-related costs and source energy savings for the two-family building under four upgrade scenarios

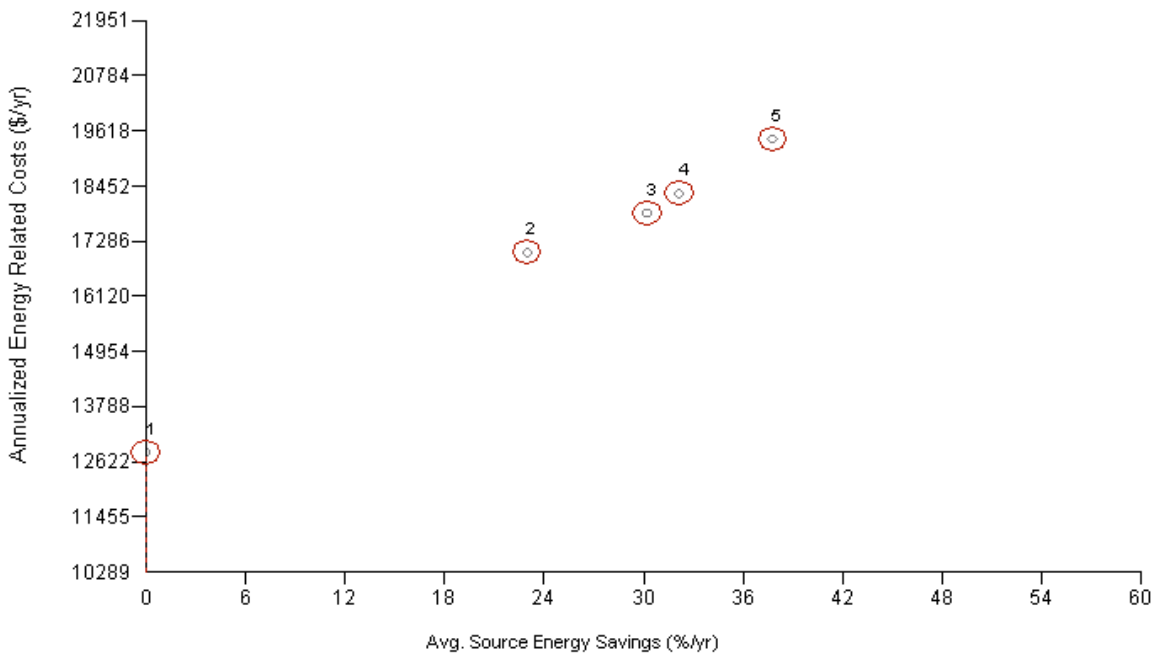
Figure 59. Predicted annualized energy-related costs and source energy savings for the larger multifamily building under four upgrade scenarios

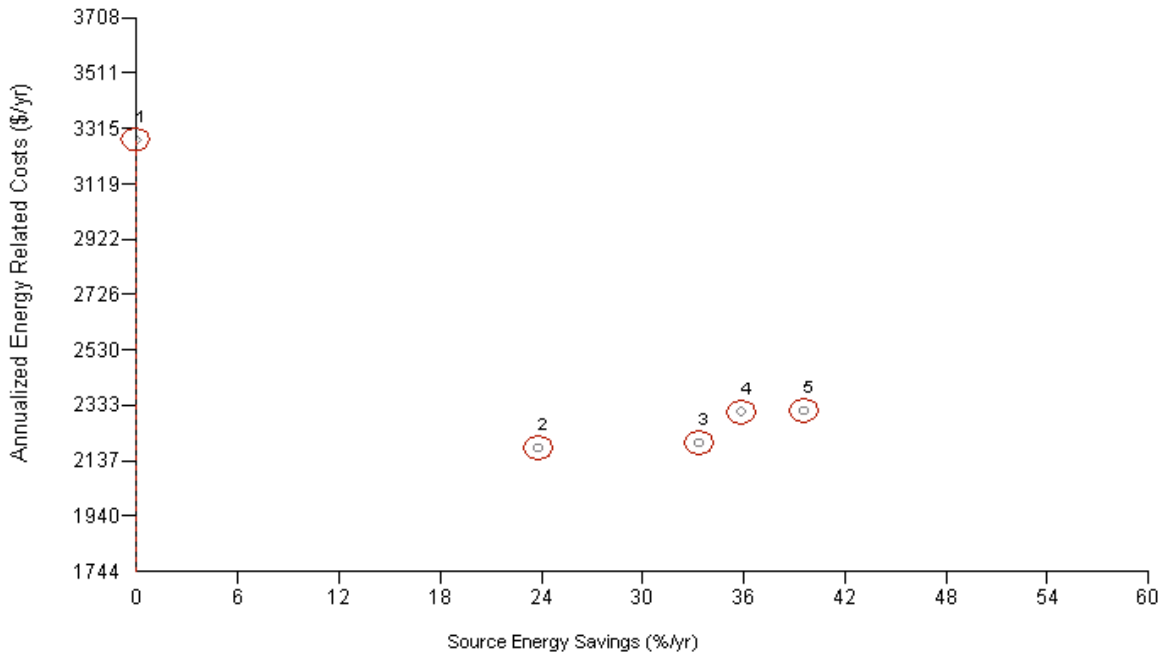
Figure 60. Predicted annualized energy-related costs and source energy savings for the two-family building under four upgrade scenarios using net energy-related measure costs

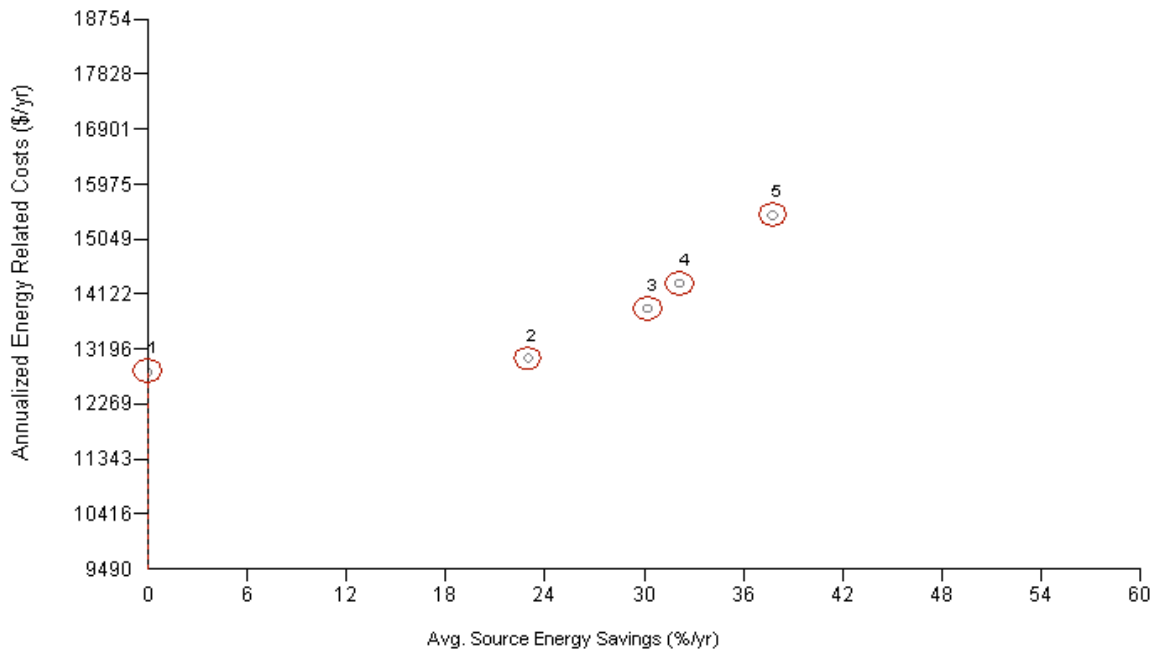
Figure 61. Predicted annualized energy-related costs and source energy savings for the larger multifamily building under four upgrade scenarios using net energy-related measure costs

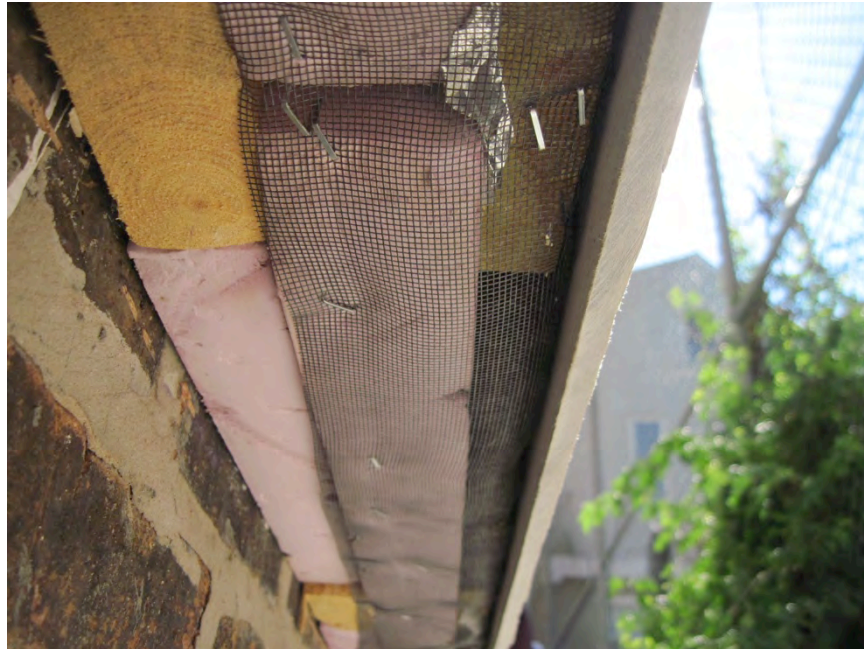
Figure 62. Screening at the base of the wall that fails to protect the exposed edge of the insulating sheathing near grade
(Credit: Scott Sanders, CEDA)
