# Retrofit of a Multi-Family Mass Masonry Building in New England

Building America Report - 1302

February 2013

### **Merrimack Valley Habitat for Humanity Technical Report: Retrofit of a Multi-Family Mass Masonry Building in New England**

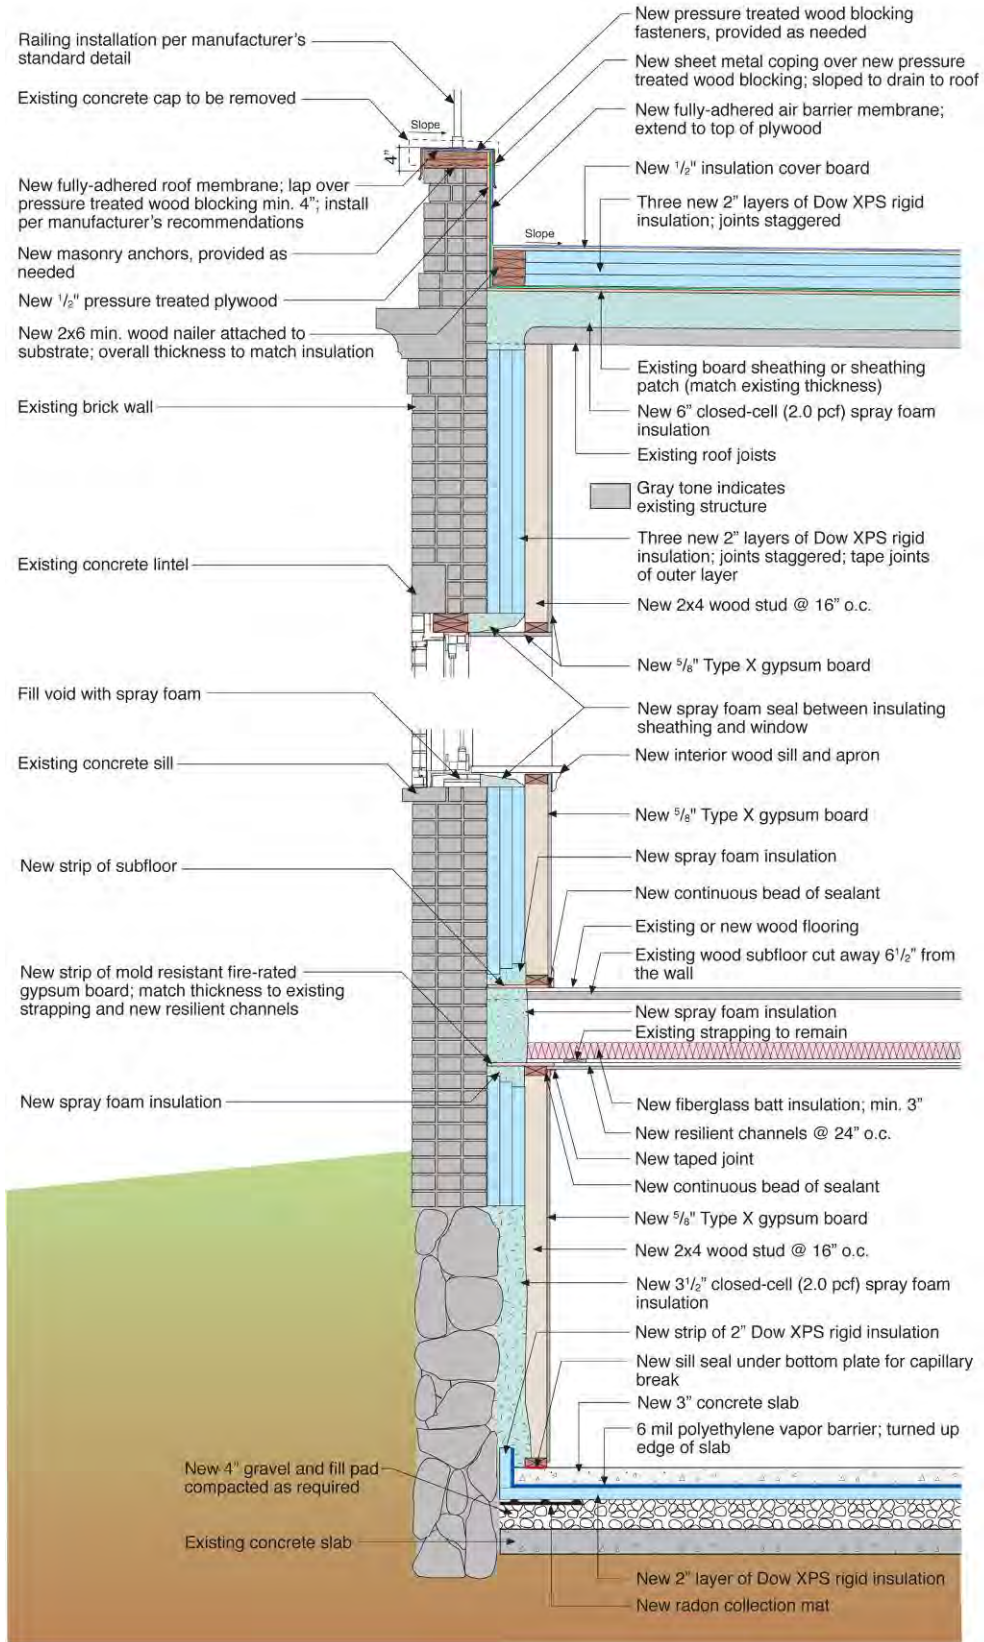
Figure 3: Merrimack Valley Habitat for Humanity building section

The original energy efficient retrofit goals for the project were to provide an R-60 roof, R-40 above grade walls, R-20 basement walls, R-10 basement slab and R-5 windows, as promulgated by National Grid (2009), and similar to targets proposed by Straube (2011). The building section shown in Figure 3 illustrates the retrofit approaches to be implemented on this project.

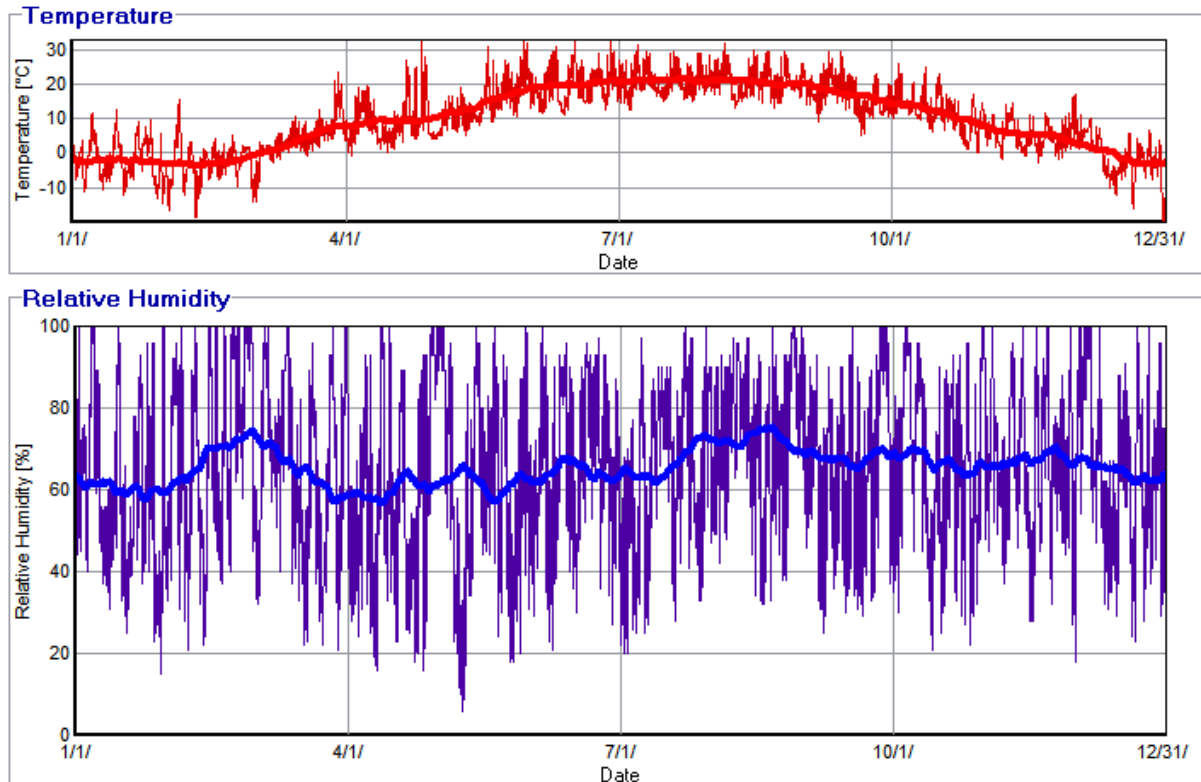
Figure 4: WUFI 5.1 Pro temperature and humidity for a ‘typical’ cold year in Boston, MA

WUFI includes climate data files for dozens of cities around the world. These climate files are typically generated from airport or other major weather station data. For the purposes of the Merrimack Valley Habitat for Humanity simulations we have used the Boston, MA ‘cold’ year weather file that is included in WUFI, summarized in Figure 4 and Figure 5. The existing interior conditions were simulated assuming heating only, as shown in Figure 6.

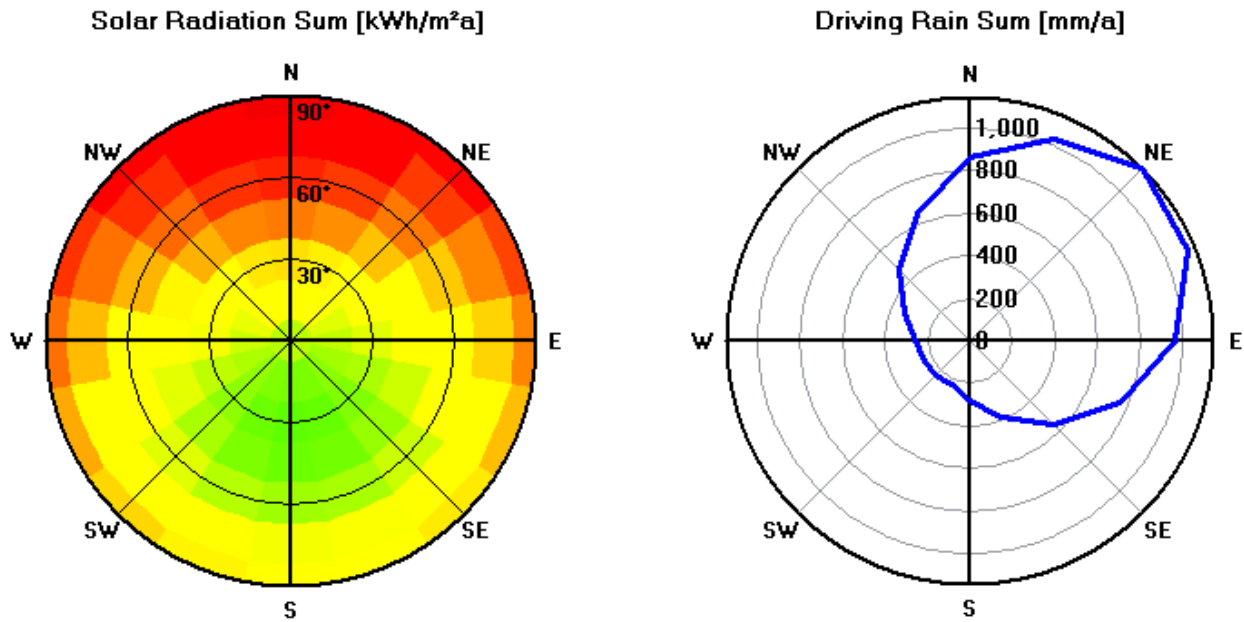
Figure 5: WUFI 5.1 Pro climate summary for a 'typical' cold year in Boston, MA

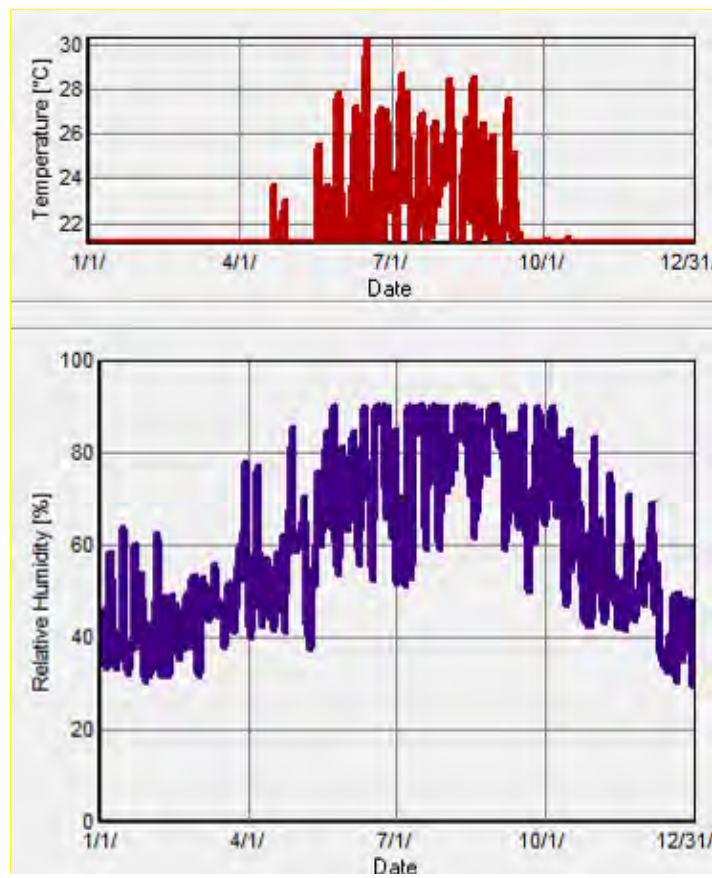
Figure 6: Indoor Conditions Used in WUFI Simulation (temperature and relative humidity)

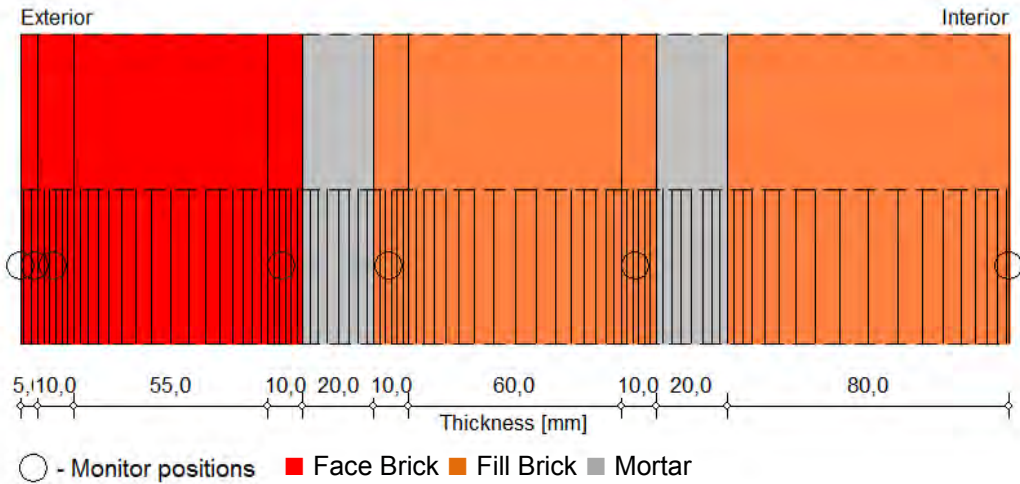
**Figure 7: WUFI model of existing original building masonry wall assembly (solid brick wythes)**

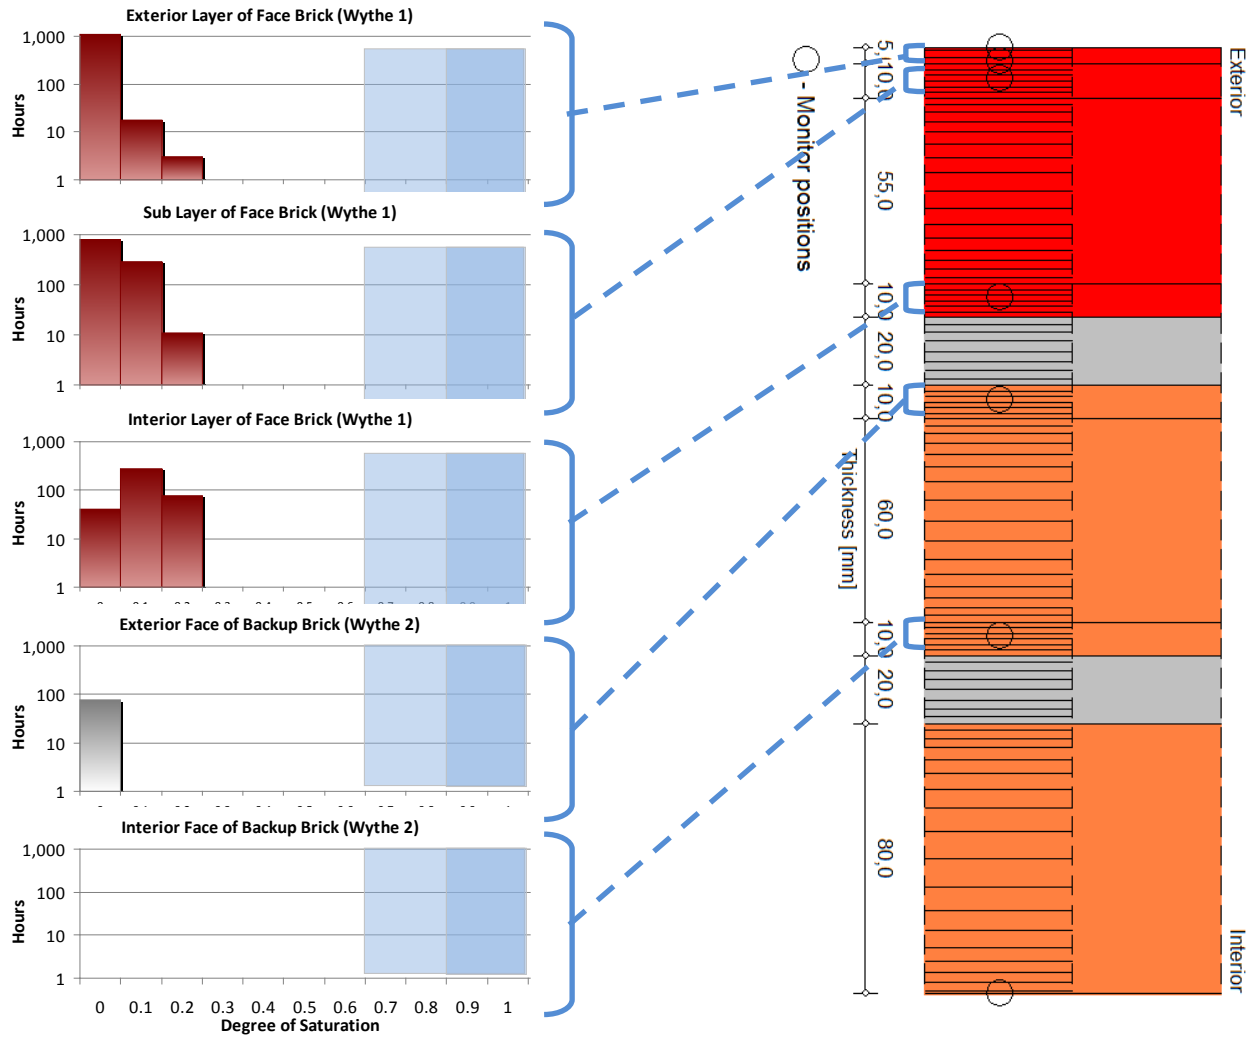
**Figure 11: Example moisture content plot, correlated with assembly layers**

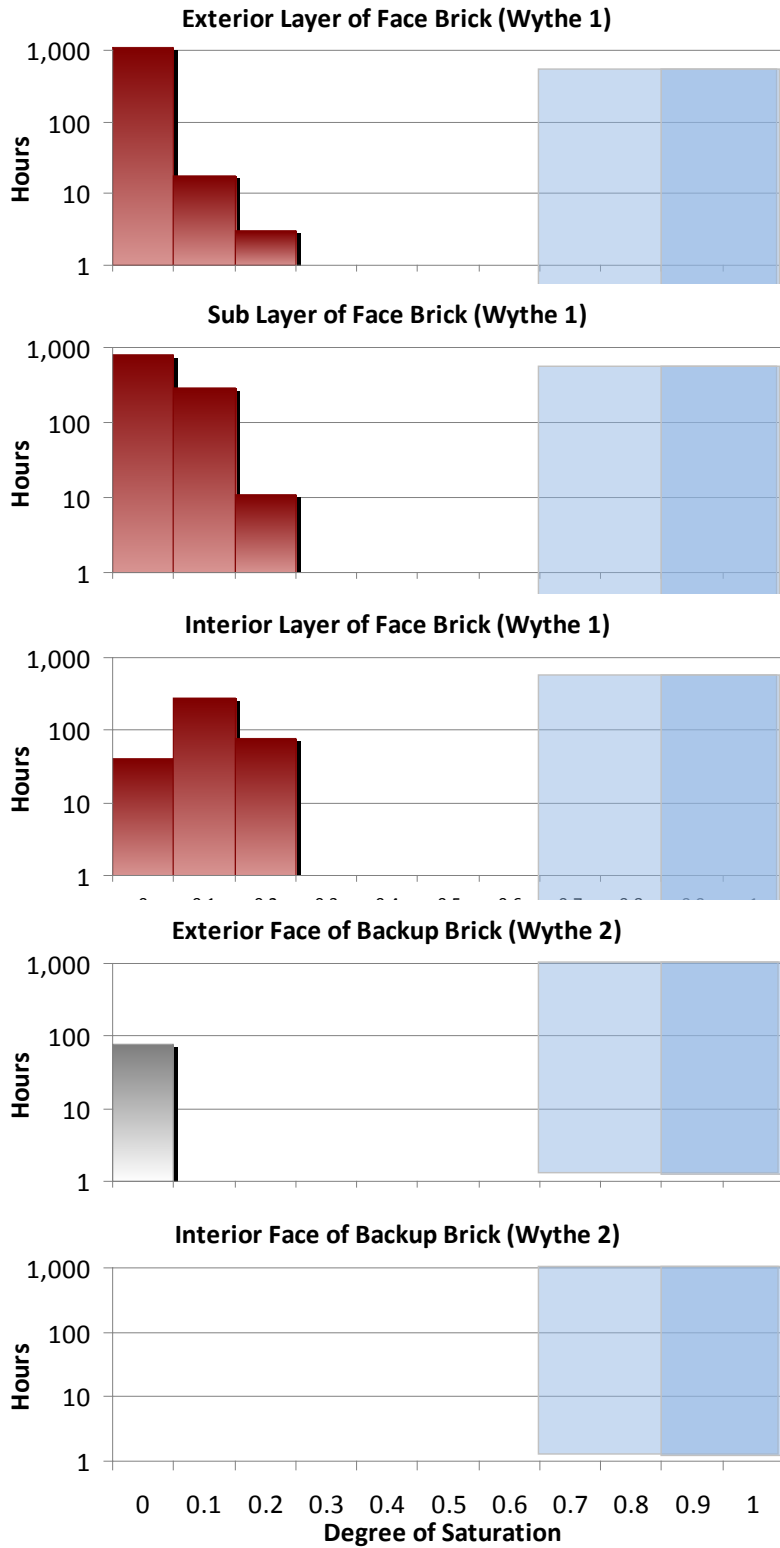
Wall assembly	Original (solid brick)
Wall condition	Uninsulated
Orientation	East
Rain exposure	Normal
Int. conditions	Heated

**Figure 12: Predicted moisture distribution during freezing temperatures: Existing Original Building Wall Assembly, Normal Exposure, East Facing, Heating Only**

No freeze-thaw cycles are predicted for any of the simulated conditions. However, the cases with the thermal insulation retrofit generally show greater moisture contents during freezing conditions. Previous simulations of many other mass masonry buildings indicate that the exterior layers of the exterior brick are the most vulnerable, and that greater rain exposure increases risk. The pattern of damage on the building generally correlated with rain exposure, such as damage at areas around missing downspouts. It is assumed that these areas are seeing much greater rain exposure than predicted in the model. It should be noted that addressing the rain water management issues associated with the existing areas of damage must be addressed, as the thermal insulation retrofit will exacerbate such problems.

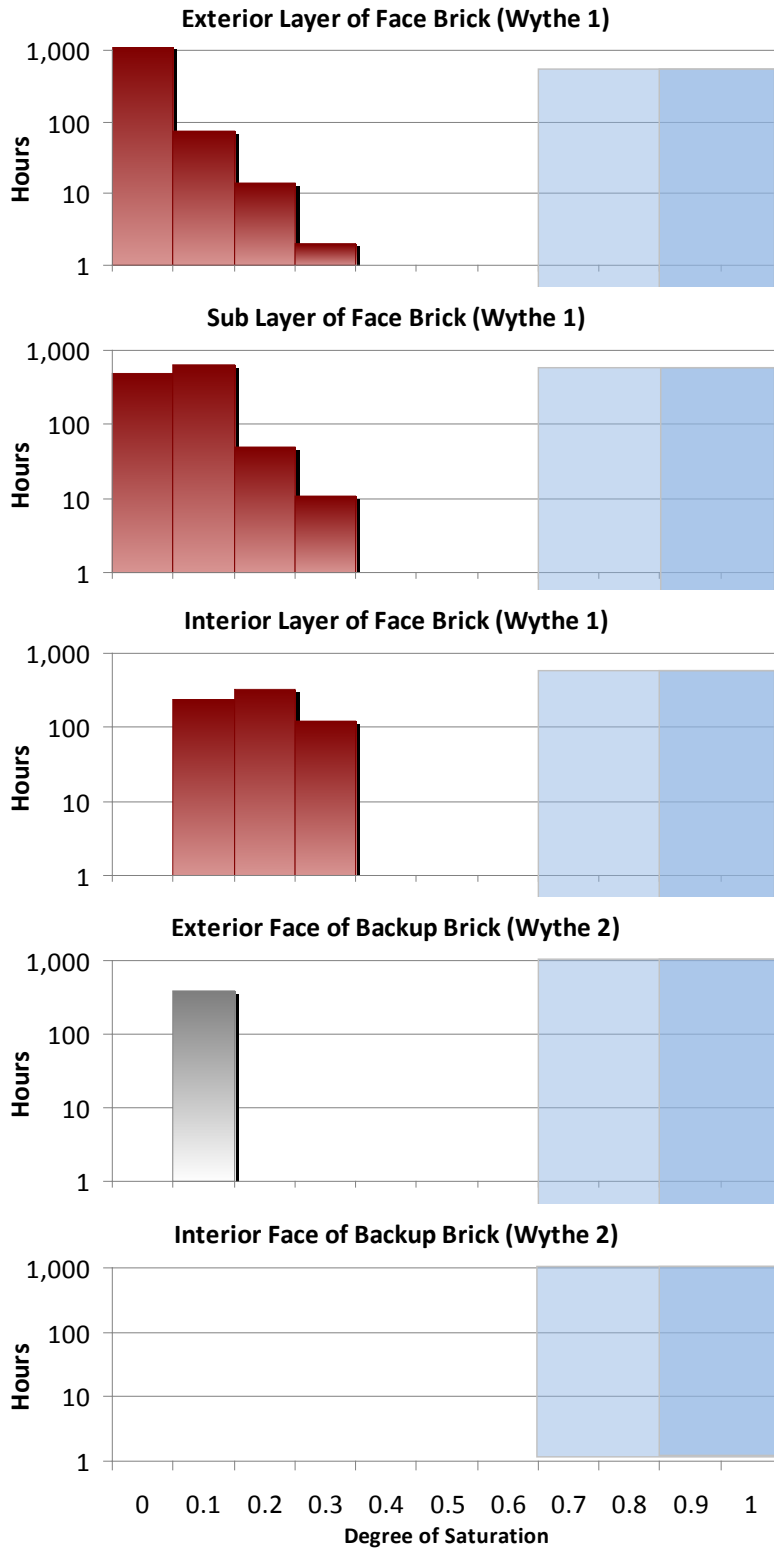
Wall assembly	Addition (clay block)
Wall condition	Uninsulated
Orientation	East
Rain exposure	Normal
Int. conditions	Heated

**Figure 13: Predicted moisture distribution during freezing temperatures: Existing Addition Wall Assembly, Normal Exposure, East Facing, Heating Only**

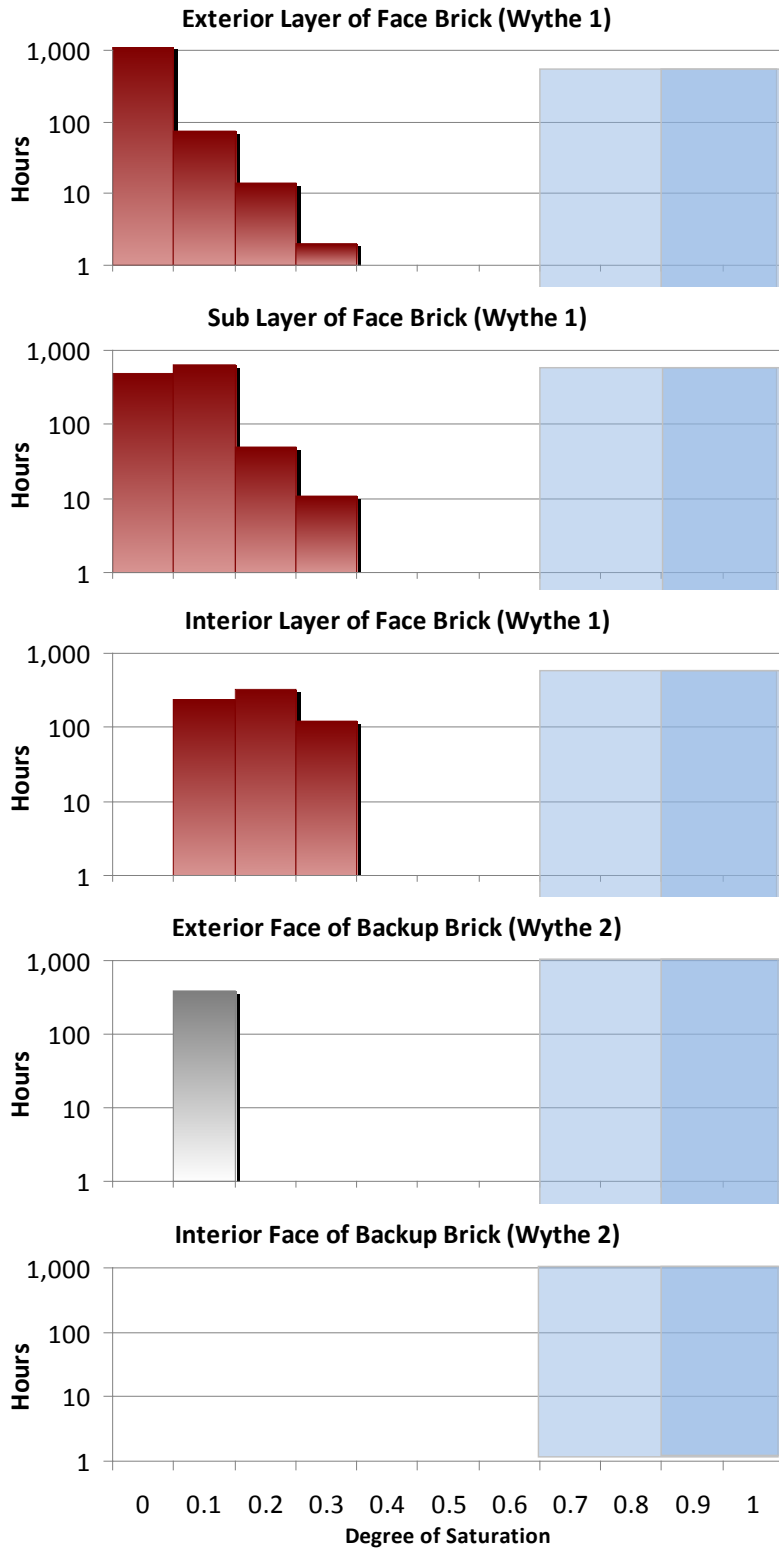
Wall assembly	Original (solid brick)
Wall condition	Insulated 6" XPS
Orientation	East
Rain exposure	Normal
Int. conditions	Heated

**Figure 14: Predicted moisture distribution during freezing temperatures: Retrofit Original Building Wall Assembly, Normal Exposure, East Facing, Heating Only**

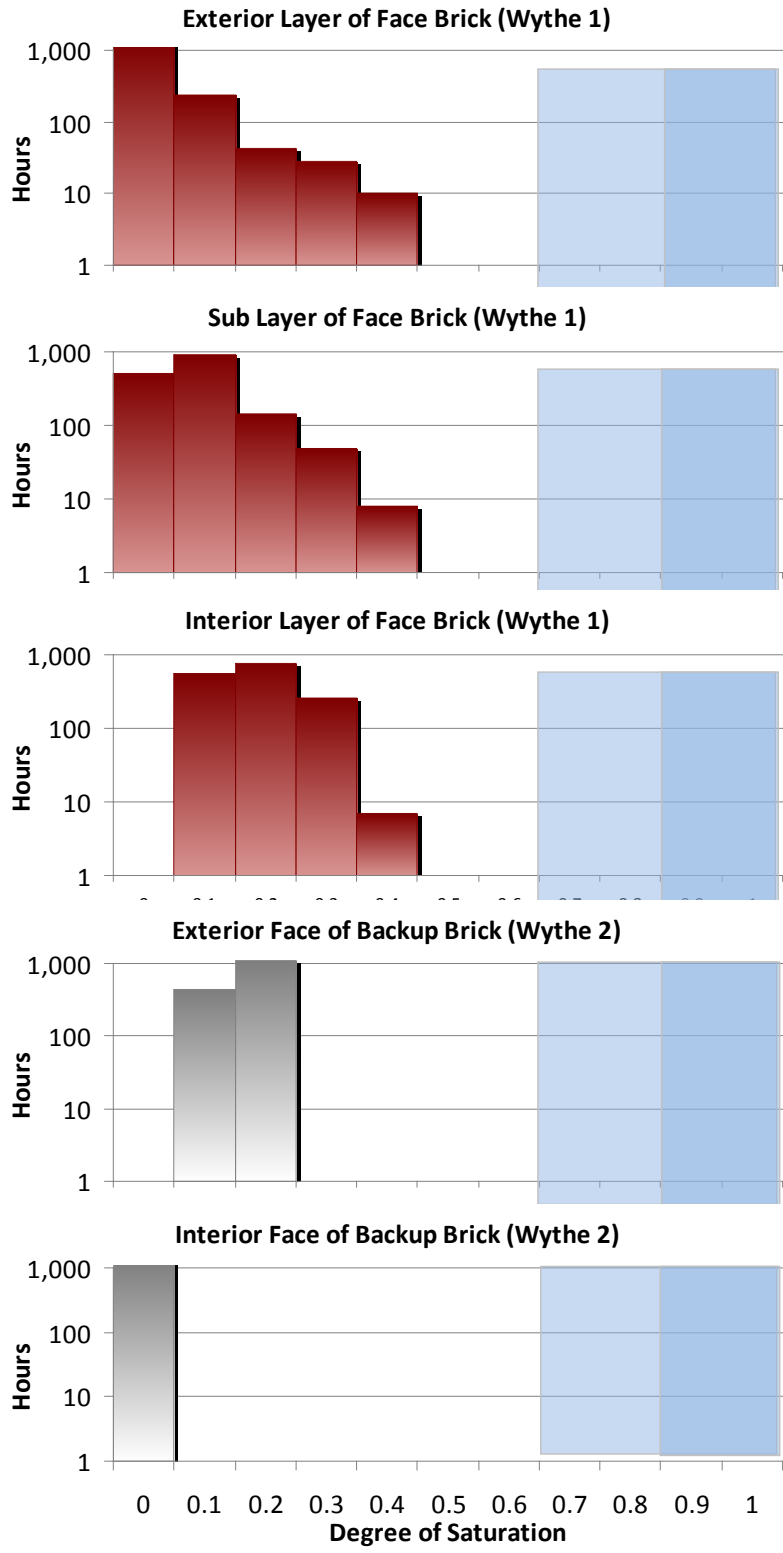
Wall assembly	Addition (clay block)
Wall condition	Insulated 6" XPS
Orientation	East
Rain exposure	Normal
Int. conditions	Heated

**Figure 15: Predicted moisture distribution during freezing temperatures: Retrofit Addition Wall Assembly, Normal Exposure, East Facing, Heating Only**

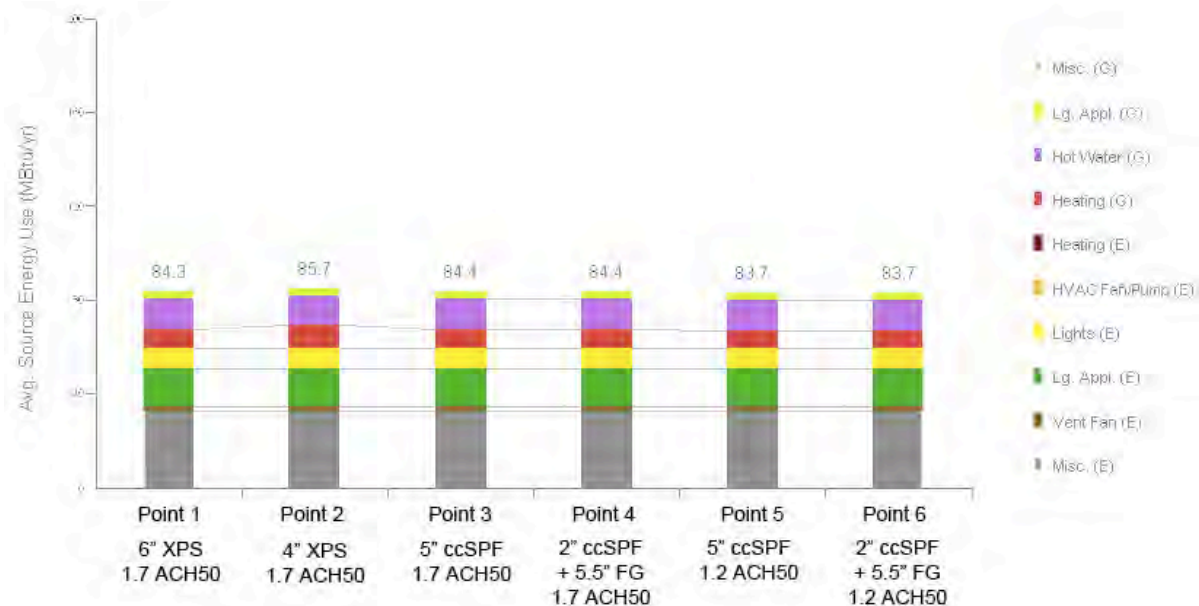
Figure 17 shows the average source energy use (MBtu/yr) for the selected four wall systems, generated by BEopt. The results indicate that options 1 (6” XPS rigid insulation), 3 (5” ccSPF) and 4 (2” ccSPF with batt insulation) use essentially the same amount of energy. Option 2 (4” XPS rigid insulation) uses 1.4 MBtu per year (~2%) more than the proposed 6” XPS rigid insulation. These results were expected, as the R-values of options 1, 3 and 4 are comparable. The reduced air leakage for Points 5 and 6 improved the energy usage minimally.

**Figure 17: Unit 8 BEopt parametric results – Average Source Energy Use**

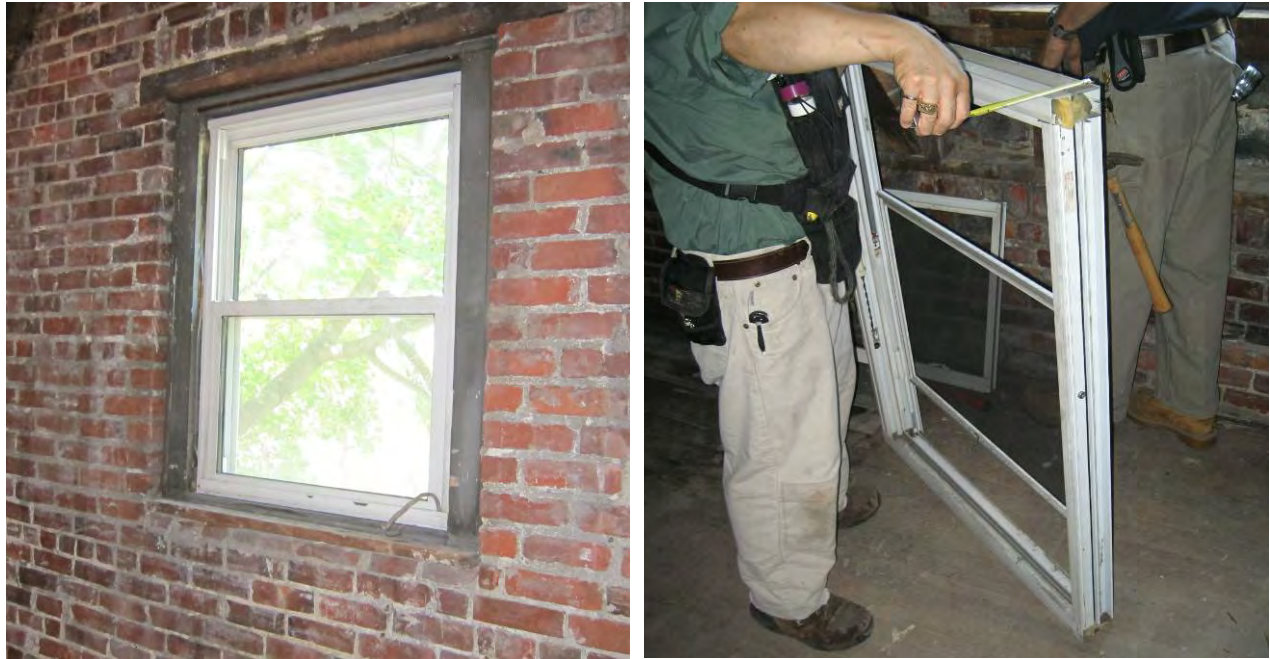
**Figure 20: Existing vinyl double glazed (clear) insert replacement windows**

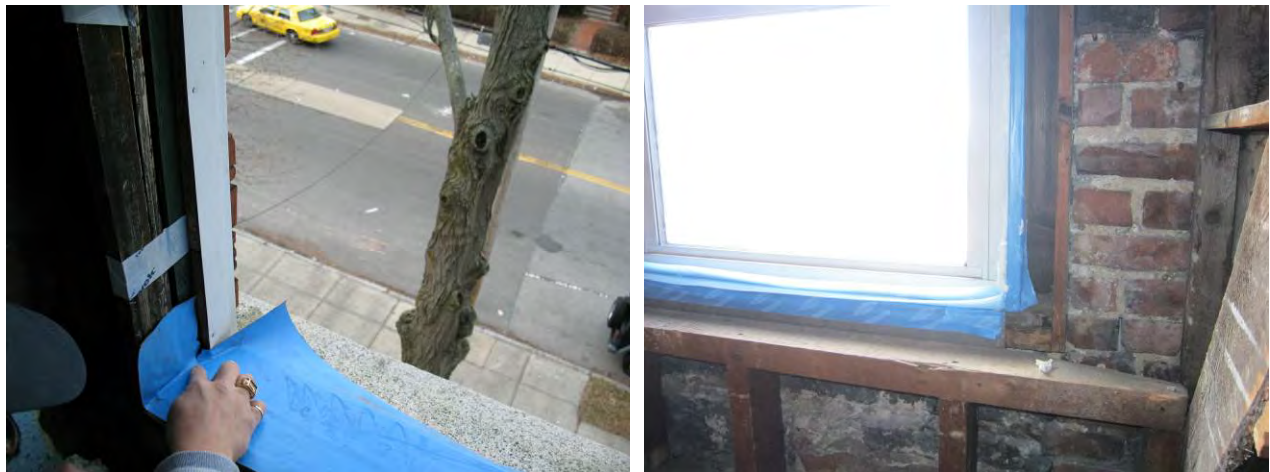
**Figure 21: Test retrofit installation of flashing at the wood framed window openings**

At that time, the energy analysis was performed to determine the Tier levels the apartment units would be able to qualify for. All units were able to reach Tier II incentives with the addition of low-e storms. Construction details were drawn to show the removal of the existing windows, installation of flashing at the wood framed window openings and reinstallation of the existing units. See Appendix B for the retrofit construction details, and Figure 21 for a test installation of these retrofit details.

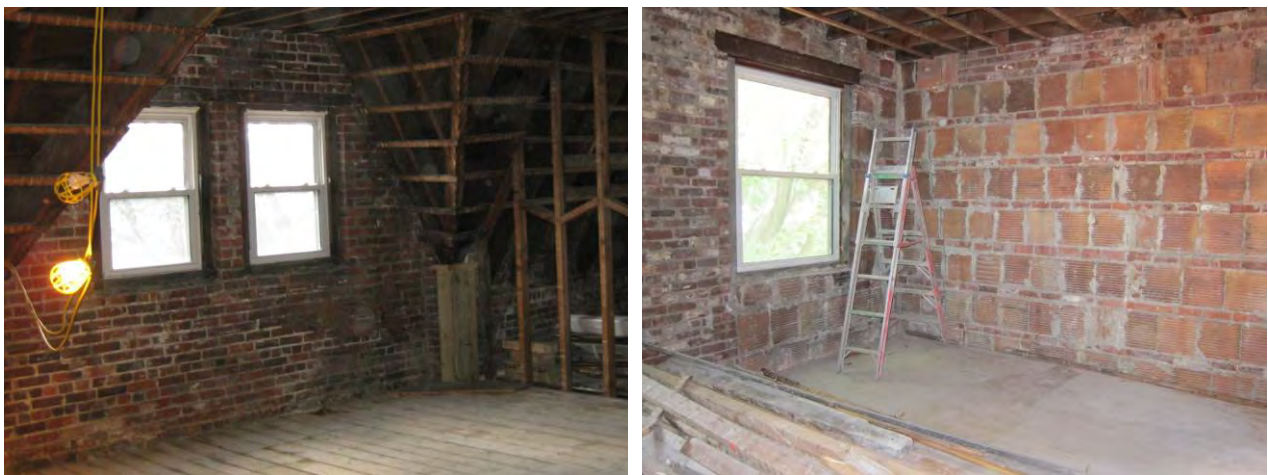
The construction of the masonry walls at this project include both multi-wythe solid brick walls, and exterior brick with a hollow clay block infill/backup wall, as shown in Figure 22. These photos show conditions after demolition of the interior furring, lath, and plaster.

**Figure 22: Exterior wall conditions at solid brick (left) and hollow clay block infill (right) conditions**

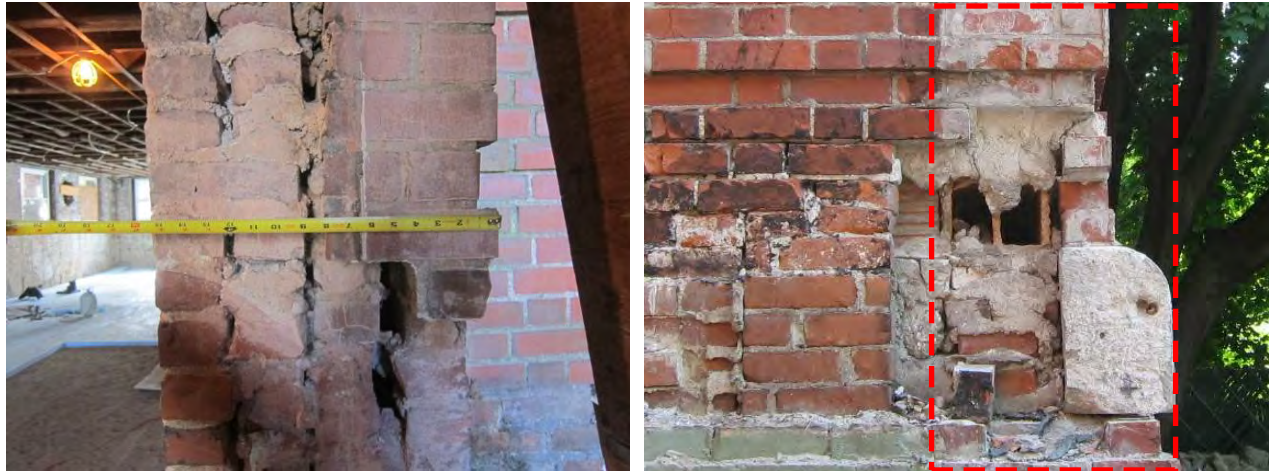
Although these assemblies appear to be monolithic from the interior and exterior, there are a variety of interconnected air spaces, such as the incompletely filled collar joints between brick wythes (Figure 23, left). In addition, the hollow clay blocks provide a major interconnected airflow network laterally across the wall (Figure 23, right).

**Figure 23: Wall section at solid brick (left) and at hollow clay block infill (right) conditions**

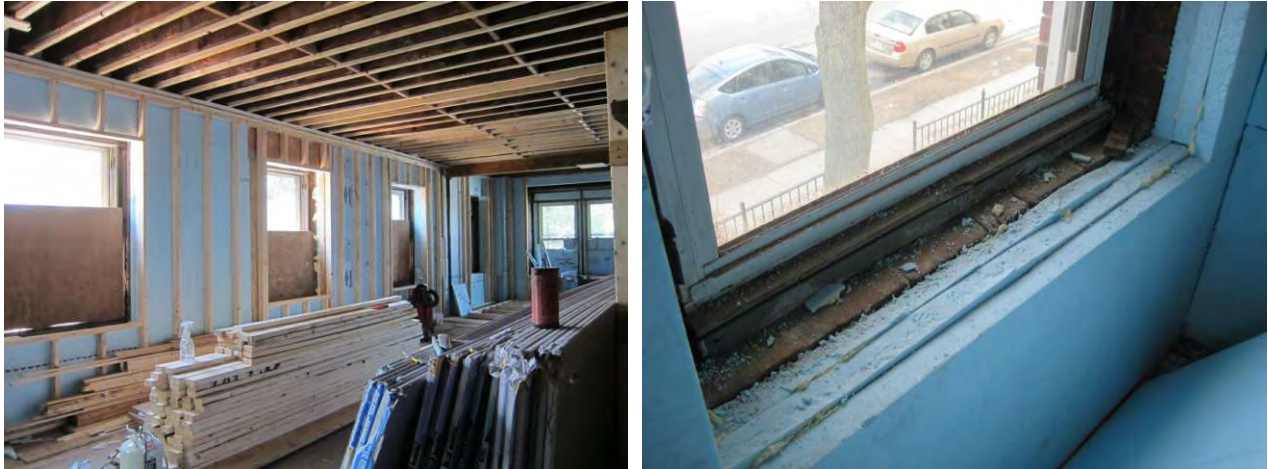
**Figure 26: Framing installed inboard of insulation (left) and conditions at window opening (right)**

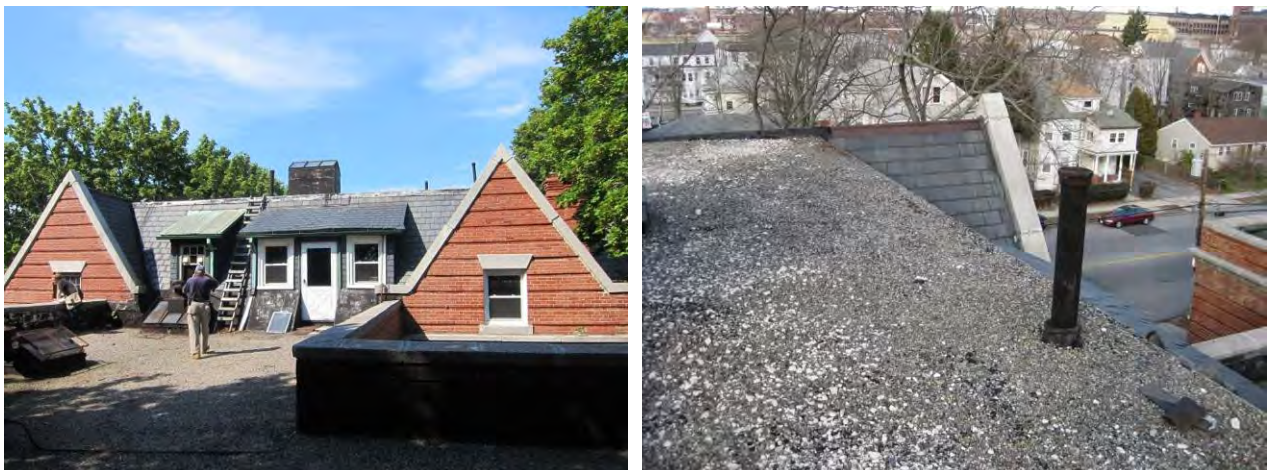
The existing roofs on this building included low-slope built-up roofs with aggregate (gravel) topping, and slate roofing on the sloping portions. There is a “lower” flat roof (ceiling of 2<sup>nd</sup> floor) with a parapet, and a smaller “upper” flat roof (ceiling of the 3<sup>rd</sup> floor), as shown in Figure 28.

**Figure 28: Lower roof, showing upper roof (left) and upper roof (right)**

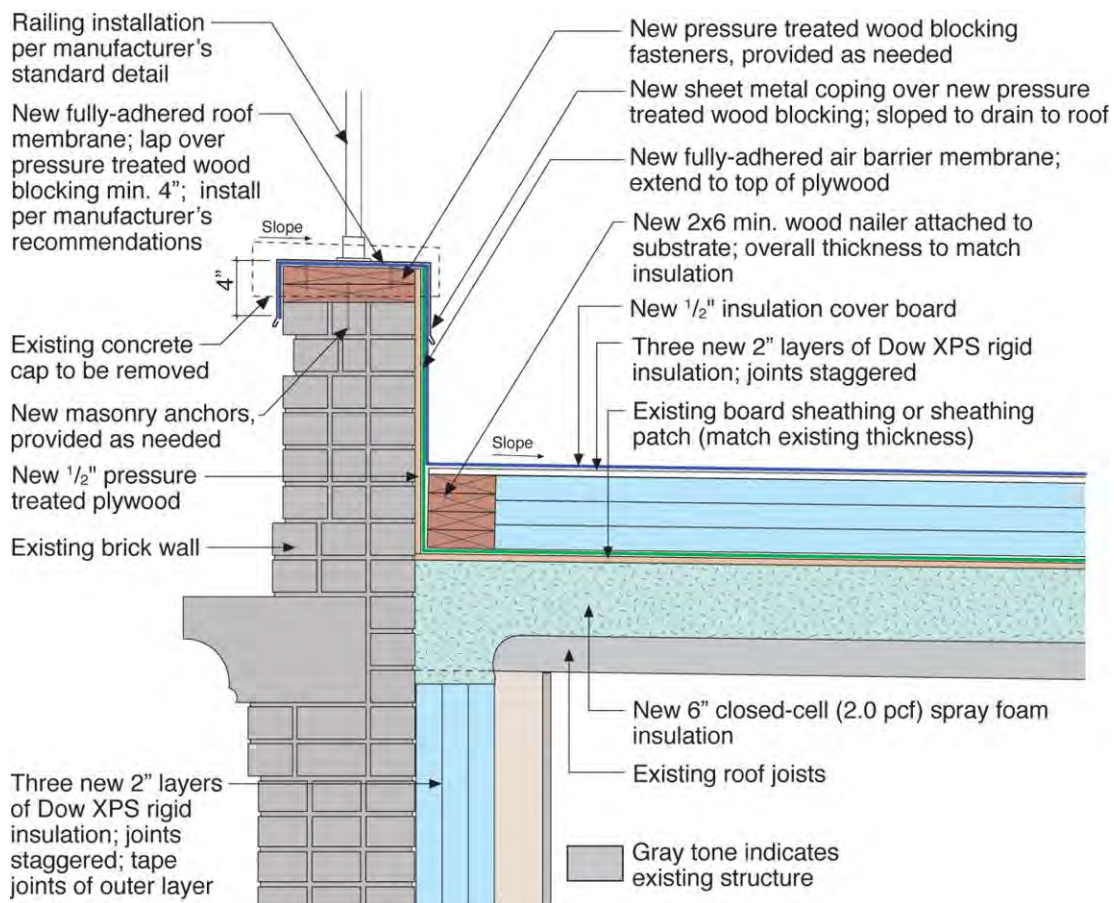
On the top side, a layer of self-adhered membrane is installed under the layers of rigid insulation and wrapped up the parapet, to provide an air barrier at the underside of the “roof sandwich” discussed above. This air barrier is actually somewhat redundant, given the spray foam installed from the underside; however, it was selected due to some of the specifics of this project.

**Figure 29: Lower roof retrofit detail at parapet**

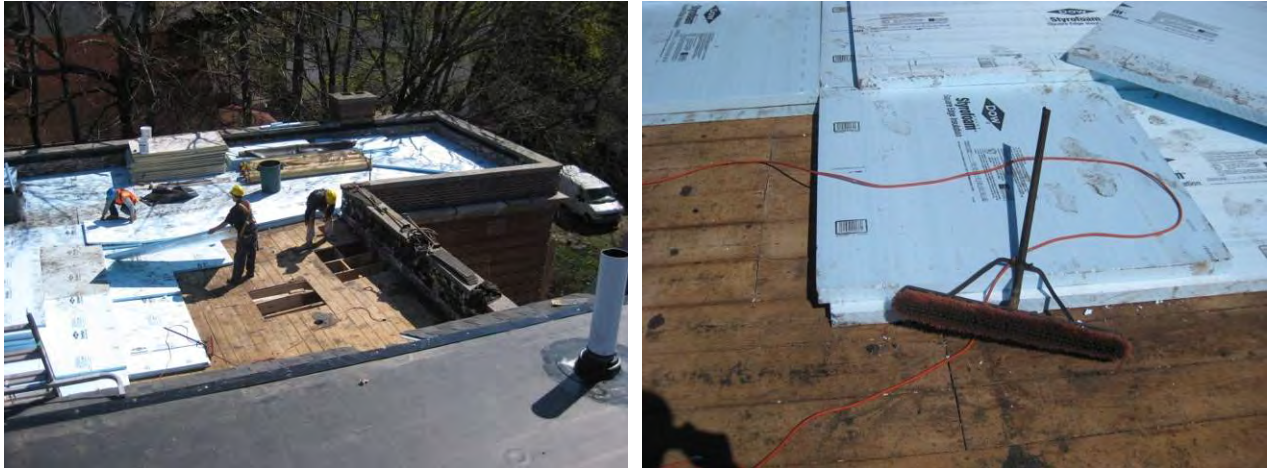
(Figure 30). The site supervisor was notified of this deficiency, and it was corrected over the weekend before completion of the roof membrane installation.

**Figure 30: Insulation of lower roof, showing lack of air barrier at board sheathing**

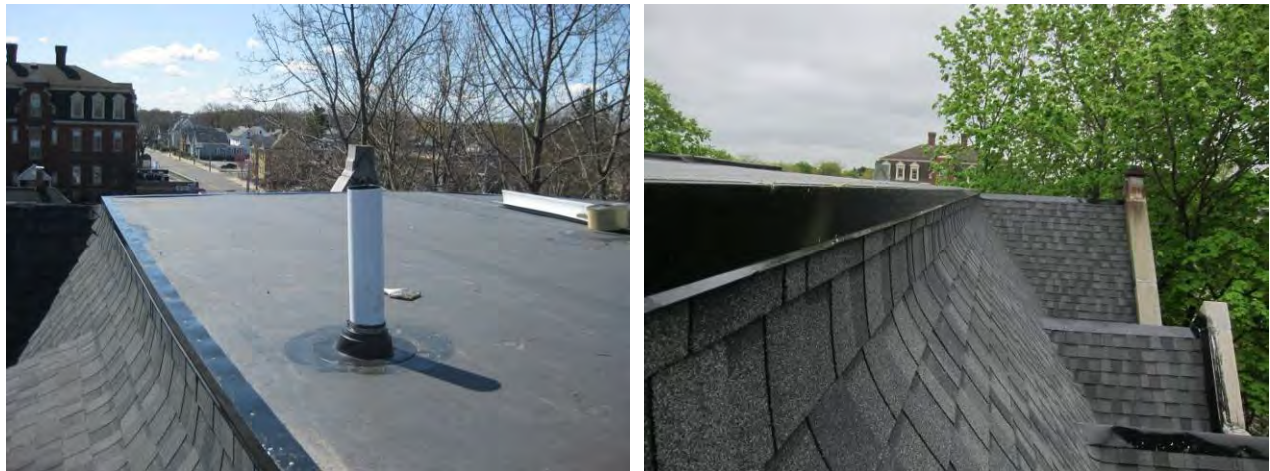
**Figure 33: Upper roof typical conditions (left) and upper roof edge detail (right)**

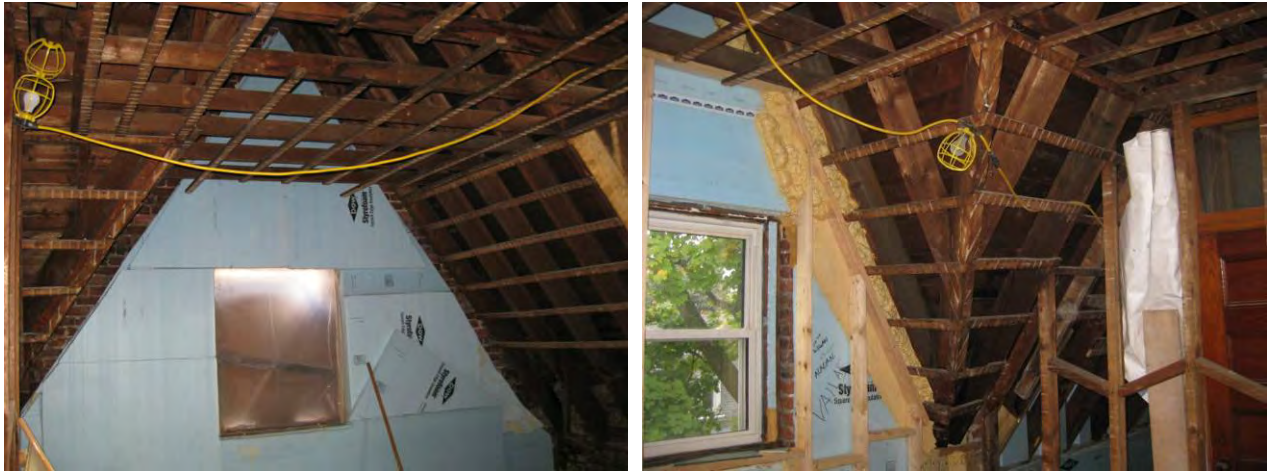
One example of the air barrier connection between the above-grade wall and sloping roof is shown in Figure 34: the wall rigid foam board was left clear of the roof, and the connection from the wall air barrier to the roof spray foam air barrier was made with closed cell spray foam. The example shown in Figure 34 was done by the volunteer crew using a spray foam insulation kit; however, it could be done instead by the professional spray foam contractor when the field of the roof is done.

**Figure 34: Rigid wall insulation left clear of roof (left) and infill with spray foam kit (right)**

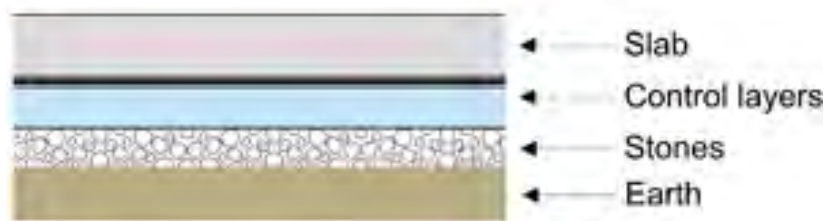
The ideal new construction slab design is shown in Figure 35, which is taken from Lstiburek (2007). It consists of (from bottom to top) some type of granular fill/gravel to create a capillary break from the earth below, a layer of moisture-insensitive insulation, an air and vapor impermeable membrane (such as polyethylene), and the concrete slab, cast directly onto the membrane.

**Figure 35: “Perfect slab,” showing polyethylene & insulation control layers (Lstiburek 2007)**

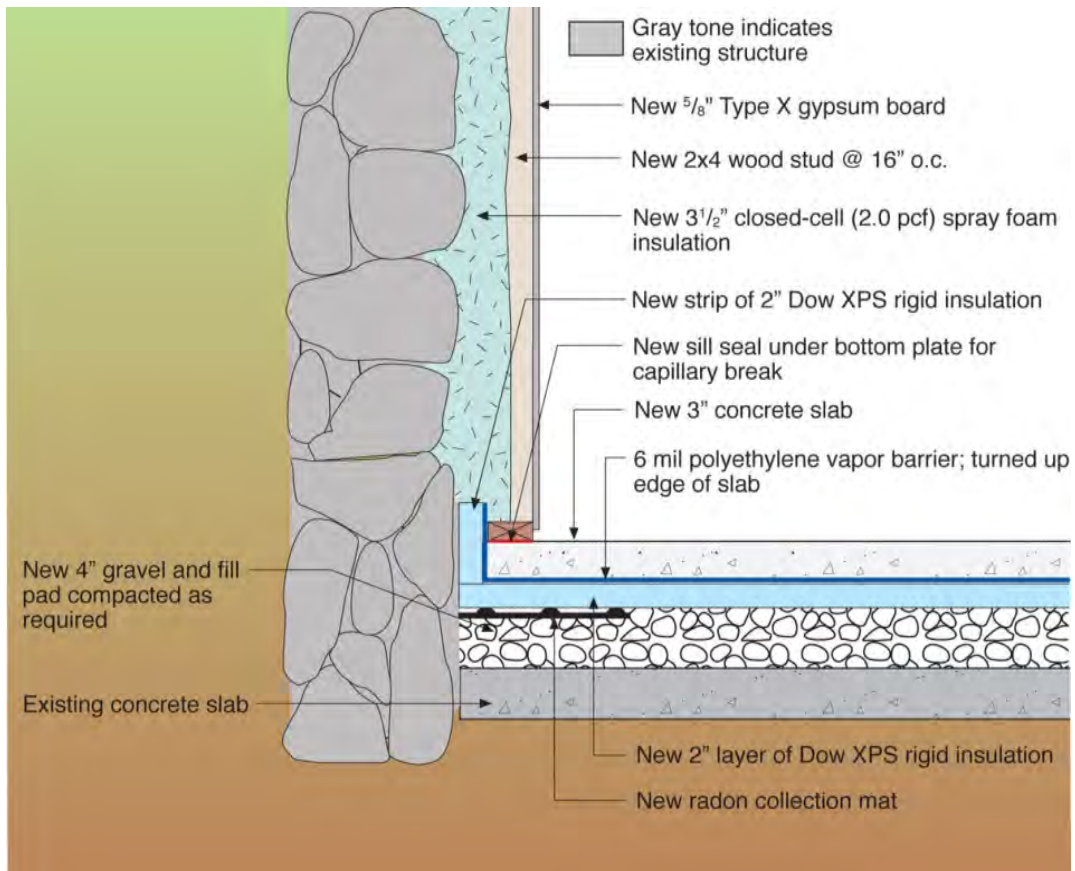
**Figure 36: Typical basement slab and bottom of wall detail**

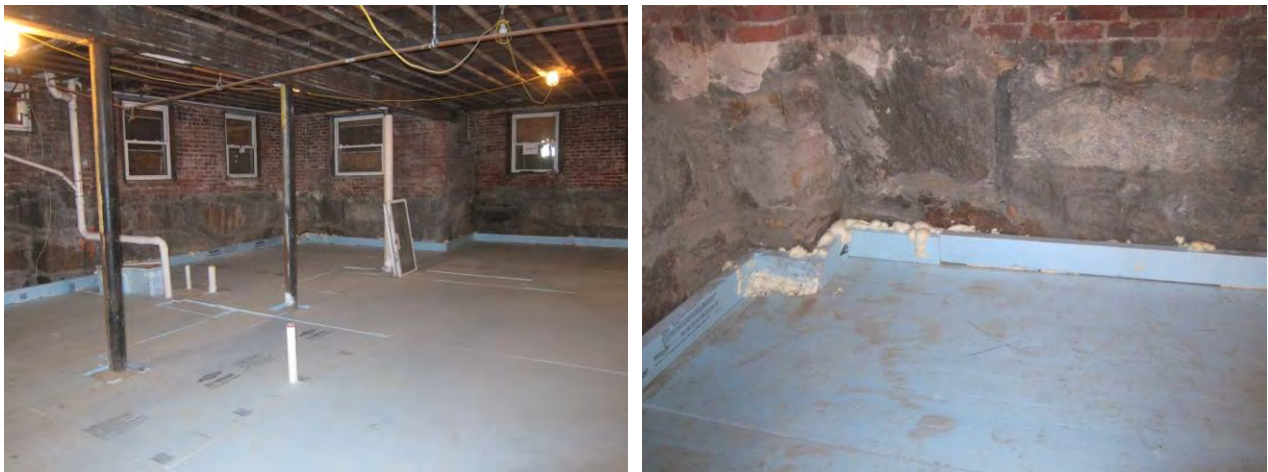
**Figure 39: Installed sub-slab insulation at basement (left) with detail of slab edge insulation (right)**

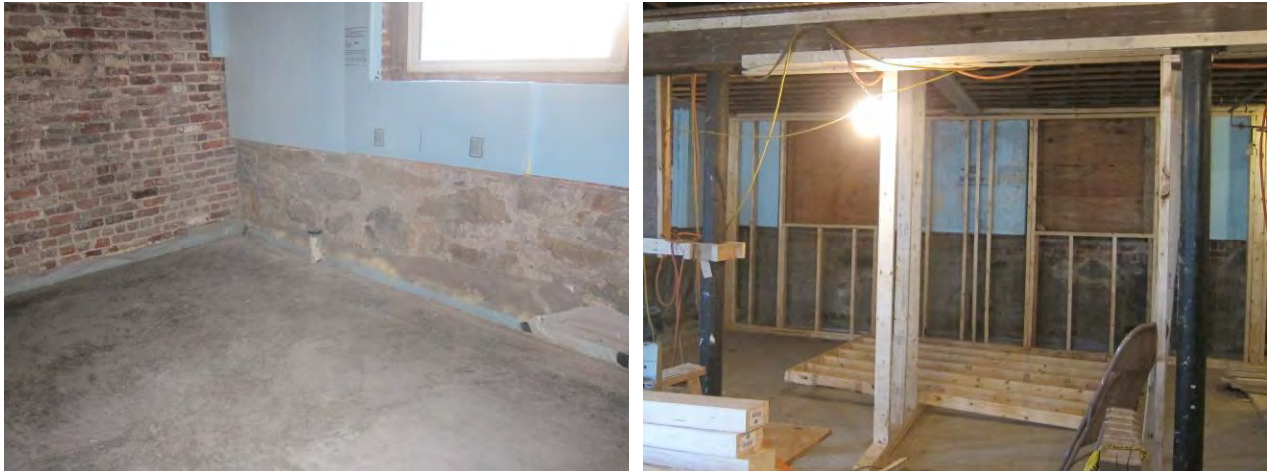
**Figure 40: Edge detail after casting of slab (left) and installation of interior framing (right)**

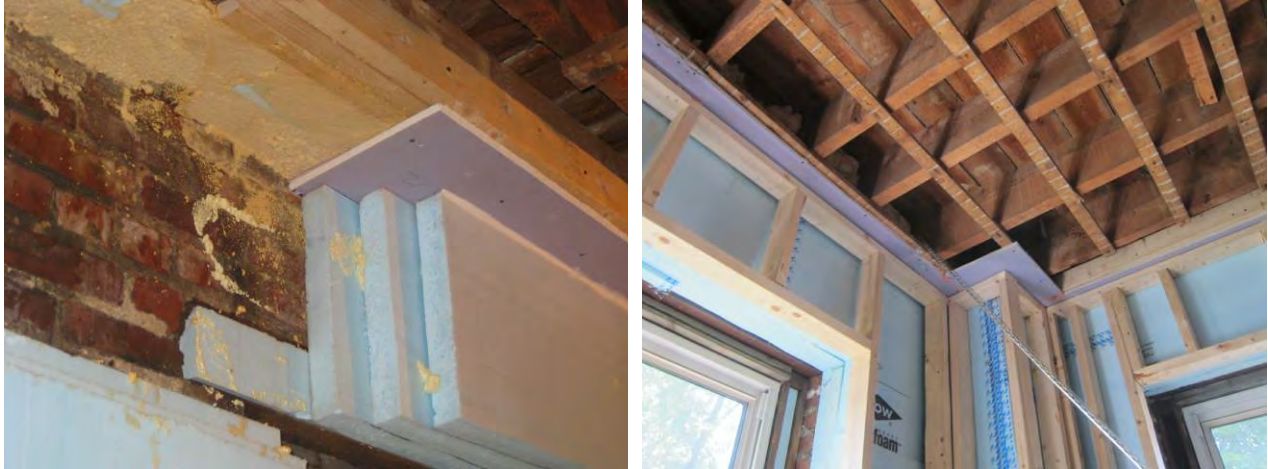
**Figure 43: Floor/ceiling fire separation gypsum board (left); conditions after interior framing (right)**
