# Retrofit of a Multi-Family Mass Masonry Building in New England

Building America Report - 1302

February 2013

### **Merrimack Valley Habitat for Humanity Technical Report: Retrofit of a Multi-Family Mass Masonry Building in New England**

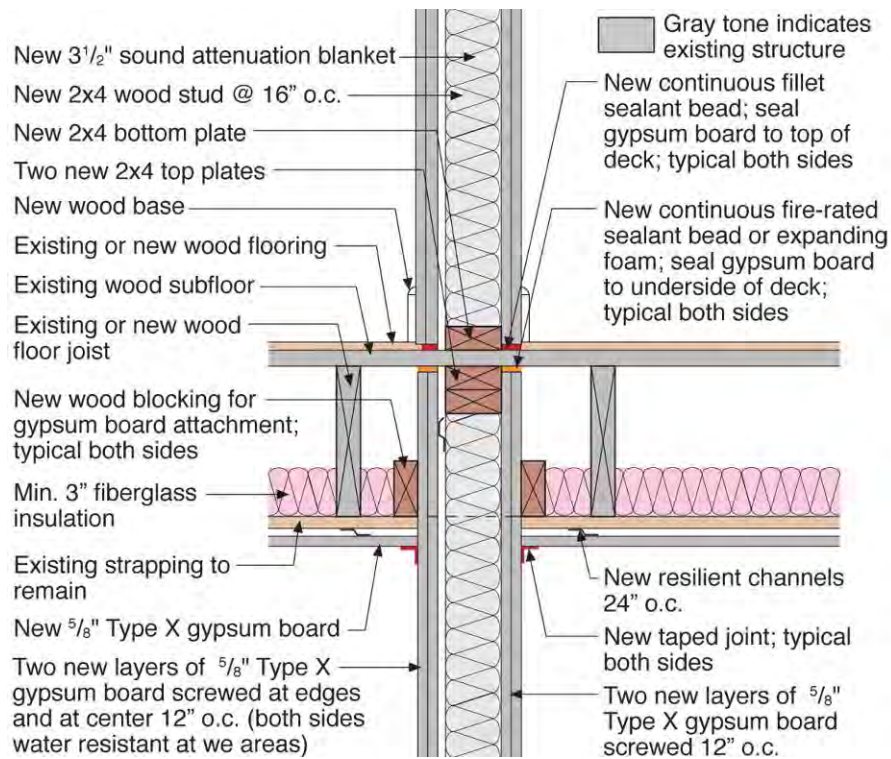
**Figure 49: Unit-to-unit (rated) floor/ceiling assembly at demising wall; joists parallel to wall**

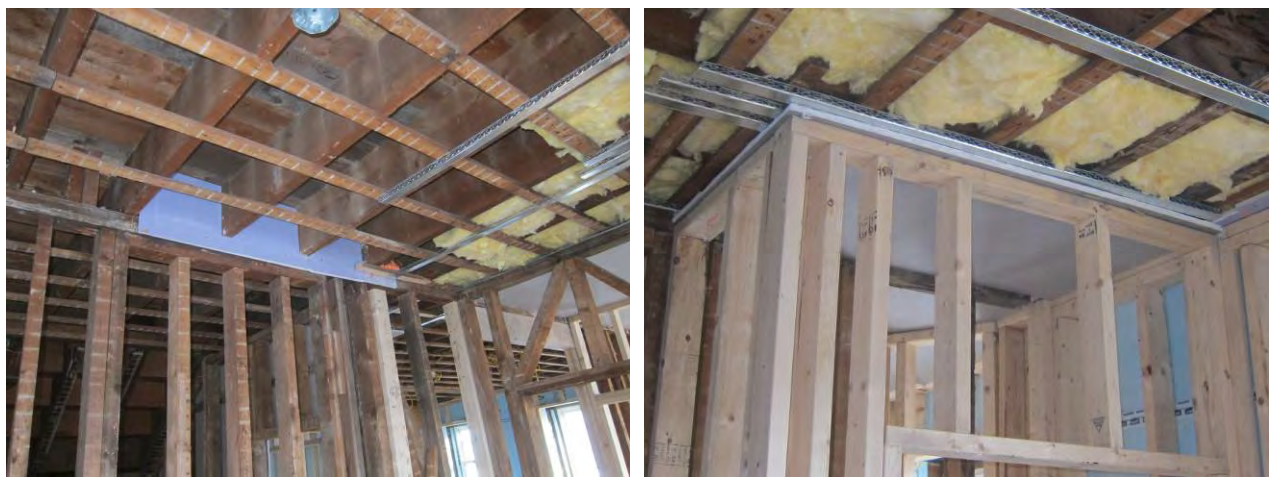
**Figure 50: Notched gypsum board at demising wall (left) and ceiling gypsum board continuous over unit interior partition walls (right)**

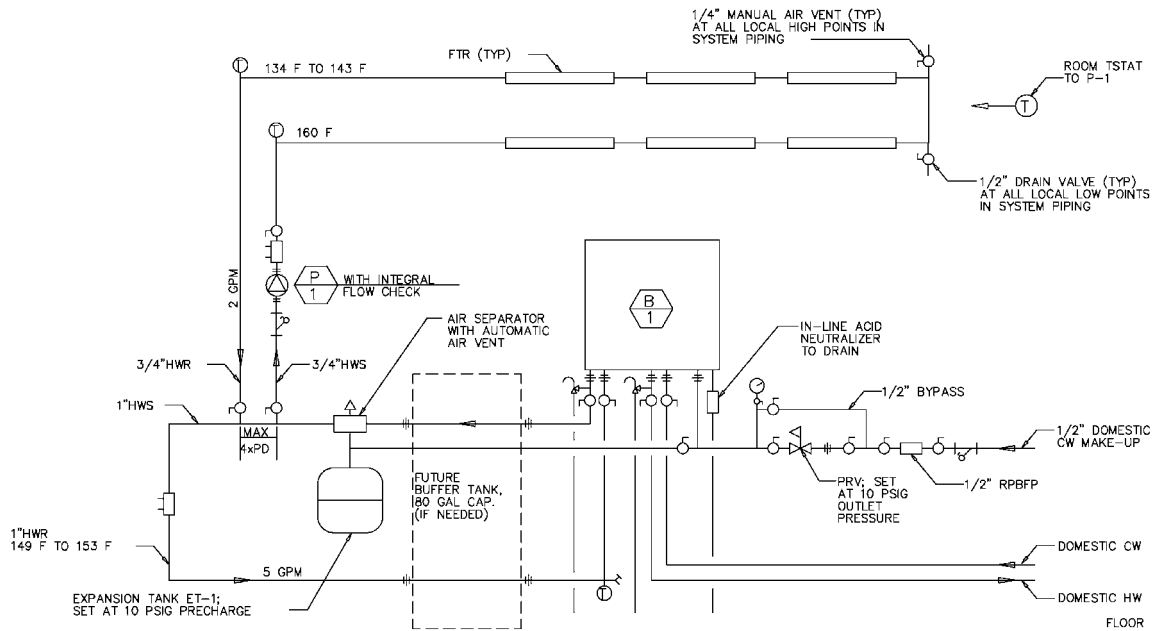
Figure 52 shows the original heating system schematic.

**Figure 52: Original Apartment Hydronic Schematic**

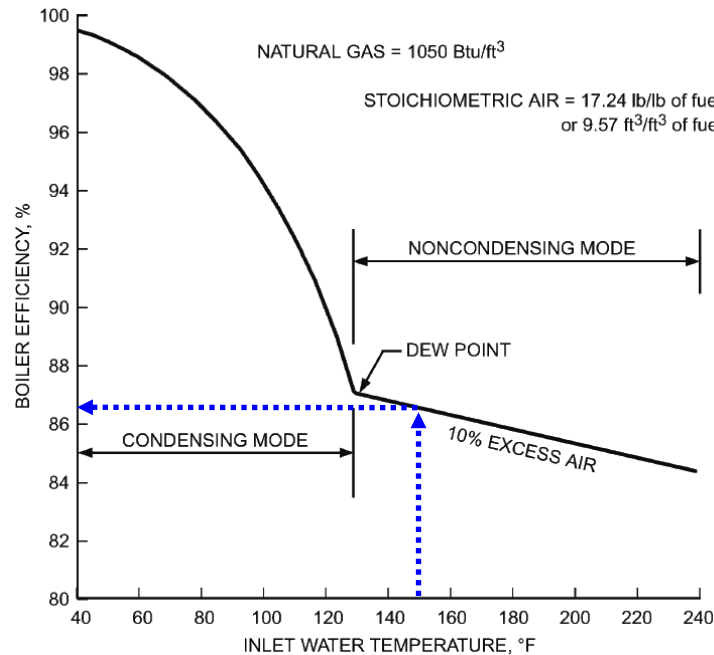
**Figure 53: Thermal efficiency plot as a function of inlet water temperature (ASHRAE 2008)**

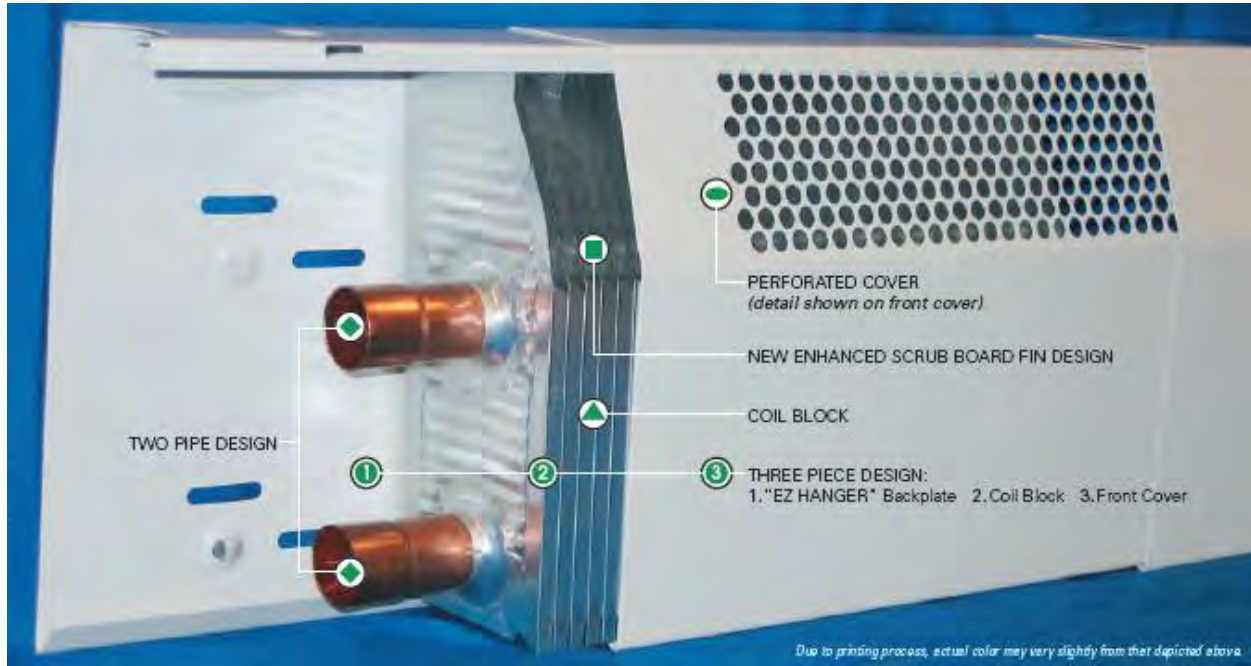
**Figure 54: Smith Environmental HE2 High Capacity Hybrid Element (from Smith Environmental)**

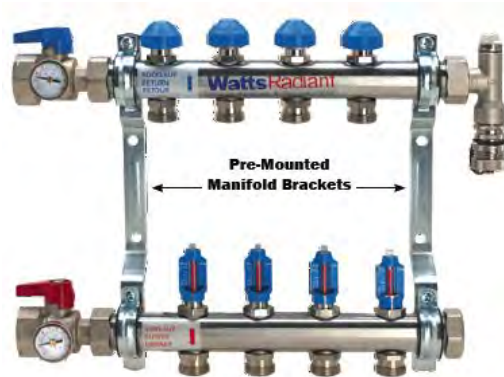
**Figure 56: Watts Manifold with flow meters and balancing valves at each tap (from Watts Water Technologies)**

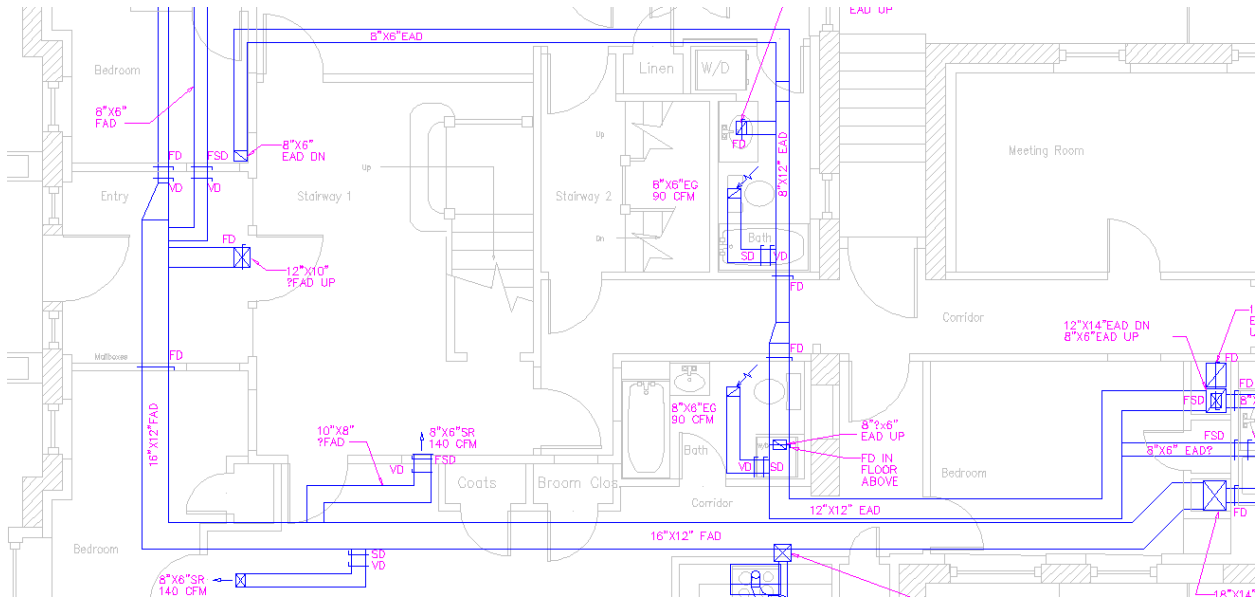
**Figure 59: Existing Ventilation Design at Unit 4**

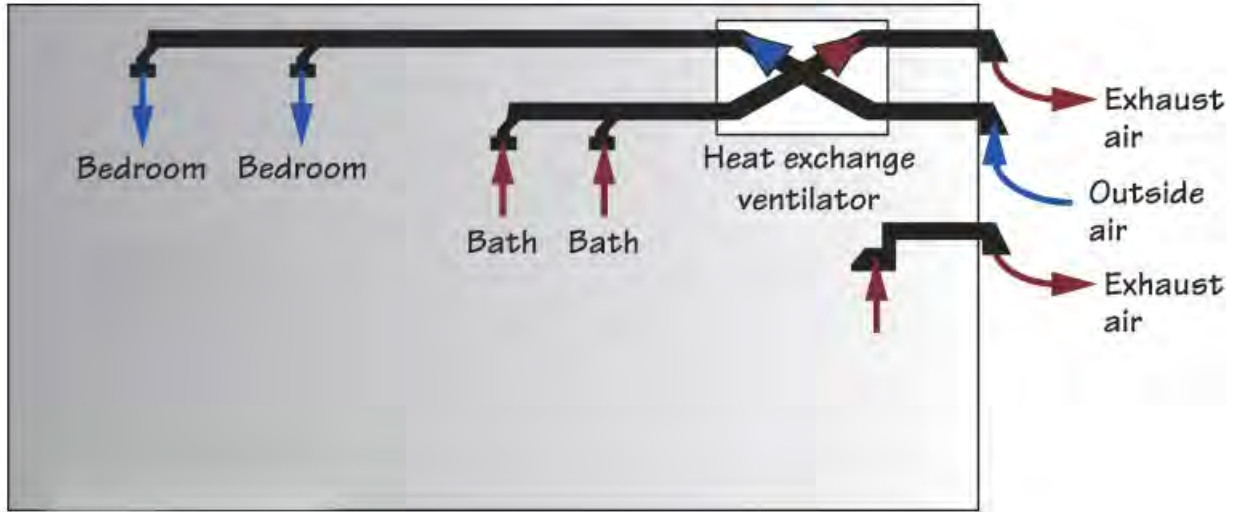
**Figure 60: Ventilation Strategy Schematic**

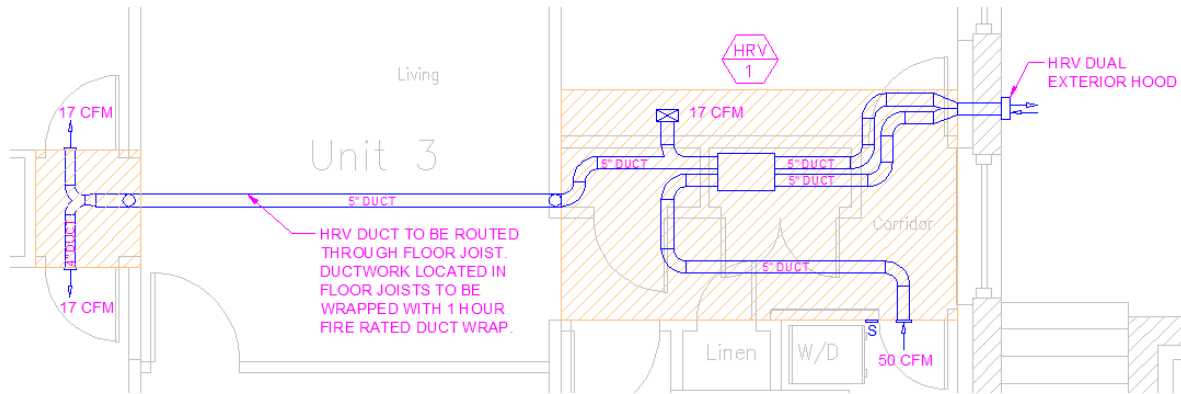
**Figure 62: Example of current HRV duct layout**

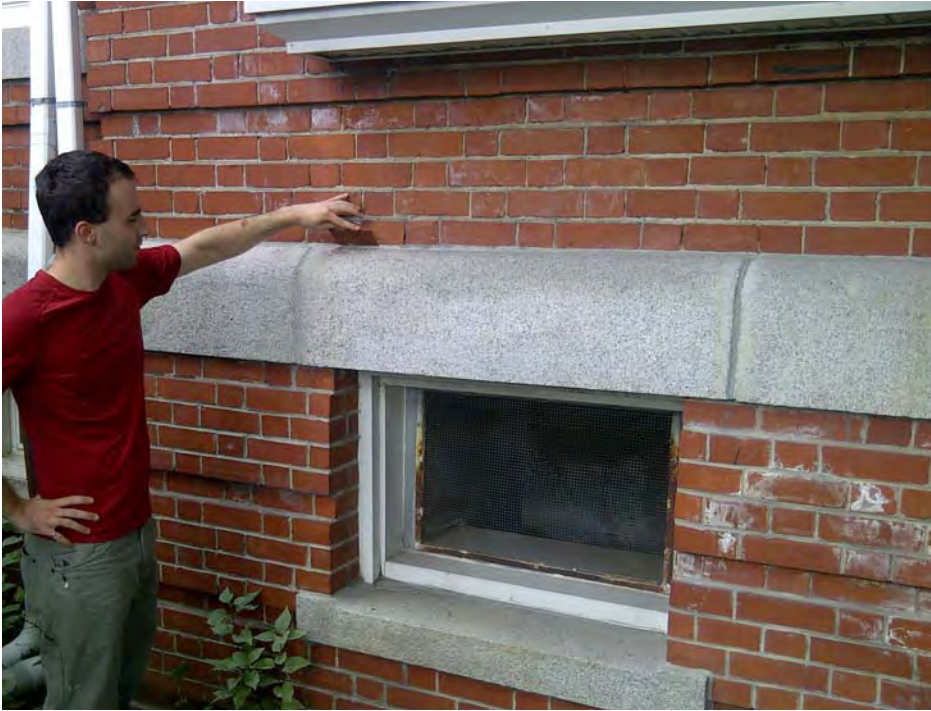
**Figure 7: Original building: brickwork spalling and surface efflorescence**

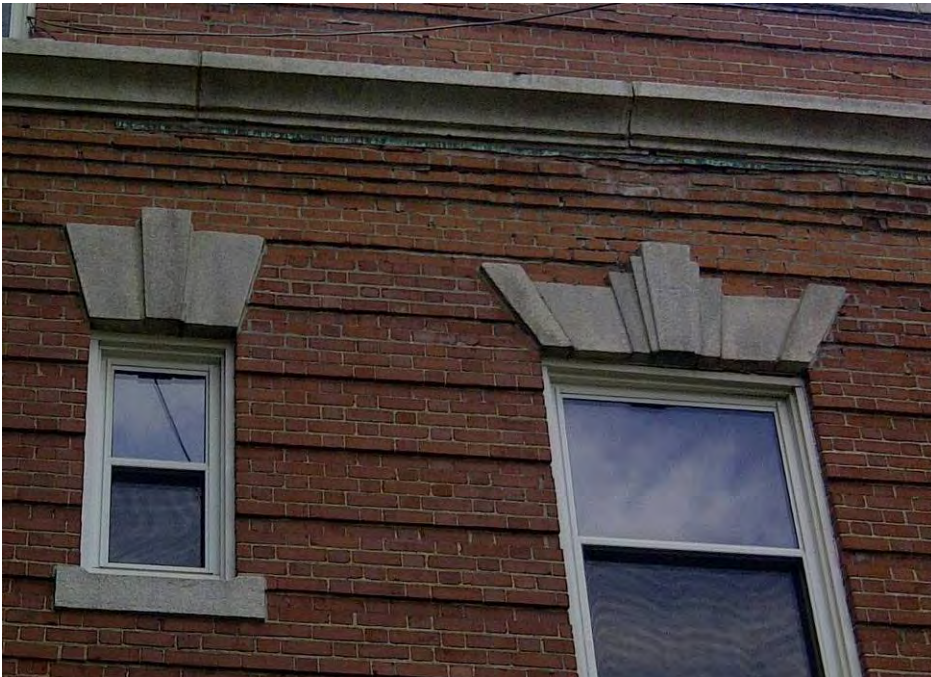
**Figure 8: Original building: brickwork and mortar damage below belt course**

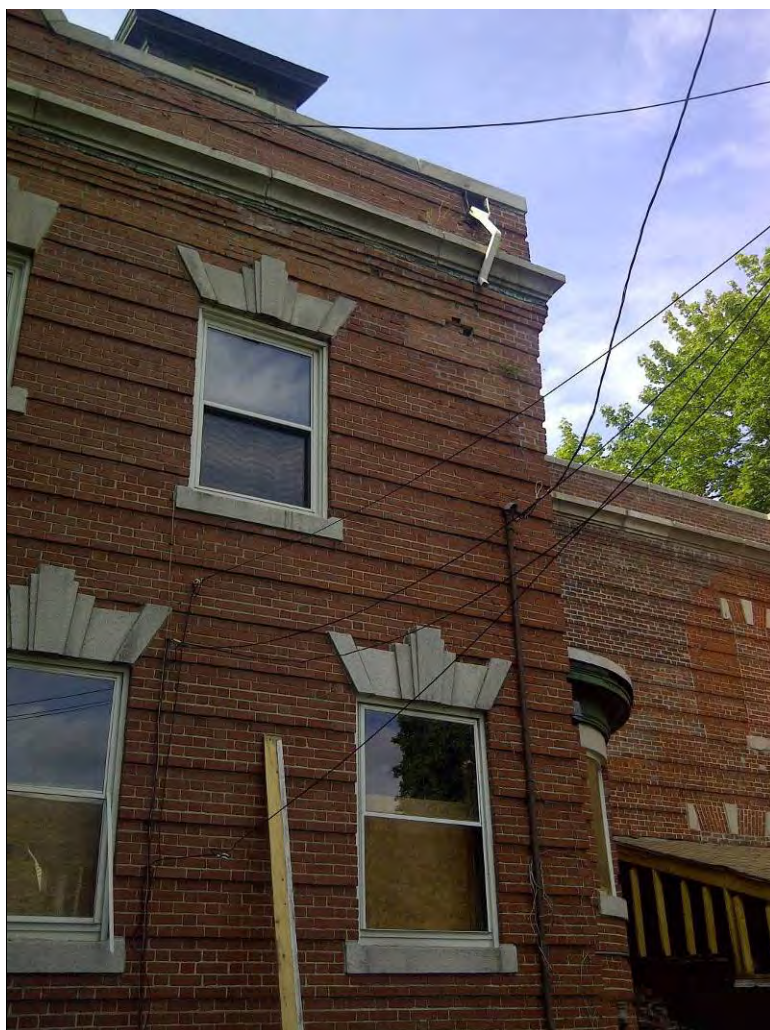
**Figure 9: Original building – missing downspout**

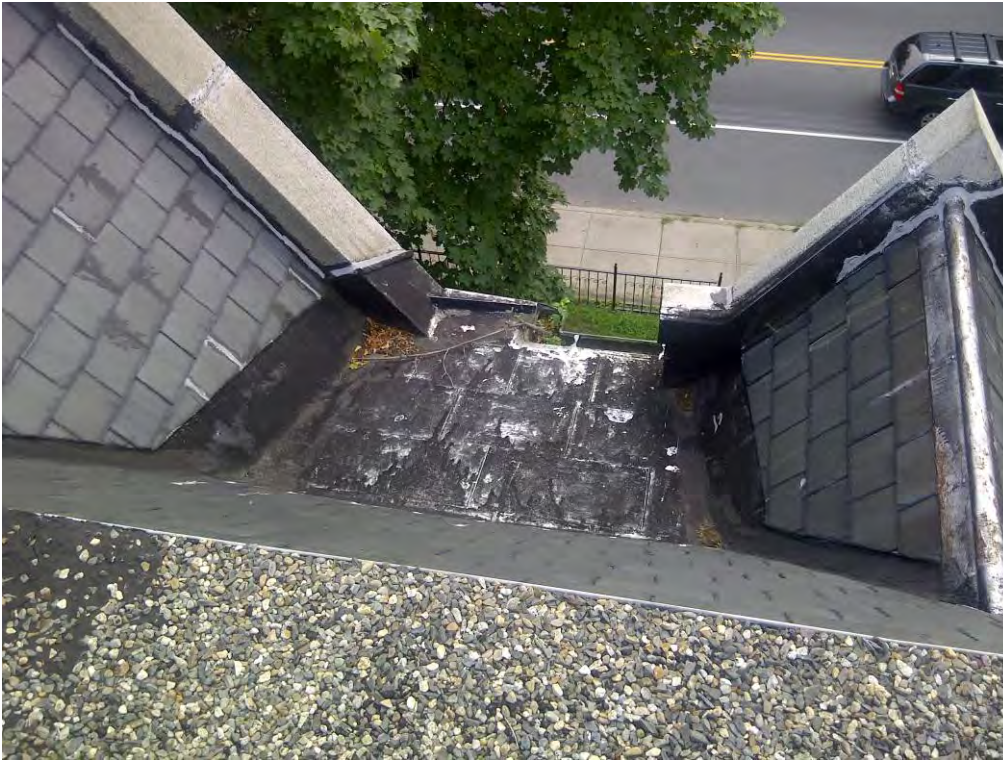
**Figure 12: Roof drain filled with debris**

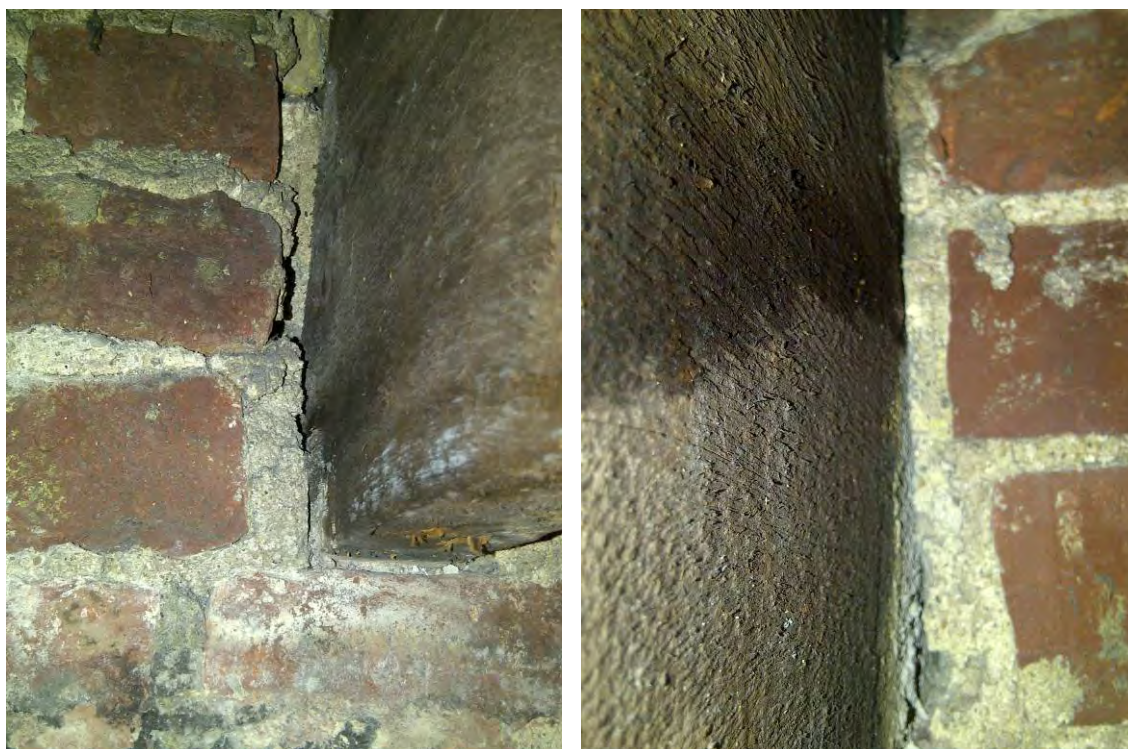
**Figure 14: Original building - floor joist to masonry wall interface**

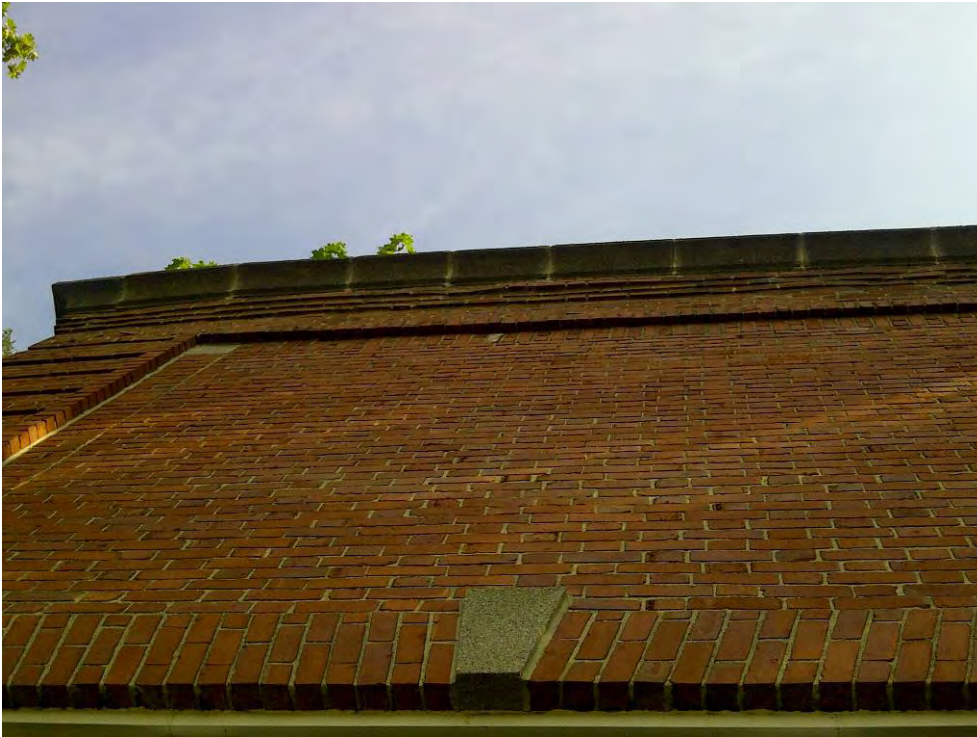
**Figure 20: Bricks and belt course pushing out on north façade**

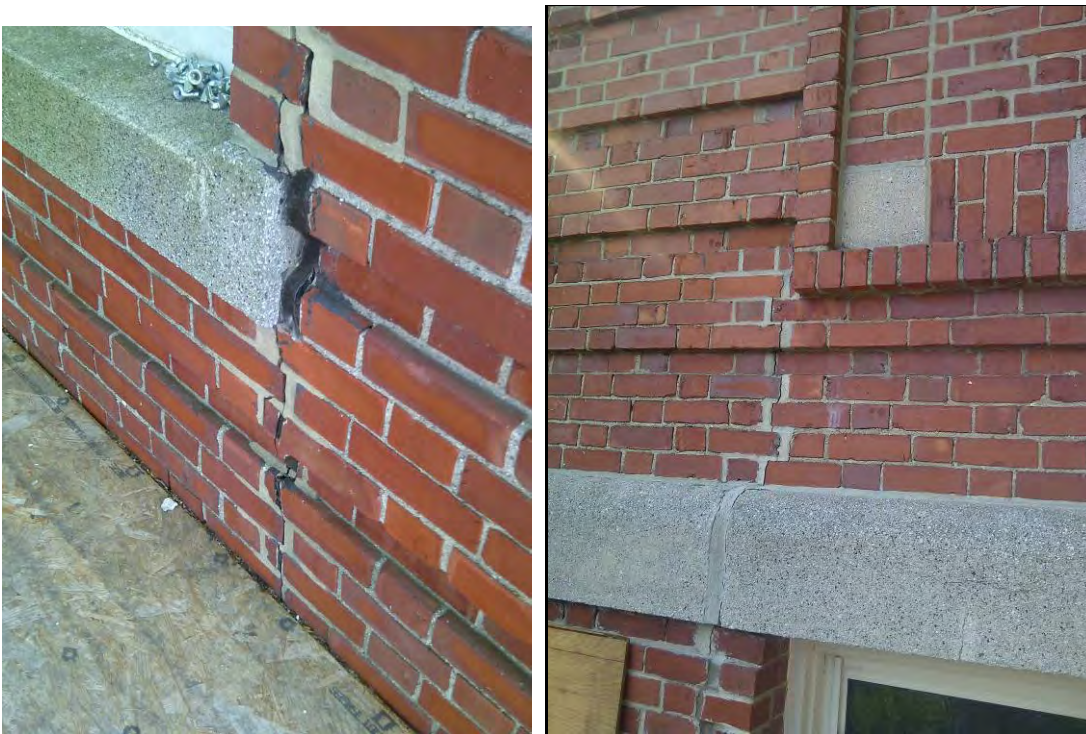
**Figure 21: Addition: cracks in brickwork**
