Building America Report - 1107

Proven Performance of Seven Cold Climate Deep Retrofit Homes

R. Osser, K. Neuhauser, and K. Ueno
Building Science Corporation

June 2012

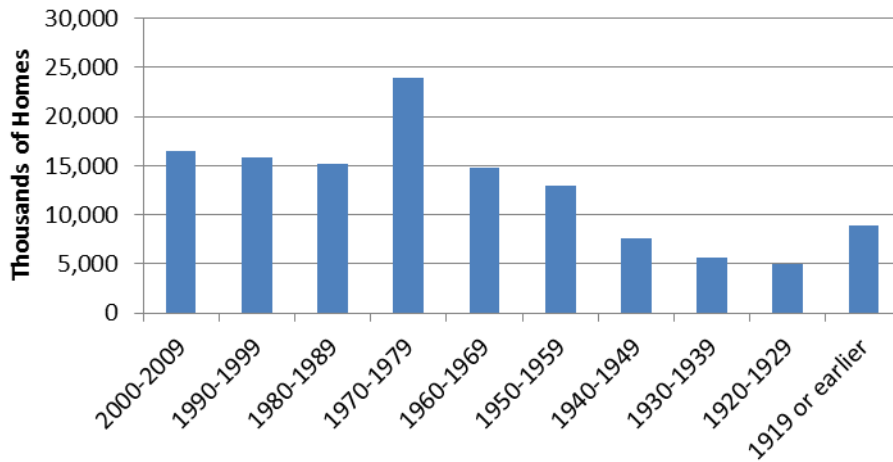
Figure 2. Vintage of U.S. Homes (EIA 2009)

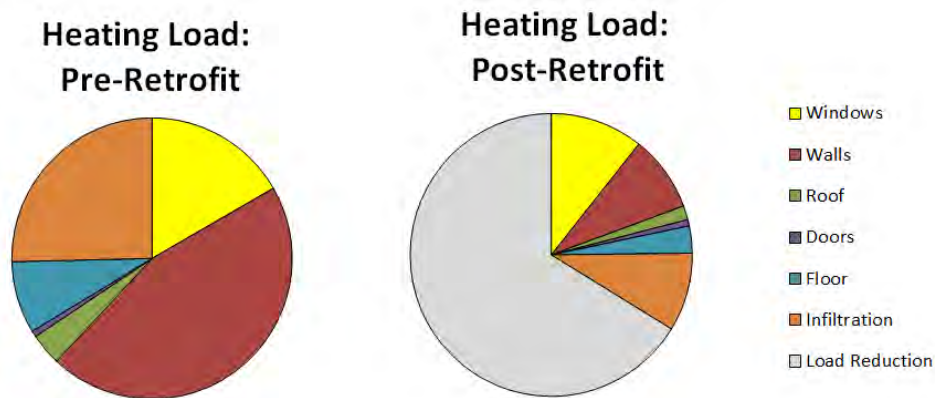
Figure 3. Sample pre- and post-DER heating load components

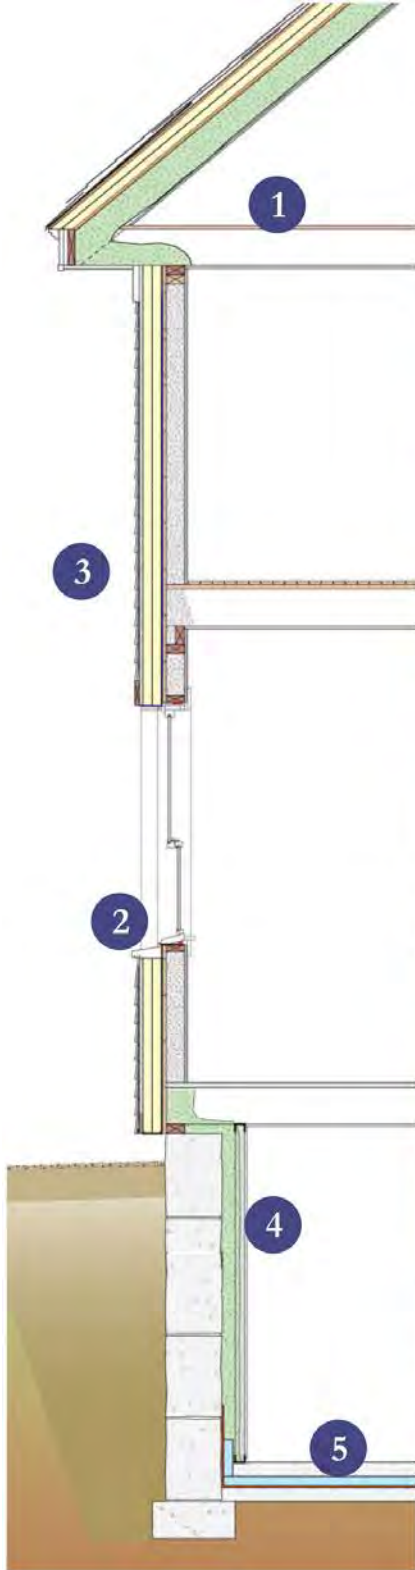
BUILDING ENCLOSURE

Roof: Unvented

Foundation: Conditioned basement

4 Foundation Wall Insulation: R-20 walls with 4" high density sprayed polyurethane foam

Infiltration: 2.5 in² leakage area per 100 ft² envelope

1 Heating: 92% AFUE sealed combustion gas boiler in conditioned space

1 3 Cooling: 13 SEER split system in conditioned space

Ducts: Sheet metal trunk and flex runouts in conditioned space

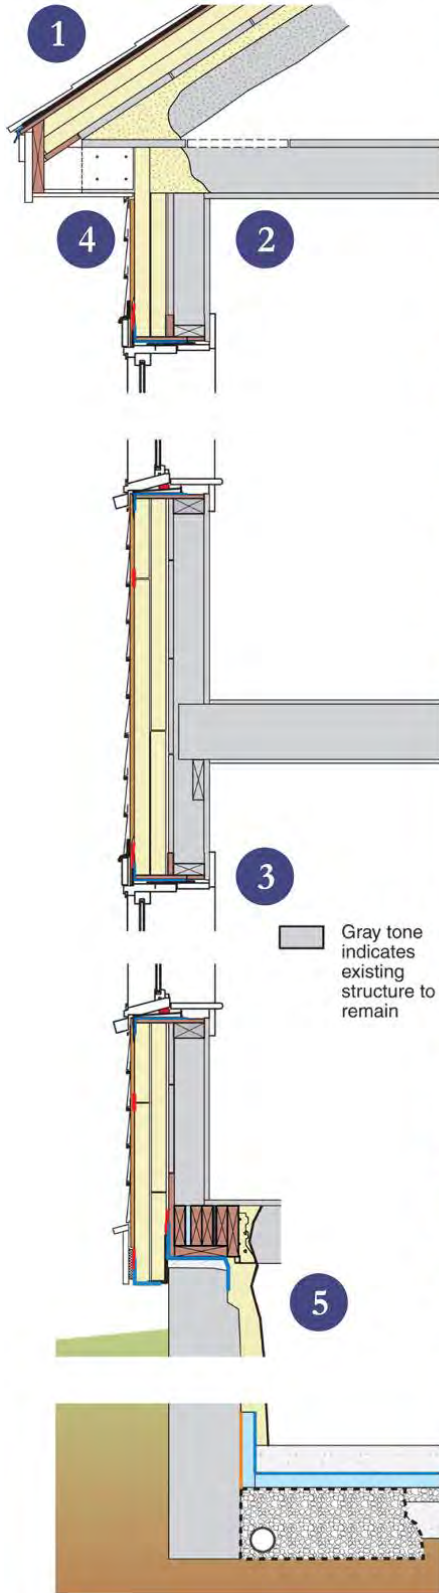
ENCLOSURE DESIGN

1 Roof Assembly: Rafter-framed unvented attic with R-56 roof insulation: unfaced fiberglass batt insulation (R-30) in rafter bay with two 2" layers of foil-faced polyisocyanurate insulating sheathing (R-26, joints staggered and taped) on top of existing/ repaired roof sheathing.

4 Air Sealing: The primary air flow control layer is the exterior face of the insulating sheathing with taped seams. Self-adhered membrane and low expansion foam sealants transition the air flow control at windows. Self-adhered ice/water membrane over the entire surface of the roof sheathing provides air flow control at the roof. Low expansion foam is used to transition the air barrier to roof framing and sheathing. Self-adhered membrane flashings transition the air control layer at the base of the above grade wall to the closed-cell foam applied to the interior of the foundation walls.

5 Foundation Assembly: Conditioned basement with 2-3" closed-cell spray foam insulation applied directly to field stone foundation walls and covered with FireFree 88® ignition barrier paint. A 12" high strip of 2" XPS as the slab perimeter thermal break also allows foundation walls to drain to the sub-slab drainage system. Trenches filled with gravel and drainage pipe connected to a sump manage bulk water below a new concrete basement floor slab, 6 mil poly, 2" XPS and continuous bed of gravel.

① **Heating:** 96% AFUE sealed-combustion gas furnace with a MERV 13 filter. Furnace installed in conditioned space.

③ **Space Conditioning Distribution:** Air handler and distribution entirely within conditioned space. Sheet metal trunks and run-outs. Ducted return from first floor with transfer grilles above bedroom doors.

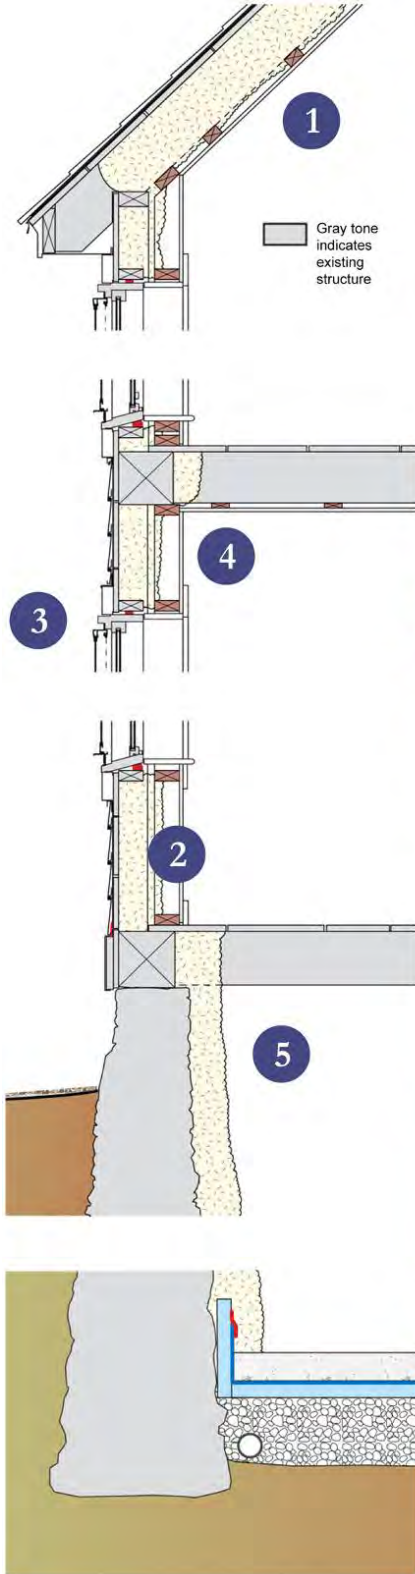
ENCLOSURE DESIGN

1 Roof Assembly: Compact (unvented) roof assembly with existing 2x8 rafter framing and 2x3 cross furring, framing cavity and portion of furring cavity filled with R-56 Demilec Heatlok Soy™ medium density spray foam insulation.

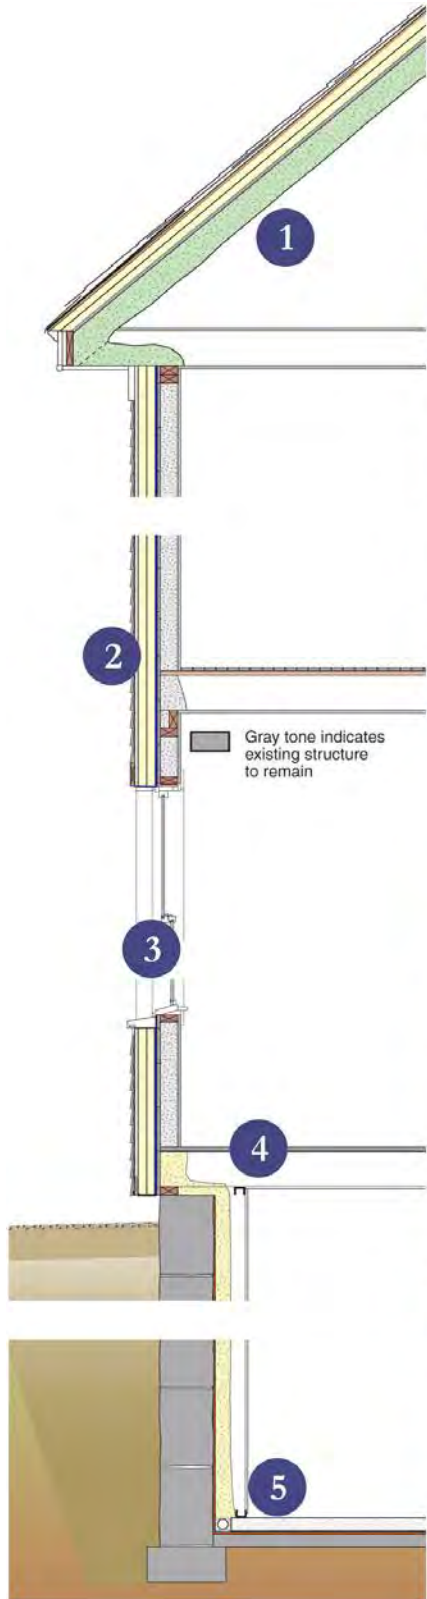
ENCLOSURE DESIGN

1 Roof Assembly: R-55 with 8" open-cell spray foam on the underside of the roof deck filling rafter bays; two layers of 2" foil-faced polyisocyanurate rigid insulation over existing roof sheathing with joints staggered and taped.

4 Infiltration: Taped roofing membrane; housewrap on above grade walls; closed-cell spray foam on foundation walls; 3.5 ACH 50 Pa.

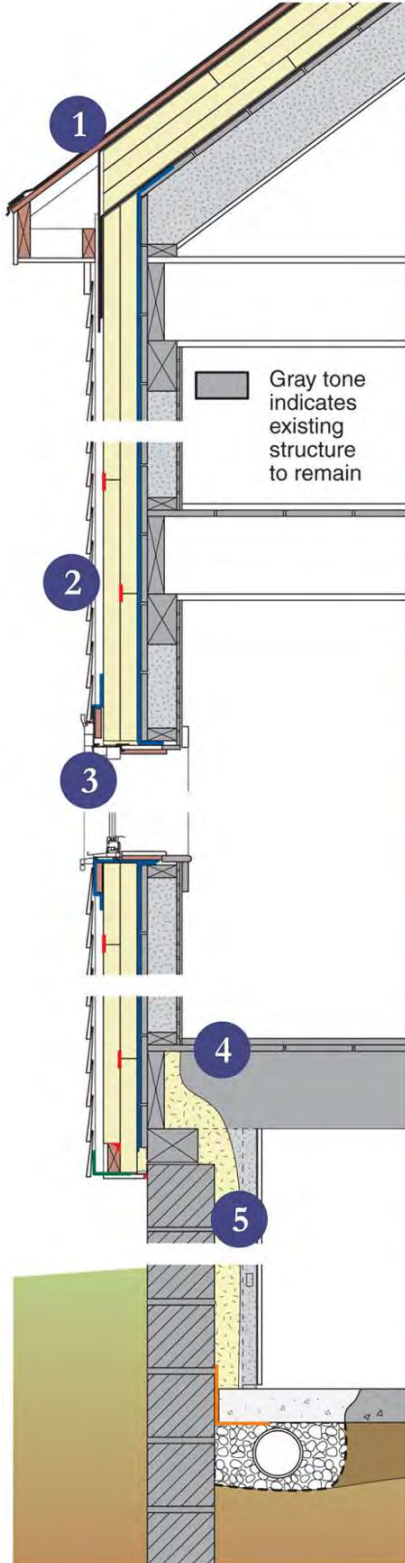
ENCLOSURE DESIGN

1 Roof Assembly: Compact (unvented) roof assembly with existing 7" deep rafter bays filled with netted cellulose insulation and with three 2" layers of foil-faced polyisocyanurate exterior insulating sheathing.

6 Site Generated Power: 4.3 kW PV system

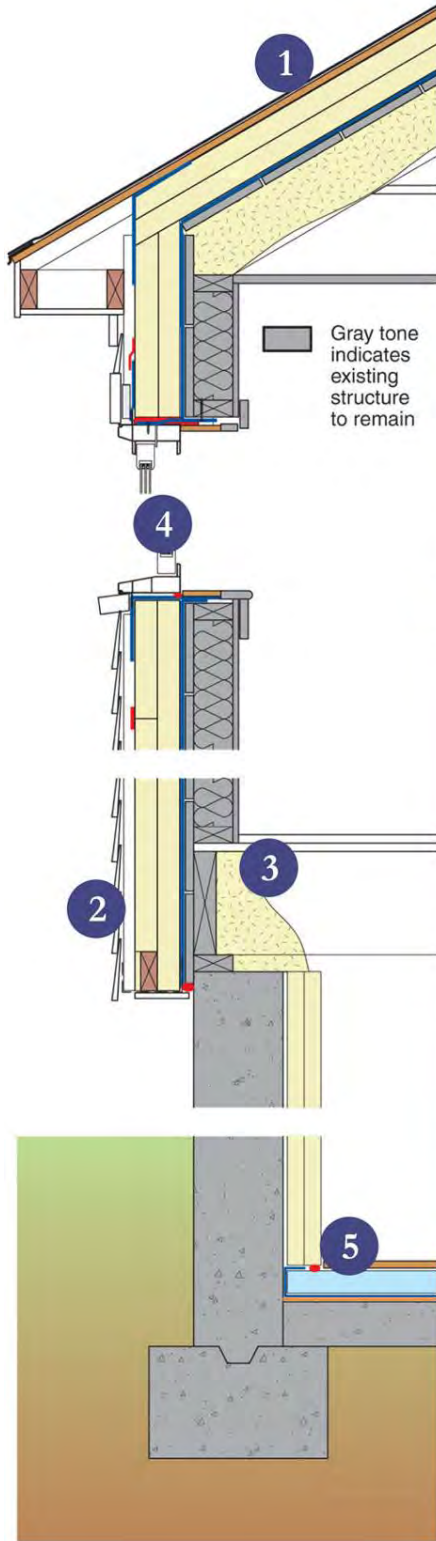
ENCLOSURE DESIGN

1 Roof Assembly: Compact (unvented) roof assembly with existing rafter bays filled with spray foam and with two 2" layers of foil-faced polyisocyanurate exterior insulating sheathing.

Distribution: Insulated sheet metal trunks with insulated flex run-outs; entire distribution system within thermal enclosure; ductwork in basement ceiling for basement air handler; ductwork in attic and kneewall space for the second floor air handler.

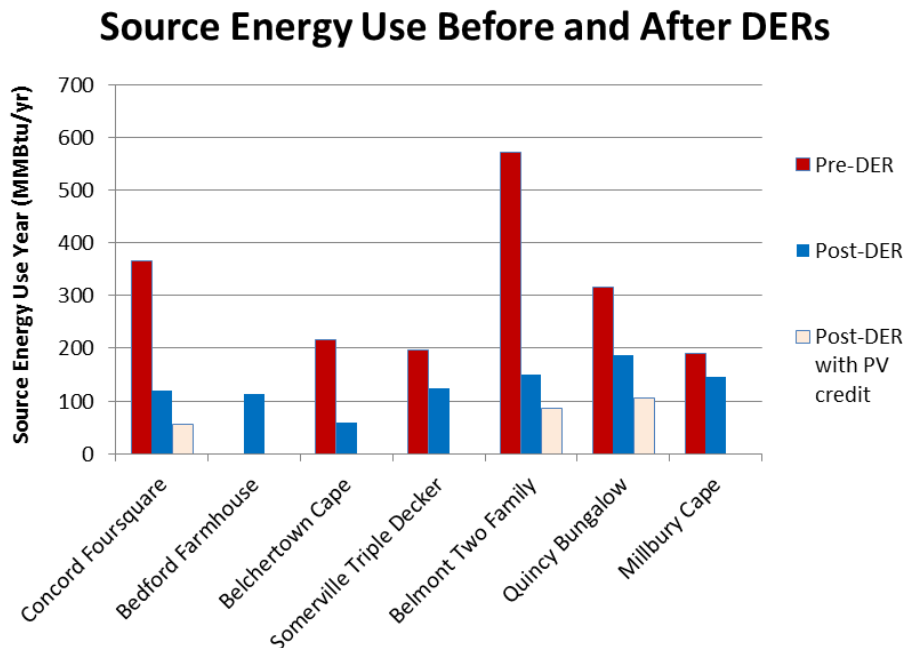
Figure 19. Source energy use before and after the retrofits for each of the 7 homes

As shown in Figure 19 and Figure 20, the Millbury Cape has the highest post-retrofit source energy use per square foot of conditioned area. The energy performance of this home compared to others is worse than anticipated; however, there are several possible factors contributing to the higher normalized energy use. One factor is that it is the smallest home in the group at only 1,868 ft², including the 768 ft² basement (Table 2). Although the Belchertown Cape is similarly sized at 1,907 ft², including the basement, it is known that the owners are extremely frugal with energy use and tolerant of more extreme interior temperatures, as described in Section 3.3.3. Smaller homes tend to have proportionally higher energy use indices because of their increased surface area to volume ratio and issues such as the fact that essentially the same appliances and miscellaneous loads are contained within a smaller space. The Millbury Cape’s source energy reduction is also confused by the fact that there was a fuel switch from oil and pellets to heat pump electricity and pellets. Wood pellets are considered to have a source to site energy ratio of 1; the factor used for electricity is 3.34 (Figure 18). Additionally, the Millbury Cape homeowners added central air conditioning in the summer. The window units they used previously may have been less frequently operated. Additional investigation and continued monitoring are needed to fully understand the long-term performance of the home.

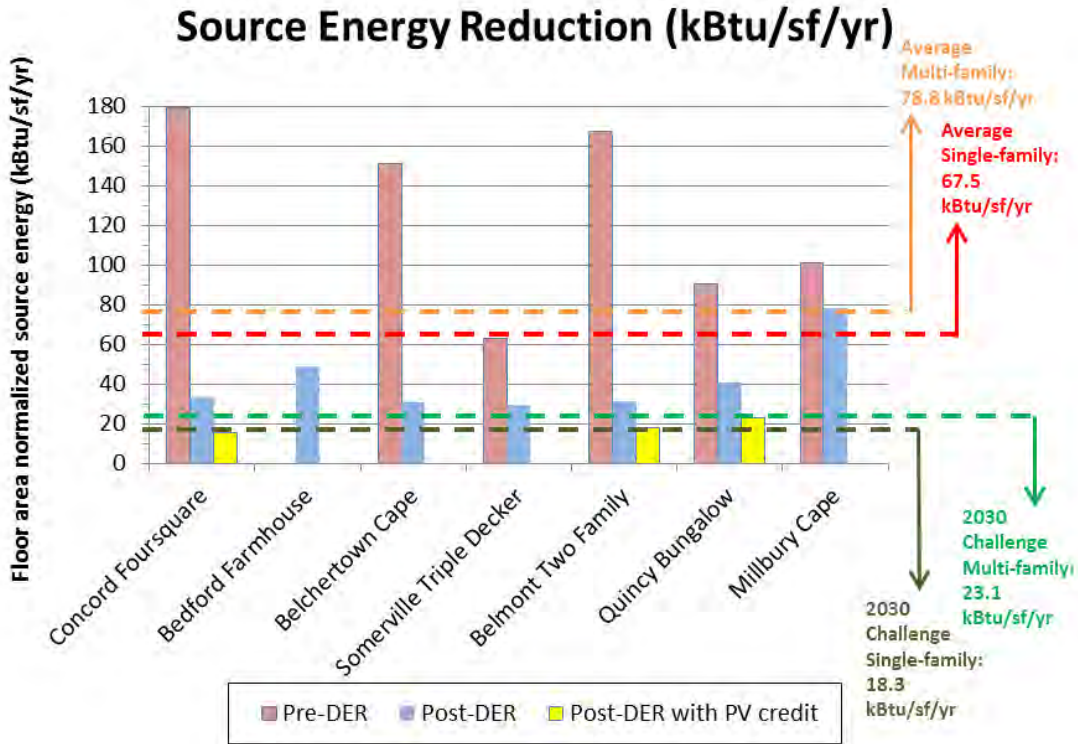
Figure 20 includes both single-family and multifamily 2030 Challenge metrics. The multifamily designation applies to both the Somerville Triple Decker and the Belmont Two Family.

Figure 20. Source energy use per conditioned area (energy use index) compared to 2030 Challenge metrics (60% energy reduction)

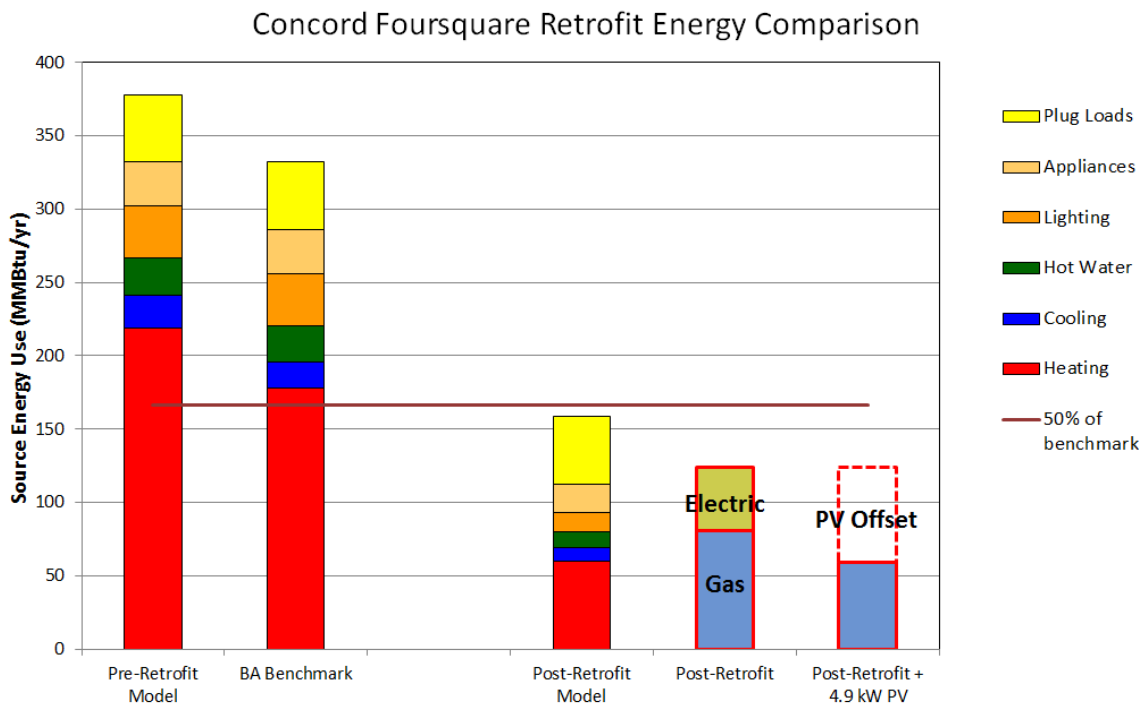
Figure 21. Concord Foursquare energy modeling comparison

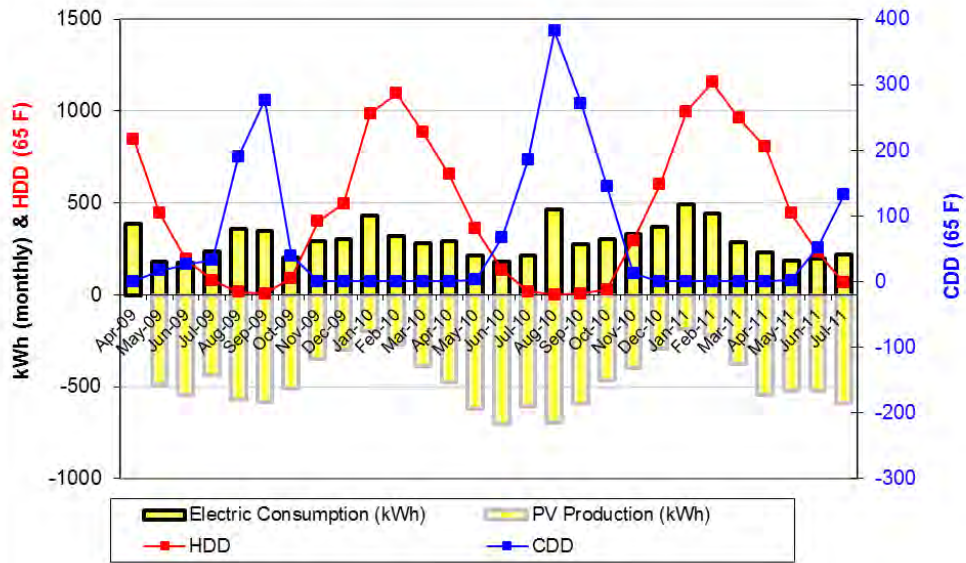
Figure 22. Monthly electricity use and generation of the Concord Foursquare

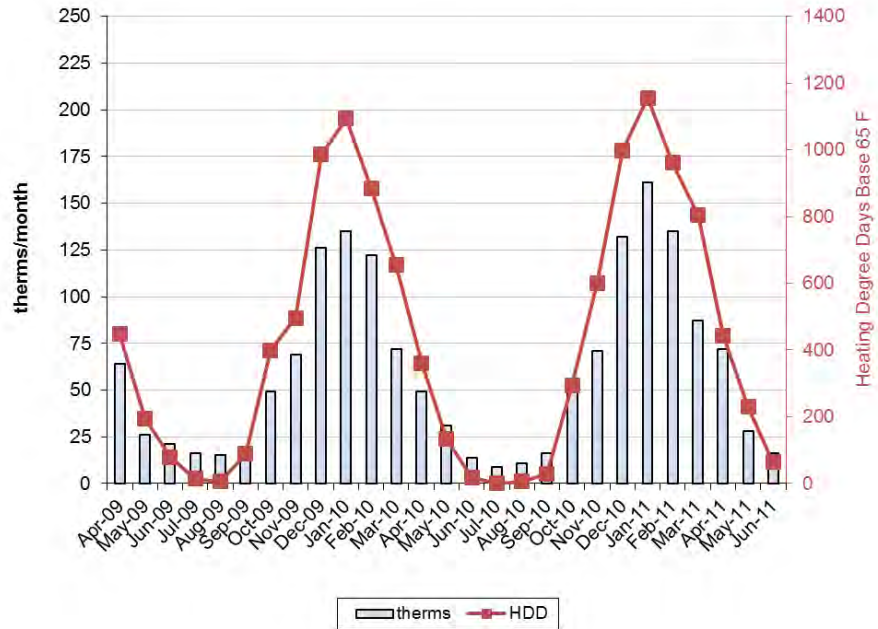
Figure 23. Monthly gas use of the Concord Foursquare

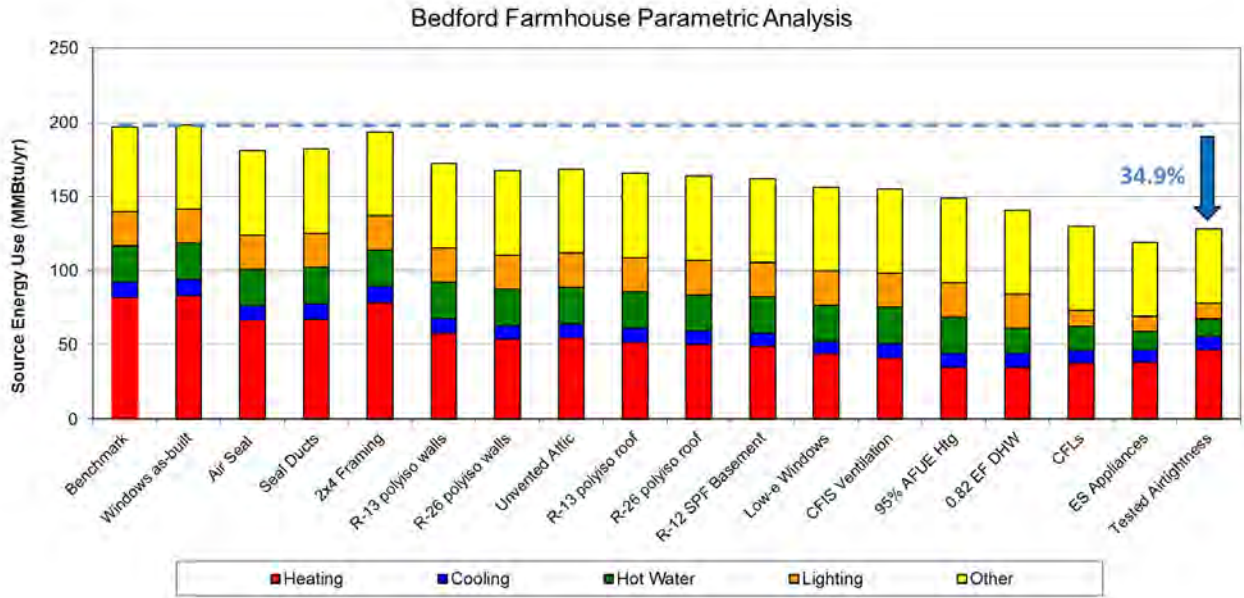
Figure 24. Parametric energy modeling of the Bedford Farmhouse

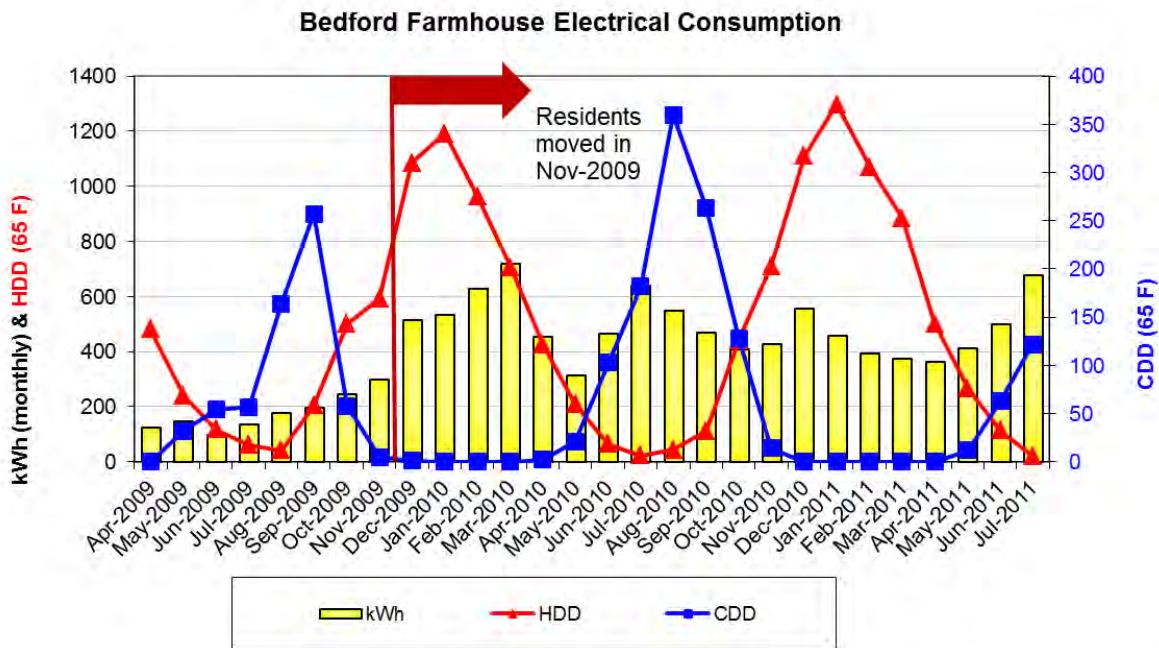
Figure 25. Electricity use monitoring of the Bedford Farmhouse

Utility bills from the completed Bedford Farmhouse have been monitored by BSC since April 2009 (Figure 25 and Figure 26). Trending shows typical seasonal variation. More than a year of post-move-in data was available, enabling initial evaluation of post-retrofit performance.

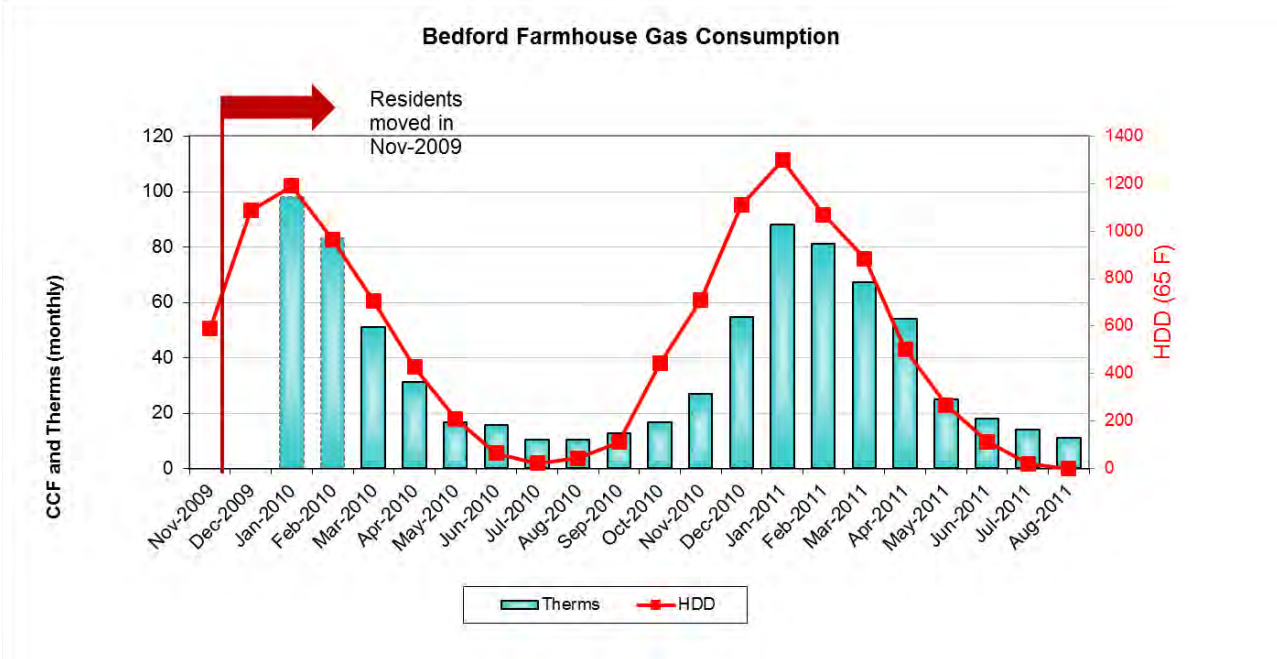
Figure 26. Gas consumption monitoring of the Bedford Farmhouse

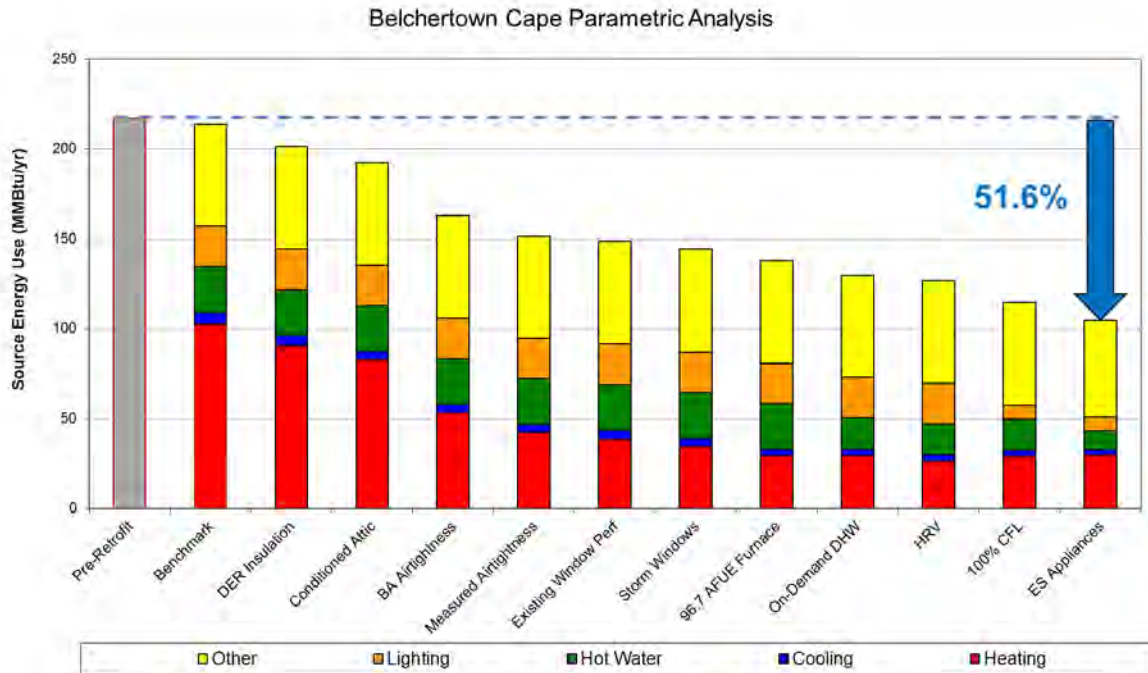
Figure 27. Parametric energy analysis of the Belchertown Cape

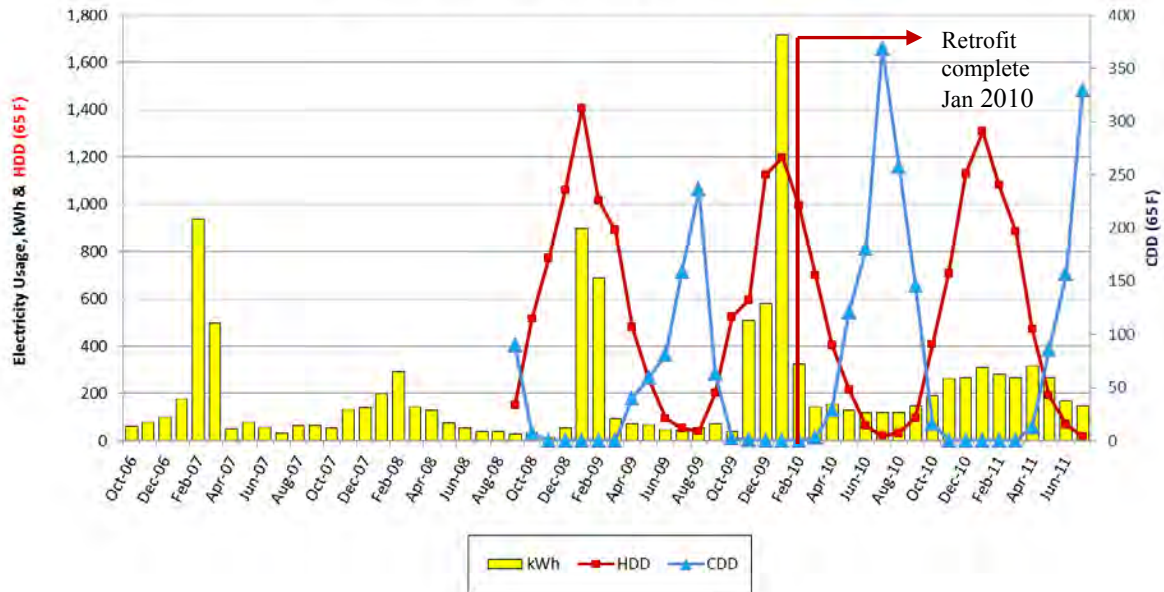
Figure 28. Electricity consumption of the Belchertown Cape

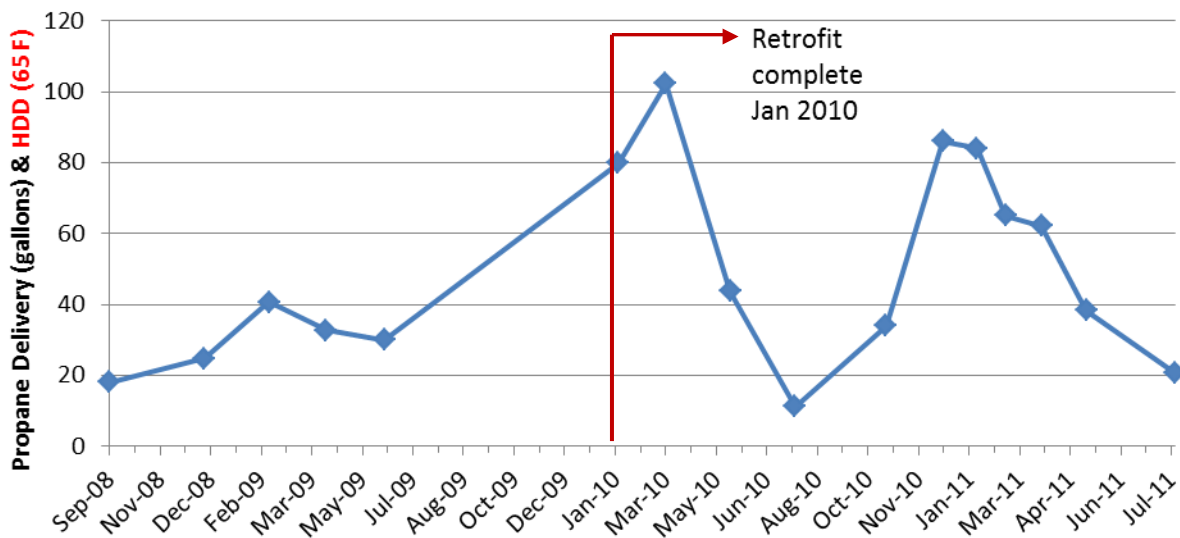
Figure 29. Propane delivery at the Belchertown Cape

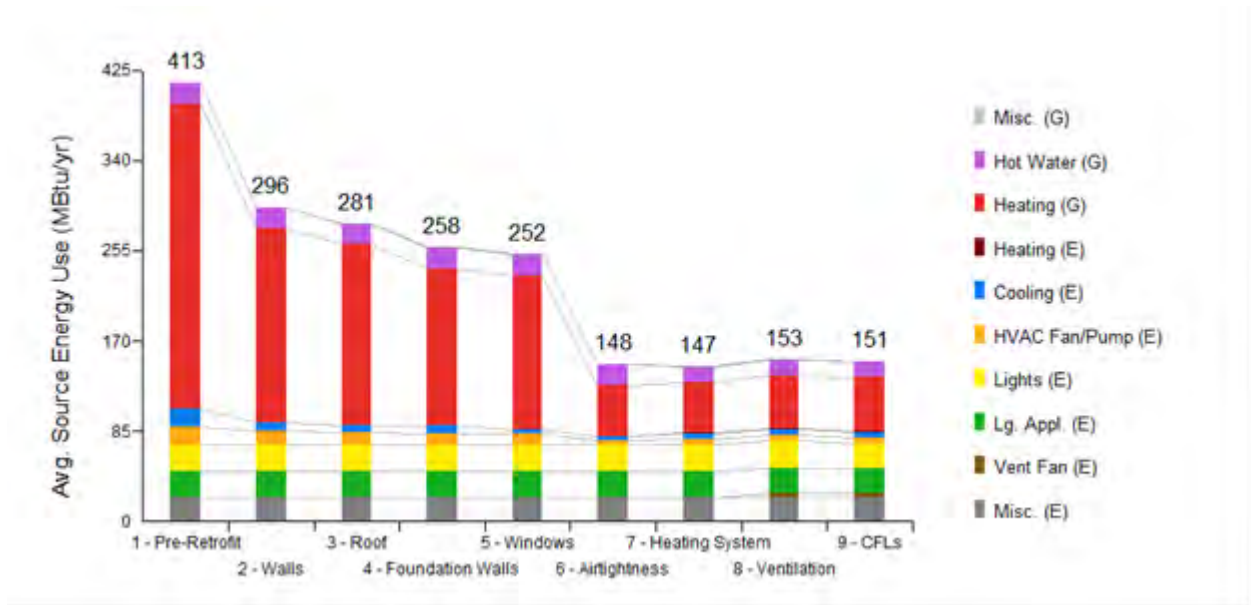
Figure 30. Parametric energy modeling of the Somerville Triple Decker

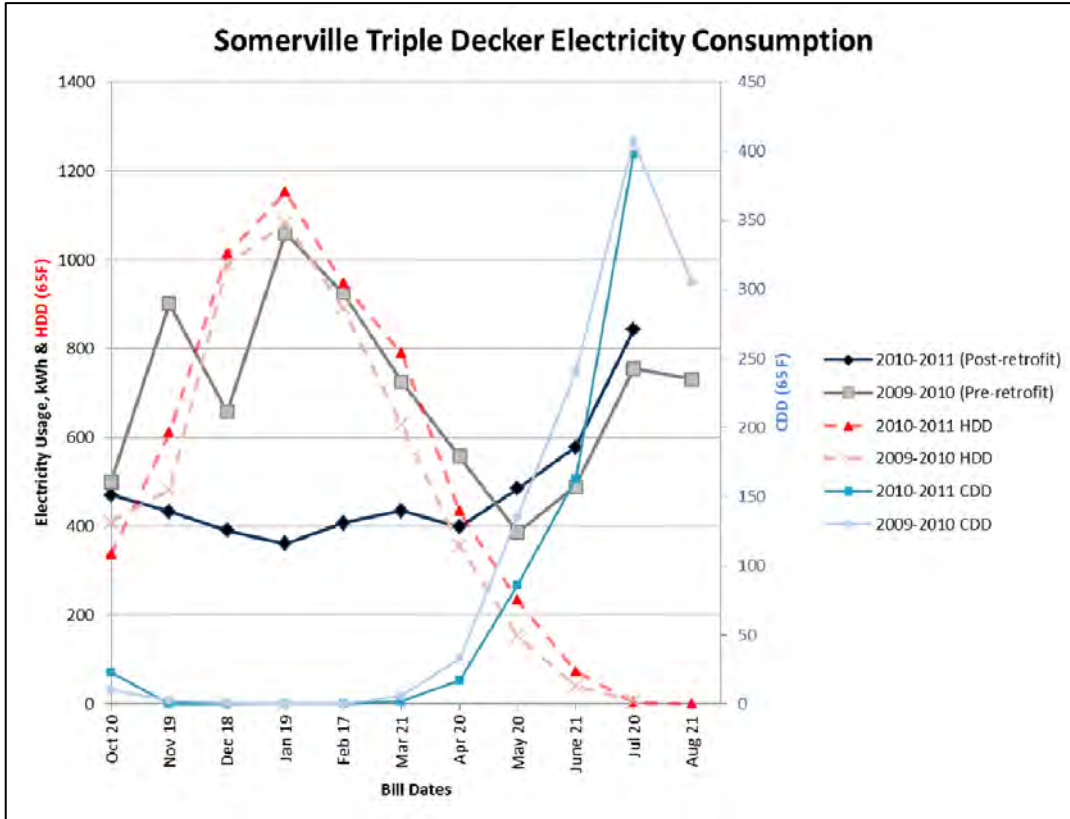
Figure 31. Somerville Triple Decker Electric consumption

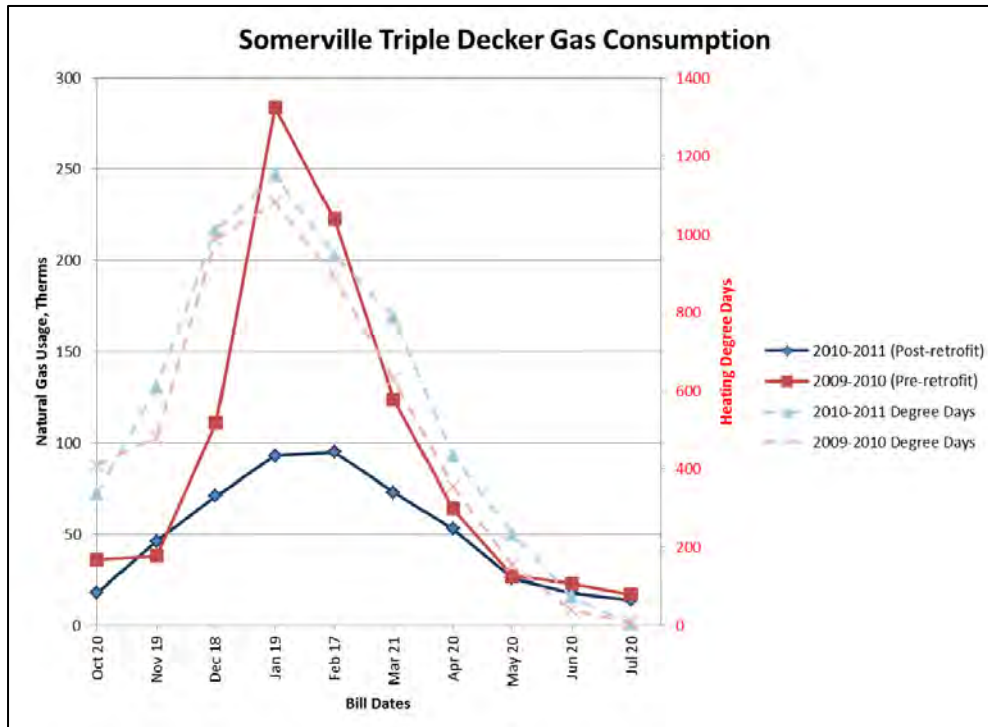
Figure 32. Somerville Triple Decker Gas consumption

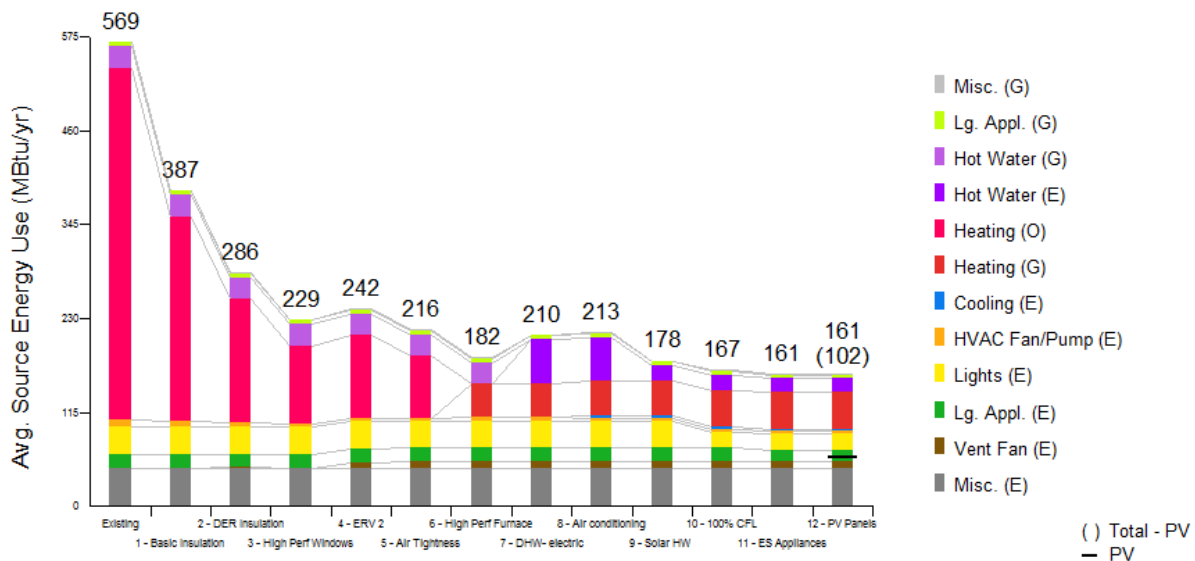
Figure 34. Belmont Two Family parametric energy analysis

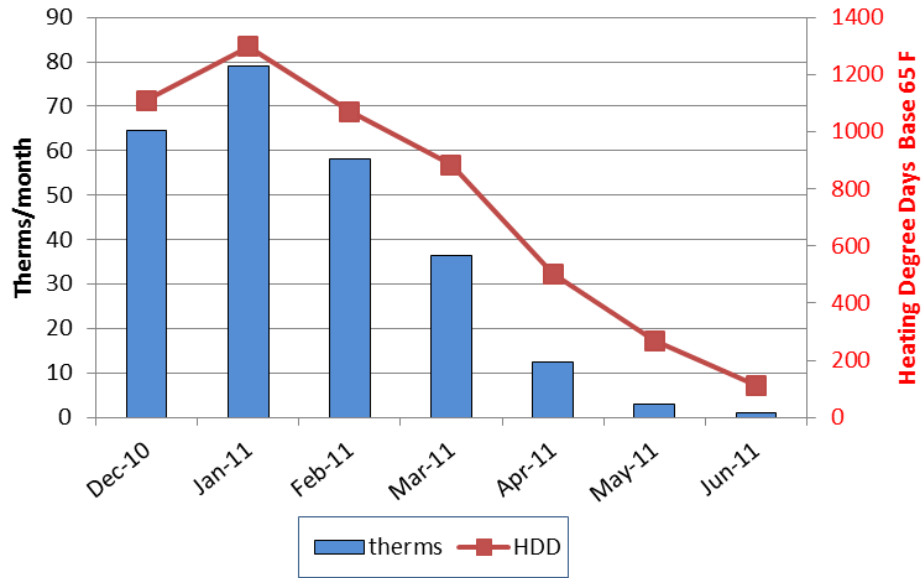
Figure 35. Belmont Two Family post-retrofit gas use

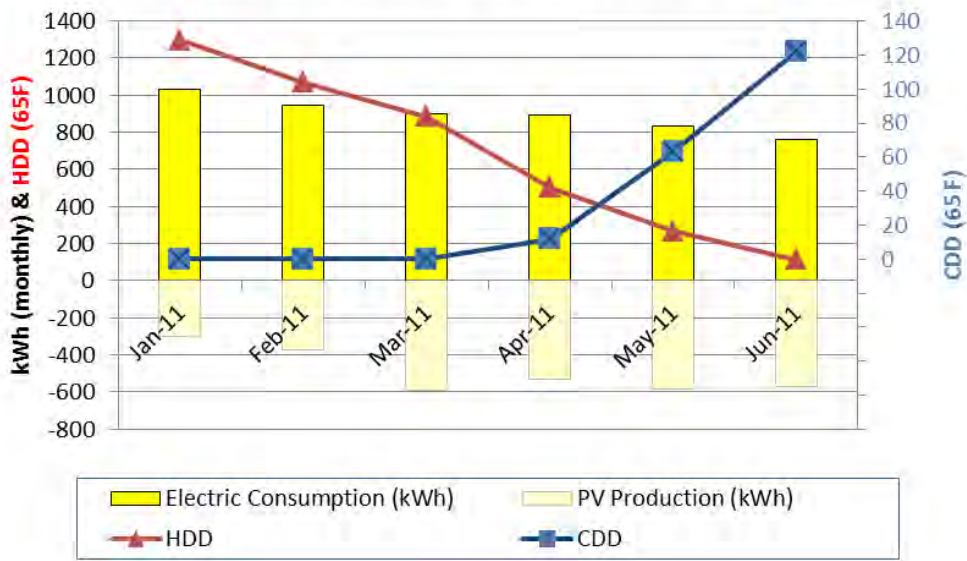
Figure 36. Belmont Two Family post-retrofit electricity use and generation

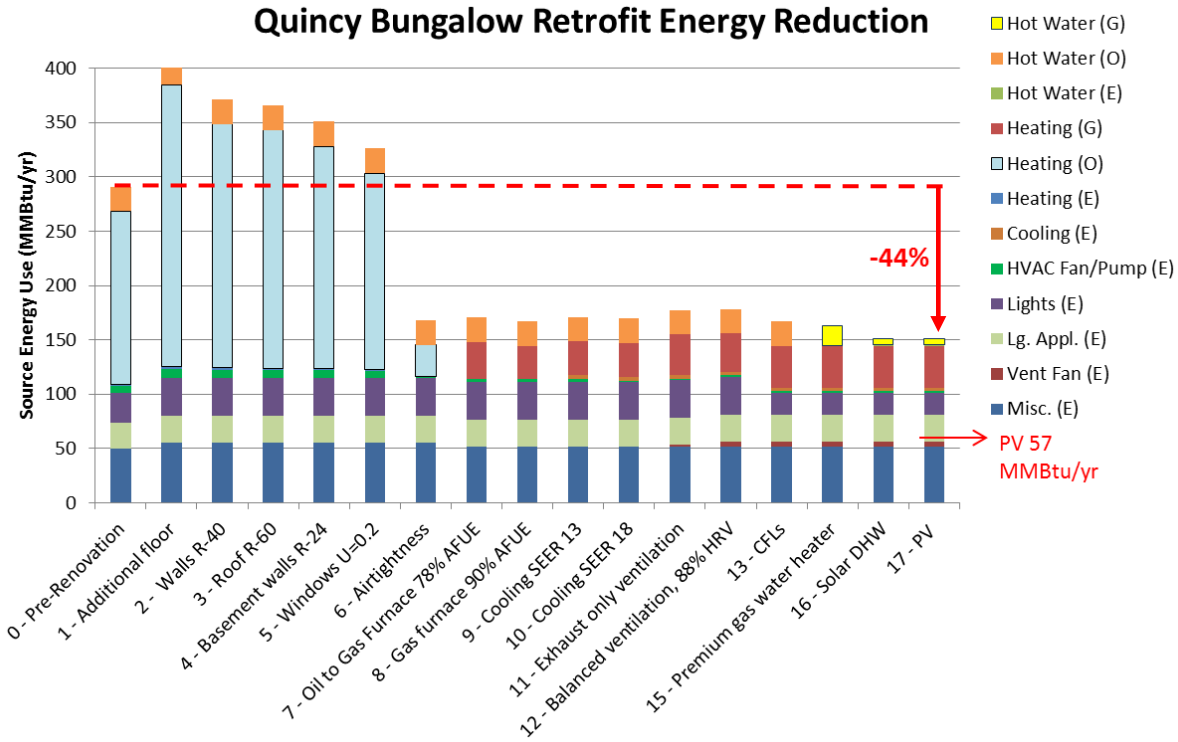
Figure 37. Parametric energy modeling analysis of the Quincy Bungalow

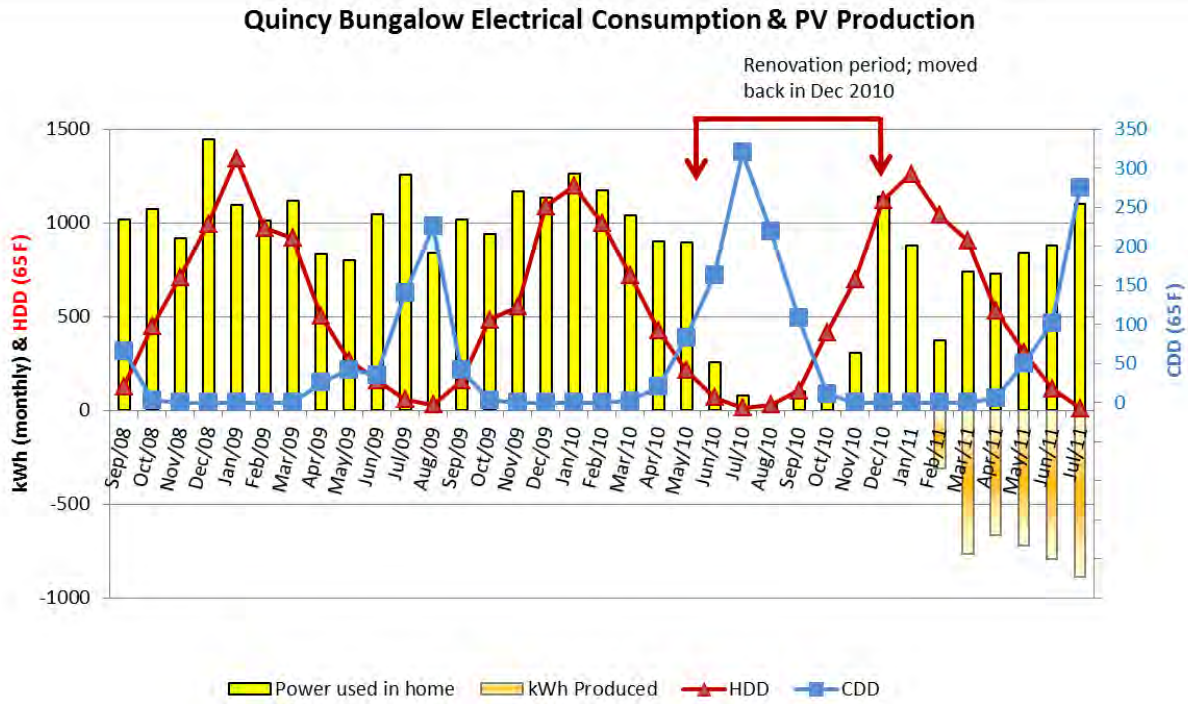
Figure 38. Graph of electricity use and PV generation of the Quincy Bungalow

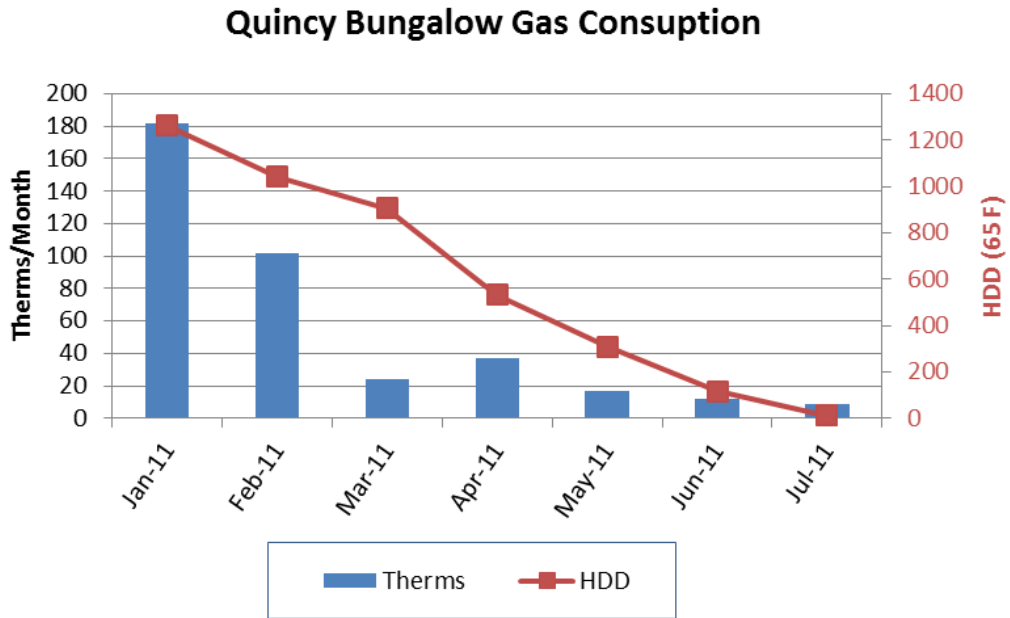
Figure 39. Graph of natural gas use following the Quincy Bungalow DER

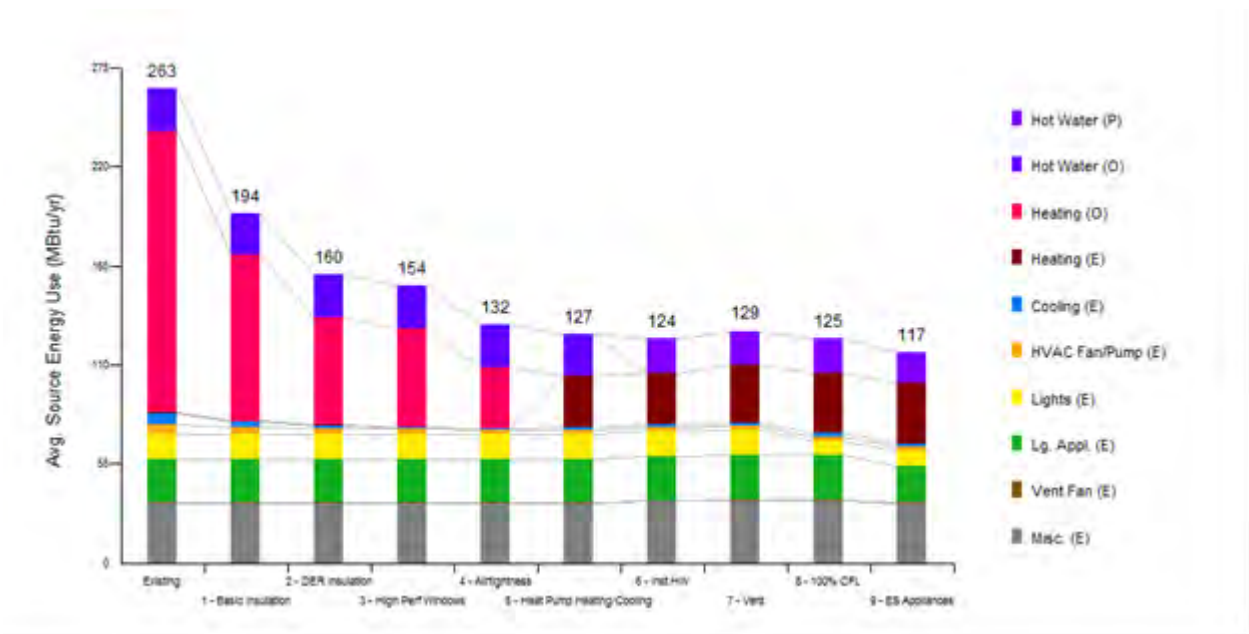
Figure 40. BEopt incremental modeling results for the Millbury Cape

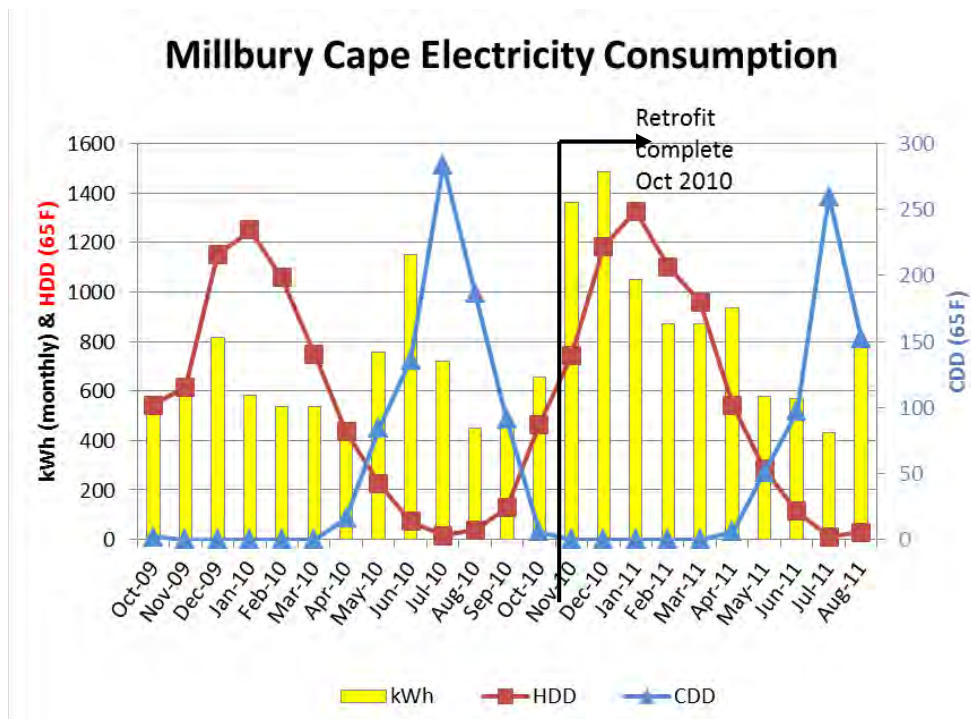
Figure 41. Pre- and post-retrofit monthly electricity use for the Millbury Cape

Available electricity use from before and after the retrofit is graphed in Figure 41. Monthly incremental use data of delivered fuels (pellets, oil, and propane) were not available; only total use data were available for the calculations in Table 5. Because of the switch from oil to air source heat pump heating, electricity use actually increased after the retrofit from 7,570 to 11,058 kWh/yr.

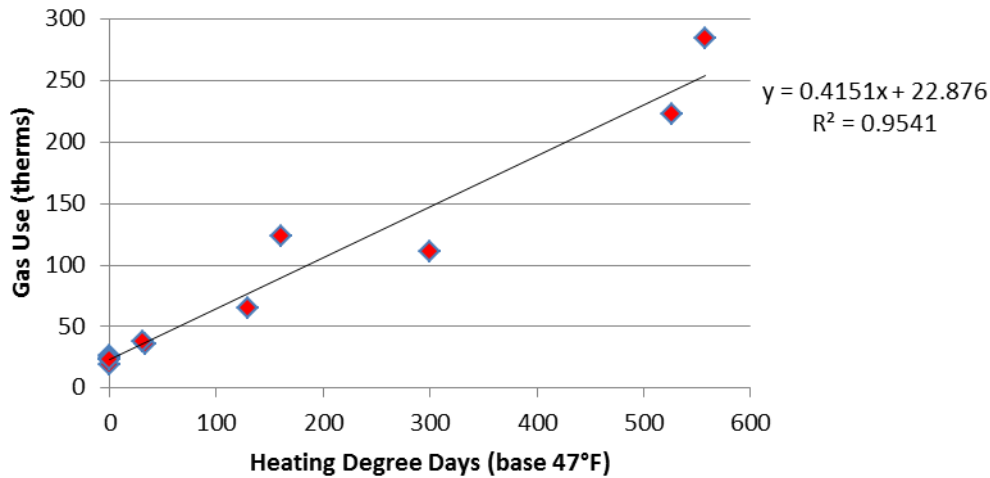
Figure 42. Pre-retrofit gas use versus base 47°F HDDs
