Building America Report - 1107

Proven Performance of Seven Cold Climate Deep Retrofit Homes

R. Osser, K. Neuhauser, and K. Ueno
Building Science Corporation

June 2012

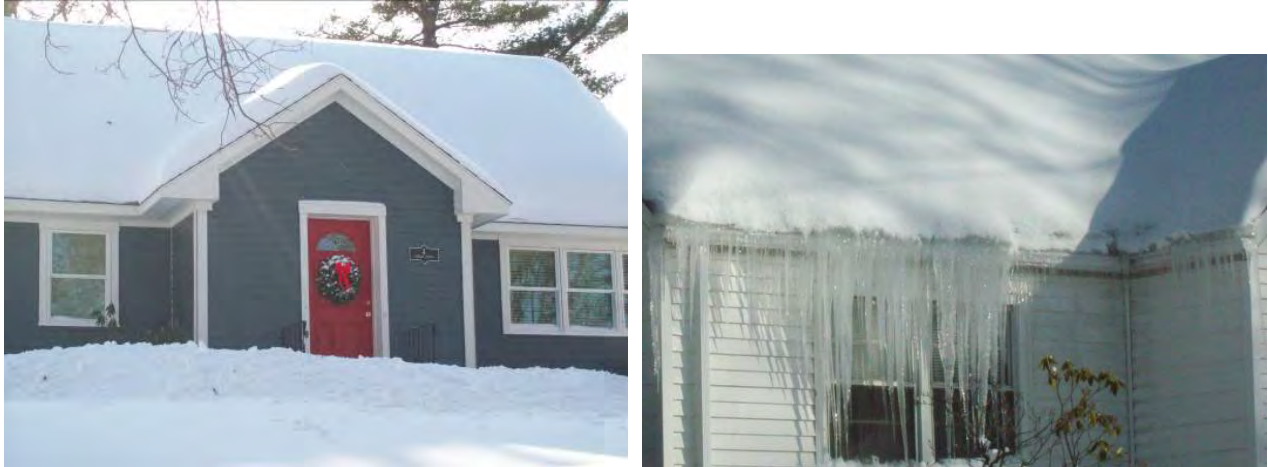
Figure 43. Left: Post-retrofit Millbury Cape; Right: Neighbor’s home with ice dams

In addition to positive comments about thermal comfort, the owners of the Millbury Cape and Somerville Triple Decker, who had both lived in their homes prior to the retrofit, noted the lack of ice dams following the roof insulation and air sealing (Figure 43). Ice dams typically occur when conductive heat or warm air escaping the roof melts snow, which then refreezes after running down to the edge of the roof (Lstiburek 2011). Ice dams often lead to water leakage into building assemblies. Worse, when an ice dam gets too heavy it can snap off, sometimes taking a piece of roof with it. Ice dams can be prevented by keeping the roof surface as cold as possible. With a vented roof, this is done by insulating and air sealing the attic floor well and ensuring outside air ventilation under the roof. For the Millbury Cape, 2 × 4s on the flat were inserted between the insulating sheathing and the outer layer of plywood, creating a vented roof capped by a ridge vent. In this case, the 2 × 4s were attached to the existing roof rafters and the plywood sheathing was attached to the 2 × 4s. This created a “vented over-roof,” successfully keeping the roof cold while still creating an attic space within the thermal enclosure.
