Diagnosing and Air Sealing Large Commercial and Residential Apartment Buildings

Hosted by:
Larry Harmon
Air Barrier Solutions, Inc.

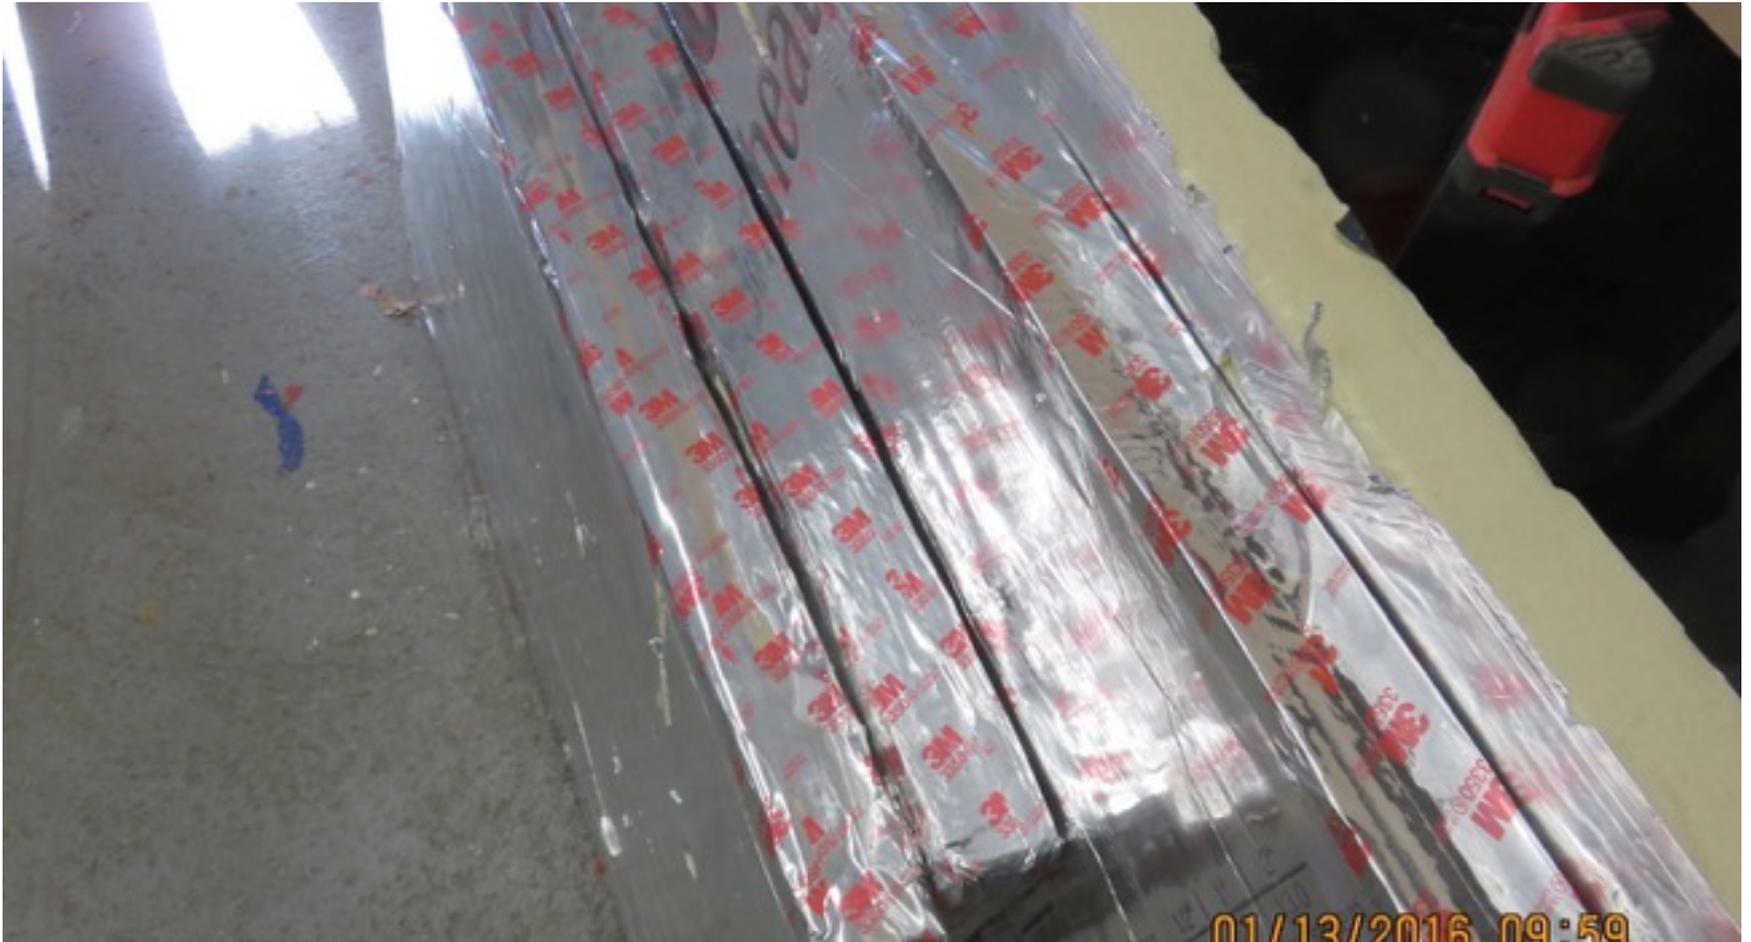
Select Proper Window Plug

Remove Sash Install Plug

Use Pick to Remove Weatherstrip

De-burr with Multi Tool

Insert New Weatherstrip and Trim

Reassemble Sash if Necessary

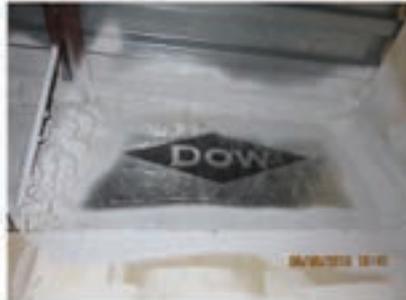
Step 4.

Fasten all edges and air seal in place. In this instance adhesive 2-component foam has done both tasks - Smart!

Fire protect as necessary. Use of a Hilti fire rated mastic or in this case DC-315 paint over foam achieves the proper protection.

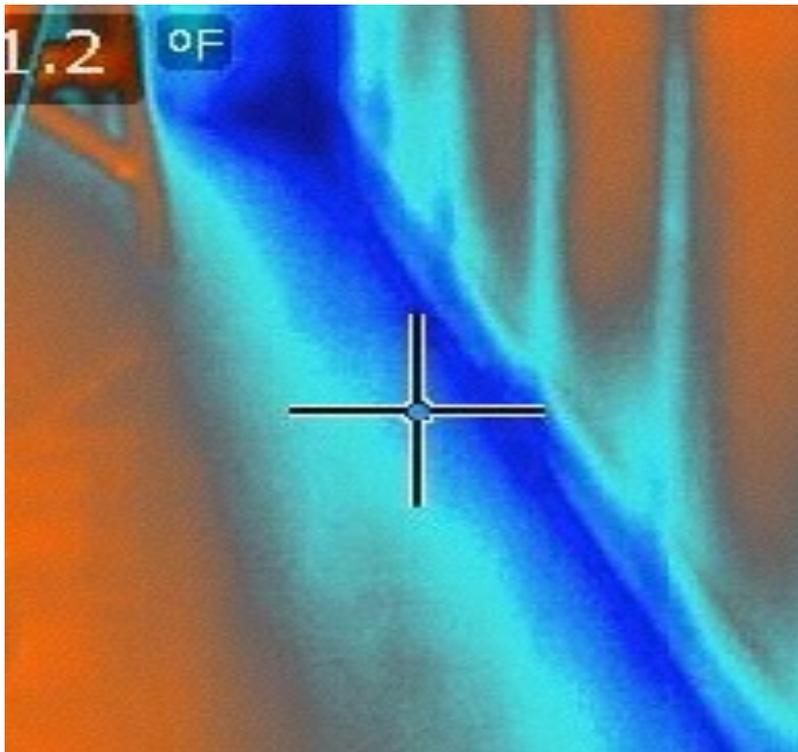
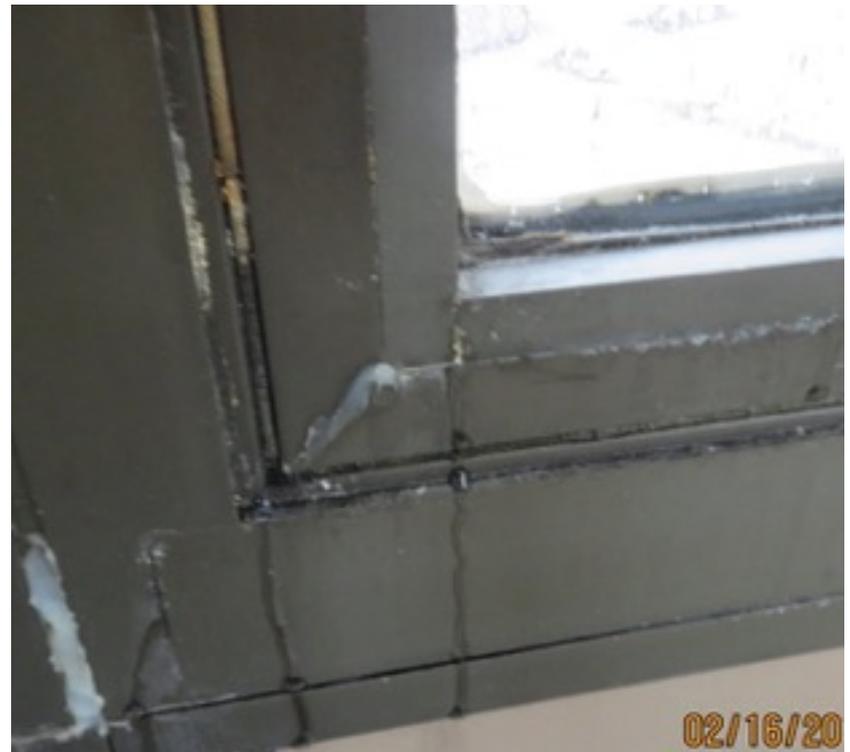
Wind Effect in Action

- **Comfort issues: hot leeward, cold windward**
- **Lack of building control during windy weather**
- **Missing insulation – generally loose fill**
- **Drifting snow – in openings onto ???**
- **Water ingress – kinetic**
- **Panels dropping**
- **Door closure**

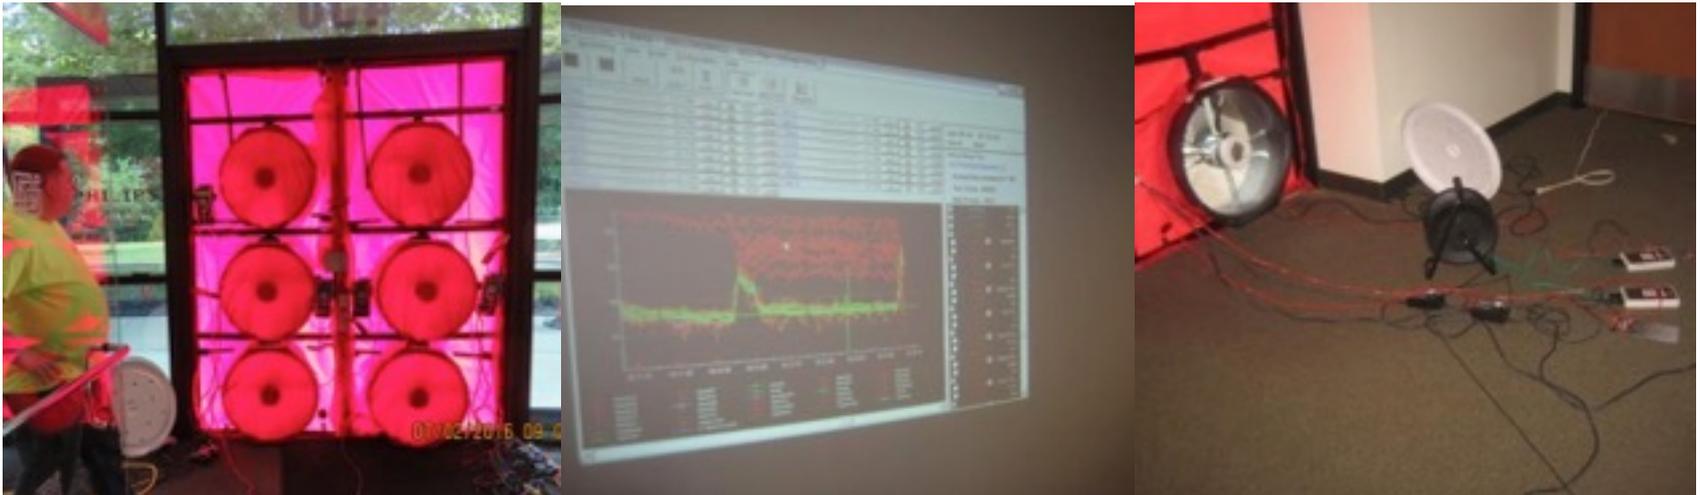
ASTM E779 – 10 **Standard Test Method for** **Determining Air Leakage Rate by Fan Pressurization**

- Quantitative test not a qualitative test

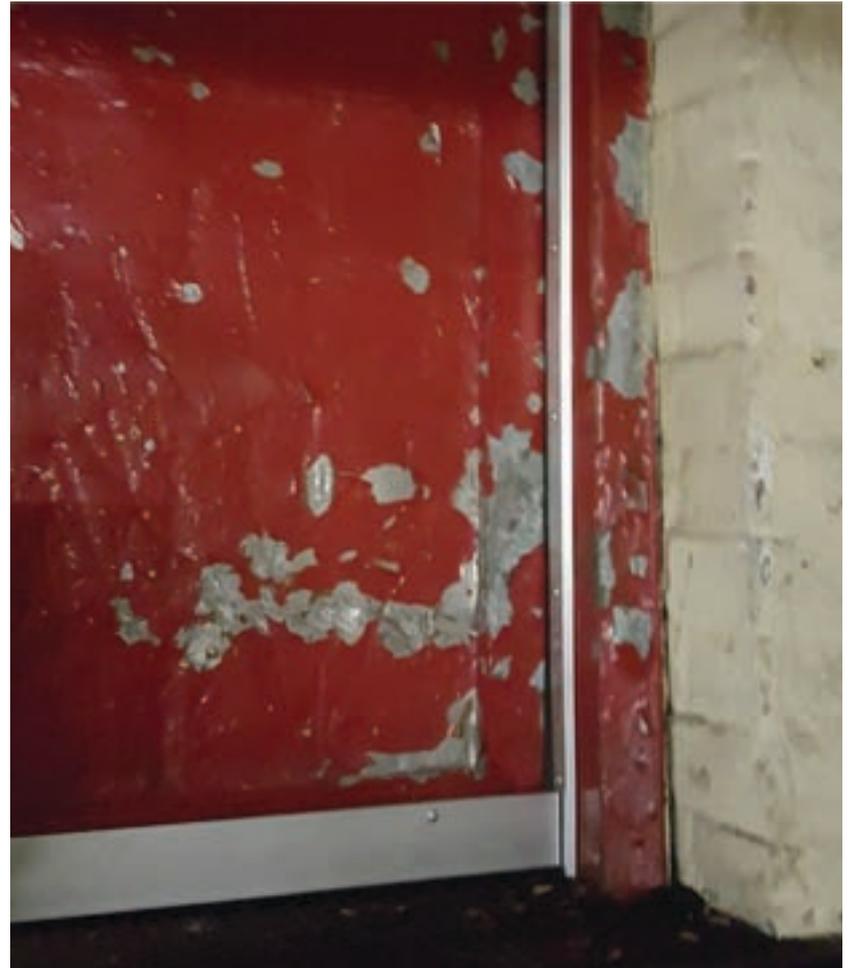
- **Old boiler room door**
- **Automatic door bottom FR SR**
- **Door gaskets on carrier FR SR**
- **What happens in the boiler room stays there**

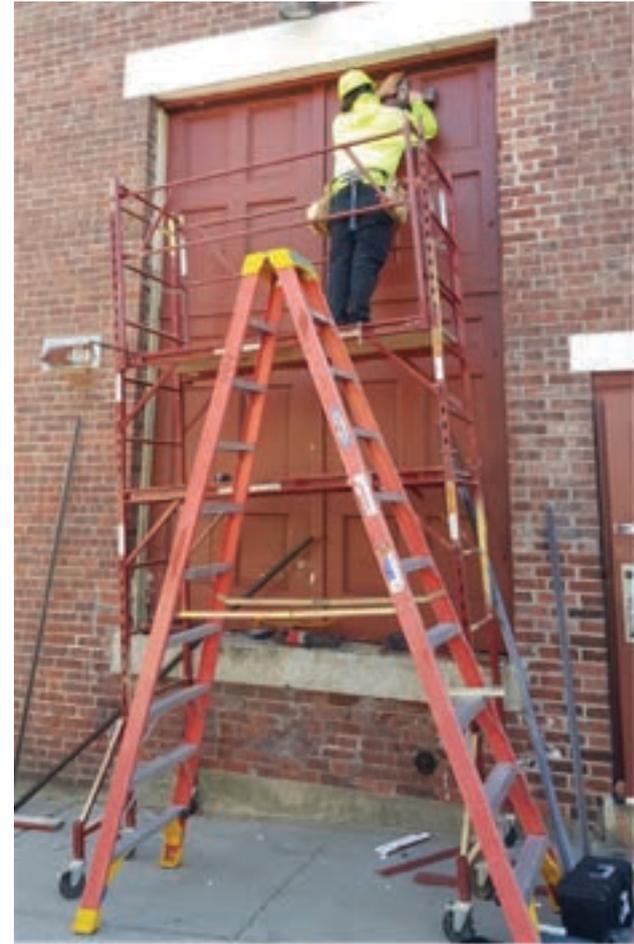
- **Masonry repair**
- **Wood trim replacement**
- **Q-Lon door gaskets**
- **Fin-seal astragals and sweeps**
- **Safety officer for pedestrians and workers**
- **Lotta time and money**
- **Leakage reduction is huge**

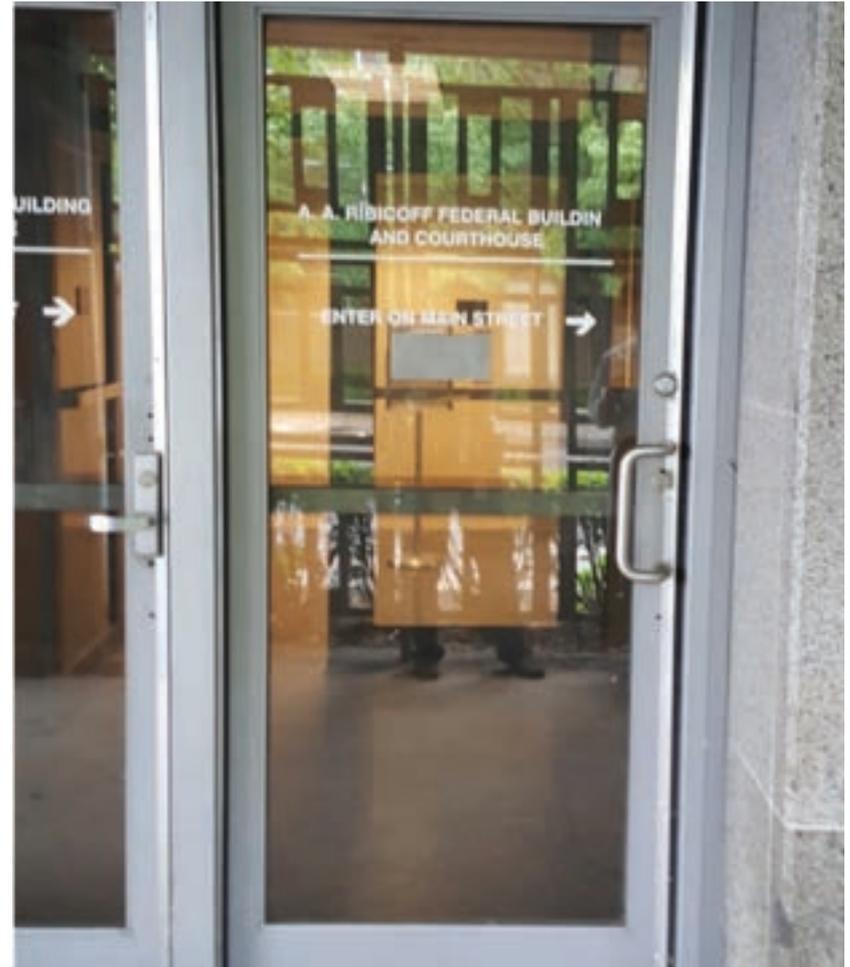
- **Change “fuzz” wherever possible**
- **Sweeps top and bottom**
- **Astragals along sides of doors**
- **A careful install will really reduce the hole size**
