Deep Energy Retrofits of Existing Single Family Homes

Betsy Pettit, FAIA
Building Science Corporation
www.buildingscience.com

National Building Museum
Washington, DC September 10, 2009

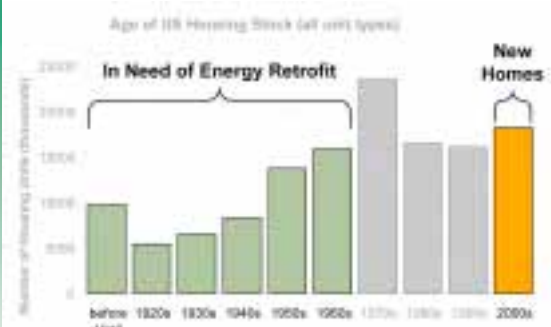
Age of US Housing Stock (all unit types)

60 million pre 1970 in need of upgrading

In Need of Energy Retrofit

New Homes

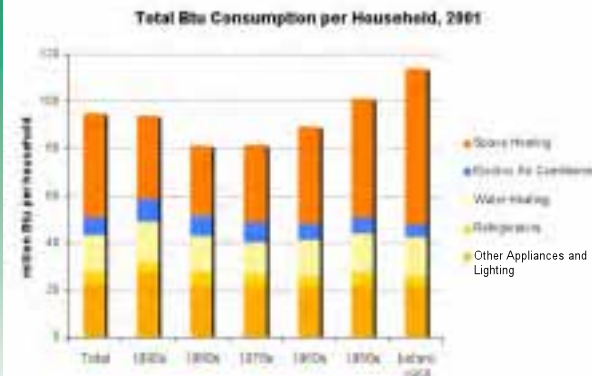
Total Btu Consumption per Household, 2001

- Space Heating
- Electric Air Conditioning
- Water Heating
- Refrigeration
- Other Appliances and Lighting

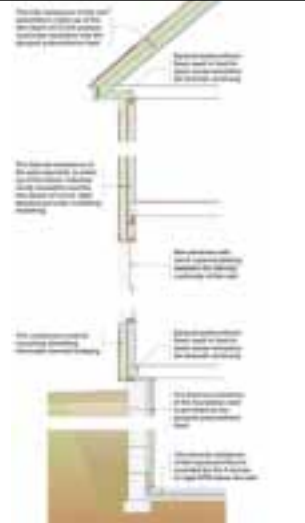
Thermal Control Layer

Must be consistent around all six sides of the cube

This diagram illustrates a cross-section of a wall and roof assembly. It shows various layers including insulation, sheathing, and structural elements. Labels point to specific components, such as the exterior insulation, sheathing, and the thermal control layer. The diagram emphasizes the importance of maintaining a consistent thermal control layer around all six sides of the building's envelope.

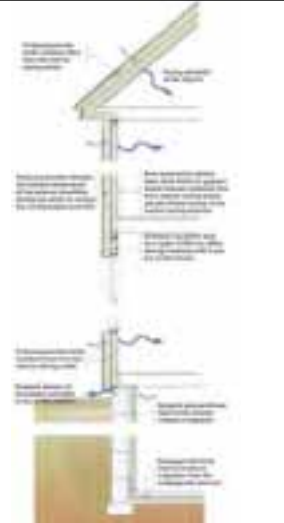
Vapor Control Layer

Make sure that no water in the vapor form gets trapped in assemblies, such that it gets cold enough to condense, turning to liquid water. When this happens things rot, corrode, and environments that are conducive to mold growth are created.

This diagram illustrates a cross-section of a wall and roof assembly, focusing on the vapor control layer. It shows the path of water vapor through the building envelope. Labels indicate the vapor control layer and the potential for condensation if it is not properly installed. The diagram explains that trapped water vapor can condense into liquid water, leading to rot, corrosion, and mold growth.

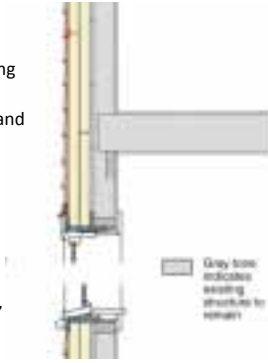
Typical Wall Section

- 4" Cellulose in Walls (R-14)
- 2" – 4" Foil-Faced Polyiso Insulating Sheathing (R-13 to R-26)
 - Joints staggered horizontally and vertically
 - All joints taped and sealed
- Wood furring strips, vinyl siding

- U = 0.31, SHGC = 0.32
- Double pane, vinyl-framed, low-e, argon fill

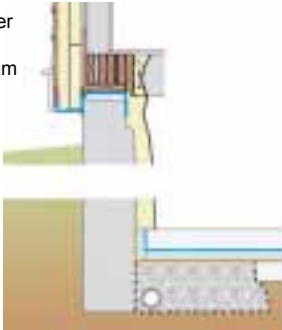
Basement Wall Section

- Capillary Break installed under new sill beam
- 2"-3" High Density Spray Foam (~R13 – R19.5) applied to Rubble Stone Foundation
- Intumescent Paint fire protection for spray foam
- R-10 XPS under New Slab

Perimeter Drain

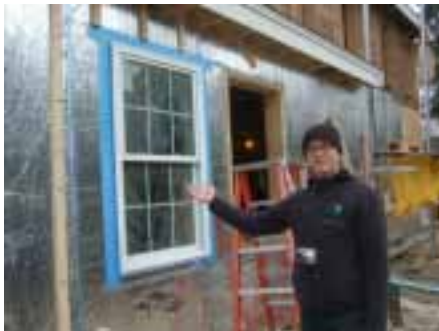
- Window installation

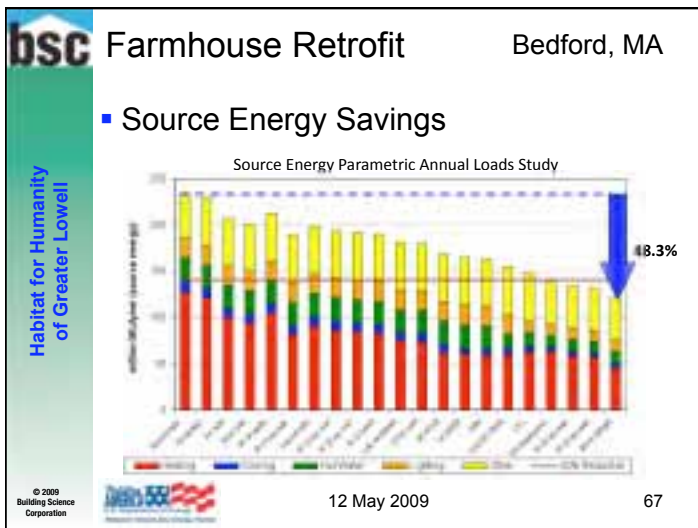
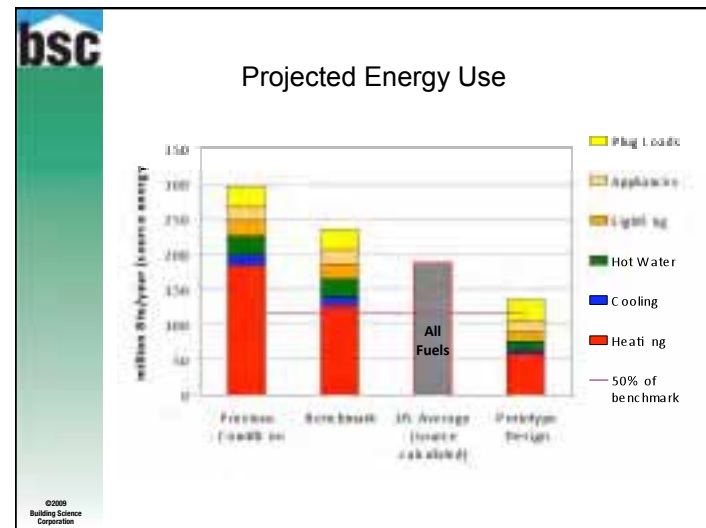
- Mechanical Details
 - 93% AFUE Furnace
 - Ducts in Conditioned Space
 - Ducts Sealed Exceptionally Tight
 - Instantaneous Hot Water Heater EF = 0.82
 - Energy Star Appliances
 - Full CFL Package
